Canterbury 2021 Flood Recovery Update 3

Ken Tarboton (Aqueus Consulting)
Shaun McCracken (Environment Canterbury)

31 March 2022

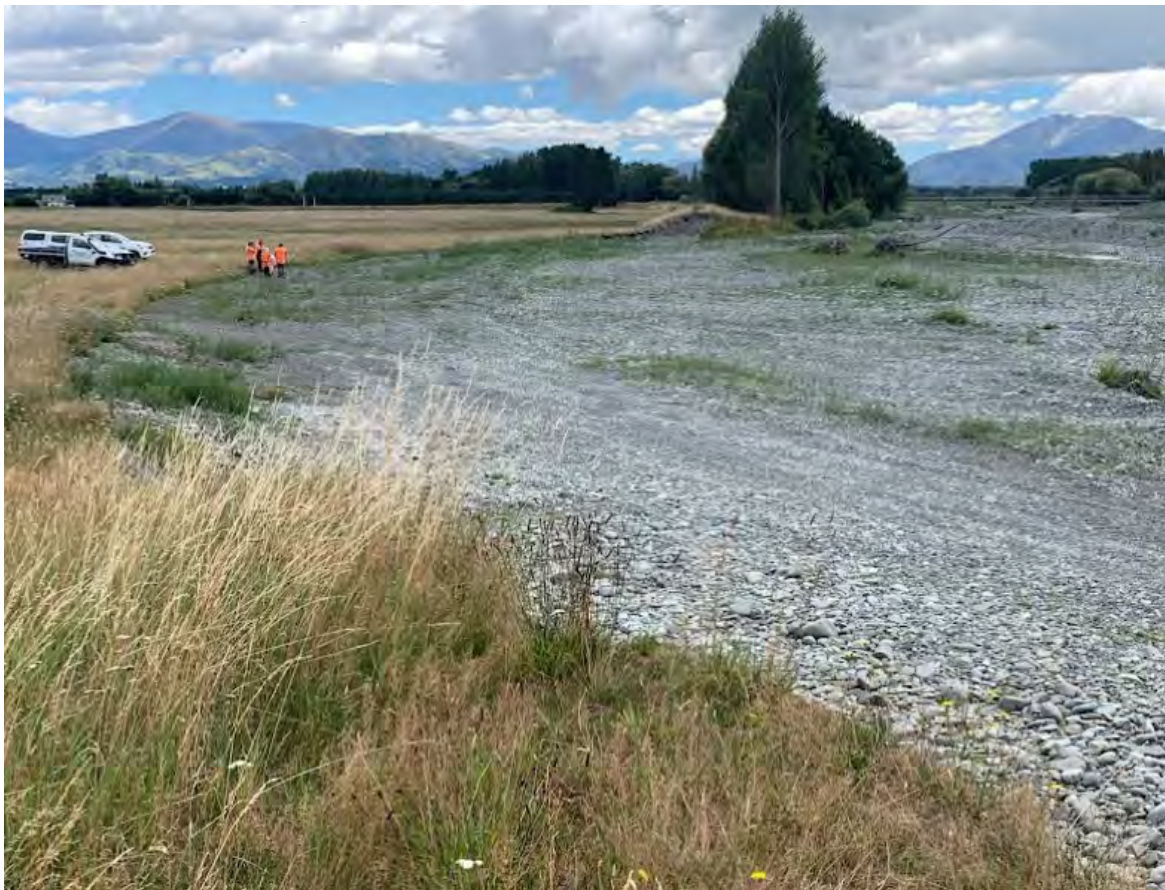
Figure 8-21: Orari at SH79: (a) following temporary bunding work prior to stopbank repairs. 27/1/2022.

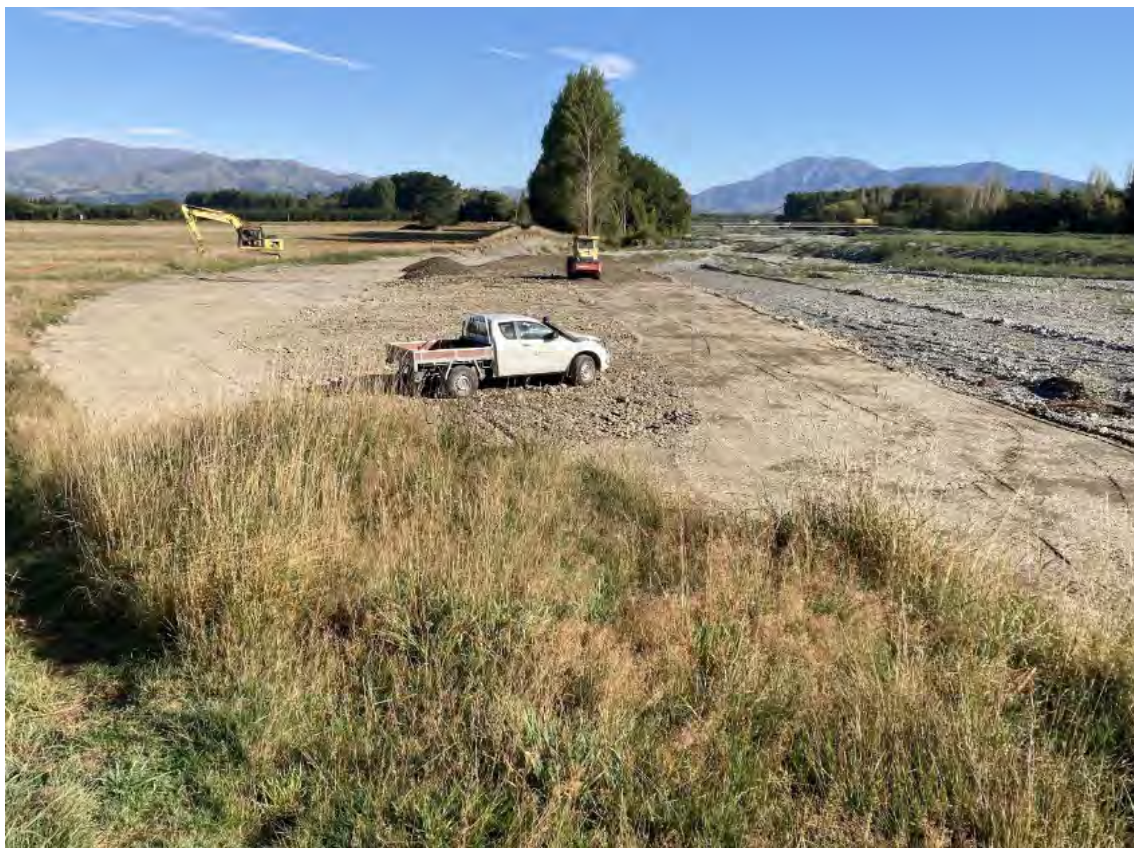
Figure 8-22: Orari at SH7 during stopbank repairs. 17/2/2022.

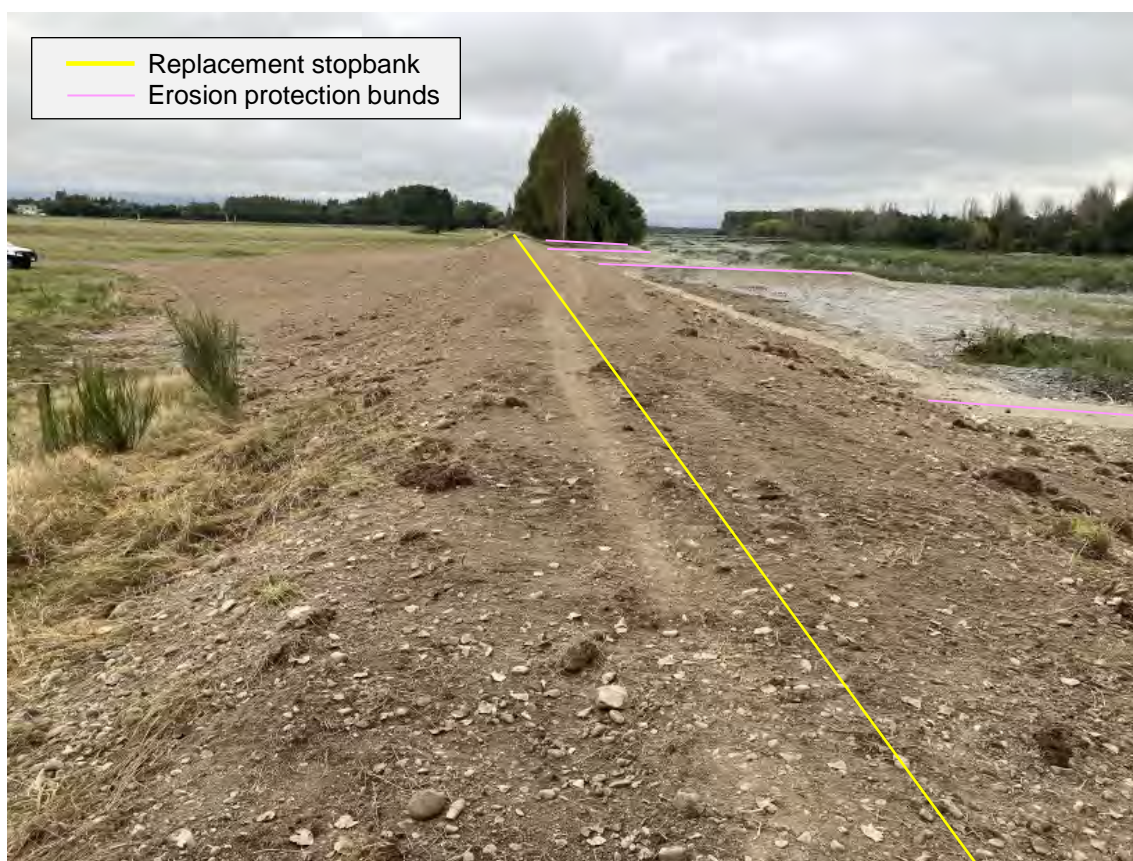
Figure 8-23: Orari at SH7 completed stopbank repairs. 18/3/2022.

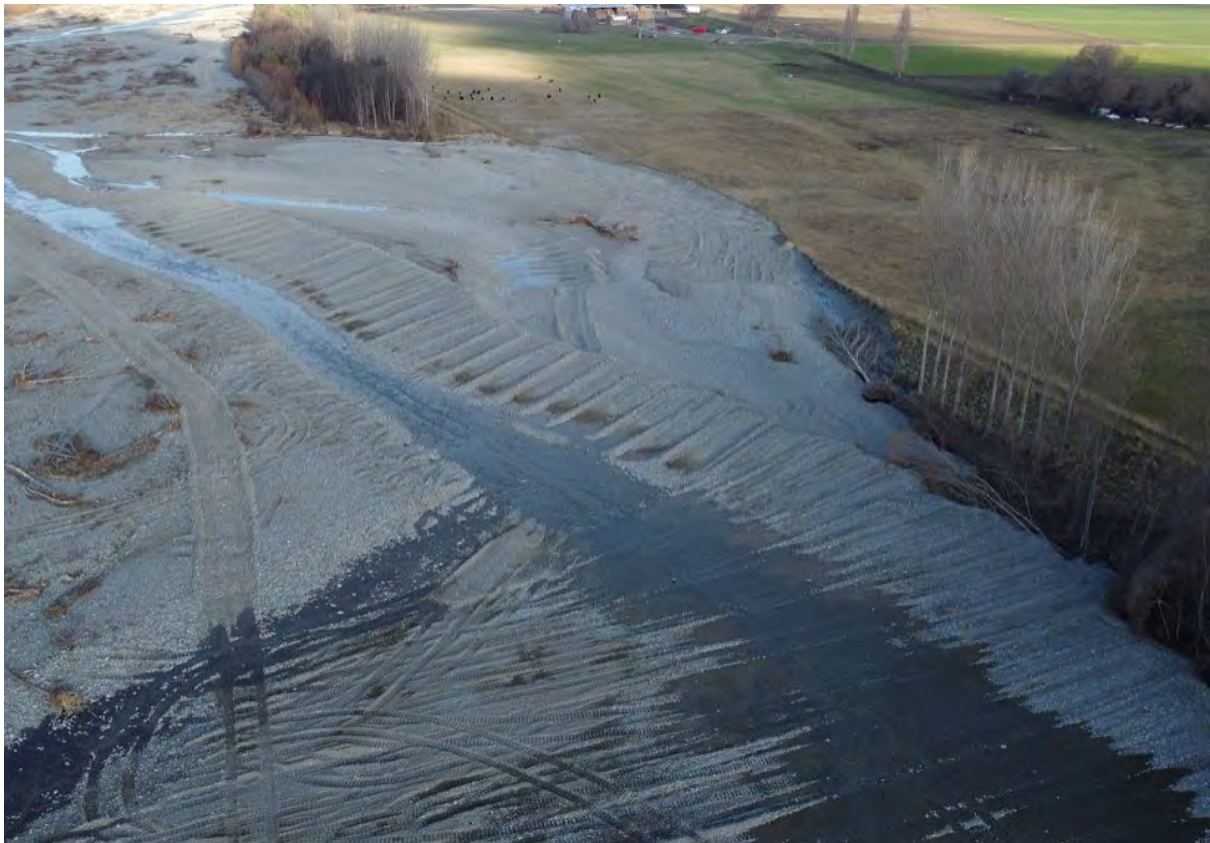
Figure 8-24: Orari at SH7 following completion of temporary repairs 5/8/2021.

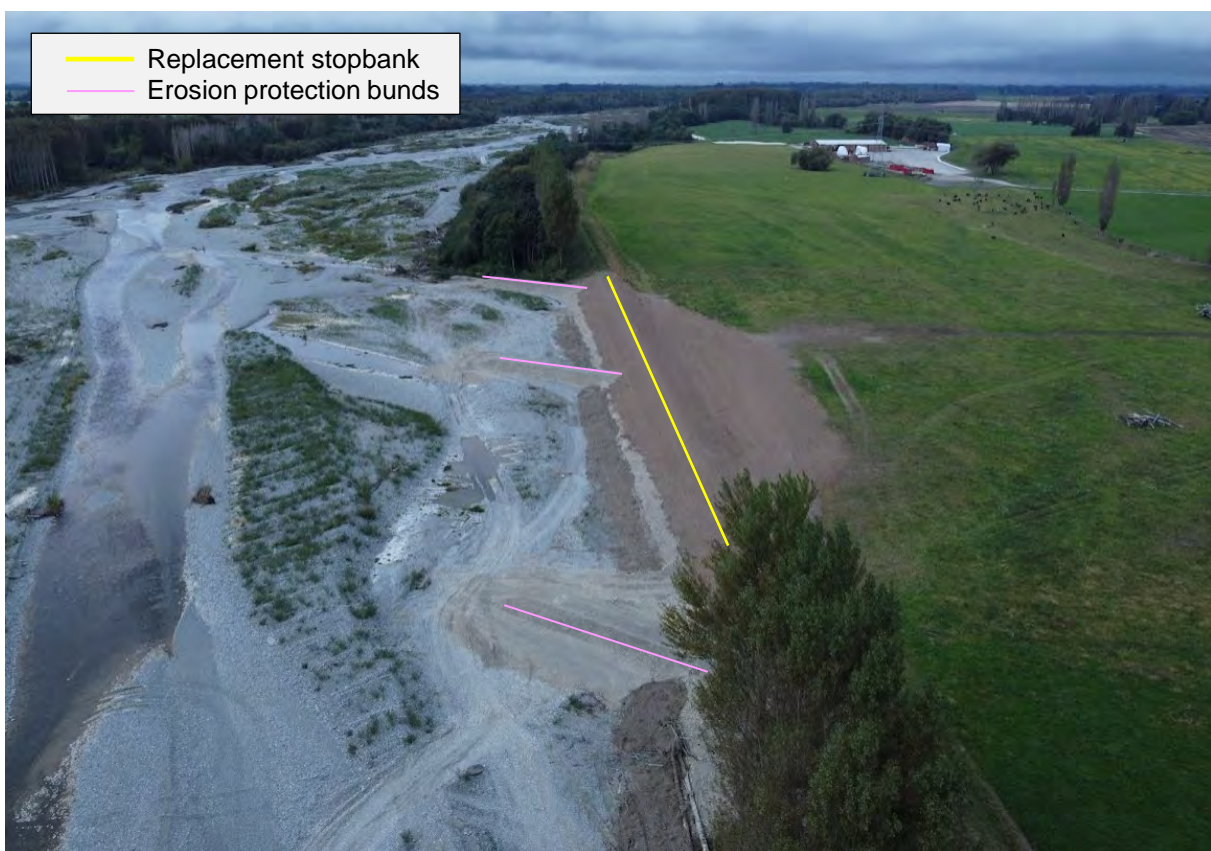
Figure 8-25: Orari at SH7 following completion of stopbank and erosion protection bund works 16/3/2022.

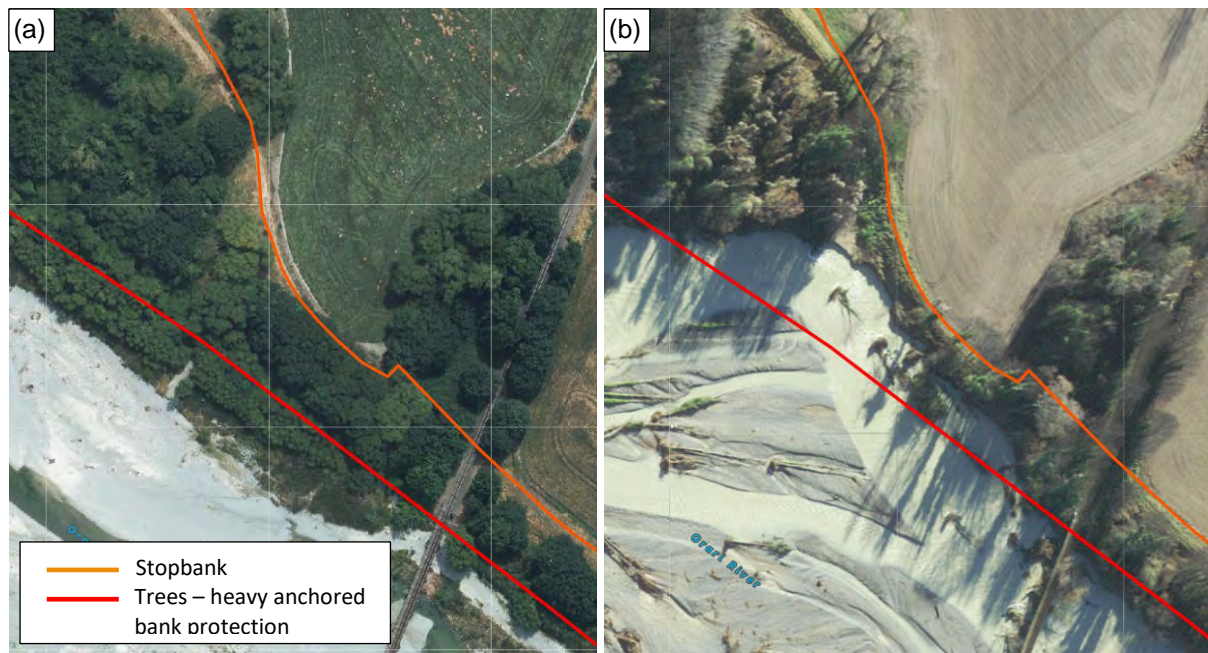
Figure 8-26: Orari at the railway bridge: (a) Aerial view prior to flood, (b) post-flood aerial showing extend of tree edge protection asset loss and stopbank damage.

Stopbank repairs on the Orari at the railway bridge have been undertaken by KiwiRail, to protect their bridge. Erosion protection bunds and anchored tree protection will still be required upstream of these works as a first step towards re-establishing the lost tree edge protection.

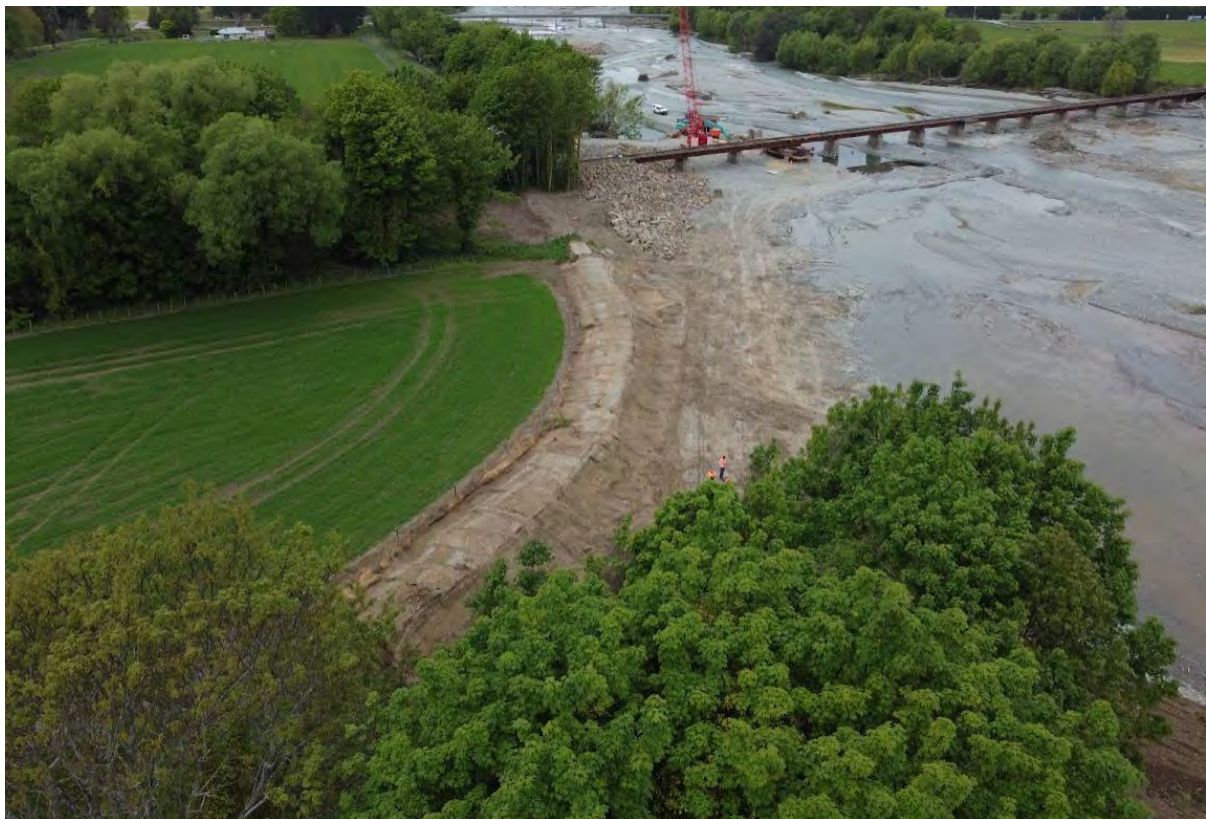
Figure 8-27: Orari at the railway bridge stopbank repair prior to adding or riprap rock protection. October 2021.

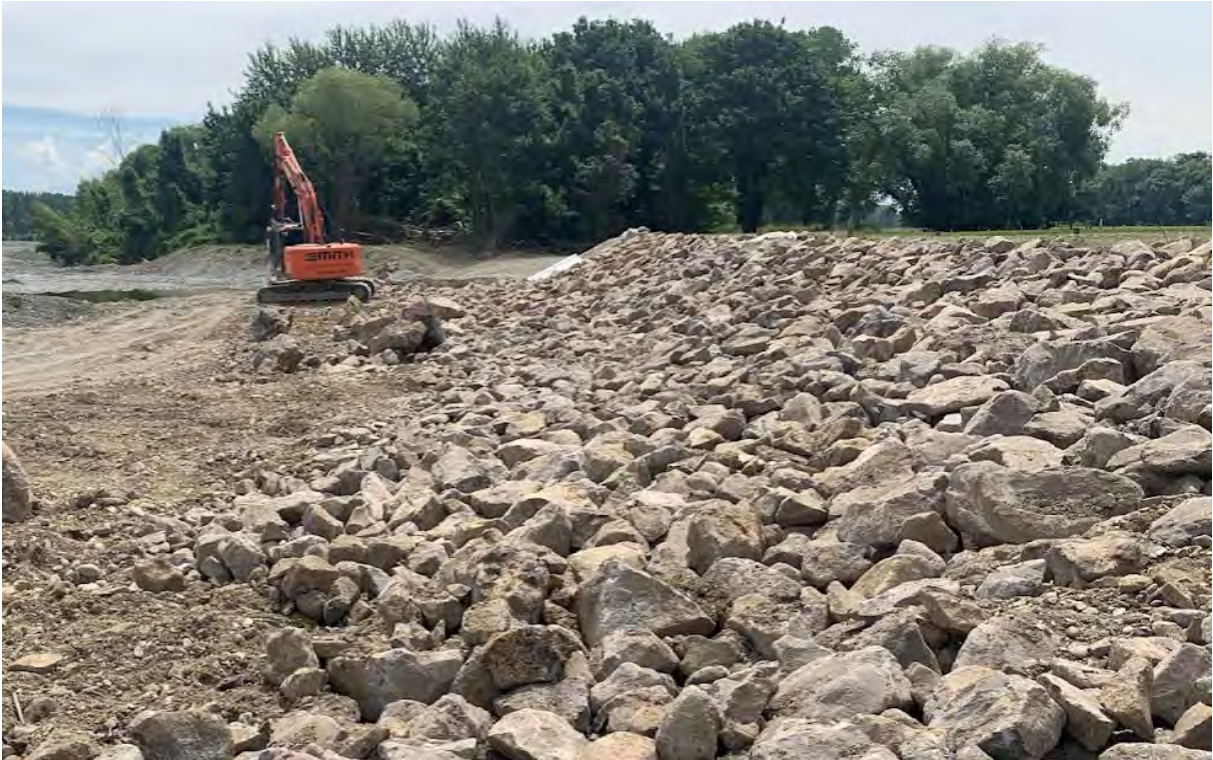
Figure 8-28: Orari at the railway bridge stopbank repair addition of rock riprap protection. November 2021.

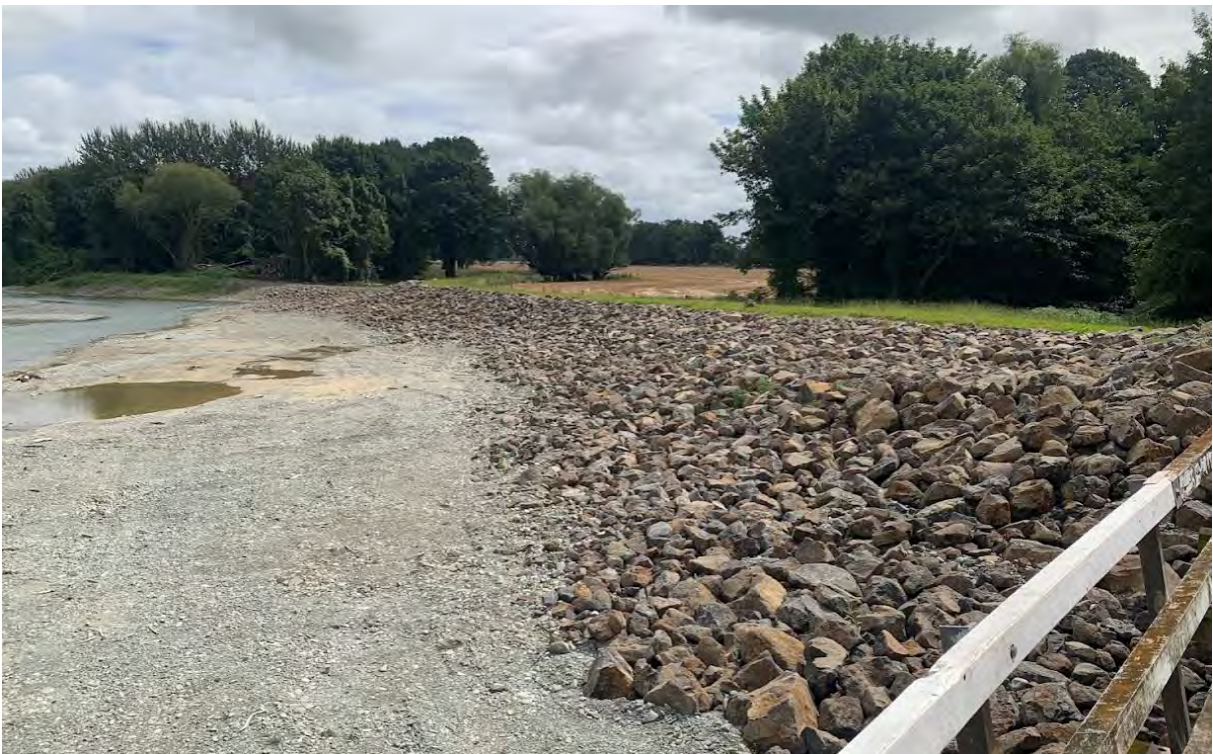
Figure 8-29: Orari at the railway bridge completed stopbank with rock protection. February 2022

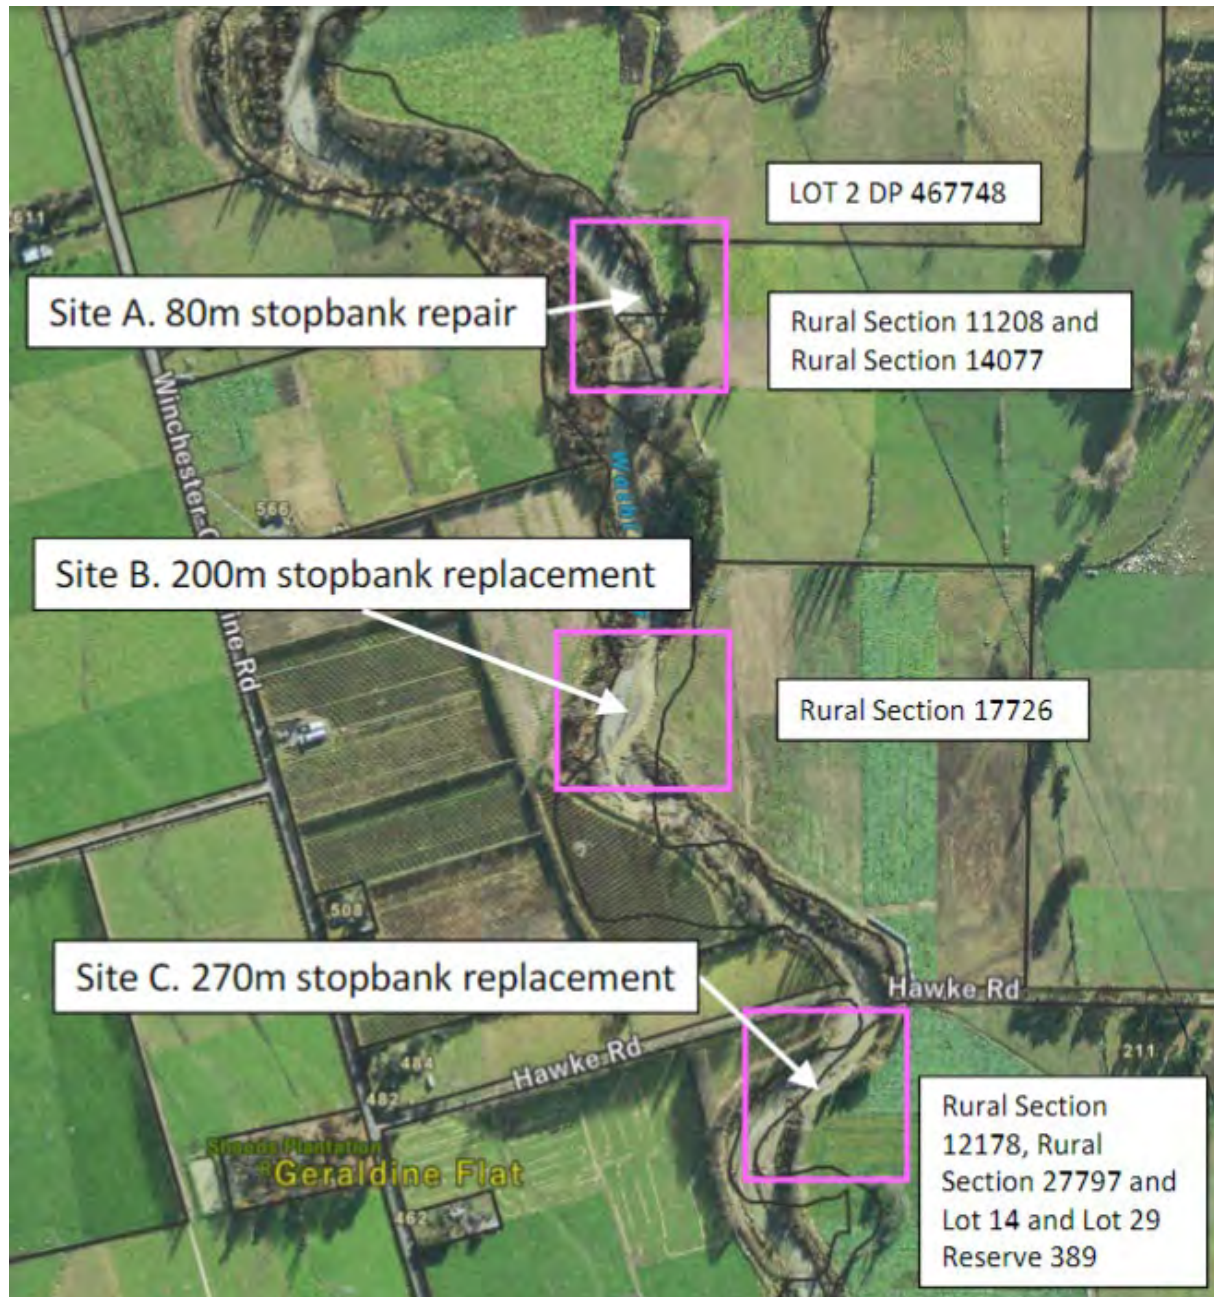
Figure 8-30: Waihi at Hawke Rd, location of three sites at which stopbank and tree edge protection assets have been lost.

Repairs were required at three sites to reinstate a total of 550m of stopbank and 880m of tree edge protection. Stopbank repairs have been completed including erosion protection bunds at the most upstream site as a first step towards re-establishing tree edge protection. Installation of anchored tree protection at the upstream site and infill tree pole planting at all three sites is due to commence in winter 2022.

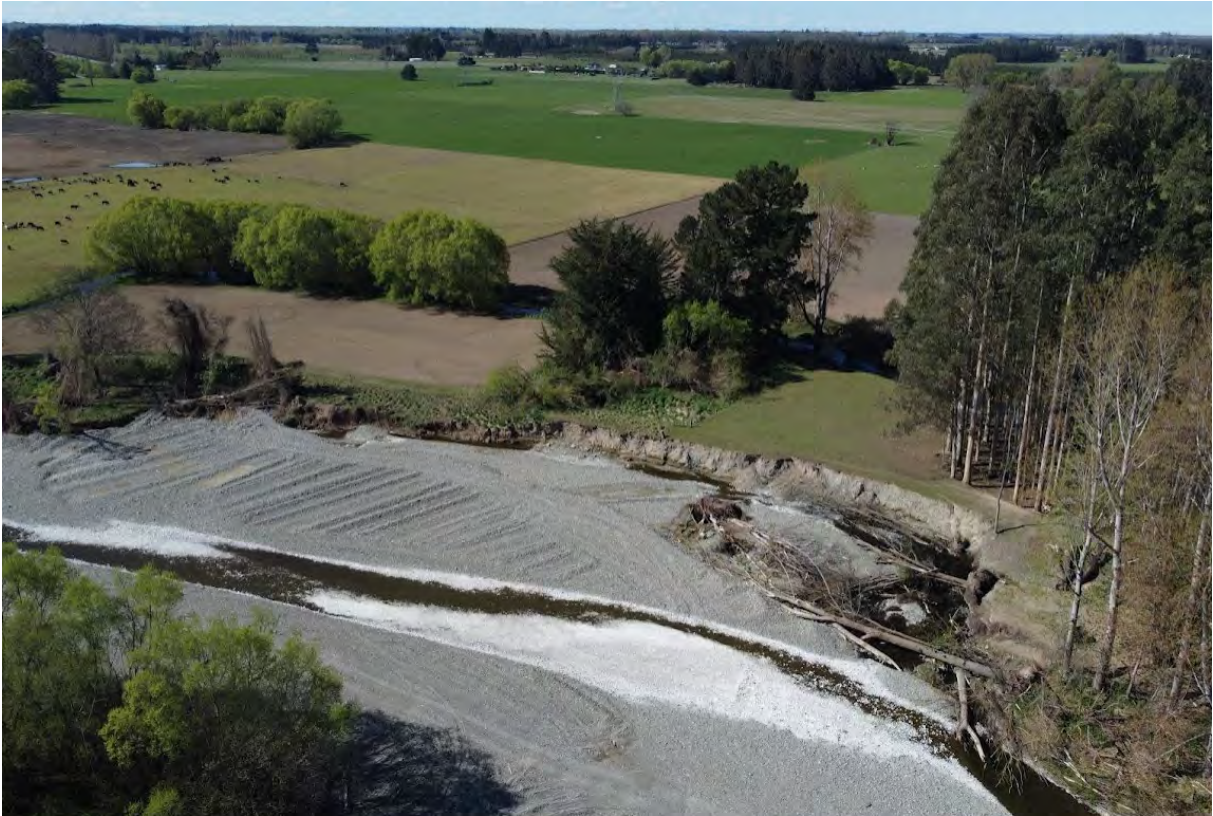
Figure 8-31: Waihi at Hawke Rd Site A, following temporary bund work prior to permanent repairs, 28/9/2021.

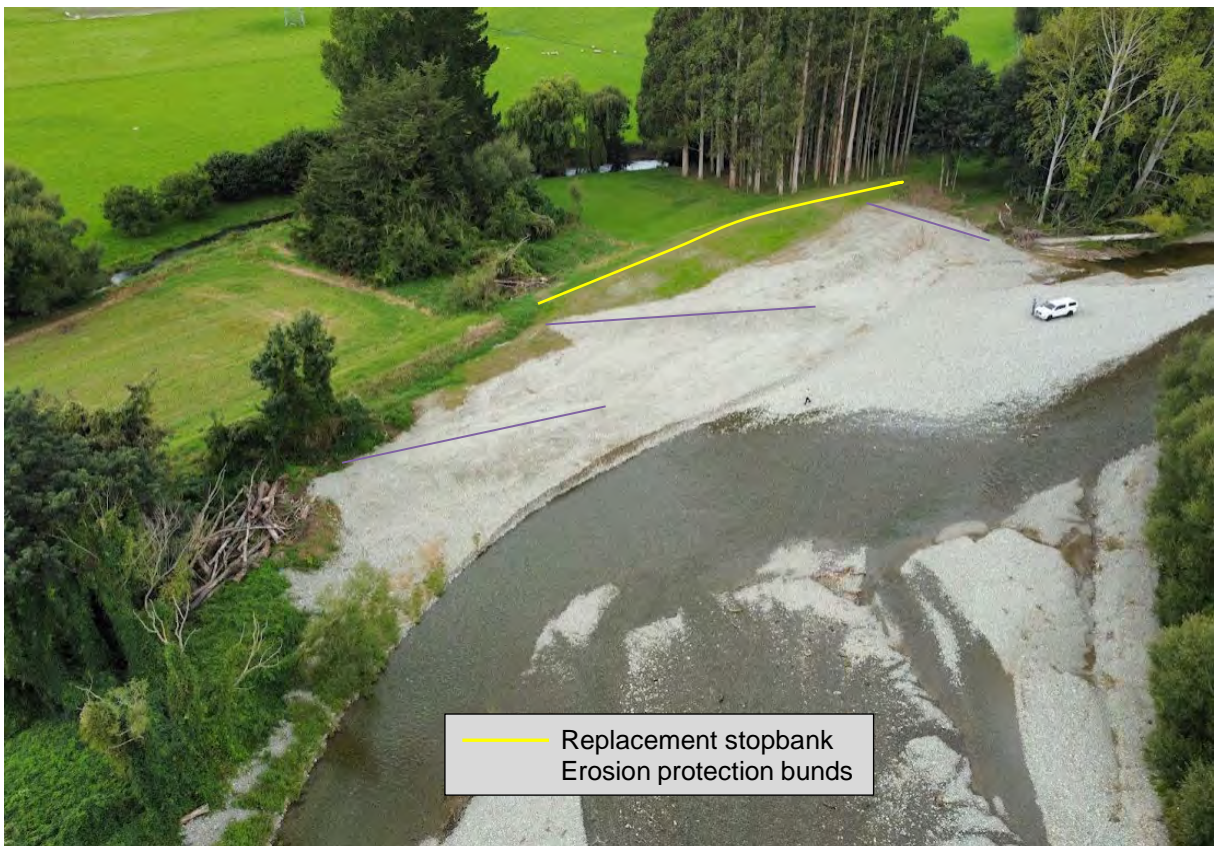
Figure 8-32: Waihi at Hawke Rd Site A following completion of stopbank repairs and installation of erosion protection bunds 23/2/2022

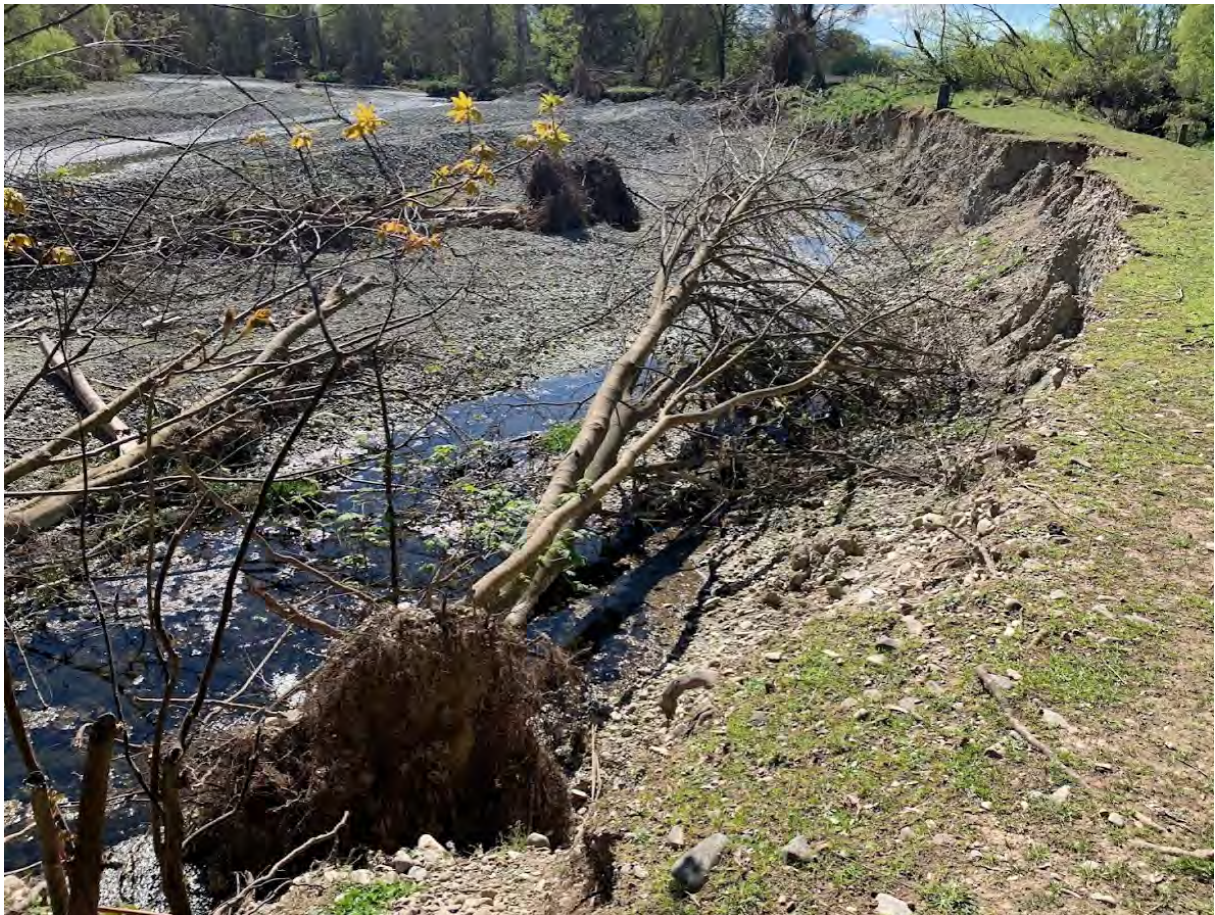
Figure 8-33: Waihi at Hawke Rd Site A, showing flood damage to stopbank 28/9/2021.

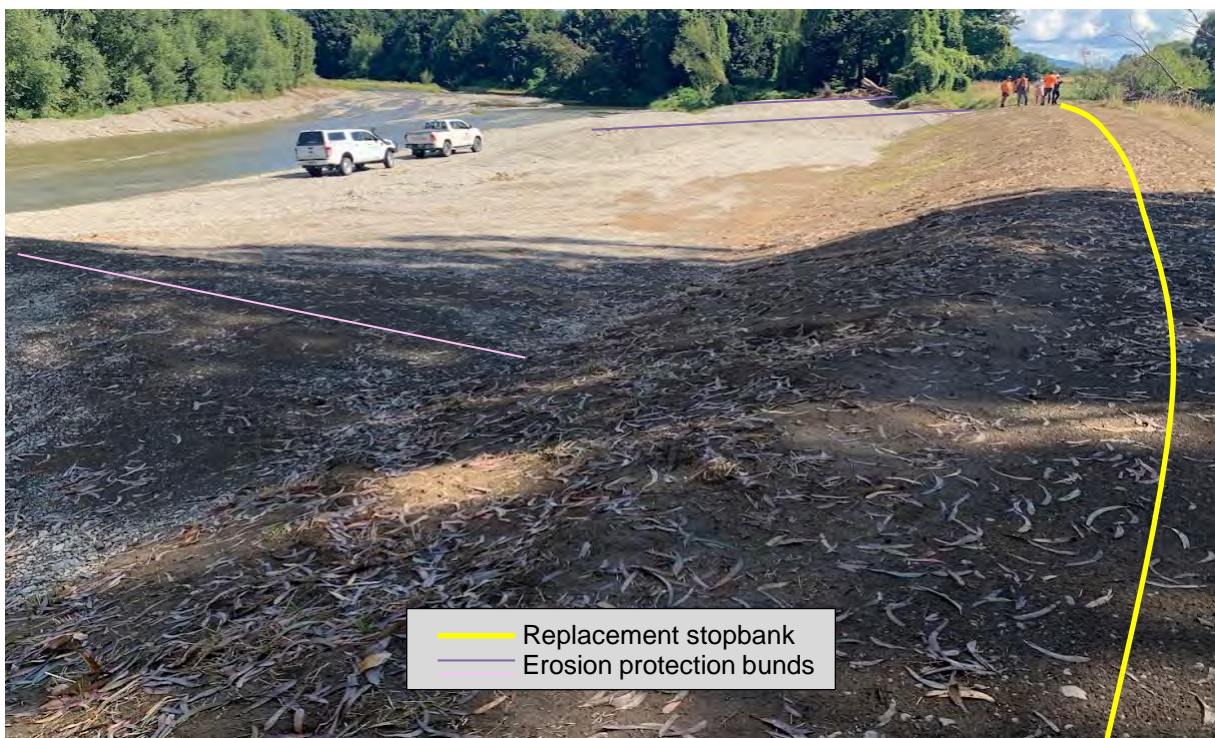
Figure 8-34: Waihi at Hawke Rd Site A, showing completed stopbank repairs and erosion protection bunds

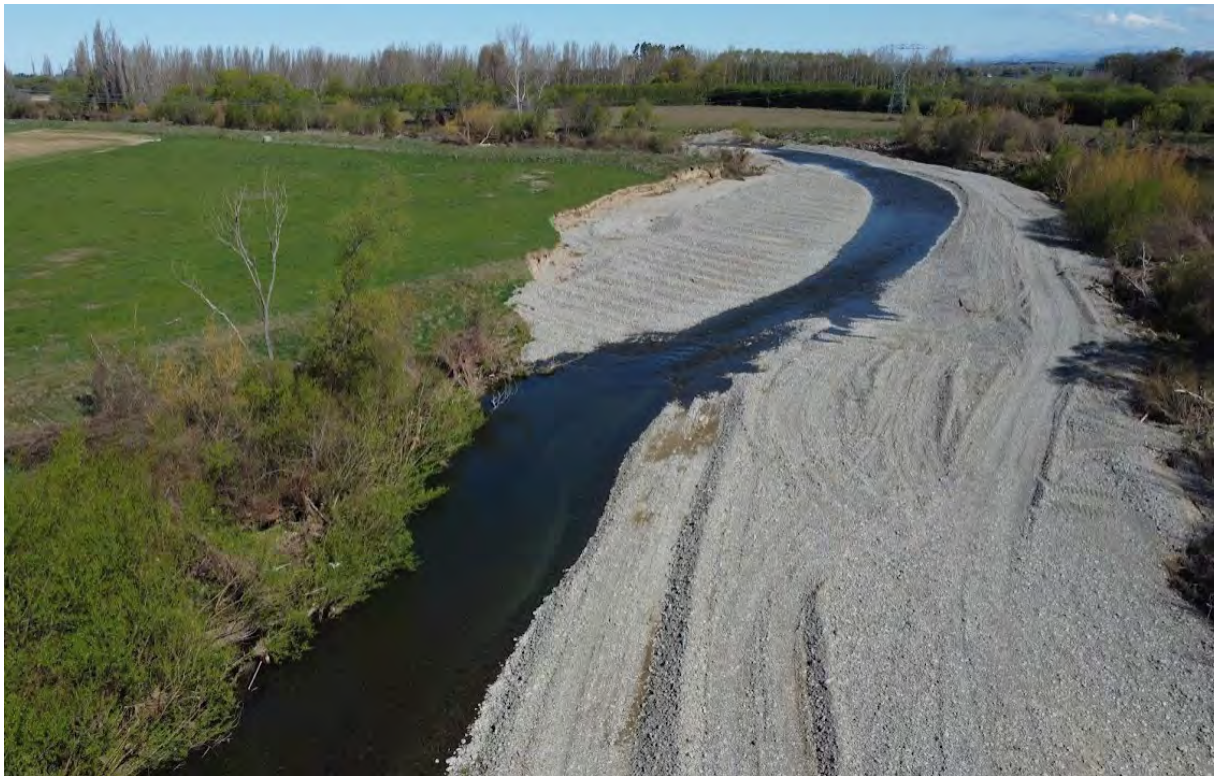
Figure 8-35: Waihi at Hawke Rd Site B looking downstream showing temporary bund work prior to permanent repairs, 28/9/2021.

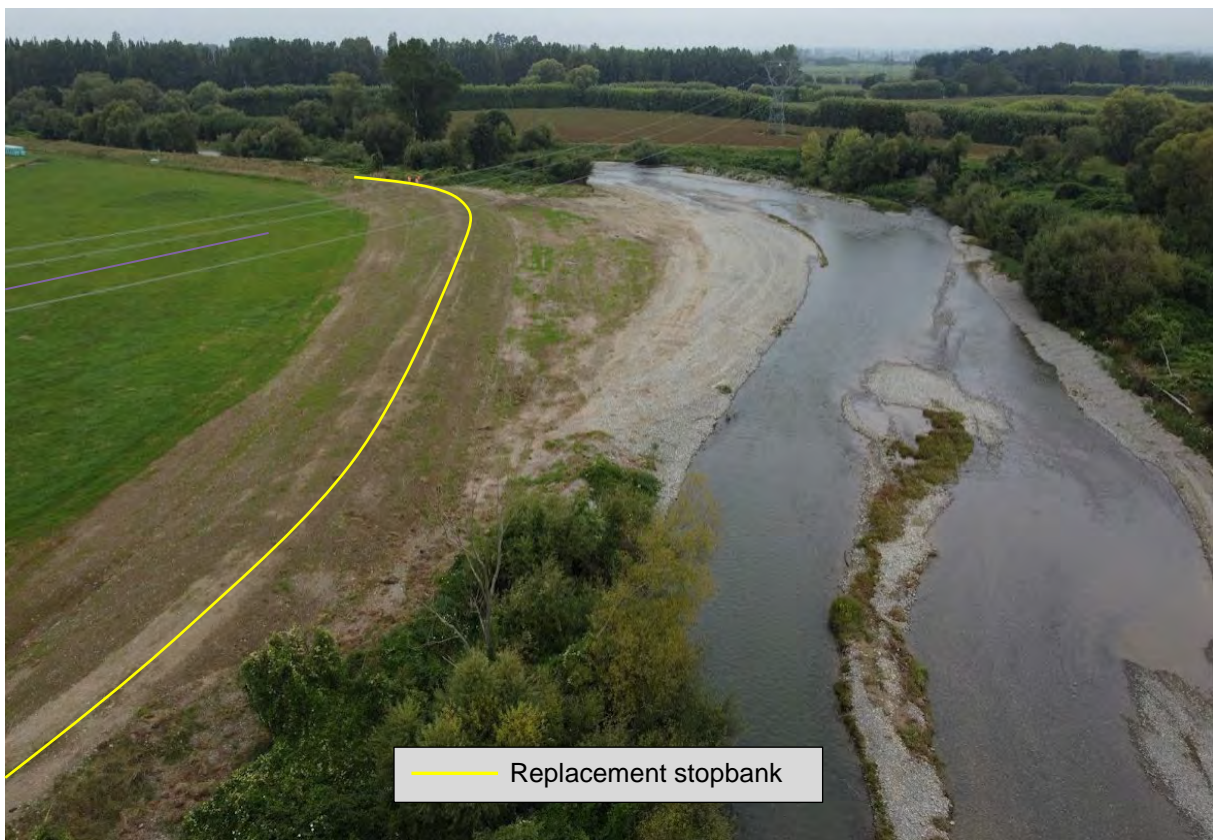
Figure 8-36: Waihi at Hawke Rd Site A, showing completed stopbank repairs and erosion protection bunds, 9/2/2022.

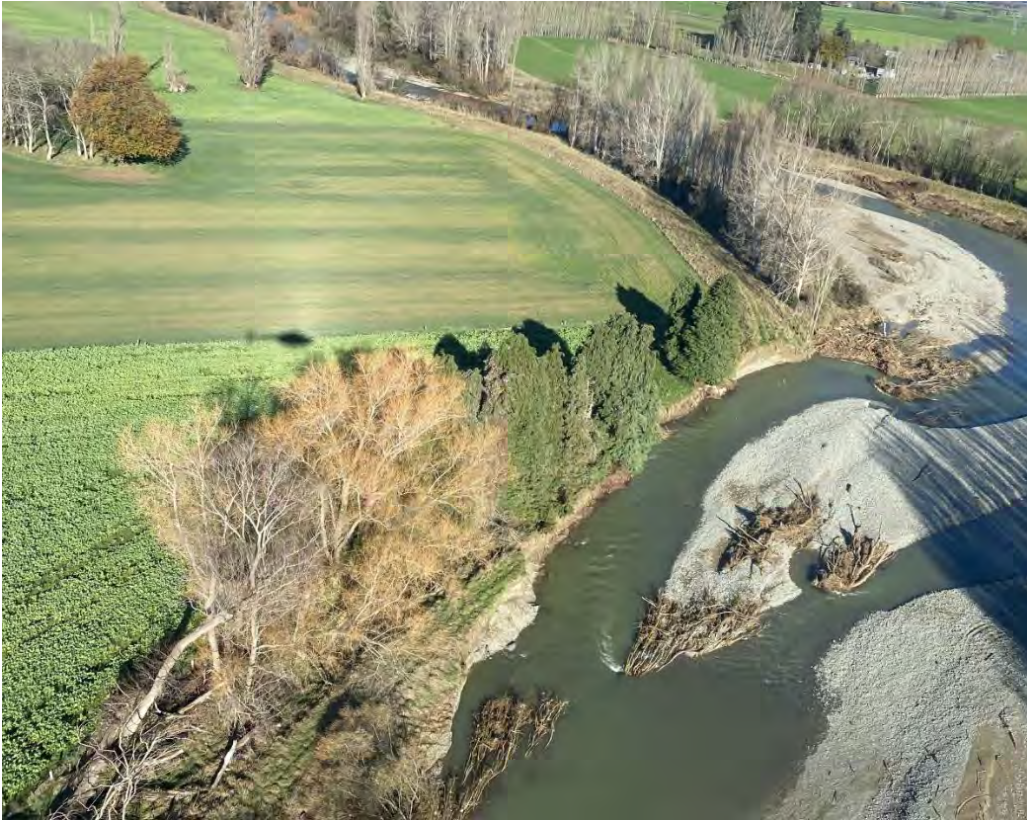
Figure 8-37: Waihi at Hawke Rd Site C looking downstream showing loss of stopbank and tree edge protection, June 2021.

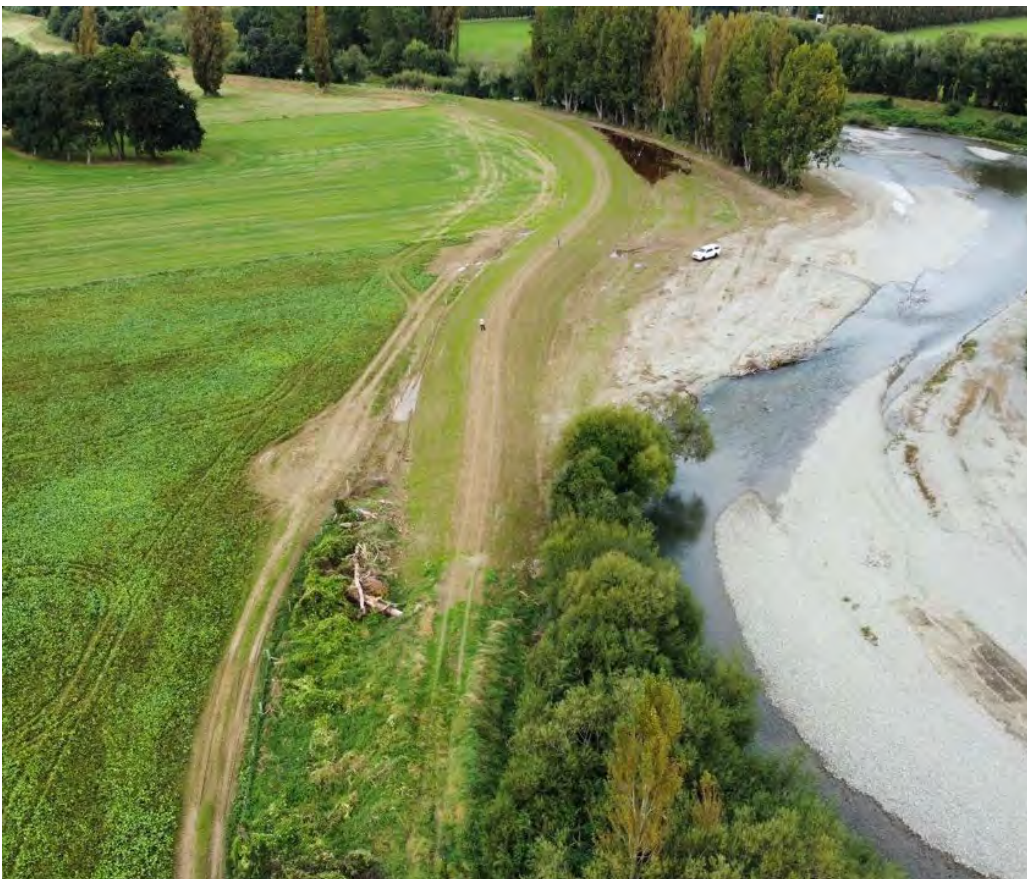
Figure 8-38: Waihi at Hawke Rd Site C looking downstream following completion of stopbank repairs, 23/2/2022.

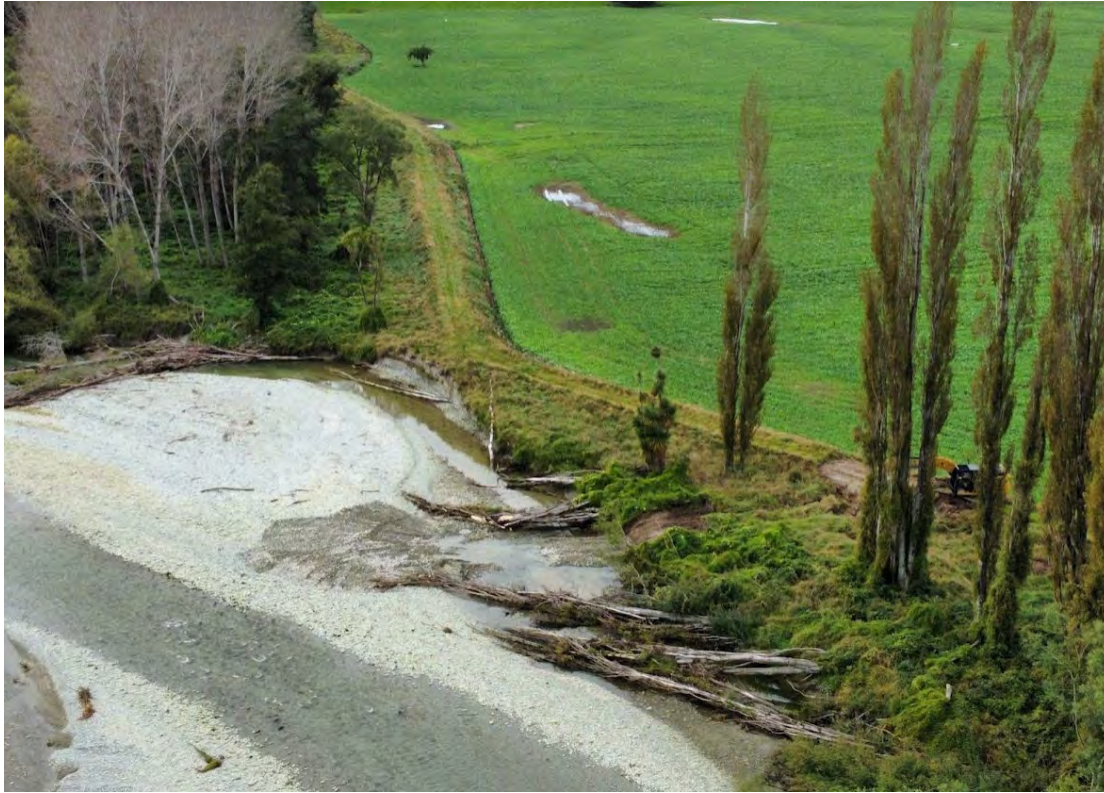
Tree edge protection was washed out and the existing stopbank partially damaged. The most cost effective repair was to relocate 120m of the stopbank inland, making more room for the river and to enable the reinstatement of 150m of tree edge protection.

Figure 8-39: Opihi at Collett Rd prior to stopbank repairs, 23/2/22.

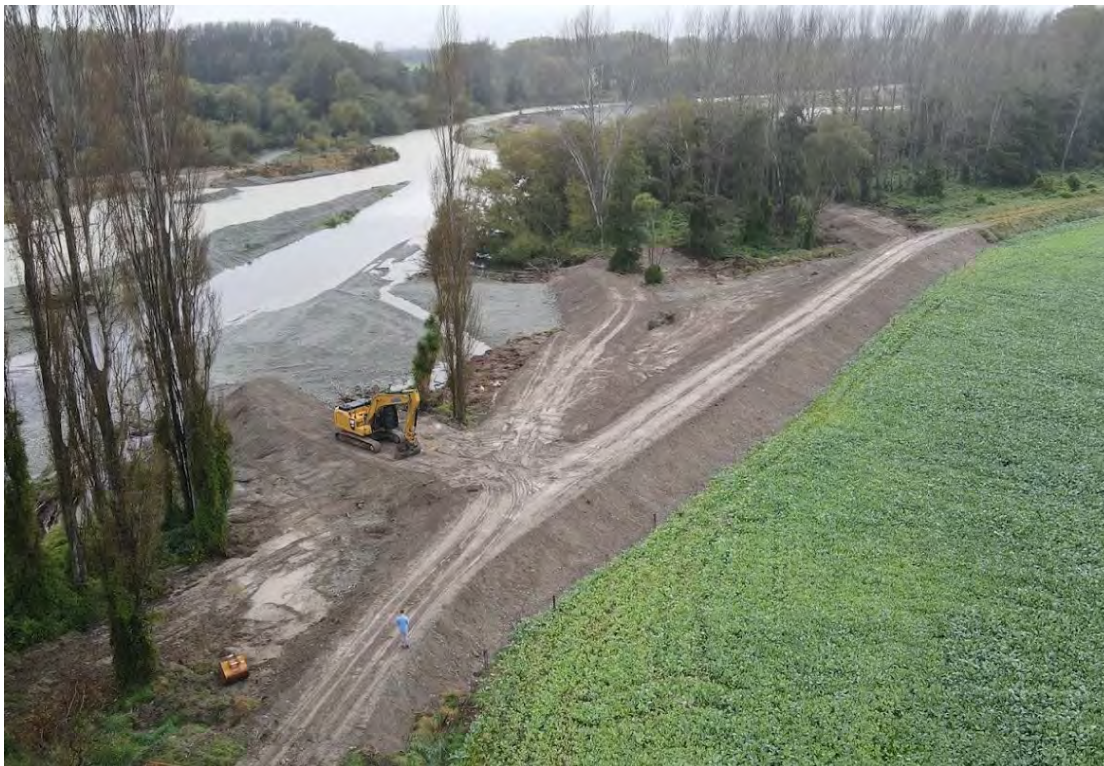
Figure 8-40: Opihi at Collett Rd, following completion of stopbank and erosion protection bund works 23/3/2022.

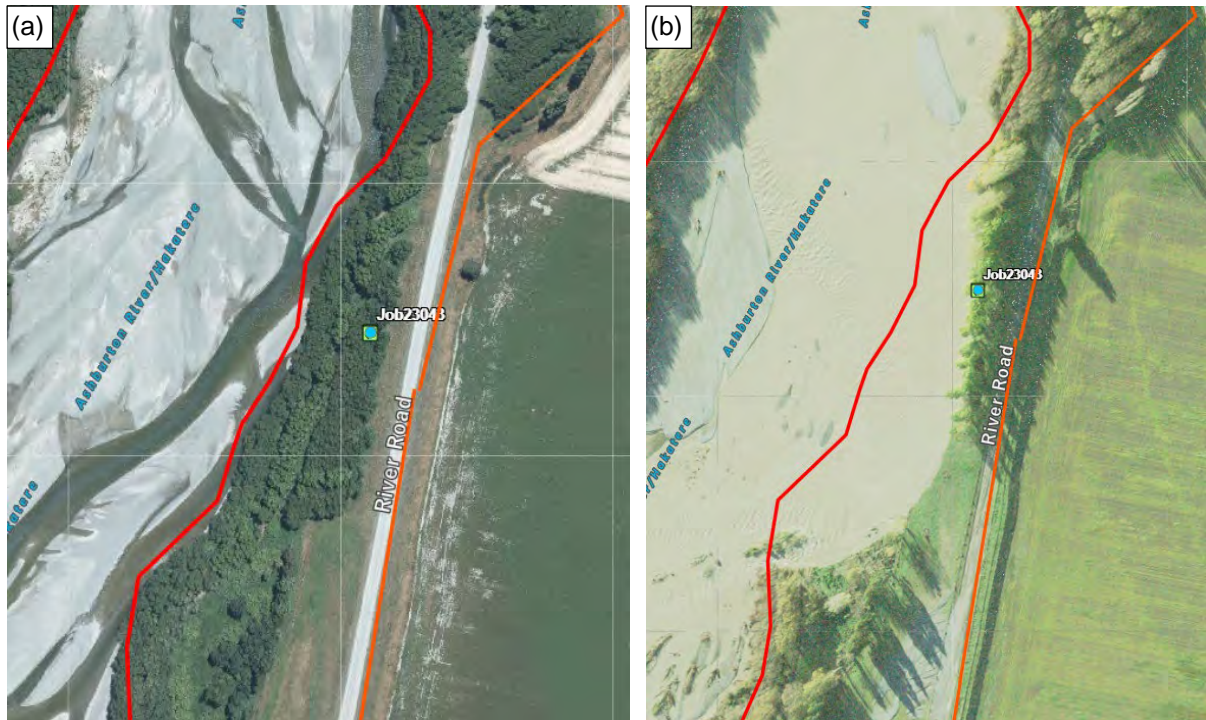
At this location 310m of tree edge protection were lost placing the stopbank and downstream dwellings at risk. Repairs have included temporary bunds followed up with greyiness and anchored tree protection to start to re-establish the tree edge protection.

Figure 9-1: Ashburton at River Rd: (a) Aerial view prior to flood, (b) post-flood aerial showing extend of tree edge protection asset loss and risk to stopbank.

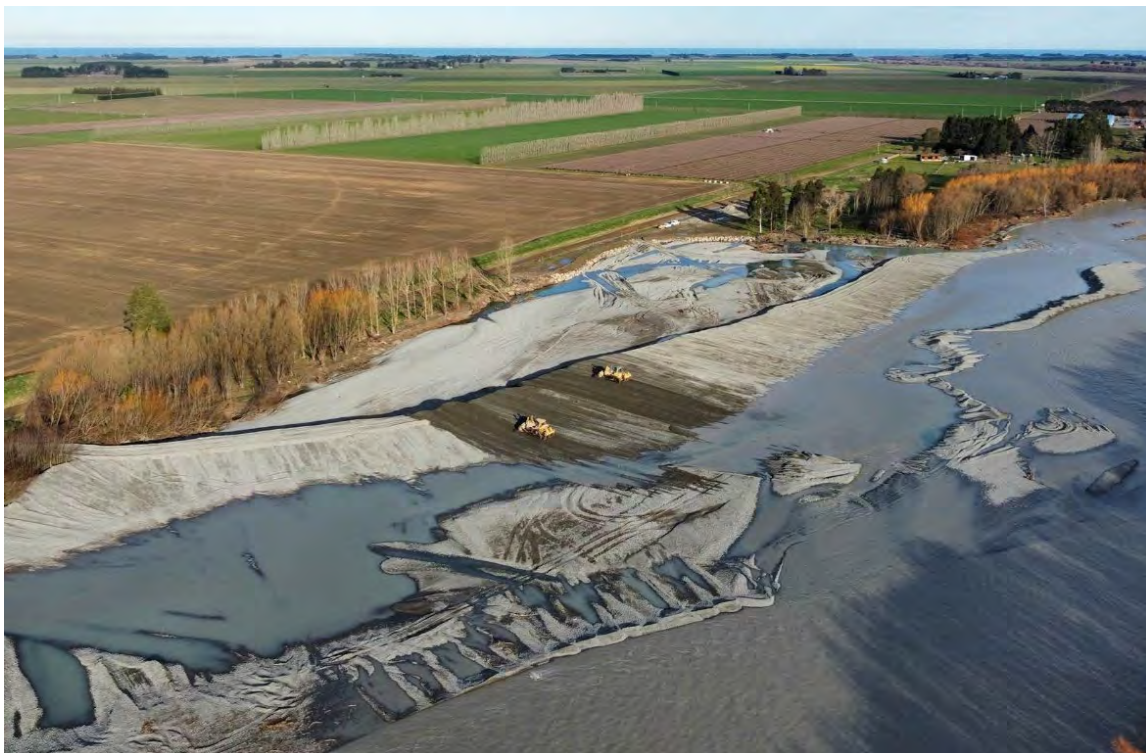
Figure 9-2: Ashburton at River Rd, initial temporary protection bunds, August 2021.
