Canterbury 2021 Flood Recovery Update 3

Ken Tarboton (Aqueus Consulting)
Shaun McCracken (Environment Canterbury)

31 March 2022

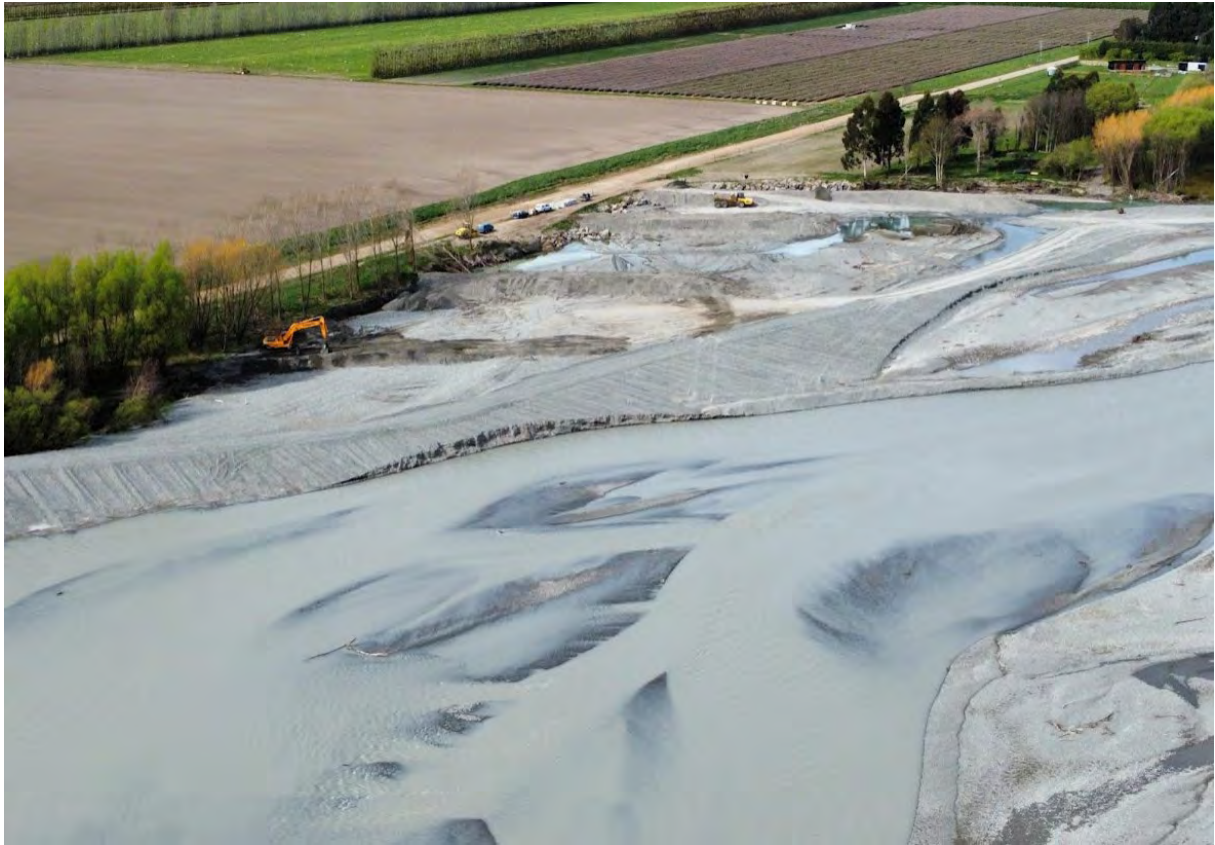
Figure 9-3: Ashburton at River Rd, erosion protection groynes under construction, 23/9/2021.

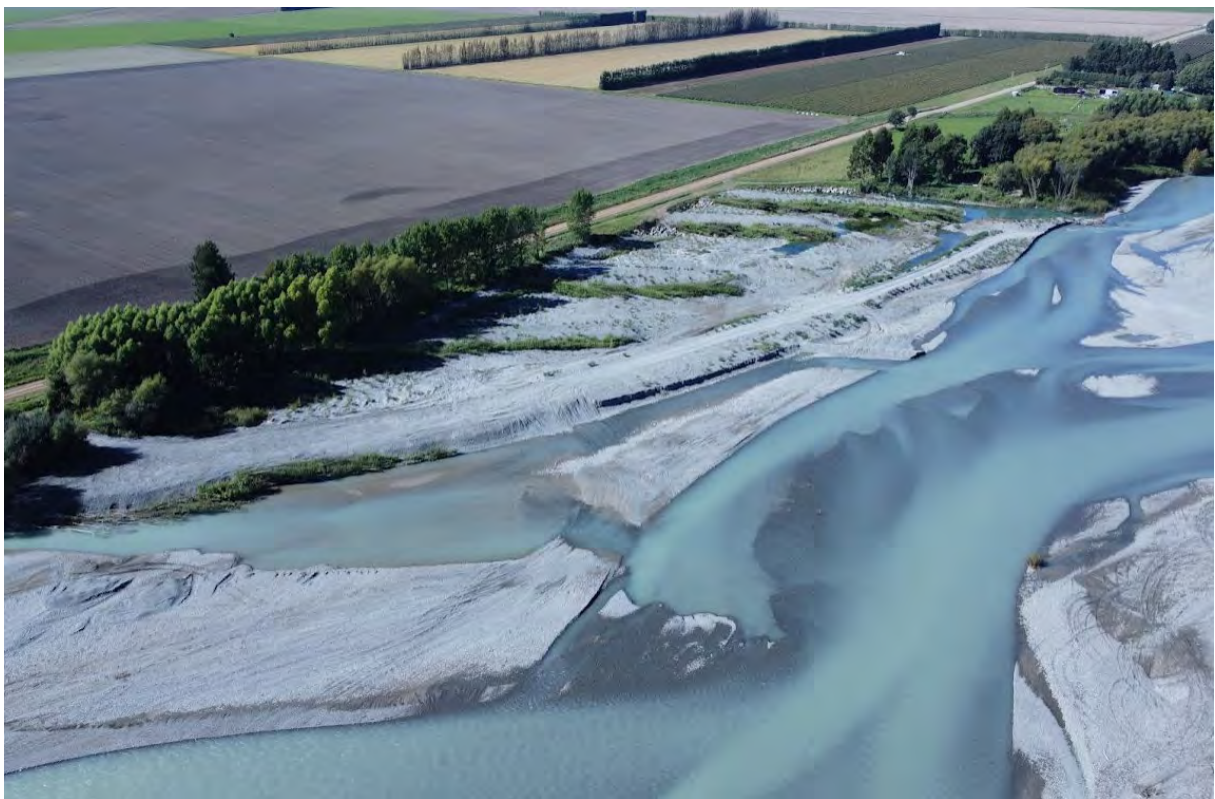
Figure 9-4: Ashburton at River Rd, completed groynes with ATP, 3/3/2022.

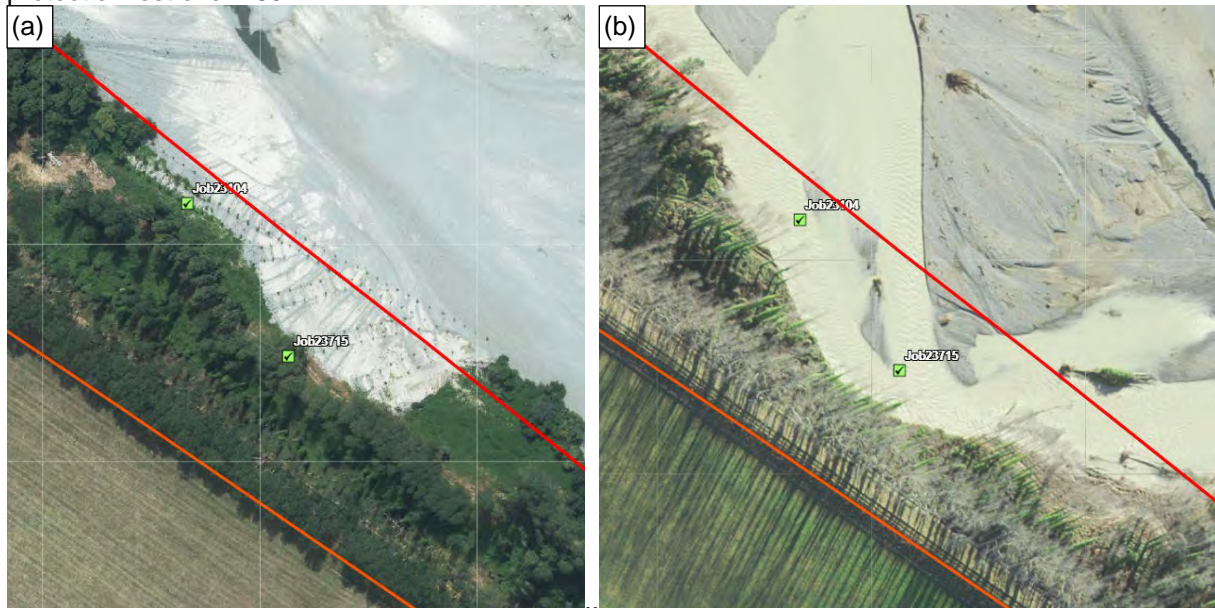
At this location temporary channel alignment was undertaken followed replacement of tree edge protection lost over 160m.

Figure 9-5: Orari at racecourse: (a) aerial view prior to flood, (b) post-flood aerial showing extend of tree edge protection lost.

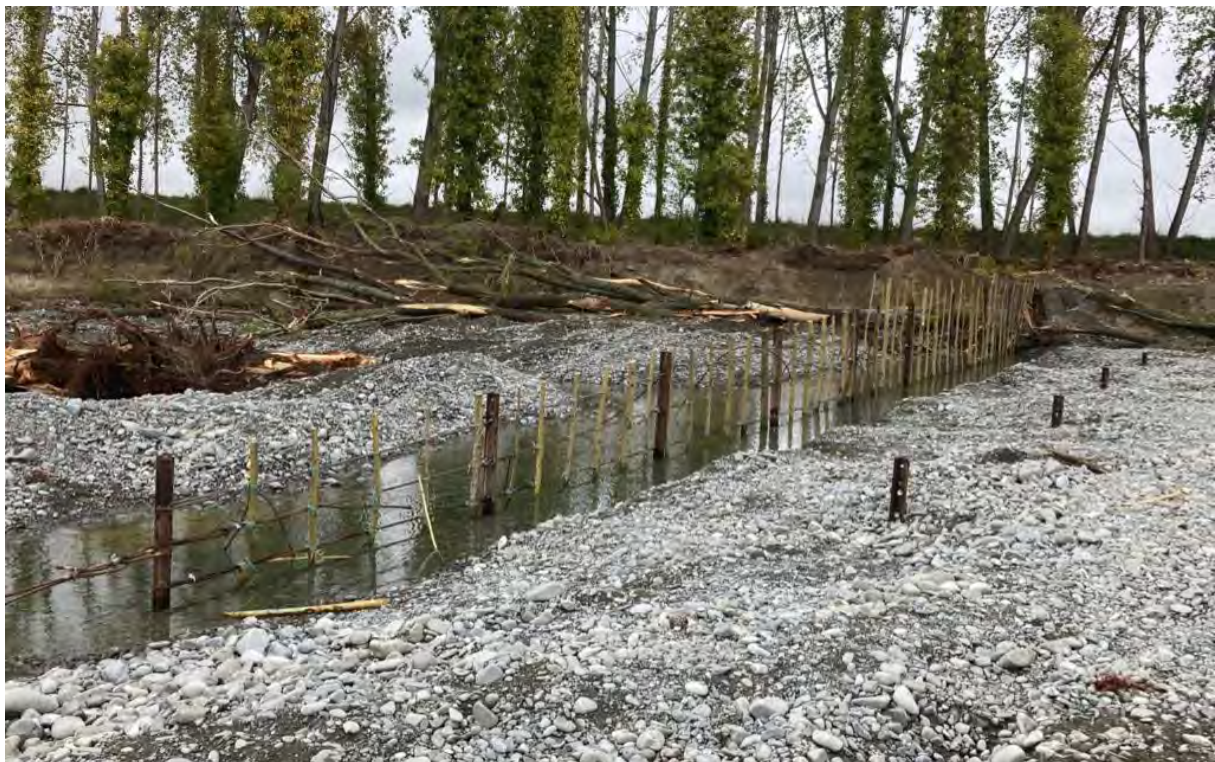
Figure 9-6: Orari at racecourse installation of rope and rail.

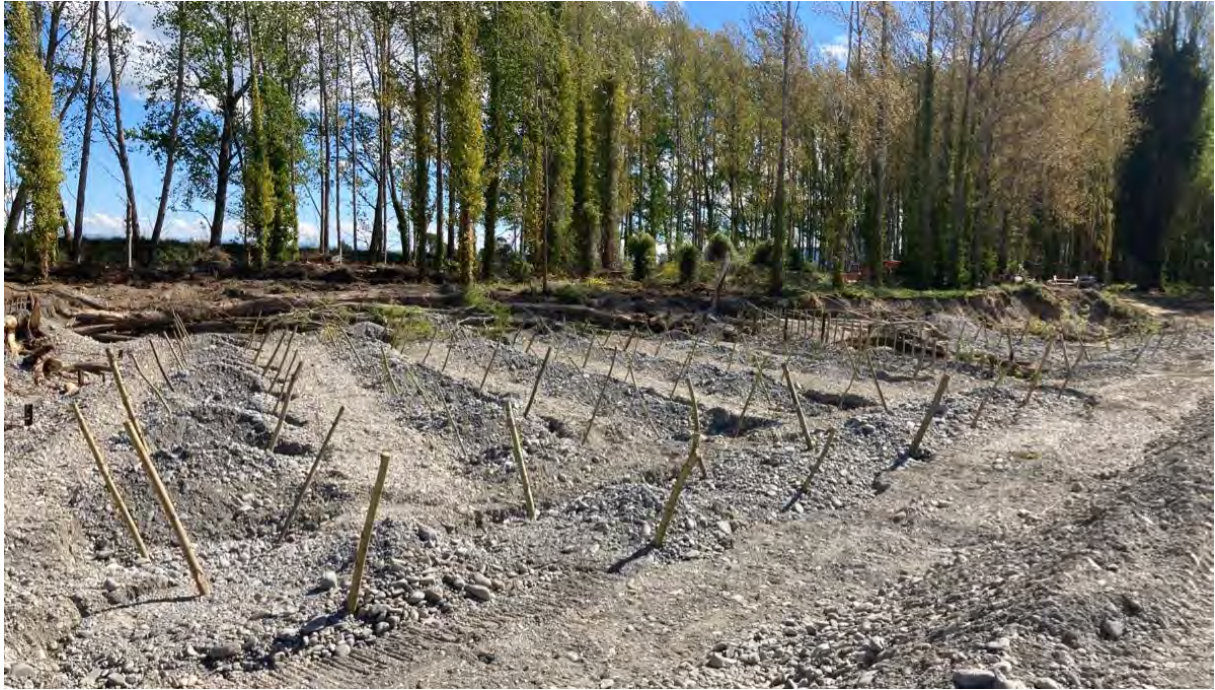
Figure 9-7: Orari at racecourse infill with willow poles.

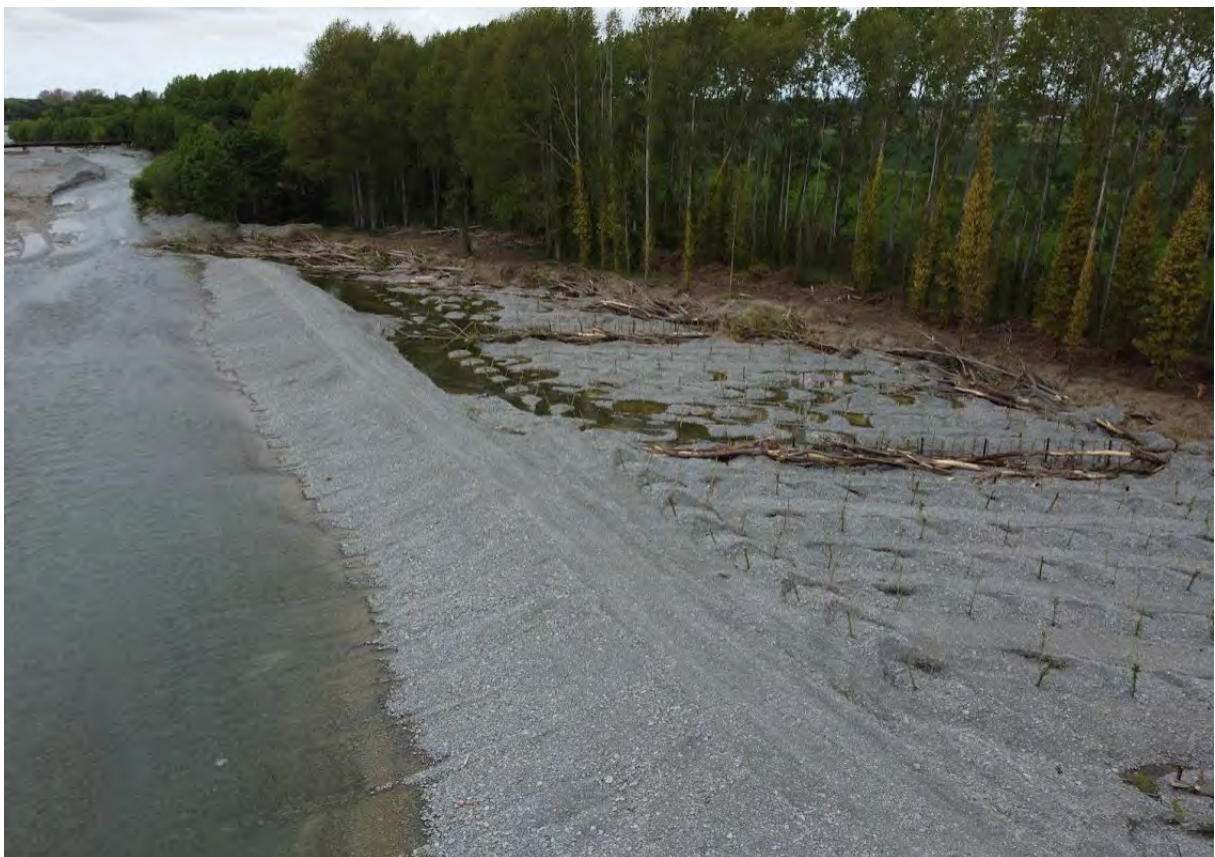
Figure 9-8: Orari at racecourse completed work 21/10/21.

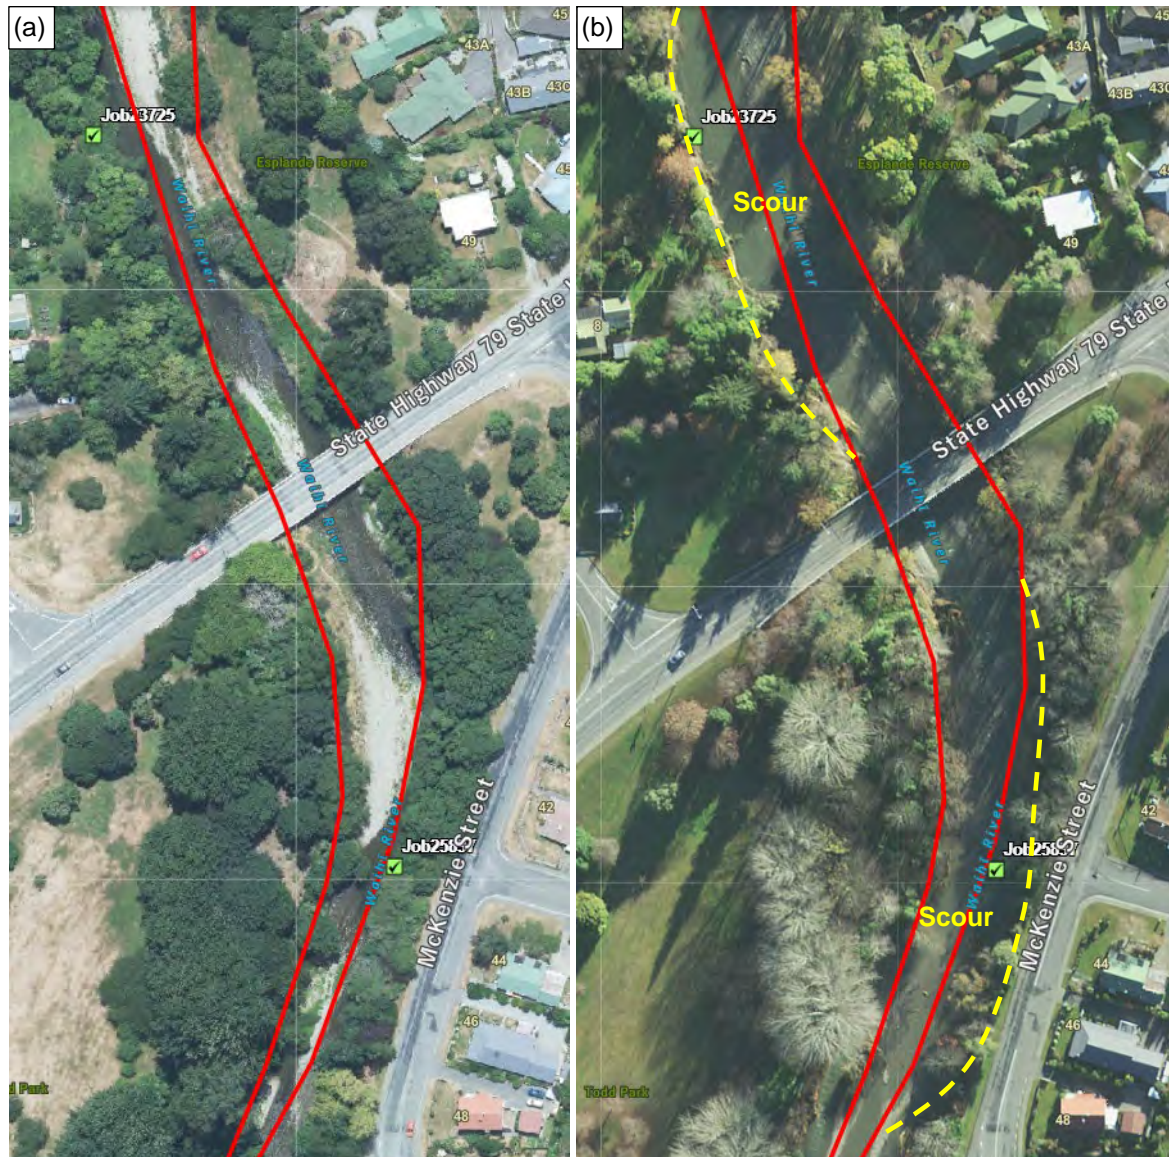
Two areas of scour occurred removing 90m of tree edge protection on the true right bank (TRB) and 100m of tree edge protection on the true left bank (TLB) directly upstream and downstream of the SH79 bridge in Geraldine. Due to the lack of space to implement other options, a “Heyman Fence” rope and rail has been installed at these sites.

Figure 9-9: Waihi at SH79, Geraldine: (a) aerial view prior to flood, (b) post-flood aerial showing extent of tree edge protection lost.

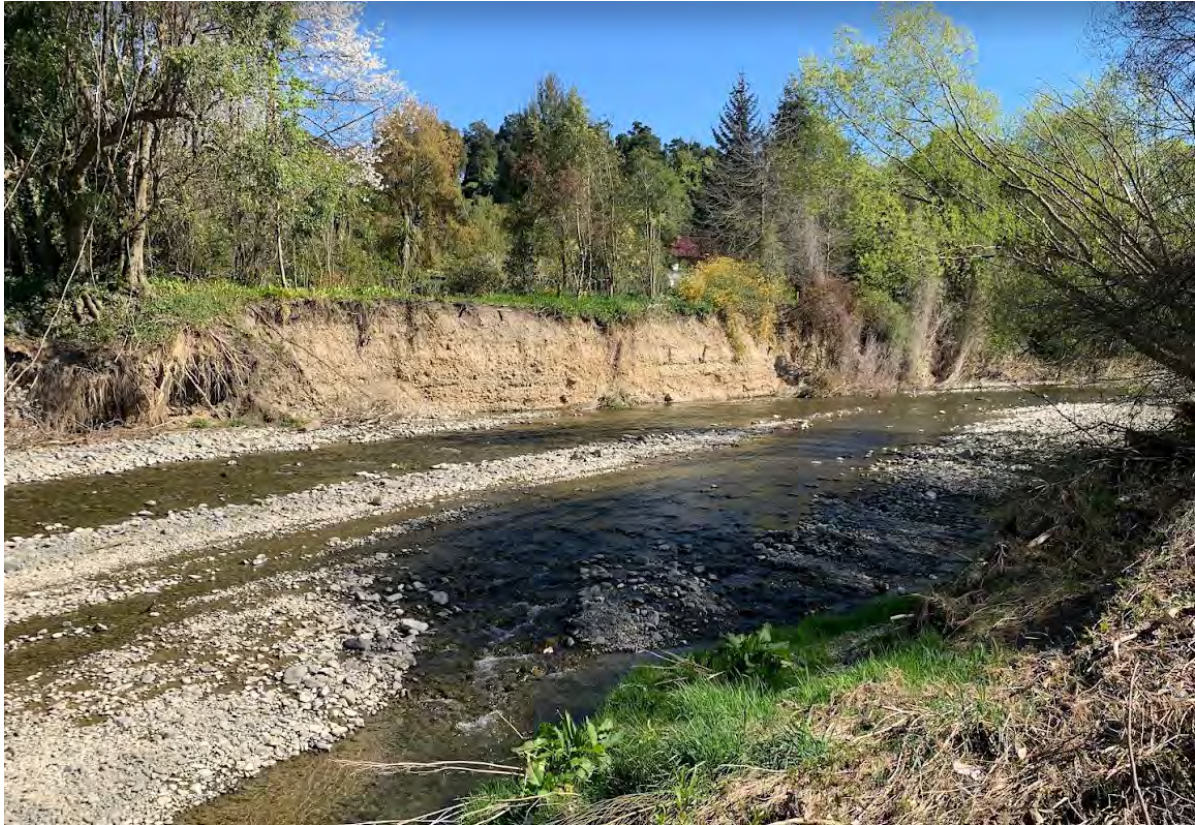
Figure 9-10: Waihi at SH79, Geraldine TRB upstream of bridge, flood damage, September 2021.

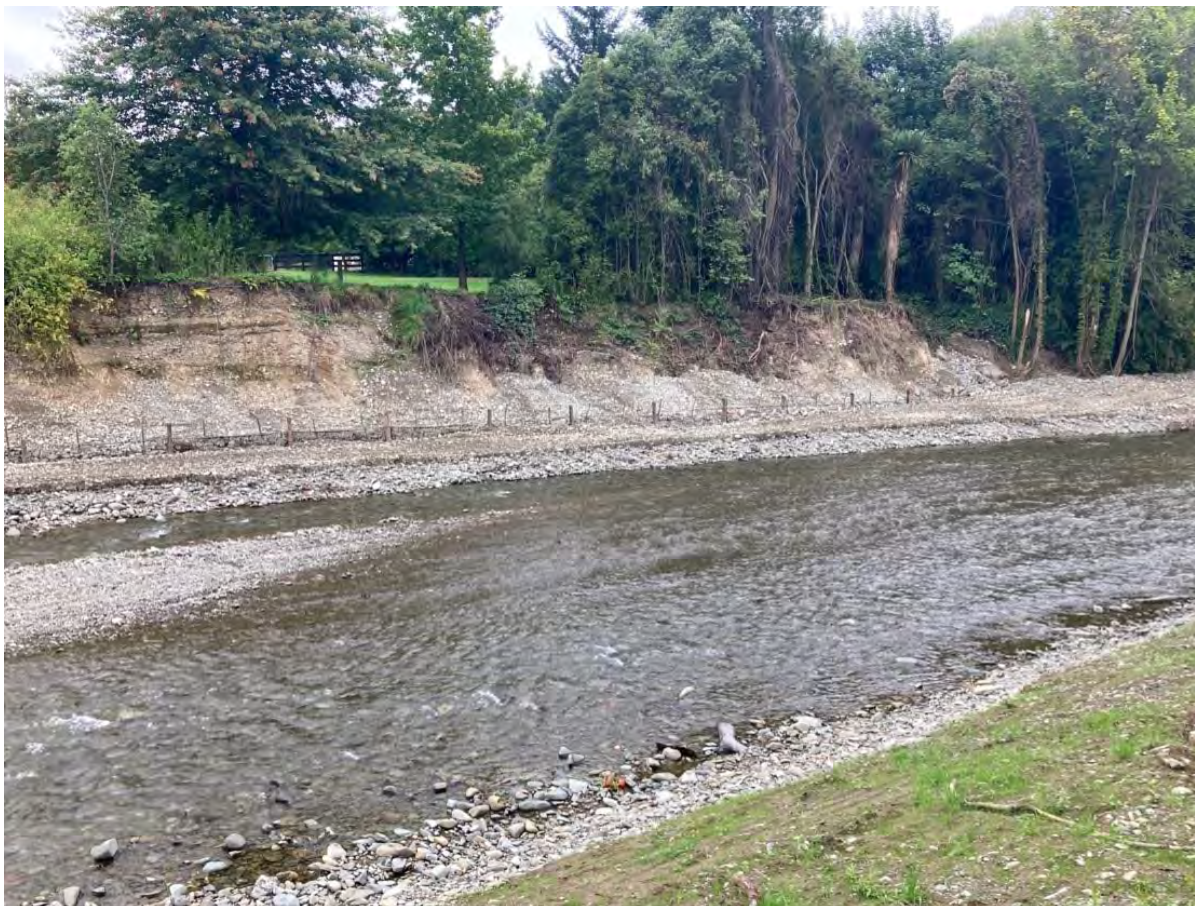
Figure 9-11: Waihi at SH79, Geraldine TRB upstream of bridge with completed Heyman Fence repair, March 2022.

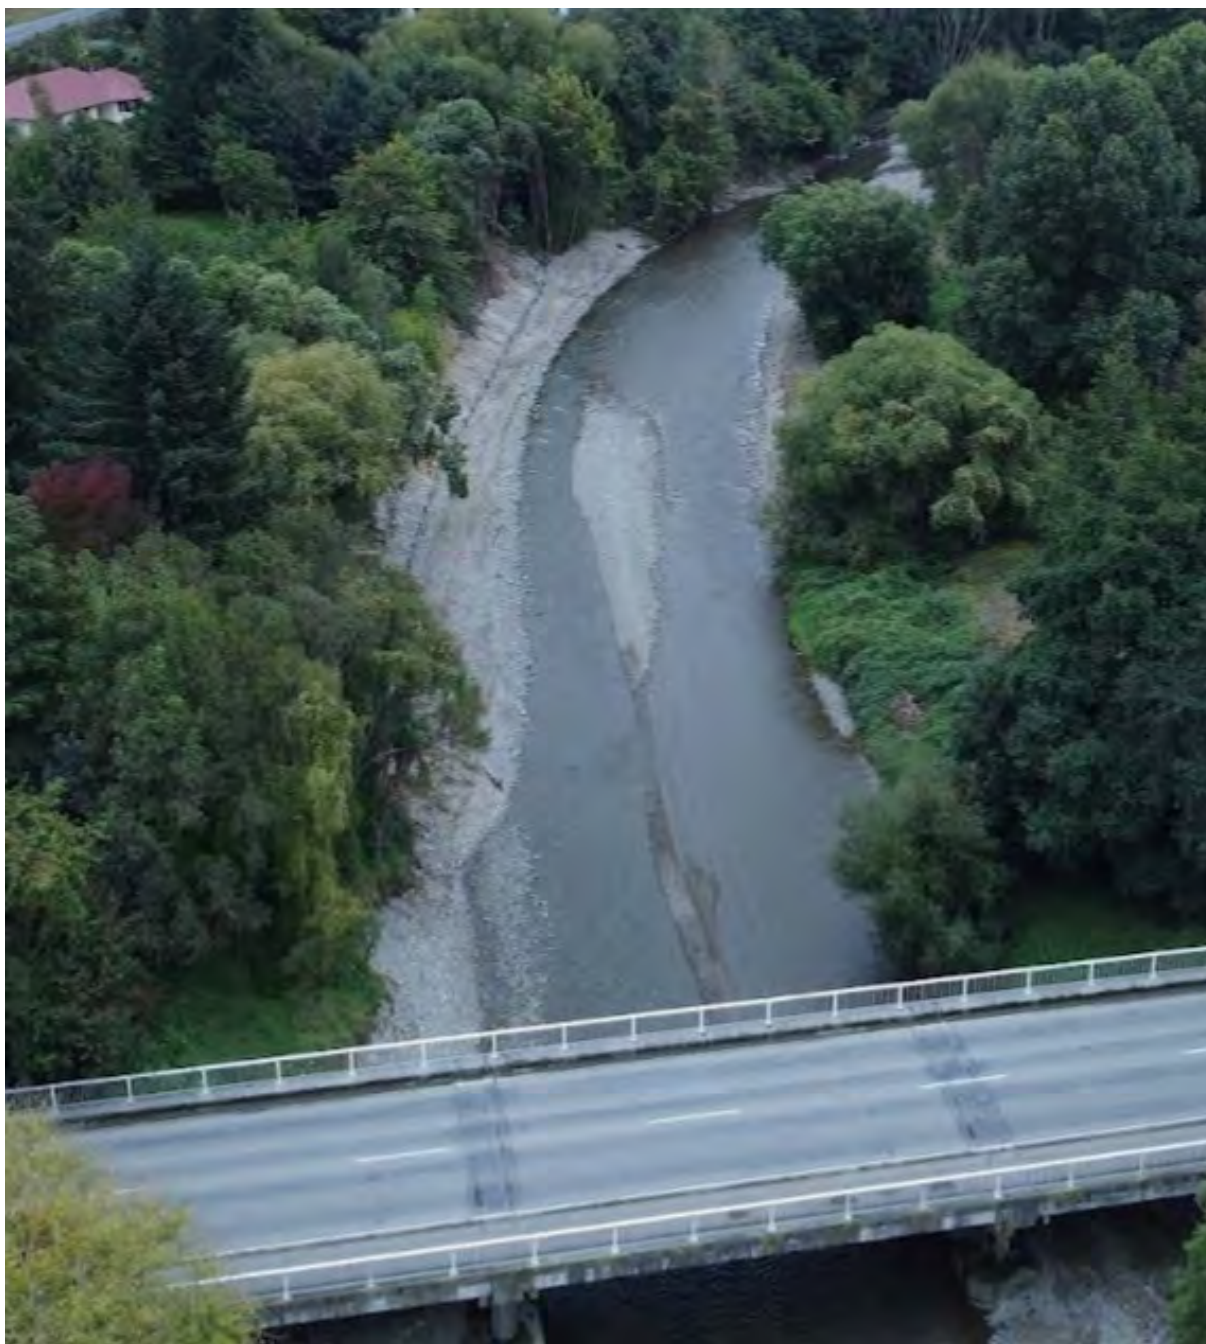
Figure 9-12: Waihi at SH79, Geraldine TRB upstream of bridge. Aerial view looking upstream - completed Heyman Fence repair. March 2022.

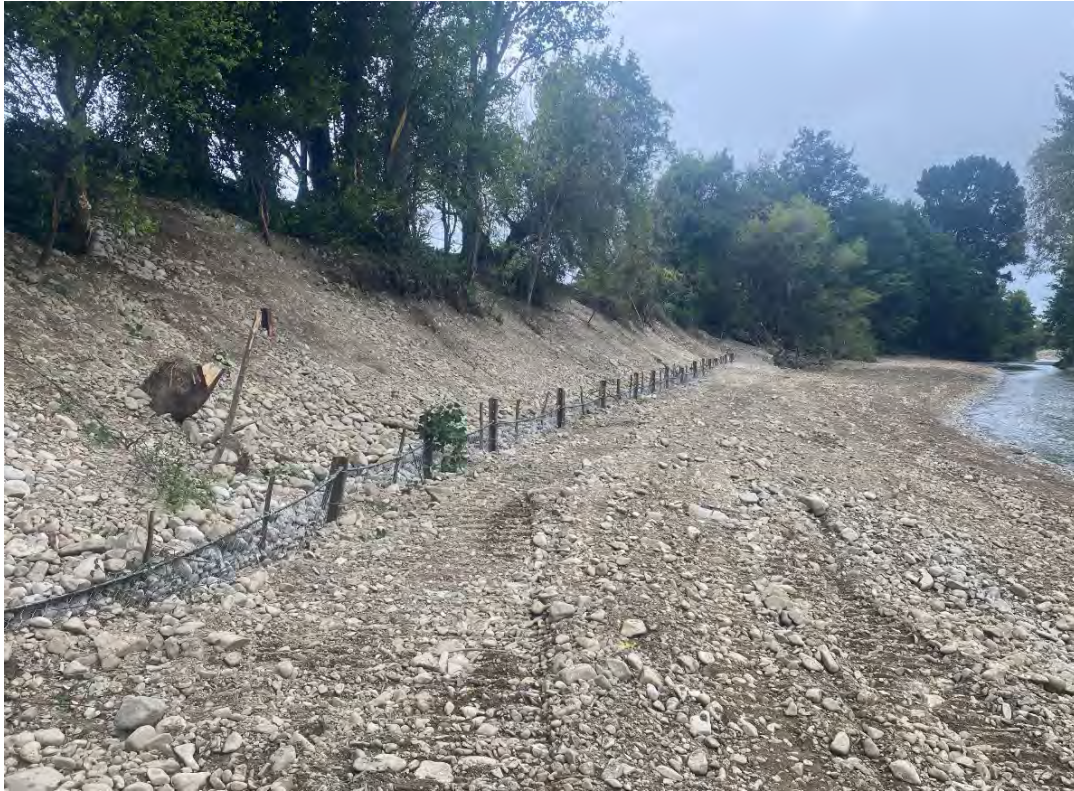
Figure 9-13: Waihi at SH79, Geraldine TLB downstream of bridge. Completed Heyman Fence repair. March 2022.

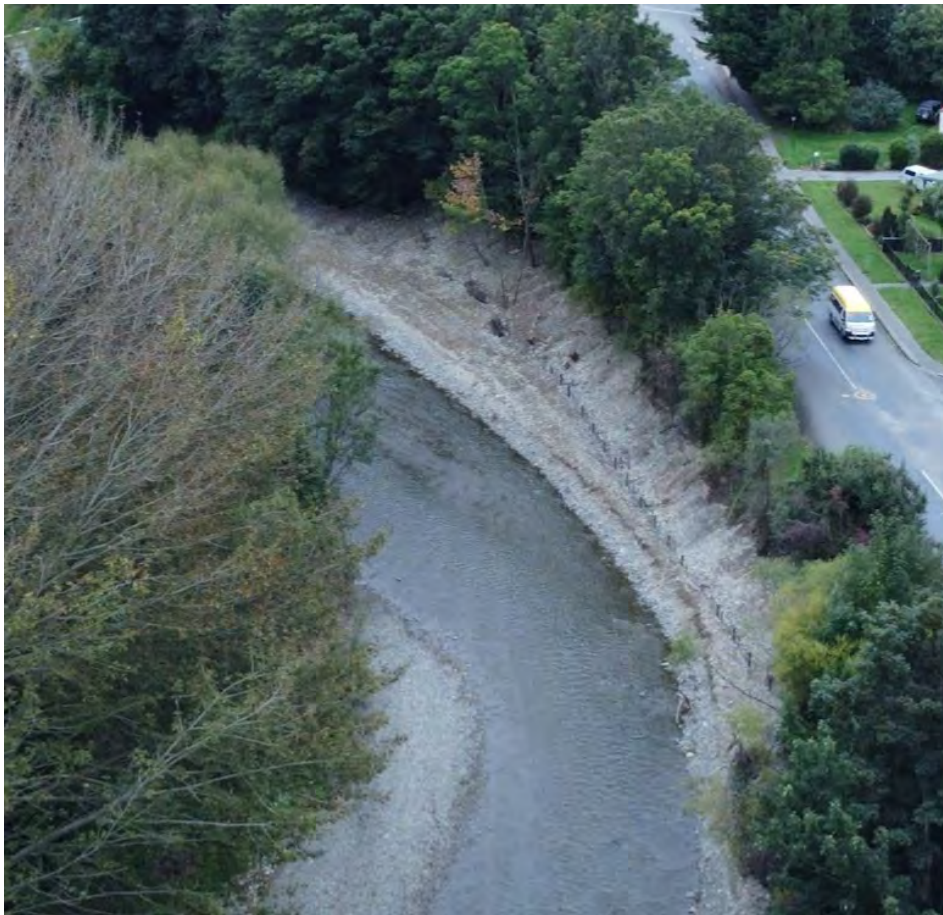
Figure 9-14: Waihi at SH79, Geraldine TLB downstream of bridge. Aerial view looking upstream - completed Heyman Fence repair. March 2022.

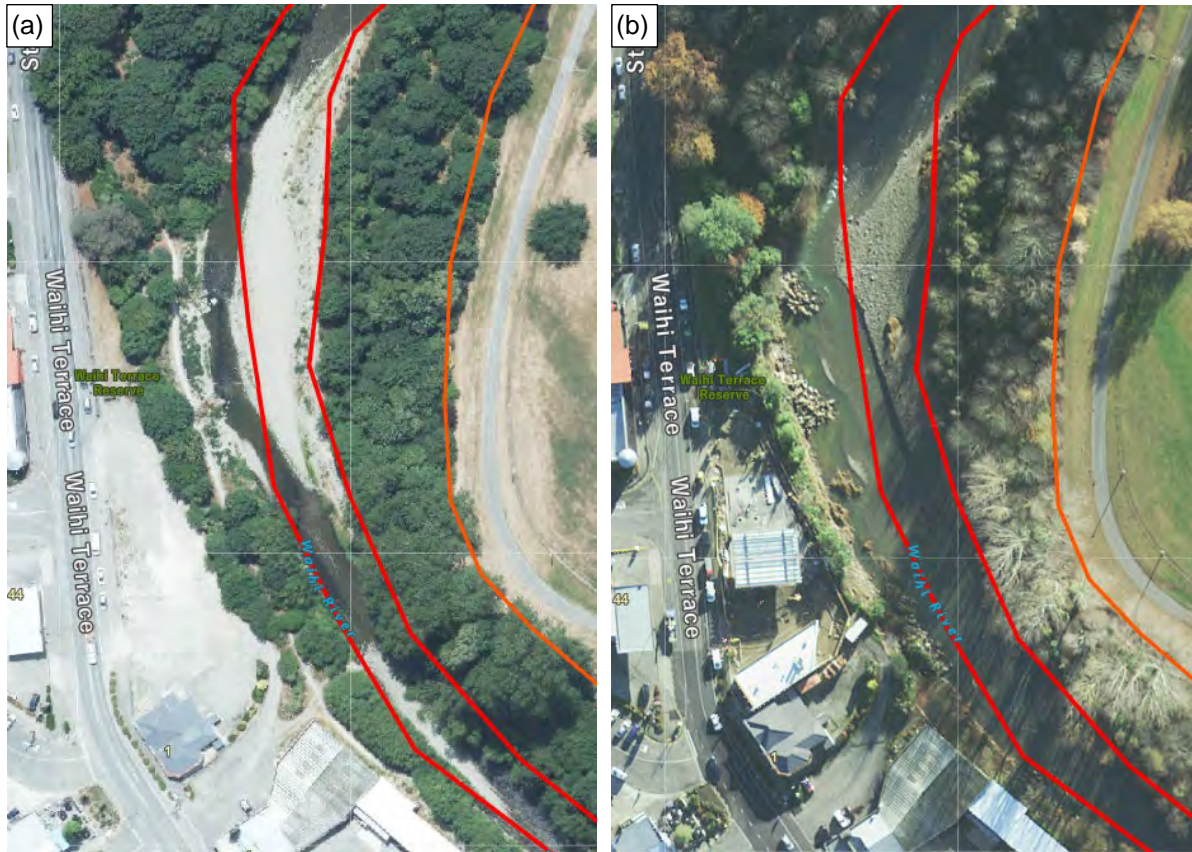
Tree edge protection was damaged and lost over a length of 150m on the TRB of the Waihi River in this area. Flood damage and scour at this location placed the NPD garage and other commercial property at risk of collapse into the river. Existing rock groynes were damaged requiring rebuilding of 4 existing groynes and building 2 new groynes to provide equivalent protection for the tree edge protection lost.

Figure 9-15: Waihi at Geraldine, NPD: (a) aerial view prior to flood, (b) post-flood aerial showing extent of tree edge protection lost.

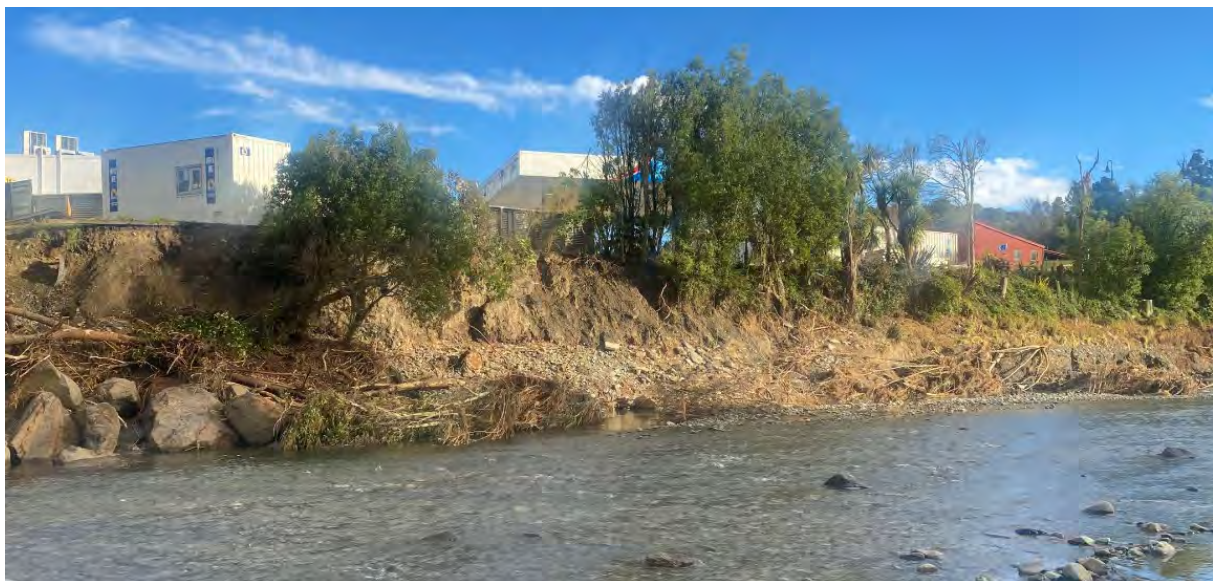
Figure 9-16: Waihi at Geraldine, NPD flood damage to rock groynes on TRB. June 2021.

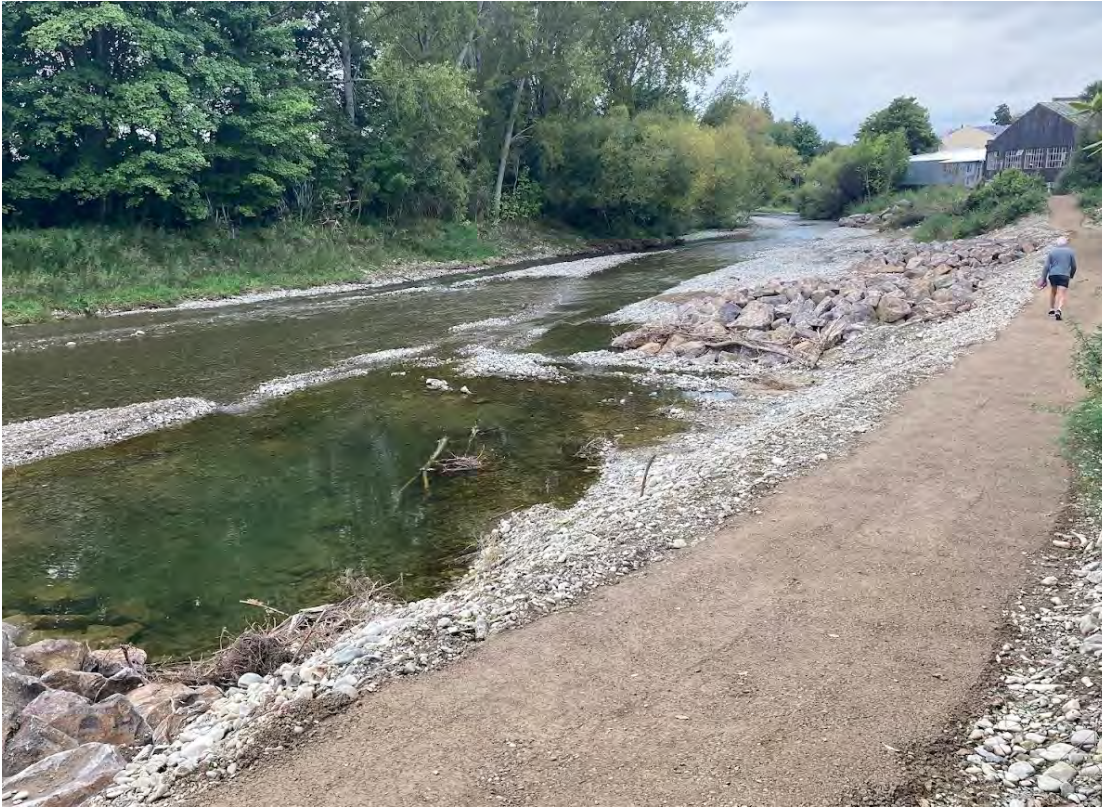
Figure 9-17: Waihi at Geraldine, NPD completed repair to rock groynes and access track on TRB. March 2022.

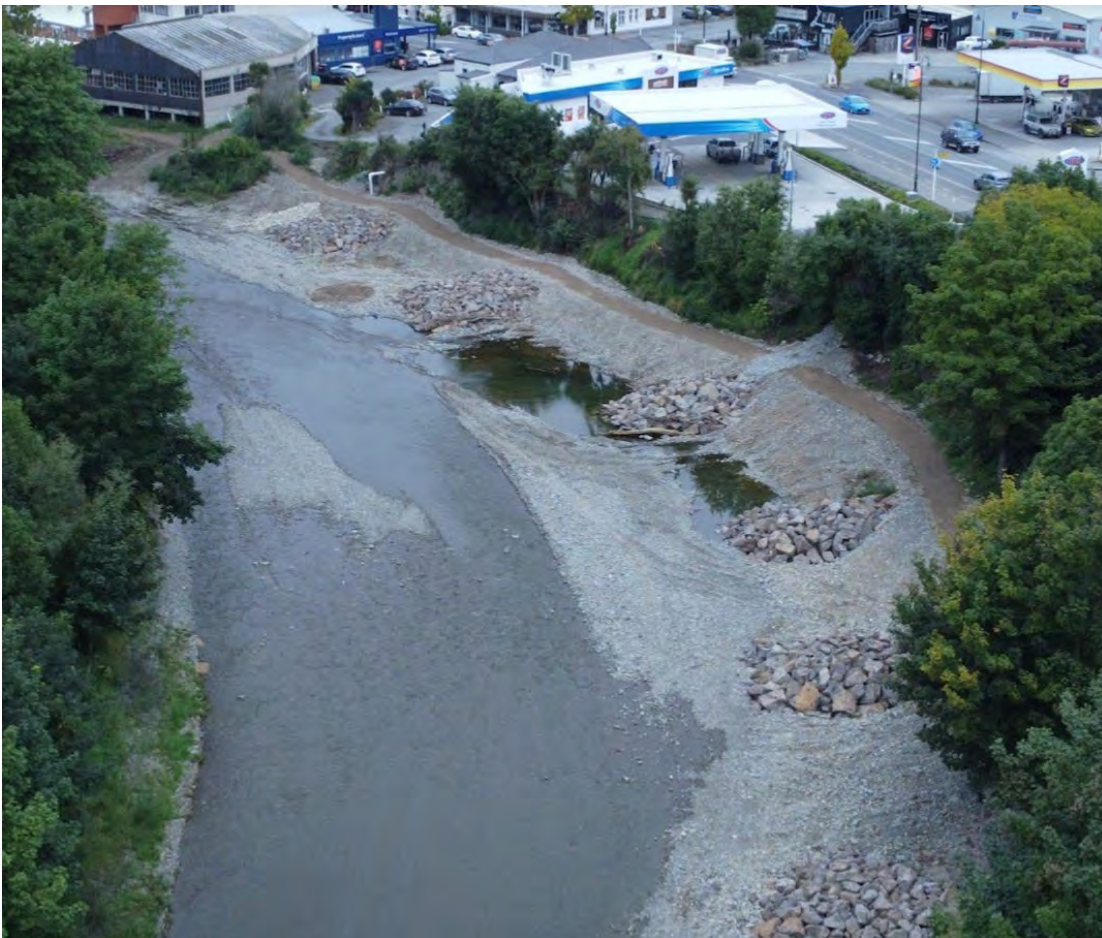
Figure 9-18: Waihi at Geraldine, NPD repaired rock groynes on TRB looking downstream. March 2022.

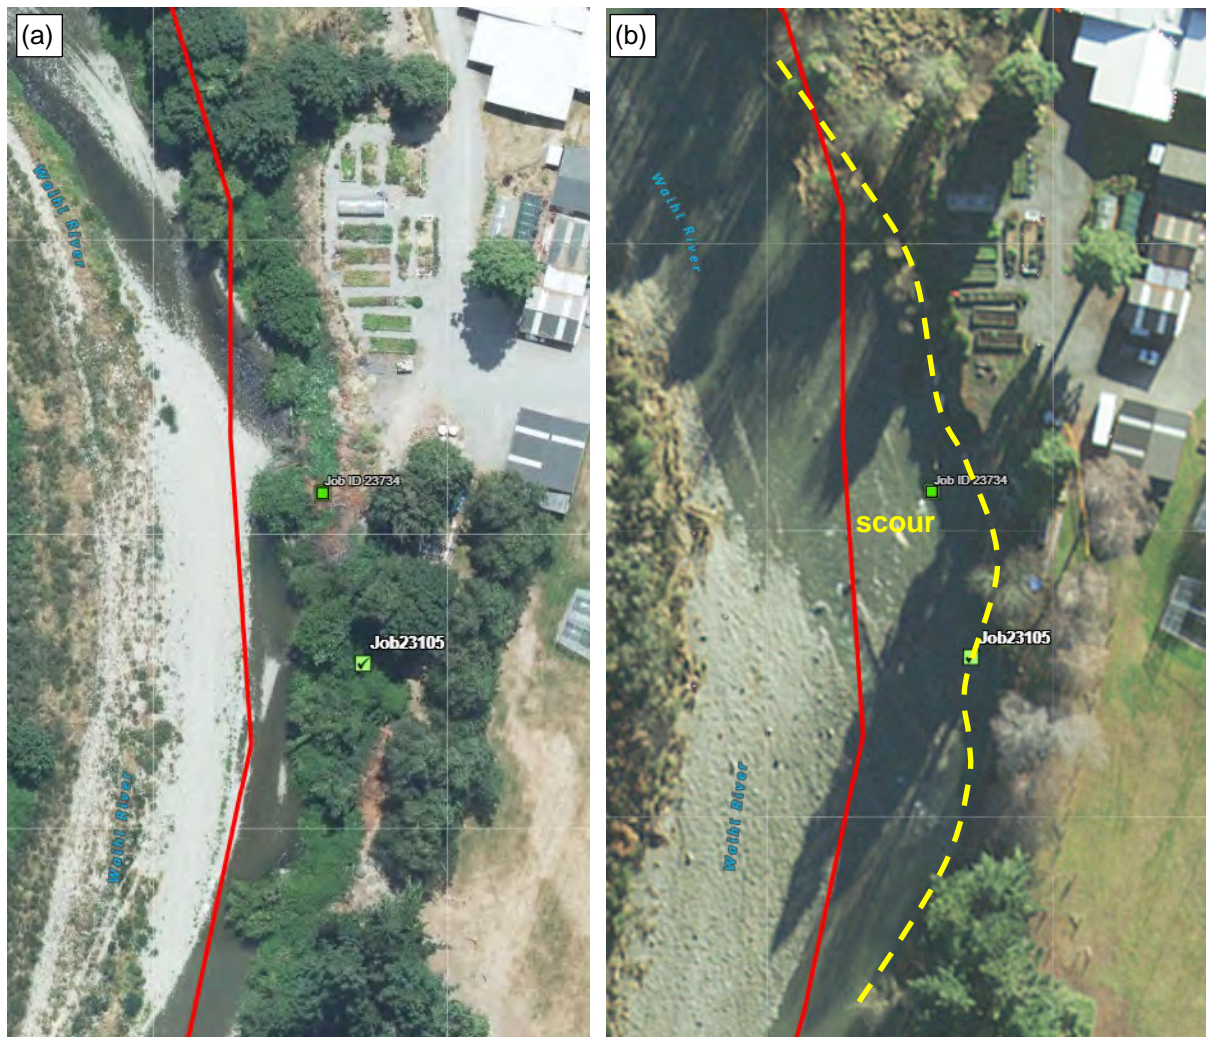
Tree edge protection was lost over 120m and subsequent bank scour placed school facilities at risk. A Hayman Fence repair has been implemented with follow up planting still to be undertaken.

Figure 9-19: Waihi at Geraldine High School: (a) aerial view prior to flood, (b) post-flood aerial showing extent of tree edge protection lost.

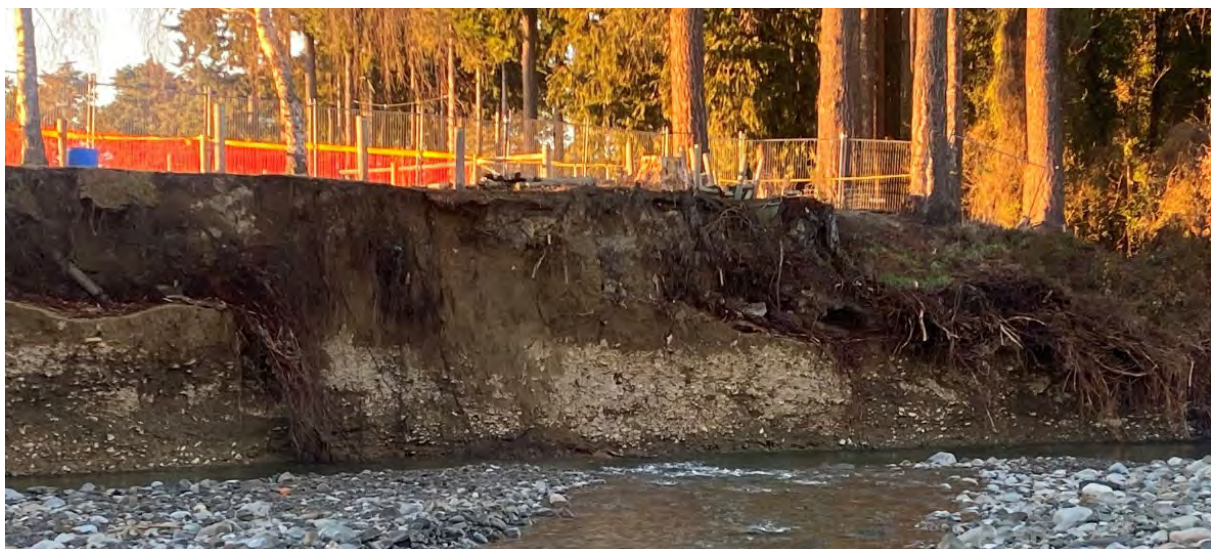
Figure 9-20: Waihi at Geraldine High School flood damage 11/6/2021.

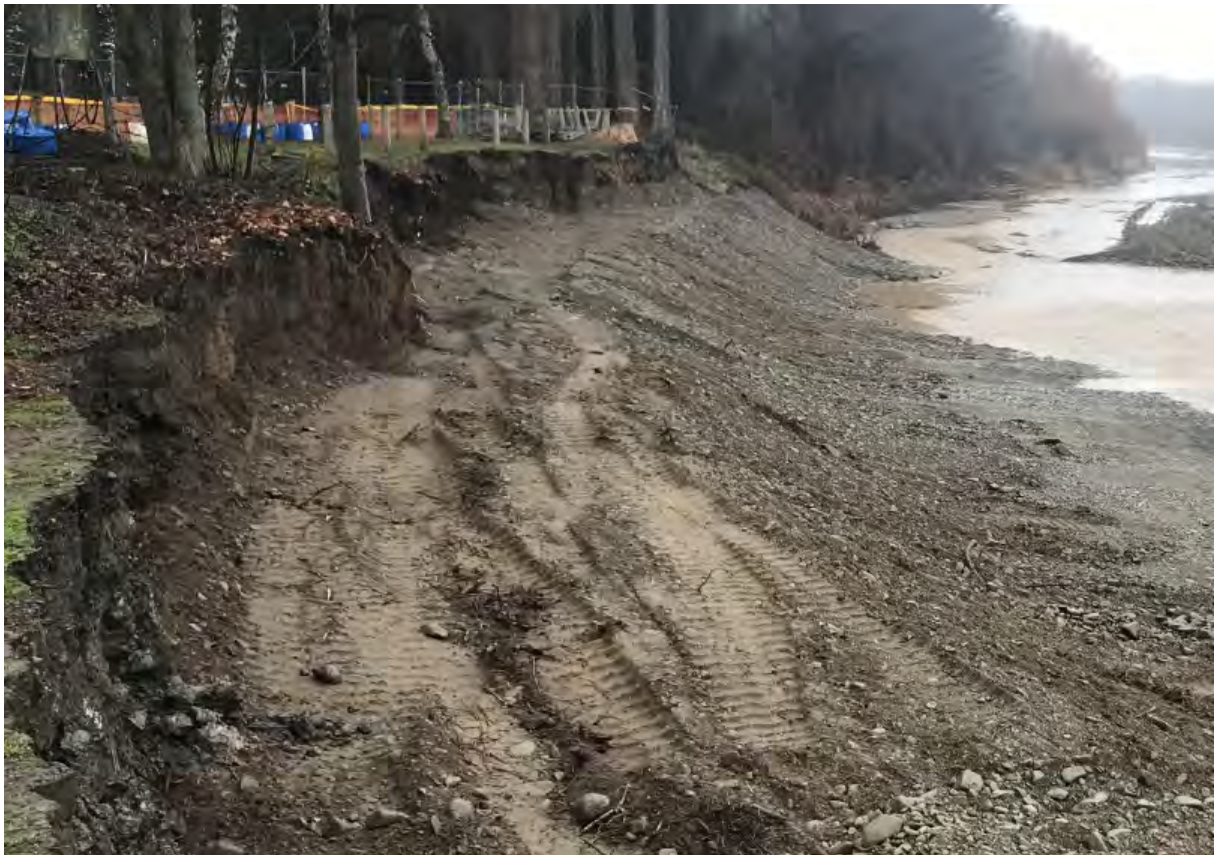
Figure 9-21: Waihi at Geraldine High School temporary repair 15/6/21.

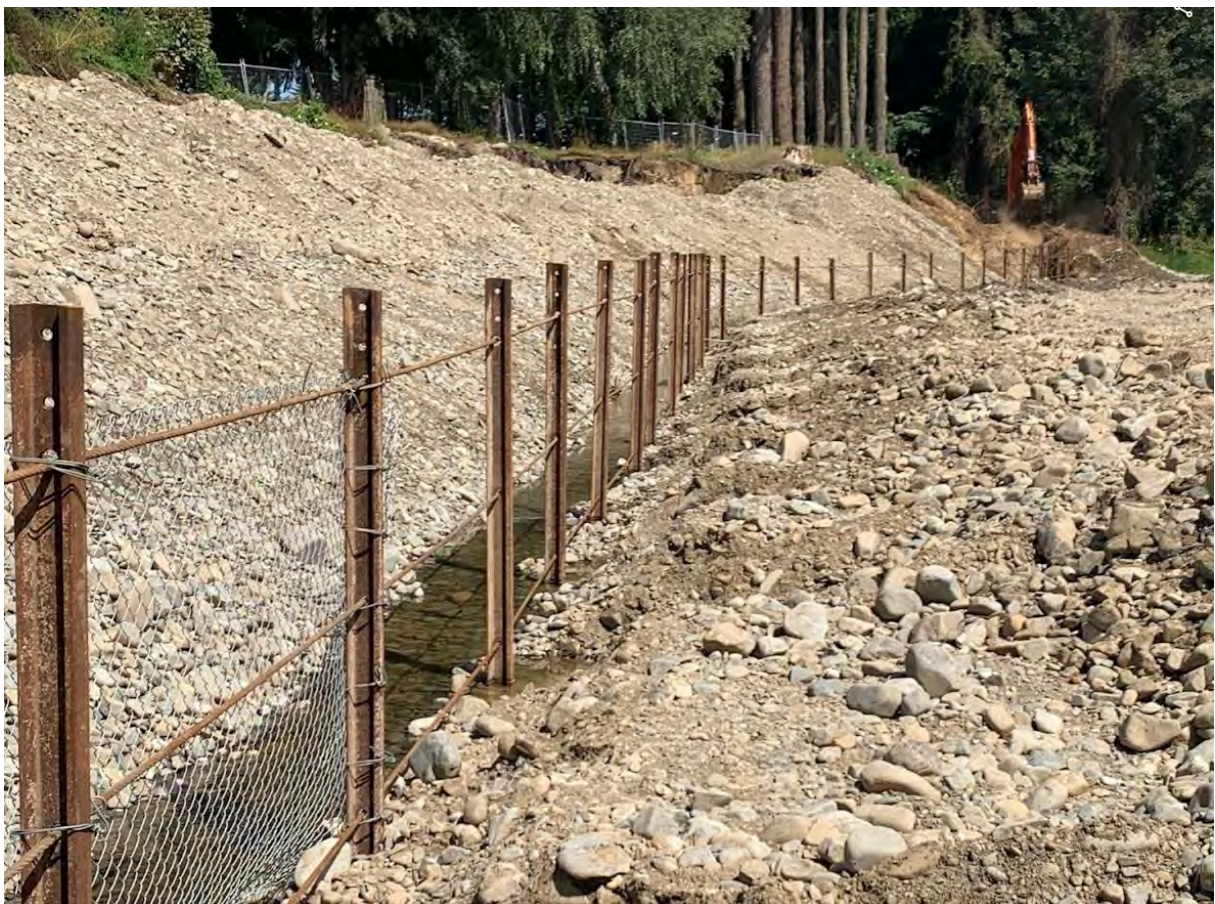
Figure 9-22: Waihi at Geraldine High School Hayman Fence being implemented 27/1/2022.

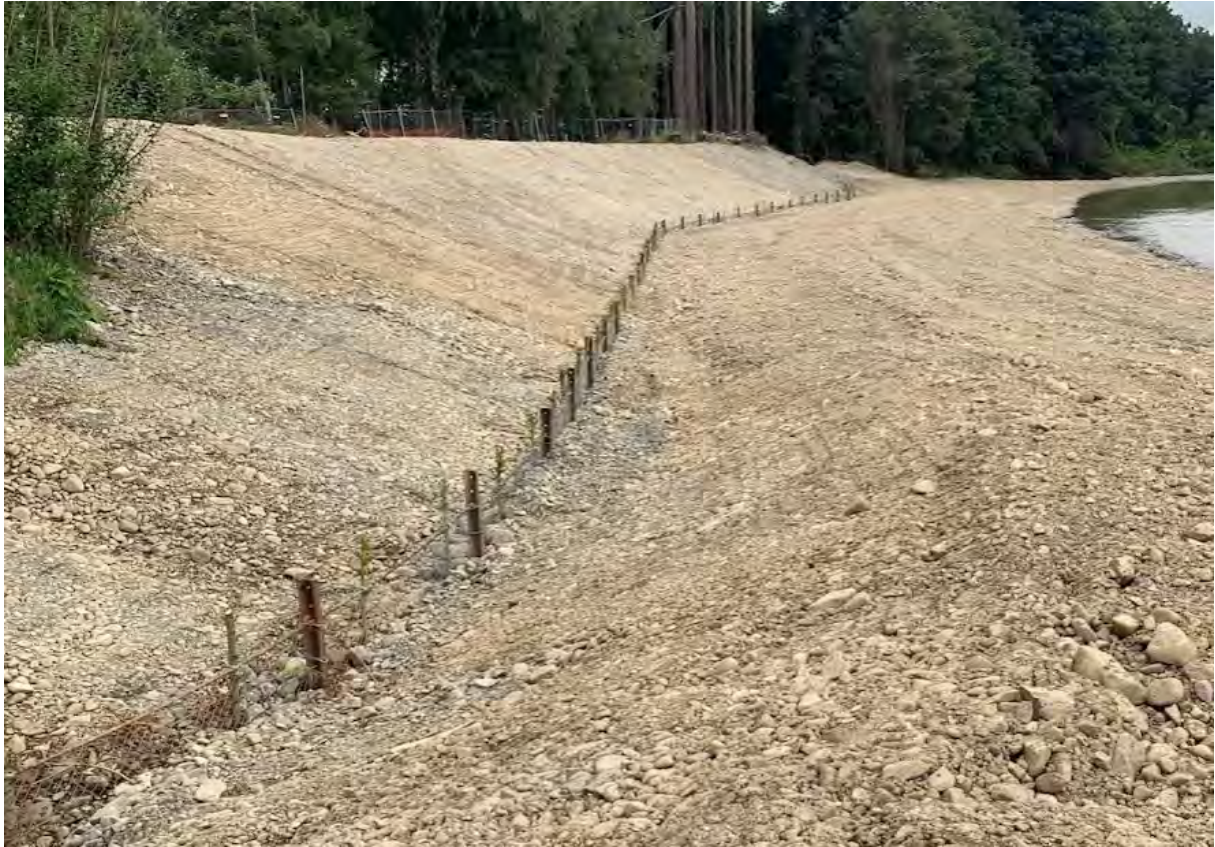
Figure 9-23: Waihi at Geraldine High School, completed Hayman Fence repair 23/2/2022.

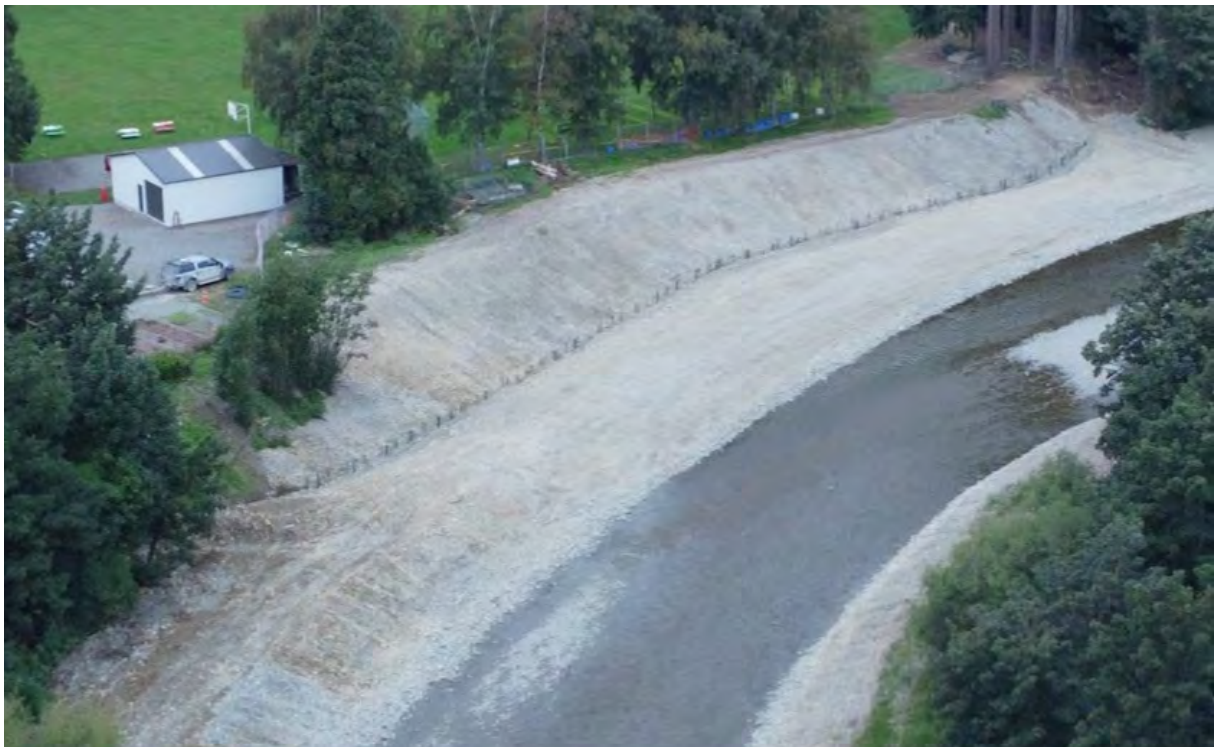
Figure 9-24: Waihi at Geraldine High School, completed Hayman Fence repair aerial view, March 2022.
