**Revised**  
**FULL RESERVE STUDY**  
**Rio Del Sol**  
**Homeowners Association, Inc.**

**Lake Havasu City, Arizona**  
**Inspected - March 18, 2021**  
**Revised - July 7, 2021**

Rio Del Sol Homeowners Association, Inc.  
Lake Havasu City, Arizona

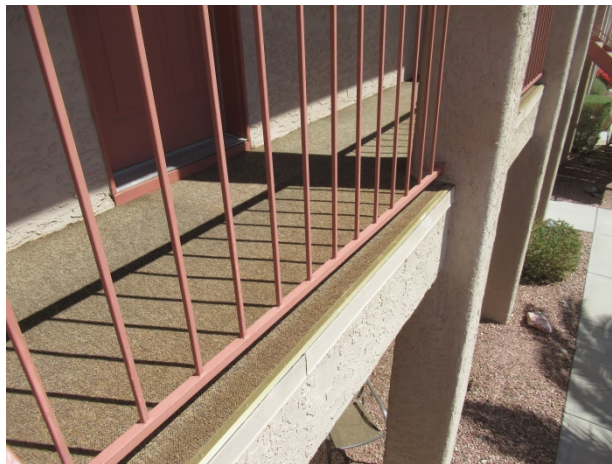
**Conditions:** The railings are in good to fair overall condition.

**Balcony railing**

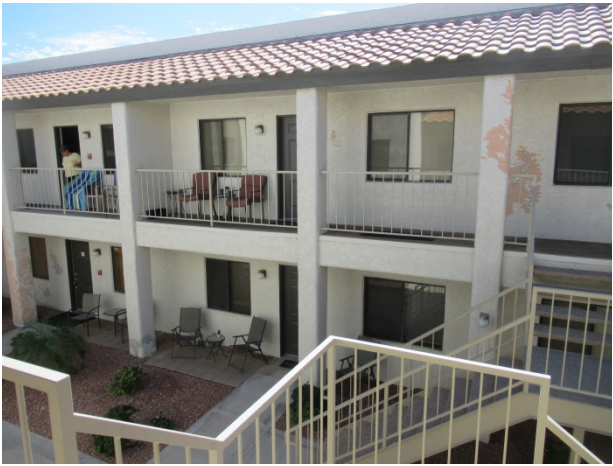
**Condition:** Good to fair overall condition though due to our non-invasive inspection, we are unable to confirm the underlying deck condition. Carpet may trap moisture and accelerate deterioration of the underlying deck.

**Balcony overview**

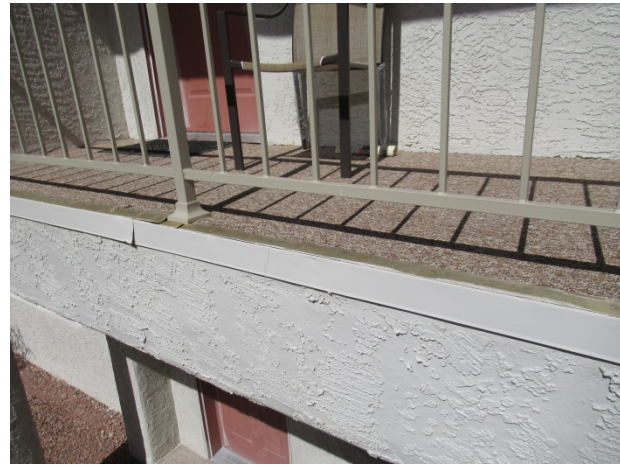
**Carpet floor covering**

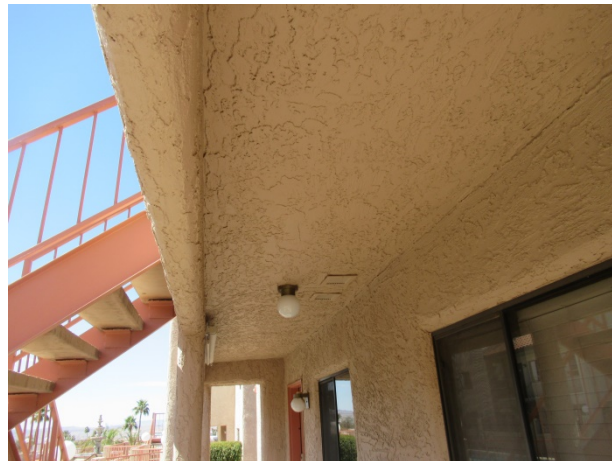
**Balcony underside**

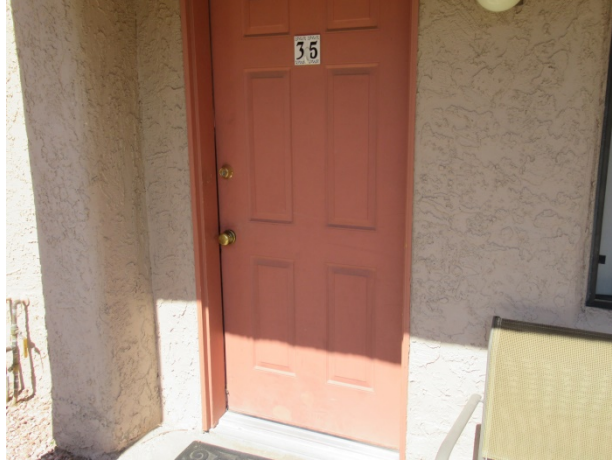
**Condition:** Good to fair overall with finish deterioration evident

**Entrance door**

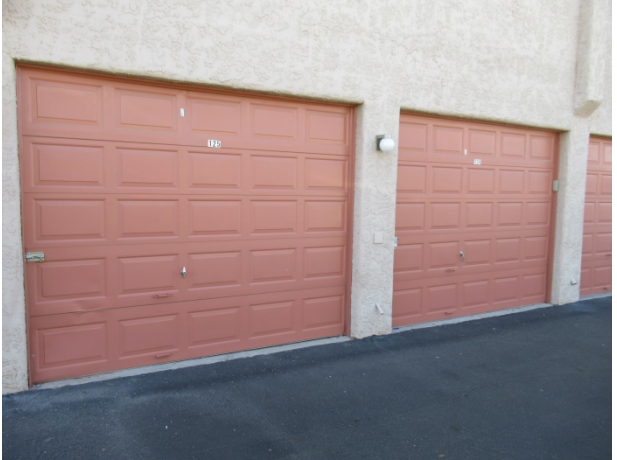
**Condition:** Good to fair overall with minor dents and damage evident

**Garage doors**

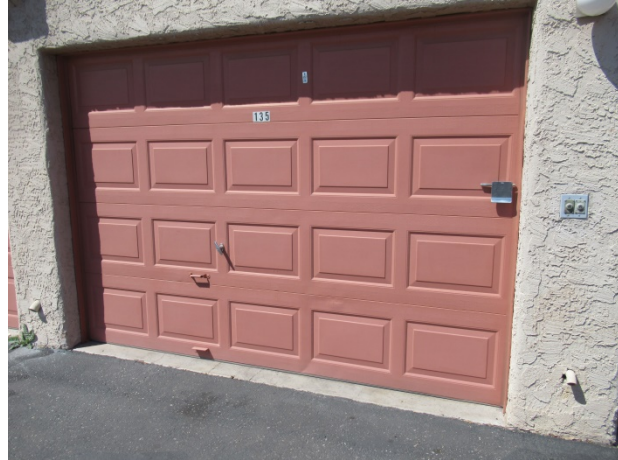
**Minor dent**

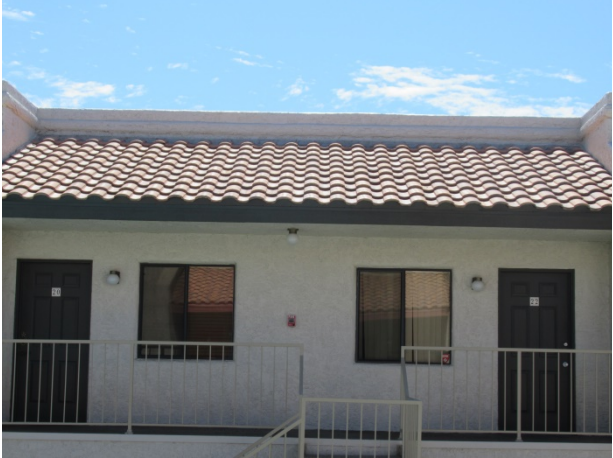
**Condition:** Good to fair overall with isolated areas of chipped and broken tiles evident. The Board does not report a significant history of leaks.

**Tile roof section**

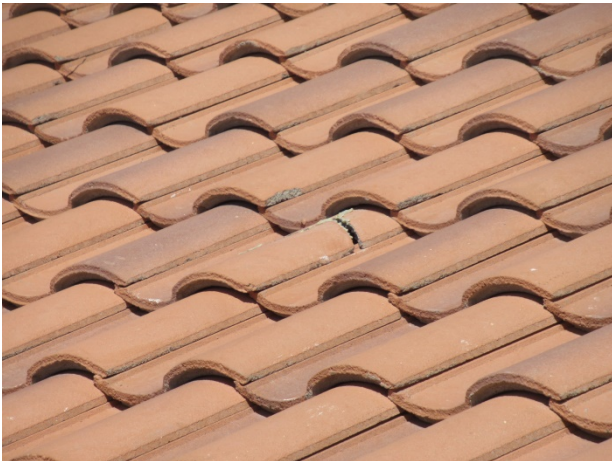
**Broken tile**

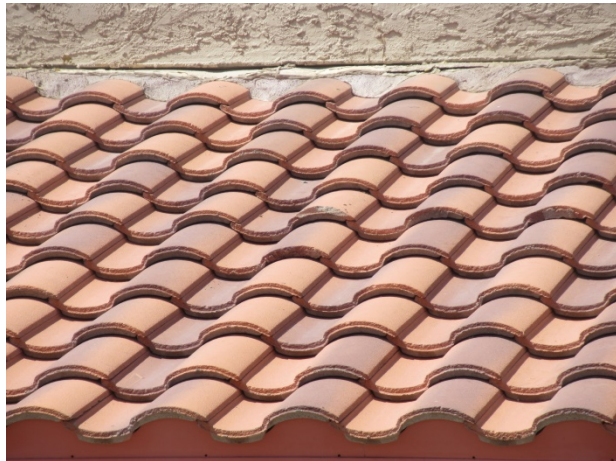
**Minor chipped tile**

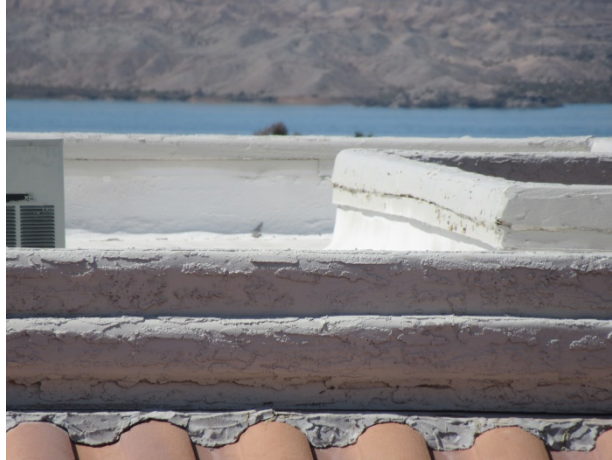
**Condition:** Reported satisfactory overall. We were unable to access the roofs at the time of our inspection. The Board does not report a significant history of leaks.

**Foam roof**

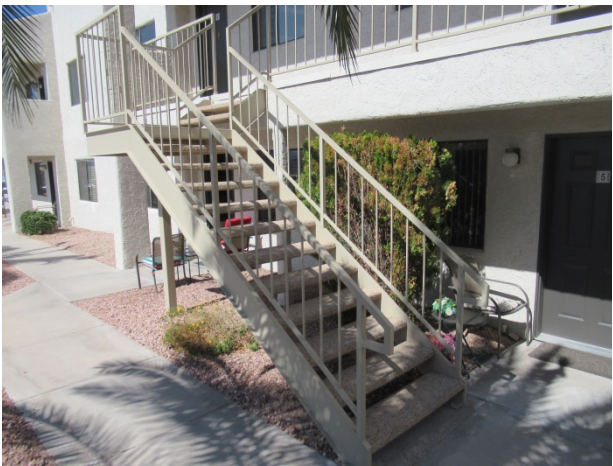
**Condition:** We note previous partial replacements of concrete treads, and limited rust evident.

**Steel staircase**

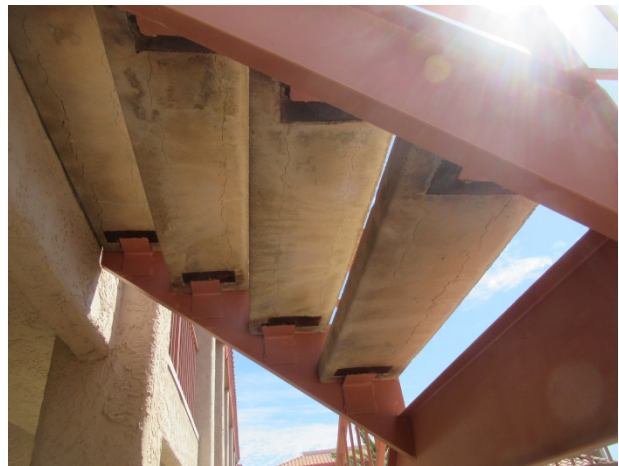
**Tread cracks**

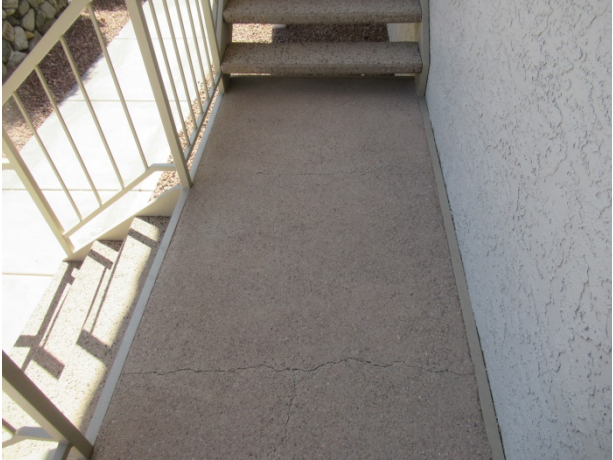
**Cracks at concrete landing**

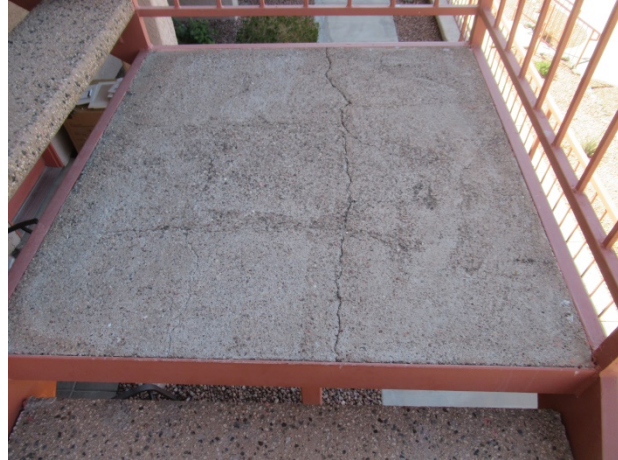
**Cracks at concrete landing**

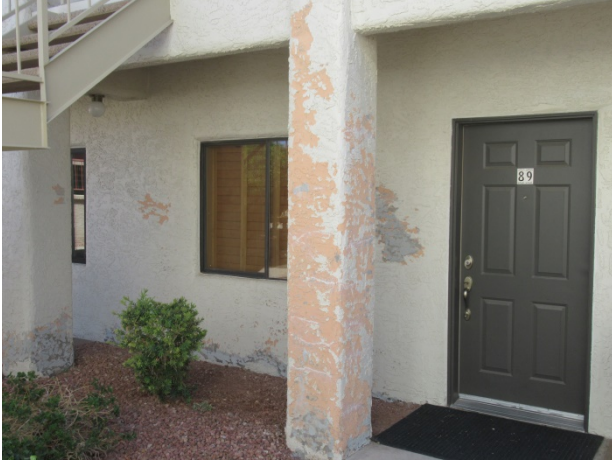
**Condition:** Fair to poor overall with cracks, water stains, finish deterioration, peeling paint and general deterioration evident throughout the community.

**Stucco façade, note – building previously being painted**

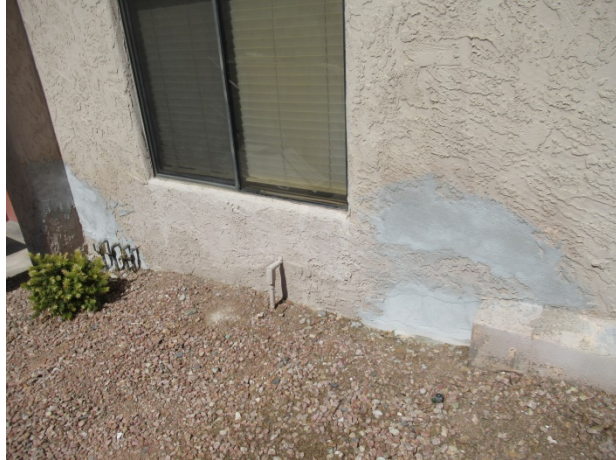
**Repairs in progress**

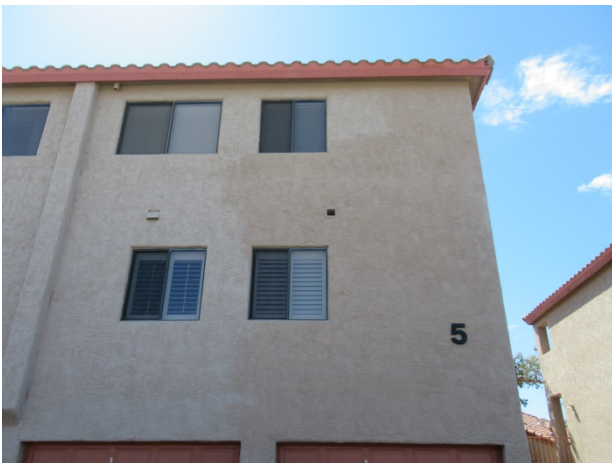
**Stucco varied finish**

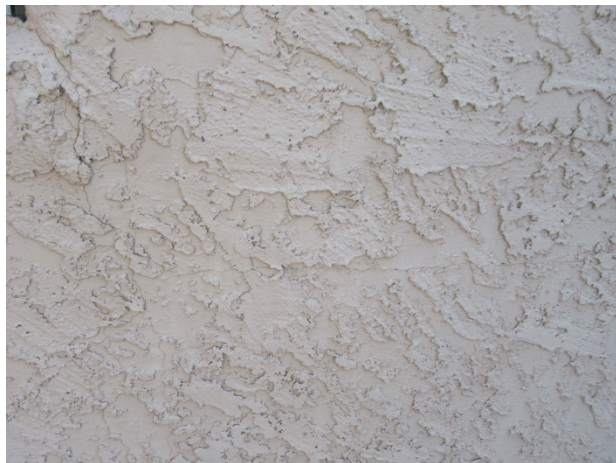
**Stucco cracks**

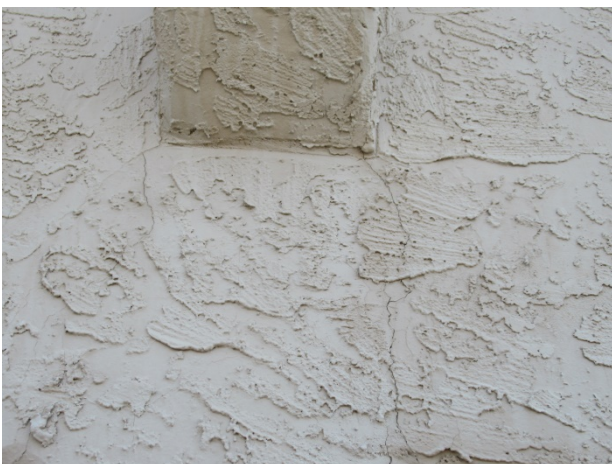
**Stucco cracks**

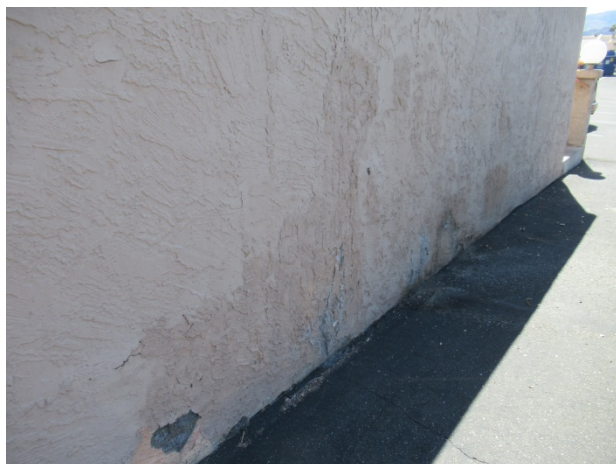
**Stucco deterioration at retaining wall**

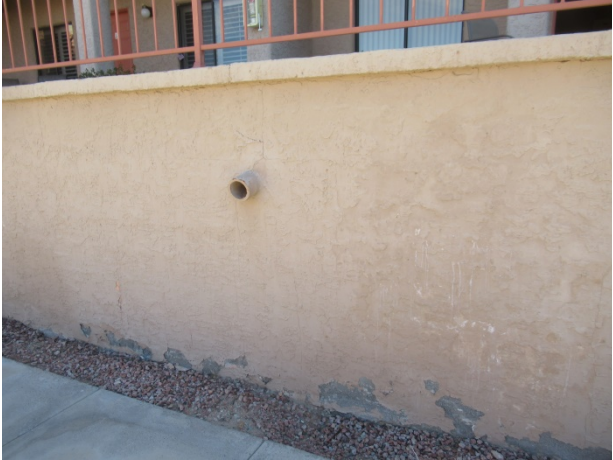
**Coating deterioration**

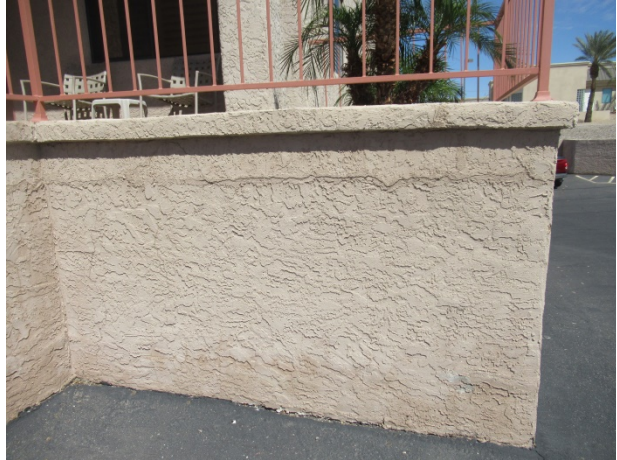
**Stucco cracks**

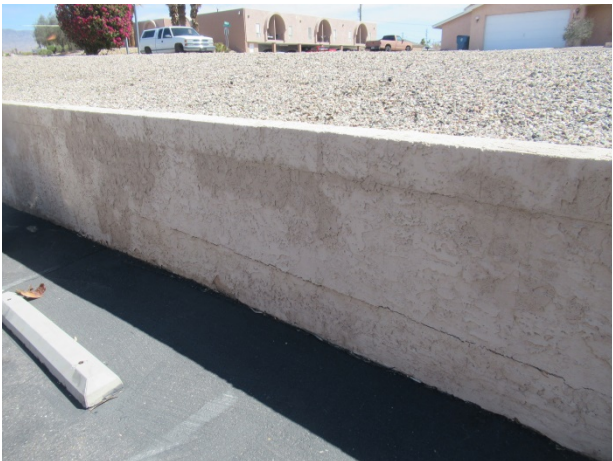
**Deterioration at perimeter retaining wall**

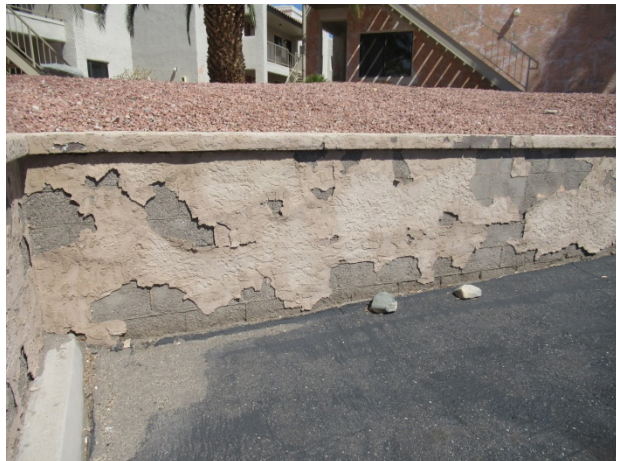
**Significant coating deterioration east of the mailboxes**

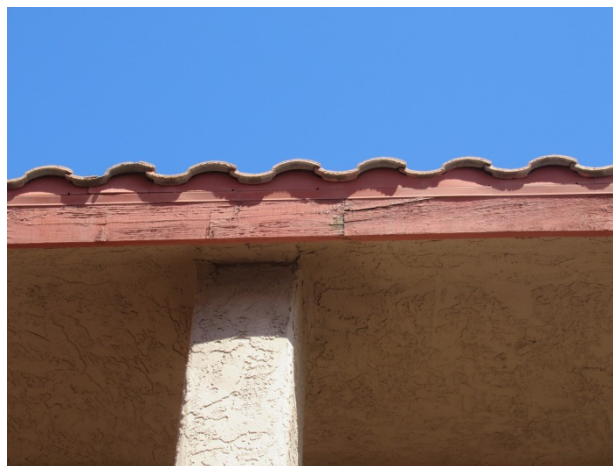
**Weathered wood**

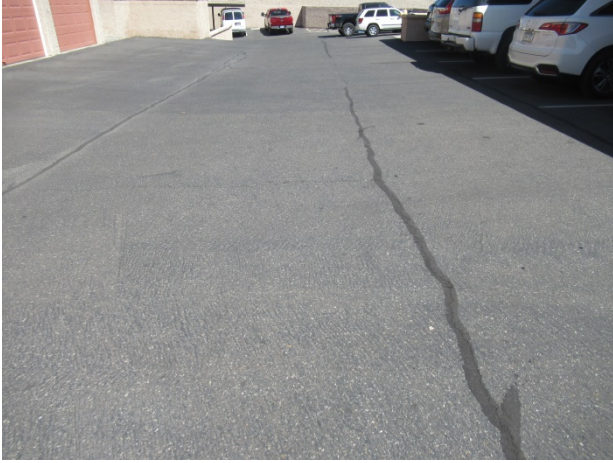
**Condition:** Good to fair overall with limited cracks evident

**Asphalt pavement overview**

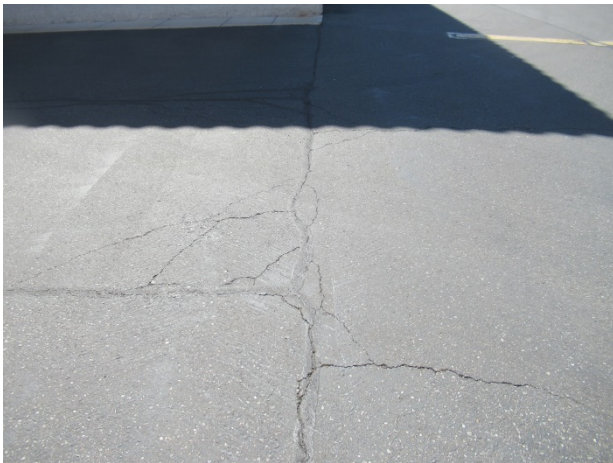
**Pavement cracks**

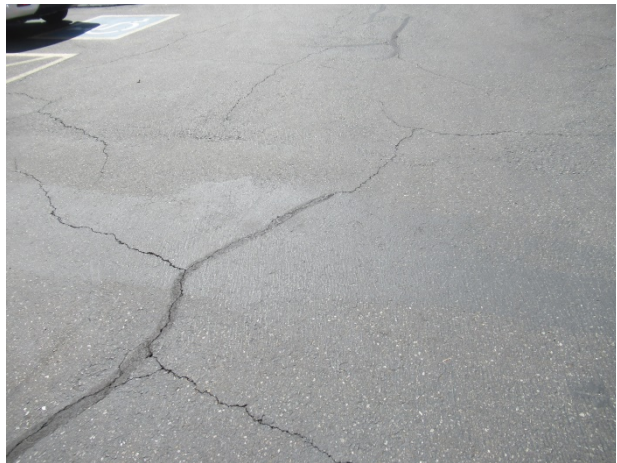
**Pavement cracks**

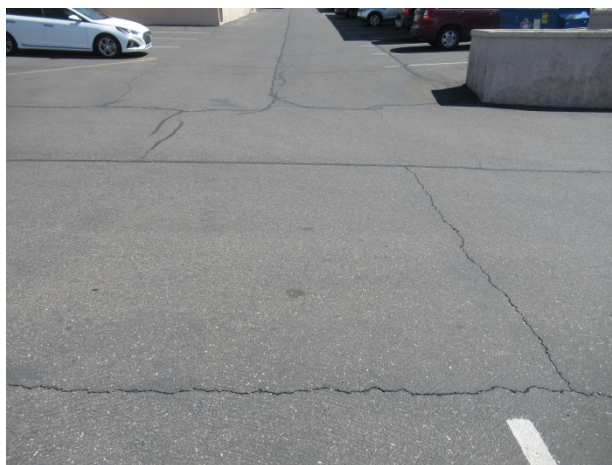
**Various cracks near southwest entrance**

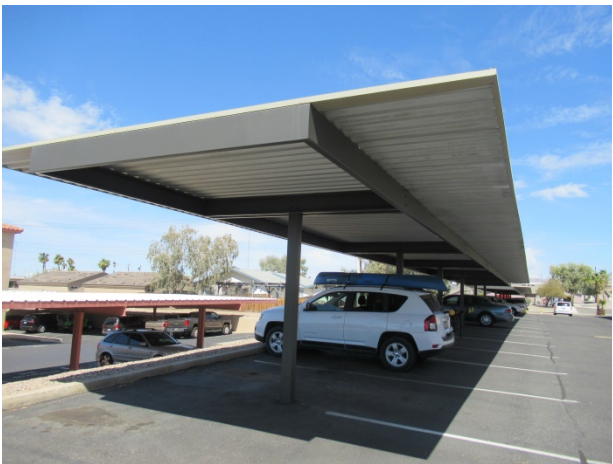
**Condition:** We note partial roof replacements, limited dented sections and isolated structure damage.

**Steel carport**

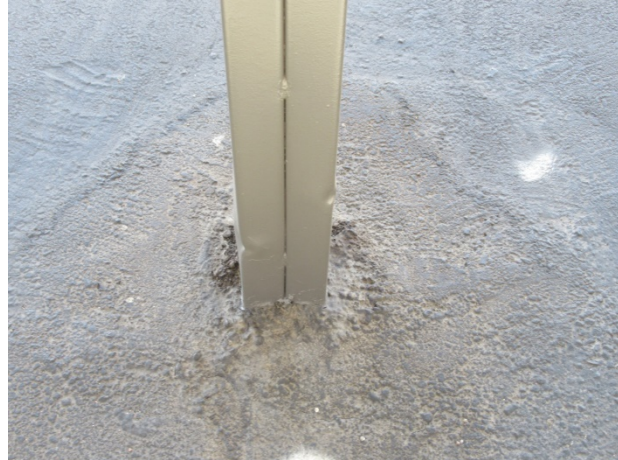
**Isolated damage**

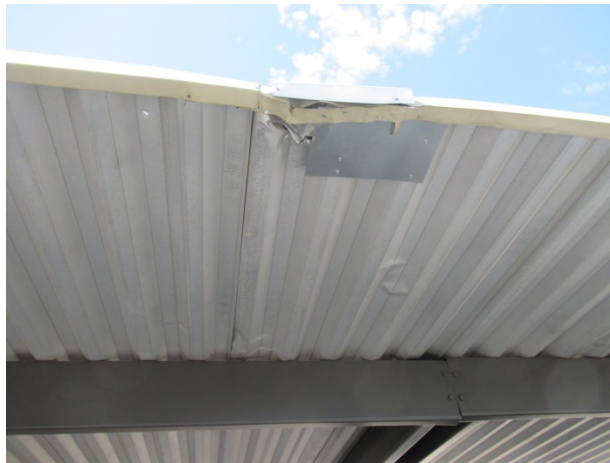
**Isolated damage**

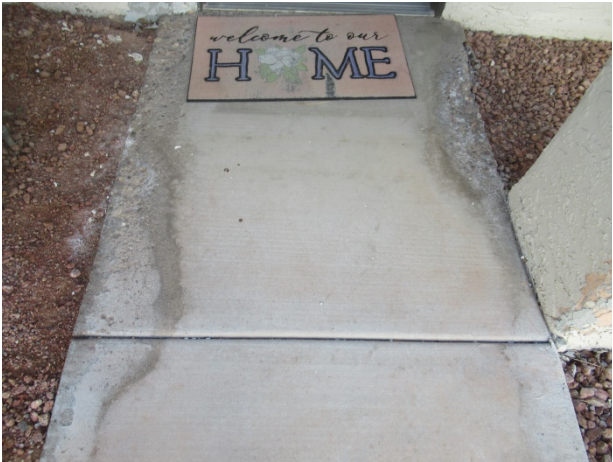
**Condition:** Fair overall with typical spalled concrete throughout the community evident. These spalls are likely the result of irrigation over watering.

**Spalled concrete**

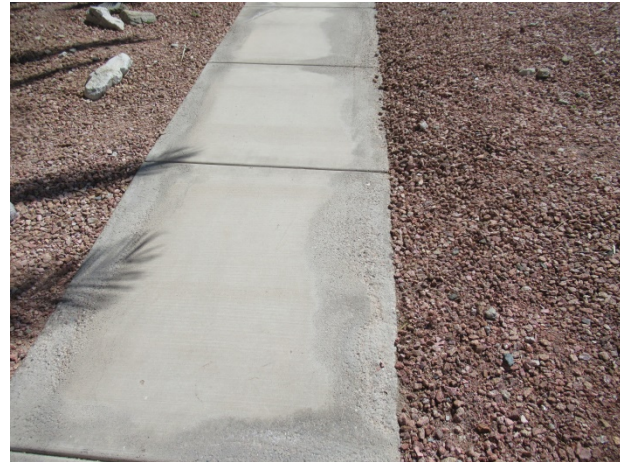
**Spalled concrete**

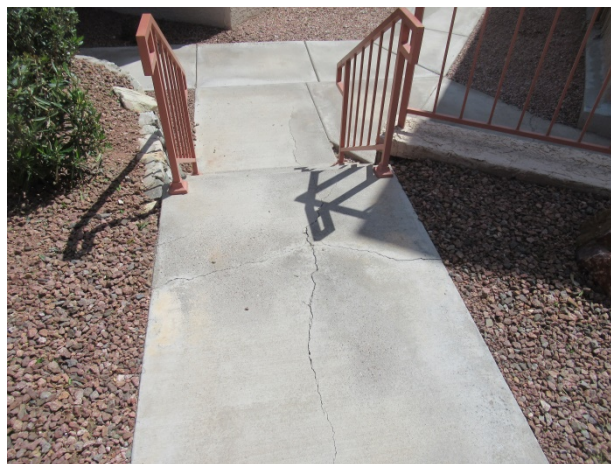
**Sidewalk cracks**

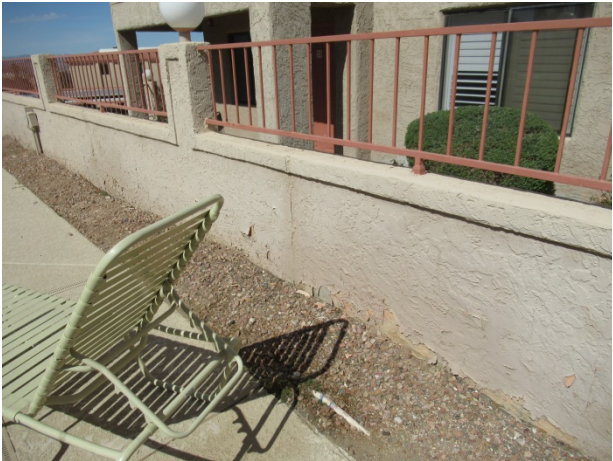
**Condition:** Fair overall condition with rust and corrosion evident

**Pool fence**

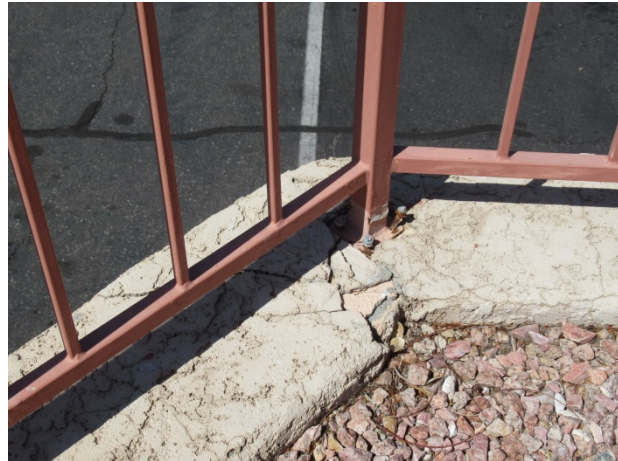
**Retaining wall coping and fence post deterioration**

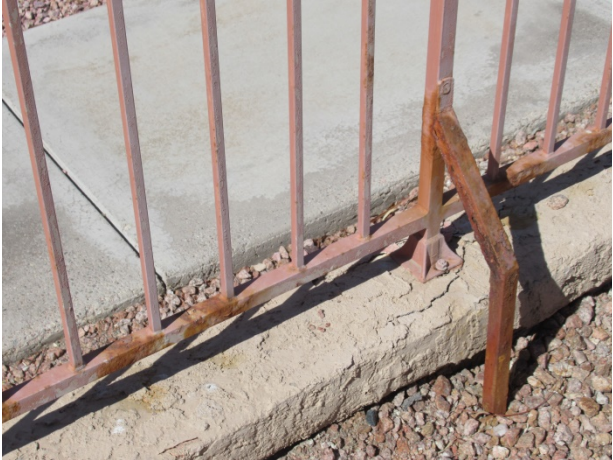
**Area of corrosion at pool fence**

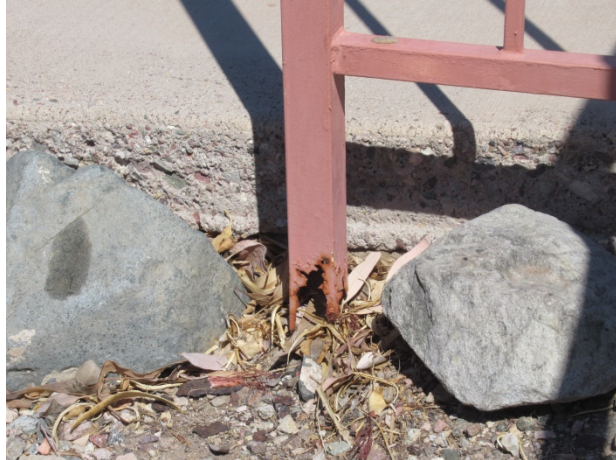
**Corroded post at sidewalk across from Buildings 4 and 5**

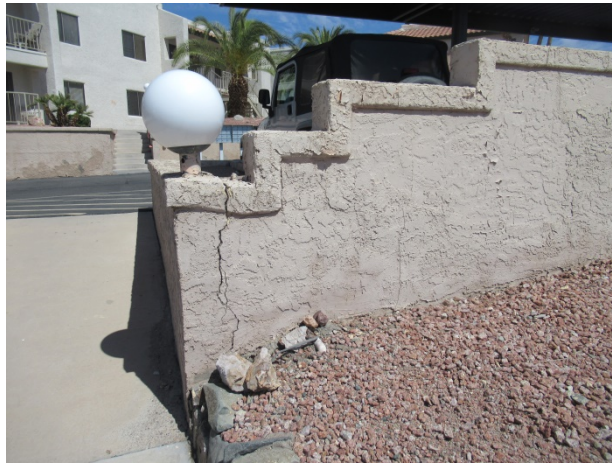
**Condition:** Fair overall

**Light fixture, note perimeter wall crack**

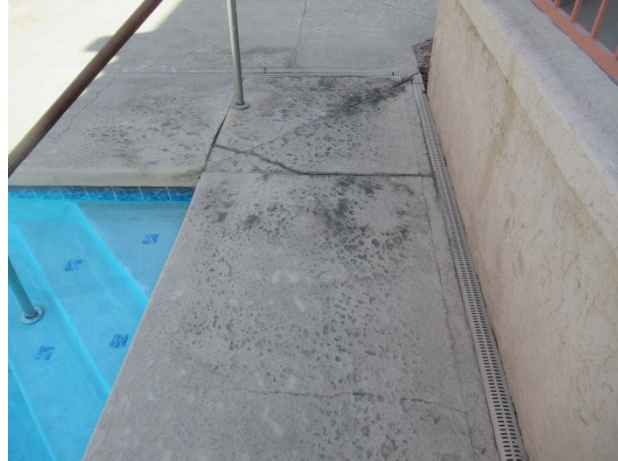
**Condition:** Good to fair condition with limited coating deterioration and isolated cracks evident

**Minor cracks and coating deterioration**

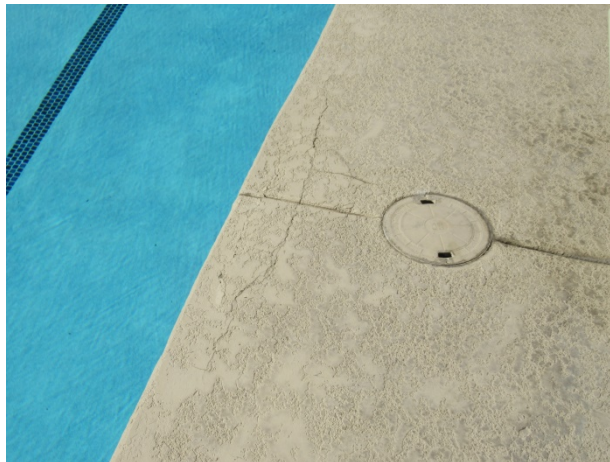
**Cracks near edge**

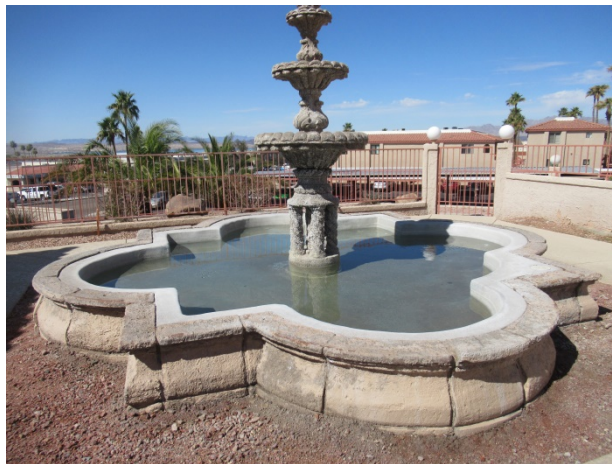
**Condition:** Good to fair with coating deterioration evident

**Fountain**

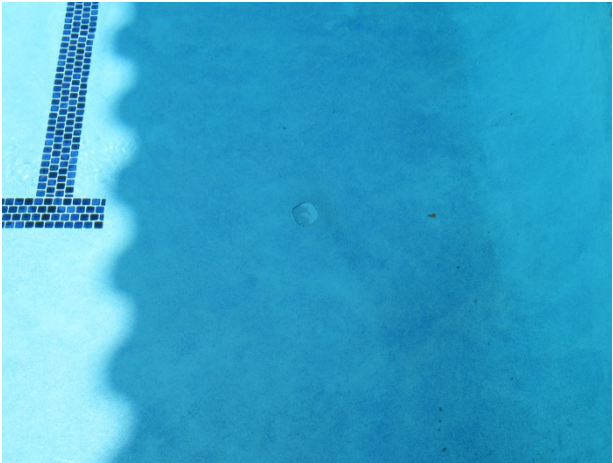
**Condition:** The main pool finish is in good to fair condition while the spa finishes are in poor condition.

**Chipped plaster at pool**
