The Wireless

December 2025

The Garden City

Mat-Matics # 126: HyGain Omni DX-88 Upgrades and Repairs

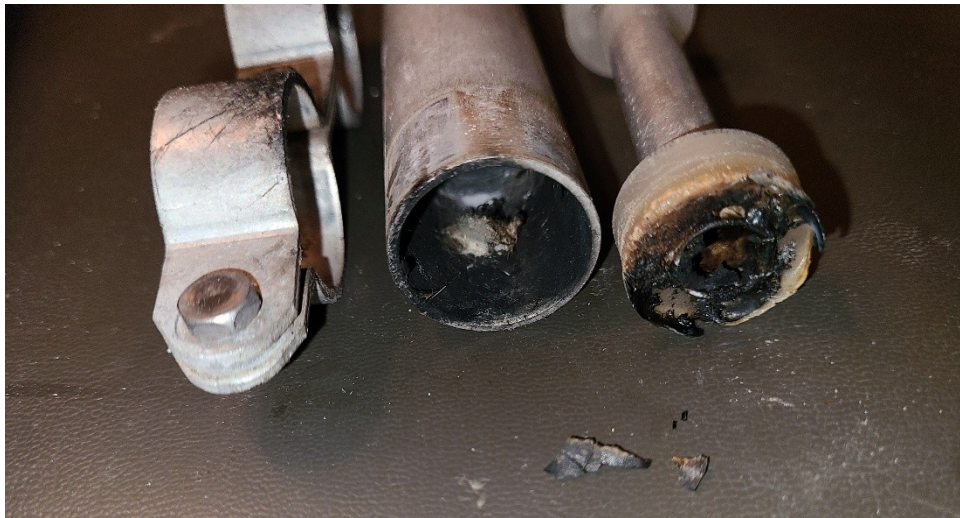
Having done only occasional tune-ups since installing the DX-88 in 2019, I decided it was time for a thorough cleaning. Upon disassembling the antenna, I discovered arcing inside the trombone capacitors of the 17M trap—likely caused by an insect or contamination that created a conductive path. This arcing persisted during transmission, leaving behind carbonized remains.

17M Trap Showing the Damage

I thoroughly cleaned all the parts and made sure any carbon was removed. I reassembled the entire antenna. During the process I also fixed a couple other concerns in different parts of the antenna. Upon testing the 17M (and all the bands) worked correctly even under max power.

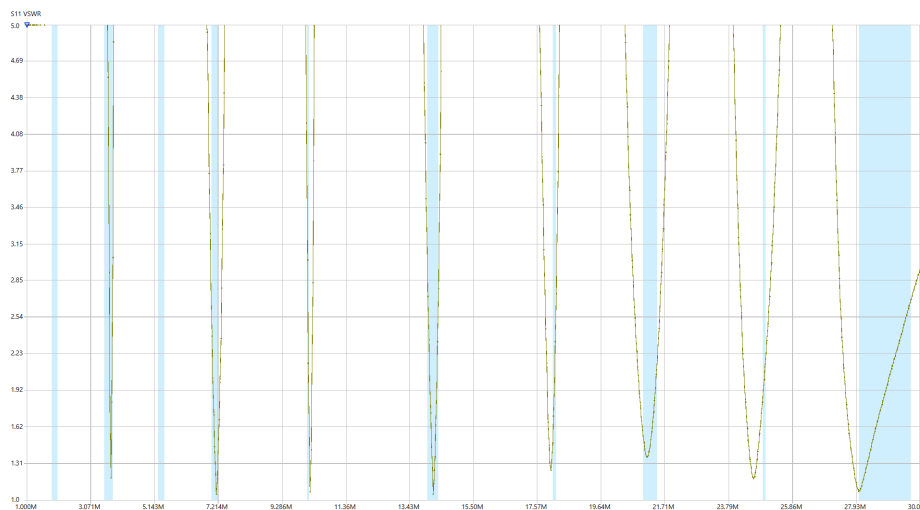
Reassembled antenna, before tuning: VSWR Chart

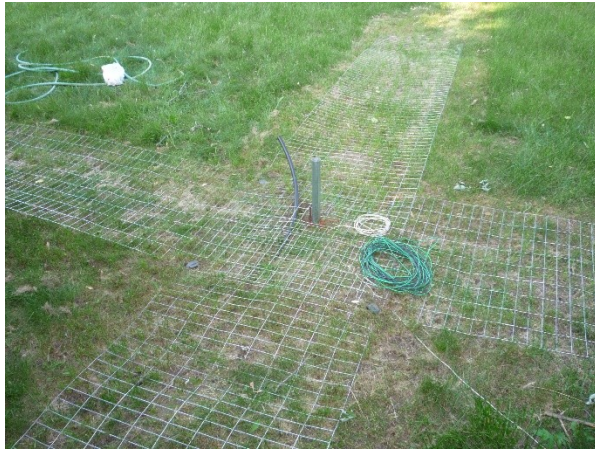
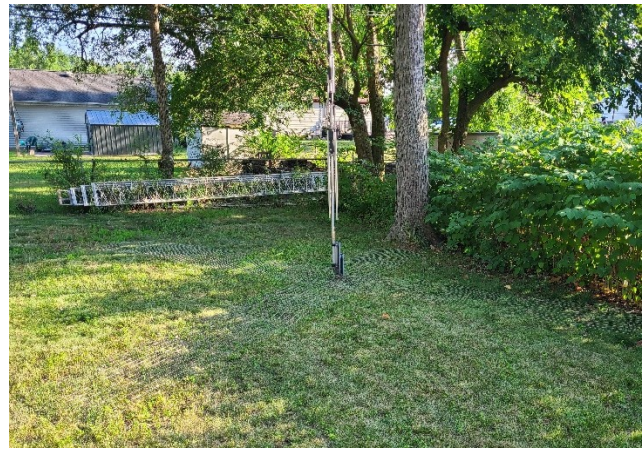
Original (left), Upgraded (right)

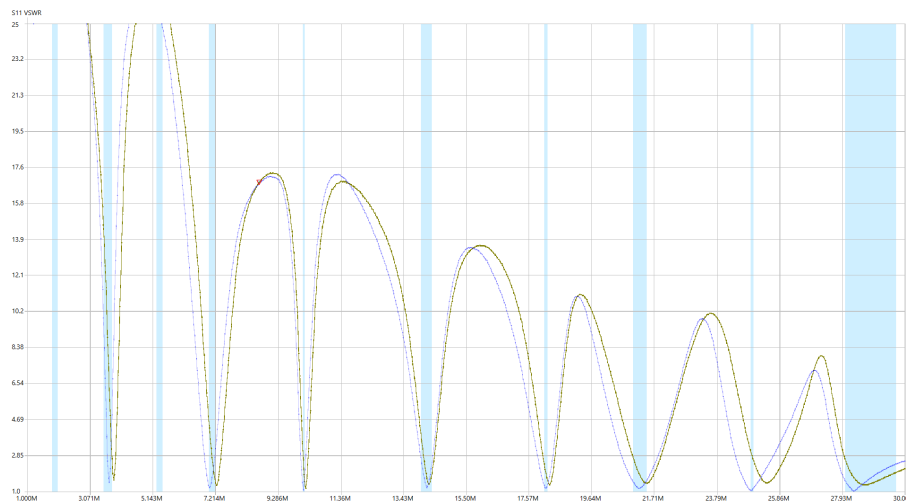
As one would expect, there was minimal effect on overall SWR. Shown below are VSRW plots from a recent measurement before the upgrade, and after. There was a slight shift in the resonance points which necessitated re-tuning.

Original in blue, upgraded in green

Based on this behavior, I believe the new ground plane increased the capacitance effect of the antenna with respect to ground, electrically shortening it slightly. This would seem to make sense as the larger surface area of the ground plane *should* result in additional ground capacitance.

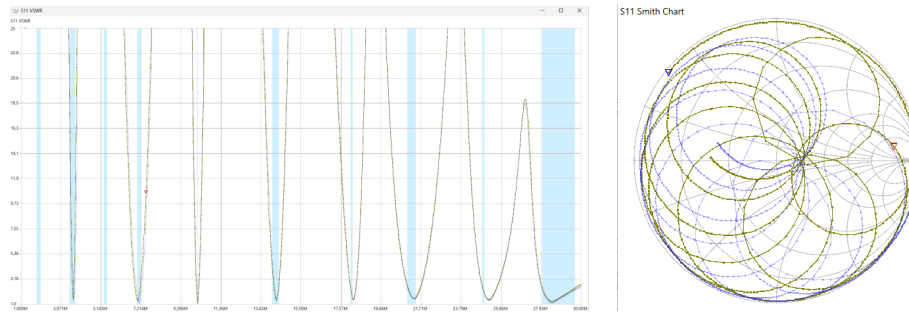
I originally tried adding the coil back in 2021 with the original ground plane. I made the coil to the HyGain specifications and did before and after installation measurements. The parallel (aka shunt) coil shifted the impedance as predicted. The overall effects are very minor and there is minimal, if any, improvement to VSWR. At the time I removed the coil.

Without (blue) and with (green) coil

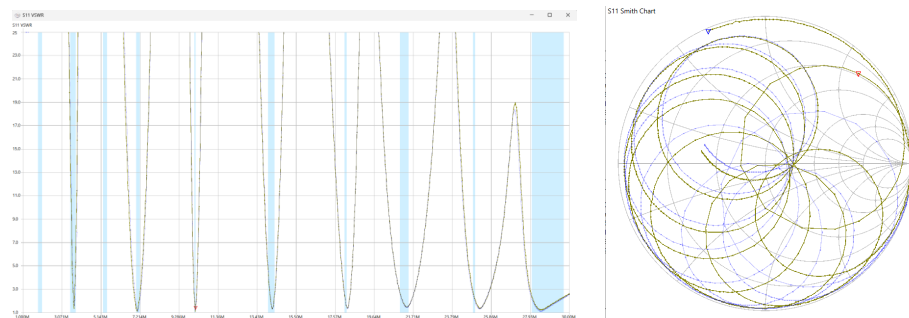
Now years later I made a new coil with a higher inductance (more wire turns on the form). I then tried this new coil to see if I could see any improvement. There was none ... the differences between having the coil and not were even smaller ... predictable.

Before (blue) and after (green) with larger shunt coil

I decided to keep the larger shunt coil on the antenna: although it doesn't improve the lower-band VSWR as advertised, it does prevent static buildup and provides a local lightning path to ground.
