Analysis of Audi 2.7L Block Failures Without the Use of a VAST Girdle

June 2018

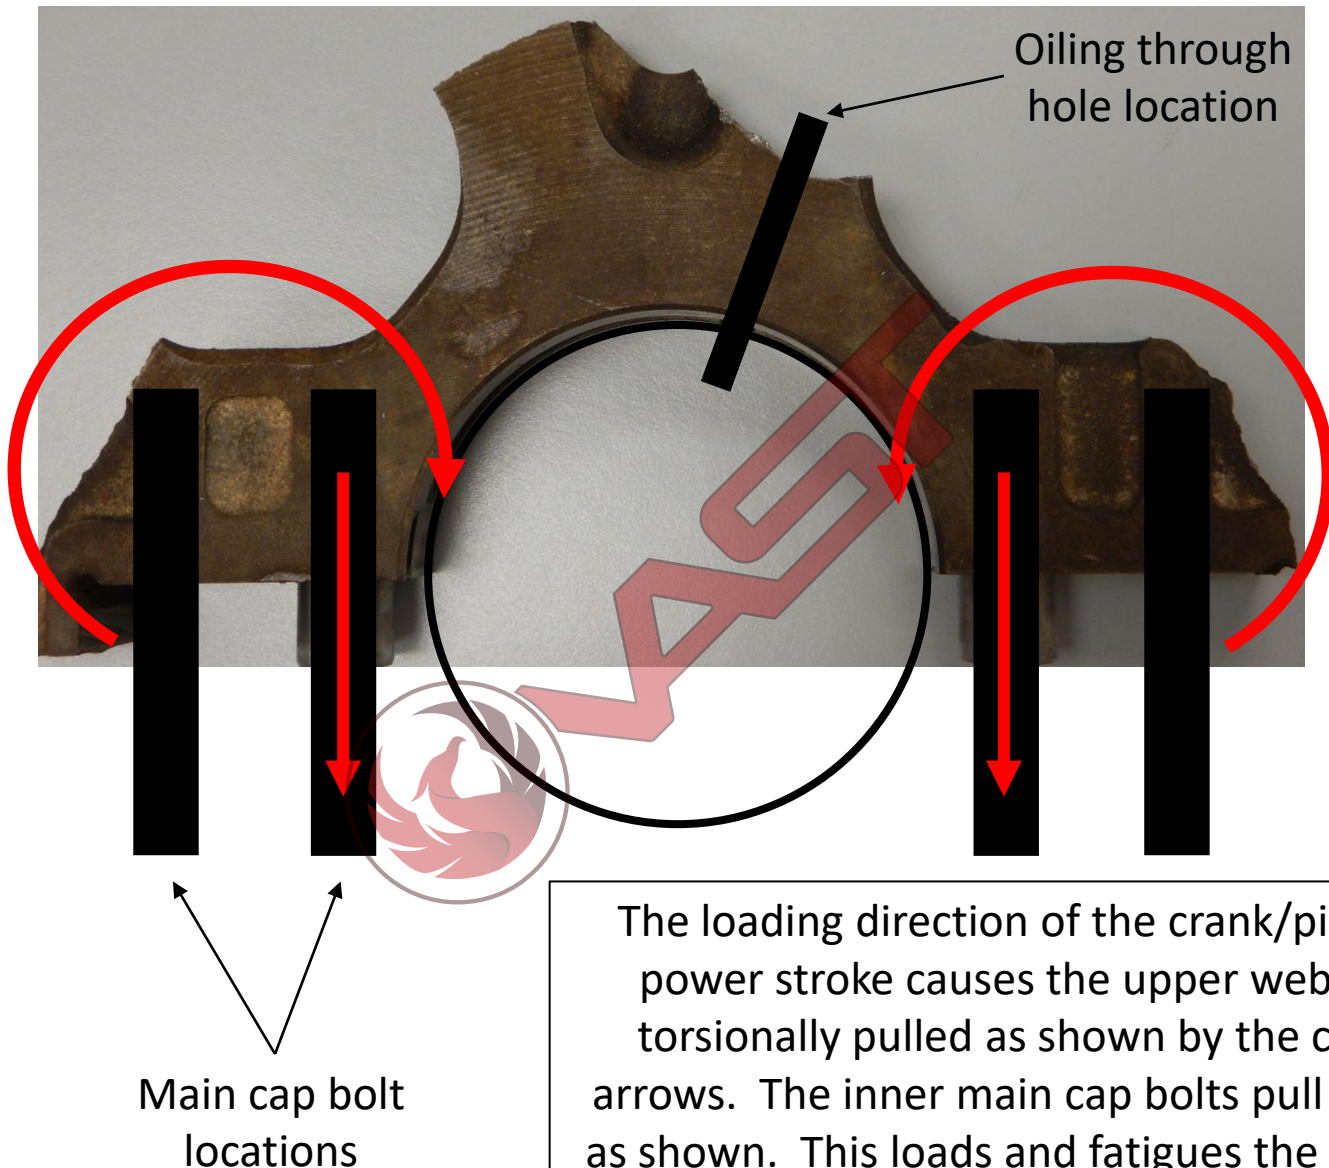
VAST Failed Block Main Support (for example)

The loading direction of the crank/piston on the power stroke causes the upper webbing to be torsionally pulled as shown by the circular red arrows. The inner main cap bolts pull on the block as shown. This loads and fatigues the smaller cross sectional areas shown in the following pages, eventually to failure.

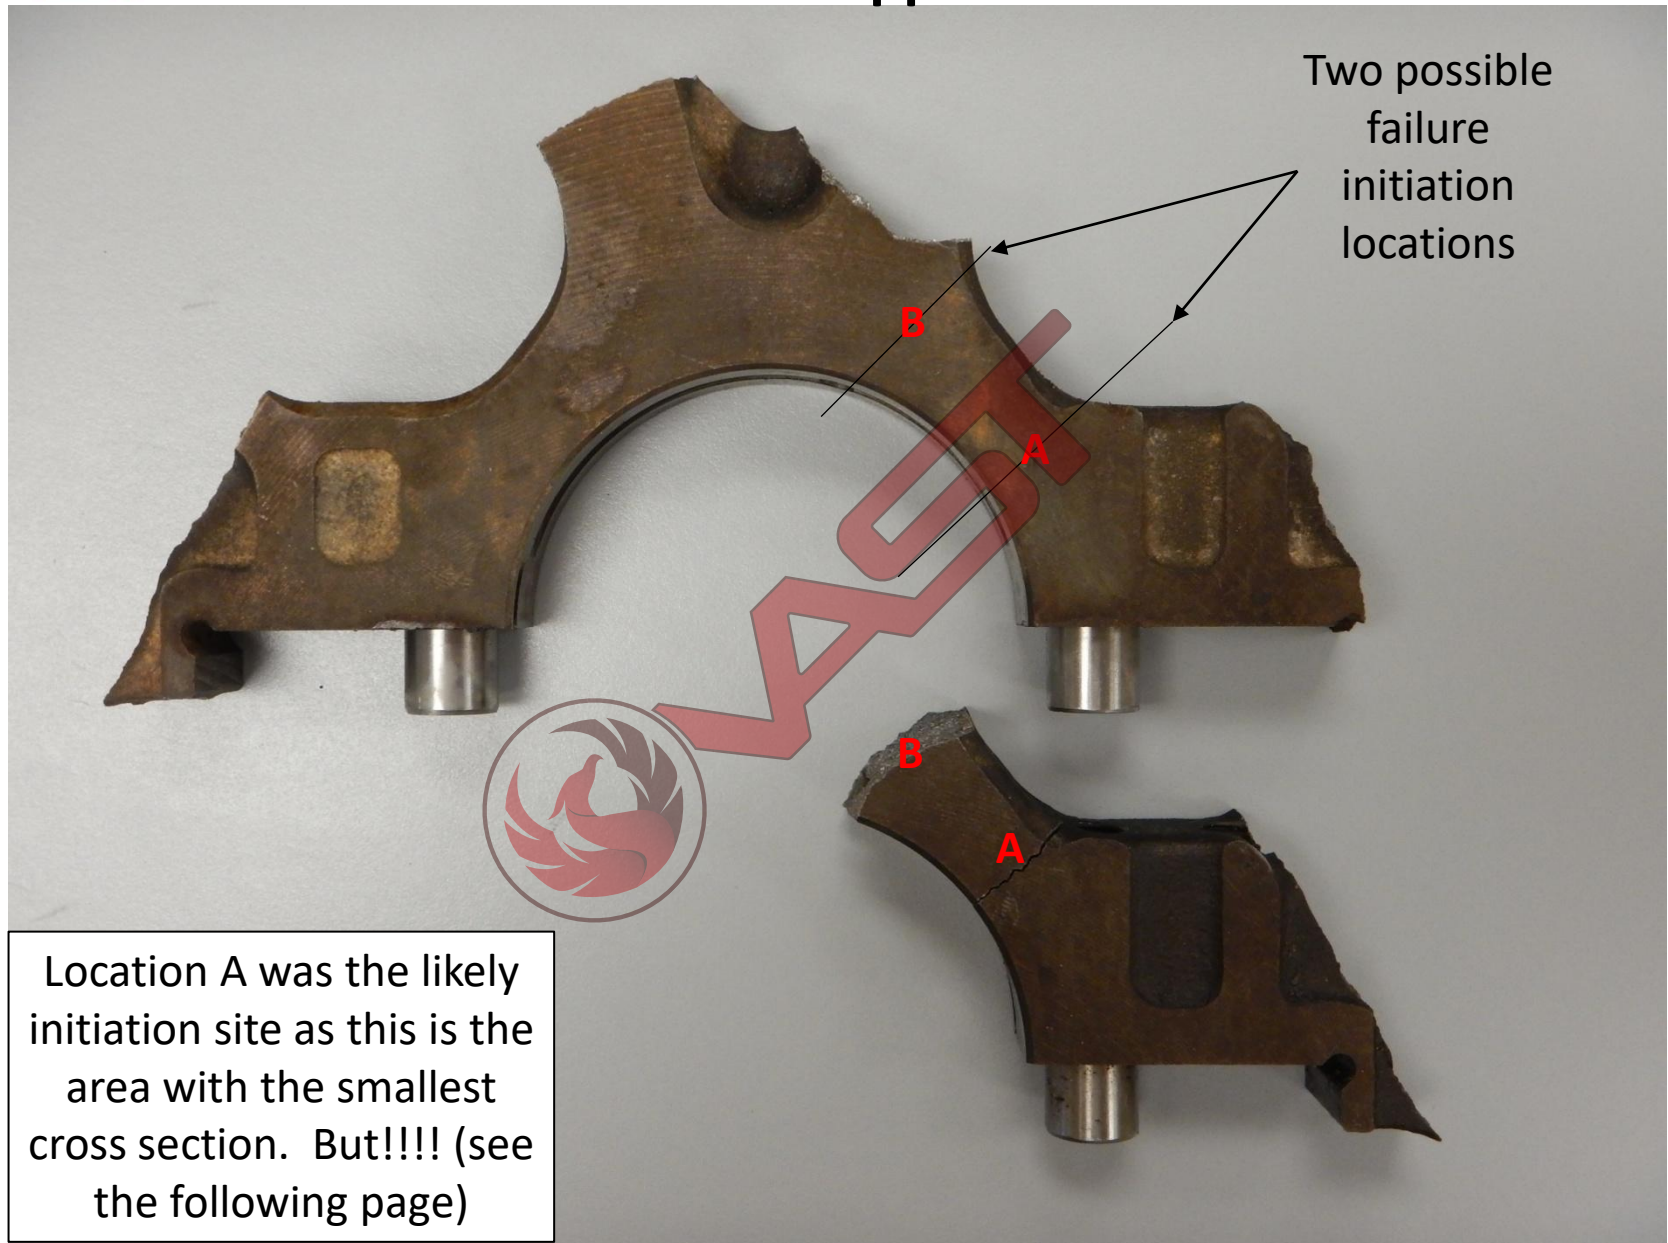
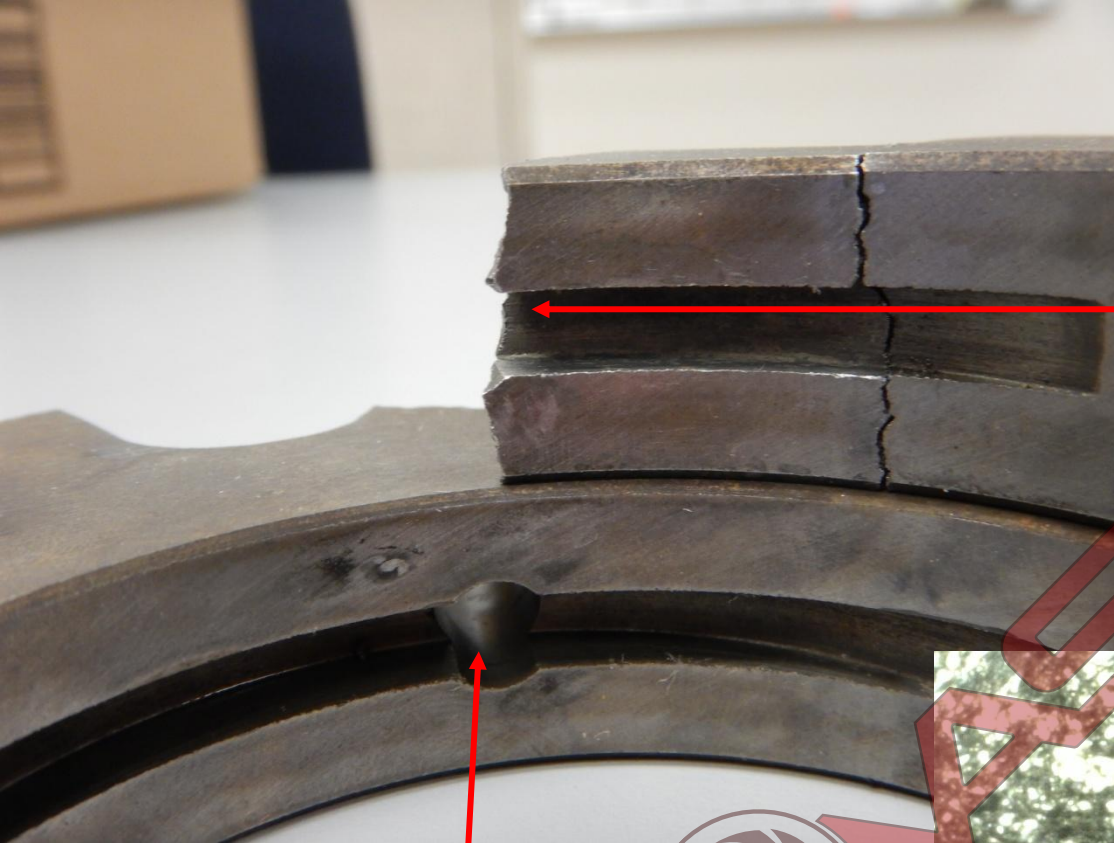
Failed Block Main Support Parts

This break initiated at the inner diameter, of the groove, coincident with the edge of the oiling hole.

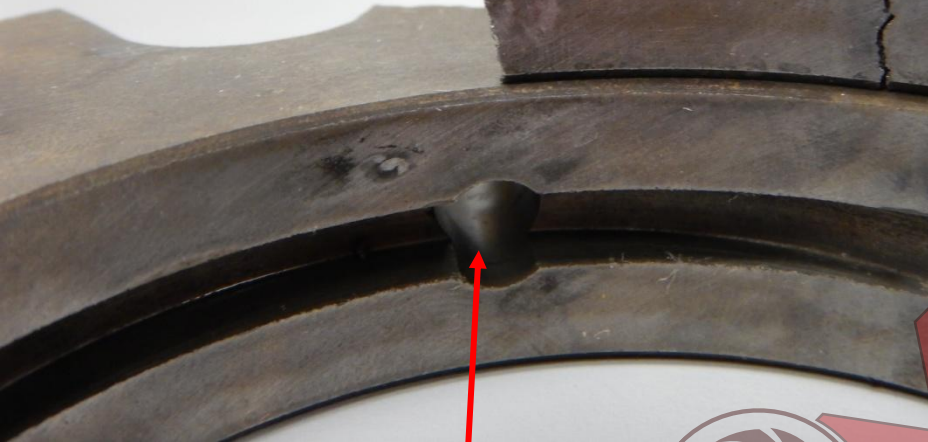
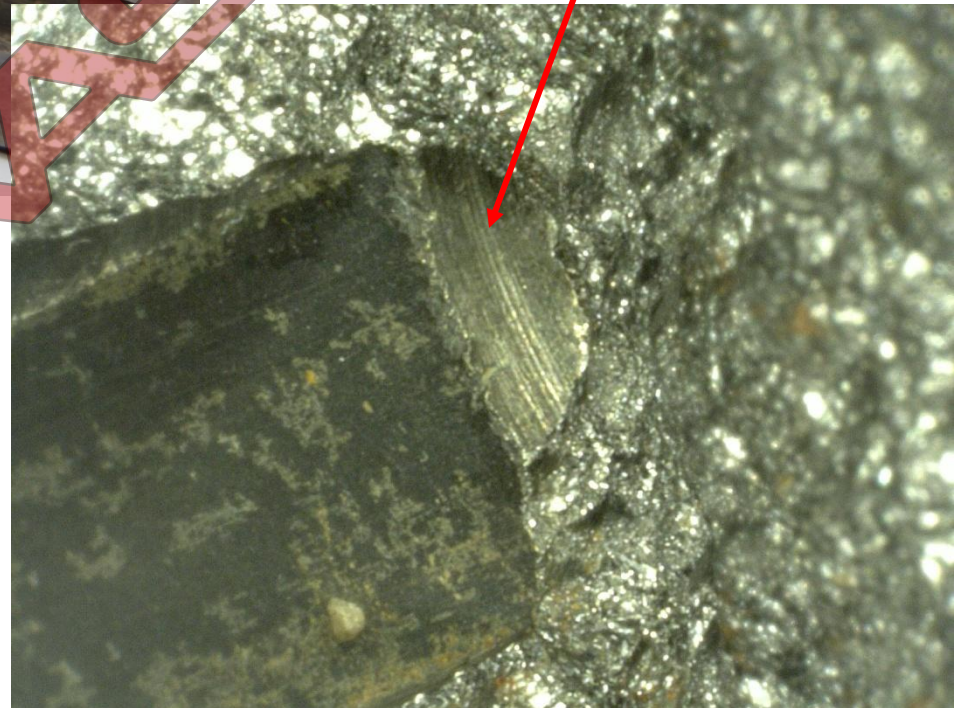
The cross sectional area of the block in the location of the through oiling hole is about the same as the other break location next to the main cap bolt through hole. And the oiling through hole creates a stress concentration area that could quickly initiate fatigue in the material.

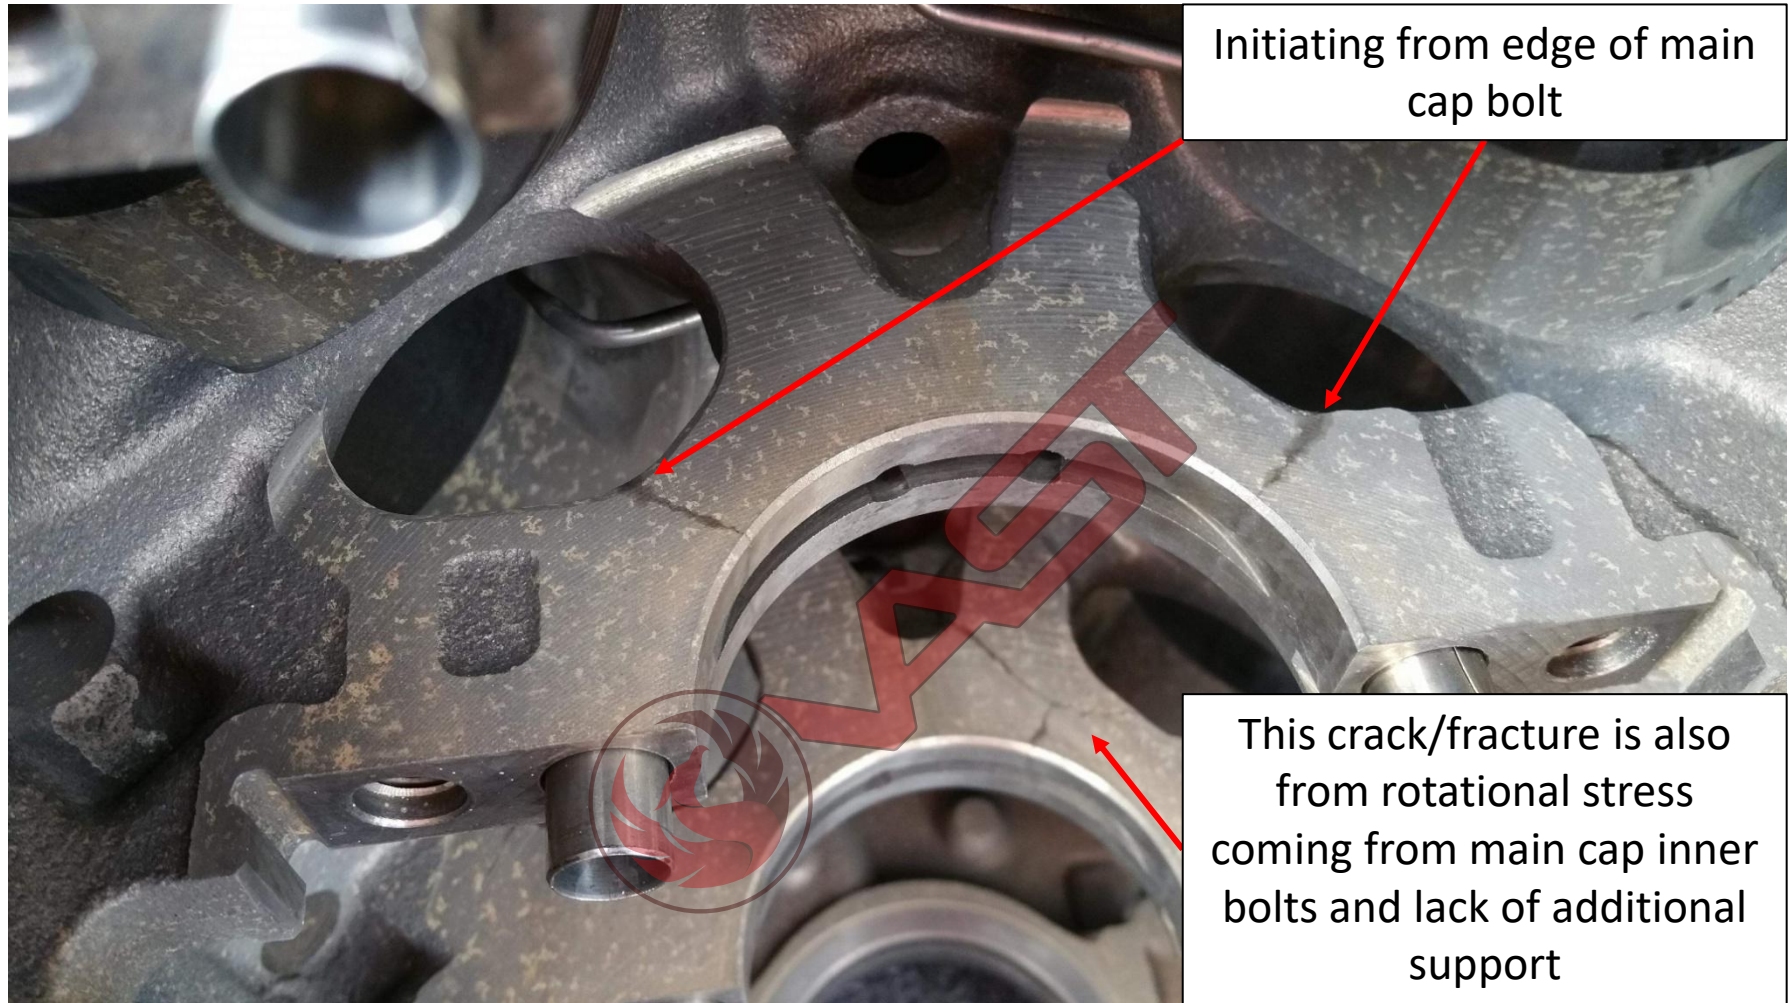
Another Block Failure (No Girdle Used)

This block is a failure that occurred a few years ago. It shows the same location of failure initiation at the inner main cap bolts where they come through on the block webbing side. In addition a crack (in the background) is occurring in the area of the oiling hole. The same failure mechanism is occurring here as previously described. As this block stayed together, it is an excellent representation of where the cracking initiates as described in this analysis.
