TYPE OF BUILDING *Ranch, Frame, Stone Veneer*

Inspection Summary

J&K PROPERTY INSPECTIONS

Record 092018 - Sample, Report 12345 Anchor Street, Denver, CO 80008

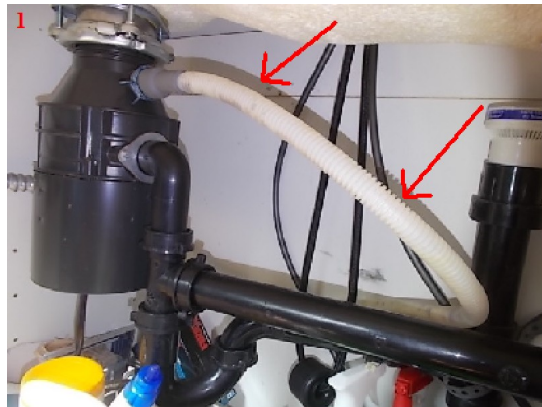
Kitchen Drain and Trap

There should be a loop in the dishwasher drain line above the point where it drains into the disposal to prevent disposal debris from draining back into the dishwasher drain line.

Contact a qualified plumber to evaluate and make repairs.

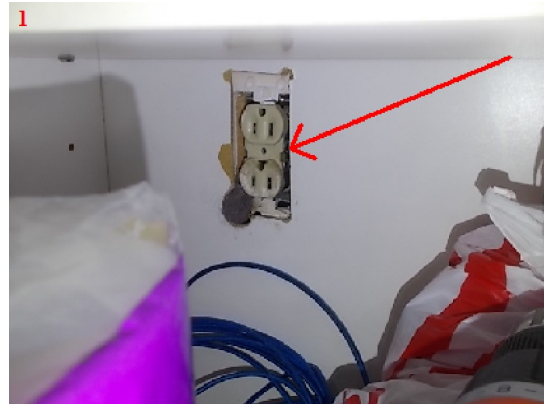
Kitchen Wall Receptacles

Missing electrical outlet cover plate noted in the kitchen lower cabinet. Covers should be installed to prevent electrical shock hazards and keep wiring / arcing contained. A qualified electrician should evaluate and make all needed repairs.

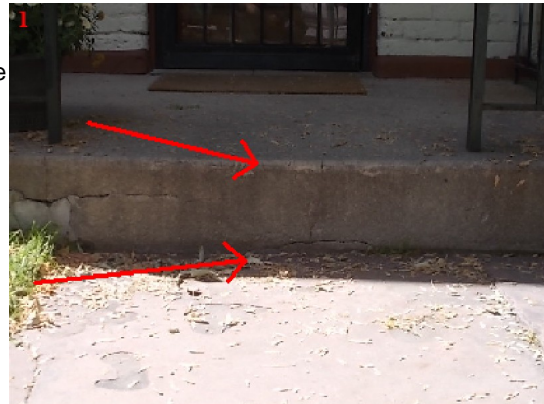
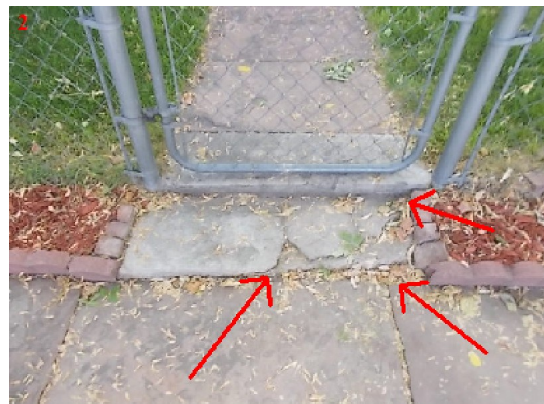
Steps

Excessive step height leading from the front sidewalk to the porch. The step height should not exceed 7 3/4 inches. Uneven stepping area also noted at the connection between the sidewalks located at the street. These locations may create a trip hazard and should be repaired. A qualified contractor should evaluate and make any needed repairs.

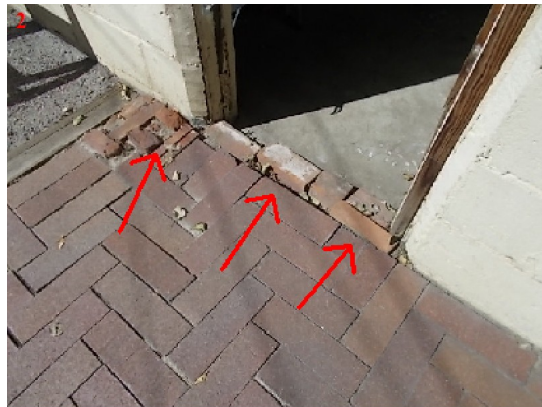
Patio

Settling and movement noted in the back patio brick pavers. This movement has created uneven stepping areas that may create trip hazards. This settlement has most likely occurred due to poor drainage of roof and surface water at the Northwest corner of the house. These areas should be evaluated and properly repaired by a qualified contractor.

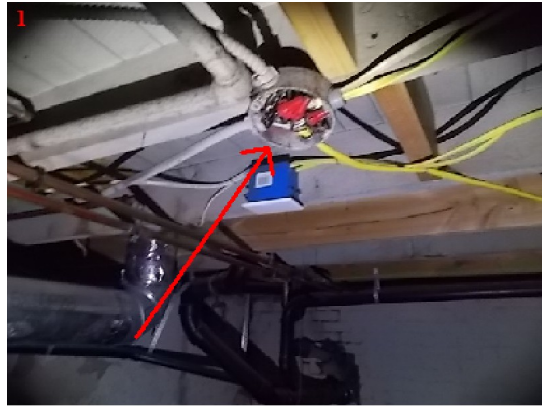
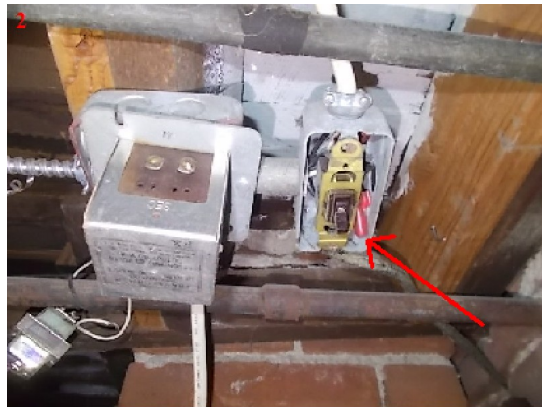
General House Wiring

Missing or damaged electrical cover plates noted in the basement area. Cover plates should be installed to prevent electrical shock hazards. A qualified electrician should evaluate and make corrections.

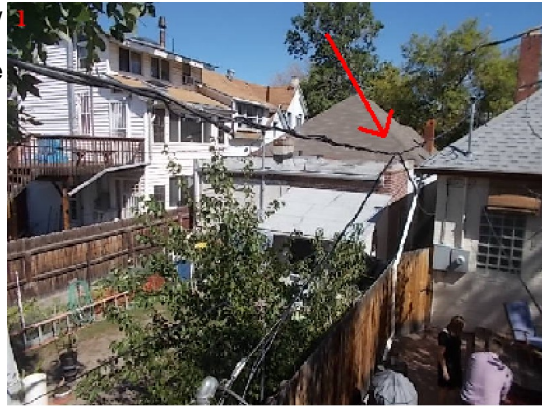
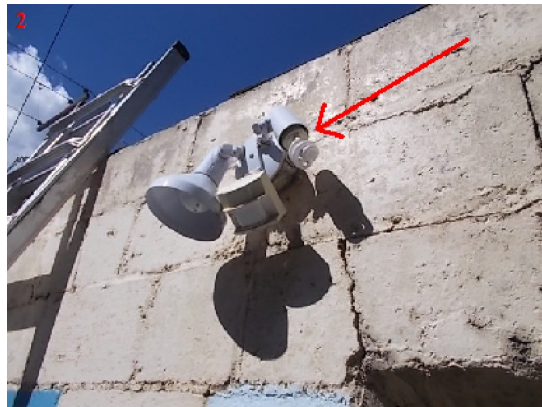
Excessive length of garage power supply wiring. This has allow the garage supply wiring to come in contact with the house supply wiring. Proper repairs and adjustments should be made to prevent hazards and damage to the these materials. A qualified electrician should evaluate and make corrections.

Missing or damaged light fixture cover noted on the South wall of the detached garage. Covers should be installed to prevent water intrusion and bulb damage. A qualified electrician should evaluate and make corrections.

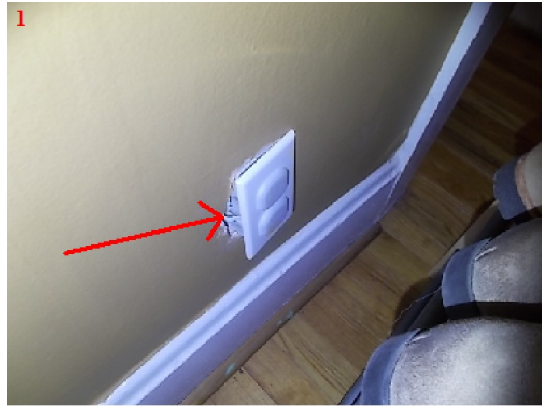
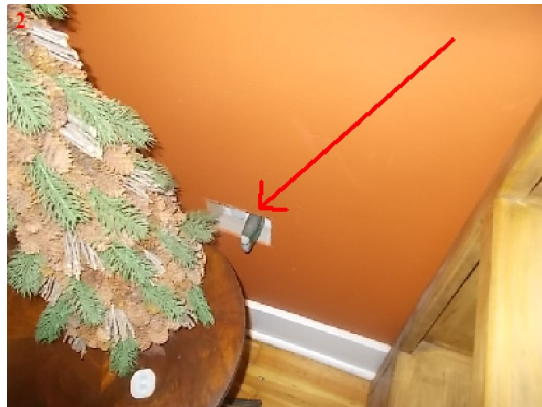
Loose electrical outlets noted in the South wall of the center bedroom. Loose outlets may cause short circuits in wiring and should be secured.

Dead electrical outlet noted at the South wall of the living room. Outlet should be repaired or replaced to allow for correct use and prevent the use of extension cords.

A qualified electrician should evaluate and make all needed repairs.

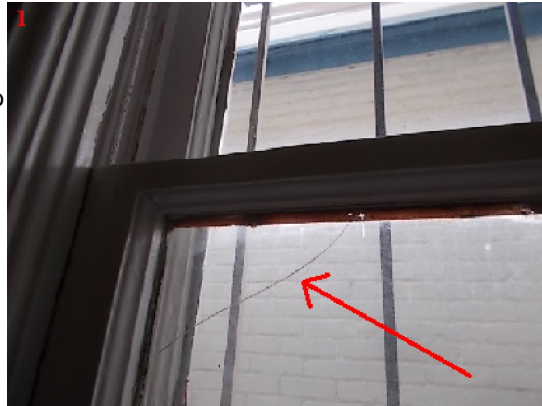
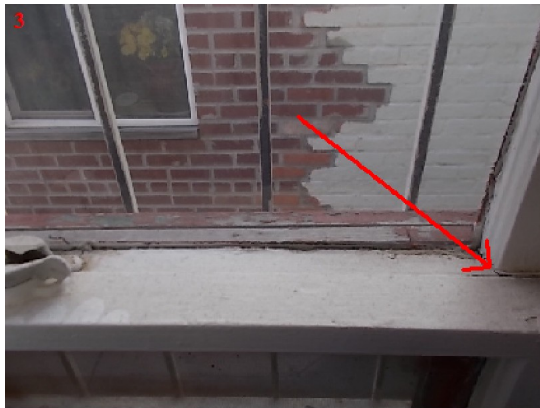
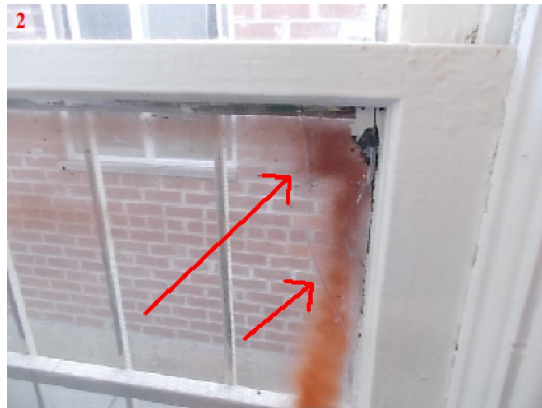
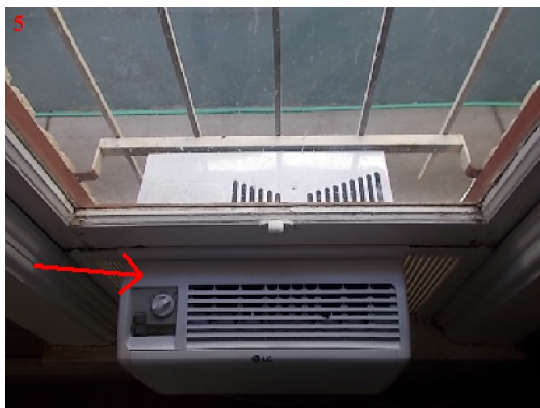
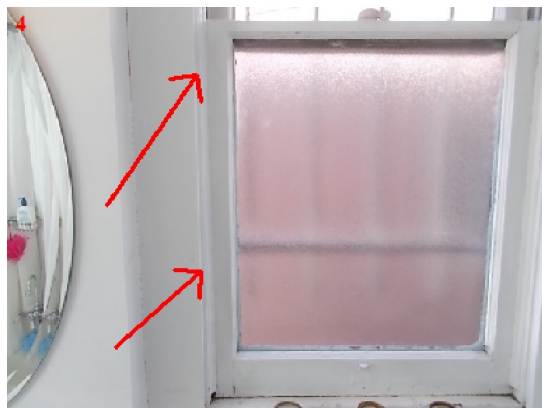
Broken glass noted in window pane at the East bedroom and center bedrooms closet. Glass should be replaced by a qualified professional to ensure proper operation and safety. Windows should be serviced by a qualified window contractor to ensure proper operation and security.

Windows located in the center bedroom and full bathroom do not open properly. Adjustments should be made to allow for correct and safe use of the window unit. This can create a hazard in the event of an emergency fire exit. This should be evaluated by a qualified contractor to determine needed repairs.

Missing screens noted in the kitchen. Screen should be replaced to prevent pest intrusion. This should be evaluated by a qualified contractor to determine needed repairs.

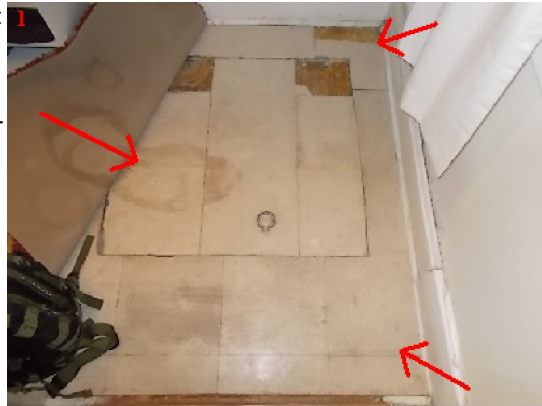
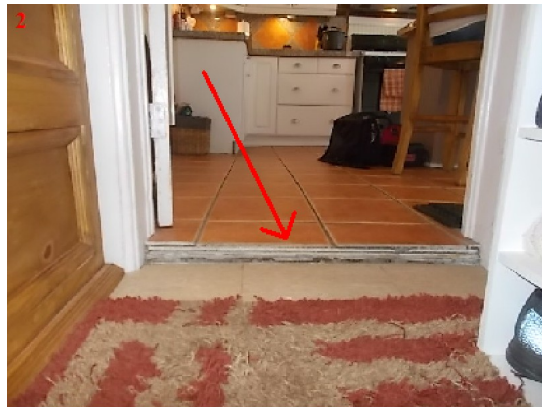
Interior Floors

Vinyl flooring located in the center bedroom closet appears to fit the style and time period when asbestos was used in building materials. The removal of asbestos vinyl sheet flooring should only be done by a licensed abatement professional since this material is considered hazardous. Contact a qualified contractor to evaluate and make needed repairs.

Uneven floor area and missing threshold noted between the center bedroom closet and kitchen. This creates a trip hazard and should be adjusted. Contact a qualified contractor to evaluate and make needed repairs.

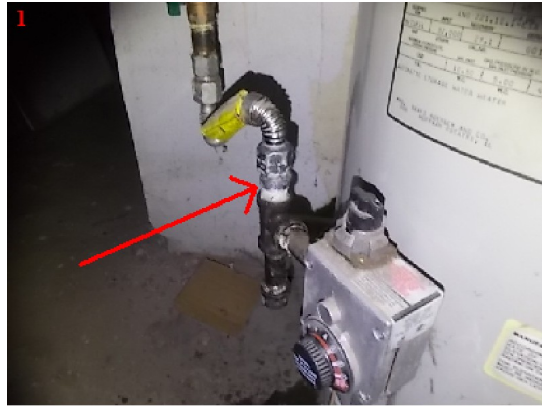
Water Heater Gas Piping

Gas leak at gas line joint to the water heater located on the basement level. Repairs should be made immediately. Contact a qualified contractor for needed correction.

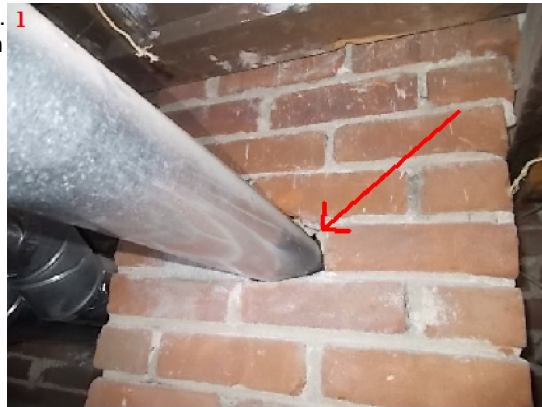
Flue Piping 1

Furnace and water heater flue pipe are vented into the chimney. All cracks at this connection should be sealed to prevent carbon monoxide hazards. Flue pipe system should be evaluated by a qualified heating contractor and all needed repairs made.

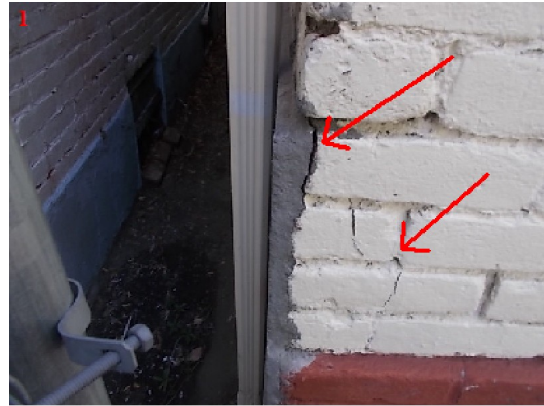
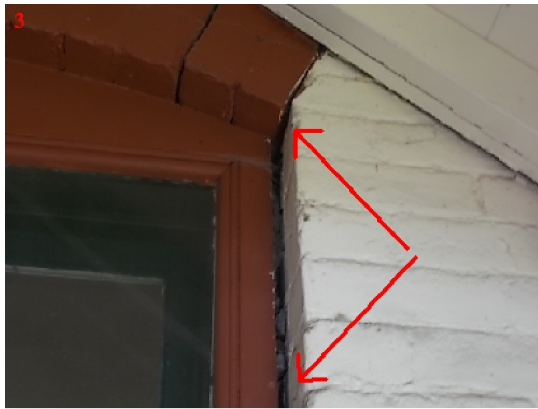
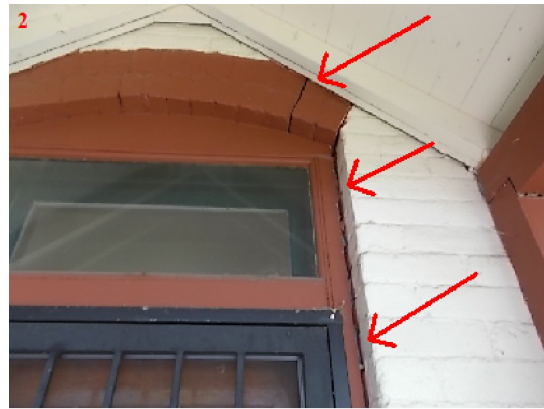
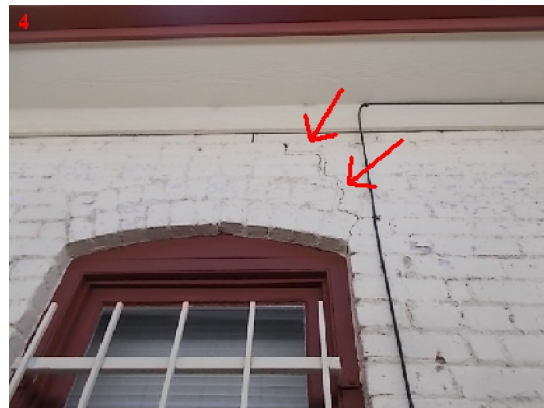
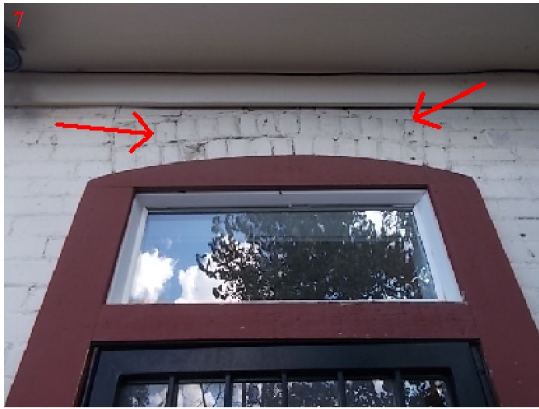
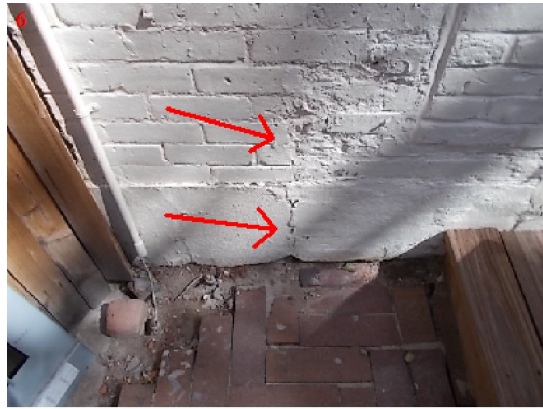
Masonry Walls

Cracking noted in the brick work at all sides of the house. Cracking may be due to previous poor drainage of roof and surface water, along with deteriorating mortar. Cracks should be properly patched or sealed to prevent water intrusion. Mortar and exterior paint should also be sealed to prevent further deterioration. Due to the large number of cracks and possibility of structural damage if repairs are not properly made in the near future this is considered a major concern. For further information I recommend contacting a structural engineer or contractor. Repairs should be made by a qualified contractor.

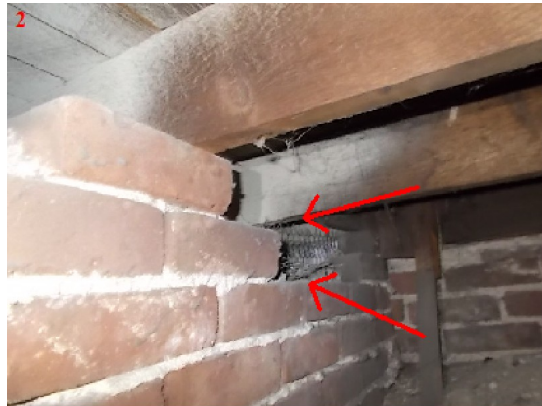
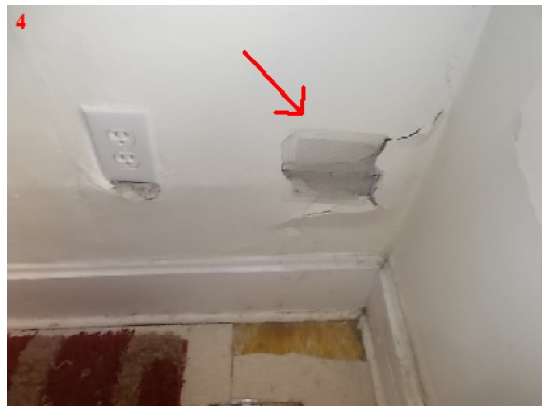
Structural Columns Crawl Space

Structural wall or brick work appear to be deteriorating. This deterioration in the mortar between the brick has allowed for movement and falling bricks. Missing bricks at these locations create excessive movement in the floor joist resulting in cracked floor grout, cracked counter top grout and cracked wall plaster. Additional support should be added at these locations to prevent further movement and damage. Mortar in the structural wall should be repointed and repaired to prevent further deterioration. This should be evaluated by structural contractor and all needed repairs made.

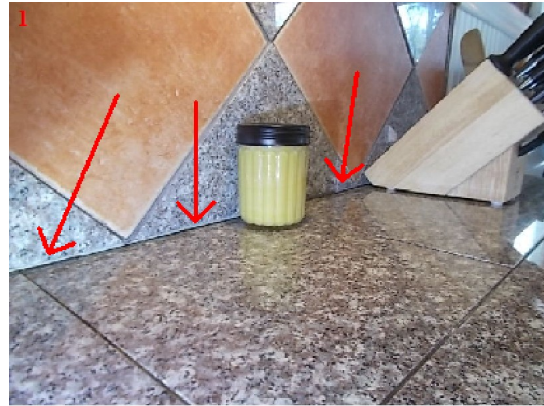
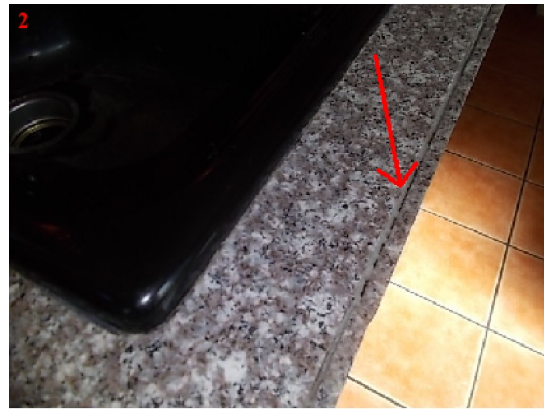
Countertops

Cracked or missing grout / sealant where the counter top material meets the back splash. This can allow water to intrude and run down the wall causing potential hidden damage . A flexible sealant such as silicone or caulking should be used to prevent continuous cracking
Contact a qualified contractor for repairs.

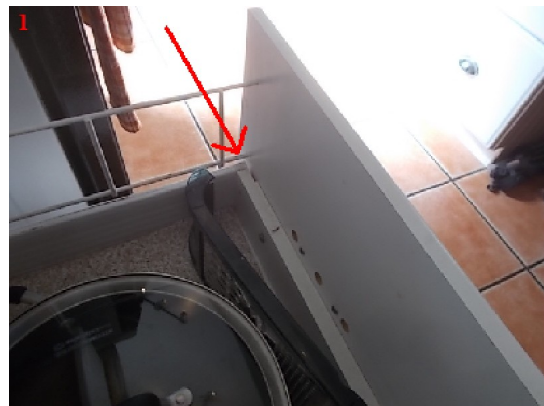
Kitchen Cabinets

Loose cabinet drawer front noted at the left side of the range. Front should be properly fastened to prevent loss of material and further damage.
Contact a qualified contractor to evaluate and make needed repairs.

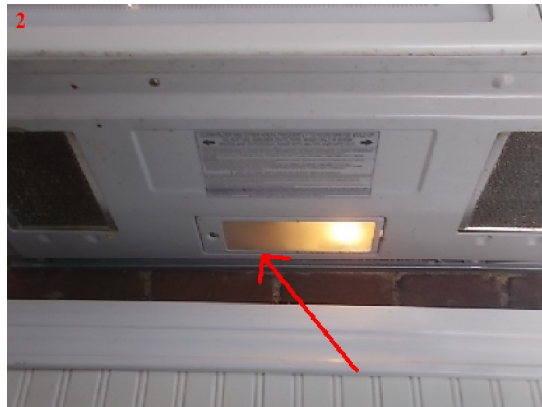
Exhaust Fan Hood

Damage noted at the front door / cover of the microwave unit. This appears to be only cosmetic. However, repairs should be made to prevent further damage. Contact a qualified contractor for corrections.

One of the lights on the exhaust hood or microwave for the range cook top does not appear to be working at time of inspection. Light bulb should be replaced prior to contacting an appliance technician. Contact a qualified contractor for any needed repairs.

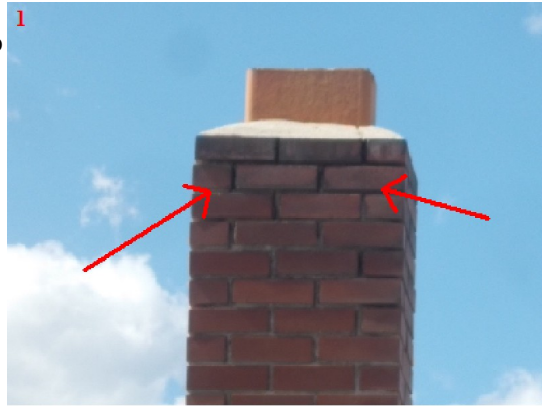
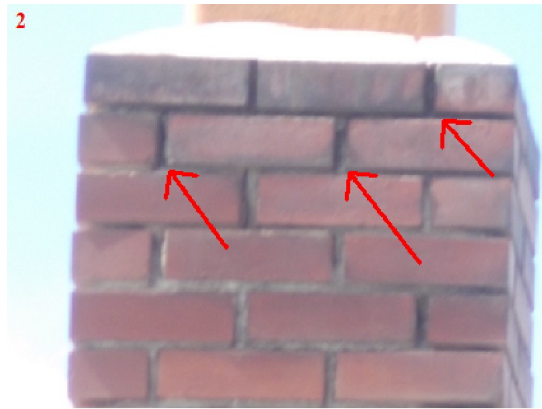
Chimney 1 Type

Some missing mortar noted between the brick work on the chimney. This may allow for water intrusion creating damage to the brick work. These locations should be repointed or sealed to prevent further deterioration. A qualified professional should evaluate and make proper repairs.

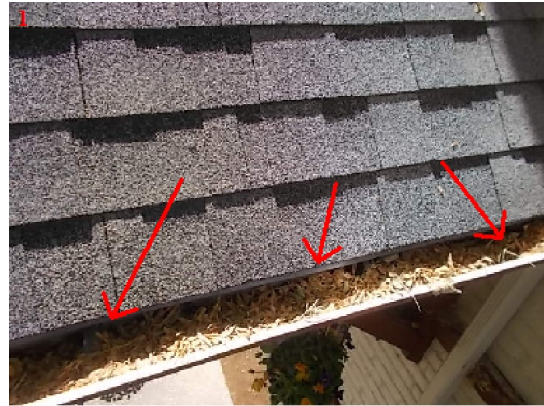
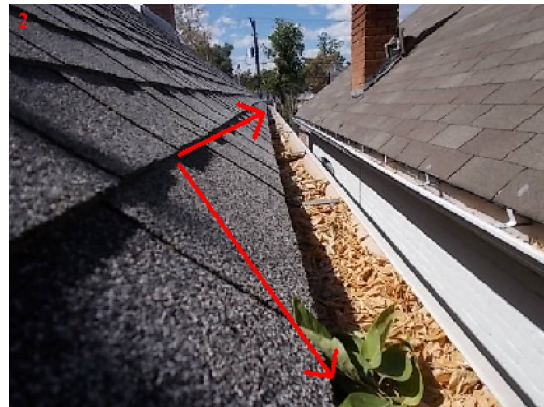
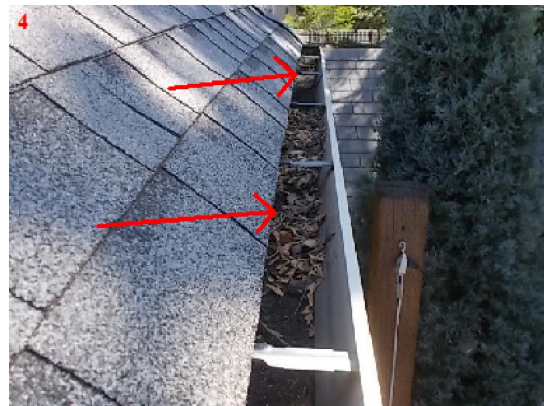
Gutter Type

The gutters are full of debris and should be cleaned so that water can drain properly. This will prevent water from overflowing the gutters causing damage to the soffit and fascia. Contact a qualified contractor to evaluate and make needed repairs.

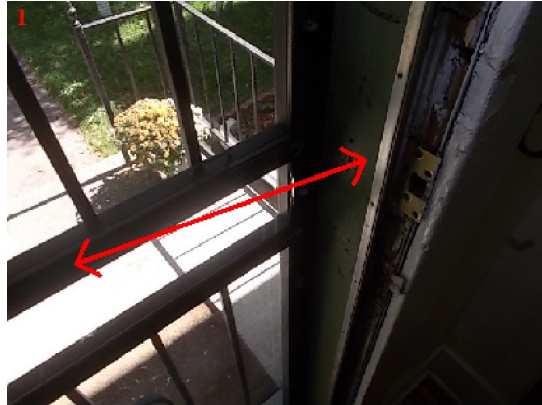
Main Entry Door

Self closing device is missing on the front screen door. The hydraulic cylinder is used to pull the door in properly and prevent the door from slamming shut. This may cause damage to the screen door if repairs are not made. Repairs should be made by a qualified contractor.

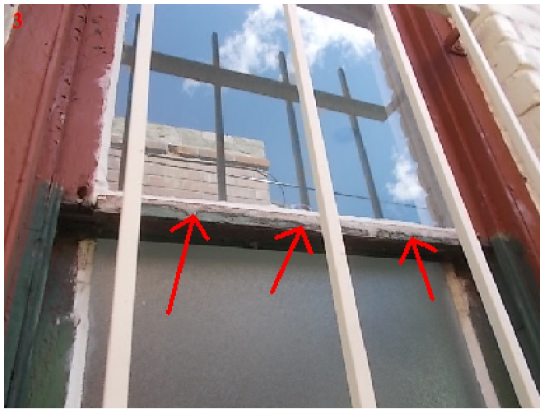
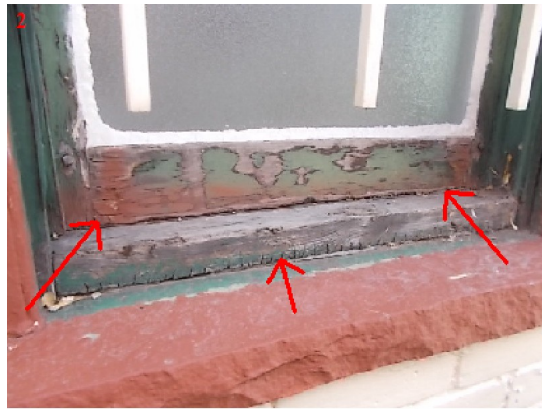
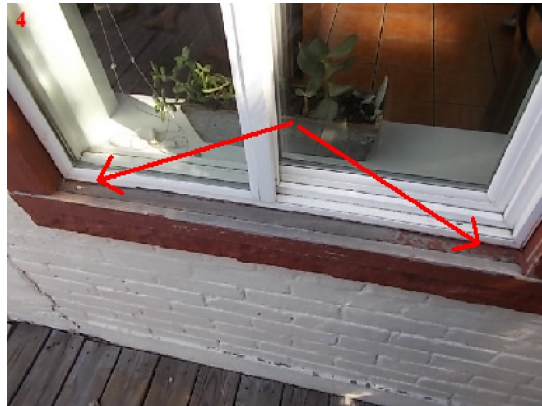
Trim Work

Chipping or peeling paint on exterior trim noted at windows. This should be scraped and repainted to prevent rot. All exterior wood products should be evaluated by a qualified contractor and all needed repairs made.

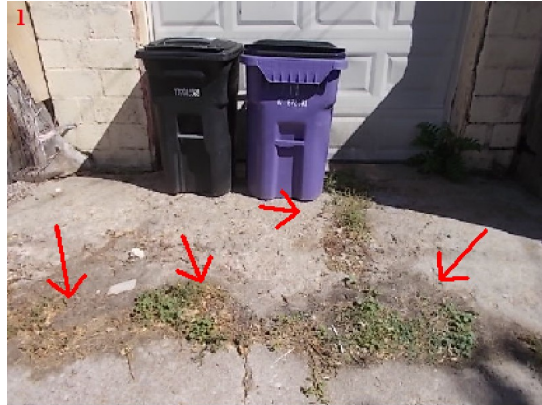
Driveway

Deterioration of driveway surface noted. Cracks should be sealed now and in the future to prevent water intrusion. Proper repairs may require slab removal and replacement. A qualified contractor should be contacted to evaluate and recommend needed repairs .

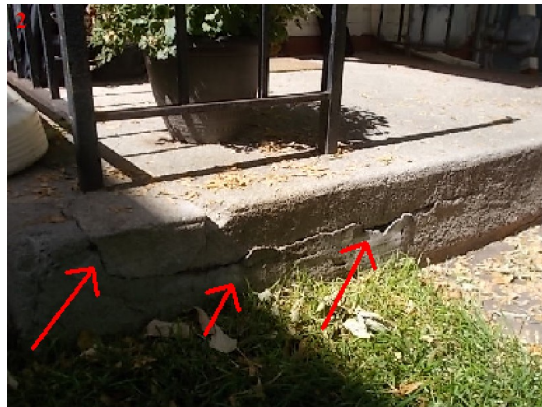
Porches

Some minor cracks noted in front porch concrete slab. Cracks should be sealed now and maintained in the future to help prevent further movement. A qualified contractor should make any needed repairs.

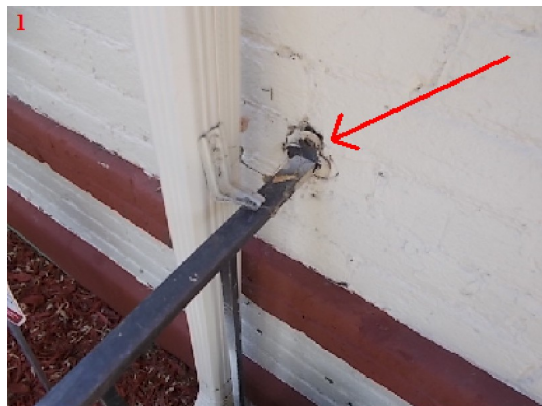
Exterior Railing

Railing leading to the front entry is loose and may create a fall hazard. The top section of the rail is not connected properly to the brick work or the anchor has come loose. This location does not require railing. However now that railing has been installed it should provide adequate support. A qualified contractor should evaluate and make needed repairs.

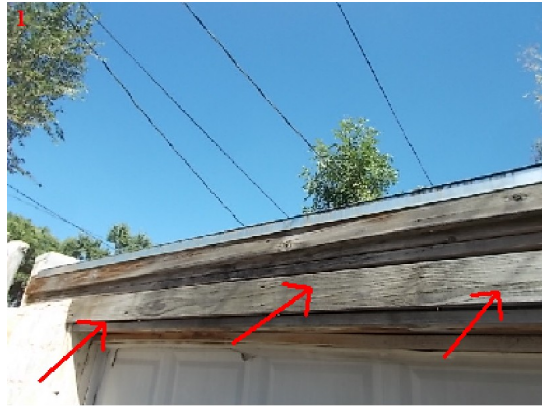
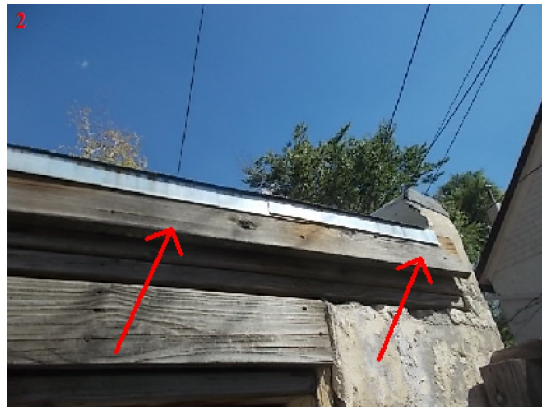
Garage Fascia\Soffit

Chipping and peeling paint on garage fascia boards should be scraped and repainted by a qualified professional. Neglect can cause material to rot. Contact a qualified contractor for needed repairs.

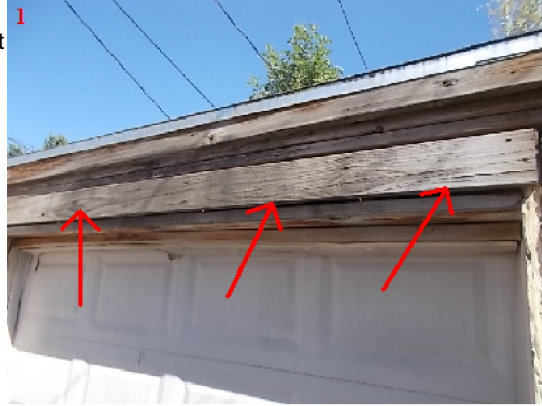
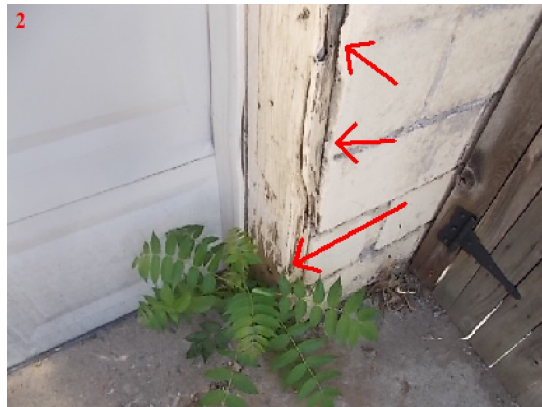
Garage Exterior Walls

Chipping and peeling paint on the exterior trim work at various locations around the detached garage. This will lead to wood rot if material is not properly sealed. A qualified contractor should evaluate and make any needed corrections.

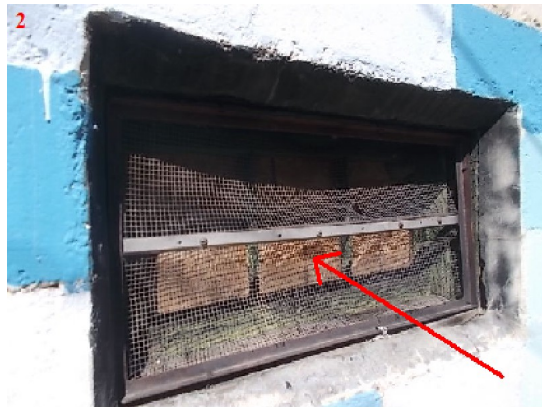
Garage Windows

Missing windows and improper repairs noted at the East and South sides of the detached garage. This locations may allow for water damage and also allows for intruder access. Windows should be serviced by a qualified contractor to ensure proper operation and safety.

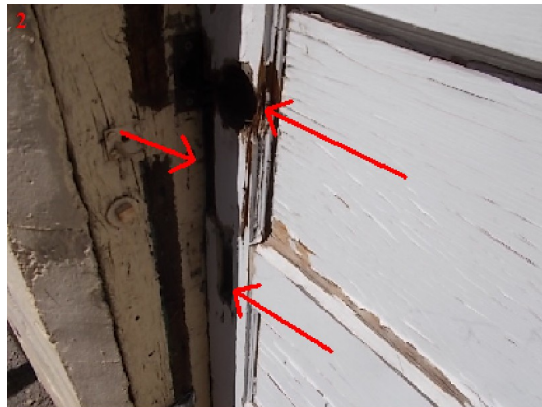
Garage Service Doors

Large amount of material damage, open holes, chipping and peeling paint on detached garage service door and frame. This should be scraped and repainted by a qualified professional. Neglect can cause material to rot. Missing weather stripping at this location can also allow for water intrusion to interior spaces.

Repairs should be made by a qualified contractor.

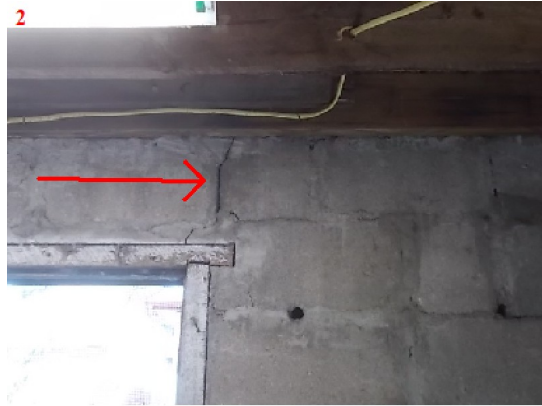
Garage Interior Walls

Cracked mortar noted at the North, East and South sides of the detached garage. This may allow for water intrusion resulting in deterioration and further movement. Cracking and movement is most likely due to poor drainage of roof and surface water at the various locations around the garage and down spout extensions. All mortar joints should be repointed or sealed after drainage has been repaired.

Improper repairs and openings noted at the header located directly above the garage vehicle door. This will allow for water intrusion and damage if not properly sealed on the exterior of the garage. Contact a qualified contractor for repairs.

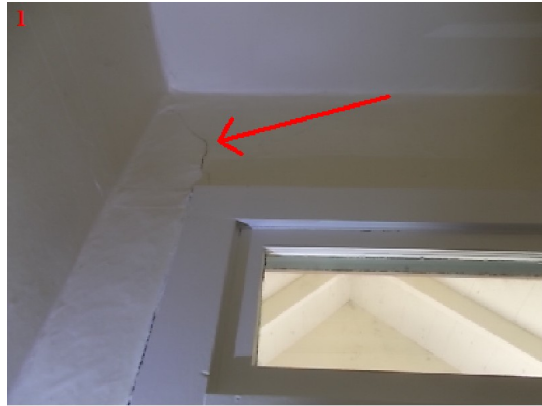
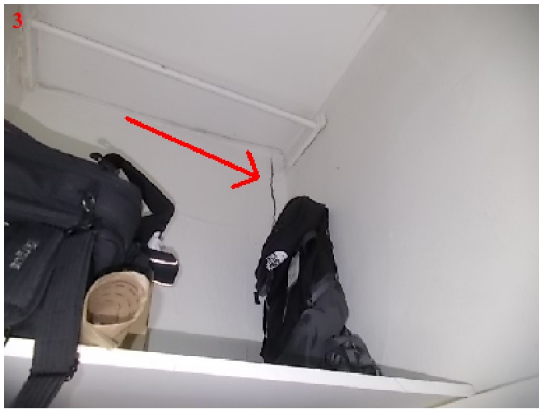
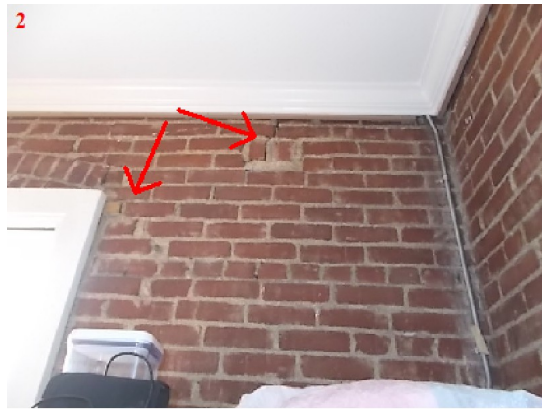
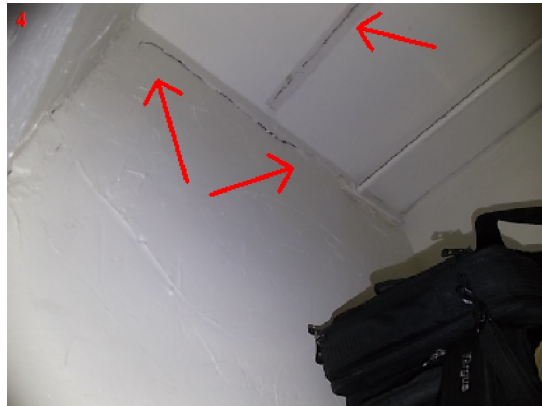
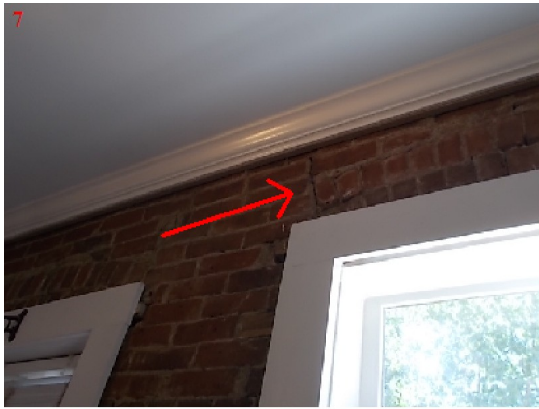
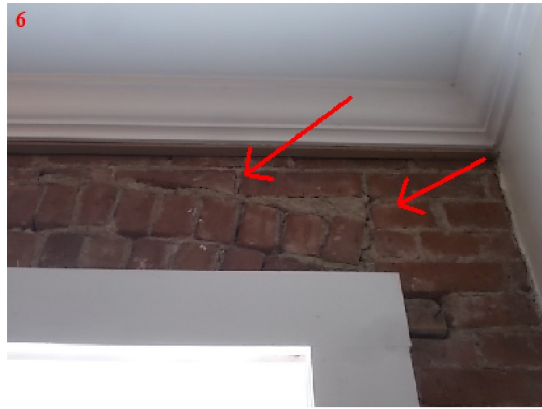
Interior Walls

Cracked plaster and brick work noted at the front entry, East bedroom closet, kitchen South and West walls and center bedroom North wall and closet. Cracking appears to be connected to movement in the foundation due to poor drainage of roof and surface water. Proper repairs should be made to the cracks once exterior issues have been resolved. A qualified contractor should evaluate and make needed repairs.

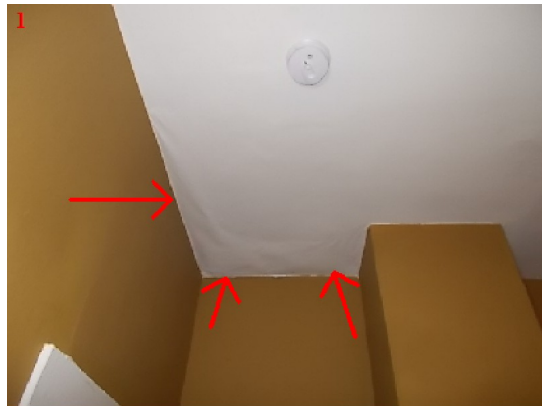
Interior Ceilings

Previous visible water leak noted directly above the kitchen center bedroom entry door. Plaster material was dry to the touch and damage appears to be minor. Proper repairs may require some material replacement. A qualified contractor should evaluate and make needed repairs.

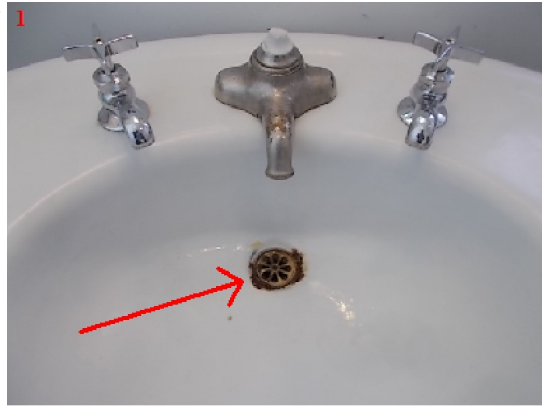
Bathroom Sink Basin

Excessive chipping in the sink basin enamel may lead to further corrosion and leaks in the full bathroom. Contact a qualified plumber for evaluation and repairs.

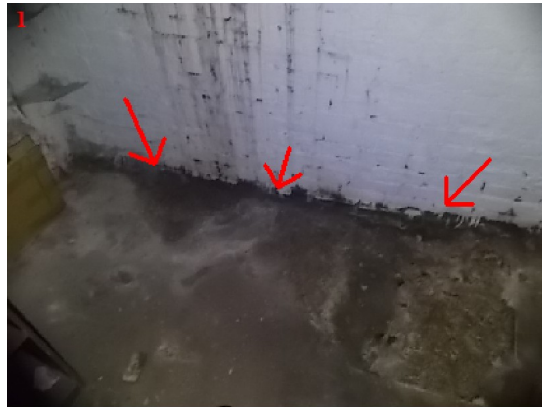
Floor Basement

Signs of water intrusion noted in the basement at the Northwest corner of the house. The cause of this movement is usually the result of a COMBINATION of deficiencies. Uncontrolled surface grade water and roof drainage water deposited next to the foundation are the leading causes. Exterior drainage at this location should be repaired to prevent further damage. Contact a qualified contractor to make repairs as needed.

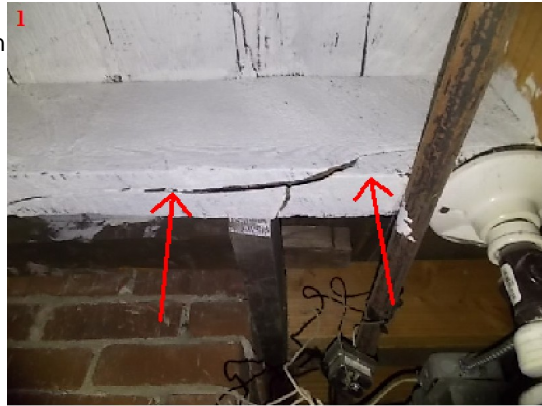
Ceiling Structure Crawl Space

Broken and cracked floor joist noted in the crawl space. Additional support should be added at either side of this location to prevent settling and sagging in the center bedroom flooring. Contact a qualified contractor for repairs.

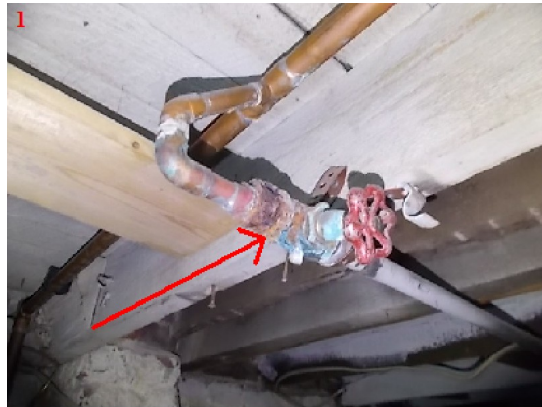
Interior Visible Water Pipes

Corrosion noted at a valve located in the basement. This can be an indication of periodic leaking or potential leaks in the future. Valve replacement should be made to prevent these issues. Contact a qualified plumber to evaluate and make any needed repairs.

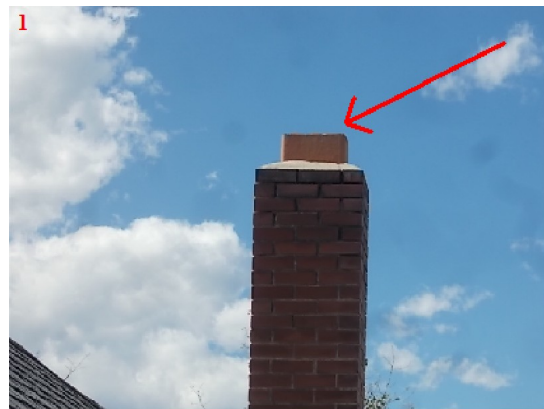
Chimney 1 Cap

I recommend having a proper rain/screen chimney cap installed. Chimney caps prevent the intrusion of rain, rodents, and snow.

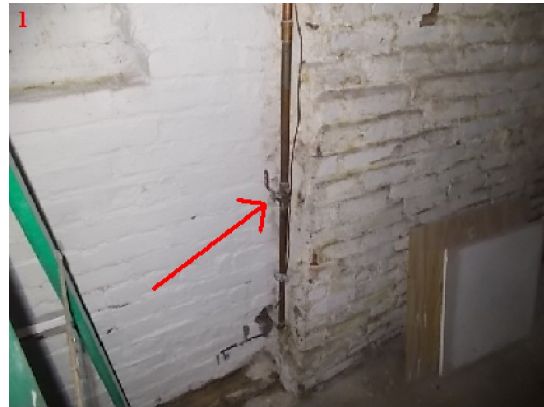
Main water shut off valve is located in the basement

I recommend turning the main water supply valve off when out of town or on vacation.

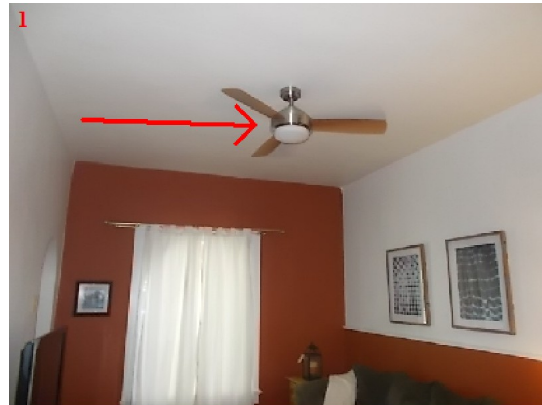
Ceiling fans located in the living room did not respond to wall switch and the remote control could not be found at the time of the inspection.

A qualified contractor should evaluate and make needed corrections.
