# Property Inspection Report

1234 Sample Inspection St.  
Dripping Springs, TX 78620

By: Jesse Bryant, Lic #TREC 8511 12/12/2018  
(Name and License Number of Inspector) (Date)

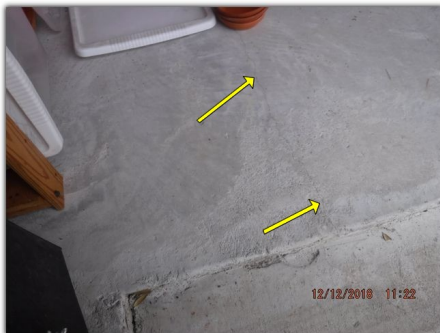
*FYI: Evidence of concrete shrinkage cracking was observed (garage floor). Surface shrinkage cracks are a result of material shrinkage that often occurs when the concrete cures (typically due to improper moisture management). These cracks are typically around 1/8 inch wide or less and do not extend through the full depth of the slab. In my opinion, the observed cracks do not indicate problematic foundation issues or failure. However, monitoring is recommended at this time.*

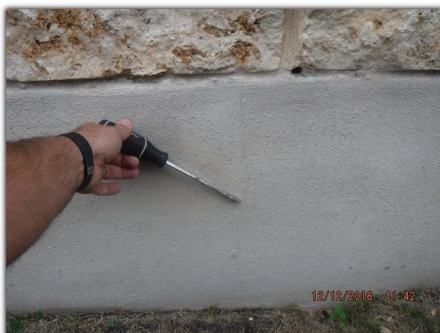
*FYI: One or more hairline cracks were observed at the foundation grade beam surfaces (South). These cracks, by themselves, do not necessarily indicate the presence of serious structural issues with the foundation, and are typically localized in the cosmetic parge coat applied to the surface of the grade beam. However, any cracks observed at the foundation grade beams should be monitored for future movement or increase in size over time.*

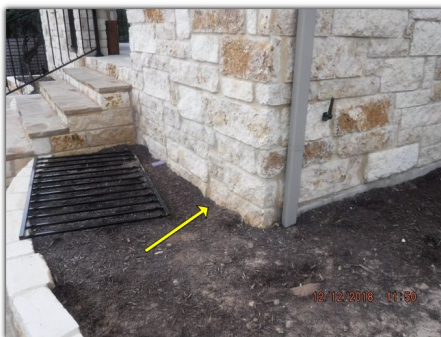
**High soil observed against the foundation / structure (rear).** Ideally, the soil line should remain 4-6 inches below the bottom edge of the masonry in order to prevent possible moisture penetration or potential wood-destroying insect activity. In some cases, where correcting the high soil creates a negative grade against the foundation, underground drainage options may need to be explored.

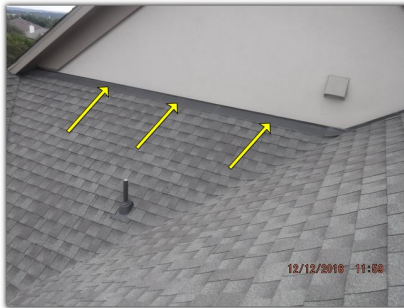
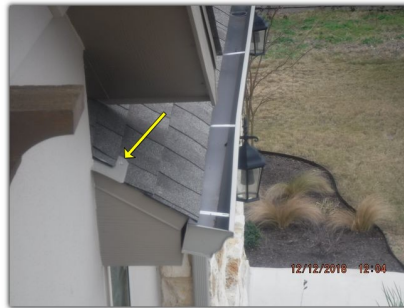
**Unsealed and exposed fasteners observed at roof surface** (North roof-to-wall flashing -- end of flashing near front entry -- etc.). All visible and exposed fasteners at the roof surface are to be sealed with an approved sealant in order to reduce the risk of water penetration. Further evaluation and repair is recommended where necessary.

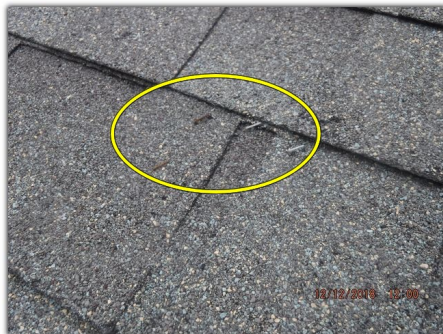
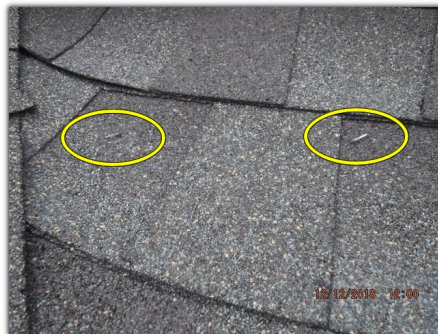
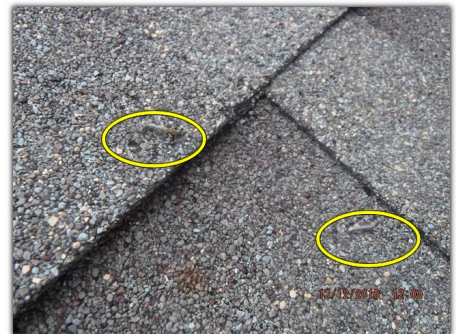
**Staples observed to be penetrating roof surface** (multiple locations where stucco walls are located directly above or near the roof surface). Exposed staples were observed to be puncturing the roof shingles beneath the stucco walls (previously used to secure protective covering to keep mortar off the roof during stucco/masonry work). Although generally only 1/4 - 5/16 of an inch in length, these staple penetrations leave the affected shingles susceptible to possible water penetration over time. Further evaluation and repair is recommended where necessary by a qualified roofing contractor.

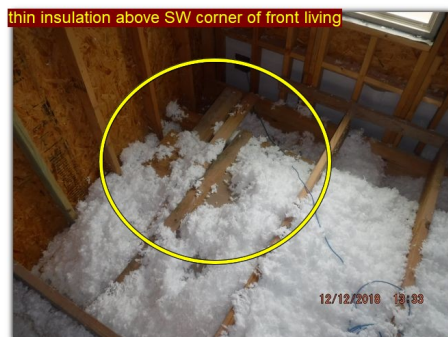
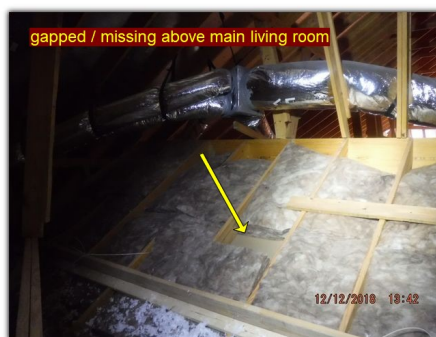
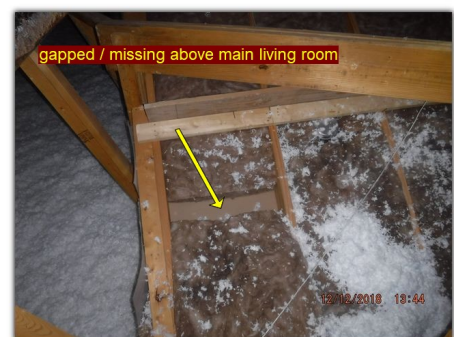
**Areas of missing / gapped / insufficient insulation observed** (above front formal living area -- main living and master bathroom vaulted ceilings). Areas of sparse or compacted insulation (especially 6 inches or less) should ideally be addressed by adding more insulation for improved efficiency. 10 to 15 inches is ideal, depending on insulation type. Further evaluation and repair is recommended where necessary by a qualified insulation contractor.

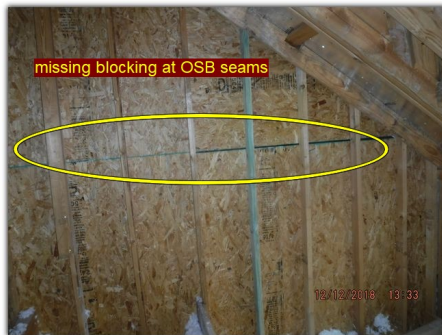
**Missing blocking at wall sheathing seams / joints** (*South gable wall above front living room*). All edges / seams of the exterior wall sheathing should be properly supported / blocked in order to resist movement; particularly when stucco wall coverings systems are present as movement within the sheathing can lead to stucco cracking. Monitoring and repair is recommended as necessary.

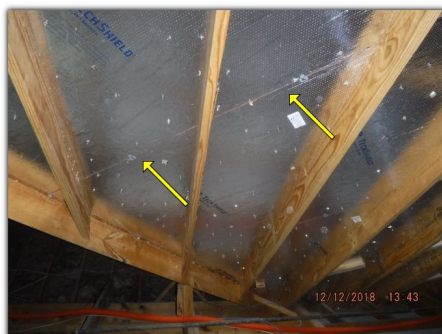
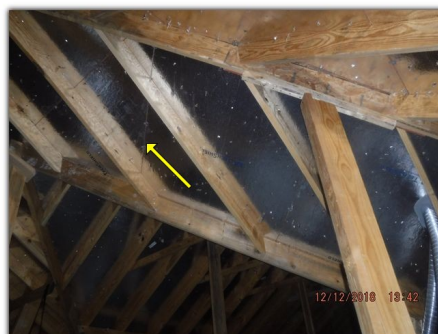
**Diagonal roof decking not installed to manufacturer specifications** (*located at various areas where nearby hips and valleys run parallel*). Some portions of the roof decking were observed to have been installed in a diagonal orientation to the rafters. A diagonal orientation of the roof decking does not provide the same strength axis as a perpendicular orientation. Most sheathing manufacturers require that the sheathing be installed with the long dimension, or strength axis, of the sheathing panel perpendicular to the framing members, with the panel continuous over two or more spans. This ensures that the span of the seams does not exceed 24 inches. No adverse affects (*sagging, separation*) were observed as a result of this installation; however, diagonal seams greater than 24 inches long should ideally be blocked or secured with additional lumber to ensure adequate support over time. Further information and repair recommendations should be obtained from a representative of the sheathing manufacturer.

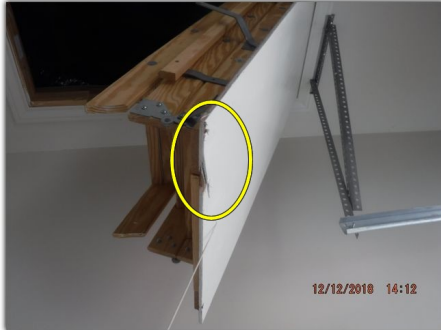
**Damaged attic stair unit cover observed** (smaller garage attic stair unit). Monitoring and repair is recommended as necessary.

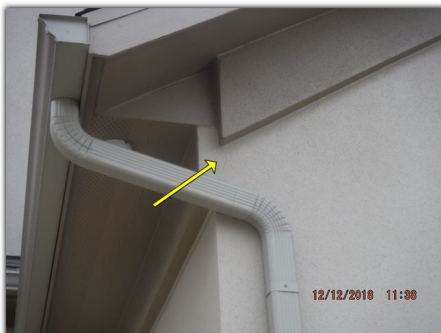
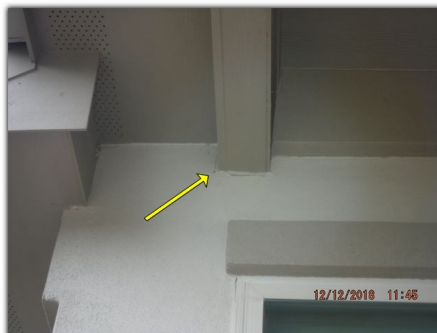
**Stucco cracks observed** (Northwest corner -- back porch area --etc.). Although is not uncommon for stucco finishes to experience some degree of cracking, if a crack exceeds 1/16 inch in width, the crack should be repaired with the stucco material or a quality caulk / sealer intended for this application. For more information on stucco cracks visit <http://www.stuccomfgassoc.com/industry/papers/crack.pdf>. Further evaluation and repair is recommended where necessary by a qualified stucco contractor or specialist.

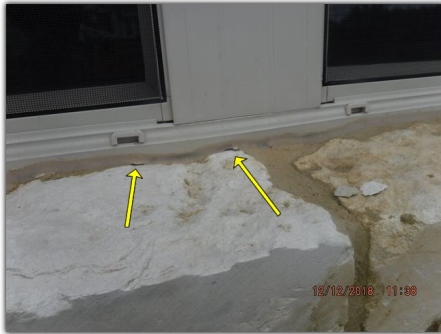
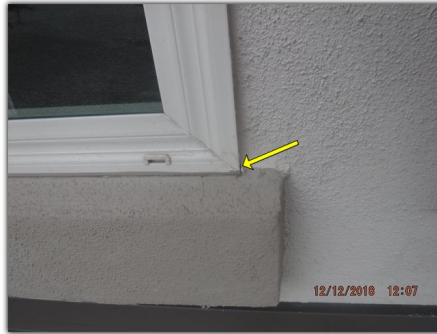
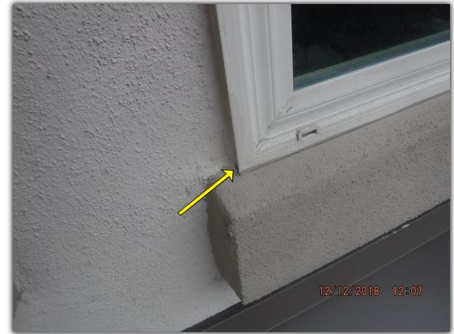
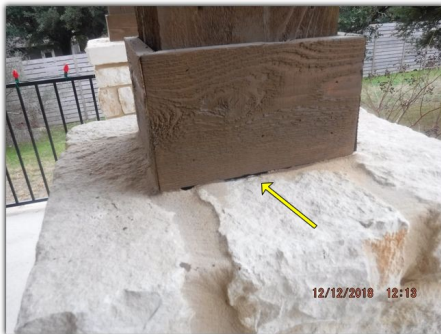
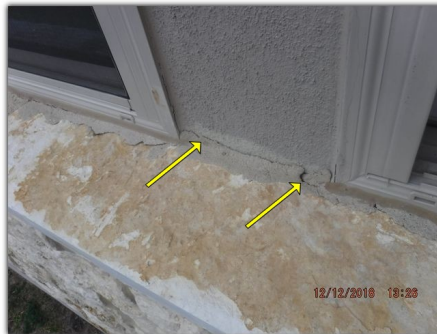
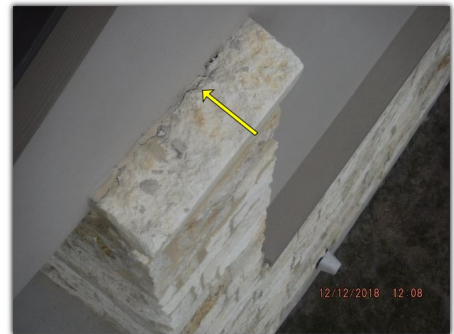
**Unsealed gaps observed at exterior wall penetrations** (*multiple locations*). Protecting the home from possible water penetration and insect / vermin activity is very important. One way to achieve this is to ensure that all gaps and openings at the stucco and masonry exterior of the home remain properly sealed and caulked. Plumbing or other wall penetrations, gaps at the stucco and masonry joints and any visible points of entry should be properly sealed (*with the exception of weep holes in the masonry*). Annual inspection and maintenance is also recommended as caulking / sealant materials can dry out and shrink over time.

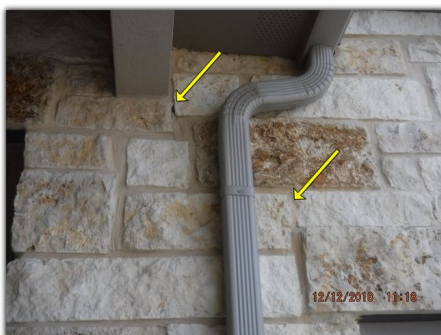
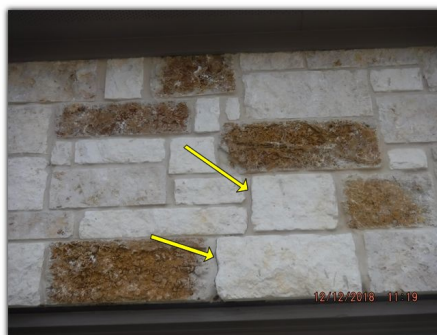
*FYI: Typical mortar cracking was observed at the masonry above the garage door opening (larger double door). This type of mortar cracking is not uncommon at this location and typically occurs when the beam and lintel that support the masonry, sag slightly over time. In my opinion, the cracks observed do not suggest the presence of serious structural issues, but should be monitored.*

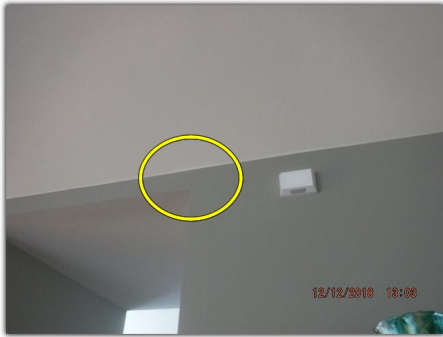
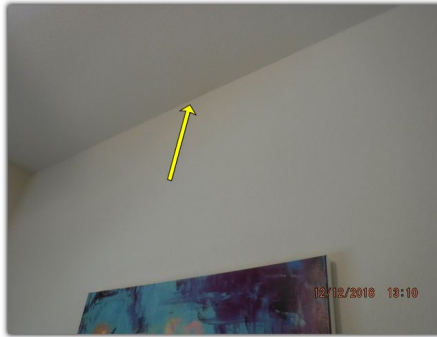
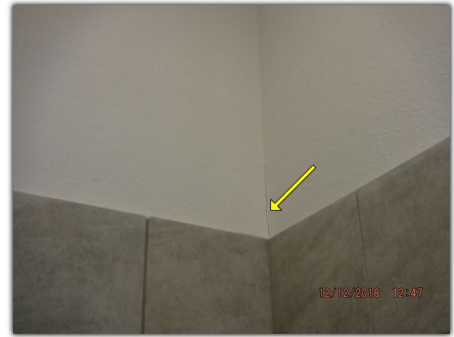
*FYI: Cosmetic drywall flaws were observed at one or more locations (Northwest bedroom -- living room -- master bathroom -- etc.). These types of flaws (cracks, nail pops, etc.) are typically the result of slight building stress over time and / or seasonal expansion and contraction of the building materials and, in this case, do not necessarily suggest the presence of serious structural problems. Other small, cosmetic flaws may become evident over the years as most structures will continue to experience some level of movement or seasonal changes in the building materials. Cosmetic repair and monitoring is recommended where necessary.*

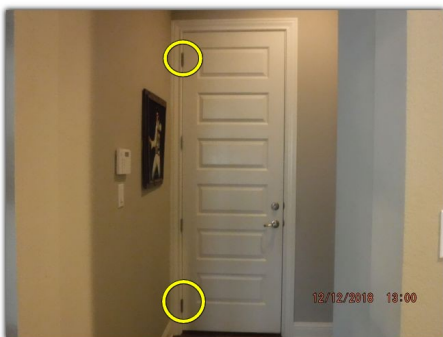
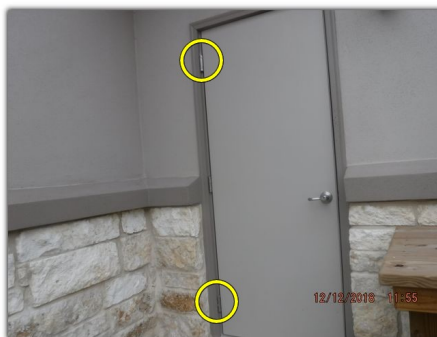
**Inoperative self-closing hinges at garage pedestrian door(s).** Self-closing hinges are part of the requirement for fire separation between the garage and living space. Repair is recommended for improved operation and safety (*prevent garage fumes and potential fire from entering the living space*). *FYI: Although not required at this location, the auto-close hinges at the rear exterior garage pedestrian door (North garage) were also found to be inoperative.*

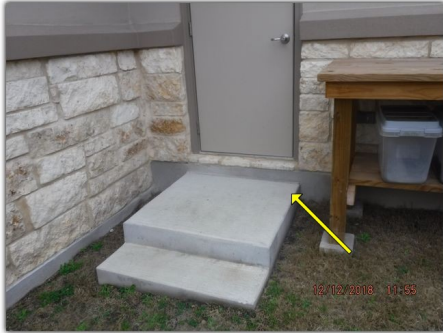
**Missing appropriate door landing at exterior door** (*Exterior garage pedestrian door*). There shall be a floor or landing on each side of each exterior door. The floor or landing at the exterior door shall not be more than 1.5 inch lower than the top of the threshold (*outswing door*) and the landing shall extend a minimum of 36 inches out from the door, with a width no smaller than the width of the door.

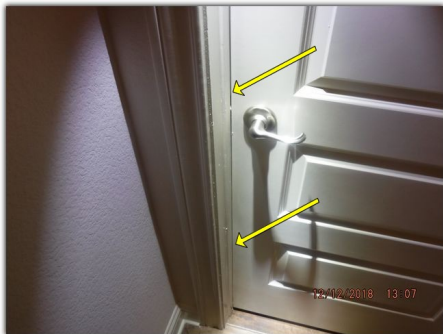
**Poor door and door stop alignment** (*Northwest bedroom*). Adjustment / repair is recommended as necessary to ensure proper operation.

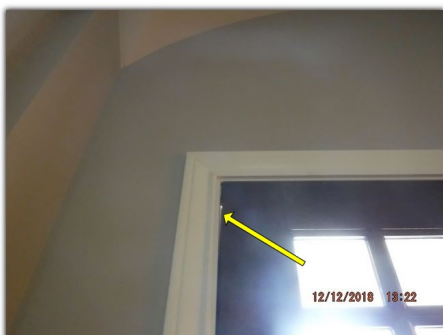
**Poor seal observed at door weatherstripping** (*front entry door*). Weatherstripping improvement is recommended where necessary in order to prevent possible water and / or insect penetration and air drafts around the perimeter of the door(s).

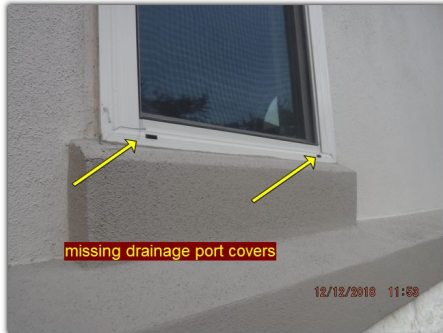
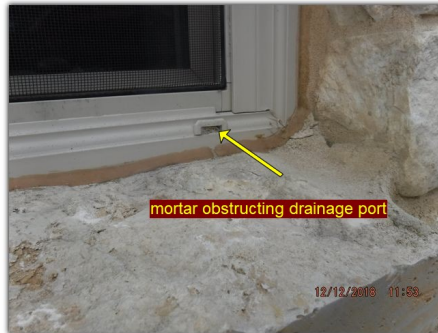
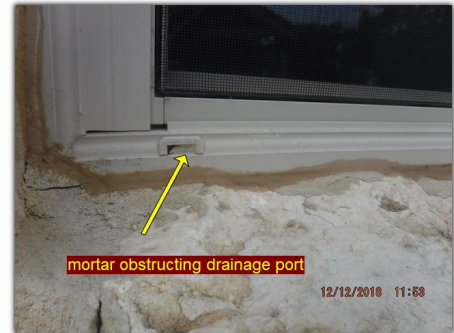
**Missing window drainage port covers** (one of the Northeast windows). These snap-in covers serve to allow for window frame drainage, while keeping insects out. Repair is recommended where necessary. *FYI: Other window drainage ports were observed to be present, but clogged with mortar from masonry installation; thereby reducing the window's ability to drain moisture accumulation.*

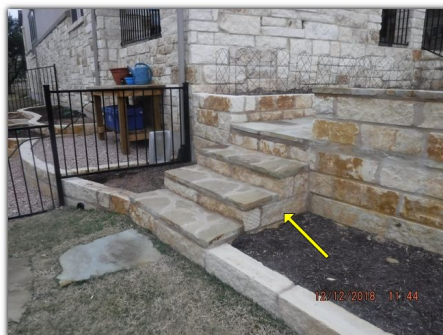
**Missing handrail at stairway** (Southeast exterior). Steps / stairways consisting of 4 or more risers are required to have a graspable handrail in place for improved safety.

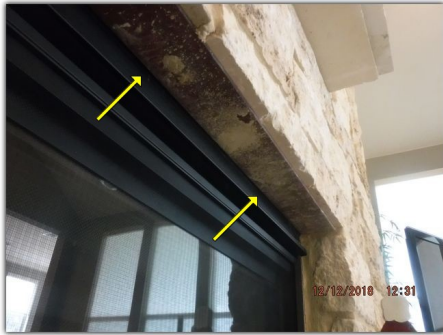
**Unsealed gap between fireplace and the masonry lintel (indoor fireplace).** The gap between the fire box and the masonry lintel is required to be sealed with an approved high temperature sealant material in order to prevent possible flame spread between the masonry and the framed wall or space behind the masonry. Further evaluation and repair is recommended.

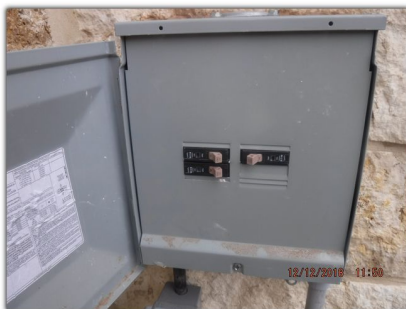
**Unmarked or illegible breakers observed within panel box(es) (Pool sub panel).** Further examination and labeling of the breakers is recommended for increased safety and convenience.

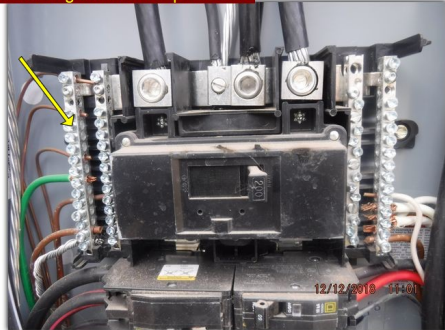
no bonding screw or strap observed

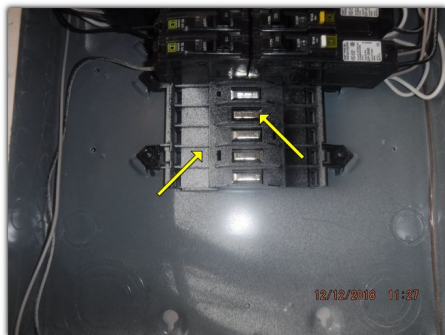
**Paint / texture over spray observed inside panel box** (*garage panel*). All internal parts of any panel box (*bus bars, wiring terminals, insulators, etc.*) are not to be contaminated by foreign materials (*paints, plasters, cleaners, etc.*). It is recommended that you consult with a licensed electrician or the panel box manufacturer in order to determine how to properly address the over spray as some of the over spray was also observed on the live bus bars.

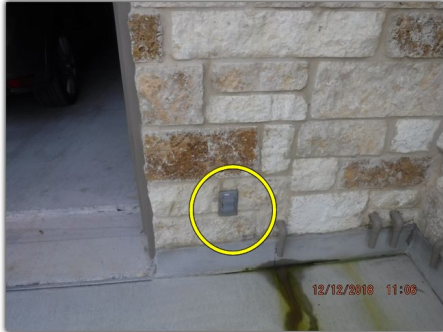
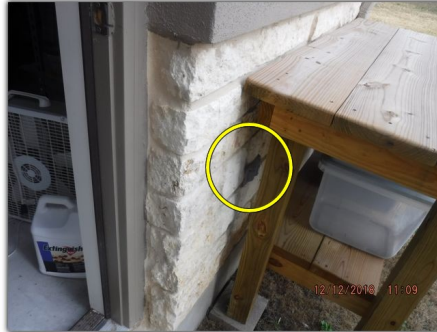
**Missing / improper exterior receptacle cover(s)** (adjacent to double garage door -- adjacent to th rear exterior pedestrian door for the North garage). Exterior receptacle covers in wet locations should ideally be changed out to newer "bubble covers". These covers keep the receptacles covered, even while in use (cords plugged in). Repair is recommended where necessary.

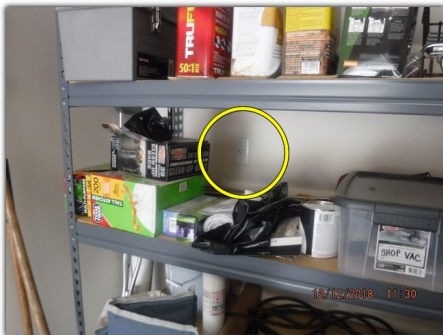
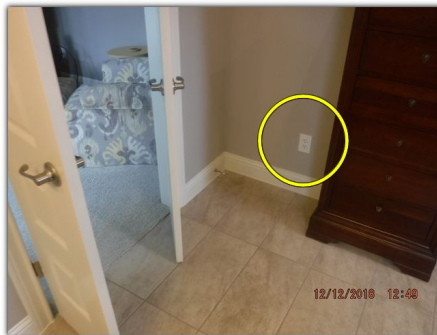
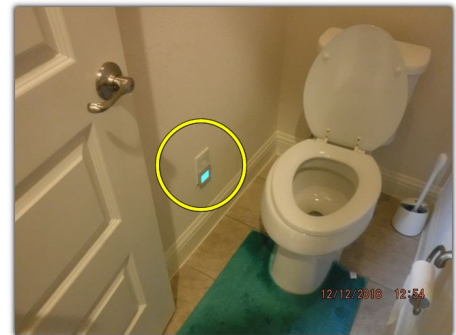
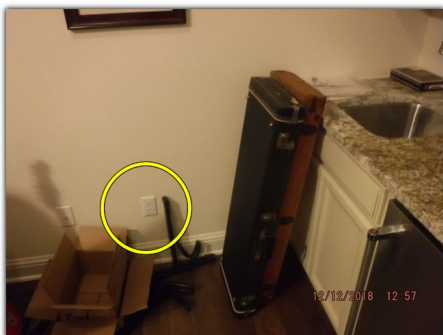
**Ground Fault Circuit Interrupter (GFCI) protection missing where required** (freezer receptacle in the main garage -- master bathroom receptacles adjacent to the door and in the water closet -- wall receptacle within 6 feet of the wet bar sink). Although this type of protection may not have been required at certain receptacles when the home was built, all bathroom, garage, laundry, outdoor, crawl space and kitchen counter receptacles (as well as receptacles within six feet of the outside edge of a sink) are to now have GFCI protection and, if lacking this protection, are required to be marked as "deficient" as per the Texas Real Estate Commission's (TREC) standards of practice for inspectors.

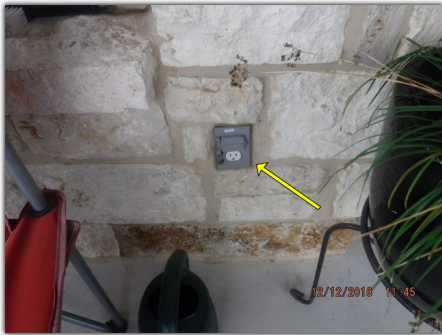
**Damaged receptacle cover observed** (back porch area). Repair is recommended.

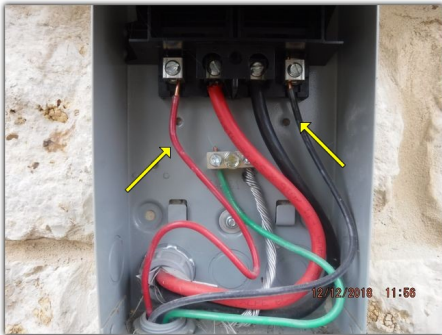
**Potentially under-sized wiring observed to be serving condenser unit** (suspected 30 amp wiring on a condenser unit with 34.8 minimum ampacity rating). Further evaluation and repair is recommended by a qualified electrician for proper wiring / equipment protection.

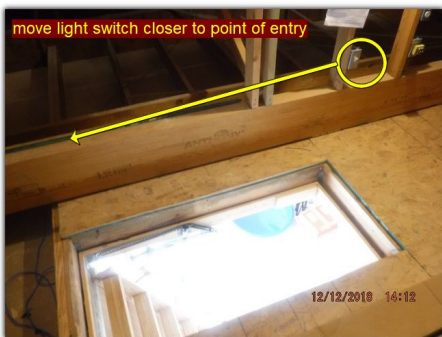
**Improper / unsafe location of attic light switch** (away from entry point to garage attic). Switch relocation is recommended so that the light can be operated prior to fully entering the attic space and without leaning out over the ladder.

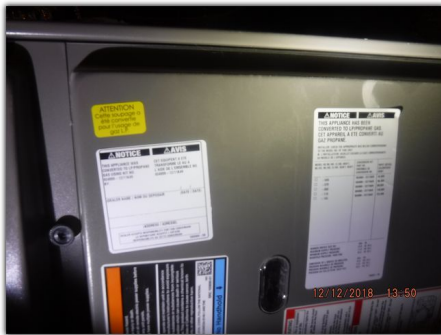
**Propane conversion sticker not filled out / completed** A propane conversion sticker was observed to have been affixed to the furnace unit, but the sticker was not filled out by the technician who performed the conversion. This sticker is to be filled out with the required information of the technician / installer to ensure that the conversion was properly performed and tested by a qualified individual.

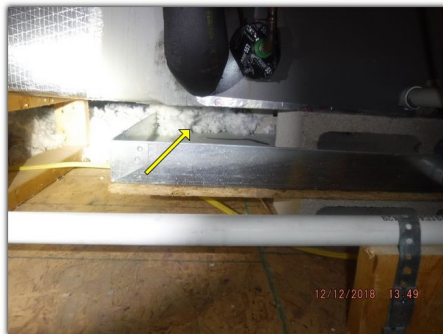
**Insulation / debris located within emergency drain pan (under evaporator coil).** Insulation/debris located within the evaporator coil emergency drain pan should be removed in order to prevent moisture wicking and to prevent the pan drain from clogging, should the evaporator coil leak.

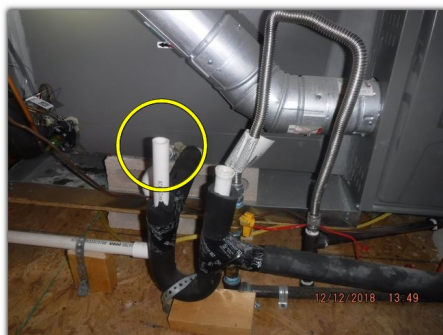
*FYI: The cleanout opening in the primary condensate line (before the trap) should ideally be capped in order to prevent conditioned air loss into the attic.*

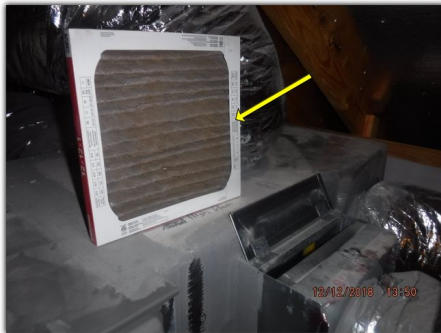
**Dirty return air filter(s) observed** (*interior and at fresh air return duct filter in the attic*). This condition can decrease the efficiency of the heating/cooling systems by hampering the flow of air over the heat exchanger and/or evaporator coils. The filters should be changed regularly (*frequency, depending on filter type*) to improve air flow and efficiency.

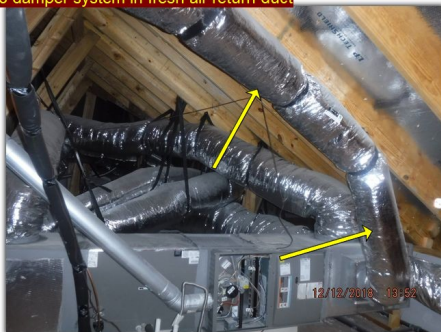
**Suspected incomplete installation of fresh air return system** (*manual fixed damper observed, but no timed or automated damper system*). An HVAC system with a constant and continuous supply of outdoor air may not operate efficiently and may have trouble regulating humidity within the home. Further evaluation and repair is recommended as required by a qualified heating and cooling technician.

**no damper system in fresh air return duct**

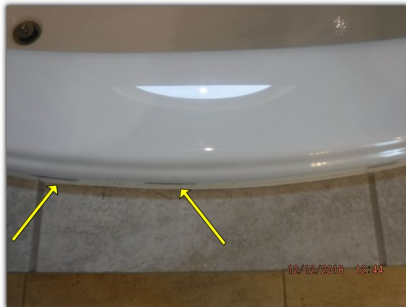
**Gapped open caulk seals at bathtub perimeter** (master bathtub). Sealant improvements are recommended where necessary.

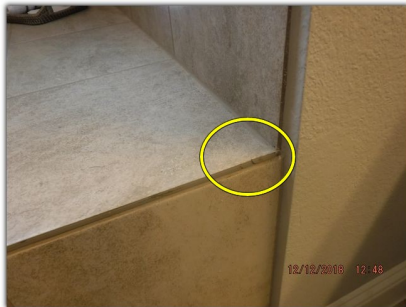
**Cracked tile observed at tub deck** (master bathroom). Monitoring and repair is recommended as necessary.

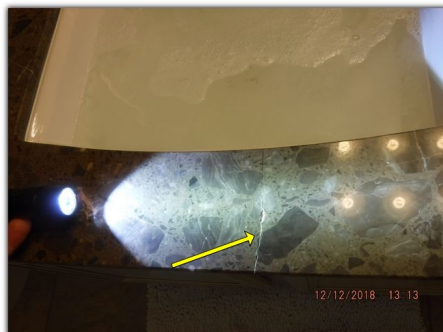
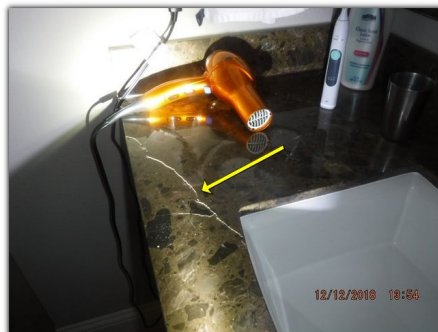
**Cracked / damaged countertop material observed** (front hall bathroom and master bathroom). Further evaluation and repair is recommended where necessary.

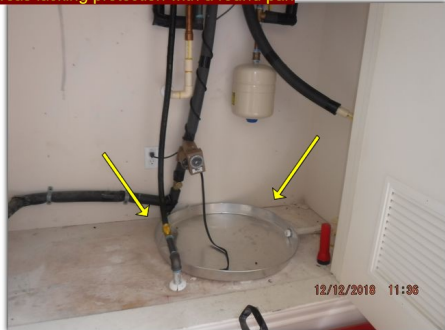
areas lacking protection with a round pan

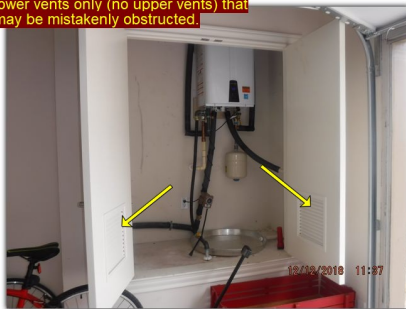
**Potential improper / insufficient combustion air provisions for water heater** (199k Btu/H water heater obtaining combustion air from garage, through lower vents only in closet - no upper vents). The supply of combustion air for the tankless water heater is perceived to be insufficient due to the lack of a proper upper combustion air vent pipe opening (both combustion air openings located at the lower portion of the closet). Upper and lower combustion air vents are used to bring fresh combustion / dilution air into the closet from the garage space. It is recommended that a lower combustion air vent pipe be installed (with the bottom portion of the pipe terminating within 12 inches of the decking) to satisfy the combustion air requirements. Furthermore, it is not known if the total cubic footage of the garage can support the 50ft<sup>3</sup> per 1k Btu/h input rating of the water heater (possibly with natural infiltration). Further evaluation is recommended by a qualified plumber and / or HVAC professional.

lower vents only (no upper vents) that may be mistakenly obstructed.

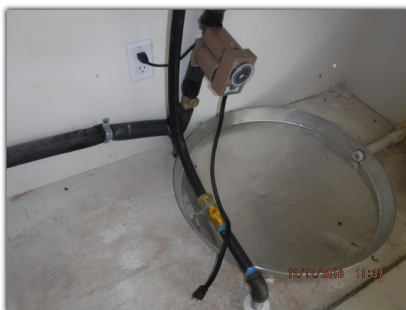
*FYI: A circulation pump was observed to be in place at the water heater, but was not currently in use. Given the long delivery time to the kitchen and master bathroom area, consideration should be given to utilizing this timer-based pump, or some type of "on-demand" pump. Further evaluation is recommended by a qualified plumber.*

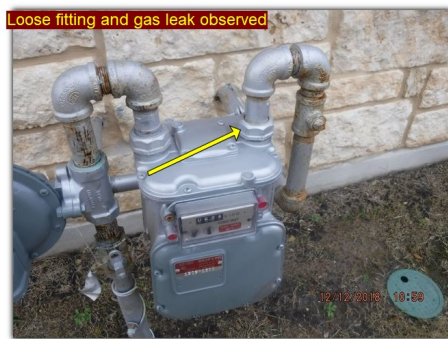
**Loose connection and evidence of a gas leak observed at meter** (downstream side of meter). Further evaluation is recommended by the gas utility provider.

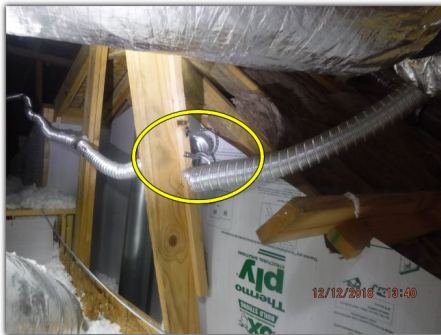
**Damaged exhaust fan duct in attic** (half bathroom exhaust fan). Repair is recommended to prevent humid air from discharging into the attic.

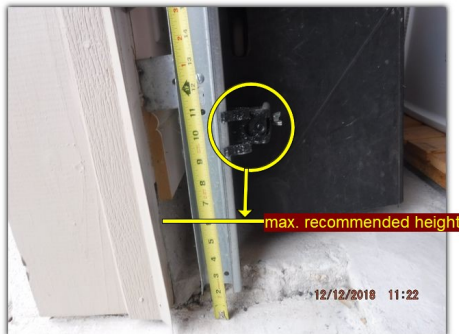
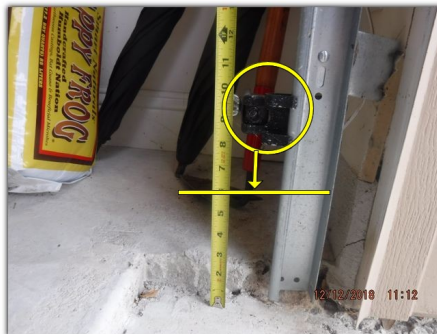
**Improper auto-reverse sensor height.** Photoelectric sensors are to be installed per the garage door operator manufacturer's instructions, with the top of the photoelectric eye lens no higher than 6 inches above the garage floor. If installation is above 6 inches, the photoelectric eyes may not detect what they are intended to protect (*an individual lying down on the garage floor under the descending door*). Further evaluation and repair is recommended by a qualified garage door operator technician.
