Property Inspection Report

1234 Sample St.
Georgetown, TX 78626

Concerning: 1234 Sample St., Georgetown, TX 78626
(Address or Other Identification of Inspected Property)

By: Jesse Bryant, Lic #TREC 8511 01/10/2018
(Name and License Number of Inspector) (Date)

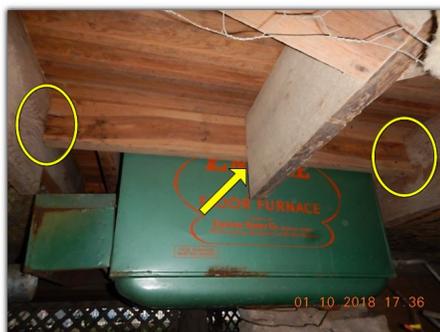
Missing hangers and poor support at opening in floor framing (where older in-floor furnace is located at North side of home). Although no evidence of movement or sagging was observed at this portion of the floor structure, monitoring is recommended.

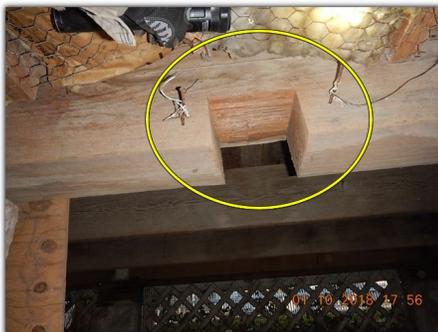
Damaged / notched foundation support beam (North exterior beam between front porch and living space). Although no evidence of beam sagging, cracking or movement was observed, further evaluation and repairs are recommended as necessary.

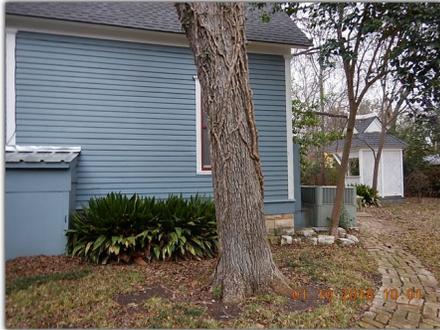
NOTE: Trees close to the foundation can possibly deplete the moisture content within the soil around the home which, in some cases, can lead to differential foundation movement. If evidence of structural movement is observed over time, near these areas, it may be prudent to consult with a qualified engineer in order to explore corrective or preventative options (root barrier installation, etc.). Monitoring is recommended at this time.

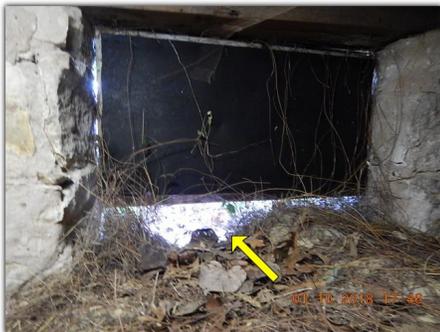
NOTE: Screening and other rodent prevention measures should ideally be implemented around the perimeter of the crawlspace to prevent possible material damage (ducts -- insulation -- etc.) within the crawlspace.

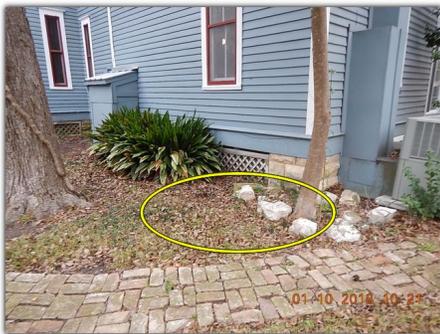
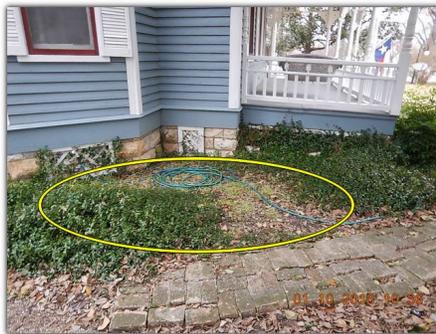
Poor or insufficient grading near the foundation (Northwest -- Southeast -- etc.). Lots shall be graded to drain surface water away from foundation walls. The slope of the grade shall fall a minimum of 6 inches within the first 10 feet away from the foundation (5% slope). Where lot lines, walls, slopes or other physical barriers prohibit 6 inches of fall within 10 feet, drains or swales shall be constructed to ensure drainage away from the structure.

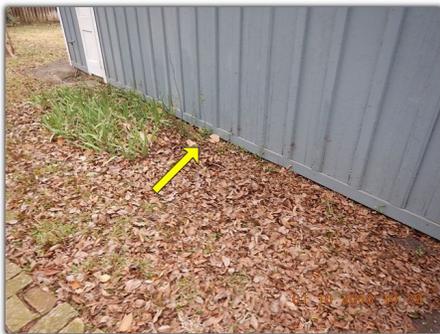
High soil against the foundation/structure (detached garage). Ideally, the soil line should remain 4-6 inches below the bottom edge of the siding in order to prevent possible moisture penetration or potential wood-destroying insect activity. In some cases, where correcting the high soil creates a negative grade against the foundation, underground drainage options may need to be explored.

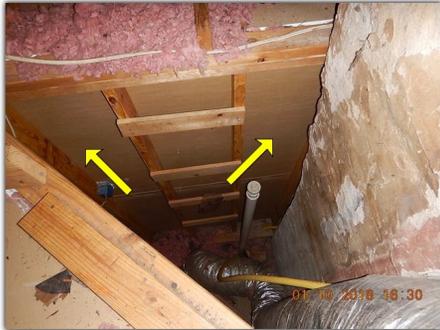
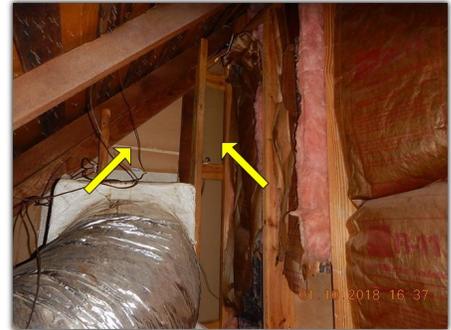
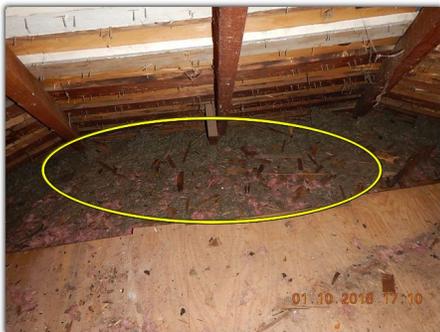
Missing/insufficient insulation (*various attic walls and attic floor locations*). Areas of sparse or compacted insulation (especially 6 inches or less) should ideally be addressed by adding more insulation for improved efficiency. Further evaluation and repairs are recommended where necessary by a qualified insulation contractor.

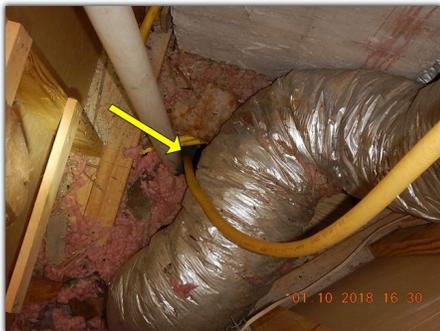
Missing or gapped fireblocking (*observed from attic, near the front chimney structure*). Fireblocking shall be provided to cut off all concealed draft openings and to form an effective fire barrier between vertical and horizontal spaces within the structure (*in this case, between wall voids and the attic space*). These gaps / openings should be properly sealed off with solid lumber, metal or tightly packed, unfaced fiberglass insulation for improved safety.

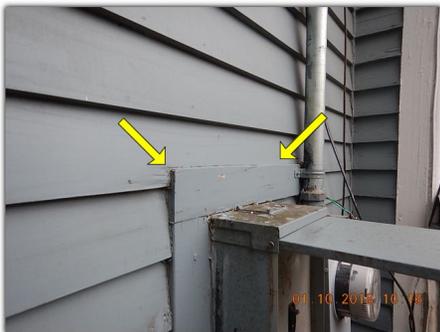
Missing wall flashing at wall protrusions or projections of the drainage plane of exterior walls (various locations around the home). Metal flashing is required where necessary to shed water over protruding building elements (such as window/door/trim flashing).

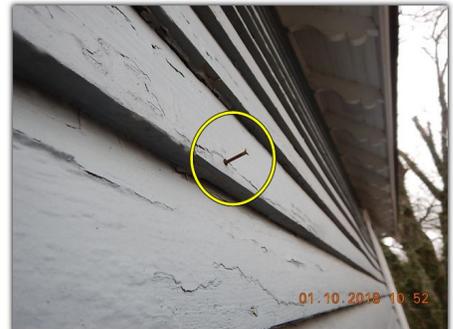
Loose / unsecured siding observed (multiple locations). Further evaluation and repairs are recommended where necessary.

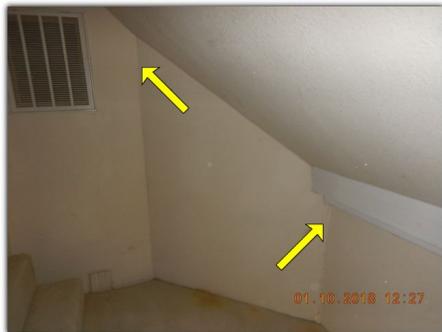
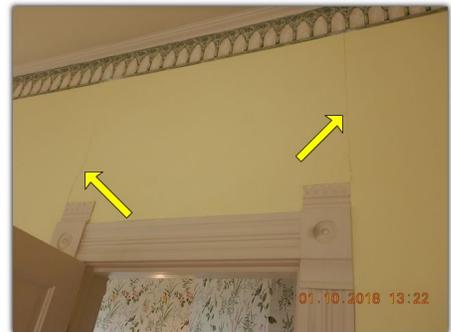
Cracks, buckled drywall tape and other evidence of previous structural stress / movement observed (various locations). Monitoring and repairs are recommended as necessary.

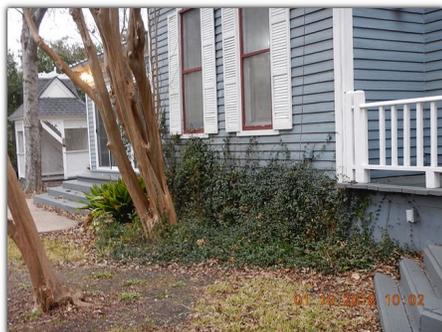
FYI: All vegetation should ideally be kept trimmed off of and at least 12 inches away from the exterior wall surfaces in order to limit or prevent insect activity, surface damage and mildew on the wall surfaces. Vegetation on / against wall surfaces also limits visibility for inspection.

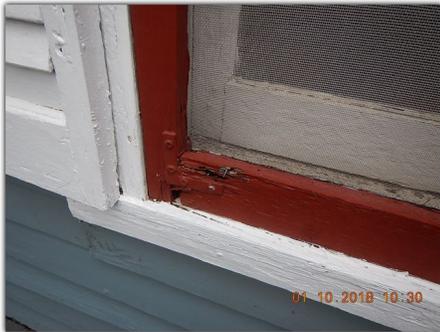
Damaged window screen material (*various locations*).

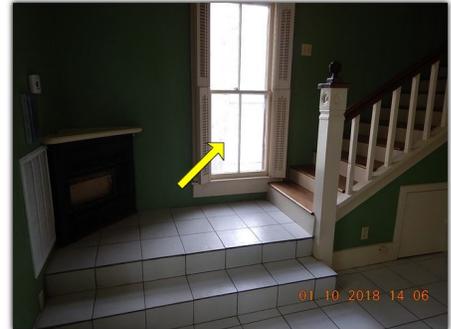
Tempered safety glass missing (*various locations where required by current safety standards*). Tempered safety glass is required for any window glass within 60 inches of the floor, that is over a bathtub or in a shower, any window glass with 60 inches of a stair step or landing and for any glass in a window that is within 2 feet of a door, and within 60 inches of the finished floor surface.

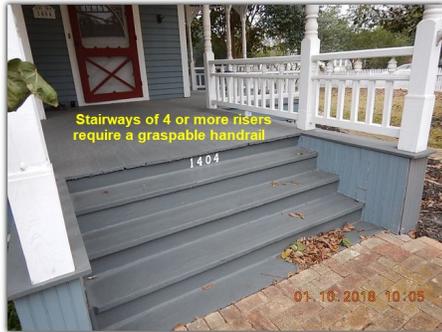
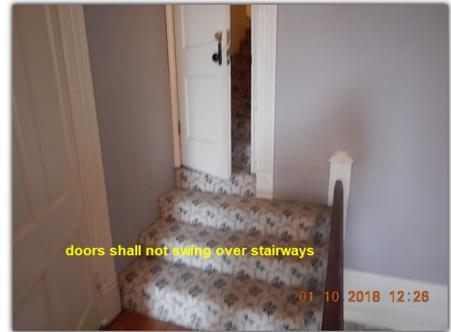
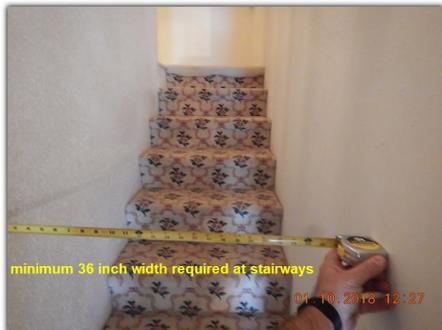
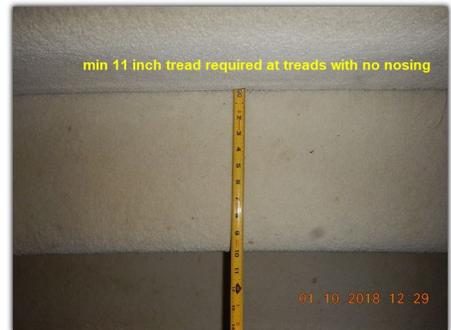
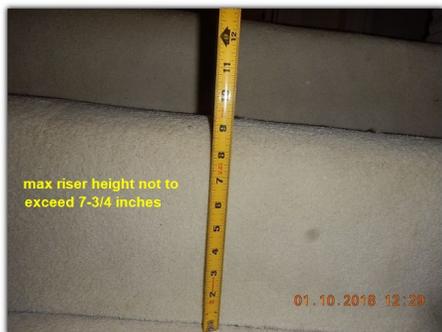
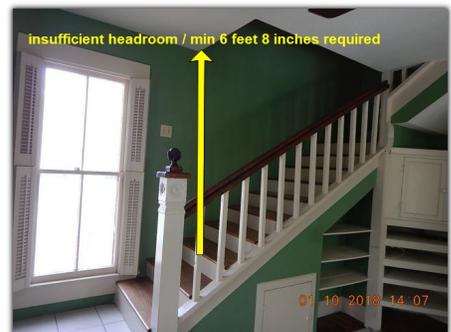
Interior and exterior stairways not built to current safety codes / standards (may be a potential safety hazard for some occupants). Further evaluation and repairs are recommended where necessary.

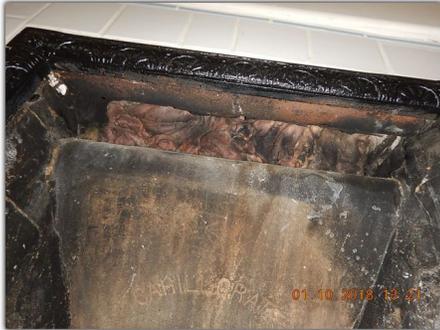
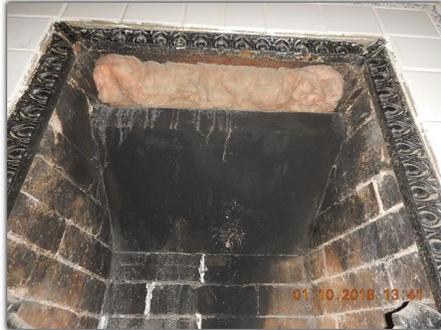
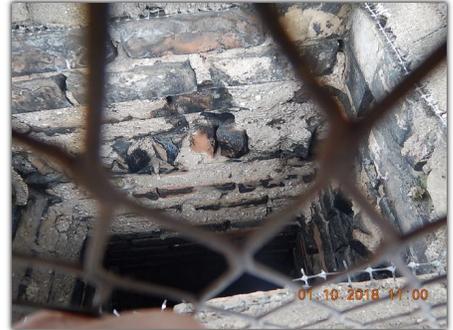
NOTE: The interior portions of the chimney structures were not visible during the inspection, due to the insulation within the flue throats and sealed in place chimney caps (no fireplaces were operated). From what could be seen from the tops of the chimneys, the chimney flues appeared to be unlined. Further evaluation by a qualified chimney sweep specialist is highly recommended.

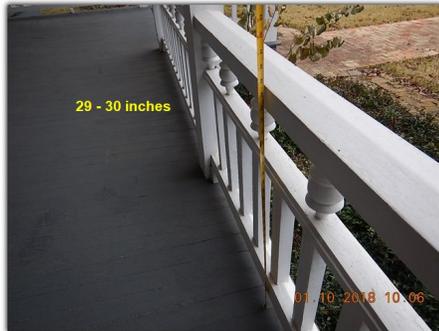
Improper guardrail height and spacing between balusters (porch railings). When guardrails are present at porches, decks, etc., they are required to be at least 36 inches tall (above the standing surface) and the spacing between the balusters shall not exceed 4 inches. This can be a potential safety concern for small children.

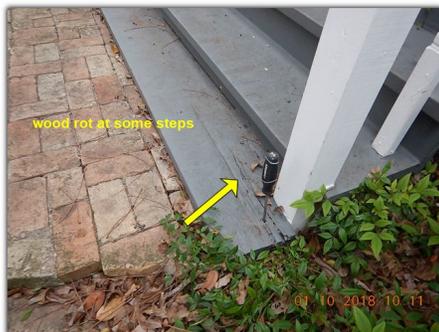
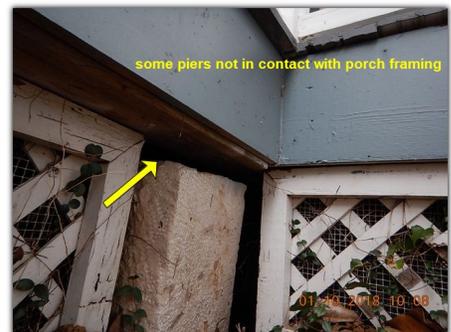
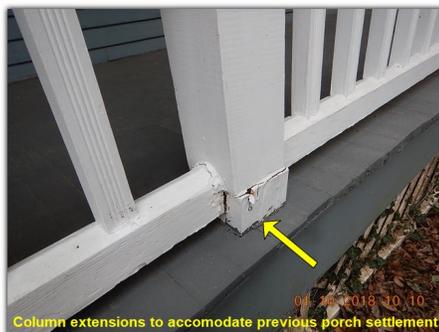
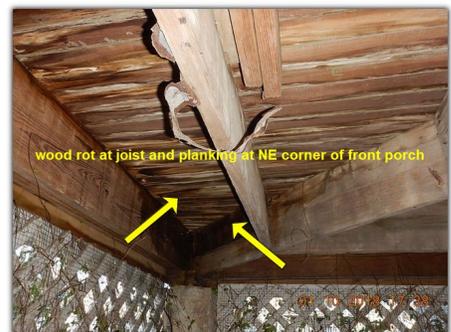
Evidence of previous settlement / movement and deteriorated materials at front and side porch structures (multiple locations). Further evaluation and repairs are recommended where necessary to prevent further movement or material deterioration.

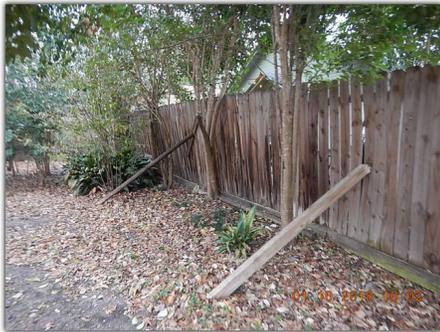
Damaged / leaning fencing materials observed (various locations).

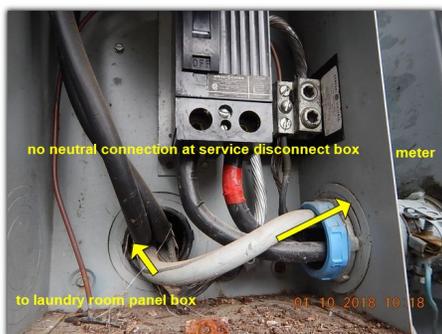
Abnormal routing of neutral conductor from electric meter to panel box (Neutral conductor leaves meter box and bypasses the first service disconnect, to terminate at the main pane box). Typically, this conductor will terminate to a lug in the service disconnect box, where it would be bonded to ground, prior then traveling into the main panel box. Further evaluation is recommended by a qualified electrician.

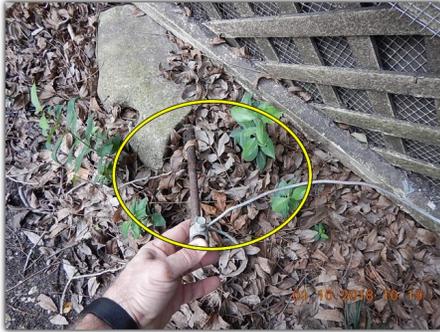
Improper / insufficient grounding electrode rod (Northwest corner of house). The grounding rod was observed to be loose and too short. Grounding rods are to be driven 8 feet into the soil for proper grounding. Other grounding methods may also be available. Further evaluation and repairs are recommended by a qualified electrician.

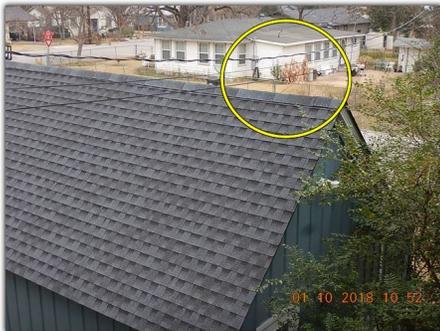
Insufficient clearance between the service entrance conductors and the garage roof. Wires over a roof surface, with less than a 4:12 slope, are required to be 8 feet above the roof. A minimum 3 foot clearance is required for roof slopes greater than 4:12.

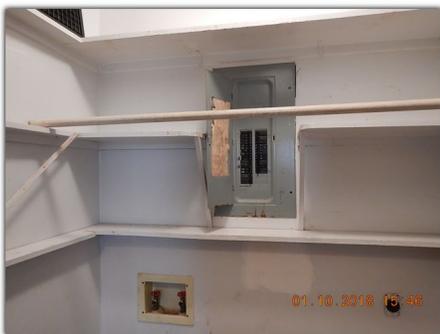
Improper clearance in front of panel boxes / electrical service equipment (main panel in laundry area). All panel boxes and electrical service equipment are required to have a minimum 30 inch by 36 inch clear area in front of the equipment, up to 6 feet from the standing surface (or as tall as the equipment).

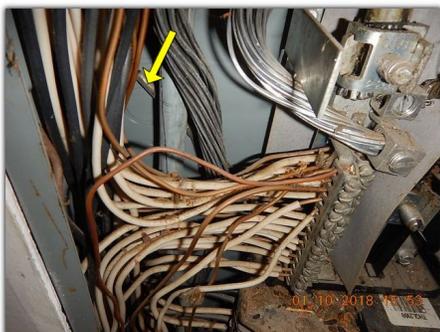
Metal panel box not properly bonded to the electrical grounding system (*ground bond strap observed to be detached from the grounding bar*). Further evaluation and repairs are recommended by a qualified electrician for improved grounding and safety.

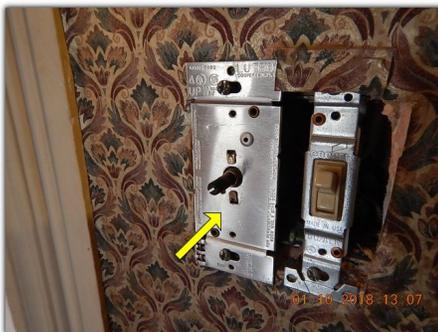
Improper dimmer switches for ceiling fan motor use (middle bedroom -- front bedroom). Some of the dimmer switches used for ceiling fan are not approved for use with a ceiling fan (*incandescent fixtures only*). This condition can be a potential fire hazard due to overheating. Proper switch replacement is recommended where required for improved safety.

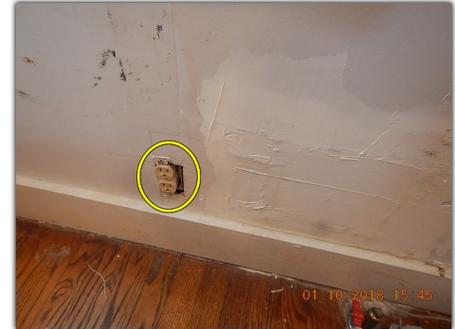
Missing receptacle/switch cover plates (*various locations*). Cover plate replacement is recommended where necessary for improved safety.

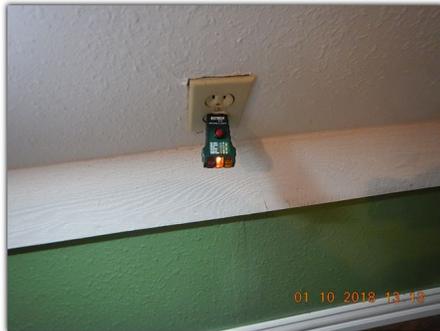
Ungrounded receptacle(s) observed (*one receptacle in the rear office area*). Ungrounded receptacles can be potential shock hazards or cause damage to appliances/equipment plugged into these receptacles. Grounding repairs are recommended where necessary for improved safety.

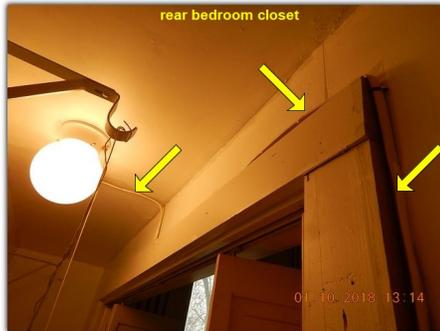
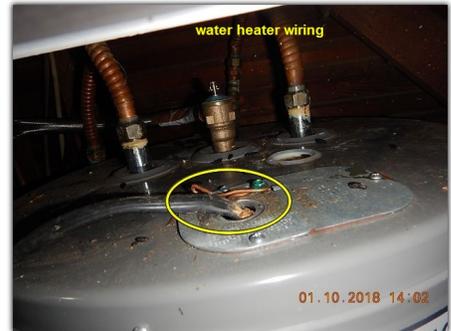
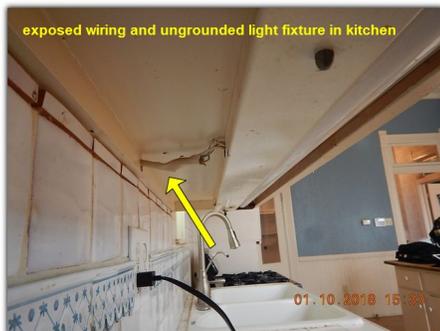
Unprotected exposed wiring (*Disposer -- both water heaters -- rear bedroom closet -- etc*). Branch circuit wiring should be properly secured and not exposed and routed on exposed surfaces; particularly in storage areas. Furthermore, where wiring enters an appliance body, an approved wire clamp is required to provide strain relief and to prevent abrasion damage. Further evaluation and repairs are recommended where necessary.

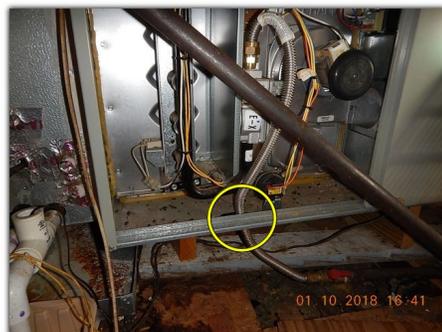
Flexible gas line connector passing through appliance case (upstairs unit). This application is not permitted as current standards require a small section of hard pipe to run through the furnace cabinet wall, prior to connecting to the flexible connector. This helps prevent vibration damage to the flexible gas line connector. Repairs are recommended by a qualified plumber for improved safety.

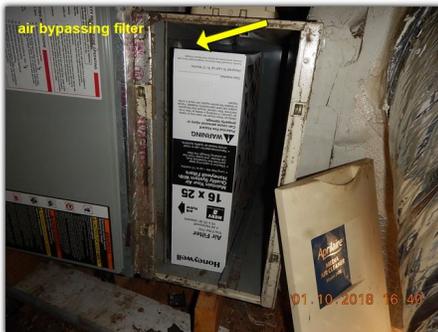
Undersized air filter (*upstairs unit*). The use of an undersized air filter can lead to a significant airflow at the evaporator coil, reduced airflow and poor heating / cooling performance. Repairs are recommended.

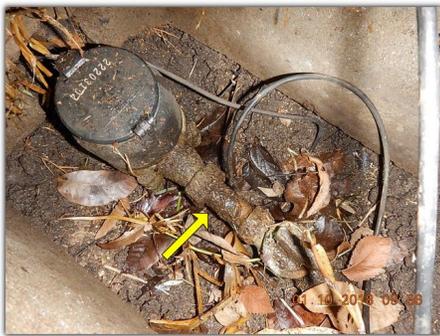
Supply plumbing leak observed (Main water line, just before the water meter). Further evaluation and repairs are recommended by the water utility provider

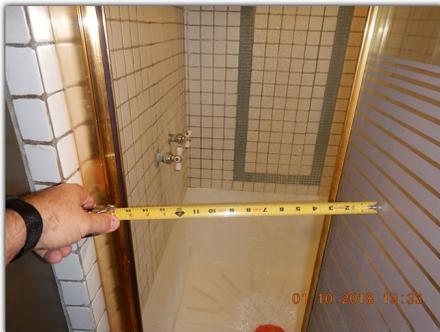
Undersized doorway to shower (*middle upstairs bathroom*). Under current standards, shower doorways are to be a minimum of 22 inches wide. Doorways narrower than 22 inches may make use of the shower difficult for some occupants.

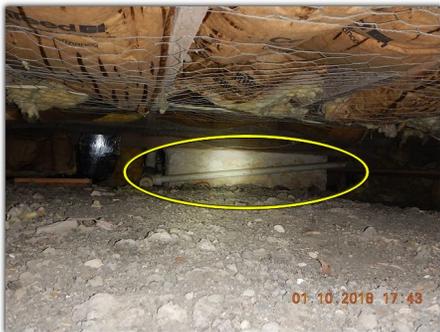
Negative slopes and "bellys" observed at portions of drain plumbing within the crawlspace (*various locations*).

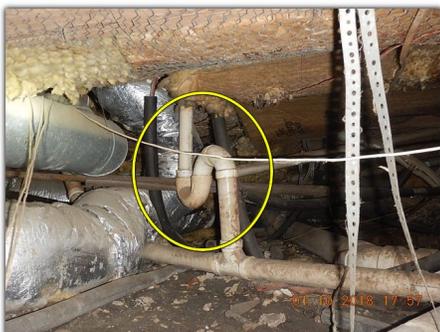
Improper drain trap installation (*downstairs half bathroom sink*). The drain trap for this sink was observed to be more than 24 inches from the sink and is an improper S trap, prone to siphoning. Lastly, the trap is located in the crawlspace without insulation.

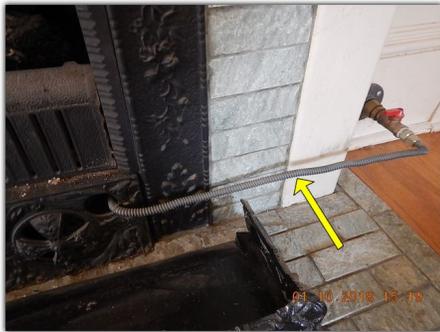
Improper use of flexible gas connector lines (*some fireplaces*). Flexible connector lines are prohibited from passing through walls or other partitions and should ideally be replaced with permanent, rigid piping.

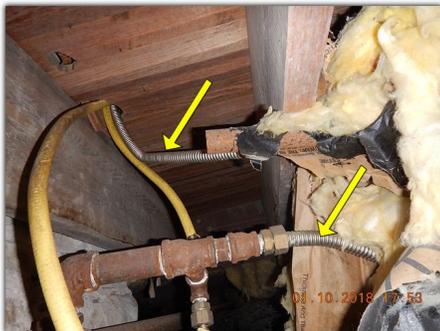
Missing protective jacket and exposed CSST gas lines (*observed in the crawlspace, near the base of front chimney / fireplace*). The yellow protective jacket for this particular gas line is required to remain intact, from fitting to fitting, in order to protect the flexible metal gas lines. Although no evidence of corrosion or damage was observed at the exposed metal lines, Further evaluation is recommended by a qualified plumber.
