PRE-DRYWALL INSPECTION REPORT

Guided Inspections

Prepared For: Sample Client
Concerning: Sample St. Austin, TX 12345
Inspector: Jesse W. Bryant TREC# 8511 01/12/18

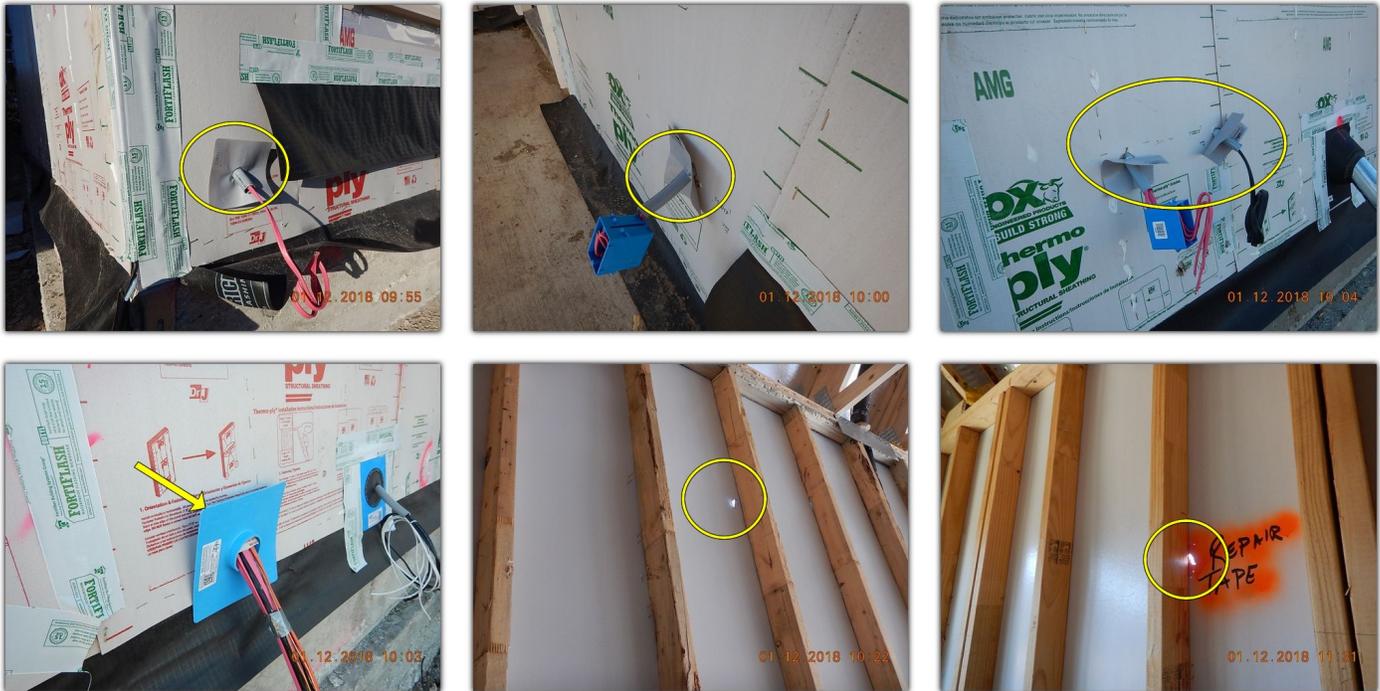
- Multiple wire penetrations were observed to be unsealed at the exterior walls and some gaps / holes were observed in the sheathing material. All penetrations, holes, etc. should be properly sealed with an approved flash top, installed in a shingle fashion, in order to prevent possible moisture intrusion. Further evaluation and repairs are recommended where necessary.

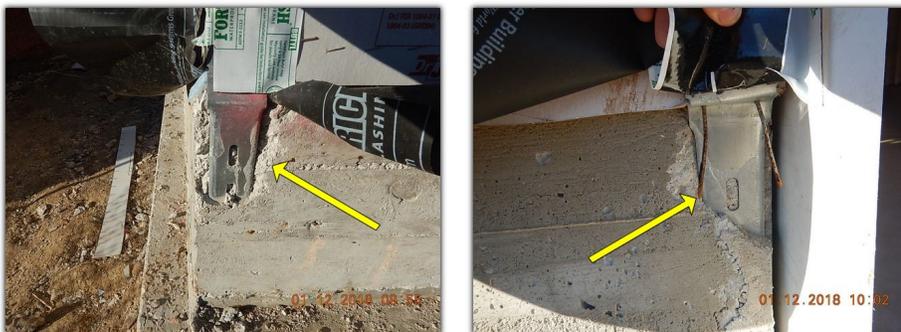
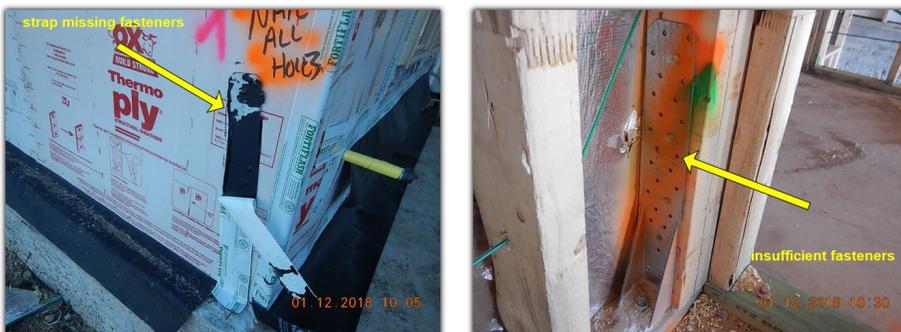
- Some of the foundation anchor straps were observed to be close to the edge of the foundation, exposed and not fully embedded in the concrete, as required by the manufacturer. Furthermore, some of the straps and interior hold-down anchor straps were observed to be missing fasteners (Check all as some straps were taped over and could not be checked). Further review by the strap manufacturer or a qualified engineer is recommended prior to proceeding with exterior masonry.

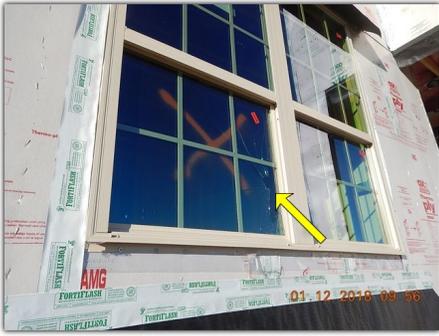
- A broken window pane was observed at one of the front windows. Repairs are recommended.

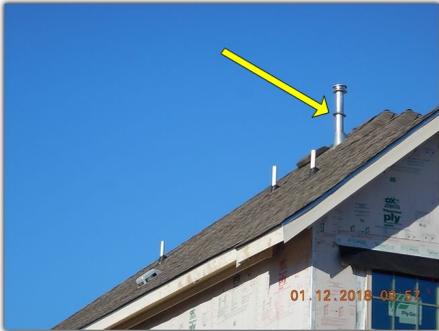
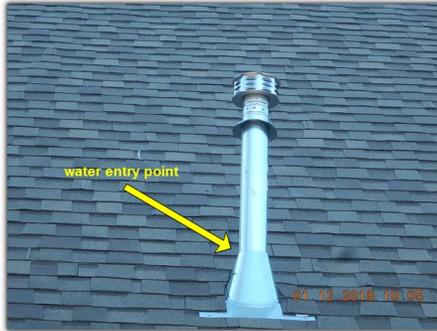
- The storm collars around the furnace / water heater vent pipes should be set and sealed prior to insulation or drywall installation.

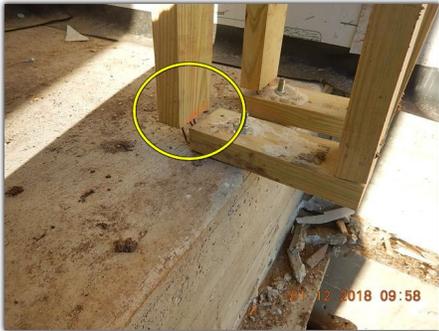
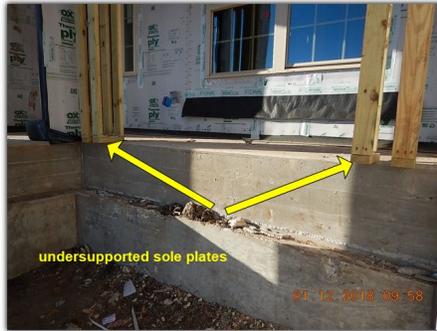
- Loose, unsecured and unsupported framing was observed at the front porch for the columns. Further evaluation and repairs are recommended as necessary in order to provide proper support / stability for the masonry to be installed around this framing.

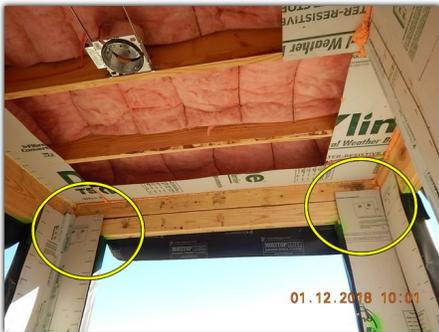
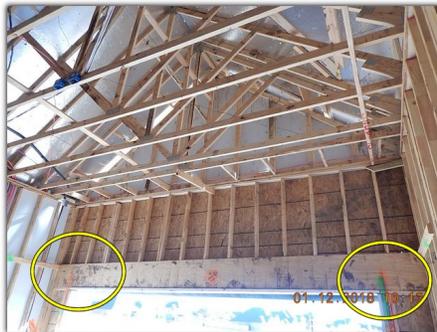
- Strap ties were observed to be missing at the garage door beam and the front porch beam. These beams are typically strapped to the support walls at each end in order to help provide resistance against wind uplift, abnormal movement, etc. A review of the building plans and fastener schedule is recommended to determine if strapping is required at these (and other) locations. Corrections are recommended as necessary.

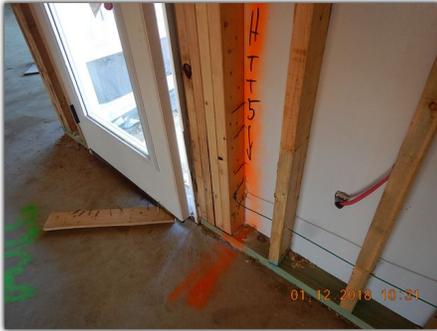
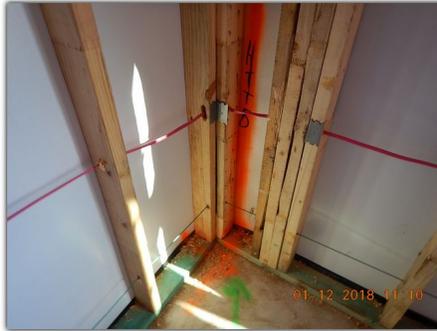
- Missing interior hold-down anchor straps were observed to be missing at various locations. Review building plans install the appropriate anchor straps, where required, prior to proceeding.

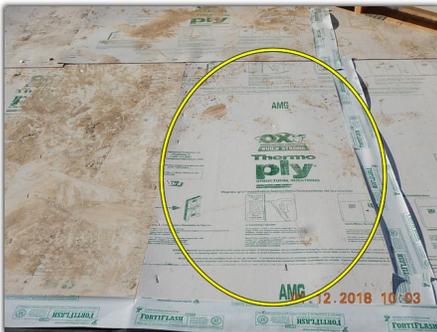
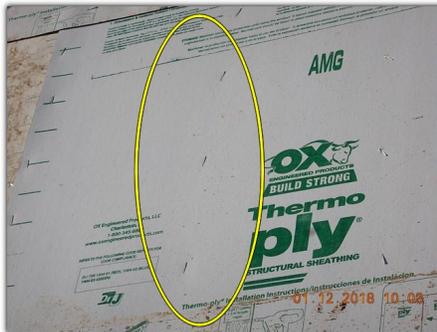
- Fastener spacing at the exterior Thermo-Ply sheathing was observed to exceed 3 inches on center at various locations. Further evaluation and repairs are recommended where necessary to ensure that the sheathing materials are properly secured to manufacturer specifications.

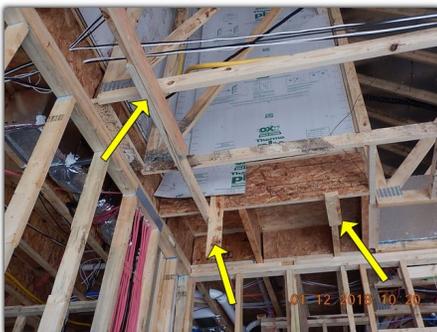
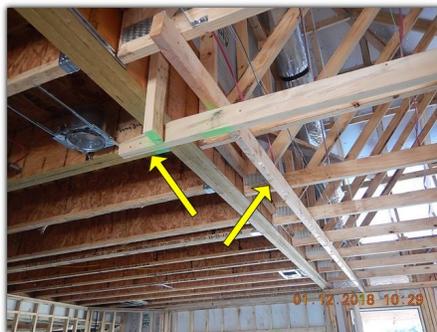
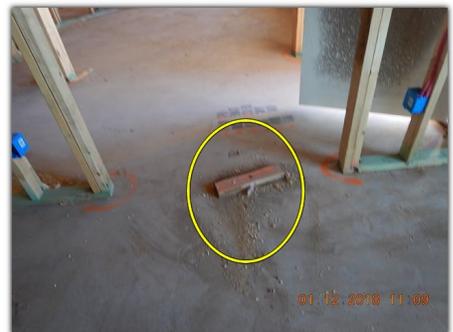
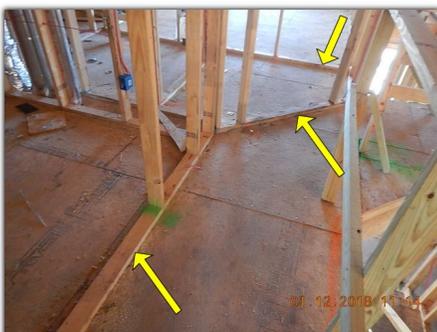
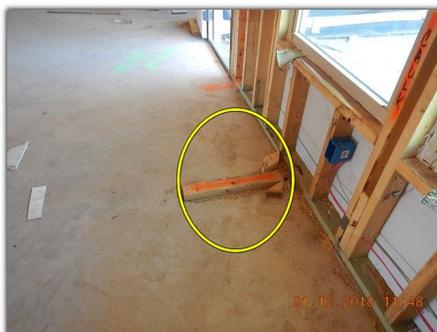
- Numerous pieces of deadwood, temporary supports, uncut sill plates in doorways were observed. Removal of this materials is recommended where necessary.

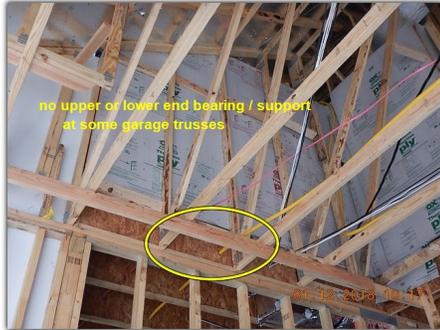
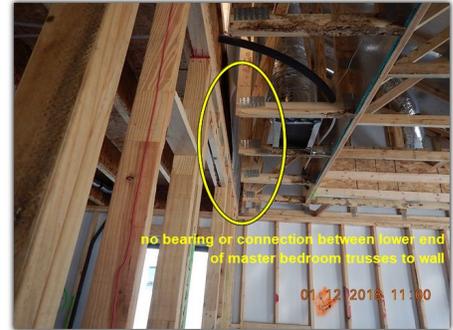
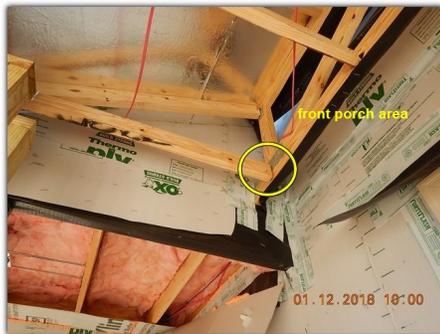
- Various truss end support / attachment points were observed to be questionable, but could not be verified or investigated further without access to building plans and / or truss details. Some of the areas of concern include:
 - truss support at some truss ends at the South garage wall
 - missing hangers / blocking at master bedroom truss ends, near the bay are of the room and at one or more front porch roof trusses
 - gap between master bedroom lower truss corners and the wall between the master bedroom and bathroom
 - unknown cross bracing requirements for these trusses

A further review of the building plans and truss details is recommended by the builder and/or the truss manufacturer to ensure proper support / attachment and bracing of all engineered roof trusses, prior to insulation and drywall

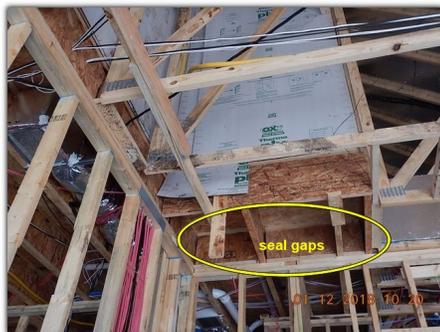
- Properly isolating and air sealing attached garages from the living space is critical for preventing the potential infiltration of carbon monoxide and other contaminants into the home. Open joist bays above the garage that extend into living spaces need to be blocked and air sealed at the garage wall. Seams along the rim joist, top plate, sill plate, and foundation wall should be caulked or sealed. At this time, no type of sealed sheathing product was observed at the walls separating the garage from the living space. Further review of this home's building plans (*and local energy code requirements*) and repairs are recommended as necessary.

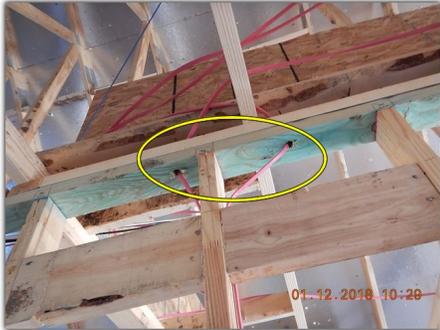
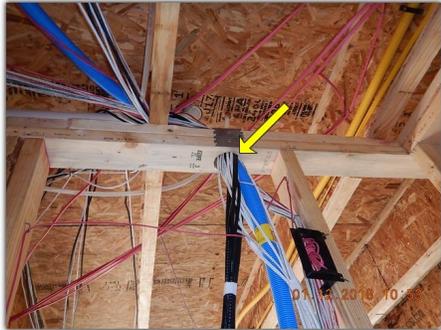
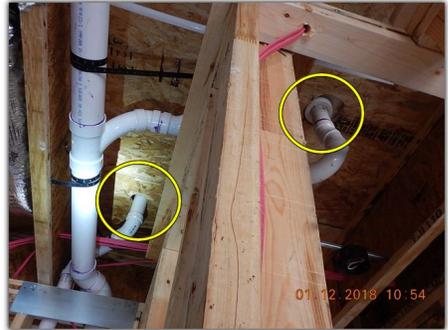
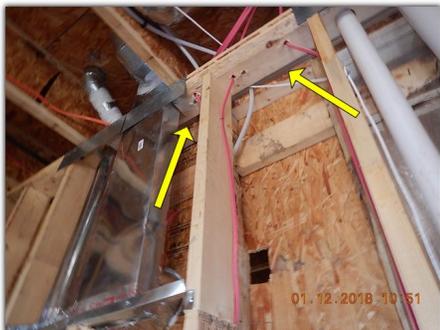
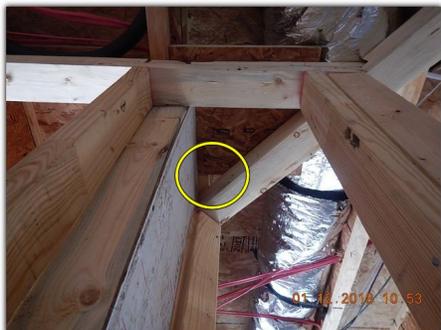
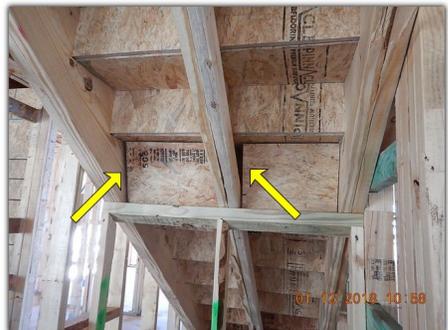
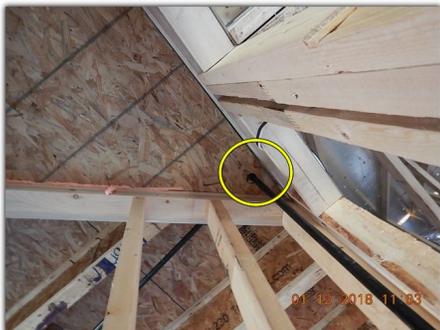
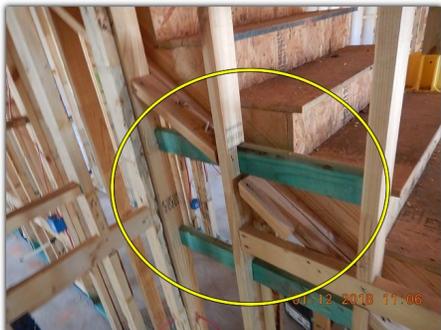
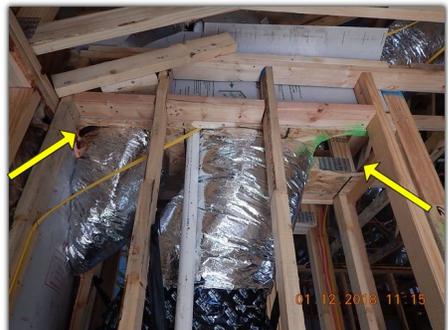
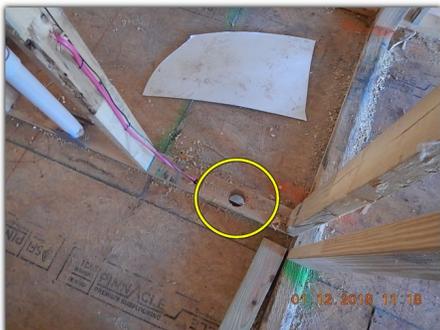
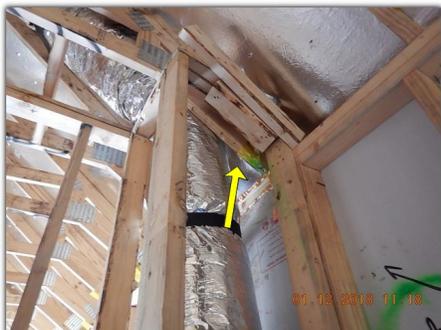
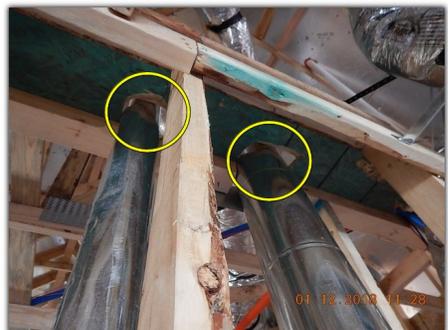
- Multiple holes and gaps were observed in the wall top plates and at portions of solid fireblocking that have yet to be sealed with an approved fire sealant foam, to include:
 - top plate penetrations
 - at furred walls between laundry / kitchen
 - duct chases
 - gas line hole in fireblocking above fireplace
 - stairway fireblocking
 - subfloor penetrations
 - etc.).

Further evaluation and repairs are recommended where necessary for improved fire blocking properties

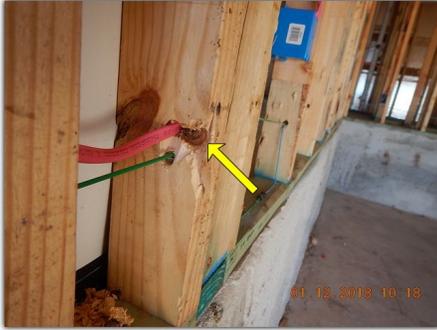
- Protective metal plates are required at the wall studs where wiring bored through the studs is less than 1-1/4 inch from the face of the stud. Further evaluation and repairs are recommended where necessary to prevent possible wiring damage during drywall installation.

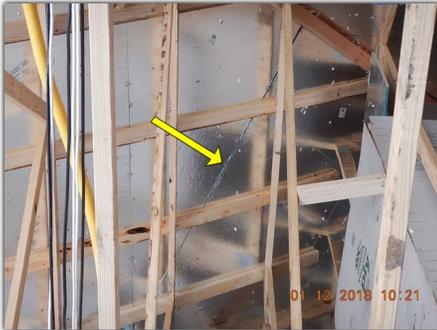
- Some portions of the roof decking were observed to have been installed in a diagonal orientation to the rafters. A diagonal orientation of the roof decking does not provide the same strength axis as a perpendicular orientation. Most sheathing manufacturers require that the sheathing be installed with the long dimension, or strength axis, of the sheathing panel perpendicular to the framing members, with the panel continuous over two or more spans. This ensures that the span does not exceed 24 inches. No adverse affects (sagging, separation) were observed as a result of this installation; however, diagonal seams greater than 24 inches long should ideally be blocked or secured with additional lumber to ensure adequate support over time.

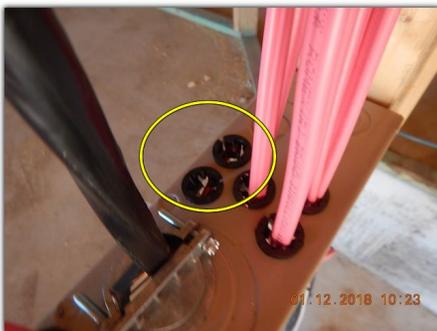
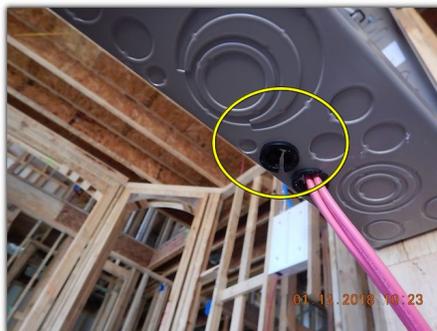
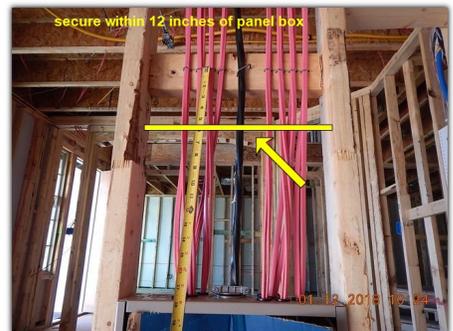
- All unused holes / openings in electrical panel boxes shall be covered or filled with appropriate knockout plates and all wiring entering the panel box shall be secured within 12 inches of the point of entry into the box. Further evaluation and repairs are recommended by a qualified electrician.

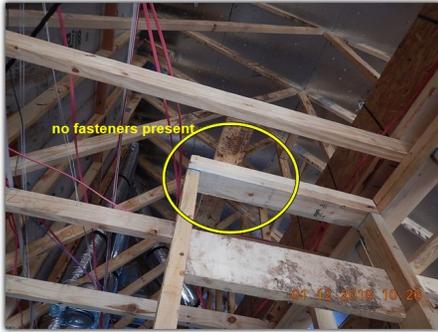
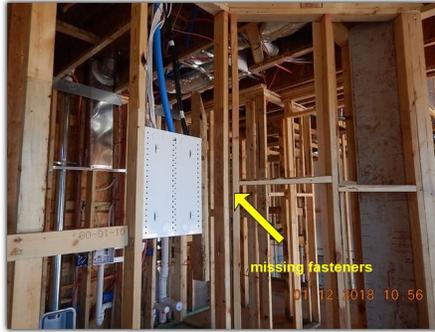
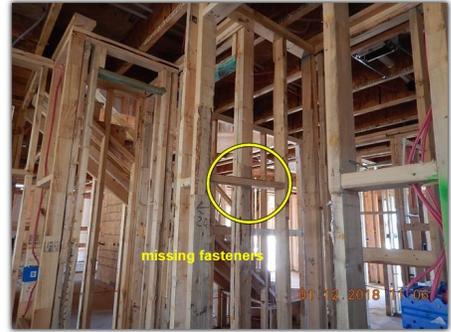
- Numerous wall intersections were observed to be missing fasteners and were not properly supported or secured (*top plate at half wall coming in from garage / various wall intersections / etc.*). Check all fastening requirements, according to plans, and repair where necessary.

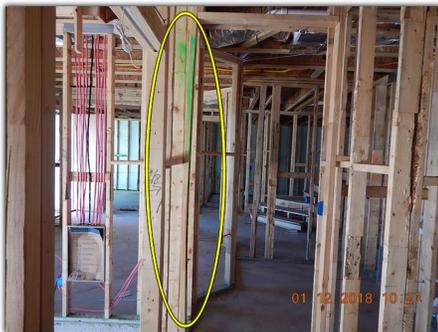
- The doorway into the laundry room was observed to be improperly nailed off and is bowed. Further evaluation and repairs are recommended (*proper blocking prior to nailing*).

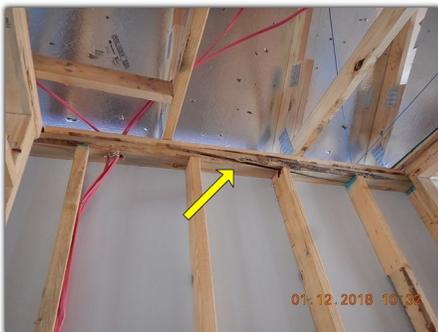
- A split cracked and protruding top plate was observed in the small room off of the nook. Repairs are recommended as necessary.

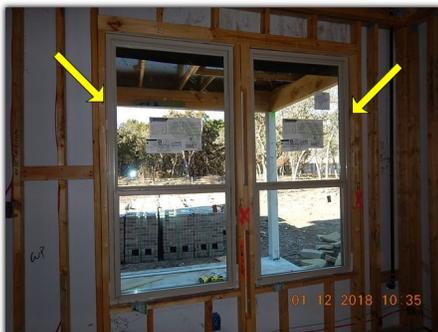
- Caulk / foam application at the perimeter of the window frames was observed to be incomplete.

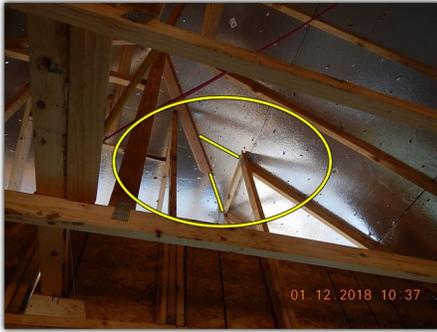
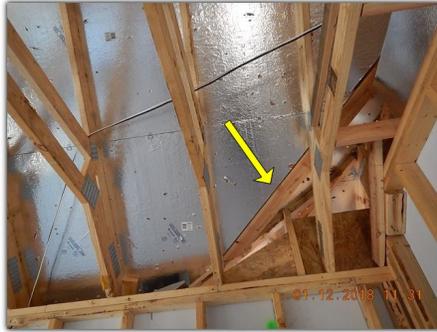
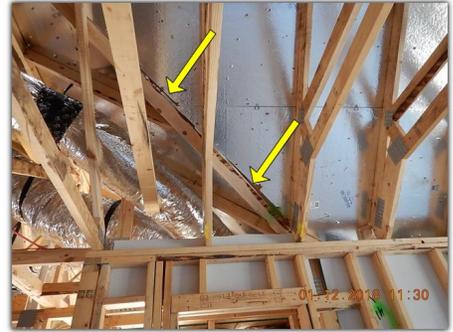
- Additional framing support is recommended at the short truss above porch roof and at multiple unsupported roof decking edges at the valleys. Further evaluation and repairs are recommended where roof sheathing edges are not blocked or supported.

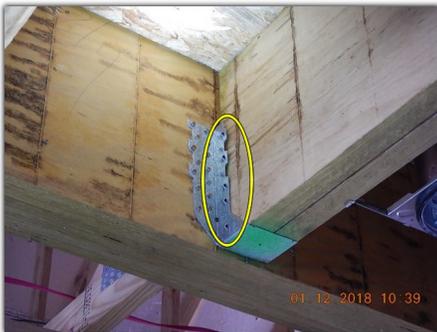
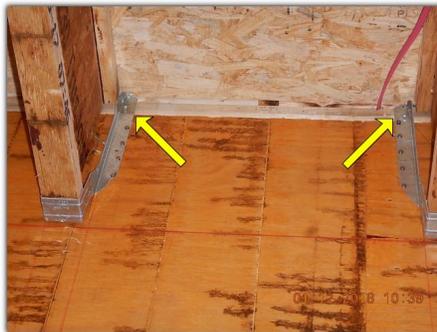
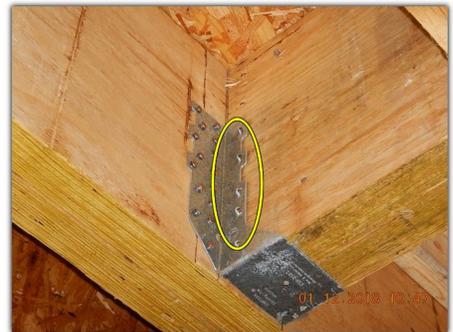
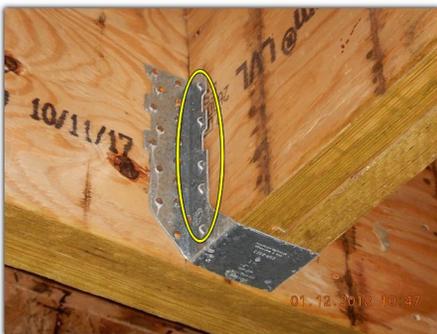
- Numerous joist and beam hangers were observed to be missing fasteners. All nail holes at these hangers are to be filled with the required fasteners. Further evaluation and repairs are recommended where necessary (*check all*).

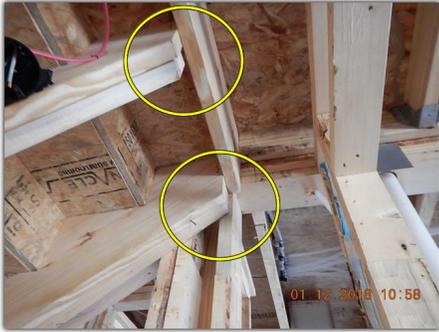
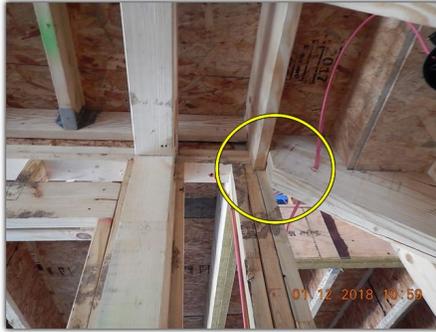
- The kitchen island framing was observed to be very loose and should be re-secured in order to protect the wiring and plumbing within the wall.
- Additional blocking or hanger support may be needed at the top end of the stair stringers as the stringer ends are not bearing fully at the ends. Further review of the plan details and repairs are recommended as necessary.

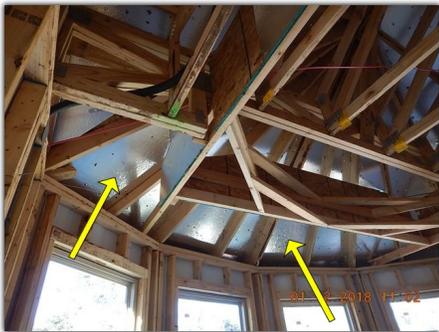
- Additional framing is recommended for ceiling drywall at master bedroom bay window area.

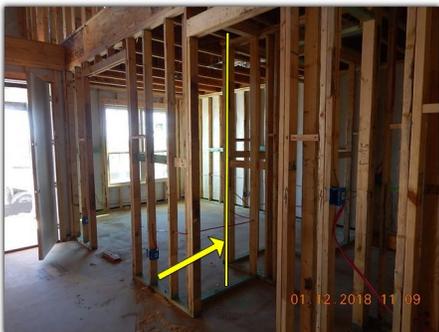
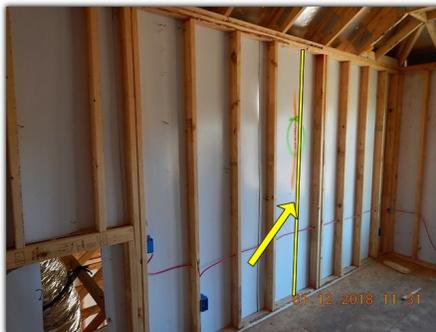
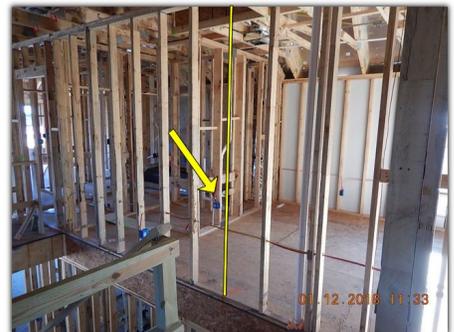
- Missing studs were observed at various locations (between front bedroom and adjacent hall, stairway, up great room, etc) and should be replaced where missing.

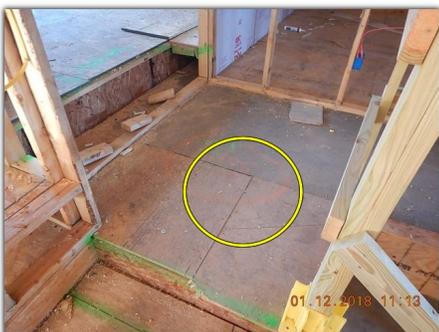
- Additional blocking / support is recommended for a section of the loose / sagging sub floor at the upstairs landing.

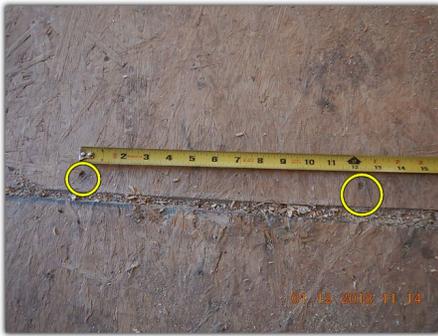
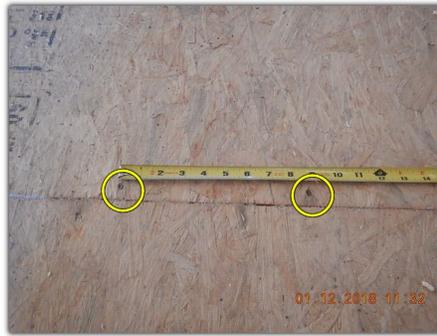
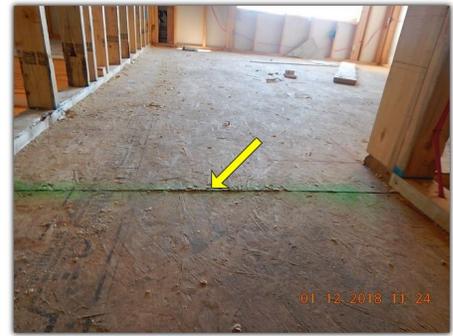
- Improper sub floor nailing was observed at various locations upstairs. The sub floor material is required to be nailed every 6 inches along the edges and 12 inches along the field of the sub floor sheets. Proper nailing helps to resist subfloor "squeaking" and movement over time. All uneven sub floor edges shall also be ground or sanded down for even transitions. Further evaluation and repairs are recommended.

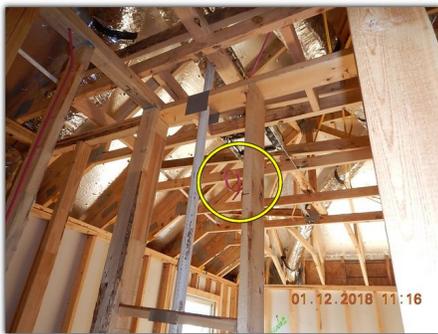
- A Missing light fixture junction box was observed at one of the upstairs vanity areas. Further evaluation and repairs are recommended by a qualified electrician.

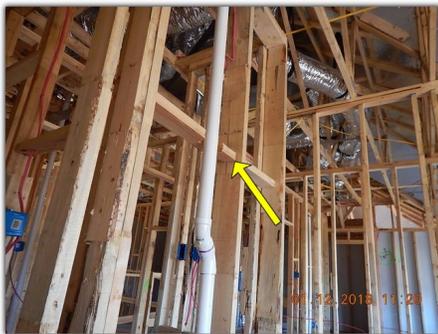
- Loose blocking was observed in the wall between the Southeast bedroom and the adjacent vanity. Repairs are recommended.

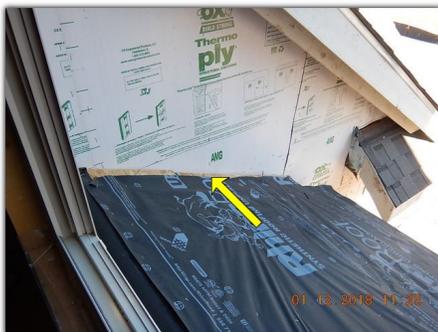
FYI: No flashing materials were observed at the front porch roof-to-wall intersections (likely to be installed during masonry installation)

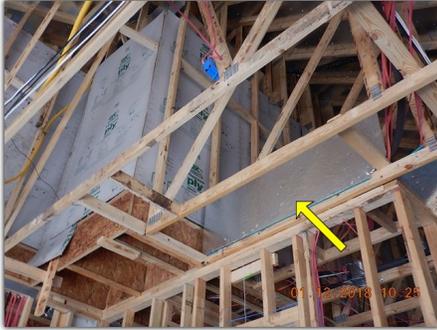
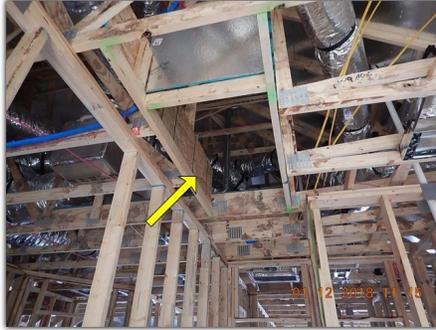
FYI: Garage and upstairs attic stair units were not installed or present at the time of the inspection.

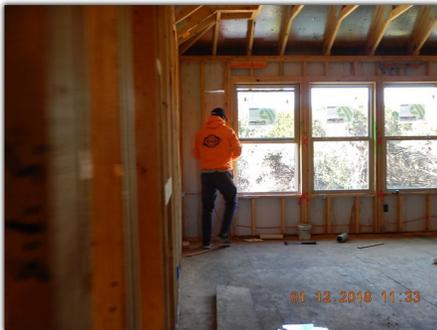
NOTE: Upon departure from the inspection, workers had arrived to deliver drywall to the property. This entailed them cutting the exterior sheathing at the rear. Ensure that the sheathing is properly sealed / repaired prior to masonry installation.
