FOUNDATION ASSESSMENT & FLOORING EVALUATION REPORT

Inspection Date: 1-31-25

Inspector: Jesse Bryant - Professional Inspector / TREC 8511

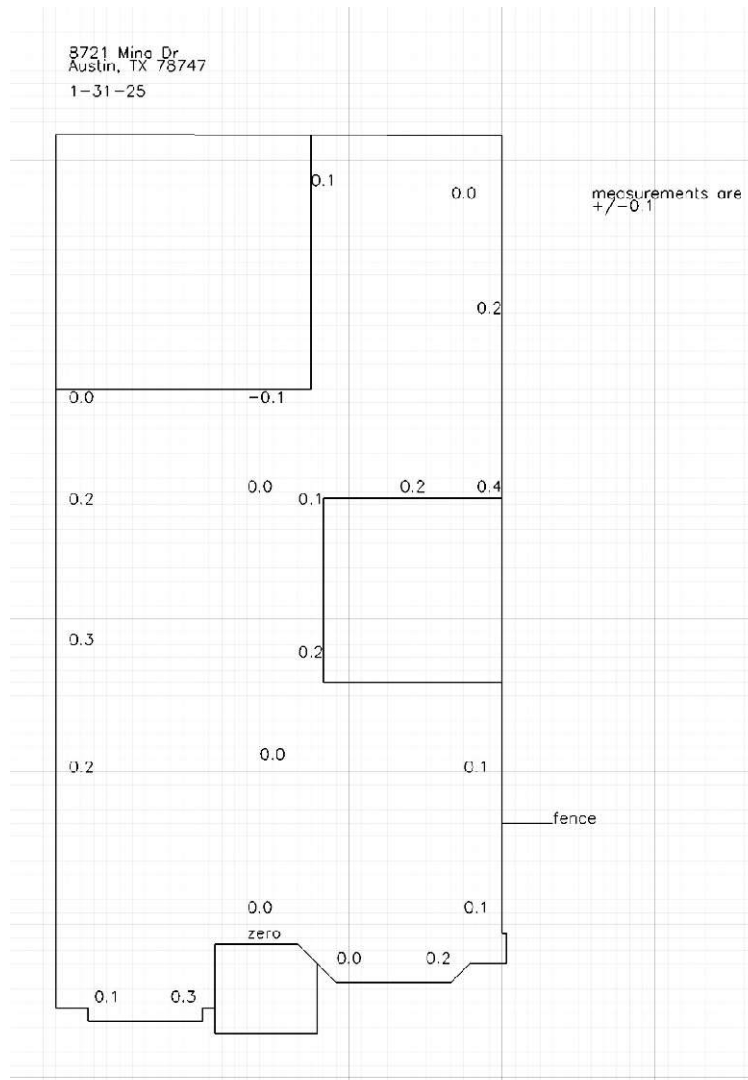
- The elevation survey showed minimal variations across the slab, with the highest point being approximately **3/8 (0.4) inch higher than the zero reference point.**
- The **centerline of the slab, running front to back, was relatively level**, with outer elevations slightly higher than the center.
- The elevation pattern suggests **minor soil-related movement**, likely due to **recent rainfall and a lack of gutters**, leading to slight expansion of the soil near the perimeter beams.
- No signs of significant foundation settlement, heaving, or structural distress were observed during the survey.

Based on the findings, **the foundation is performing adequately and does not show evidence of abnormal structural movement**. The minor elevation differences are within normal tolerances for slab-on-grade foundations in this region and do not appear to be the primary cause of the tile failure.
