EVALUATION OF STAINLESS STEEL PIPING FOR HIGHLY CORROSIVE LOCATIONS

The objective of this project was to select, demonstrate, and evaluate alternate materials for corroded fire-suppression water pipelines at the Chimu-Wan tank farms on Okinawa Island, Japan.

Members of the research team inspected piping at the three Chimu-Wan tank farms. Chimu-Wan 3 was determined to be in the poorest condition, so it was selected as the test site. Given the highly corrosive chloride-infused environment at the site, SAE* low-carbon stainless steel grades 304L (pipe sections) and 316L (flange fasteners) were selected as the demonstration materials. A rehabilitation design was developed, installed and tested on above-ground sections of fire-protection piping.

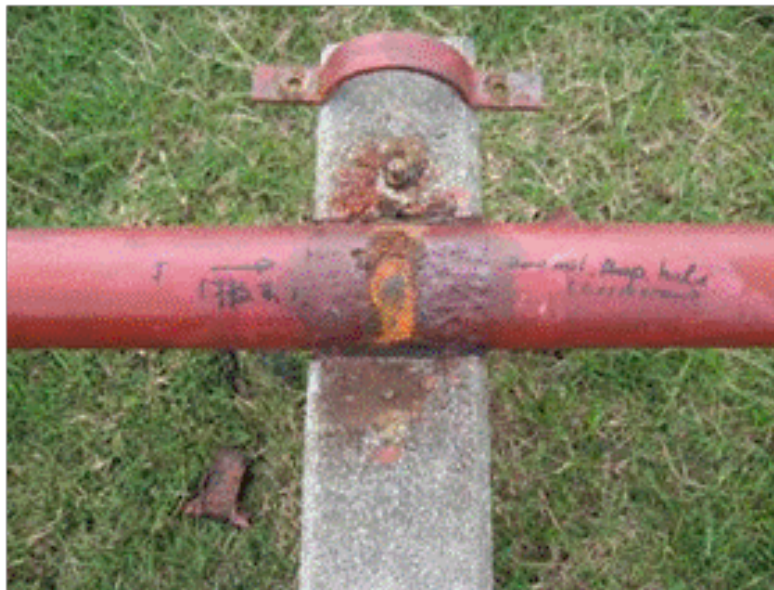
After meeting with QMBN and Directorate of Public Works (DPW) at Camp Courtney, inspections of the fire-protection pipelines were conducted at each of the three Chim-Wan bulk fuel tank farms. Within each tank farm, the fire protection pipelines were examined, noting areas of active corrosion. The piping within all three tank farms exhibited areas of significant corrosion activity and metal loss. The most significant corrosion was on the piping within Chimu-Wan 3 tank farm. Extensive corrosion was found along the bottom, at supports, risers, and valves of the above grade piping. Figure 1 shows severe corrosion at a pipe support, and Figure 2 shows a severely corroded flange bolt at a valve.

Figure 1. Severe corrosion at pipe support.

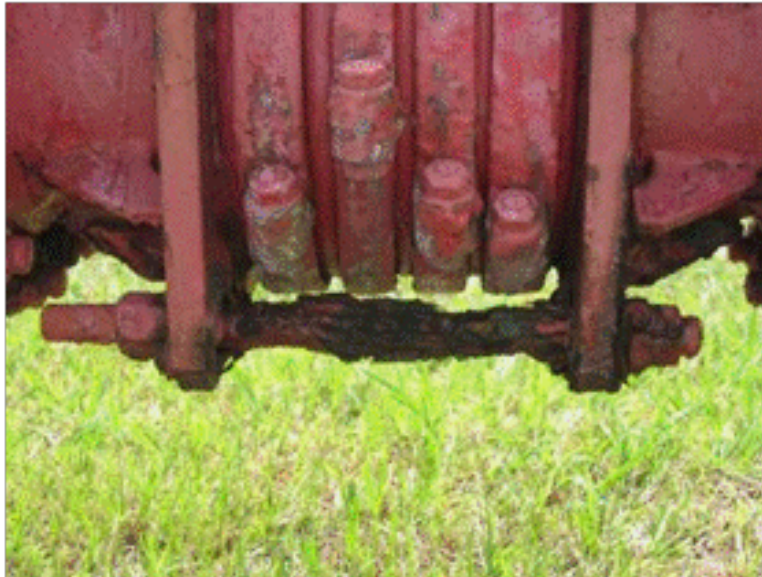
Figure 2. Severely corroded flange bolt

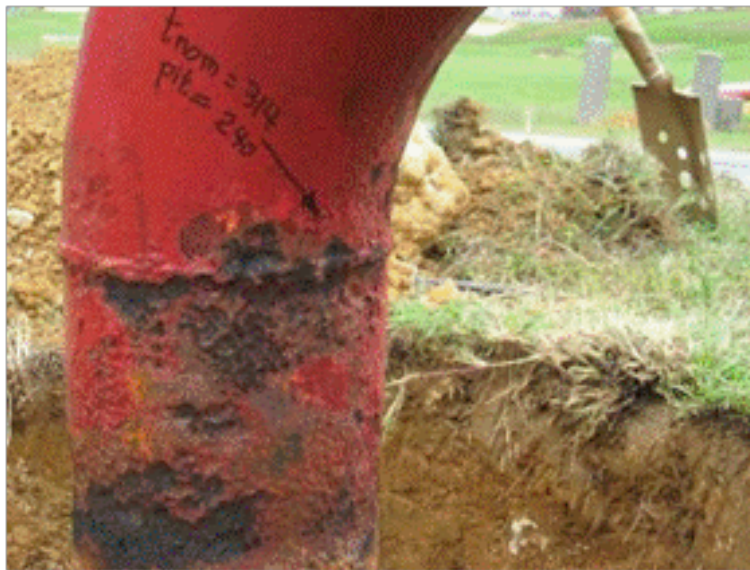
The underground fuel lines for each of the bulk fuel tank farms are coated and protected by impressed-current cathodic protection. The water lines are electrically grounded to the fuel lines, so they also benefit from the cathodic protection systems. Electro-chemical potentials were recorded where the underground water lines exit the soil. The measurements were recorded using a Fluke Model 179 voltmeter with a saturated copper/copper-sulfate reference cell. These data are presented in Appendix E. The data show that the underground water lines were effectively protected, meeting the NACE RP0285-2002 -850 mV instant-off criterion. The cathodic protection system only protects the below grade segments. The above-grade risers were severely pitted, as shown in Figure 3.

Figure 3. Severe pitting on above-grade riser.

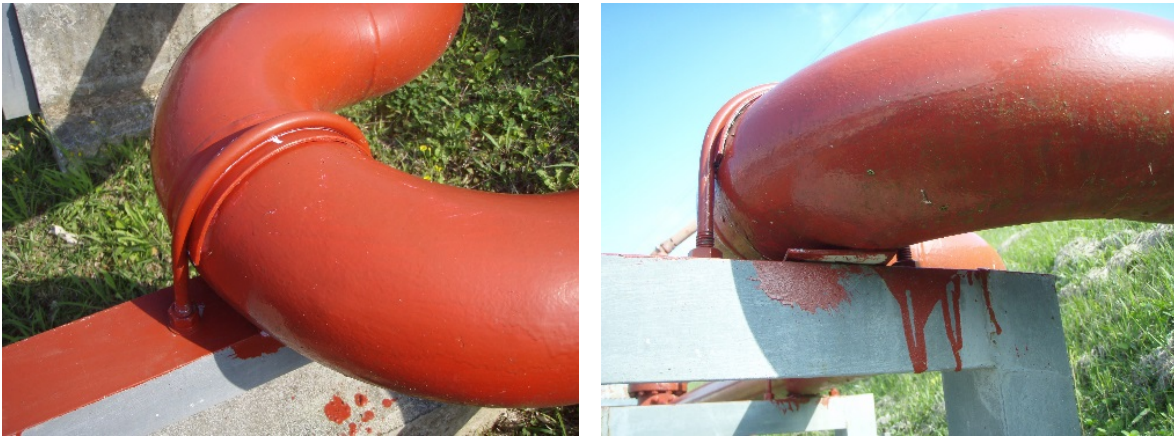
The replaced fire-suppression system pipes were visually inspected in March 2017 to evaluate the performance of the demonstrated technology. The inspection found all sections of the piping to be in good condition, with the replaced pipes and supports showing no significant corrosion damage. Figure 6 shows examples of spotting and running on pipe supports that indicate some recent touch-up recoating was done to a few sections of pipe. Installation records show that no contracted painting has been done on these areas since the installation, so it is likely that the touch-up work was done by DPW personnel or the tank farm operator.

Figure 6. Two sections of installed pipe showing evidence of touch up painting.

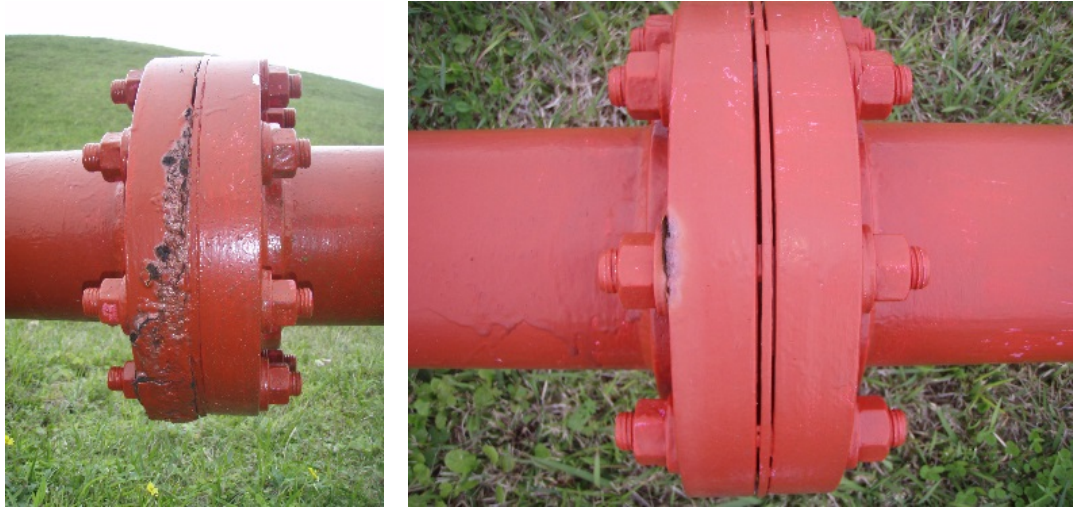
Photographs of the replaced pipe confirm that the overall condition is good. Some surface corrosion has occurred, mainly at flanges and bolted connections (Figure 7). These areas were not typical, and the level of corrosion is not considered significant. However, the inspection results confirm that periodic inspections and maintenance should be performed to clean and coat such areas.

Figure 7. Corrosion at a pipe flange (left) and bolted connection (right).

Based on the inspection report, the pipe appears to be performing as expected. Routine maintenance will be required to address the areas of surface corrosion. With proper maintenance (a \$5,000 annual maintenance budget is assumed in the cost analysis) this pipe should easily meet the expected 30 year useful life projected for this application.

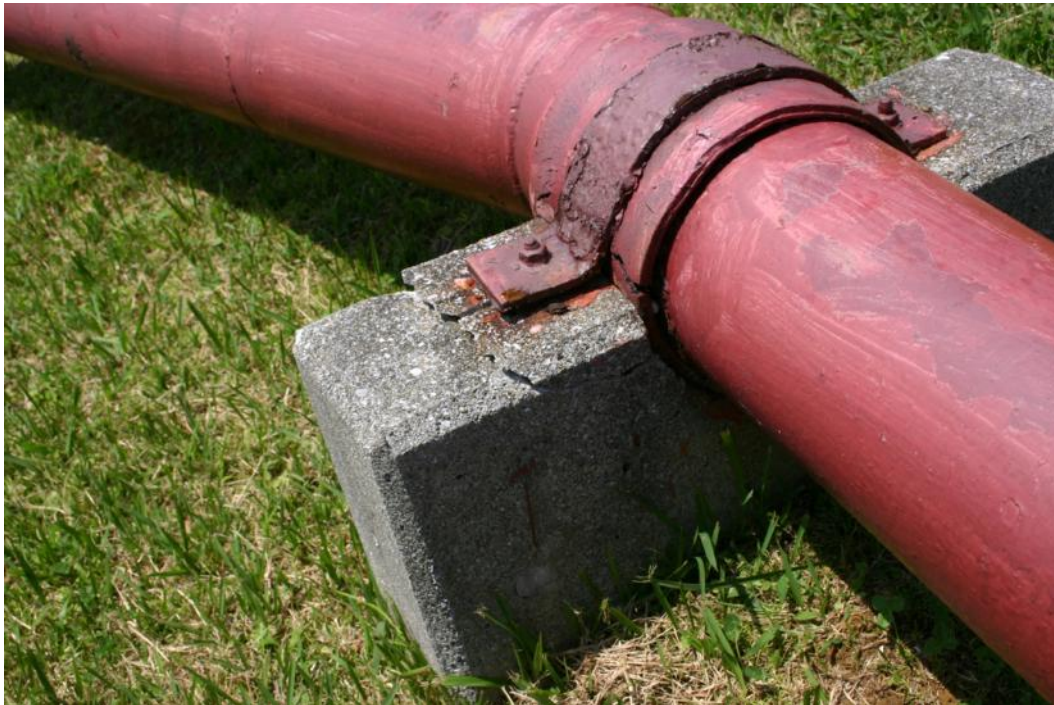
Figure B5. Photograph of the structural damage caused by corrosion of the pipe at the Chimyu-Wan Tank Farm #3, Okinawa, Japan.

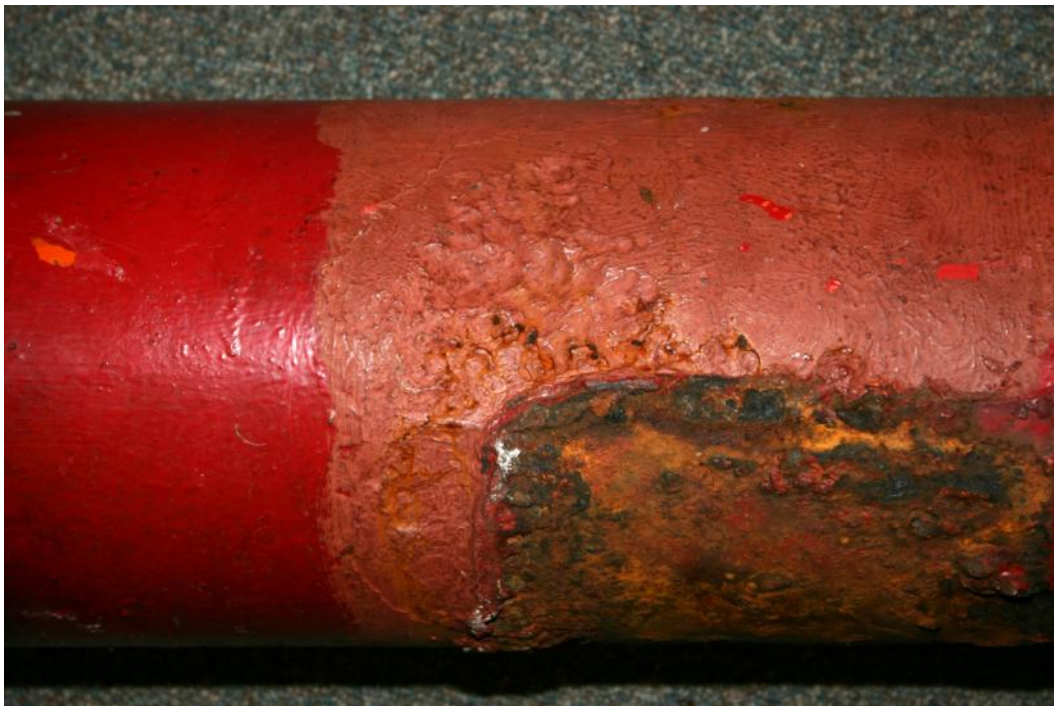
Figure B6. Photograph of the pipe section as received from Okinawa showing the area near and under the support saddle.

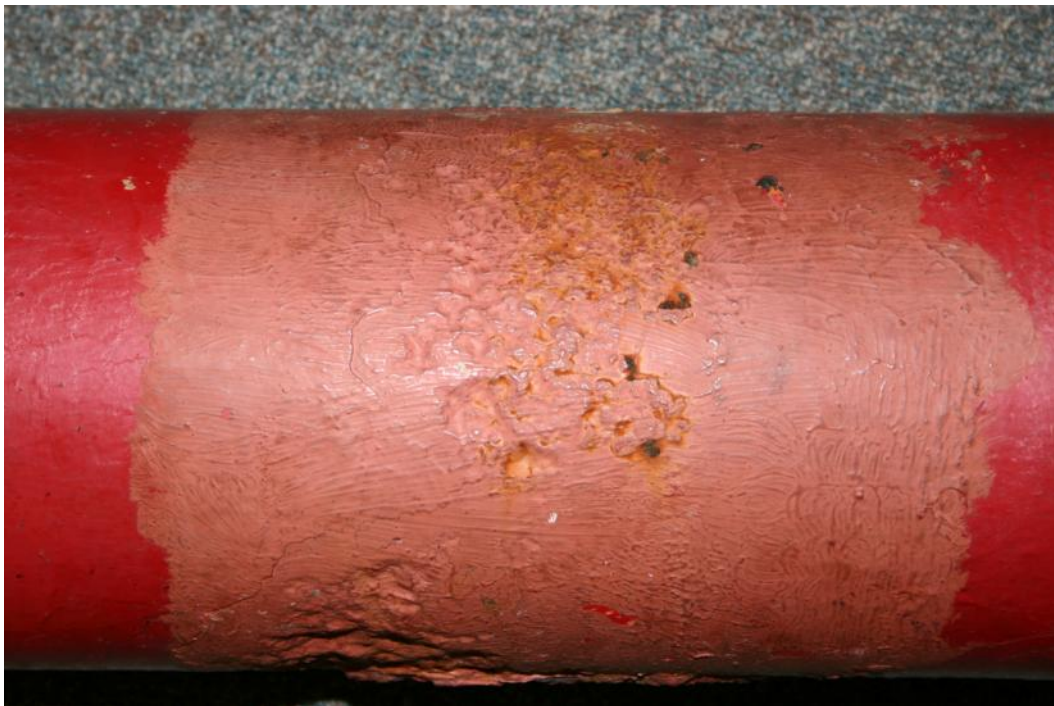
Figure B8. Photograph of the pipe section showing the area under the strap used to hold the pipe to the saddle.

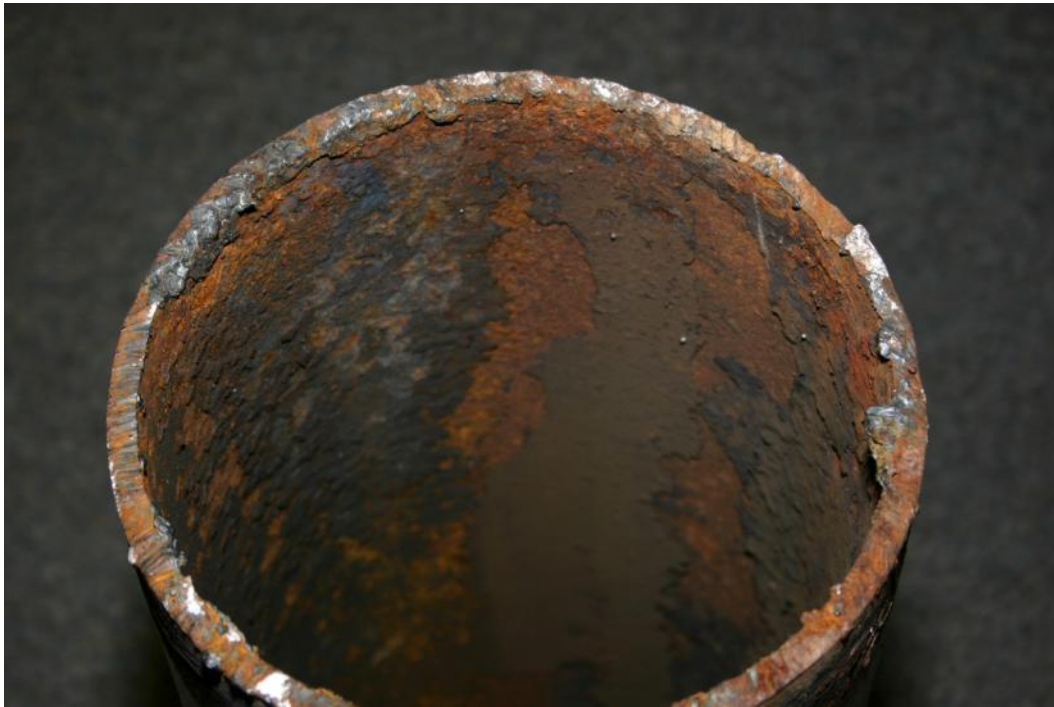
Figure B9. Photograph of the interior of the pipe as received from Okinawa showing light general corrosion.

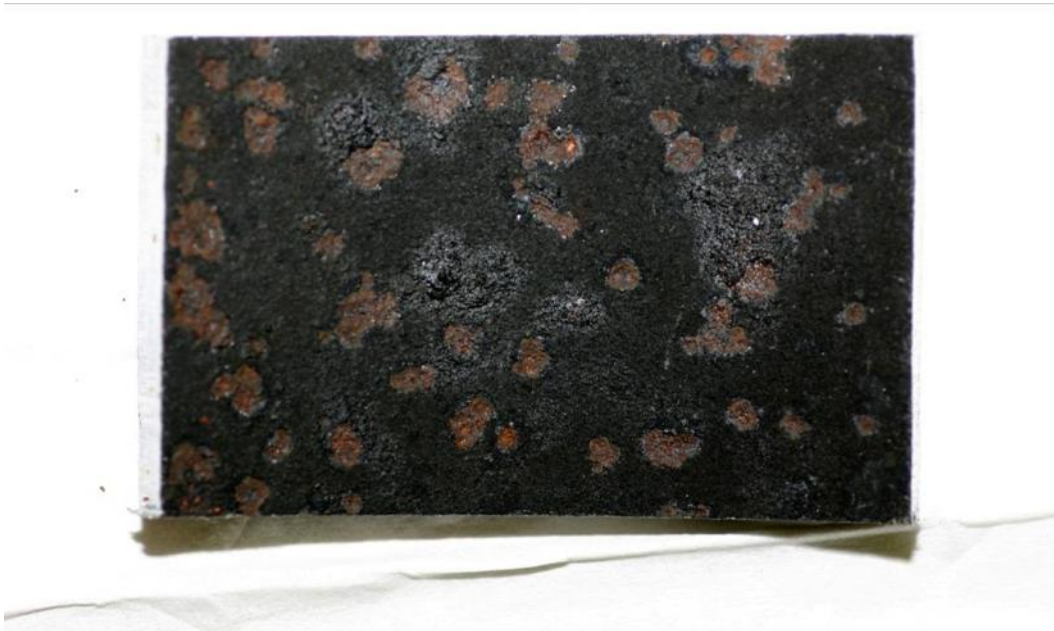
Figure B10. Photograph of the interior of the pipe showing the beginning of pitting corrosion from the water carried in the pipe.

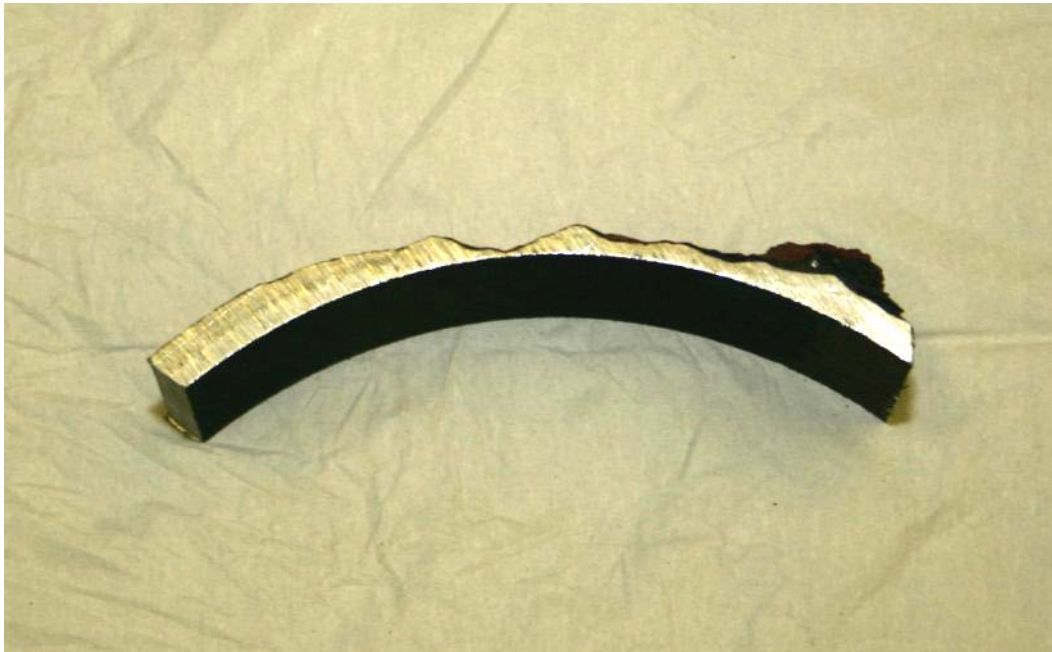
Figure B12. Photograph of the deeply corroded area on the outside of the pipe.

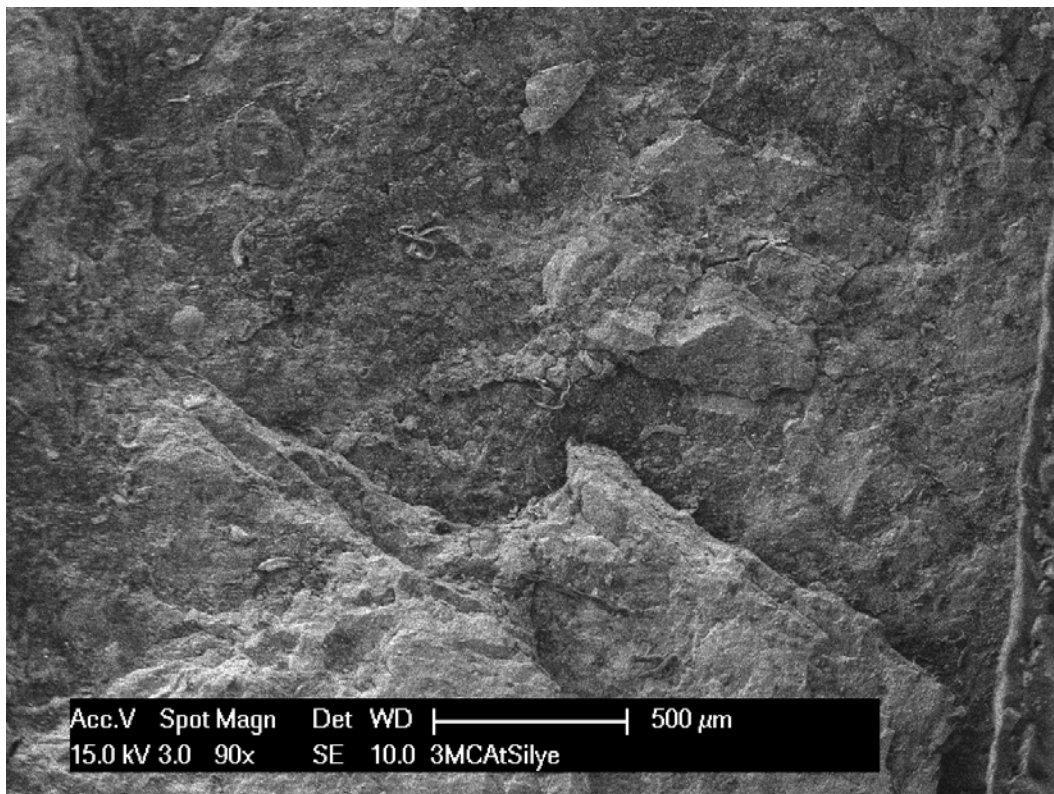
Figure B13. Photomicrograph of the exterior surface from the supply pipe of the fire suppression system at Chimyu-Wan fuel storage, Okinawa, Japan. (90x)

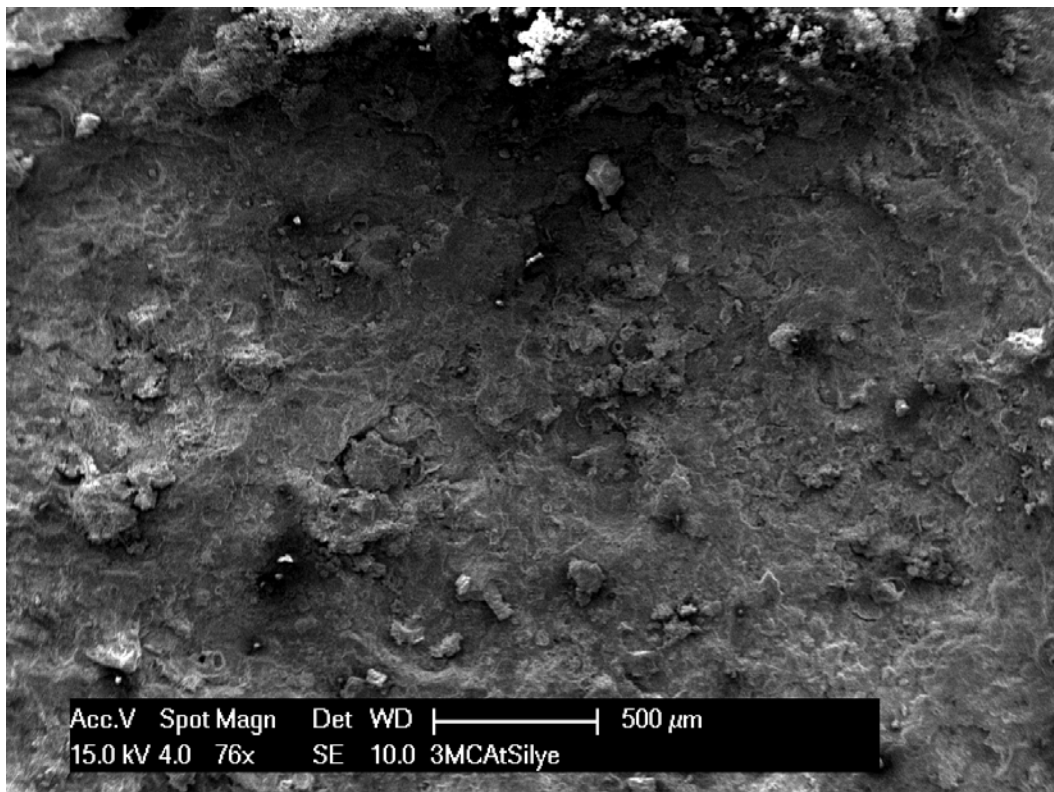
Figure B15. Photomicrograph of the interior surface of the pipe sample where corrosion had thinned the pipe wall. (76x)

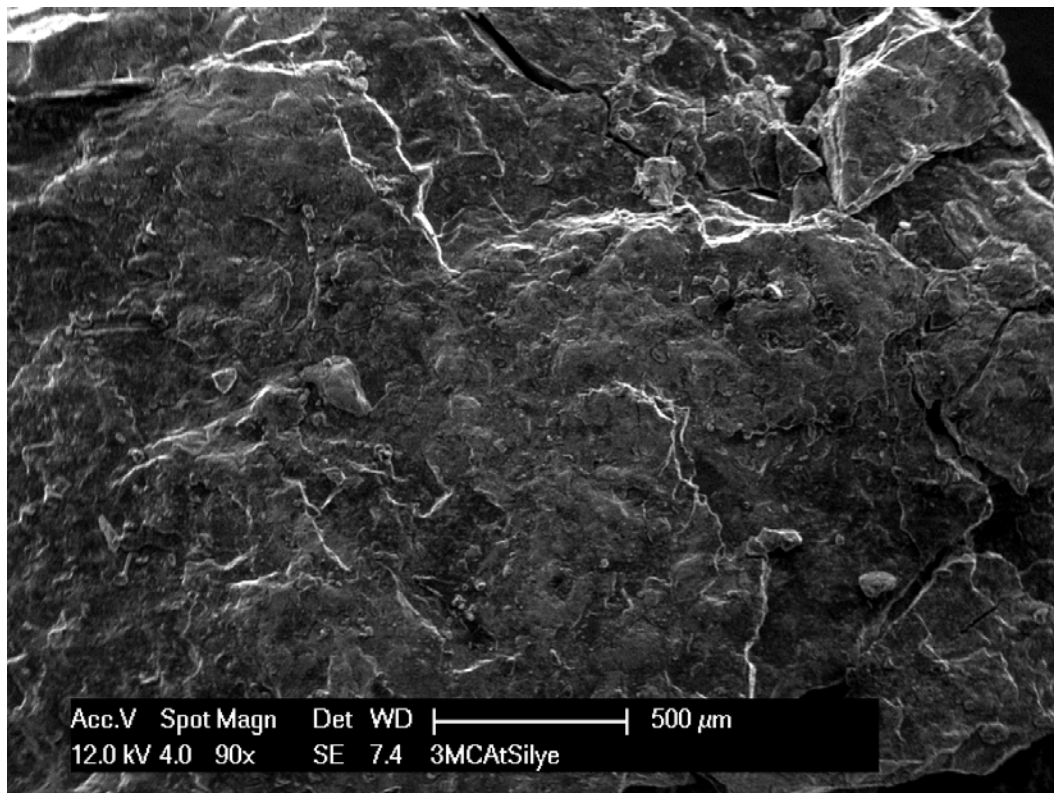
Figure B17. Photomicrograph of the scale from the exterior of the pipe. (90x)
