Williams Geismar Olefins Plant

Reboiler Rupture and Fire Geismar, Louisiana

Incident Date: June 13, 2013

No. 2013-03-I-LA

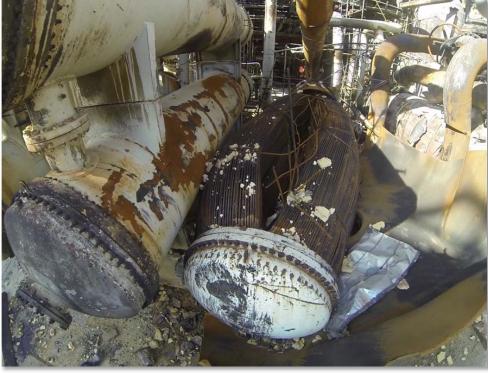
FIGURE 7

Post-incident photo of the ruptured Reboiler B.

The high pressure generated from liquid thermal expansion of the propane cracked the reboiler shell. The shell contents began to vaporize near the crack opening, and a jet release of liquid and vapor accelerated out of the crack. The pressure loading on the open edges of the crack caused the crack to continue to grow along the vessel length. As the crack opening increased in size, the liquid and vapor jet release also rapidly grew. The continued internal pressure caused the reboiler shell to fail suddenly and catastrophically, splitting wide open (Figure 7 and Figure 12).

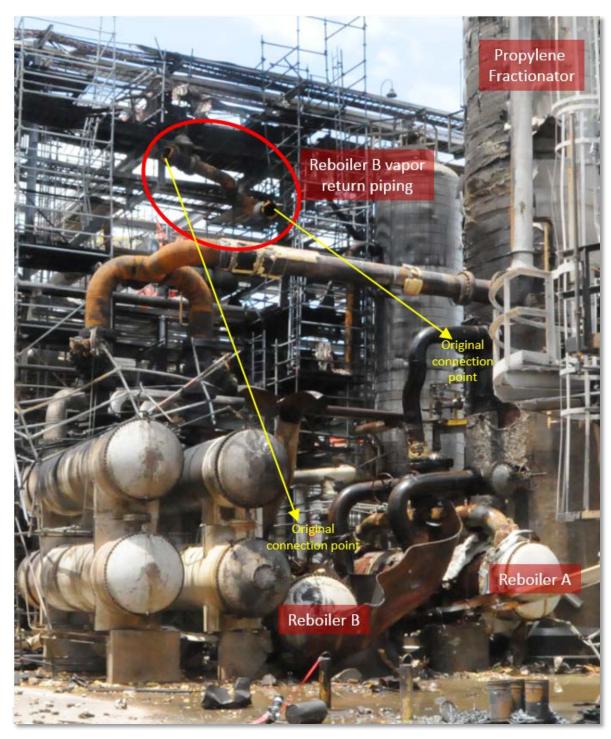
Post-incident photo of the propylene fractionator reboilers and surrounding area. The Reboiler B vapor return piping can be seen overhead in the pipe rack (red circle). The approximate original configuration of the piping and equipment is shown in Figure 9 and Figure 14.

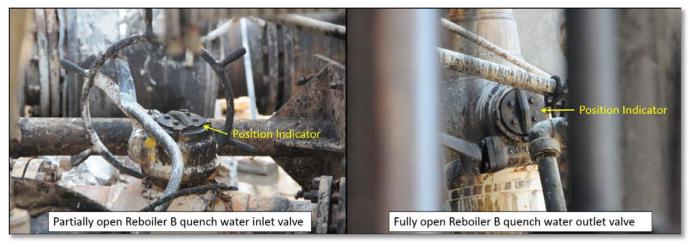
Post-incident, the Reboiler B quench water inlet ball valve was found partially open (left), and the Reboiler B quench water outlet ball valve was found fully open (right). When the position indicator is parallel to the pipe, the valve is open; when the position indicator is perpendicular to the pipe, the valve is closed.

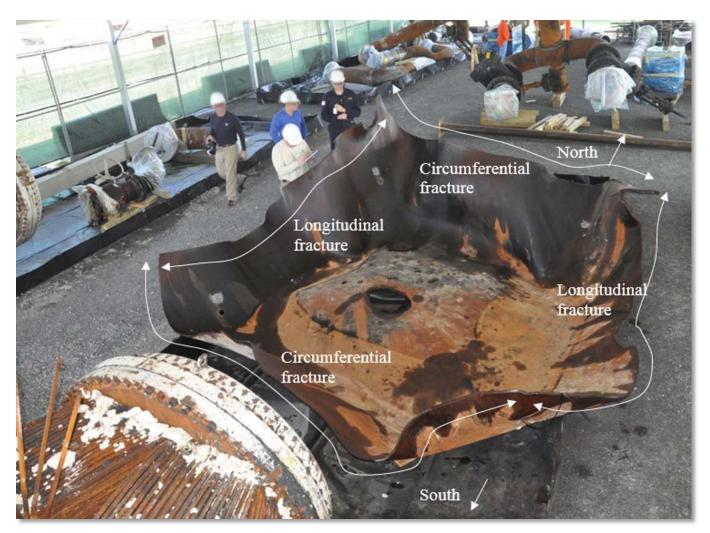
FIGURE 12

The propane then found an ignition source and ignited, creating a massive fireball. The blast effects flattened the reboiler shell (Figure 12).

Post-incident photo of Reboiler B shell. The pressure forces during the event flattened the cylindrical steel reboiler shell.

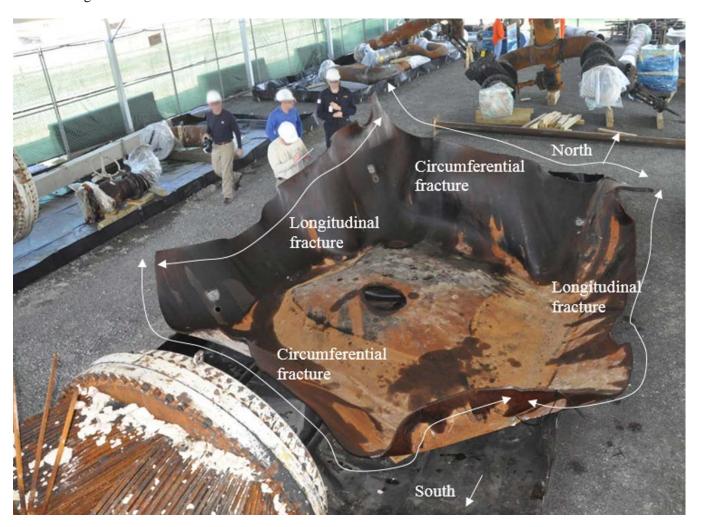
FIGURE B-4

When the reboiler shell failed locally (cracked) due to liquid thermal expansion of the shell contents, the shell contents began to flash near the failure opening and a two-phase (liquid and vapor) jet release would have accelerated out of the failure opening. The two-phase flow would have choked in the failure opening, maintaining the pressure in the vessel for a short period of time. The pressure loading on the open edges of the failure caused the crack to continue to grow along the vessel length and the failure opening rapidly increased in size. As this opening increased in size, the two-phase jet would have grown rapidly. At some point, the full opening of the vessel would have resulted in an explosive release of the remaining vessel contents. This explosive release is called a boiling liquid expanding vapor explosion (BLEVE). The pressure forces during this process usually flatten the vessel cylinder on the ground (Figure B-4). The escaping propane mixture then found an ignition source and ignited.

Post-incident photo of Reboiler B shell. The originally cylindrical shell was flattened during the event.
