DEEPWATER HORIZON GULF OF MEXICO - 2010 ACCIDENT INVESTIGATION

INVESTIGATION REPORT VOLUME 1

EXPLOSION AND FIRE AT THE **MACONDO WELL** (11 Fatalities, 17 Injured, and Serious Environmental Damage)

MISSISSIPPI CANYON BLOCK #252, GULF OF MEXICO

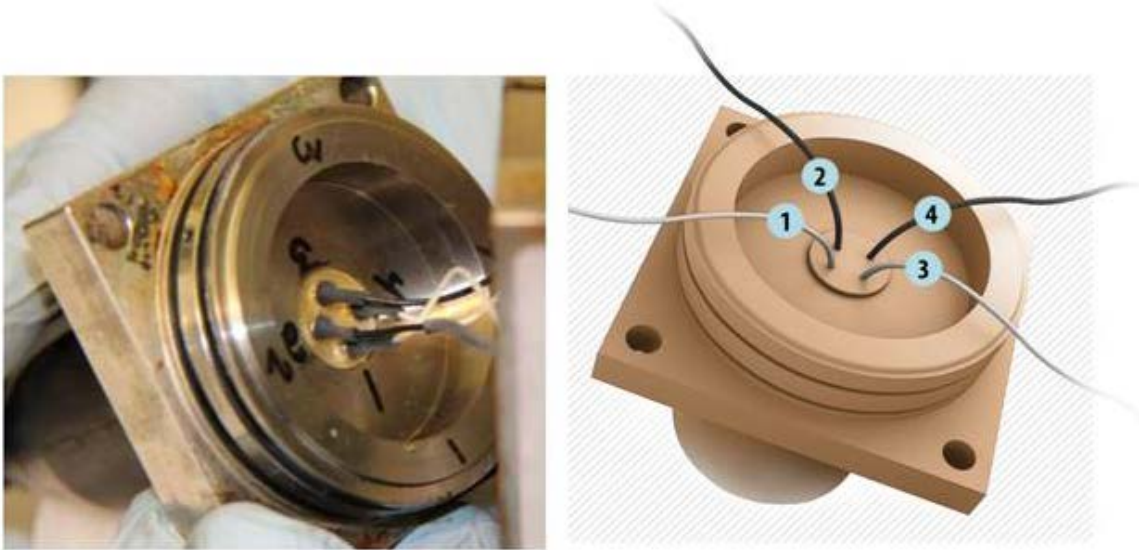
Figure 3-1. (Left) Photograph of Y103 wire arrangement from Phase II testing with pins 1 and 4 connected to white wires and 2 and 3 connected to black wires. (Right) Schematic of correct arrangement of wires, with pins 1 and 3 connected to white wires and 2 and 4 connected to black wires.

Phase II analysis of the Y103 solenoid valve from the yellow pod revealed that it had been miswired. Figure 3-1 shows where pins 1 and 3 should be attached to the white wires and pins 2 and 4 to black wires, which was not the case with Y103. As a result, when both solenoid coils were energized during bench testing, the miswiring produced opposing magnetic fields, which canceled out each other and caused the solenoid valve to remain closed.

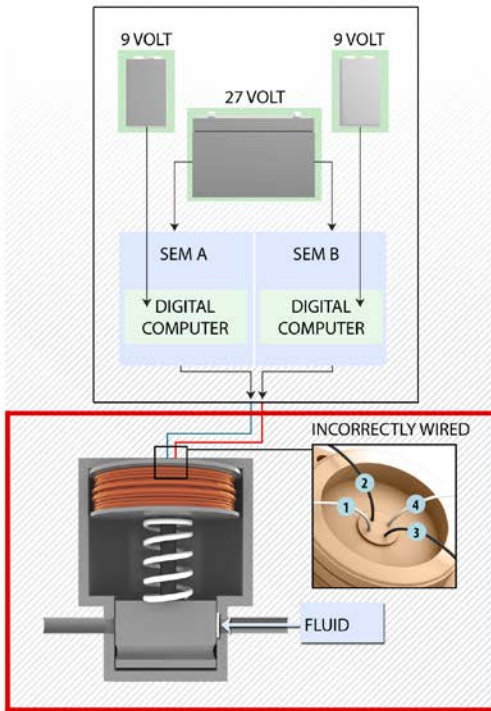
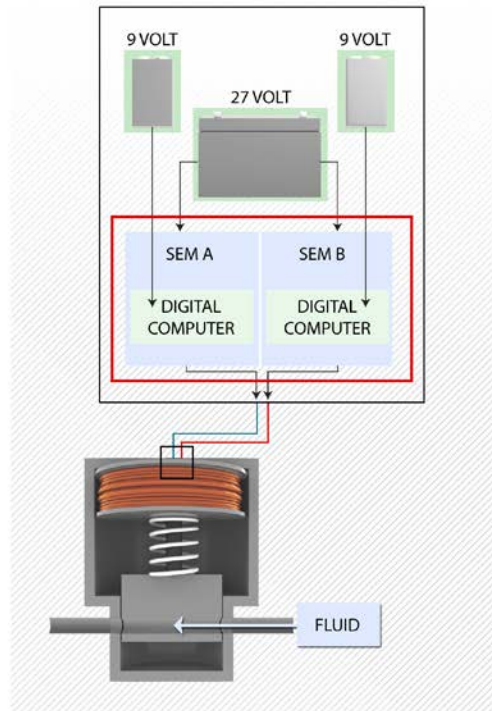
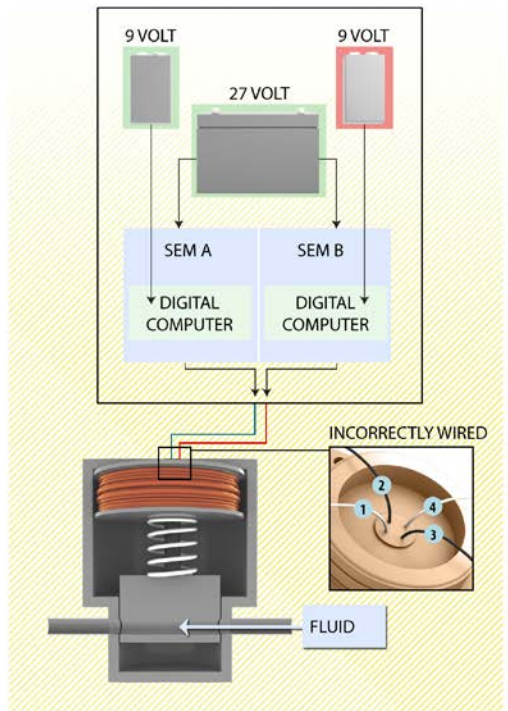
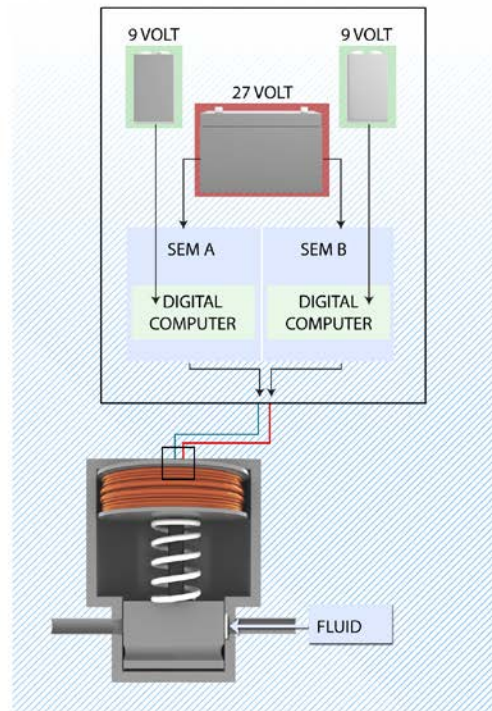
Figure 3-2. Miswiring in the blue pod caused the critical 27-volt battery to drain, rendering the pod inoperable during the incident. A drained 9-volt battery in the yellow pod left one of the coils in the miswired Y103 solenoid valve inoperable, allowing the other coil to activate unopposed and initiate closure of the blind shear ram.

The failure of the SEM B battery during the yellow pod AMF/deadman tests in Phase I occurred when the SEM was operating in an ambient temperature near 21°C (70°F). Borrowing from the car analogy, an SEM battery that barely produced sufficient power when operating in ambient temperatures might not have functioned when operating in subsea temperatures near 2°C (36°F).^a Therefore, on the day of the incident, SEM B in the yellow pod was likely not operational, allowing the SEM A coil of Y103 to function unopposed and successfully execute the AMF/deadman sequence. (See Figure 3-2 and Figure 3-3.)

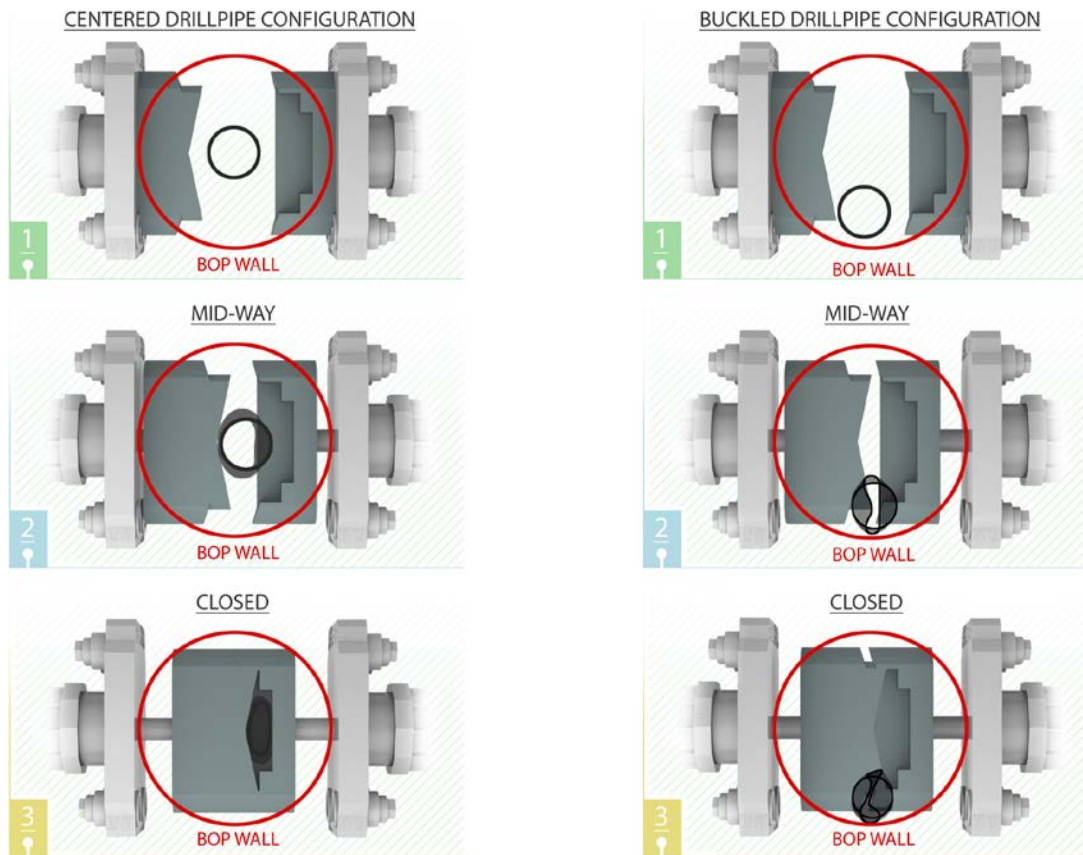
Figure 3-4. The Deepwater Horizon BOP was designed to shear centered drillpipe (left) in the BSR and then seal the well. During the Phase I examination of the BOP, the drillpipe was found off-center (right), causing the BSR to close only partially, leaving the well unsealed.

As discussed in detail in Volume 2, both manual and automated emergency systems within the blowout preventer were activated in an attempt to shear the drillpipe and seal the well. However, pressures in the well had caused the drillpipe to buckle, which inhibited the BOP from sealing the well.
