Investigation of the April 19, 2018, Communication Tower Collapse in Fordland, Missouri.

U.S. Department of Labor
Occupational Safety and Health Administration
Directorate of Construction

October 2018

Report Prepared by
Bryan D. Ewing, Ph.D., P.E.
Mohammad Ayub, P.E., S.E.
Office of Engineering Services
Directorate of Construction

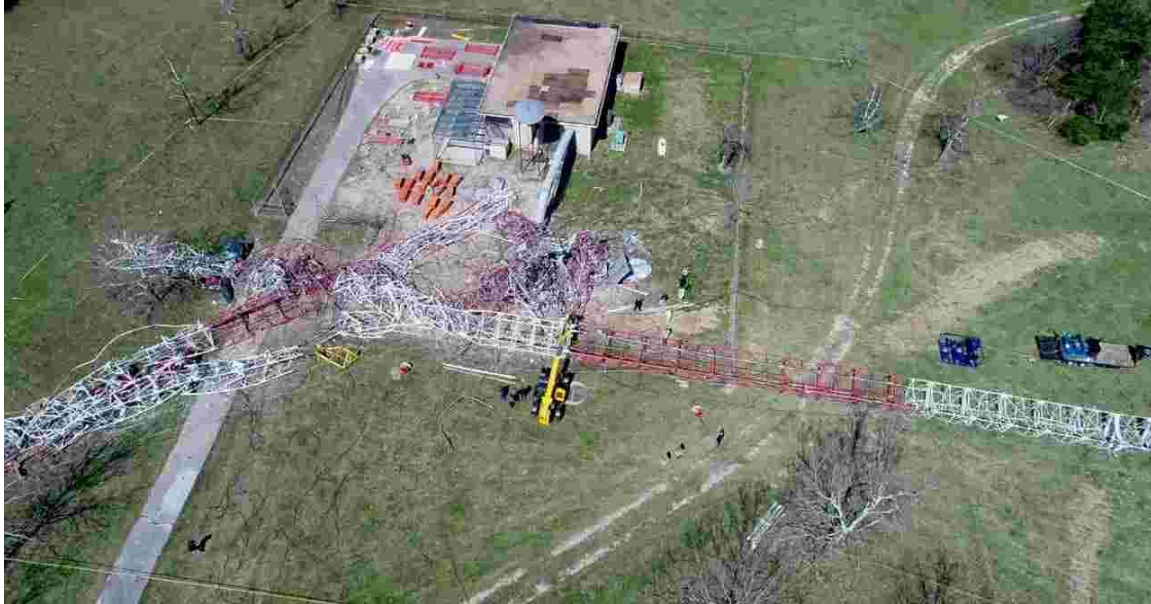
Figure 5. Collapsed Communication Tower (Google Image Search)

As shown in Figure 5, it appears that as the tower began to collapse onto itself, the tower initially fell in the southern direction. Then the tower tilted and fell over itself back in a northern direction. As the top tiers of the tower fell, they remained essentially intact. As shown in Figure

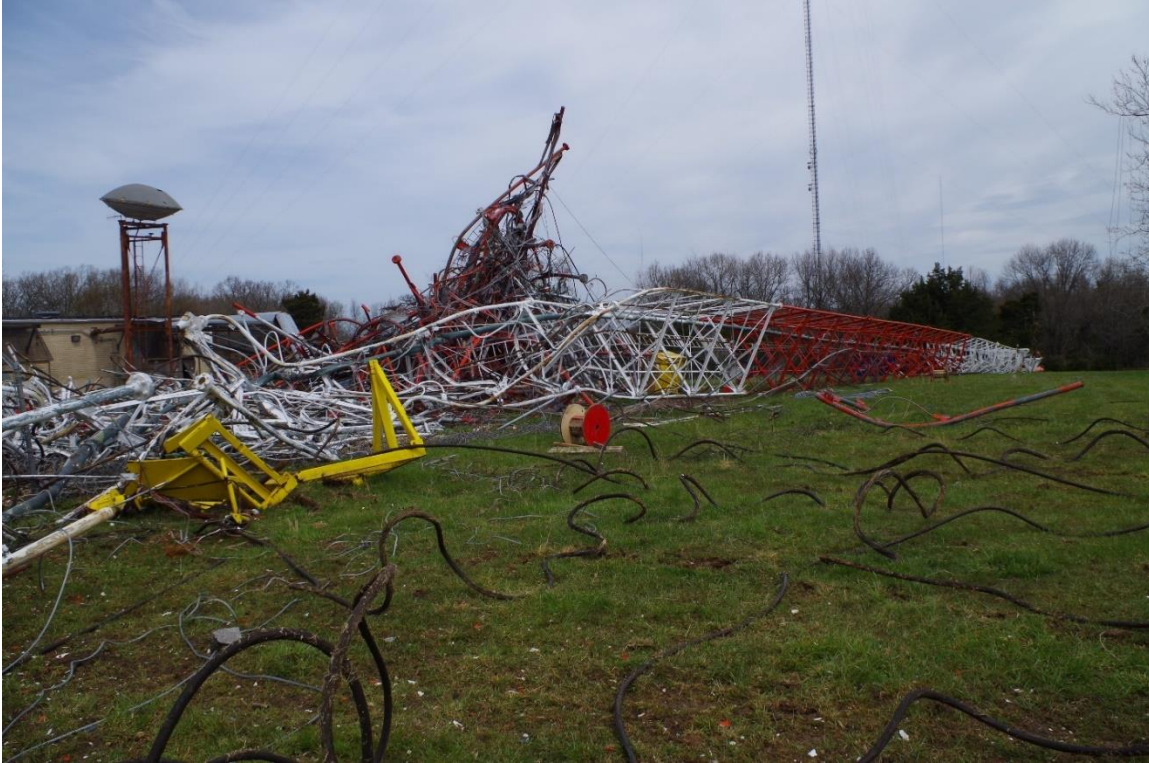
Figure 6 Top Section of Collapsed Communication Tower

6, all the guy wires disengaged from their anchor points and whipped about slashing through tree limbs and fencing. The man-basket, original and new diagonals and tools, including two come-a-longs were buried under the wreckage. The tower section from 90' to 120' was recovered and stored on-site for further observation. This tower section is shown in Figures 7 to 10. The slings and diagonals were found at the 105' tower elevation as shown in Figure 11. Several wires of the sling used for the come-a-long attachment to the tower panel point was severed and others were bird-nesting. A total of six bolted connections were missing. Two bolts were missing at the connection point between the two diagonals and the redundant horizontal bar. Two more bolts were missing from each gusset plate at the connection between the tower legs at the 100' elevation of the diagonals (see Figure 11). This was consistent with witness statements that the crew was working on the final third bay of diagonals at the 105' elevation at the time of the incident. The redundant bar and the tower leg appeared to have buckled.

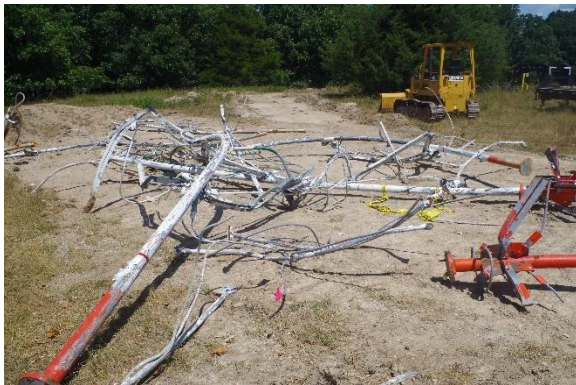
*Figure 7. Recovered Section of the Tower
90'-120'*

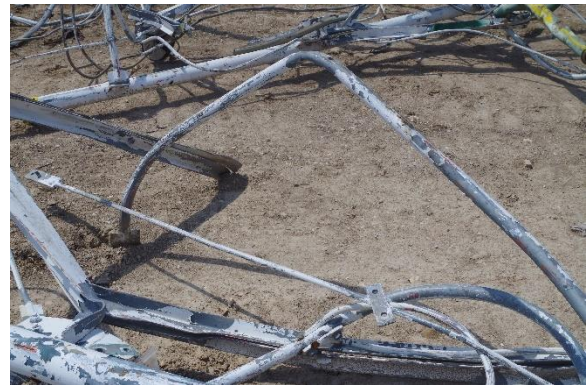
*Figure 9. Bent Redundant Member at 105'
Tower Elevation*

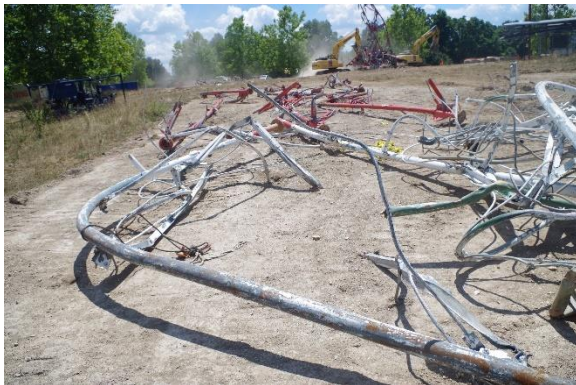
*Figure 8. Bent Tower Leg from the
Recovered Section*

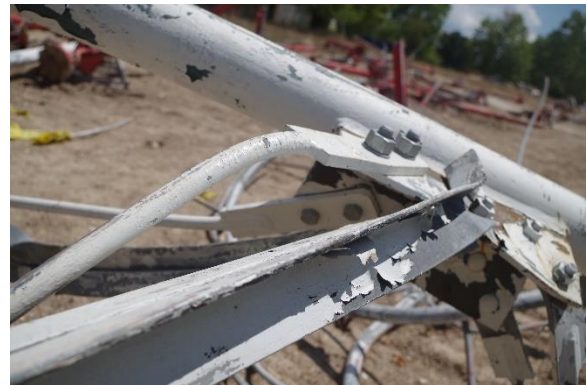
*Figure 10. New bolts Installed on Two
Diagonals at 100' Tower Elevation*

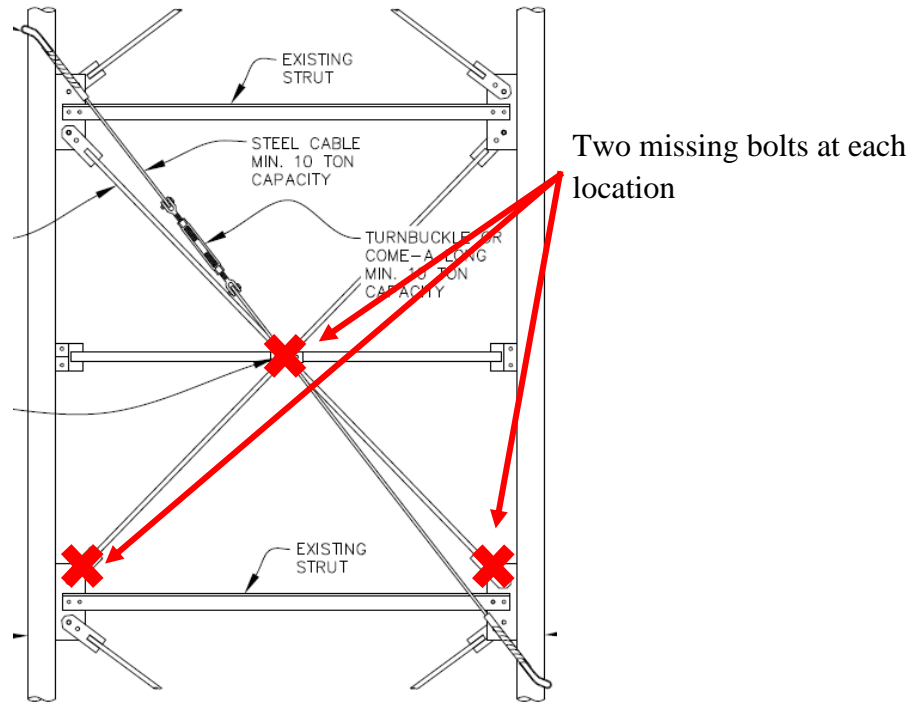
Figure 11. Missing bolts at the 105' Tower Elevation

- 2) The cause of the communication tower collapse was the weakening of the compressive strength of the tower legs by removing the bolts at the connection of the diagonals to the horizontal redundant. The compromised redundant effectively doubled the unbraced length of the tower leg which reduced the compressive capacity of the tower leg.

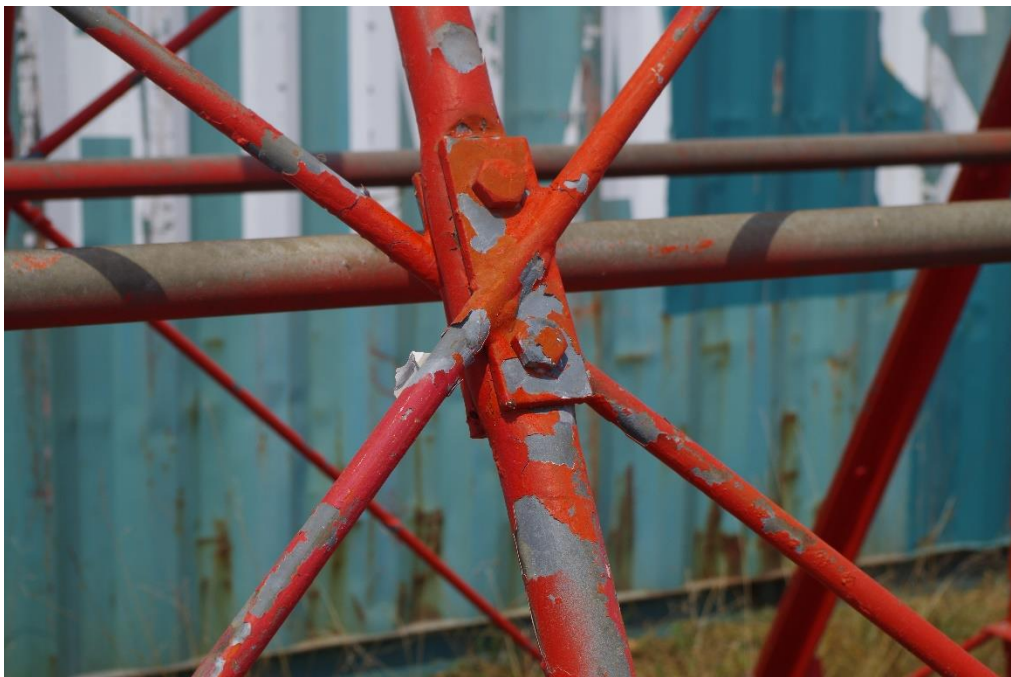
Figure 13. Bolted Connection between Diagonals and Redundant Horizontal

TCI's erection drawings states that the diagonals must be replaced one at a time. However, in order to replace a diagonal, the two bolts on each end of the diagonal and the two bolts at the diagonal's mid-span must be removed. The removal of the bolts at the mid-span, however, results in doubling the unbraced length of the tower legs and redundant from five to ten feet.

This doubling of the unbraced length creates three problems for the redundant member. First, the redundant member exceeds the allowable slenderness ratio for main compression members other than leg members and for secondary members (200 and 250 respectively) as outlined in ANSI/TIA-222-G. The resultant slenderness ratio of the redundant member without the bolted connection at its mid-span is 274. Second, the unfactored compressive resistance is reduced from 32 kips to 8 kips. This 75% reduction of compressive strength created the third problem for the redundant member. The redundant no longer satisfied the ANSI/TIA-222-G requirement for minimum bracing resistance for the tower legs. ANSI/TIA-222-G requires that the strength of the brace is at least 1.5% of the axial design compressive force of the supported member. Therefore, the unbraced length of the tower legs has doubled to ten feet.

The ANSI/TIA-222-G design strength of the tower legs was reduced by 68% due to the doubling of the unbraced length. The tower legs require a minimum bracing resistance of approximately 13 kips. However, the horizontal redundant member is only capable of providing 8 kips. The resultant unfactored design strength of the tower legs reduces from 865 kips to 279 kips. The total dead load from the guy wires and the weight of the tower above the 105-foot elevation is 316 kips. Furthermore, any incidental wind load would increase the compressive load on some of the tower legs. The overstressing of the tower legs could have been a reason for why some of the diagonals did not fit and required re-boring of the bolt holes.

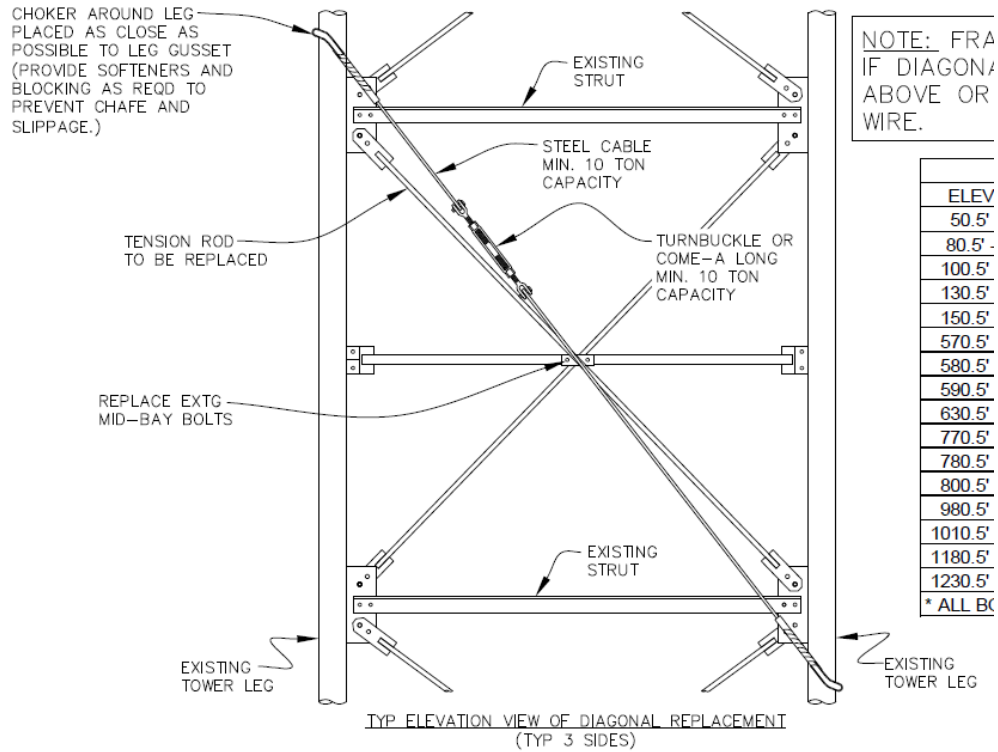
Figure 14. TCI Diagonal Replacement (E-5)

The diagonal replacement procedure is described on sheet E-5 of TCI's erection drawings document and is partially shown in Figure 14. The diagonal replacement procedure requires the use of a come-a-long to eliminate the tensile forces in the diagonal to facilitate the removal of the diagonal. TCI requires the use of a come-a-long with a ten-ton capacity. However, Lemay used a come-a-long device (GripHoist/Tirfor® T-532D) with a rated working load of 8,000 pounds (4 tons). An identical model come-a-long used on-site is shown in Figure 15. The come-a-long used on the tower is shown in Figure 16 while in the debris field and which was recovered later is shown in Figure 17.

- 1) TCI's suggested diagonal replacement procedure was flawed in that it compromised the effectiveness of the integrated surrounding braces and the load bearing capacity of the tower legs. A single diagonal brace could not be removed without affecting the integrity of the redundant brace because the braces share two common bolts at the diagonal/redundant connection.

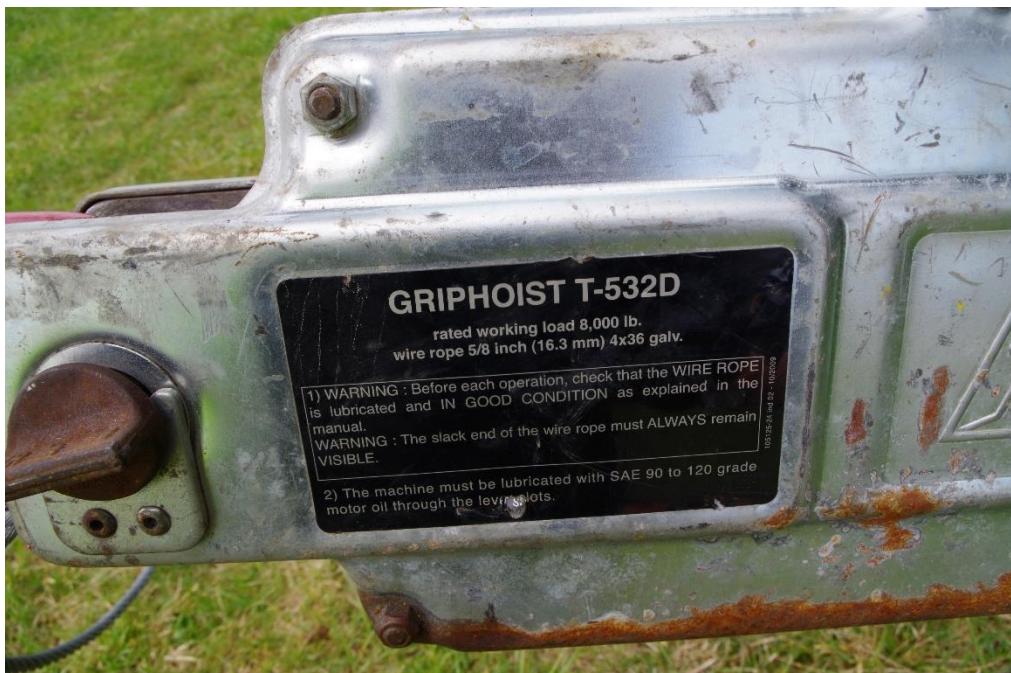
Figure 15. Lemay Come-a-long Used On-site

- 3) Lemay used an undersized come-a-long while removing the diagonal braces.
- 4) Lemay failed to provide the design of the required temporary frame for diagonal replacement above or below a guy level. TCI failed to confirm the use/design of a temporary frame as TCI is required to approve the adequacy of the temporary frame prior to diagonal replacement according to TCI's construction documentation.

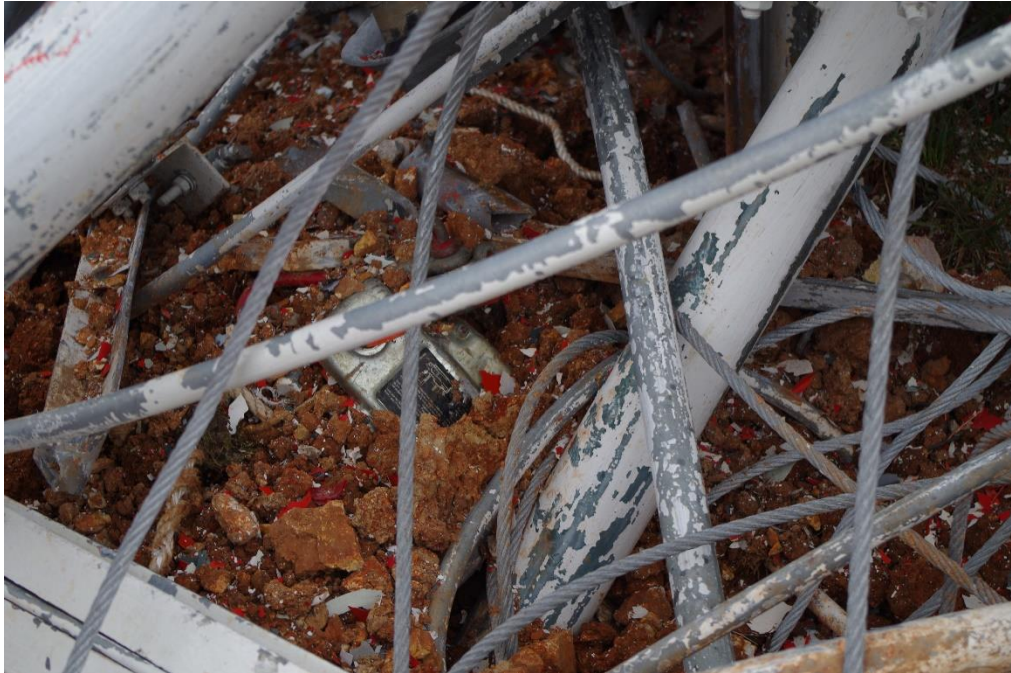
Figure 16. T-532D Come-a-long in Debris

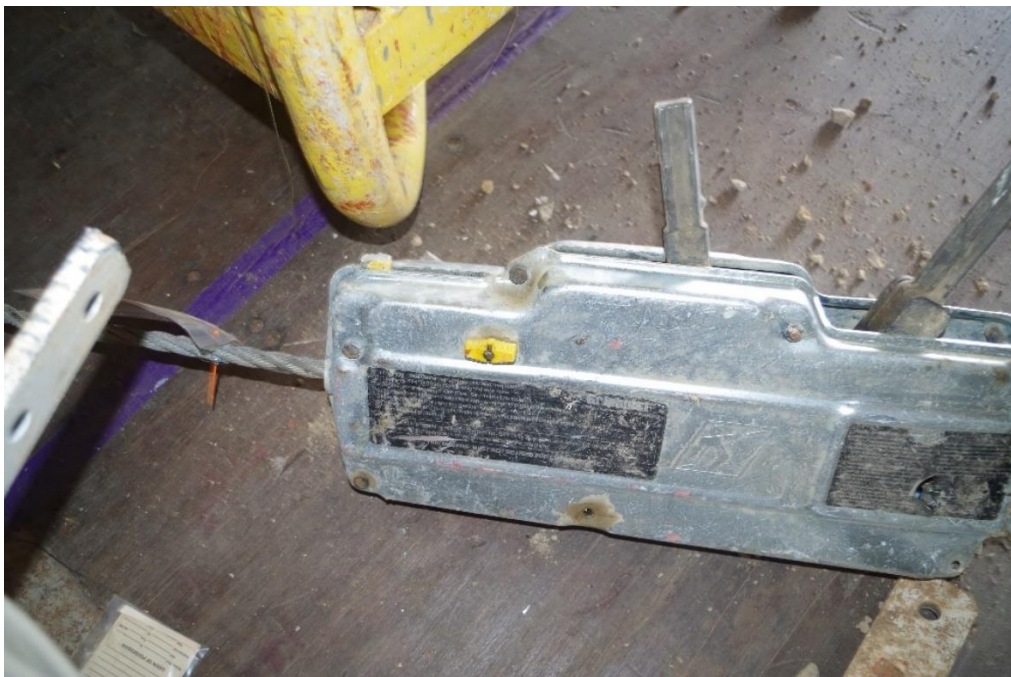
Figure 17. T-532D Come-a-long Salvage from Debris
