BONNEVILLE POWER ADMINISTRATION 115KV LINE 2013 ACCIDENT INVESTIGATION

Level I Accident Investigation Report

Wilson Construction Company Employee Fatality on the Bandon-Rogue No. 1 115kV Line

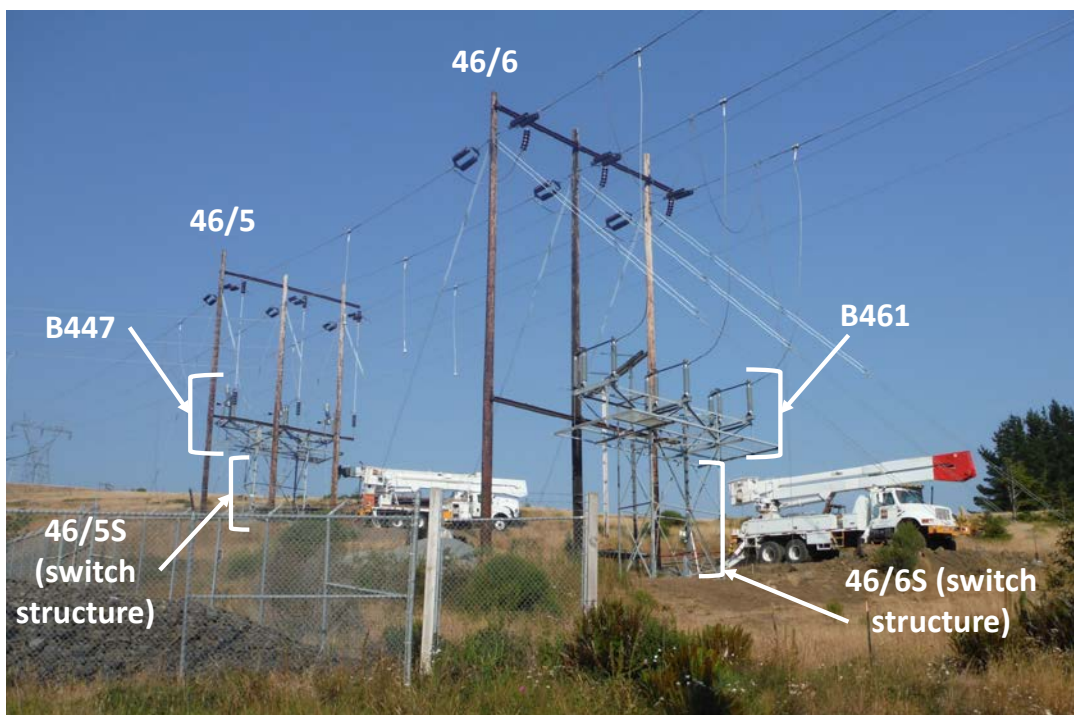
Figure 1: Geisel Monument Worksite

The specific work required at structure 46/5 and 46/6 included relocating switch stands 46/5S and 46/6S (Figure 1), two additional feet away from their respective transmission structures and two additional feet away from the Geisel Monument Substation fence.

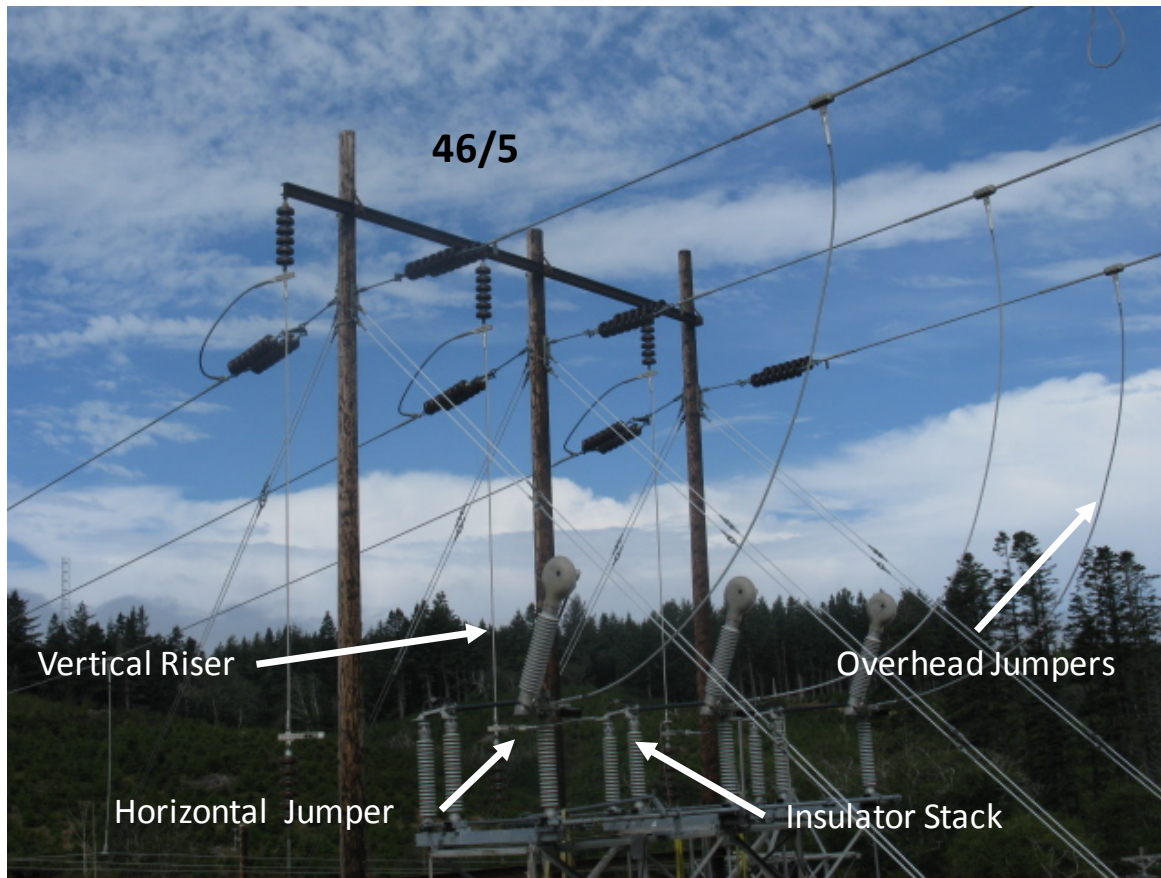
Figure 2: Riser and Jumper Location on Structure 46/5

In addition, new vertical risers were to be installed from the bottom cross arm to the upper cross arm on each structure and the horizontal jumpers from the bottom cross arm to the switch were to be replaced with a higher capacity conductor (Figure 2). Jumpers from the overhead line to the harp end of the switch were to remain in place as constructed in the original release.

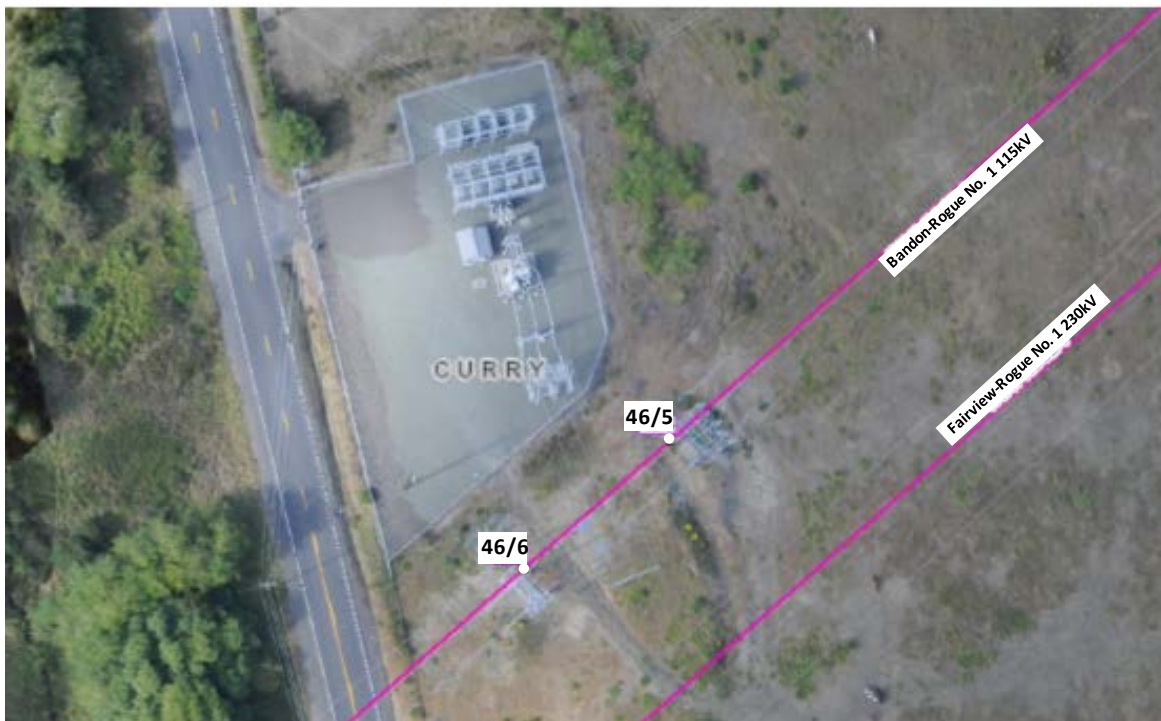
Figure 3: Aerial View of the 46/5 and 46/6 Structures at the Geisel Monument Tap

Upon arrival at the Geisel worksite at approximately 0800, the crews conducted the job briefing of the specific work hazards and how the work was to be performed. The plan of the day was for the six men to break into two crews for work on their respective switch at 46/5 and 46/6. Crew 1 was at structure 46/6 and Crew 2 at structure 46/5. (Figure 3)

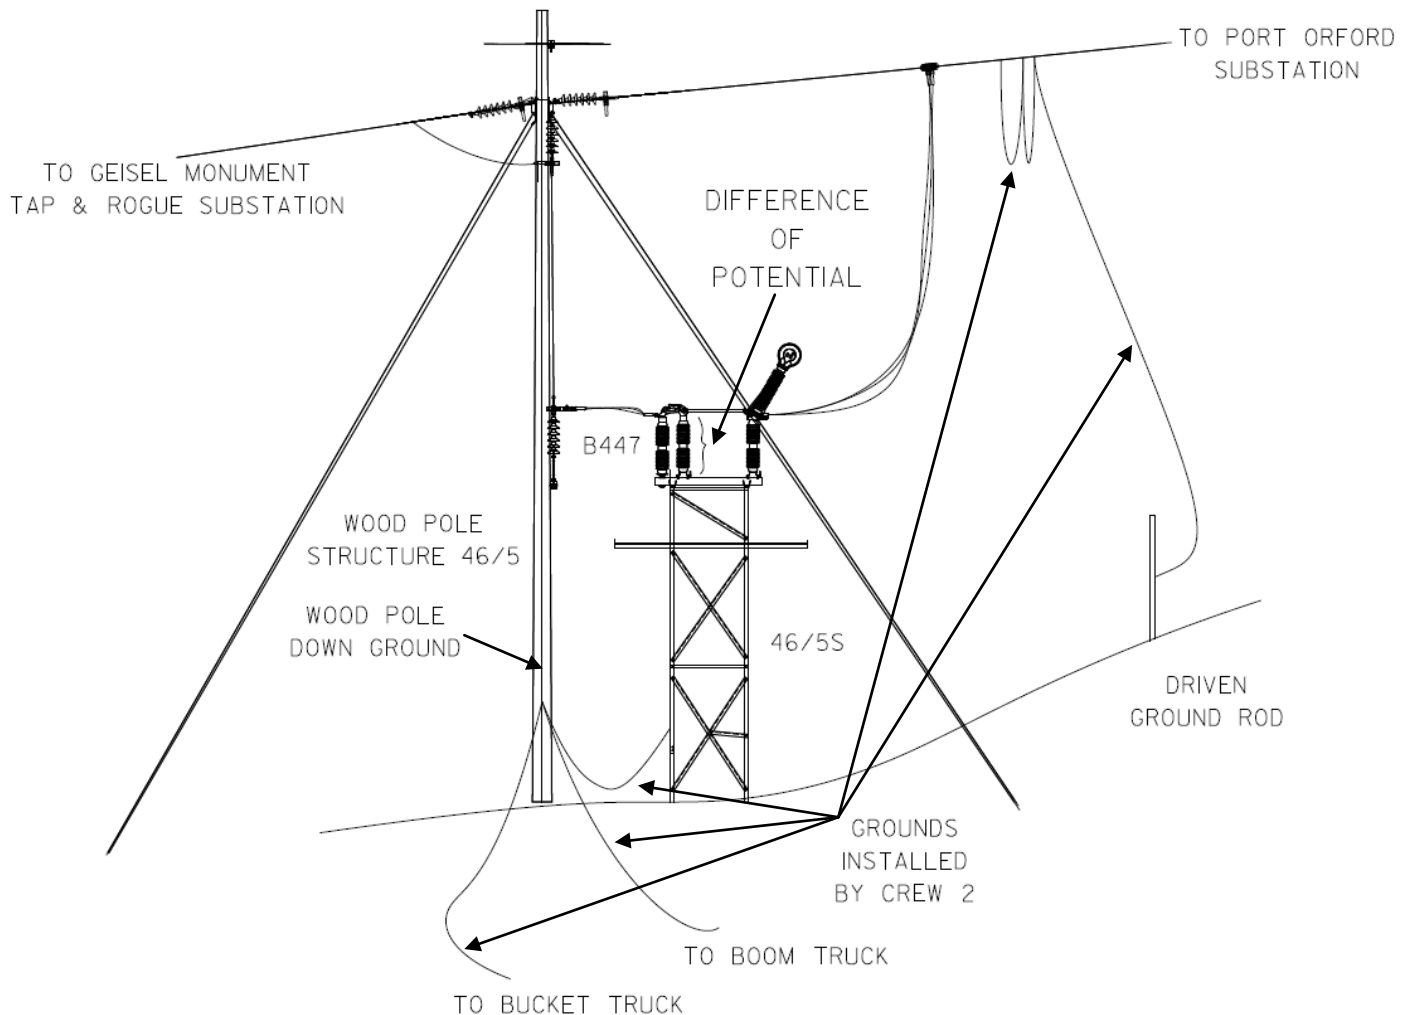
Figure 4: Grounds Installed by Crew 2 at Worksite 46/5

A three phase ground set was installed on the overhead line above the worksite at 46/5 by Crew 2. There was no step and touch voltage measurement taken at the 46/5 ground rod. No EPZ was established by Crew 2 at 46/5 because they did not bond the driven ground rod to 46/5S. (Figures 4 and 5) The tap into Geisel Monument was left ungrounded as neither crew installed a master set of grounds on the tap line.

FINDING 13: The Board found that Crew 2 did not install a ground between 46/5S and the driven ground rod thus failing to establish an EPZ between all the conductive parts at their worksite.

FINDING 14: The Board found that neither Crew 1 nor Crew 2 installed master grounds between either of their work locations (B447 or B461) and the Geisel Monument Tap section.

RECOMMENDATION 11: The Board recommends that WCC management establish and implement a formal training program on all grounding processes and procedures.

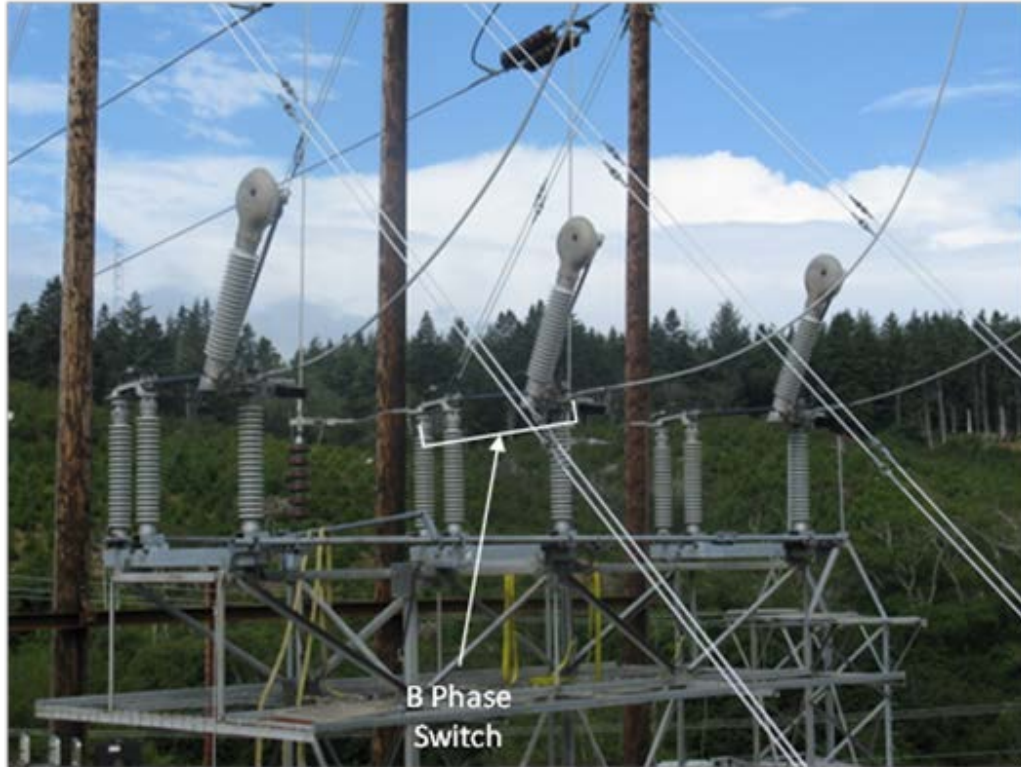
Figure 5: Structure 46/5S Switch B447

The Board concluded the **direct cause** of the accident was that CF2 made contact with a difference of potential across the blade end insulator stack of B447.

The Board concluded the **root cause** of the accident was Crew 2's failure to establish an equipotential zone (EPZ).

By about 0930 at structure 46/5, JL2 was in the bucket truck removing the sectionalizing jumper on A-Phase when CF2 climbed up to the top of the switch stand to attach lift slings suspended from the crane. Once the lift slings were placed and pulled up snug, CF2 positioned himself at the east side of the center switch to assist JL2 in the removal of the blade end sectionalizing jumper on B-Phase.

At approximately 0945, CF2 made contact with a difference of potential across the blade end insulator stack on B447.
