IDAHO NATIONAL ENGINEERING LABORATORY ELECTRICAL SHOCK 1996 ACCIDENT INVESTIGATION

**Type A Accident
Investigation Board Report
August 13, 1996
Electrical Shock
at
TRA-609, Test Reactor Area,
Idaho National Engineering Laboratory**

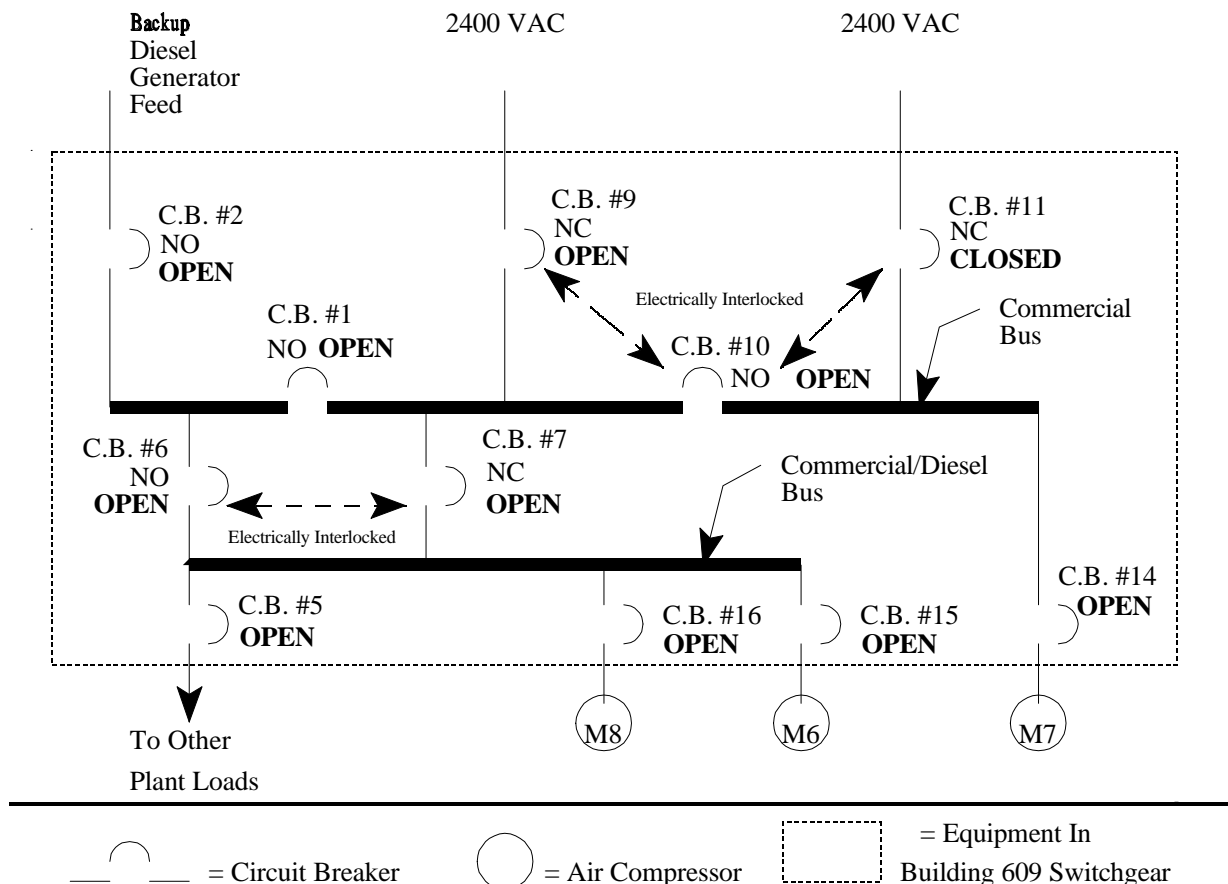
Figure 2.1 TRA Switchgear Configuration
(**Bold** indicates conditions at the time of the accident.)

Planned lockout/tagout was performed, leaving the M-7 bus energized.

to other electric loads including the demineralized water supply pumps for the ATR and the ATR Canal, and for TRA area and perimeter lighting. This was considered acceptable since the limited work to be performed related to the M-7 compressor was intended to be done by opening only the potential transformer drawer, leaving intact the physical barriers limiting access to the energized 2400 VAC bus.

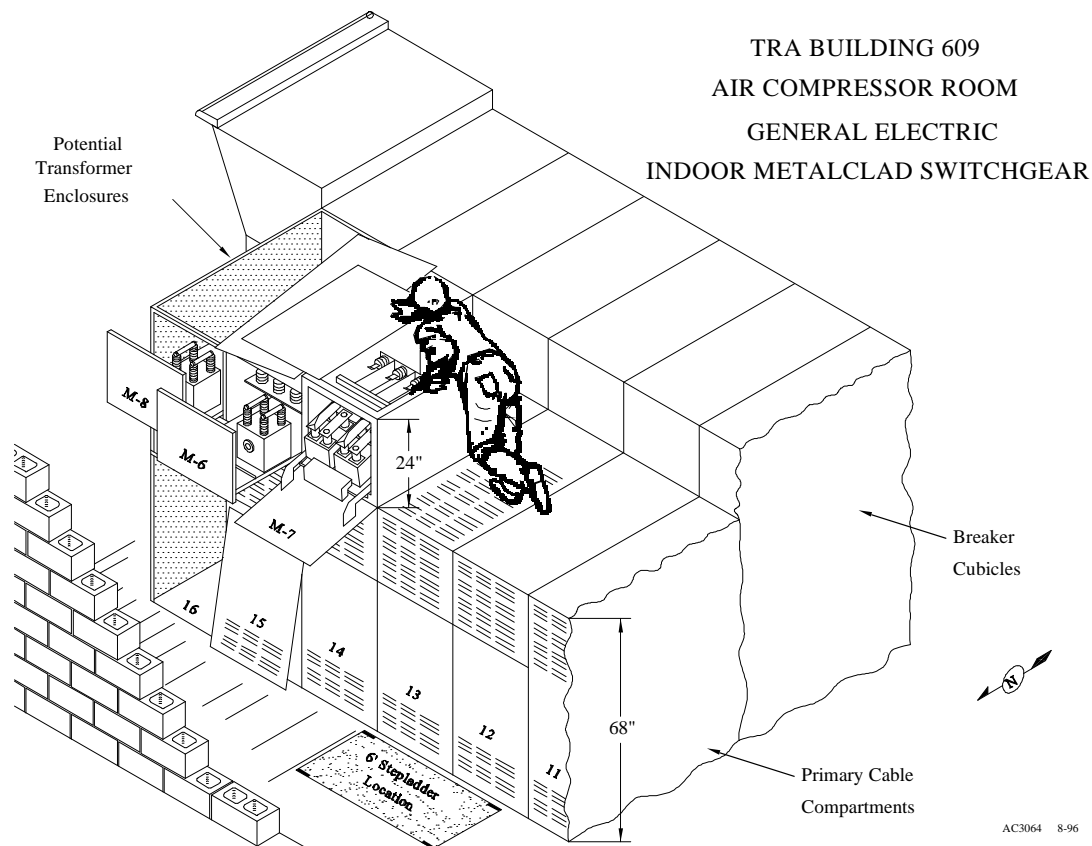
Figure 2.2 CFA Electrician's Work Location

At about 11:15 AM, concern was expressed by the Utility Area Controller that the temporary, portable air compressor might be having overheating problems. The Utility Area Controller asked what could be done to restart one of the site air compressors quickly, if necessary. The Leadman informed the Utility Area Controller that it would be difficult to restore M-6 or M-8 quickly. He indicated that he would expedite the M-7 work, since there was limited work to do and the M-7 compressor could be returned to service more quickly than the other two. The Leadman went to the other side of the switchgear to look at prints, and the CFA electrician went around to the back of the switchgear to start the work in the M-7 potential transformer drawer (See Figure 2.2).

The CFA electrician used a ladder to climb on top of the adjacent enclosure and then removed the cover from above the M-7 drawer. A red danger placard on the front of the M-7 drawer, not visible from the CFA electrician's position, indicated that work should not be performed on components in this drawer unless the 2400 VAC bus had been de-energized by opening, racking out and tagging out/locking out two particular breakers (See Figure 2.3). The CFA electrician stated that he did not notice this warning. The CFA electrician stated that he had noted earlier that access to the required components was not available through the tilted M-7 drawer. He stated that he recalled talking about it to the Leadman and informing him that removing the cover over the M-7 drawer space would be required. The Leadman does not recall this conversation. Removing this cover removed a crucial safety barrier and allowed direct access to energized 2400 VAC bus components in the area under the removed cover.

In an effort to expedite placing the M-7 compressor back in service, the CFA electrician removed the enclosure cover, exposing energized electrical components.

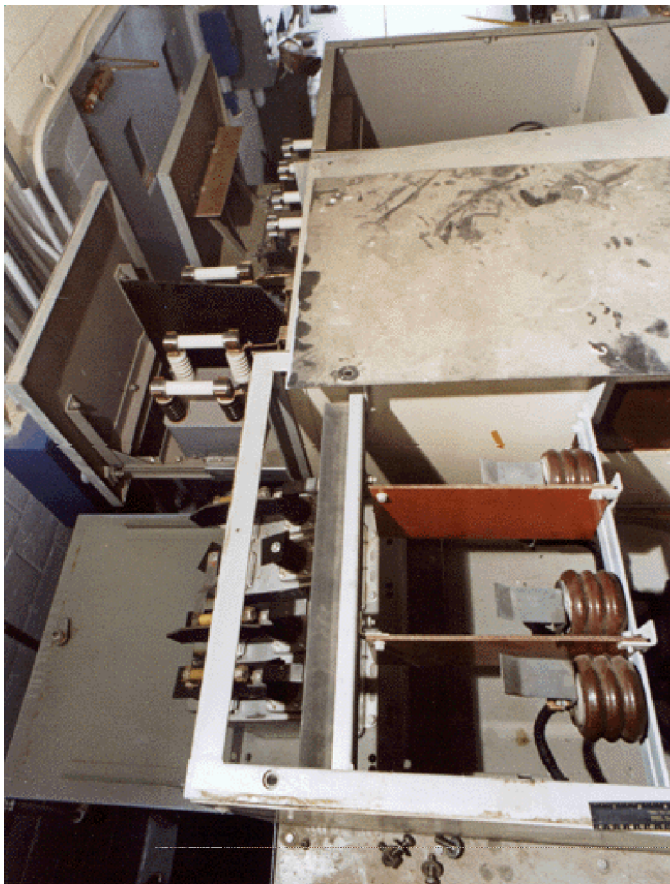
Figure 2.4 M-7 Drawer

Upon their return from lunch about 12:45 PM, the Leadman continued his work in the front of the switchgear and the CFA electrician returned alone to the back of the switchgear to complete the work on the M-7 drawer. The CFA electrician thought that the 2400 VAC bus supplying M-7 was de-energized and tagged out. He did not recognize the three large flat metal “stabs” in the back of enclosure (that mate up with similar stabs on the drawer when fully inserted) as electrical components connected to the main bus by cable (See Figure 2.4).

Following lunch, the CFA electrician returned alone to the back of the switchgear to complete the work on the M-7 drawer.

At approximately 12:49 PM, as he reached in from the top of the enclosure to clip some small wires in the M-7 drawer, the CFA electrician's right forearm, near the wrist, contacted a phase stab on the energized 2400 VAC bus (calculated at 1385 VAC phase to ground). He received a severe electrical shock that physical evidence indicates was primarily grounded through his right elbow to the cabinet frame. He immediately cried out, briefly retained consciousness, and then blacked out.
