PRYOR TRUST GAS WELL BLOWOUT & FIRE – 2018 ACCIDENT INVESTIGATION

Pittsburg County, Oklahoma | Incident Date: January 22, 2018 | No. 2018-01-I-OK

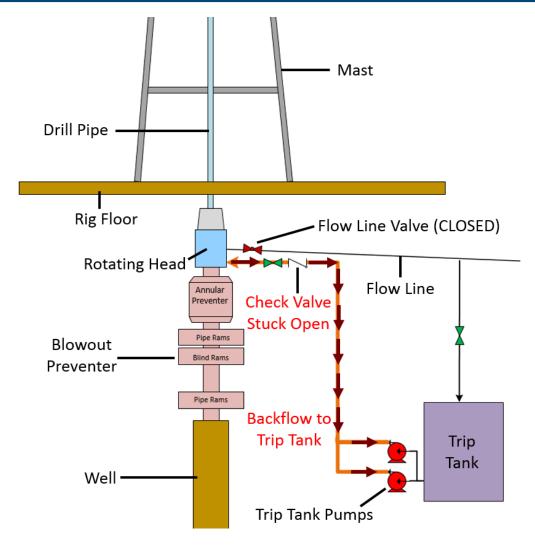
Figure 14. Pressurized mud backflowed through trip tank discharge piping, stuckopen check valve, and centrifugal pumps into trip tank.

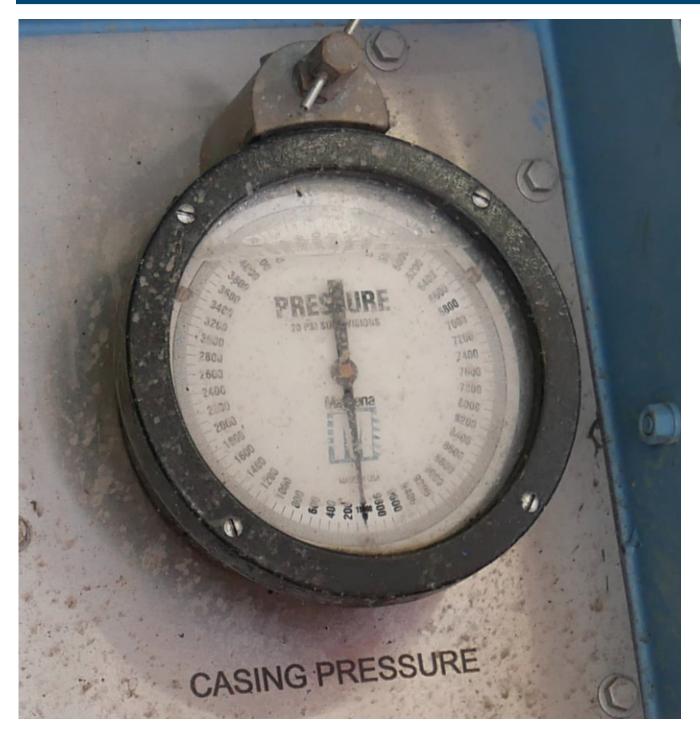
Figure 16. Photo of casing pressure gauge on an exemplar Patterson drilling rig. The pressure gauge could indicate pressures up to 10,000 psi. Low pressures might have been difficult to read on the Rig 219 pressure gauge, or the pressure gauge might not have worked properly at low pressures. The valve on the choke system ("HCR valve") that needed to be opened to measure annular pressure might have been closed during pressure readings, or the line might have been plugged.

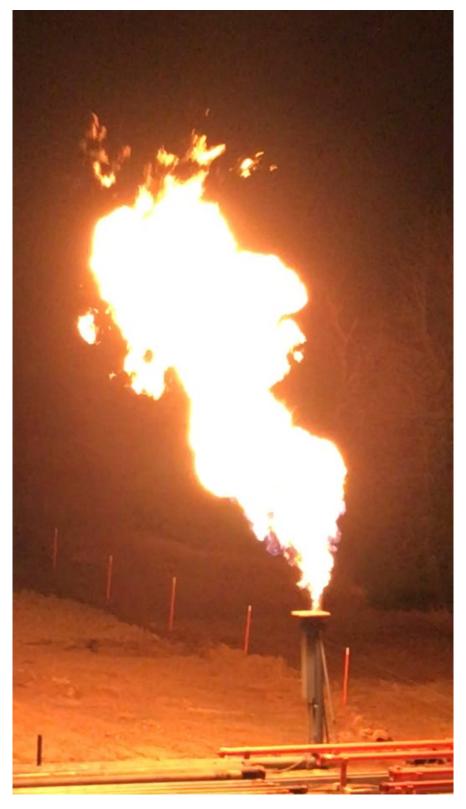
Figure 19. Image of flare from video captured at 11:06 pm on January 21, 2018.

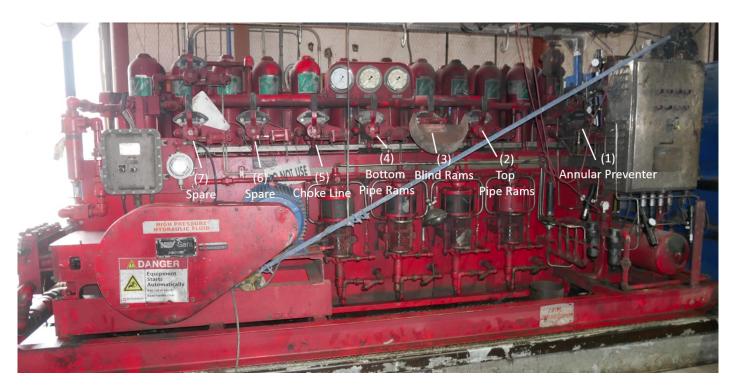
Figure 31. Photo of the BOP accumulator, which is used to function the BOP rams. The rig manager closed the BOP control handles in the following order: (1) annular preventer, (2) top pipe rams, (3) blind rams, and (4) bottom pipe rams. The blowout preventer did not seal the well to stop the blowout when the rig manager functioned the control handles.

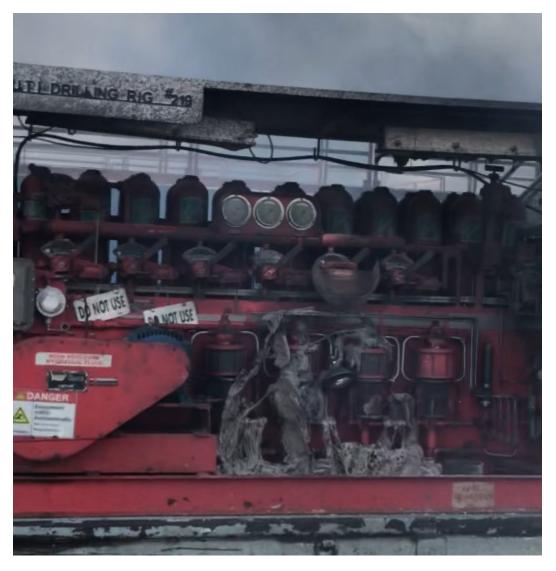
Figure 32. Video captured at 11:51 am on January 22, 2018 shows all BOP handles in the closed position.

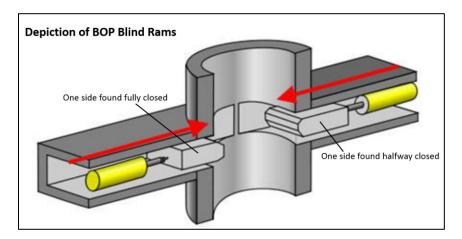
Figure 33. Depiction of BOP blind rams. A Boots & Coots responder found that the south-side blind ram was fully closed, and the north-side blind ram was halfway closed. Source: drillingformulas.com [11] with notations by CSB.

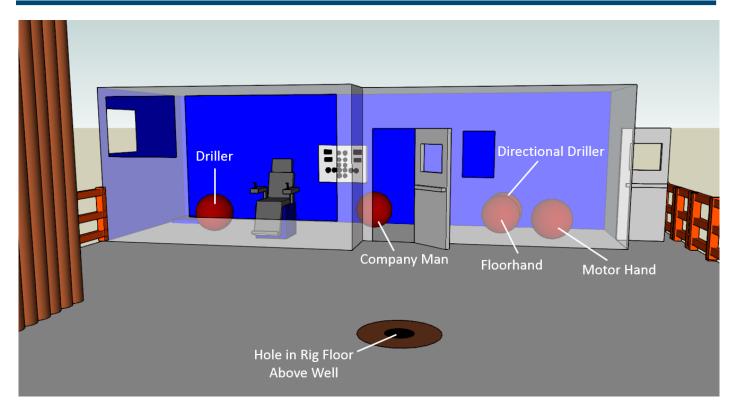
Figure 42. Locations where victims were found in the driller's cabin

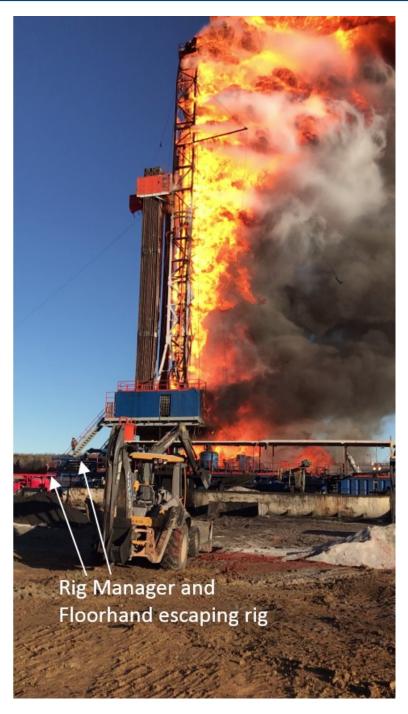
Figure 43. Still from video captured at 8:36 am, shortly after blowout started. The rig manager and floorhand can be seen escaping the rig. At this point, the fire has engulfed the driller's cabin (far side of photo).

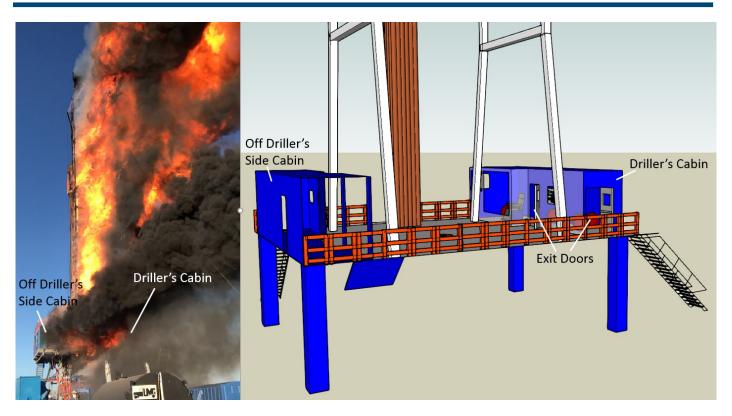
Figure 44. Both exits from the driller's cabin were engulfed by fire.

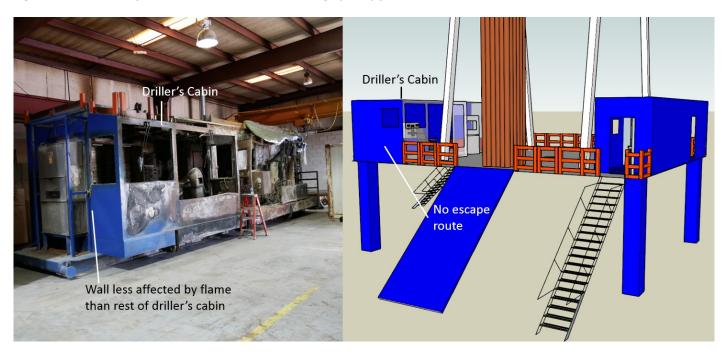
Figure 45. One part of the driller's cabin appeared to be less affected by fire, evident by the paint remaining post-incident. There was no escape route near that location.

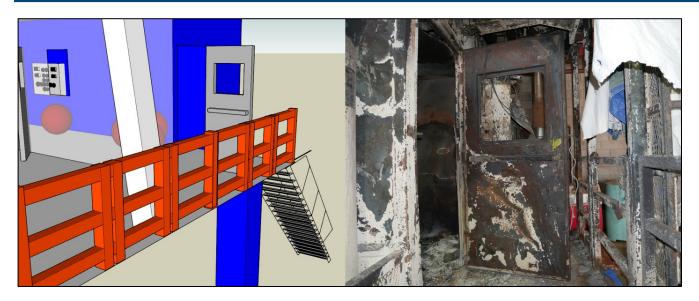
Figure 46. The most viable exit door was hinged such that when the door was opened, the door blocked the escape path to the ground.

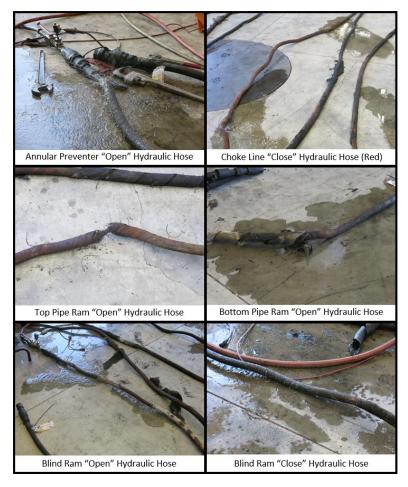
The blowout preventer also failed to close when its activation was attempted after the fire started. The CSB determined the BOP did not function likely because the control hoses that supplied hydraulic fluid to the BOP to function the rams had burned in the fire and leaked the hydraulic control fluid, soon depleting the accumulator stored pressure to the point the blowout preventer could not be closed.

Figure 50. Photos of hydraulic hoses that were installed between the accumulator and BOP, used to send high-pressure hydraulic fluid to the BOP rams to open or close the rams. The hoses were damaged by fire. The hydraulic hoses were leak tested using 40-50 psig water, and all hoses leaked water.

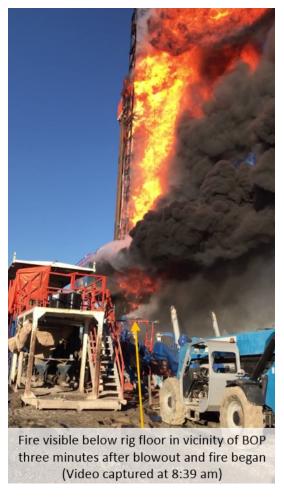
Figure 51. Video still of Patterson Rig 219 fire, taken 3 minutes after blowout began.

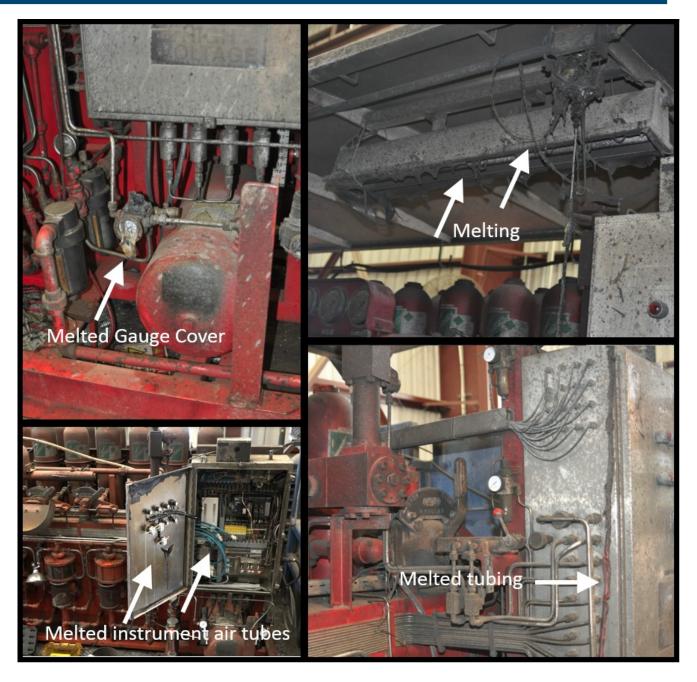
Figure A- 2. Photos of observed heat damage to Patterson Rig 219 accumulator

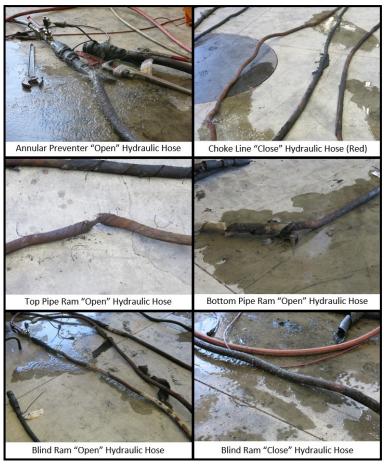
Figure A- 5. Photos of hydraulic hoses that were installed between the accumulator and BOP, used to send high-pressure hydraulic fluid to the BOP rams to open or close the rams. The hoses were damaged by the fire. The hydraulic hoses were leak tested using 40-50 psig water, and all hoses leaked water.

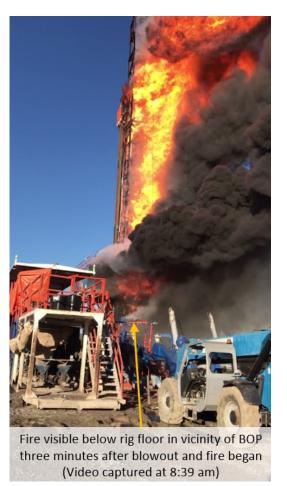
Figure A- 6. Video still of Patterson Rig 219 fire, taken 3 minutes after blowout began.
