# ALLIED TERMINALS TANK COLLAPSE - 2008 ACCIDENT INVESTIGATION

# INVESTIGATION REPORT

## ALLIED TERMINALS, INC.— CATASTROPHIC TANK COLLAPSE

(Two Serious Injuries, Community Evacuation)

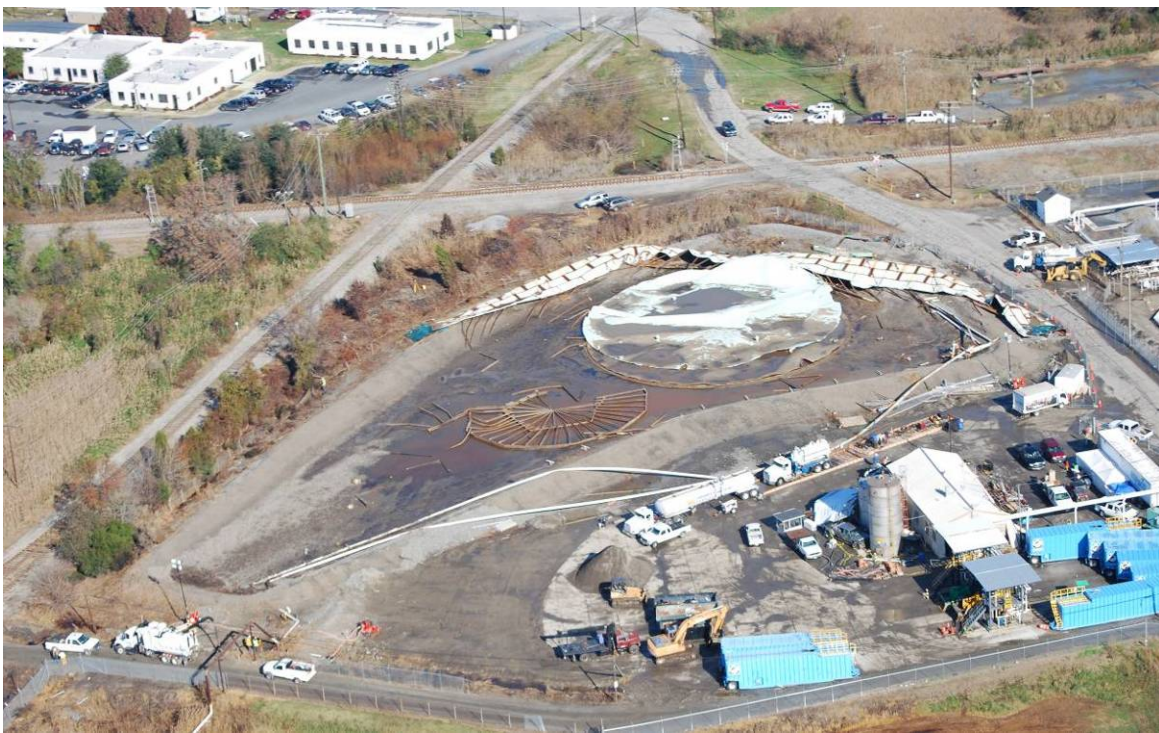
Figure 1. Allied collapsed tank and neighboring business.

On November 12, 2008, at about 2:20 pm, a 2-million-gallon nominal capacity liquid fertilizer tank catastrophically failed at the Allied Terminals, Inc. (Allied) facility in Chesapeake, Virginia (Figure 1). The tank split open vertically and nearly instantaneously released about 2.1 million gallons of liquid fertilizer. A welder and his helper were working on the opposite side of the tank as it collapsed. Both sustained serious injuries due to the collapsing tank and immersion in the liquid fertilizer. Employees from a neighboring business (shown in upper left of Figure 1) rescued the two workers.

As the liquid fertilizer released, it overtopped the secondary containment berm<sup>1</sup> surrounding the tank. The product flooded Rosemont Avenue, blocking egress for more than 100 employees at the adjacent business. It reached portions of the South Hill neighborhood, an adjacent residential community of 43 homes bordered on two sides by Allied's property (Figure 2). The City of Chesapeake Fire Department ordered residents to evacuate for several days. Weeks later, residents again had to leave their homes while an environmental cleanup firm repaired the damage to their property.

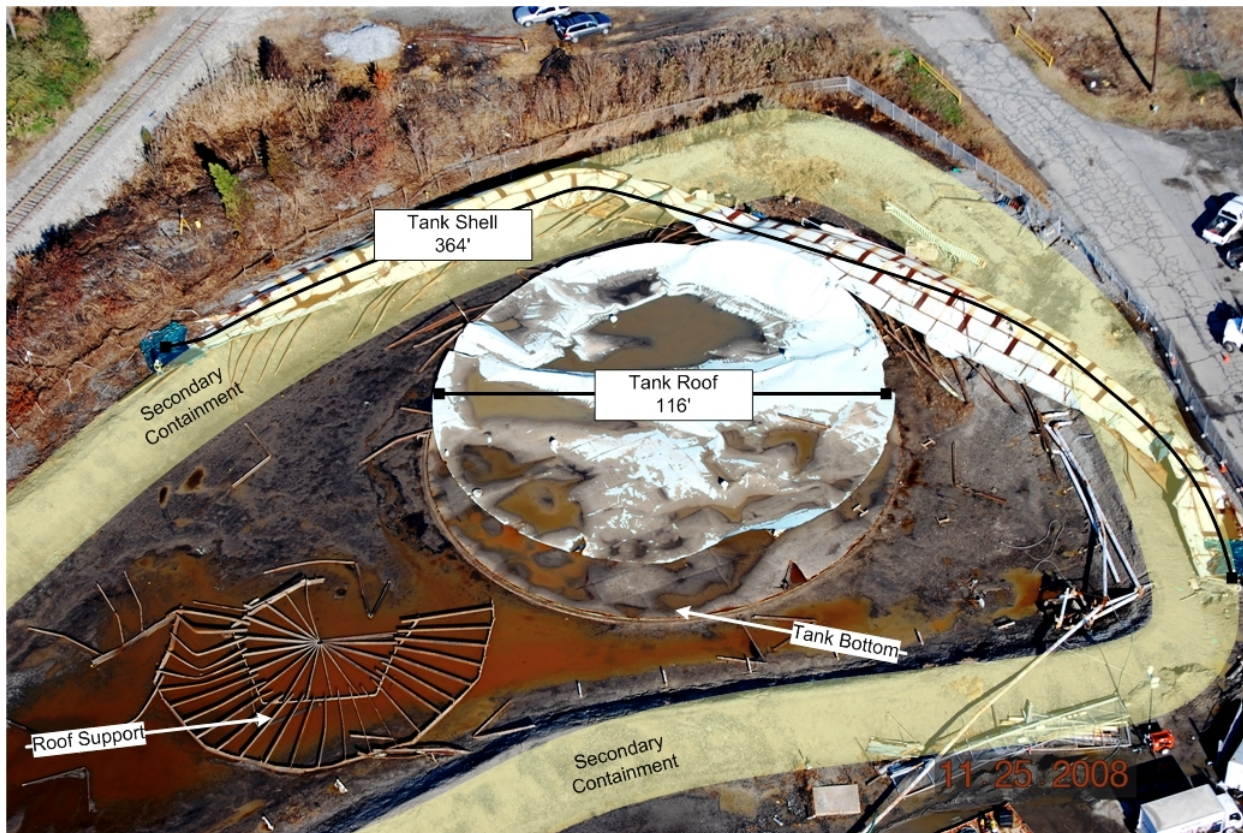
Figure 4. Tank 201.

At about 2:20 pm, as the tank reached a level of 26.72 feet, a vertical split started midway up the shell and rapidly extended to the floor and roof of the tank on the side opposite the workers. As the pressure of the liquid fertilizer inside the tank opened the split, the tank shell separated from the bottom and roof (Figure 4), rapidly releasing the tank's contents.

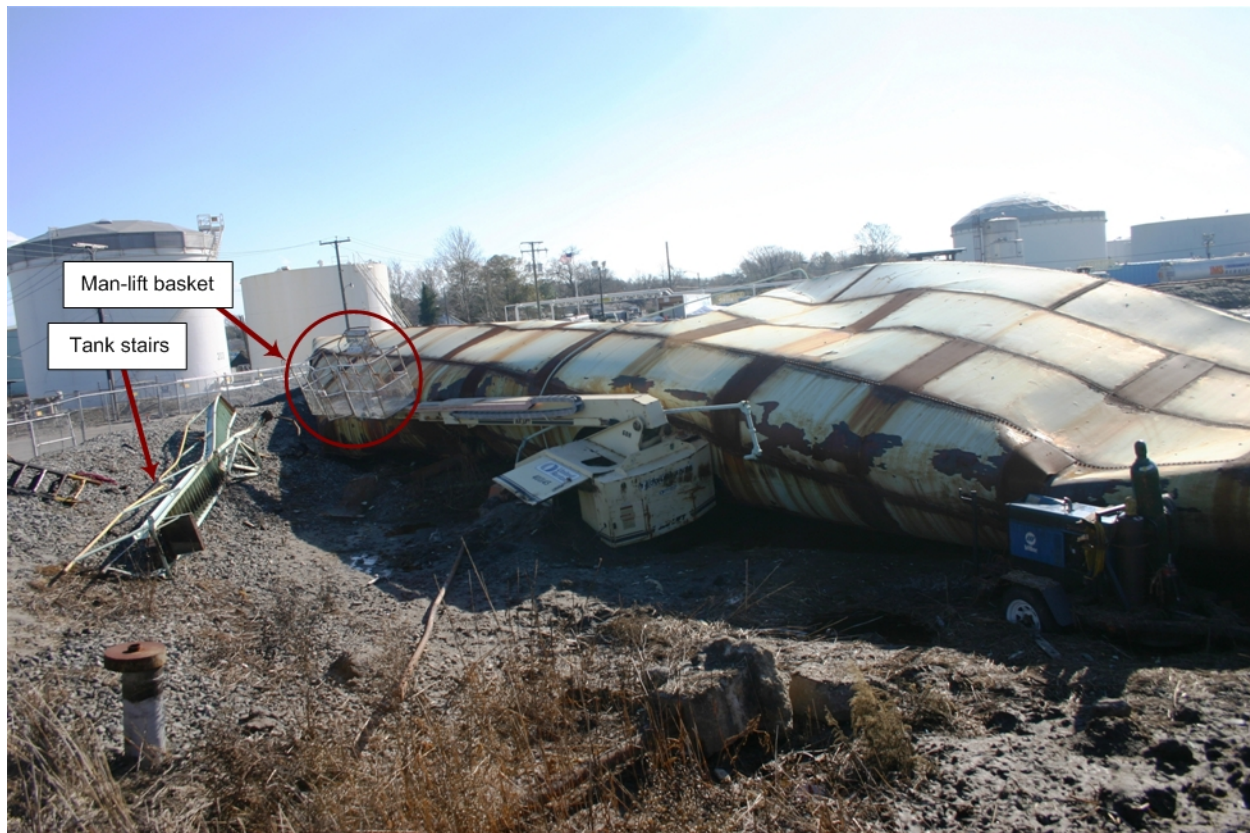
Figure 5. Location of injuries.

The collapsing tank shell impacted the man-lift, seriously injuring the welder in the man-lift basket. The tank stairs fell away from the tank and pinned the helper to the ground. Both workers were briefly submerged under the liquid fertilizer. Employees from a neighboring business witnessed the accident and quickly extricated the workers. Figure 5 is a close-up of the accident scene showing the man-lift and stairs.

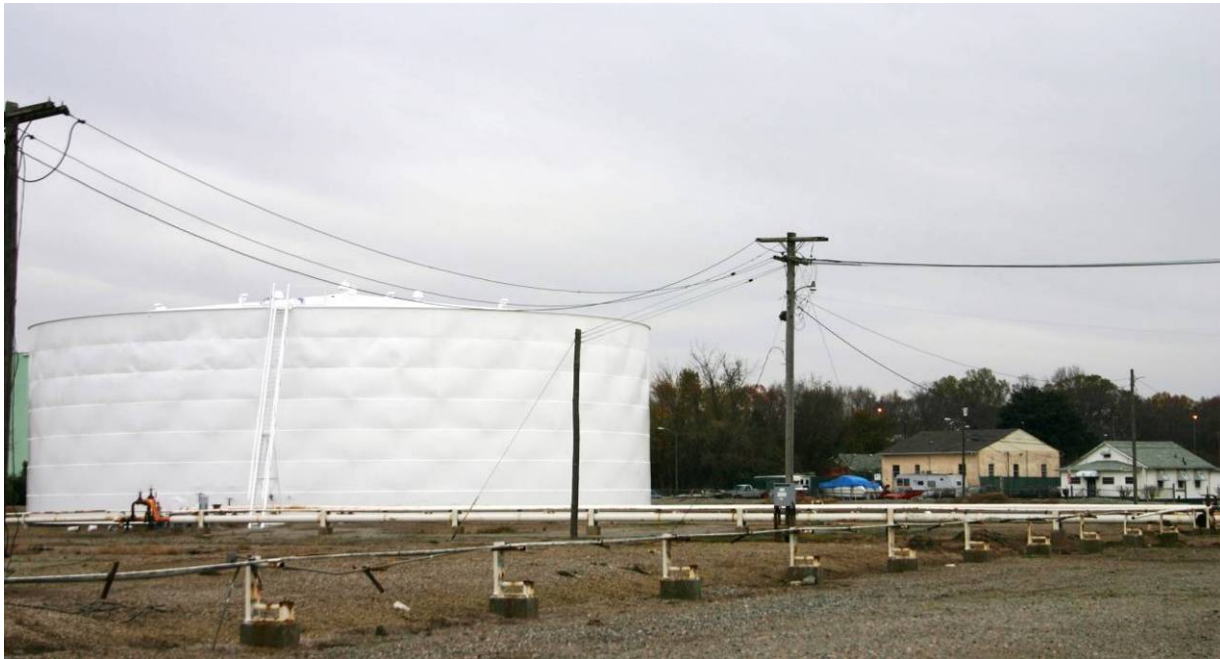
Figure 6. Tank 209.

The City of Chesapeake, through the Fire Marshal's Office, independently investigated the Allied incident. Based on the evidence collected and the concern for the safety of the residents of the South Hill neighborhood, the City of Chesapeake found Tank 209 to be an imminent danger, condemned the tank on December 22, 2008, and ordered Allied to drain it within 30 days. Allied drained the tank in accordance with the City's order.

In response to the CSB's urgent recommendations, Allied contracted Thielsch Engineering, Inc. (Thielsch) to conduct an evaluation of the vertical weld joints on Tanks 202, 205, and 209. Thielsch performed visual and non-destructive inspections<sup>12</sup> of the welds. For Tank 209, the inspections indicated up to 75 percent lack of penetration (LOP) in the vertical butt-weld joint of the insert plates.<sup>13</sup> Based on these results, Thielsch calculated the maximum liquid level for the liquid fertilizer in Tank 209 as 10.227 feet, significantly less than the 32.14-foot maximum liquid level established in September 2007 by HMT. Thielsch's report is included as Appendix B.

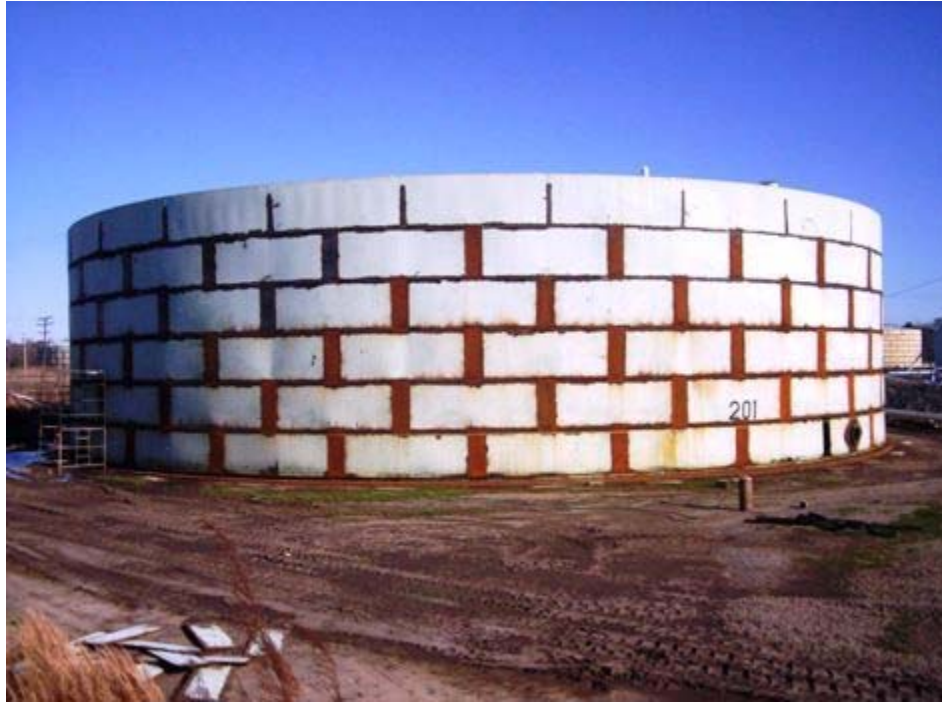
Figure 9. Modified Tank 201.

Following the modifications, Allied paid a non-destructive testing company to examine the welds for defects using spot radiography.<sup>15</sup> However, Allied paid for the examination of only the lower two courses of Tanks 202 and 209. The upper courses of Tanks 202 and 209 and the entirety of Tanks 201 and 205 were not radiographed prior to returning these tanks to service. The radiography performed identified multiple weld defects in the lower courses of both 202 and 209.<sup>16</sup>

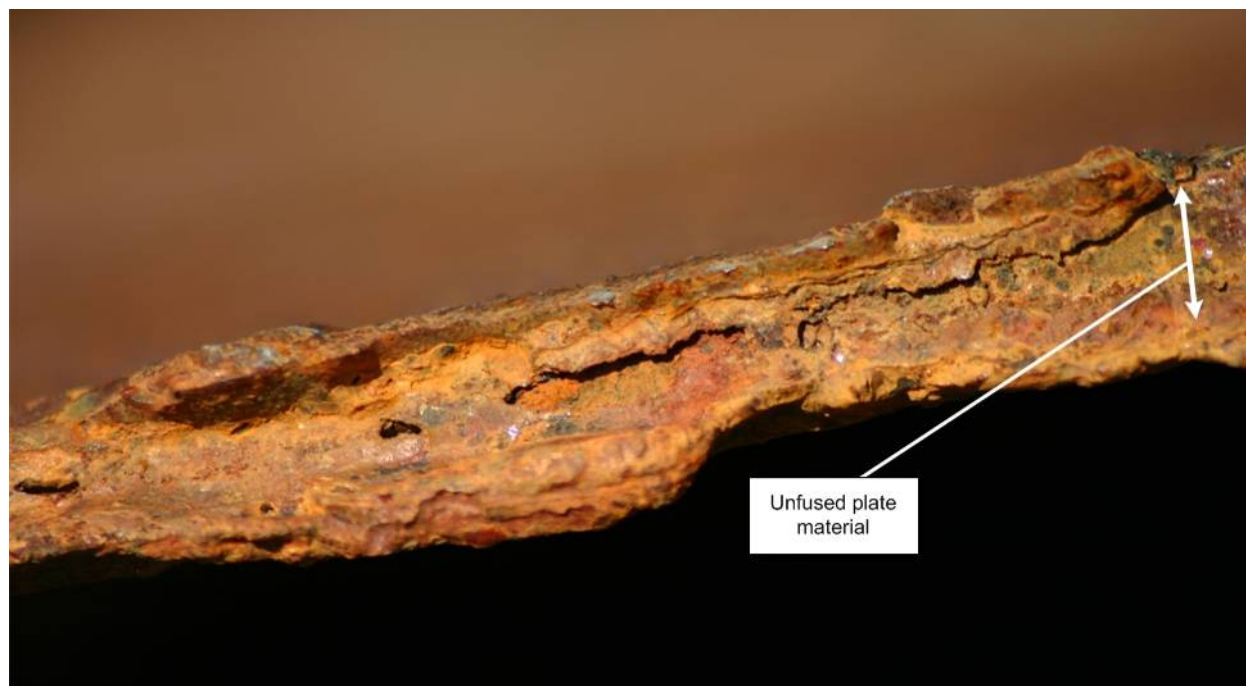
Figure 10. Failed tank weld on course three.

Welds on the plates to replace the vertical riveted joints failed because the welds (Figure 10) did not meet generally accepted industry quality standards for tank fabrication. The welds did not penetrate the full thickness of the plates. Furthermore, the welds contained defects—porosity (holes from gas bubbles in

the weld) and undercut (insufficient weld material along the edge of the weld)—that significantly degraded the strength of the welds.

Had the welds been radiographed as required by API 653, these weld defects would most likely have been detected and should have been repaired.
