U.S. CHEMICAL SAFETY AND HAZARD INVESTIGATION BOARD

INVESTIGATION REPORT

CATASTROPHIC VESSEL OVERPRESSURIZATION (4 DEATHS)

Sonat Exploration Company
Temple 22-1 Common Point Separation Facility
Pitkin, Louisiana
March 4, 1998

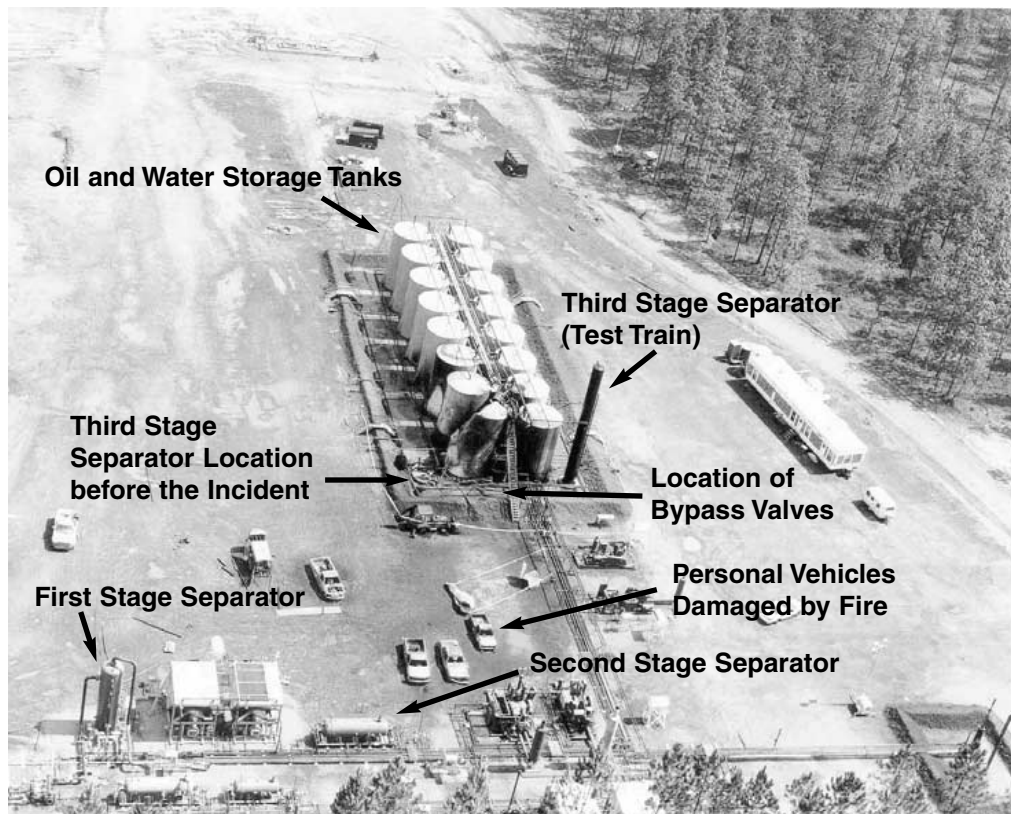
Figure 1. Aerial View of the Temple 22-1 Common Point Separation Facility after the Incident

In addition to the fatalities, the incident resulted in about \$200,000 worth of damage, including the destruction of the third-stage separator, four private vehicles, and a backhoe and damage to the facility storage tanks. Figures 1, 7, and 8 document the condition of the facility after the incident.

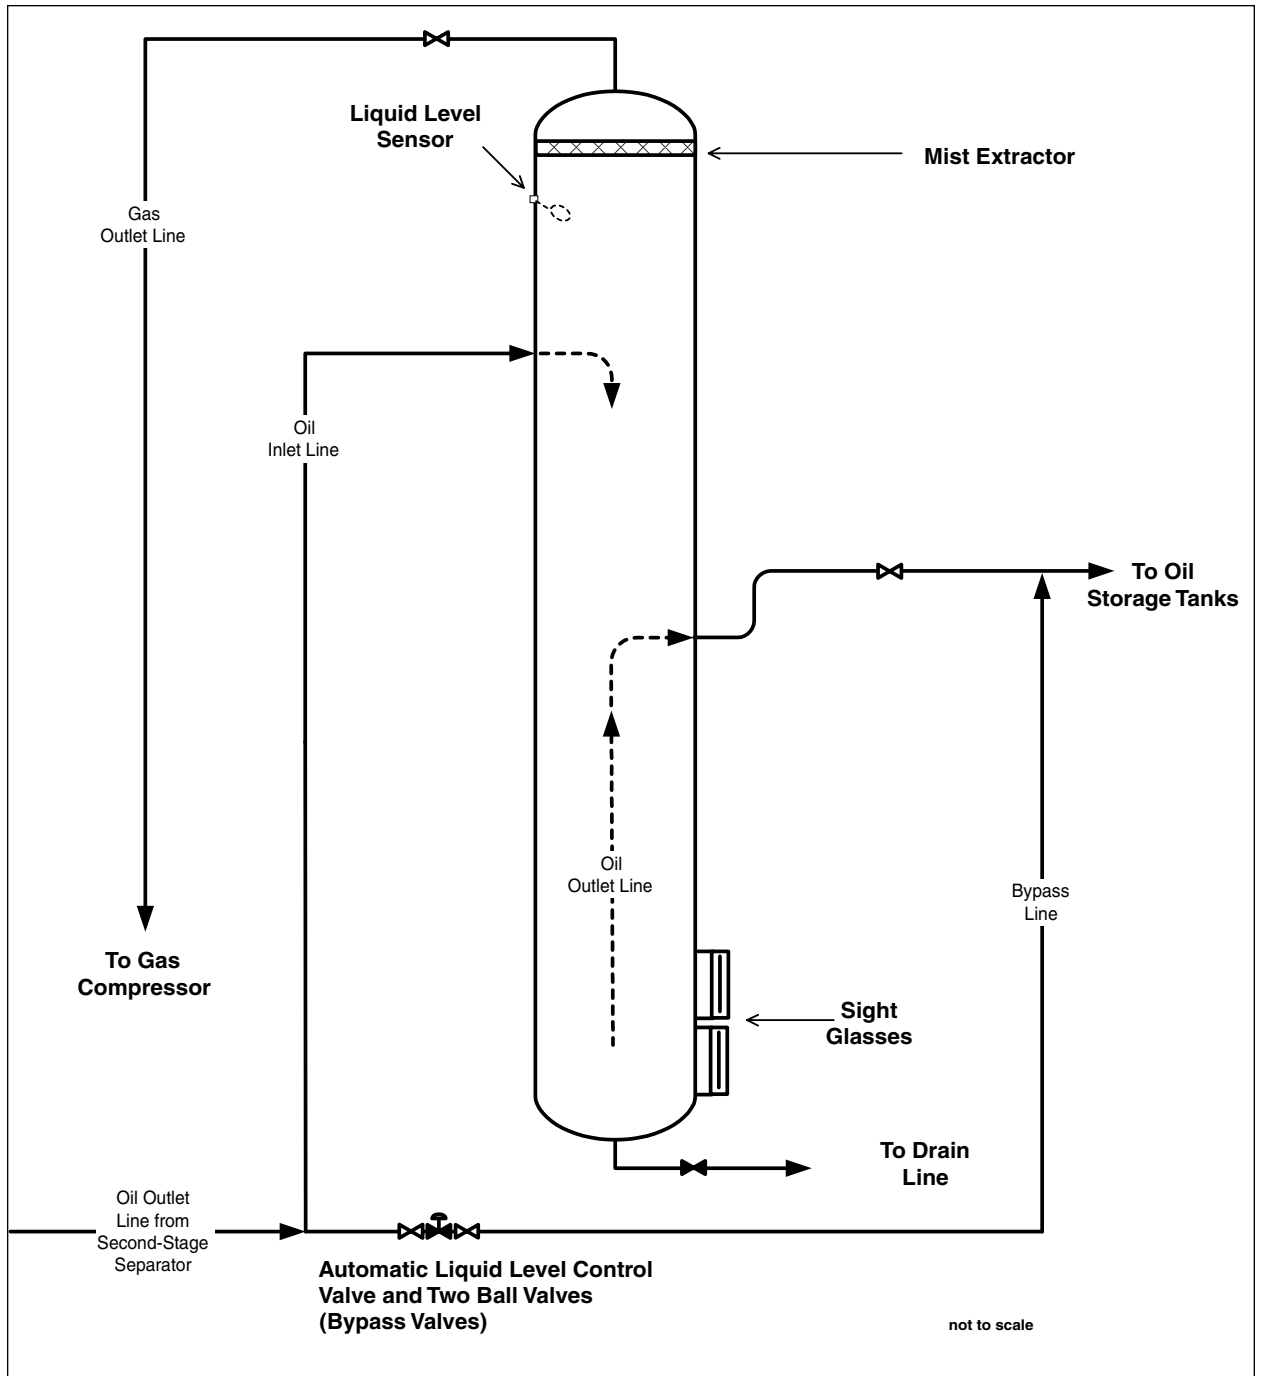
Figure 4. Third-Stage Separator Schematic

Each third-stage separator (Bulk and Test) was a 45-foot-tall vessel with a diameter of four feet (see Figure 4 for details). In operation, the vessel would be approximately 80% full with fluid. Well fluid was introduced into the separator at a height of approximately 35 feet, and separated

The third-stage separator was only rated for atmospheric pressure service (14.7 psia). Vessel failure was the result of overpressurization by purge gases and was both sudden and catastrophic. Four personnel were within 40 feet of the third-stage separator at the time it ruptured.²⁷

Deficiencies in the design and installation of the third-stage separator were important to the causality of the incident. Equipment that may potentially be exposed to pressure hazards, either through human error or mechanical failure, should either (a) be designed to withstand those hazards, or (b) be equipped with appropriate pressure-relief systems. An appropriately sized and designed pressure-relief system would likely have prevented the incident.³⁰

Another design deficiency was the absence of an inlet block valve upstream from the third-stage separator. Such a valve could have been used to isolate the separator from the high-pressure purge gases that caused the vessel failure. An inlet block valve would be an adjunct, not a substitute, for a pressure-relief system on the separator. Similarly, the inclusion of a block valve (valve **15**) on the oil outlet line of the third-stage separator allowed the separator to be isolated from the storage tanks, whose roof hatches offered a potential means of venting. At the time of the incident, valve **15** was closed. The third-stage separator also had an outlet line to a gas compressor; excess flow into the compressor would be vented via the gas flare. However, the gas

Prior to operating the Bulk Train, the third-stage separator should thus have been equipped with a pressure-relief system, as recommended by API consensus guidance.³³

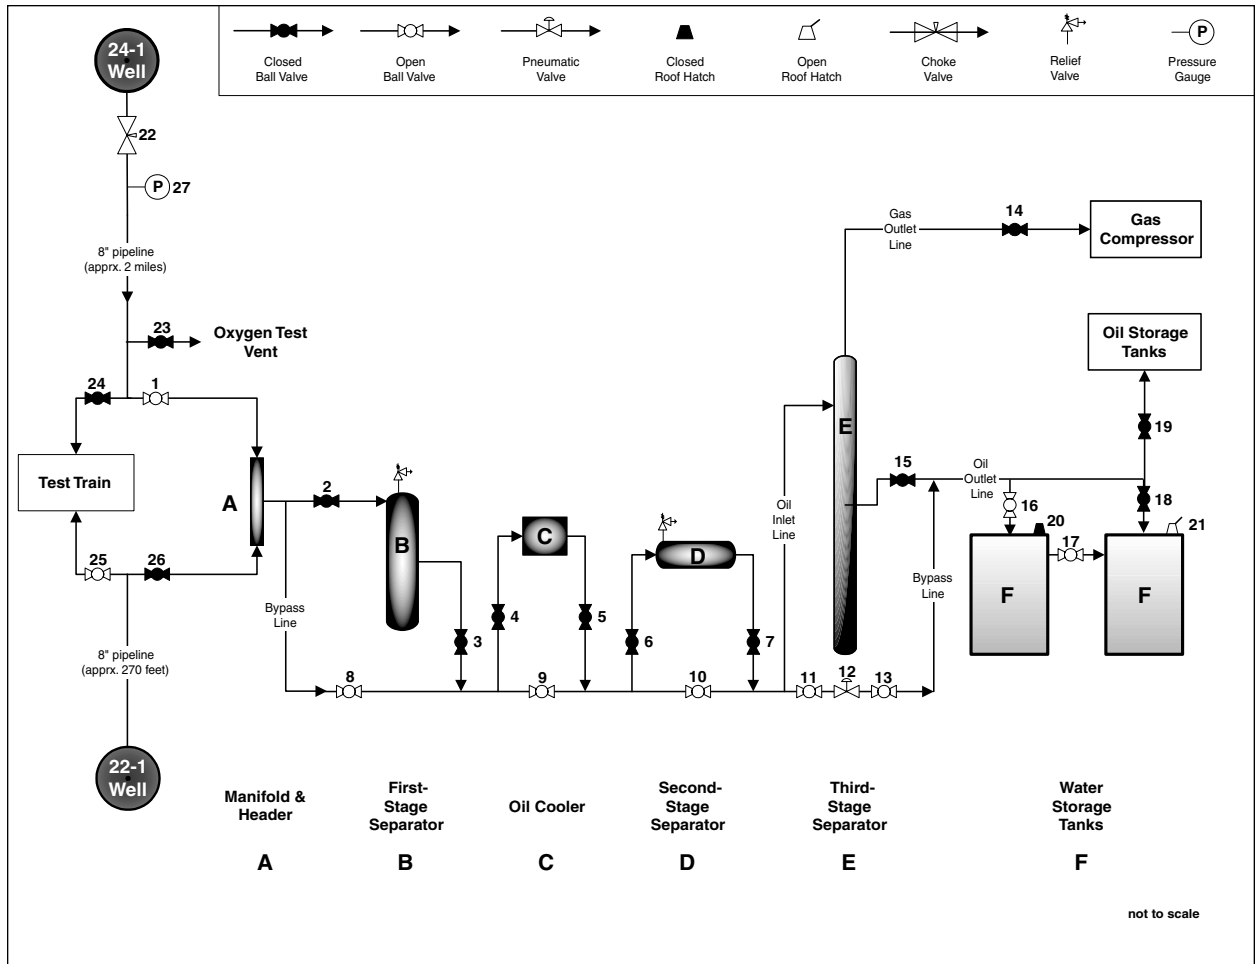
Figure 5. Intended Valve Positions after the Final Alignment

Executing the plan required at least 11 valves to be manually repositioned, an activity that was performed without written procedures or valve position checklists. While most valves were manually operated ball valves,²² valve **12** was a pneumatic valve actuated by a liquid level probe located inside the third-stage separator. A high liquid level within this vessel would automatically cause valve **12** to open, allowing fluid to bypass the separator provided that the adjacent manual ball valves **11** and **13** were open. On the morning of March 4, workers had disconnected the supply of control gas to valve **12**, causing the valve to remain open thereafter.

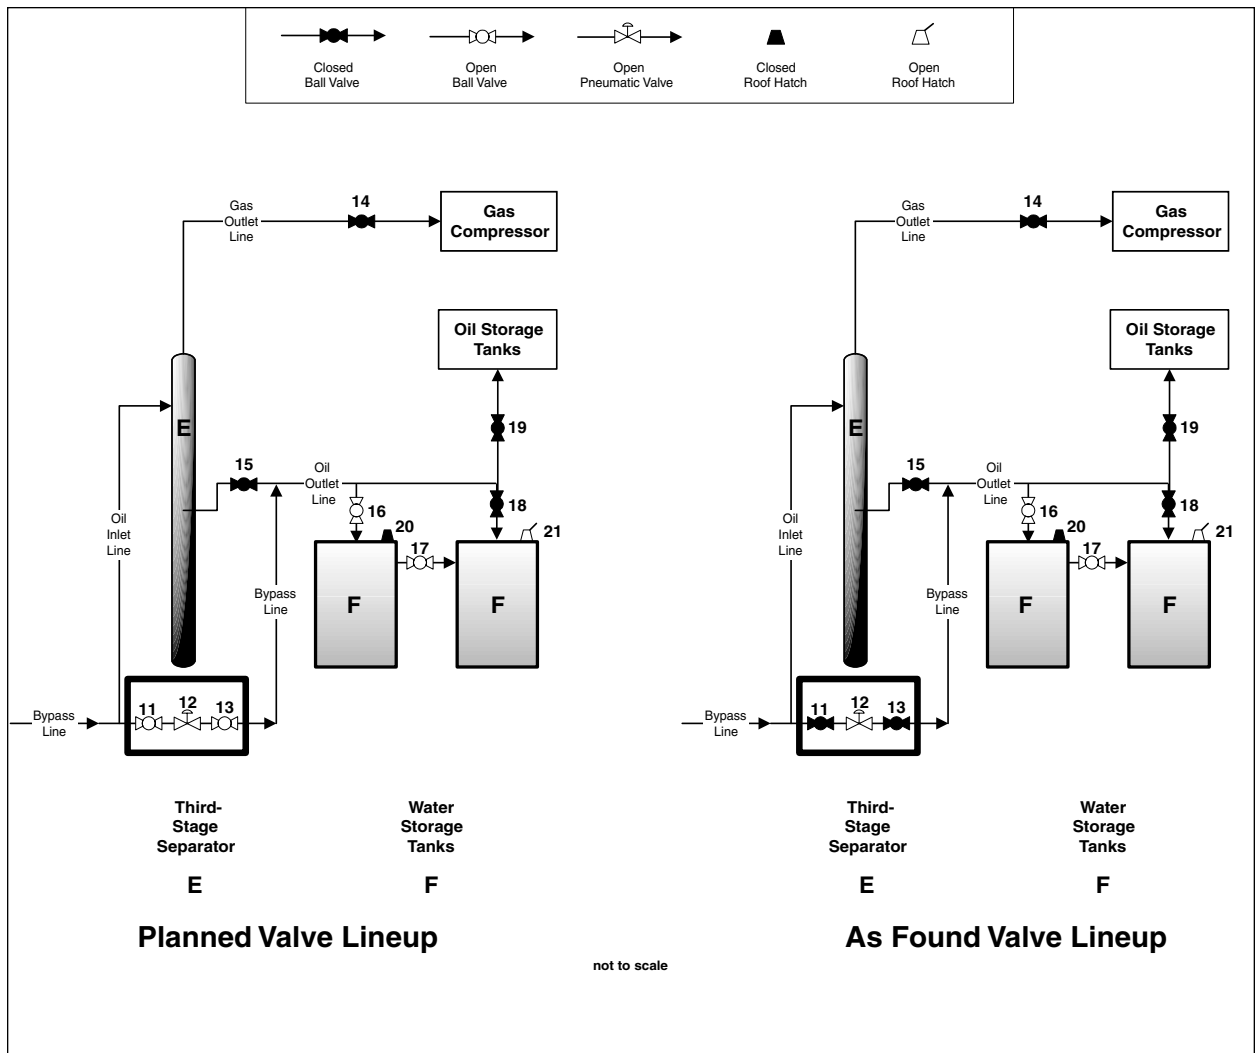
Figure 9. Comparison of Valve Alignments as Planned and as Found after the Incident

Soon after the fires stemming from the incident had been brought under control, Louisiana State Police inspected the area around the failed separator. They were accompanied by the Sonat production and construction supervisors. It was then discovered that, in contrast to the planned valve alignment, valves **11** and **13** were actually in the closed position.

Similarly, the timing of the closure of valves **11** and **13**, which triggered the vessel failure, could not be absolutely determined.²⁸ These two valves were opened in the morning but then closed early in the afternoon prior to the purging of the Bulk Train separators. The valves were not continuously monitored during most of the day. It is possible that the valves were not reopened as intended prior to the final purging process, and remained closed until vessel failure finally occurred. Alternatively, the valves may have been correctly opened during the final valve alignment, only to be manually closed later. However, no surviving personnel reported seeing the valves closed during any part of the final purging process, and there was no operational reason to close the valves once the purging was under way. The surviving supervisors did not report giving any such instruction, nor were any Bulk Train valve realignments whatsoever planned during the final purging process. Valves **11** and **13** were not intended to be closed once the Bulk Train entered routine production.²⁹
