BIOCHEMICAL EXPLOSION- 2003 ACCIDENT INVESTIGATION

U.S. CHEMICAL SAFETY AND HAZARD INVESTIGATION BOARD

EXPLOSION AT BIOCHEMICAL FACILITY: LIQUID NITRIC OXIDE RELEASE

No. 2003-15-C-OH
August 2004

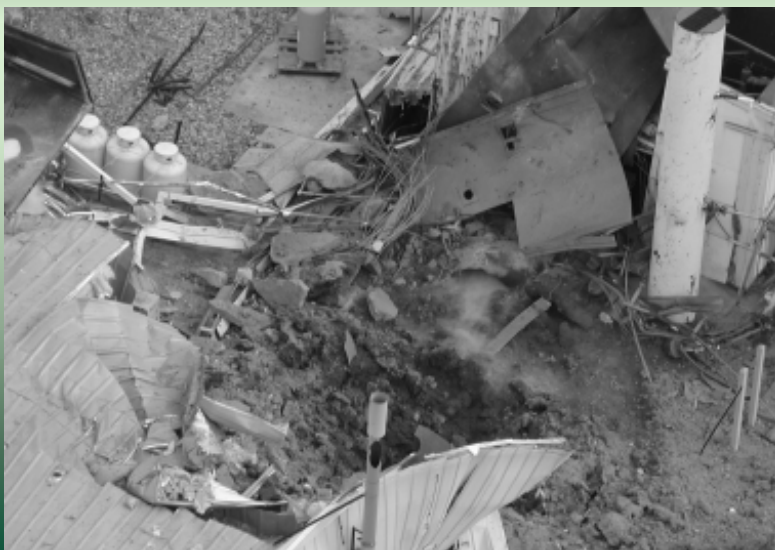
Figure 1

At 10:15 am—with no warning—a violent explosion destroyed the distillation column, the blast containment structure, and nearby buildings (Figure 1). Windows were blown out of the main office building, about 140 feet from the explosion; and glass shards lacerated the hand of an Isotec employee. No other injuries were reported.

20-foot-diameter, 8-foot-deep crater and structural damage caused by NO process unit explosion

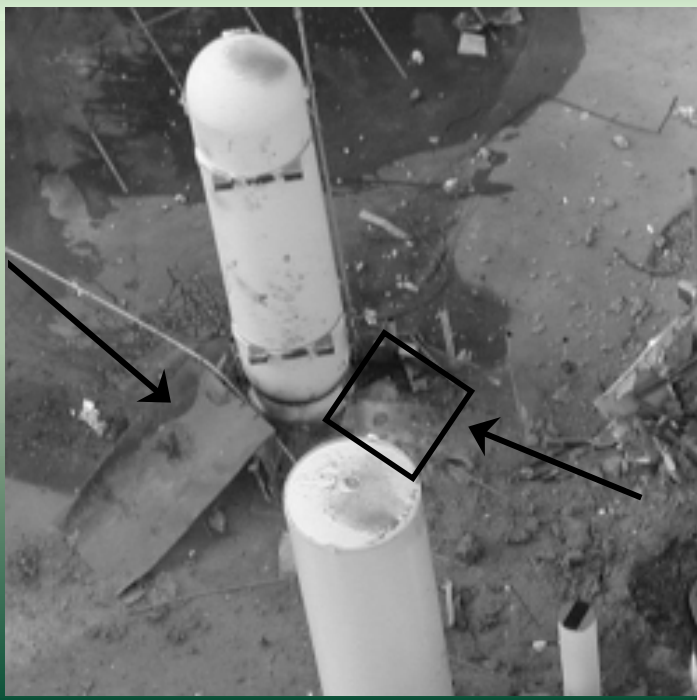
Figure 2

A large steel panel from the blast containment structure struck and dislodged a 52,000-pound gaseous carbon monoxide (CO) storage vessel, pushing it about 10 feet off its foundation (Figure 2). A second steel panel severely damaged adjacent equipment (Figure 3). A ruptured fill line vented CO gas, which then ignited and burned for about 1 hour, until the vessel was empty (Figure 4).

52,000-pound, 42-foot-tall CO vessel pushed 10 feet off foundation (right arrow) by blast panel (left arrow)

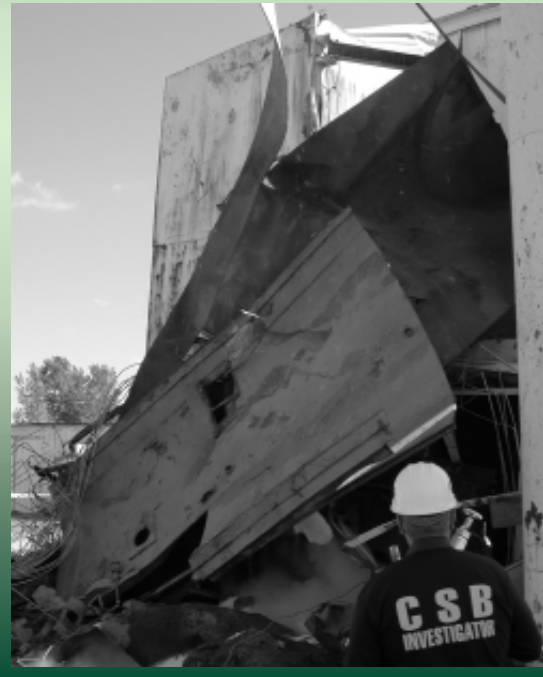
Figure 3

Blast containment structure damaged by steel blast panel

However, the total destruction of the structure caused major damage to the surrounding facility, including dislodging the CO vessel and rupturing the CO piping—which resulted in the community evacuation, as discussed in Section 1.0.

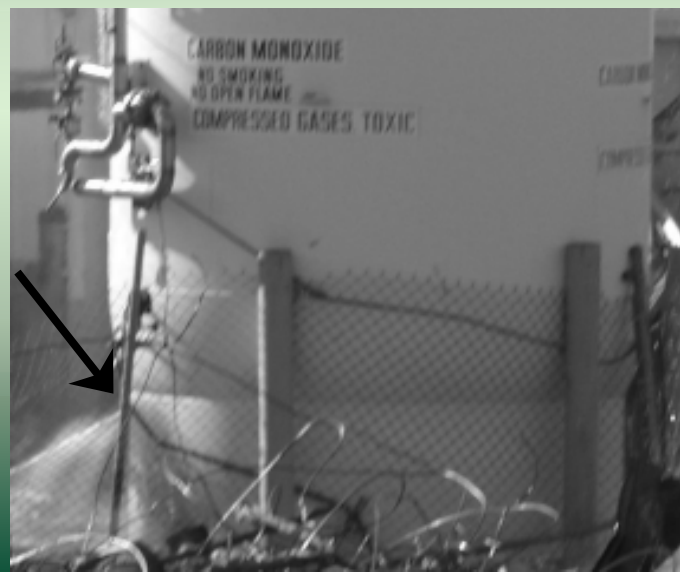
Figure 4

CO gas venting from ruptured fill line (arrow) on displaced vessel

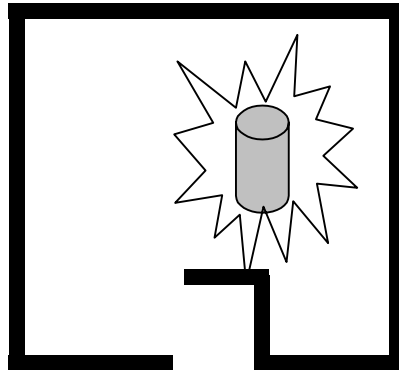
Figure 9

Labyrinth opening to release pressure and block projectiles

A more effective blast shield structure would have included a labyrinth opening (Figure 9) and a steel wire mesh top similar to the LANL blast structure. This configuration would be much less likely to catastrophically fail.

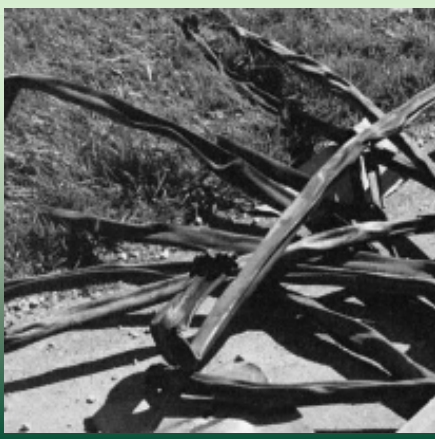
Figure 10

Distillation column components ejected from near the top of the well casing provided strong evidence that the column piping experienced high temperature and extreme crushing pressure, most likely from a high-energy explosion in the vacuum jacket (Figure 10). The debris from the vacuum jacket consisted of small metal shards (Figure 11), indicating high-order explosive failure.¹¹

2-inch-diameter stainless-steel piping oxidized and crushed

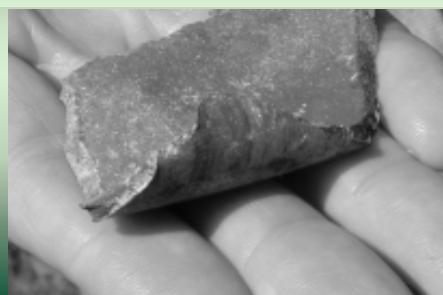
Figure 11

¹¹ NFPA 921 characterizes a high-order explosion as shattering of the structure, producing small, pulverized debris. Rapid rates of pressure rise splinter or shatter walls, roofs, and structural members; and the building is completely demolished.

Stainless-steel shard,
likely from vacuum jacket
