CONFINED SPACE ASPHYXIATION ACCIDENT - 2005 ACCIDENT INVESTIGATION

Confined Space Entry - Worker and Would-be Rescuer Asphyxiated

No. 2006-02-I-DE

Valero Energy Corporation Refinery

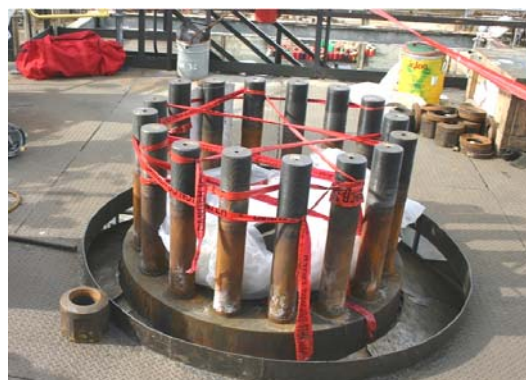
Two days before the incident, workers employed by Catalyst Handling Services Corporation (CHSC), the catalyst contractor, finished loading the reactor with the new catalyst and placed a temporary plastic tarp and wooden cover over the open manway to prevent moisture and debris from falling into the reactor. They also attached a confined space warning sign to the studs surrounding the opening. About five hours before the incident, a CHSC foreman wrapped red “danger” tape around the studs.

Figure 1. Plastic sheet and plywood disk on R1 manway. Red “danger” tape on the studs alerted workers of the unsecured confined space access opening.

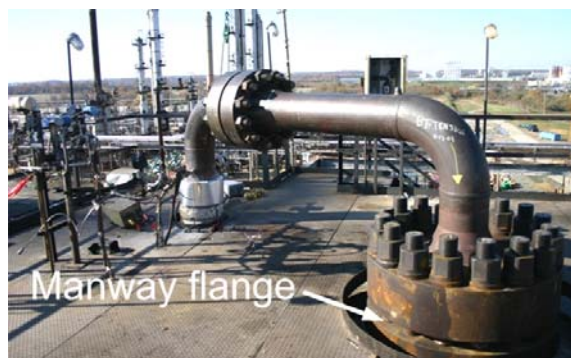
At about 11 p.m., two Matrix boilermakers removed the wooden cover and plastic tarp and cleaned the manway flange surface, a prerequisite to reinstalling the pipe assembly (Figure 2).

Figure 2. Pipe assembly connects 12-inch diameter process pipe to the reactor top manway (photo taken after the incident).

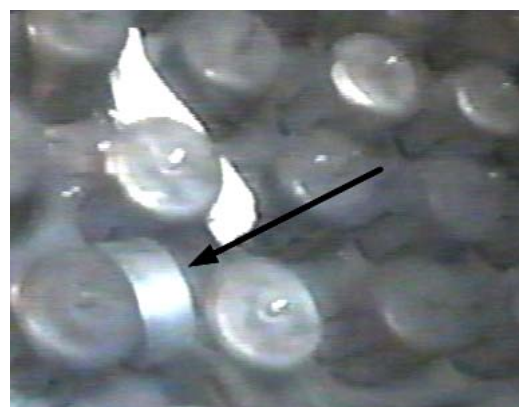
While the boilermakers were cleaning the manway flange surface, a Matrix pipefitter told them that a roll of duct tape was lying on the distribution tray⁶ (Figure 3) about five feet below the opening. The boilermakers knew that reactor cleanliness criteria prohibited leaving the tape inside the reactor, so they discussed retrieval options with their foreman.

Figure 3. Roll of duct tape on the top distribution tray inside reactor R1 (photo taken after incident).

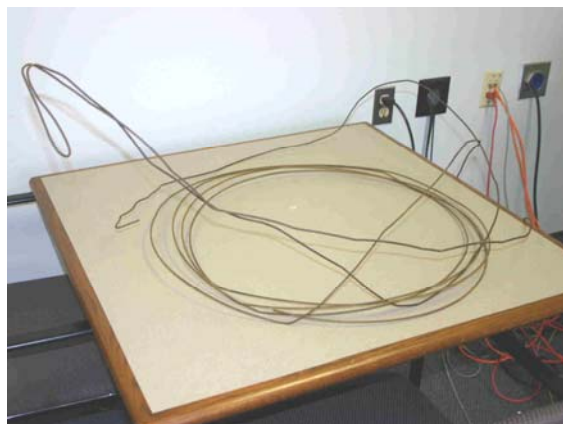
A few minutes before the incident, nearby workers saw the first victim standing next to the studs surrounding the open manway trying to retrieve the tape with the wire. One worker saw him kneeling next to the studs while he worked with the wire. Nobody saw him enter the nitrogen-filled reactor, but he either fell in or intentionally went into the reactor.

Figure 4. Fifteen foot wire with hook formed on end used by the first victim to retrieve the duct tape.

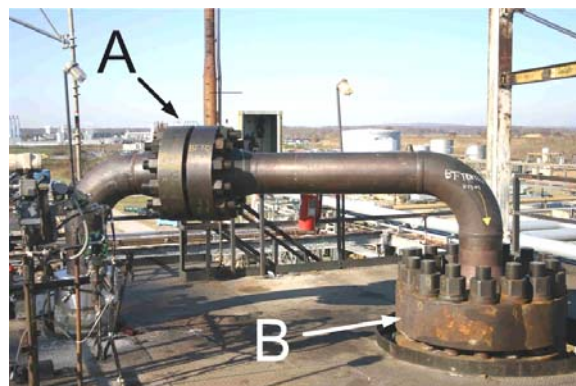
reassembling the 12-inch flange to the process pipe (Figure 5, flange A). The work description on the permit limited the pipefitters to “set up [the] job,” which in this case meant taking tools and equipment up to the platform work area. Their permit correctly informed them of the continuing nitrogen purge.

Figure 5. Top elbow pipe assembly includes 12-inch flange (A) and 24-inch manway flange (B).

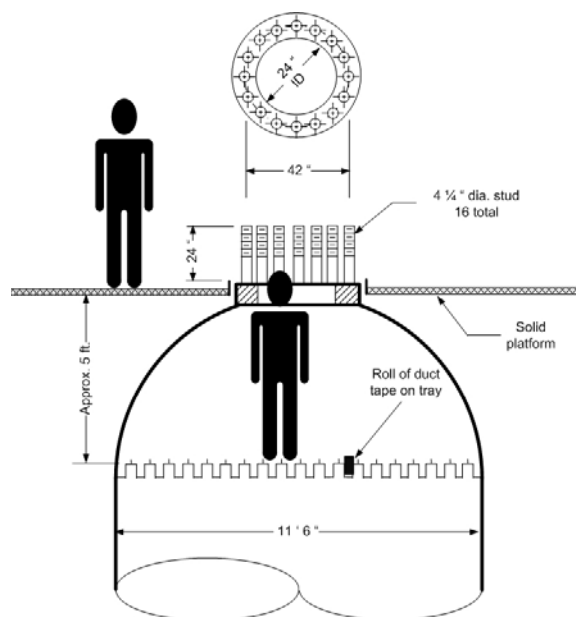
The CSB concluded from the physical evidence, including the autopsy report, size of the reactor manway opening, and tall studs surrounding the opening, that it was extremely unlikely for the first victim to have fallen into the reactor from either the standing position directly over, or next to the manway, or while kneeling next to the manway (Figure 6). However, if he stepped over the studs, sat down, and dangled his legs inside the reactor he could pass through the manway.¹⁶

Figure 6. Reactor R1 work platform (figures approximately to scale).

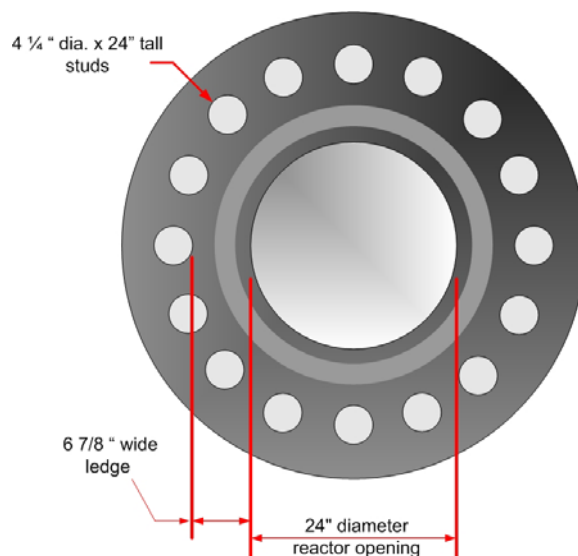
Although nobody saw him go into the reactor, the CSB concluded that the first victim likely stepped over the manway studs and then sat on the narrow ledge (Figure 7). From this position, he might finally be able

From the sitting position, and possibly leaning with one arm inside the reactor to get as close to the tape as possible, the first victim could have been exposed to an oxygen-deficient atmosphere above the opening. Then, without warning, he could have become disoriented or lost consciousness from oxygen deprivation (see Table 1) and slid into the reactor. He might also have lost his grip and simply slid off the narrow ledge and into the reactor.

Figure 7. The first victim most likely sat on the narrow reactor manway ledge between the studs and the opening to get closer to the tape.

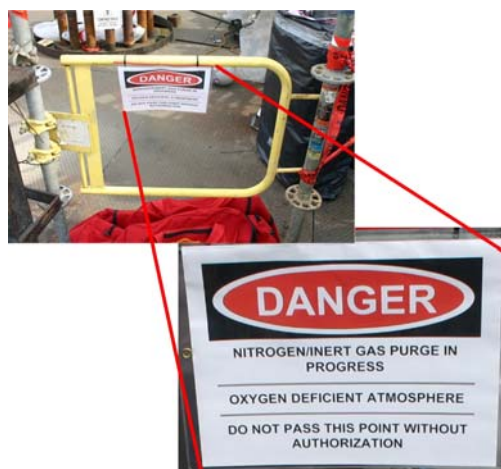
The Valero refinery has safe work procedures for using nitrogen, but they were inadequately implemented the night of the incident. The procedures required operators to install a barricade and post warning signs at all equipment access points (Figure 8) before the nitrogen purge was started, and to list all personnel working inside the barricaded area using a controlled area entry log. The barricade and control log were not used at the R1 manway the night of the incident, even though the reactor was on a nitrogen purge that vented directly onto the work platform area.

Figure 8. Nitrogen-purge controlled area barricade and warning installed on the R1 platform after the incident.

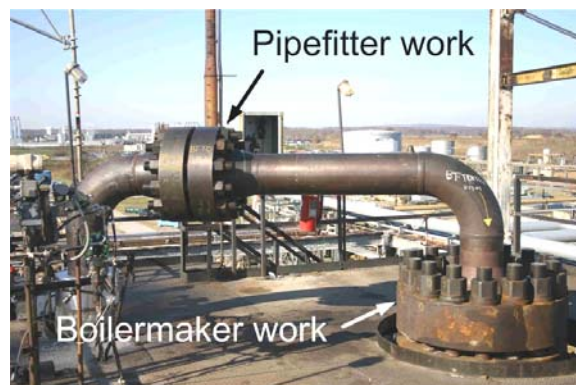
The CSB also noted that the Valero permit-preparer was inconsistent in preparing the work permits for the two crews. The work permit issued to the pipefitter crew correctly checked the "nitrogen purge or inerted" box "yes" for the flange reassembly setup. The boilermakers, on the other hand, would need to work very close to the open manway (Figure 9) where the nitrogen was venting from the reactor, possibly exposing them to unsafe oxygen levels.

Figure 9. Pipefitters assembled 12-inch pipe flange, boilermakers assembled 24-inch manway flange.

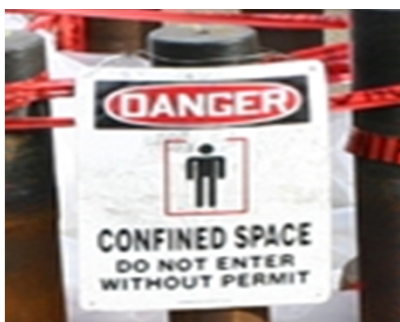
The Valero site procedure for permit-required confined space entry required all open, permit-required confined space access points to be clearly identified with a warning sign (Figure 10).²³

Figure 10. Typical sign used to identify unsecured confined space access opening.

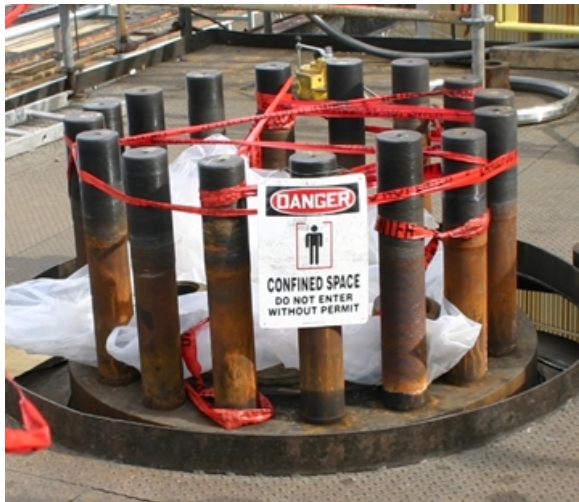
The employer is also required to post danger signs (Figure 11) or other equally effective means to identify the hazard [§146(c)(2)]. In this incident, the red tape was the only warning on the manway—no warning sign was in place at the time of the incident.

Figure 11. Confined space warning sign on the unsecured reactor manway after the incident.
