# TREE REPORT

***FAIRWATER SOCIAL CLUB  
22 Plas-Mawr Road  
Cardiff  
CF5 3JP***

***Pre – Development BS5837  
TREE SURVEY***

***February 2023***

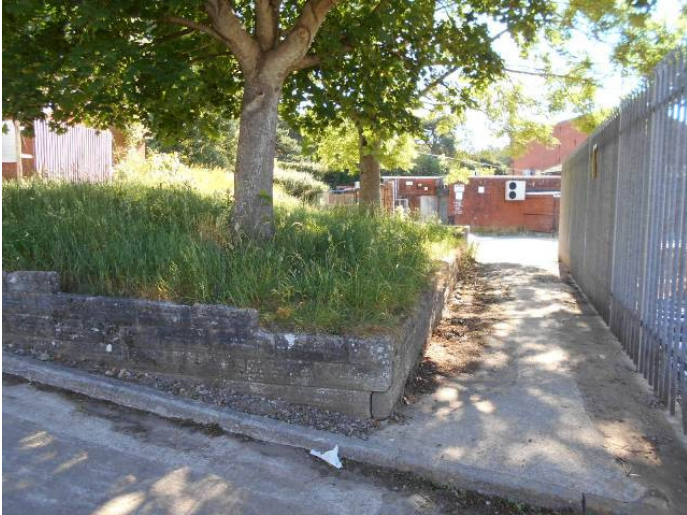
T1 – View of path and retaining wall close to base of tree

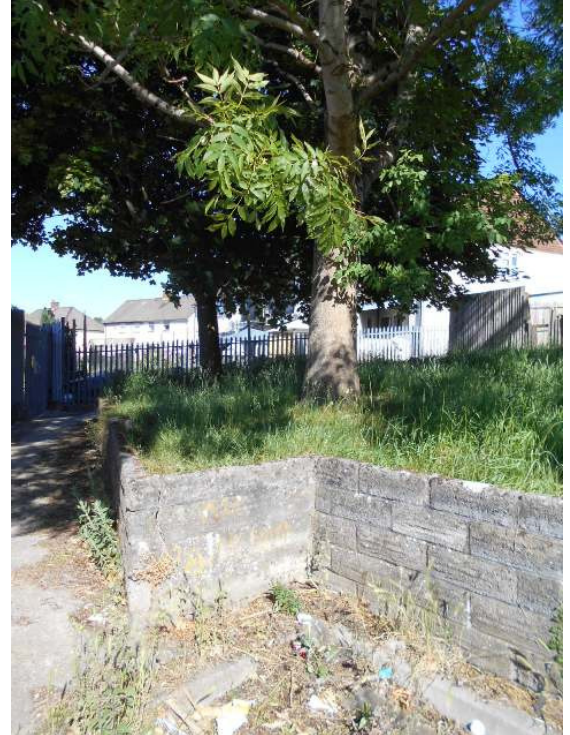
T2 – View of path and retaining wall close to base of tree

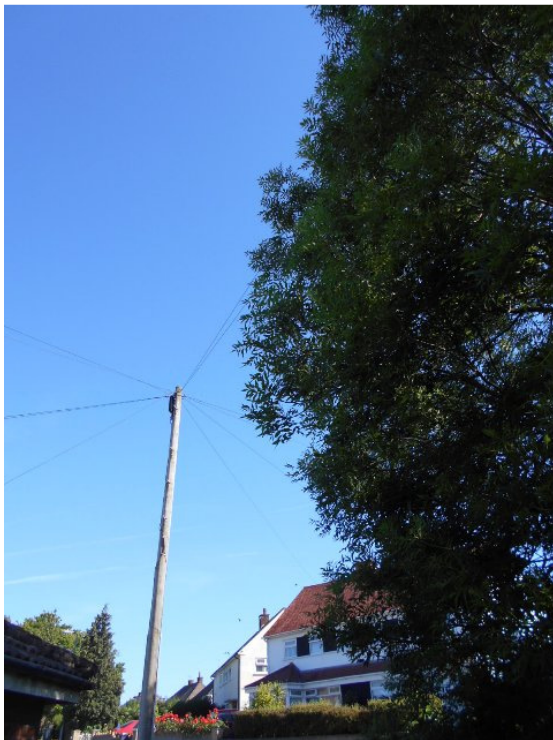
3	Ash	15	360	0.5	Mi	5.0	6.0	5.0	5.0	GOOD	<ul style="list-style-type: none"> <li>• No Ash Dieback symptoms</li> <li>• Minor dead wood lower crown centre</li> <li>• Overhead telephone wires through mid outer crown West</li> <li>• Co-dominant stems from fork at 2m</li> <li>• Slightly suppressed to East by T4</li> <li>• No other visible external defects</li> </ul>	No works required	20	<b>B1</b>	4.3
4	Ash	15	460	0.5	Mi	6.0	8.0	8.0	5.0	GOOD	<ul style="list-style-type: none"> <li>• Minor Ash Dieback symptoms in upper mid crown</li> <li>• Slightly suppressed to West by T3</li> <li>• 3 large buttress surface roots visible in grass beneath crown spread</li> <li>• 4 co-dominant stems from branch / trunk union at 2m</li> <li>• Lower crown North recently cut back from pavement</li> <li>• No other visible external defects</li> </ul>	No works required	20	<b>B1</b>	5.5

T3 – View of overhead wires through mid crown West

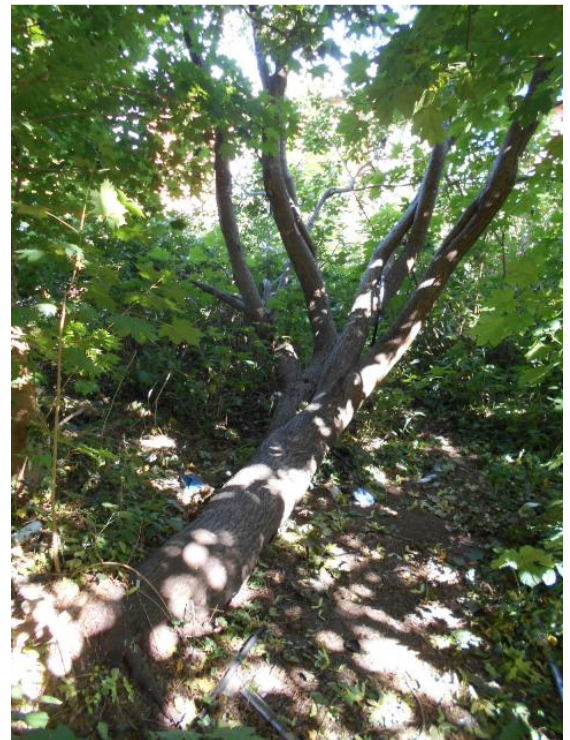
T6 – View of fallen tree, still alive

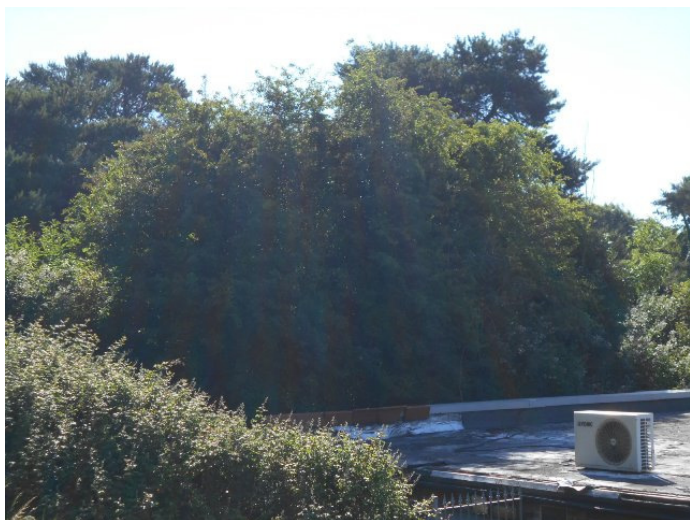
Gp 1 – View of position on top of retaining wall to East of existing building

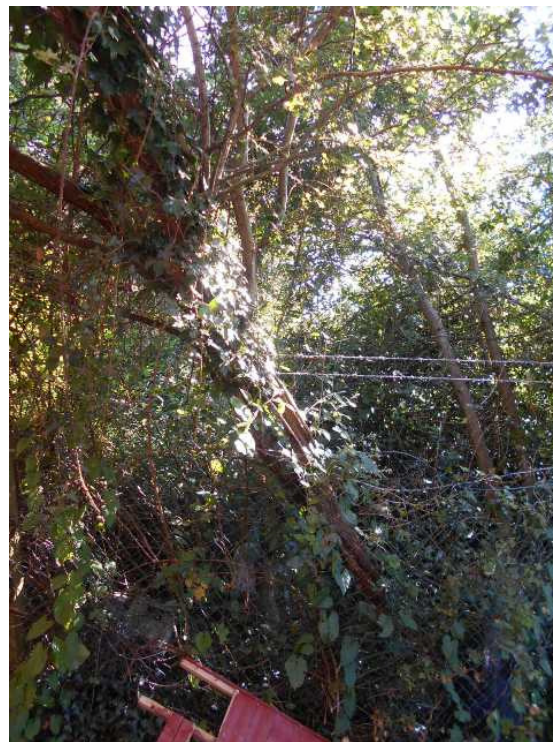
Tree Tag No.	Species	Height (m)	Calculated Stem diameter (mm)	Height crown clearance / (m)	Age Class	Branch spread (m)				Vitality	Structural condition notes	Recommended Works	Est remain years	Category grading	RPA radius (m)
						N	S	E	W						
Gp 1	Hawthorn x 2 Ash	8	250	0.0	Mi	3.0	3.0	3.0	3.0	GOOD	<ul style="list-style-type: none"> <li>No access to trees – behind building in fenced off area</li> <li>Single line closely spaced</li> <li>Ash Dieback to upper half of Ash</li> <li>Appear to be on top of steep slope with high retaining wall at base</li> <li>No other visible external defects</li> </ul>	No works required	20	C2	3.0
Gp 2	Hawthorn x 2	8	120	3.0	Mi	2.0	3.0	3.0	2.0	FAIR / POOR	<ul style="list-style-type: none"> <li>Located just beyond boundary fence</li> <li>North-most tree has partially uprooted and fallen onto fence</li> <li>South tree twin-stemmed</li> <li>Tarmac path at base at 1m to West</li> <li>No other visible external defects</li> </ul>	Remove fallen tree off fence	10	C2	1.4

Gp 2 – View of fallen Hawthorn resting on fence

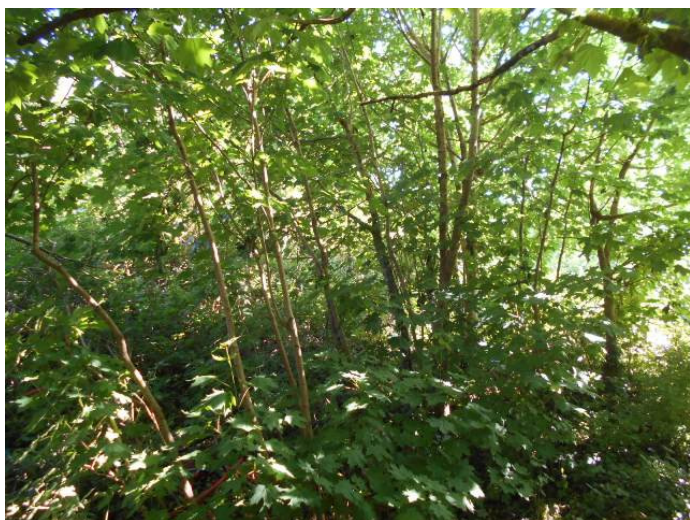
Gp 3	Rowan Ash x 6 Norway Maple x 18 Goat Willow	6 (av)	120	1.0	Y	2.0	2.0	2.0	2.0	FAIR	<ul style="list-style-type: none"> <li>Scattered group of young trees</li> <li>Some are multi-stemmed</li> <li>Minor Ash Dieback symptoms to Ash</li> <li>Dense Bramble understorey</li> <li>Other young seedlings among group</li> <li>No other visible external defects</li> </ul>	No works required	10 to 20	C2	1.4
5	Norway Maple	12	600	1.0	M	9.0	5.0	8.0	8.0	GOOD	<ul style="list-style-type: none"> <li>Located on side of slope S of Gp 3</li> <li>5 stems from branch / trunk union – 2 much larger than others</li> <li>Slightly suppressed to South by row of tall conifers in adjacent park</li> <li>No other visible external defects</li> </ul>	No works required	20 to 40	B1	7.2
6	Goat Willow	8	350	1.0	Mi	4.0	1.0	4.0	3.0	FAIR / POOR	<ul style="list-style-type: none"> <li>Has uprooted and fallen to North, still alive with crown returned to vertical</li> <li>4 upright co-dominant stems from branch / trunk union</li> <li>Overshadowed and suppressed by T5 to South and Gp 3 to West</li> <li>No other visible external defects</li> </ul>	No works required	10	C1	4.2

Gp 3 – View of dense group of young trees

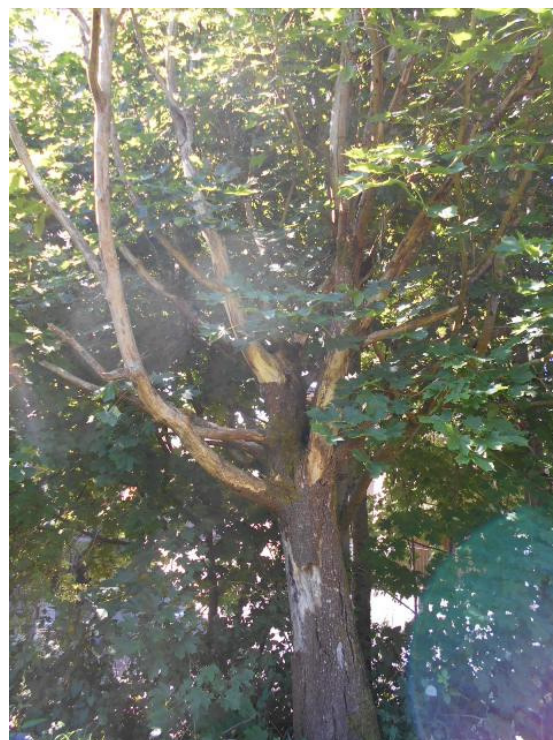
Gp 4 – View of dead tree at East end of group

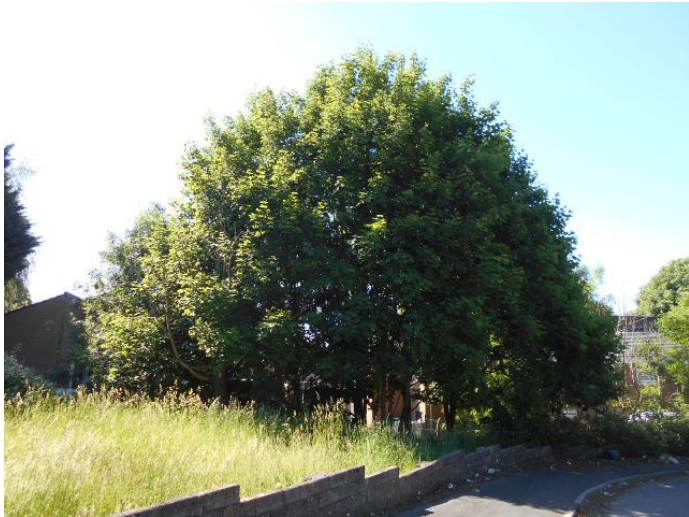
Gp 4 – View of co-dependent crown of group

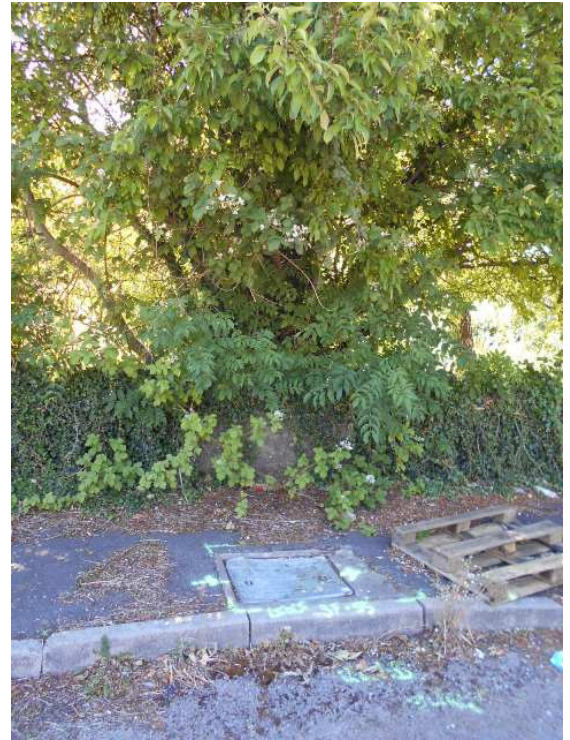
T8 – View of wall, path and drive at base of trees to West

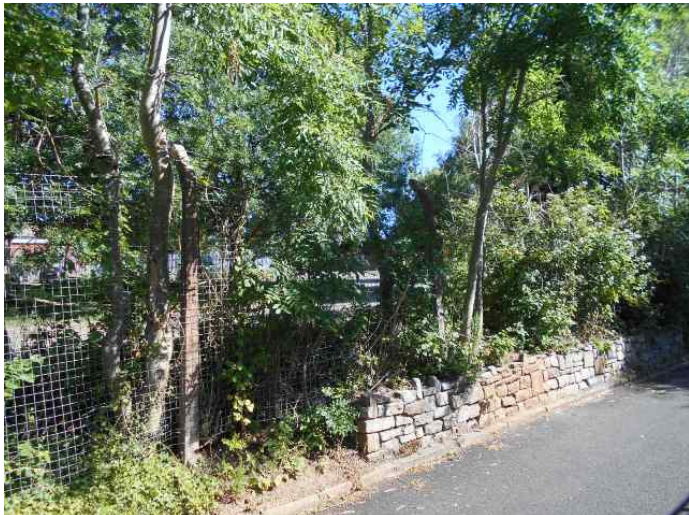
Gp 5	Sycamore Ash x 18	8 (av)	250	1.0	Y	2.0	2.0	2.0	2.0	POOR	<ul style="list-style-type: none"> <li>Single line of closely spaced self-sown saplings along boundary fence</li> <li>Most Ash dead from Ash Dieback – and other Ash have ADB symptoms</li> <li>Some saplings growing through and around fence</li> <li>Located on top of low retaining wall</li> <li>No long term viable future</li> </ul>	<b>Remove dead trees</b>  Would all have to be removed if fence were to be replaced	<5	U	3.0
9	Hazel	6	200	0.5	Mi	2.0	2.0	3.0	3.0	FAIR / POOR	<ul style="list-style-type: none"> <li>Multi-stemmed x 5</li> <li>Growing through and around boundary fence</li> <li>Base of tree on edge of kerb to South</li> <li>Has been cut back from road to South</li> <li>No other visible external defects</li> </ul>	Would have to be removed if fence were to be replaced	10	C1	2.4

Gp 5 – View of group growing on top of low wall and through and around fence

- 4.6 Groups 5 and 6 consist mostly of self-sown Ash saplings growing around and through the South boundary fence. Most of the Ash are infected with, or have died from, Ash Dieback. It will not be possible to retain these trees if the boundary fence is to be replaced, and they should not be considered a material constraint to development.

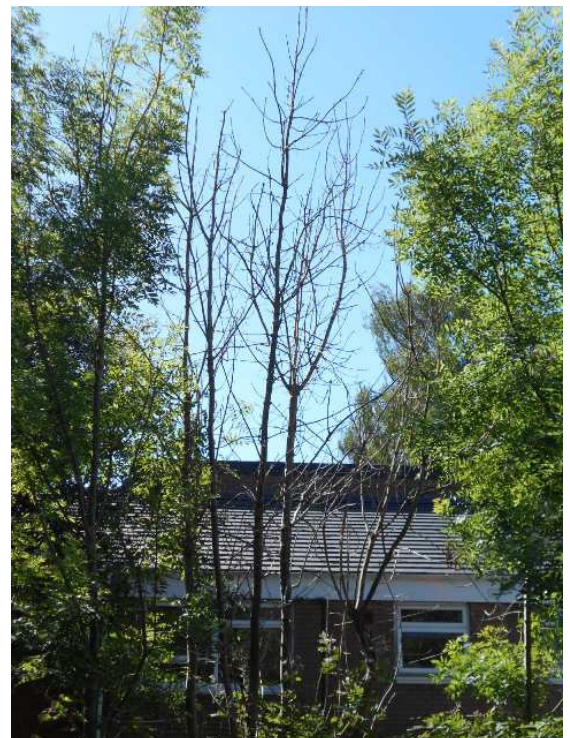
Gp 5 – View of dead Ash in group killed by Ash Dieback

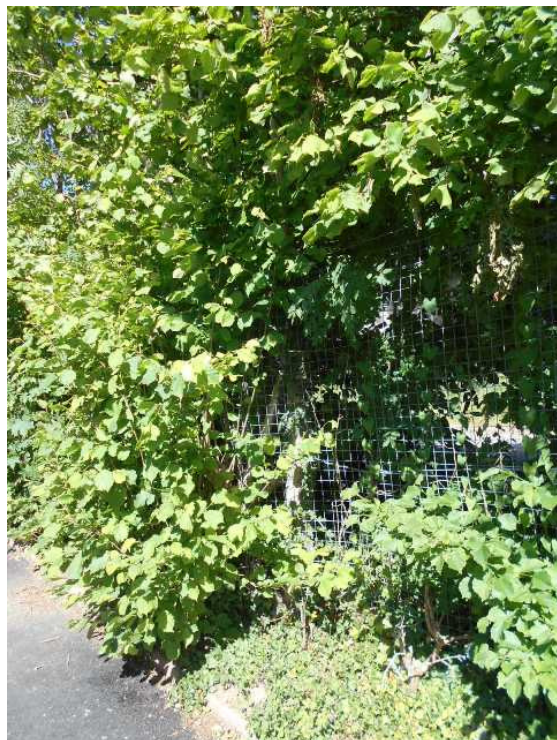
T9 – View of proximity to road and stems growing through boundary fence

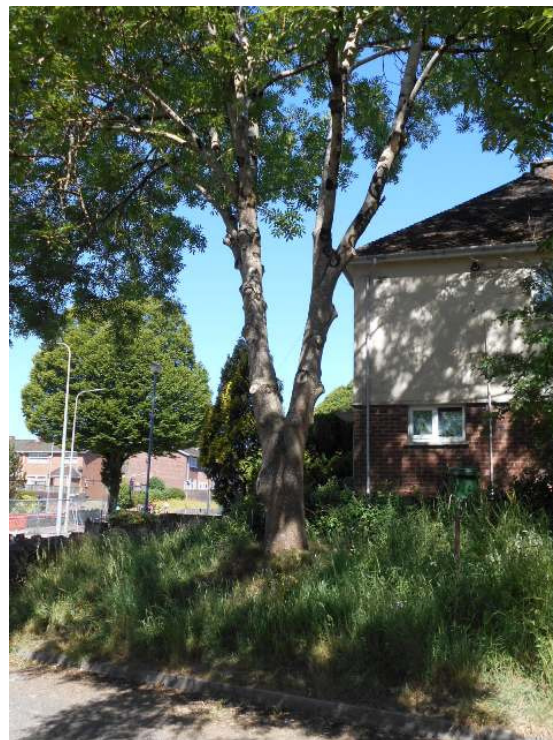
T11 – View of crown lifting clearance around adjacent house

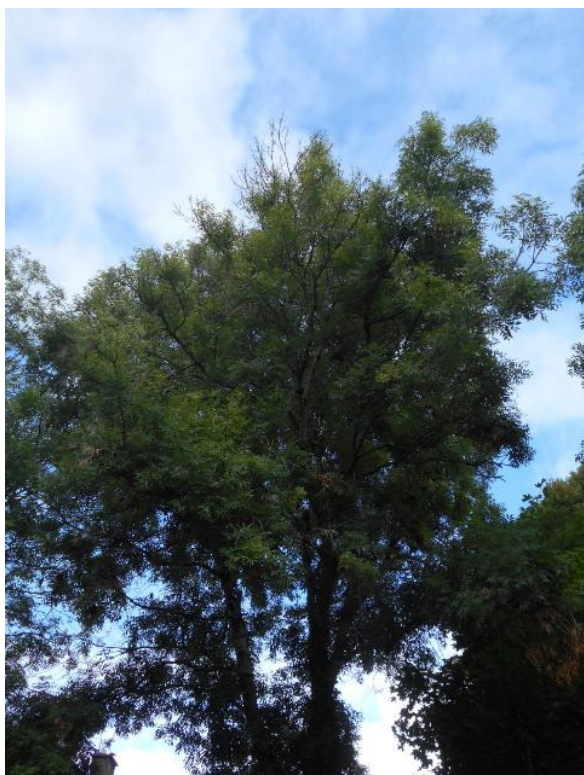
12	Ash	18	470	6.0	M	5.0	6.0	4.0	4.0	GOOD	<ul style="list-style-type: none"> <li>Widespread Ash Dieback symptoms to ends of twigs in mid outer crown</li> <li>Co-dominant from fork at 2m</li> <li>North stem forks again at 4m</li> <li>Slightly suppressed West by T11</li> <li>No other visible external defects</li> </ul>	No works required	<10	<b>C1</b>	5.6
13	Ash	12	350	1.5	Mi	4.0	6.0	4.0	4.0	GOOD	<ul style="list-style-type: none"> <li>No Ash Dieback symptoms</li> <li>Large surface roots visible on all sides beneath canopy spread</li> <li>3 co-dominant stems from branch / trunk union at 2m</li> <li>No other visible external defects</li> </ul>	No works required	20	<b>B1</b>	4.2

T12 – View of Ash Dieback to upper outer edges of crown

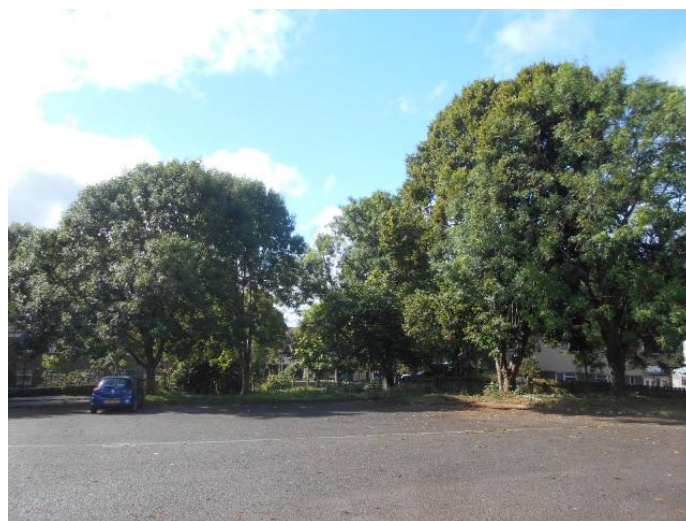
T12 – T17 – view of other Ash trees with no Ash Dieback

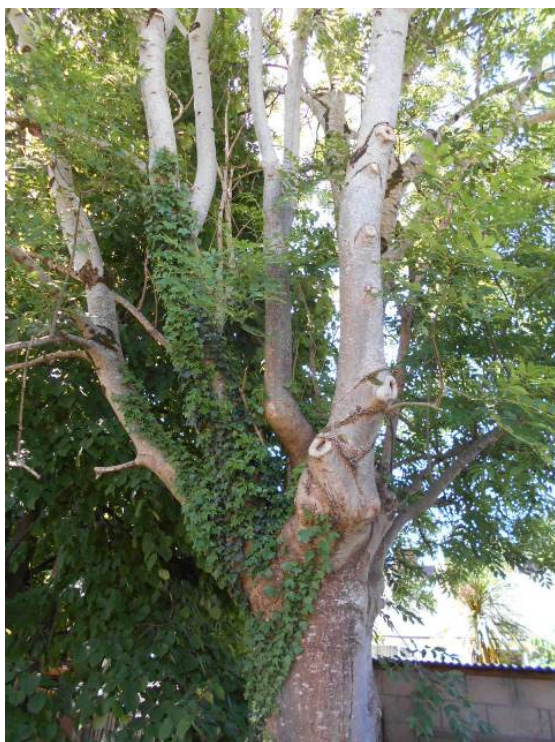
20	Ash	20	680	E-2 N-6	M	4.0	4.0	8.0	8.0	GOOD	<ul style="list-style-type: none"> <li>5 large upright co-dominant stems from old pollard point at 3m</li> <li>North edge of crown pruned back from adjacent electricity sub-station site</li> <li>Suppressed to South by T19</li> <li>No other visible external defects</li> </ul>	No works required	20	B1	8.2
21	Scots Pine	10	530	1.5	Mi	5.0	7.0	5.0	5.0	GOOD	<ul style="list-style-type: none"> <li>Broad flat topped crown with low hanging edges</li> <li>No other visible external defects</li> </ul>	No works required	40	B1	6.4
22	Scots Pine	12	500	3.0	Mi	5.0	4.0	3.0	3.0	GOOD	<ul style="list-style-type: none"> <li>Slightly suppressed S and E by T23</li> <li>Large dead wood stub 1.2m long upper trunk West</li> <li>No other visible external defects</li> </ul>	No works required	40	B1	6.0
23	Scots Pine	10	440	3.0	Mi	7.0	4.0	5.0	2.0	GOOD	<ul style="list-style-type: none"> <li>Suppressed to W and S by T22</li> <li>Crown out to North and North East</li> <li>No other visible external defects</li> </ul>	No works required	40	B1	5.3

T20 – View of upright stems from old pollard point

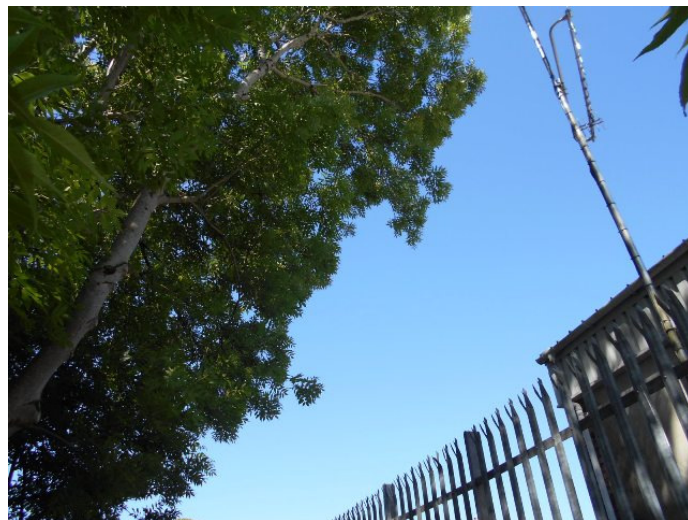
T20 – View of North side of crown pruned back from adjacent electricity sub station

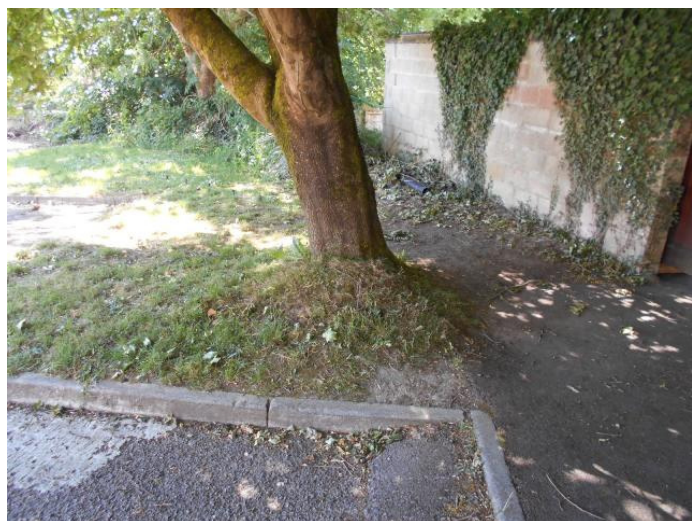
T18 – View of proximity of kerb and tarmac area to base

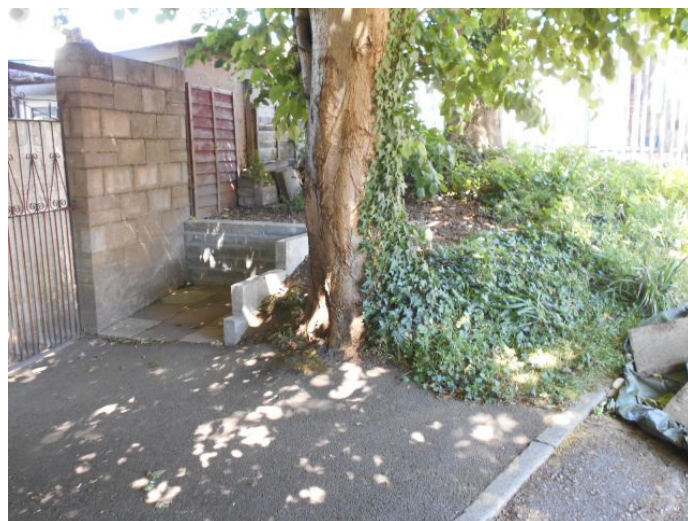
T19 – View of tarmac drive, parking area and retaining walls to base of tree

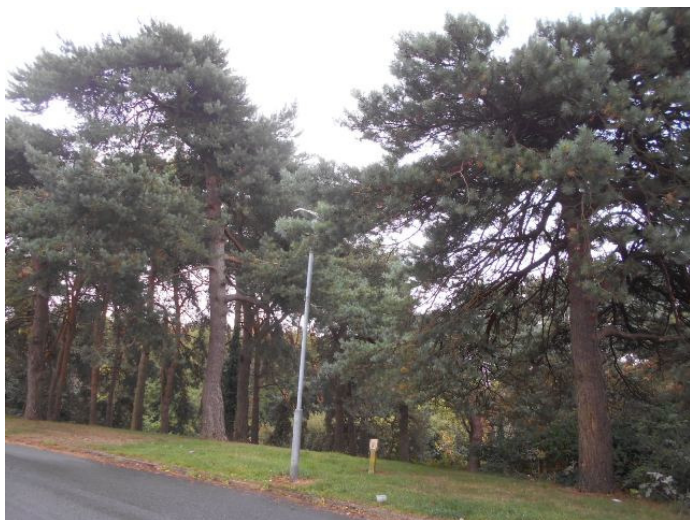
T21 – T38 – View of closely spaced trees in P. O. S

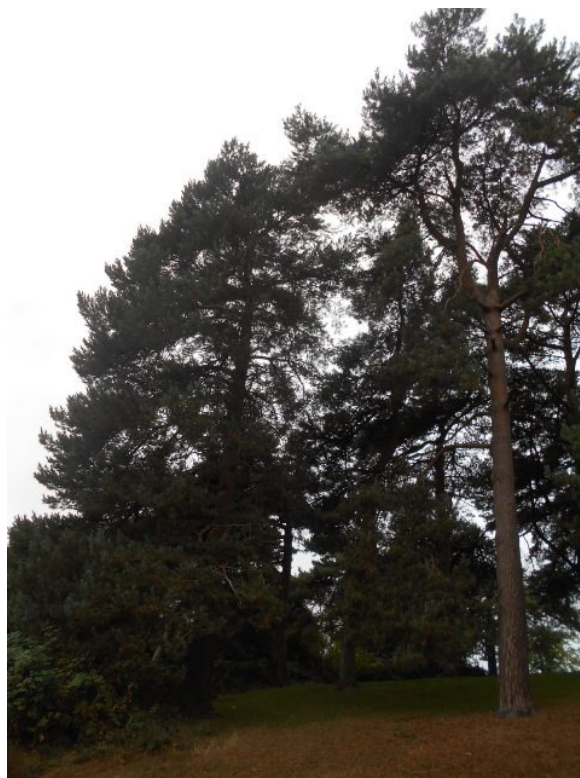
T35 – T38 – view of taller trees at lower end of P. O. S

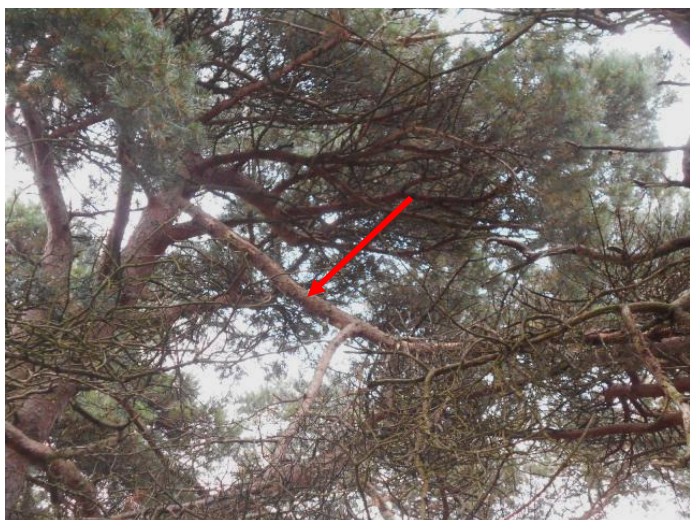
T25 – View of broken hung up branch mid crown

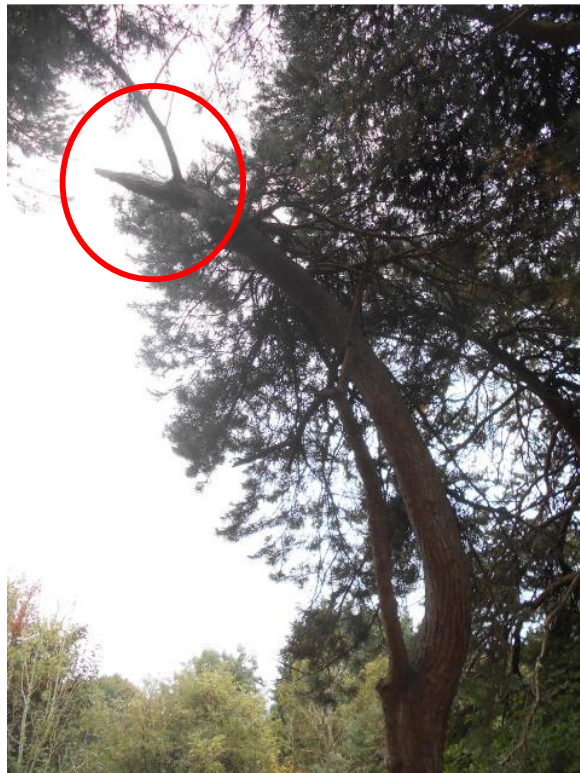
T32 – view of old wound from previous storm damage

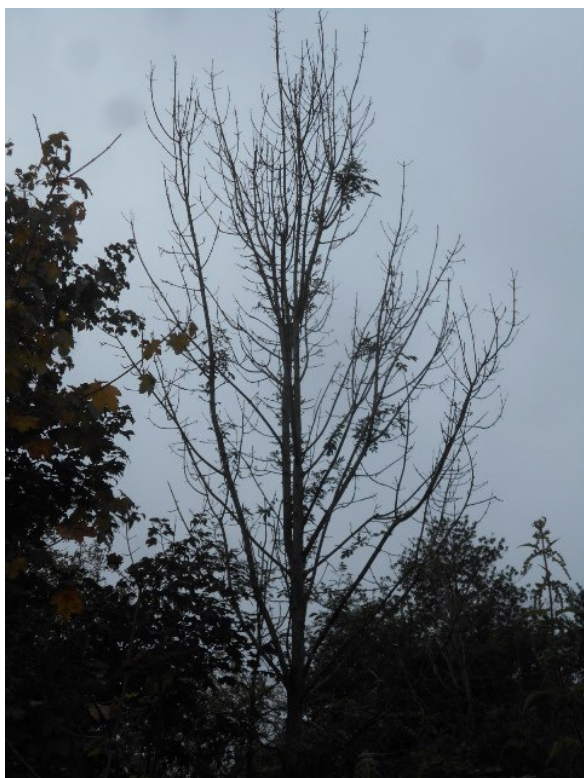
39	Ash	6	156	2.0	Y	1.0	1.0	1.0	1.0	POOR	<ul style="list-style-type: none"> <li>95% dead from severe Ash Dieback</li> <li>Twin stemmed from base</li> <li>No other visible external defects</li> </ul>	FELL	0	U	1.9

T39 – View of most of crown dead from Ash Dieback

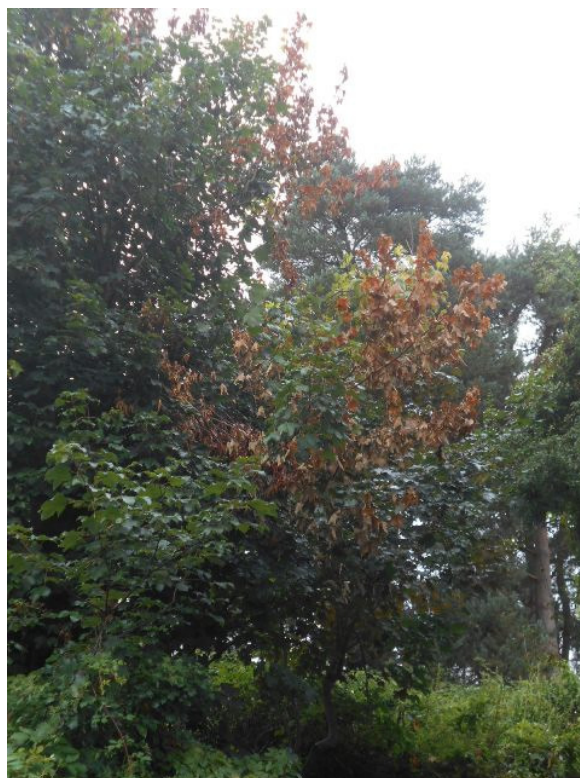
T41 – view of isolated dead branches within crown from squirrel damage

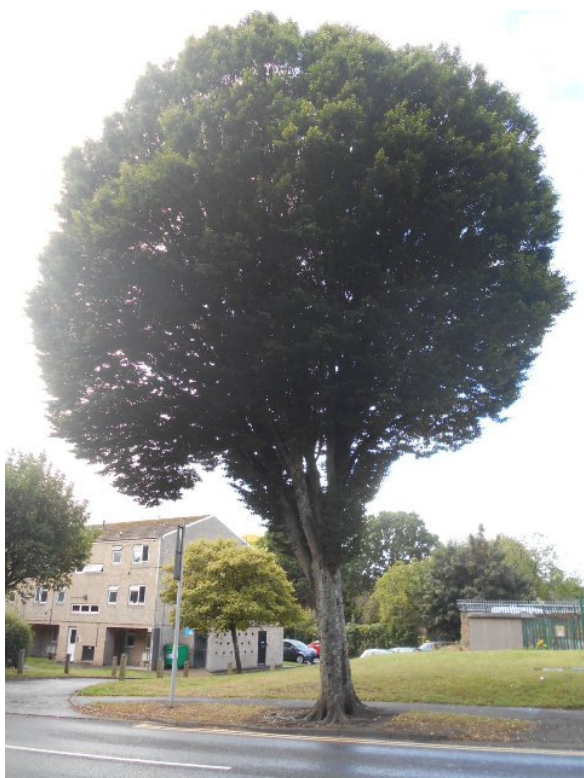
T44 – View of street tree opposite entrance to site

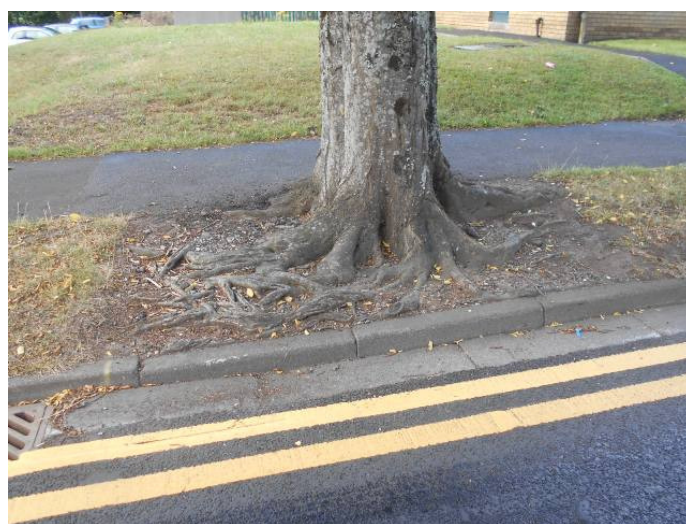
T44 – view of large surface roots within verge area

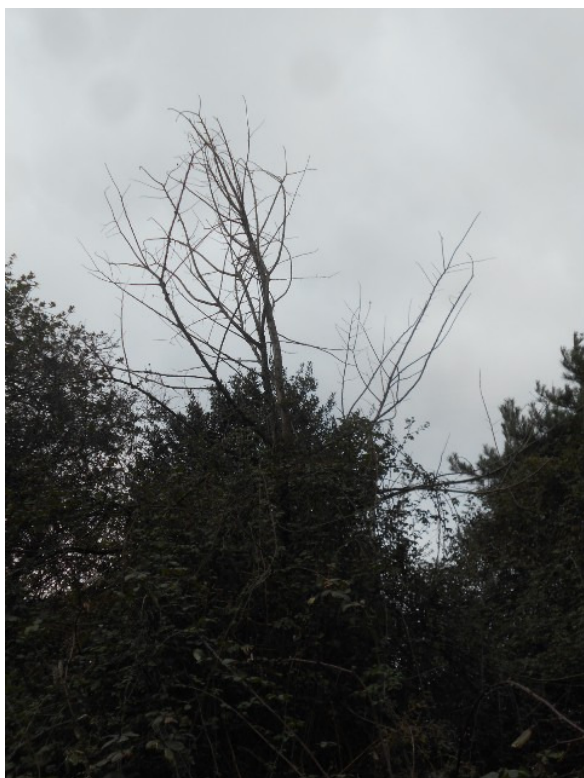
T45 – View of dead Elm covered in brambles

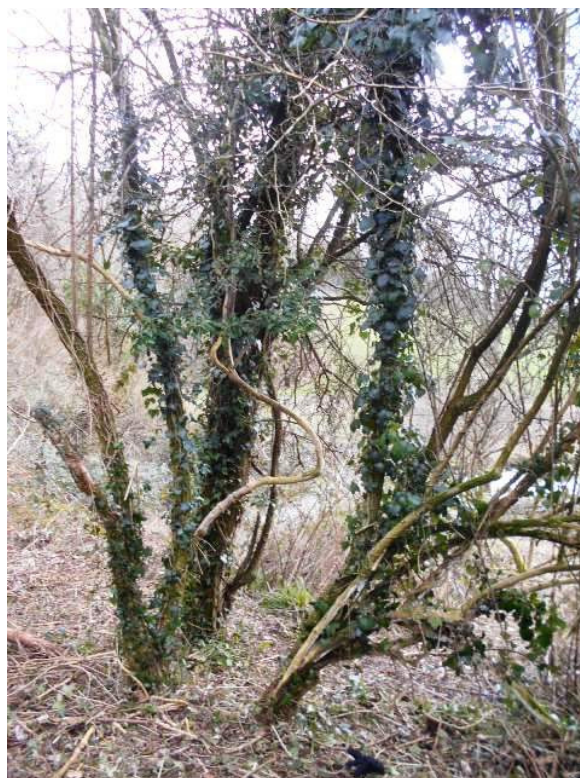
46	Hawthorn, Elderberry x 2	5	100	0.5	M	2.0	3.0	3.0	2.0	FAIR	<ul style="list-style-type: none"> <li>Triangular group closely spaced</li> <li>Ivy growth to mid crowns</li> <li>No other visible external defects</li> </ul>	No works required	10	C2	1.2

T46 – View of closely spaced triangular group

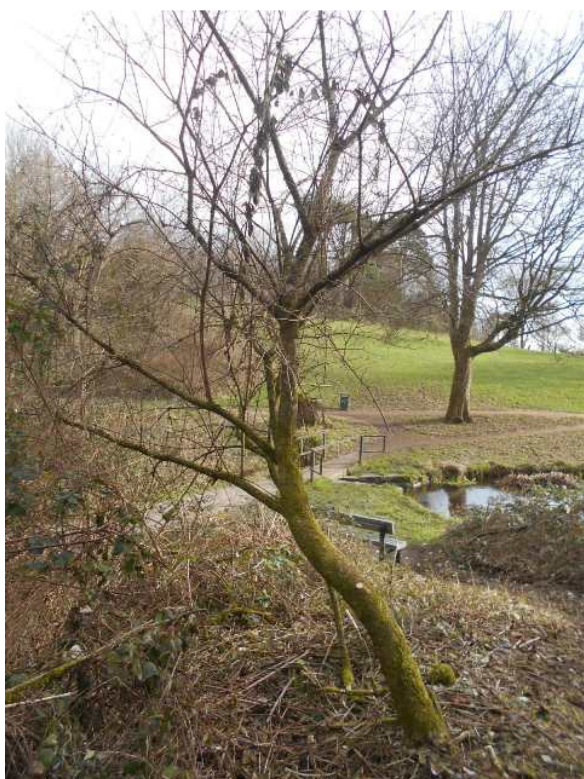
T47 – View of leaning small stunted Maple species

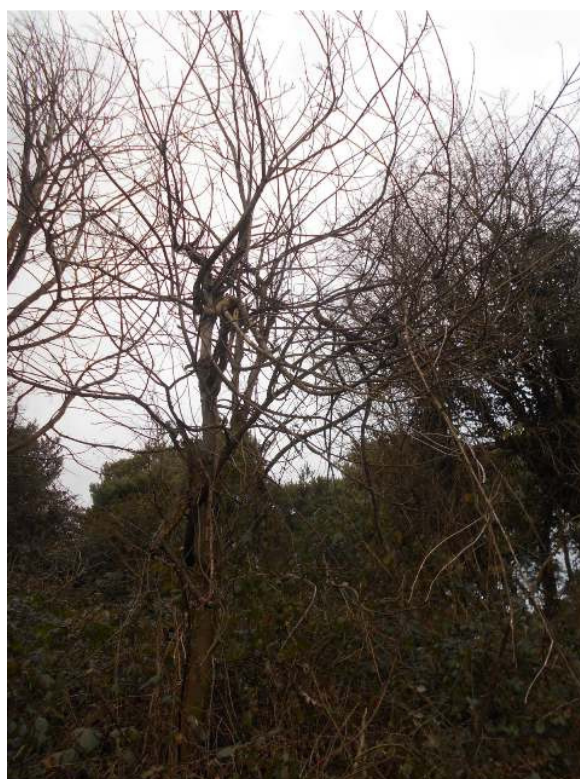
T48 – View of mis-shapen crown due to squirrel damage

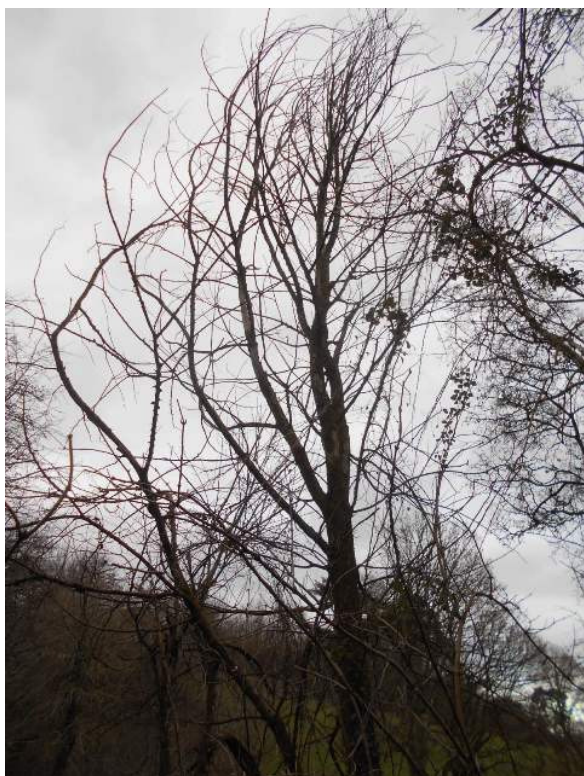
T49 – View of dead Elm

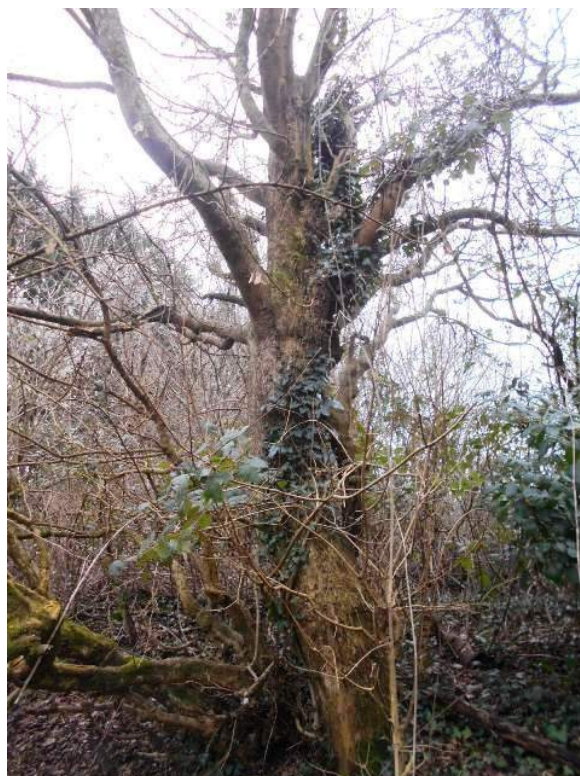
T50 – View of low branch / trunk union

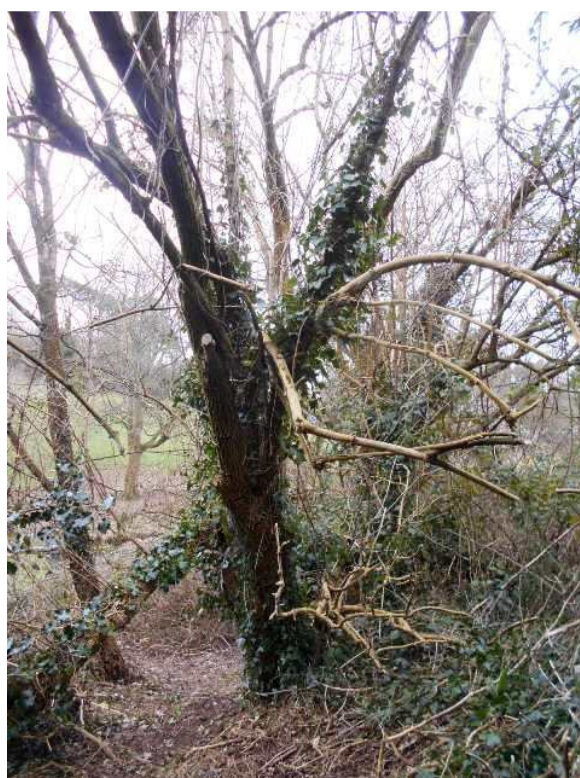
T52 – View of leaning trunk

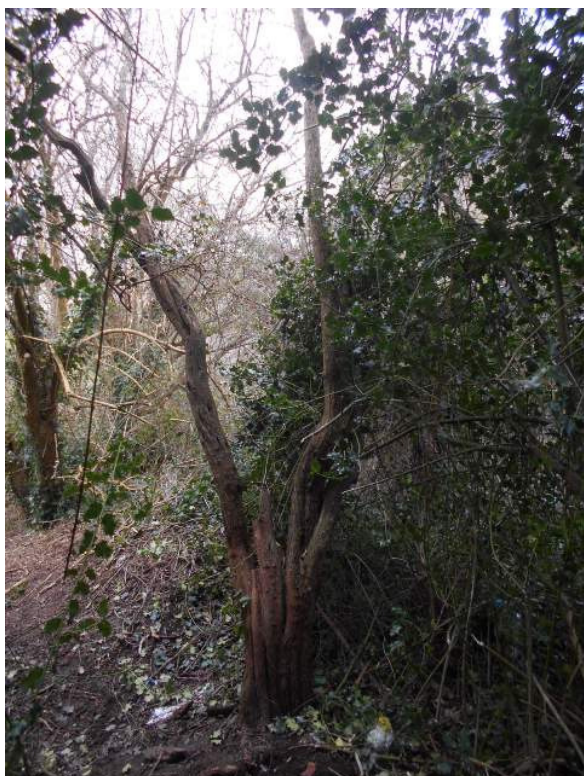
T53 – View of partially collapsed dead Hawthorn

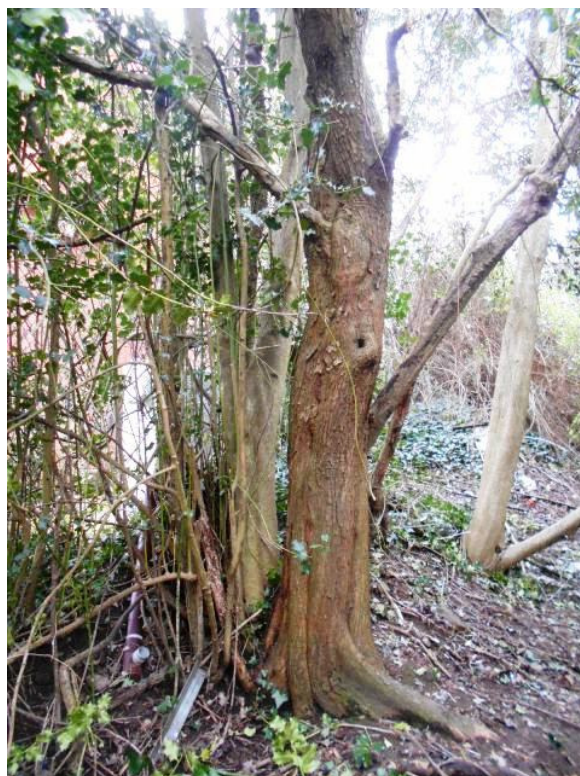
T54 & T55 – View of close proximity of stems

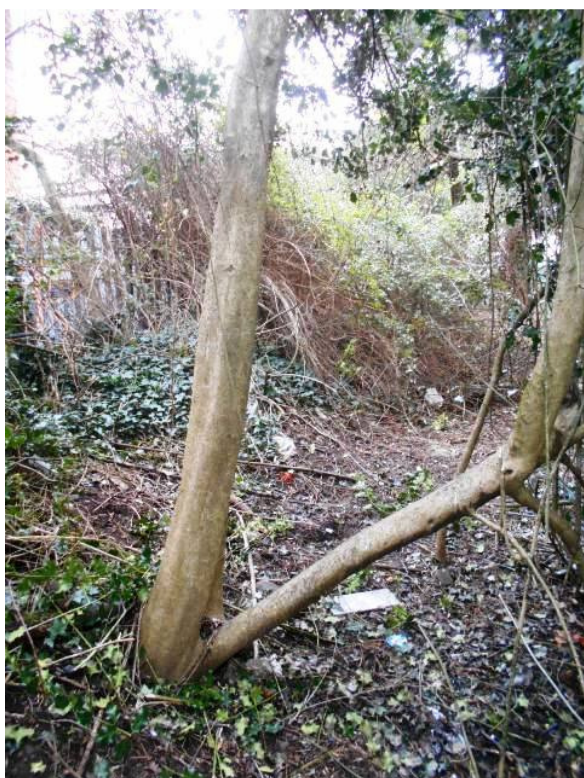
T56 – View of smaller leaning stem

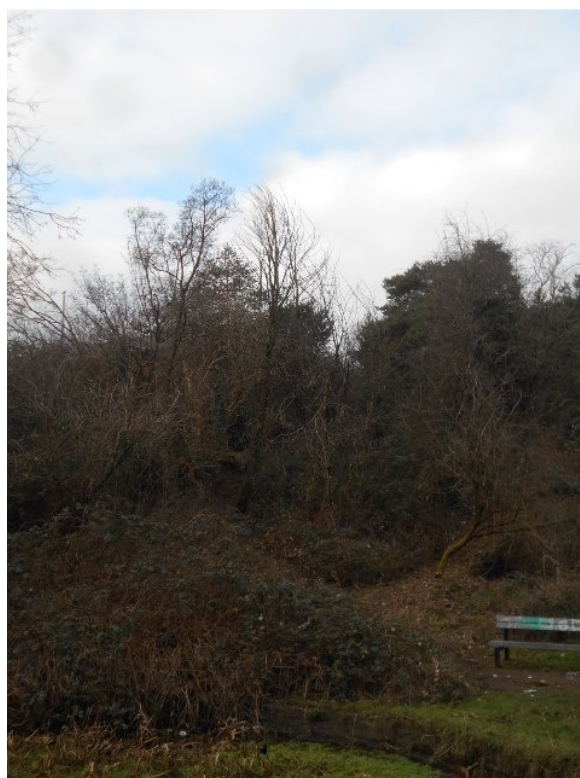
View of trees 45 – 56 among bramble covered overgrown area to North of pond and East of buildings
