## Home Inspection Report

101 Wallace Ct  
Portland, TN 37148

Inspected On Fri, May 24, 2024 at 10:00 AM

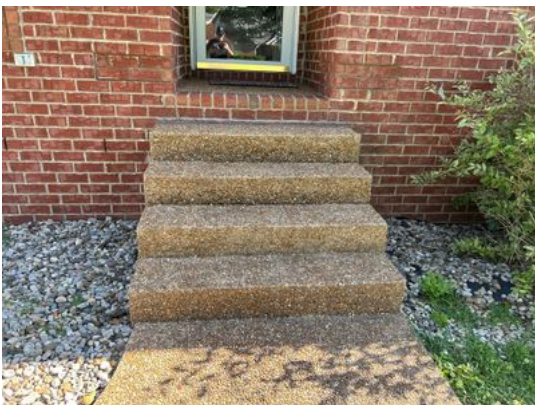
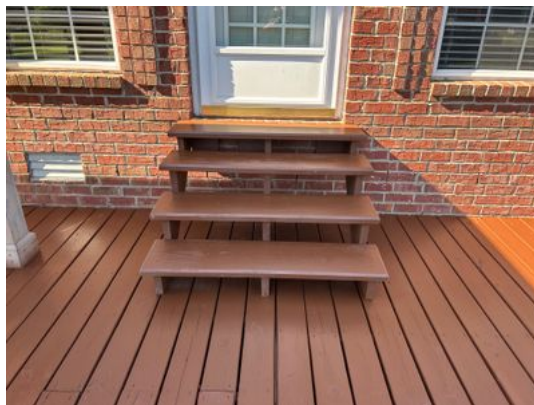
Concrete, Wood, Front is concrete, rear are wooden.

Condition: Recommend handrail at front and rear steps.

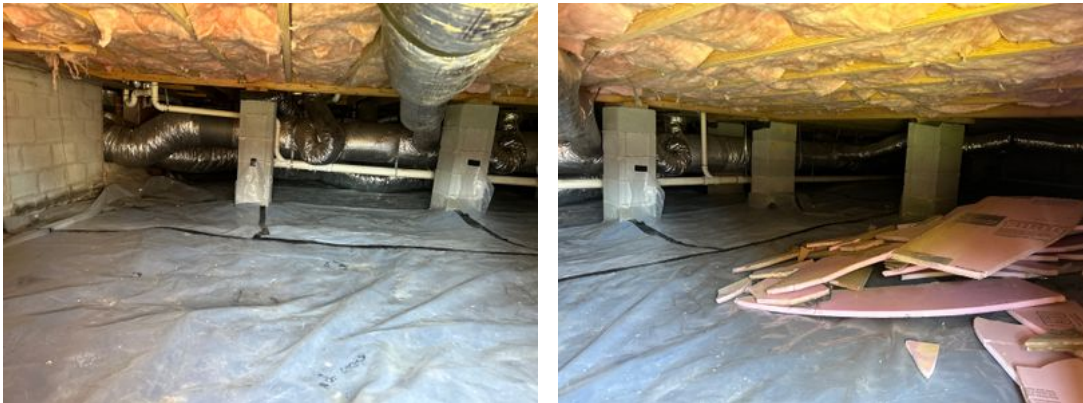
Debris should be removed from crawlspace.

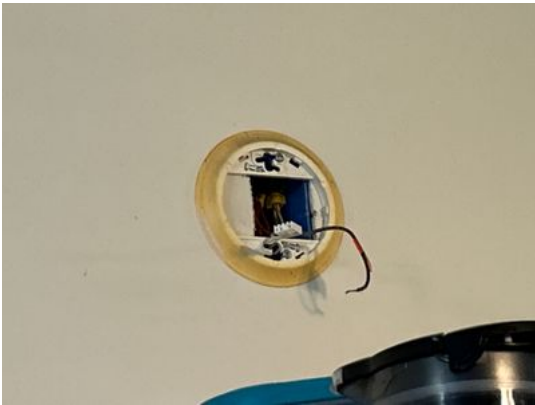
Condition: 1 missing in the garage.

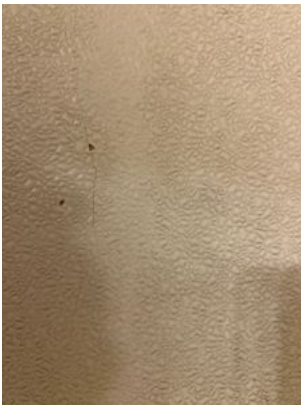
Condition: Repair or Replace

Fiberglass bathtub has a small hairline crack in the bottom of it. Recommend repair or replacement.
