## Bayview Condominium Association *Millbrae, CA*

Report #: 14259-17  
Beginning: January 1, 2025  
Expires: December 31, 2025

# RESERVE STUDY Update "With-Site-Visit"

November 26, 2024

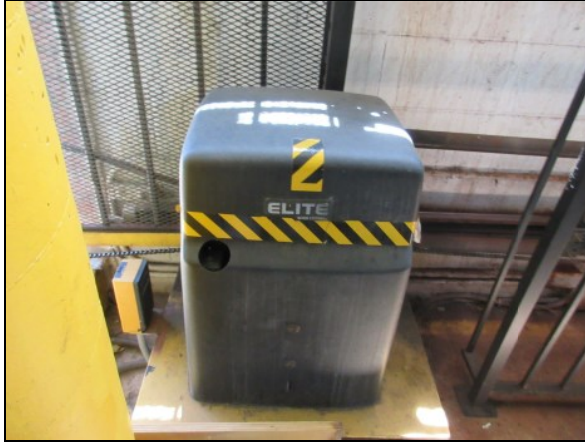
Comments: This is the Frontera Way Elite gate operator with serial #11309856885. Gate operator continues to function, but due to its age, anticipate the need for replacement in the near future.

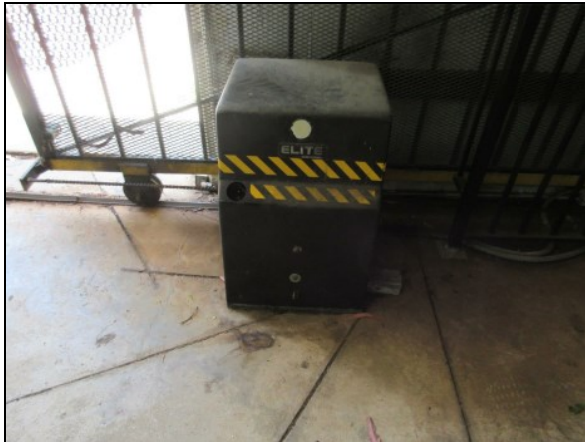
Comments: This is the Vallejo Drive Elite gate operator with model #SL3000UL. Gate operator continues to function but due to its age, anticipate the need for replacement in the near future.
