Pathway and Retaining Wall NW Edge of Lake

Paradise Cove HOA

Retained geotechnical engineering consultant to evaluate subsurface conditions and offer recommendations

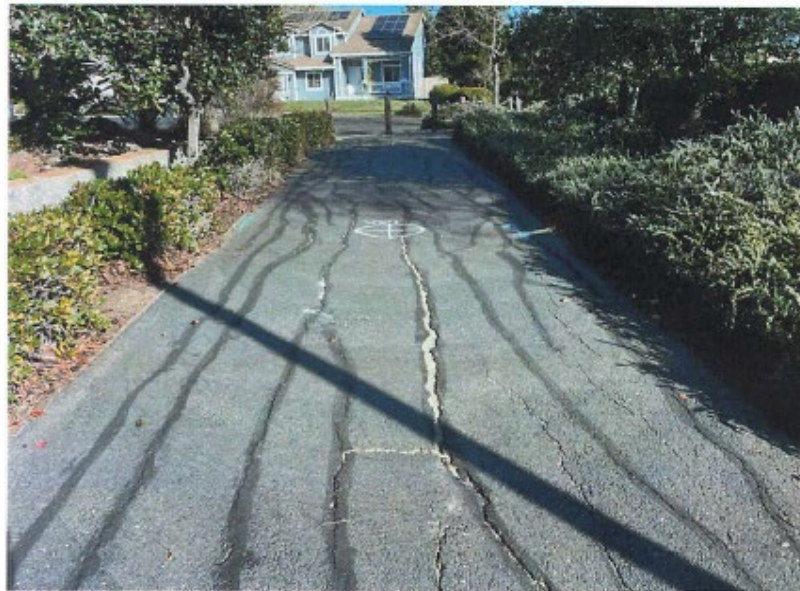
- Distressed pathway and retaining wall result from soil movements related to very highly to critically expansive subsurface clay and claystone, along with long-term lateral spreading and down slope soil creep forces of the adjacent pond embankment.
- Settlement of the sanitary sewer trench backfill also has contributed to distress of the pathway and leaning retaining wall.

- Walkway has an insufficient pavement section and no underlying reinforcement to withstand seasonal shrinking swelling of the very highly expansive materials and lateral soil creep of the adjacent pond embankment.
- Retaining wall constructed without geogrid reinforcement to resist lateral earth pressures.

- Removed and replace walkway with a new asphalt concrete and aggregate base section with underlying geogrid reinforcement.

- Repair/restrain retaining wall by reconstruction with the same block materials, adding geogrid reinforcement between the keystone blocks — will require removal of the wood fence and excavation into the adjacent residential yard areas.

- New reinforced concrete or masonry block wall supported on a drilled pier foundation system in place of the existing wall.

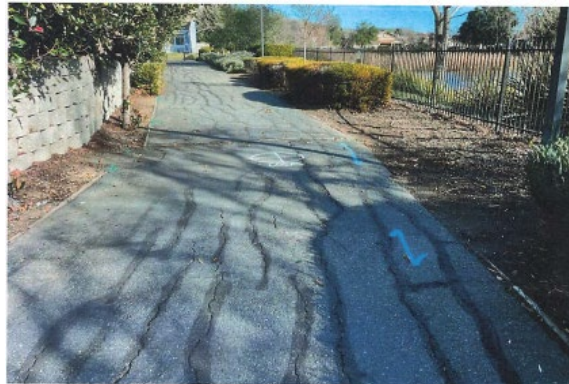
- Cracks in pathway filled in with asphalt/tar
- Retaining wall leaning observed near sewer cover, retaining wall rebuilt in that area

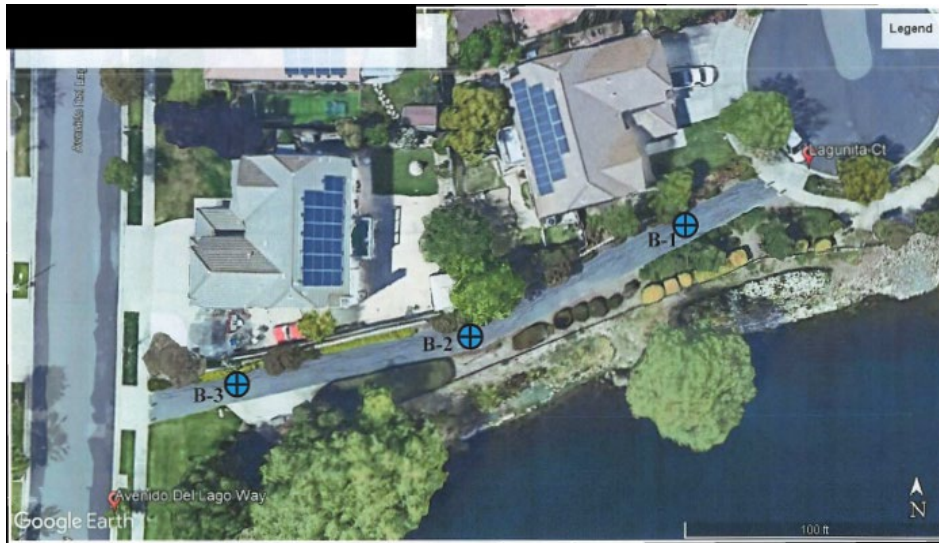
3 boreholes were drilled

- 2 inches of asphalt
- 4 inches of sandy gravel (dirty base rock)
- Stiff, very highly to critically expansive clay, down to 4 feet below the surface
- completely weathered and friable to weak claystone bedrock to the maximum depth explored of 19 feet below the surface

- 2 inches of asphalt
- 4 inches of sandy gravel (dirty base rock)
- stiff highly expansive sandy clay fill and stiff native sandy clay down to 4 feet
- highly to completely weathered and friable to moderately strong claystone bedrock down to the maximum depth explored of 21.5 feet below the surface

- 2 inches of asphalt
- 4 inches of sandy gravel (dirty base rock)
- very highly to critically expansive very stiff native clay with claystone chunks down to 3 feet
- completely to highly weathered and friable to moderately strong claystone bedrock down to the maximum depth explored of 14.5 feet below the surface
