RE: Hazardous Materials Survey Report
Pre-Demolition
Asbestos
Former Fashion Tannery
108 Van Road
Johnstown, NY
Ambient Project Number: 230928AB

HAZARDOUS MATERIALS SURVEY

Pre-Demolition

*Former Fashion Tannery
108 Van Road
Johnstown, NY*

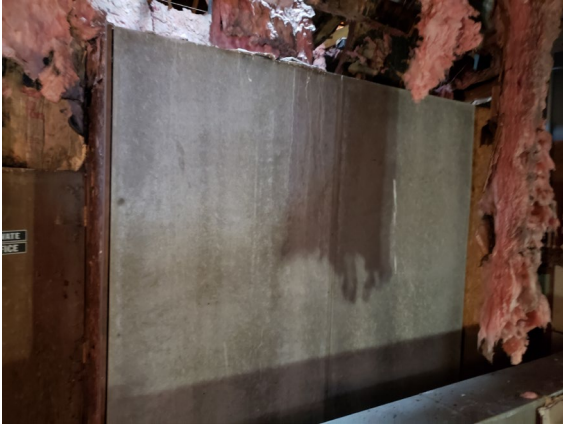
Photograph 1 – 006-01 Transite Panels

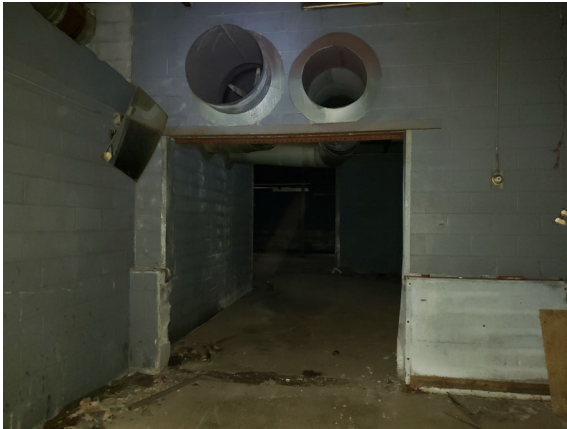
Photograph 2 – 009-01 Wall Construction Adhesive

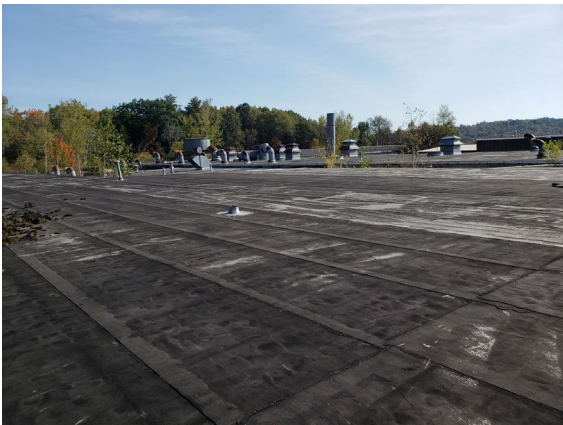
Photograph 3 – 014-01 Roofing Silver Coat - Assumed

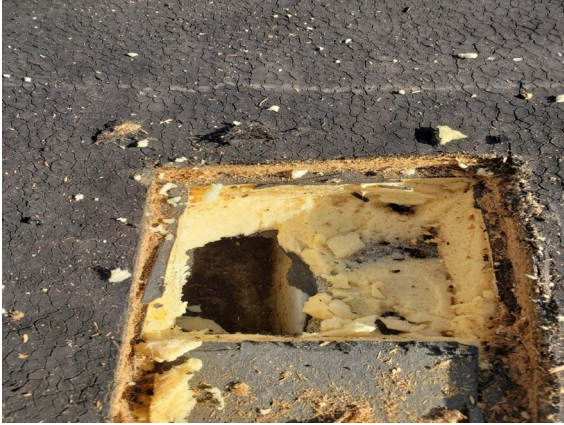
- Refer to Section 1.0 Purpose and Scope of Services of this report to see clarification of survey locations that were in our scope of work.
- Structure A roof is assumed to be ACM. The roof was unable to be sampled due to the roof being unsafe to access and damage throughout the roof.

Photograph 4 – 015-01, 016-01, 017-01 & 018-01 Built Up Roofing, Built Up Roofing, Roofing Insulation & Roofing Vapor Barrier –Assumed

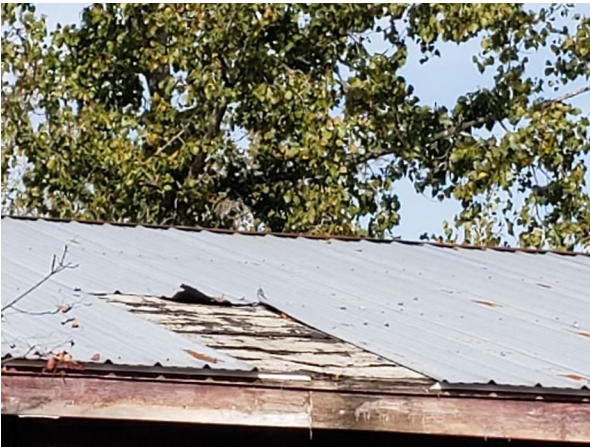
- There is a transite disturbance in bldg. A. ACM built up roofing and ACM roof shingles are disturbed through bldgs. A&B. This disturbance will require a contamination assessment and the potential development and submission of a NYS DOL Site Specific Variance to allow for the clean-up and abatement of this material by a NYS licensed and certified asbestos abatement contractor. This area should be cordoned off and not occupied by any uncertified asbestos personnel until the proper cleanup has been completed.

Photograph 6 – 025-01 Roofing Shingles

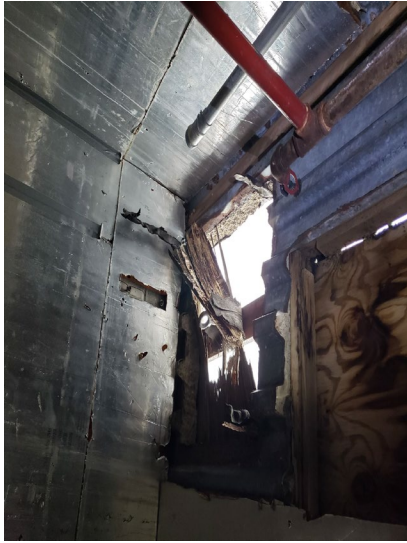
Photograph 7 – 027-01 Built Up Roofing

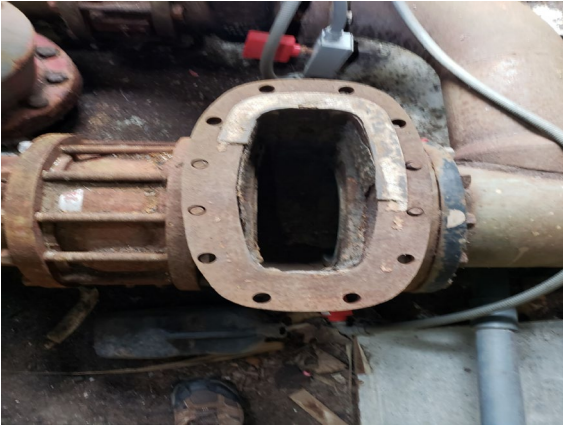
Photograph 8- 028-01 Flange Gasket

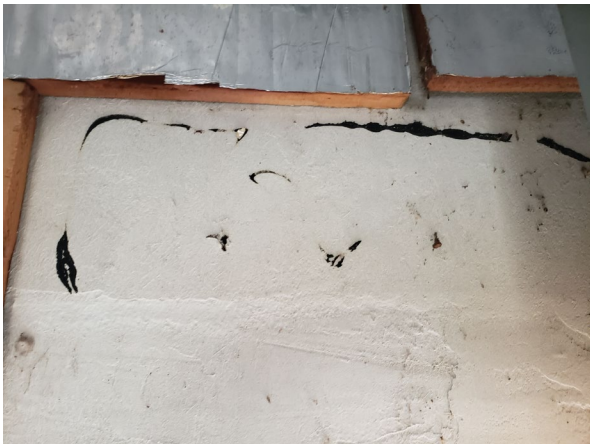
Photograph 9 – 029-01 Foam Insulation Adhesive
