**RE: PRE-DEMOLITION ASBESTOS SURVEY FOR THE FORMER NEWPORT SCHOOL:
7456 EAST STREET, NEWPORT, NEW YORK (HRP PROJECT #HER1506.BA)**

**Asbestos Sample
Location Map**

7456-7458 East Street
Newport, New York

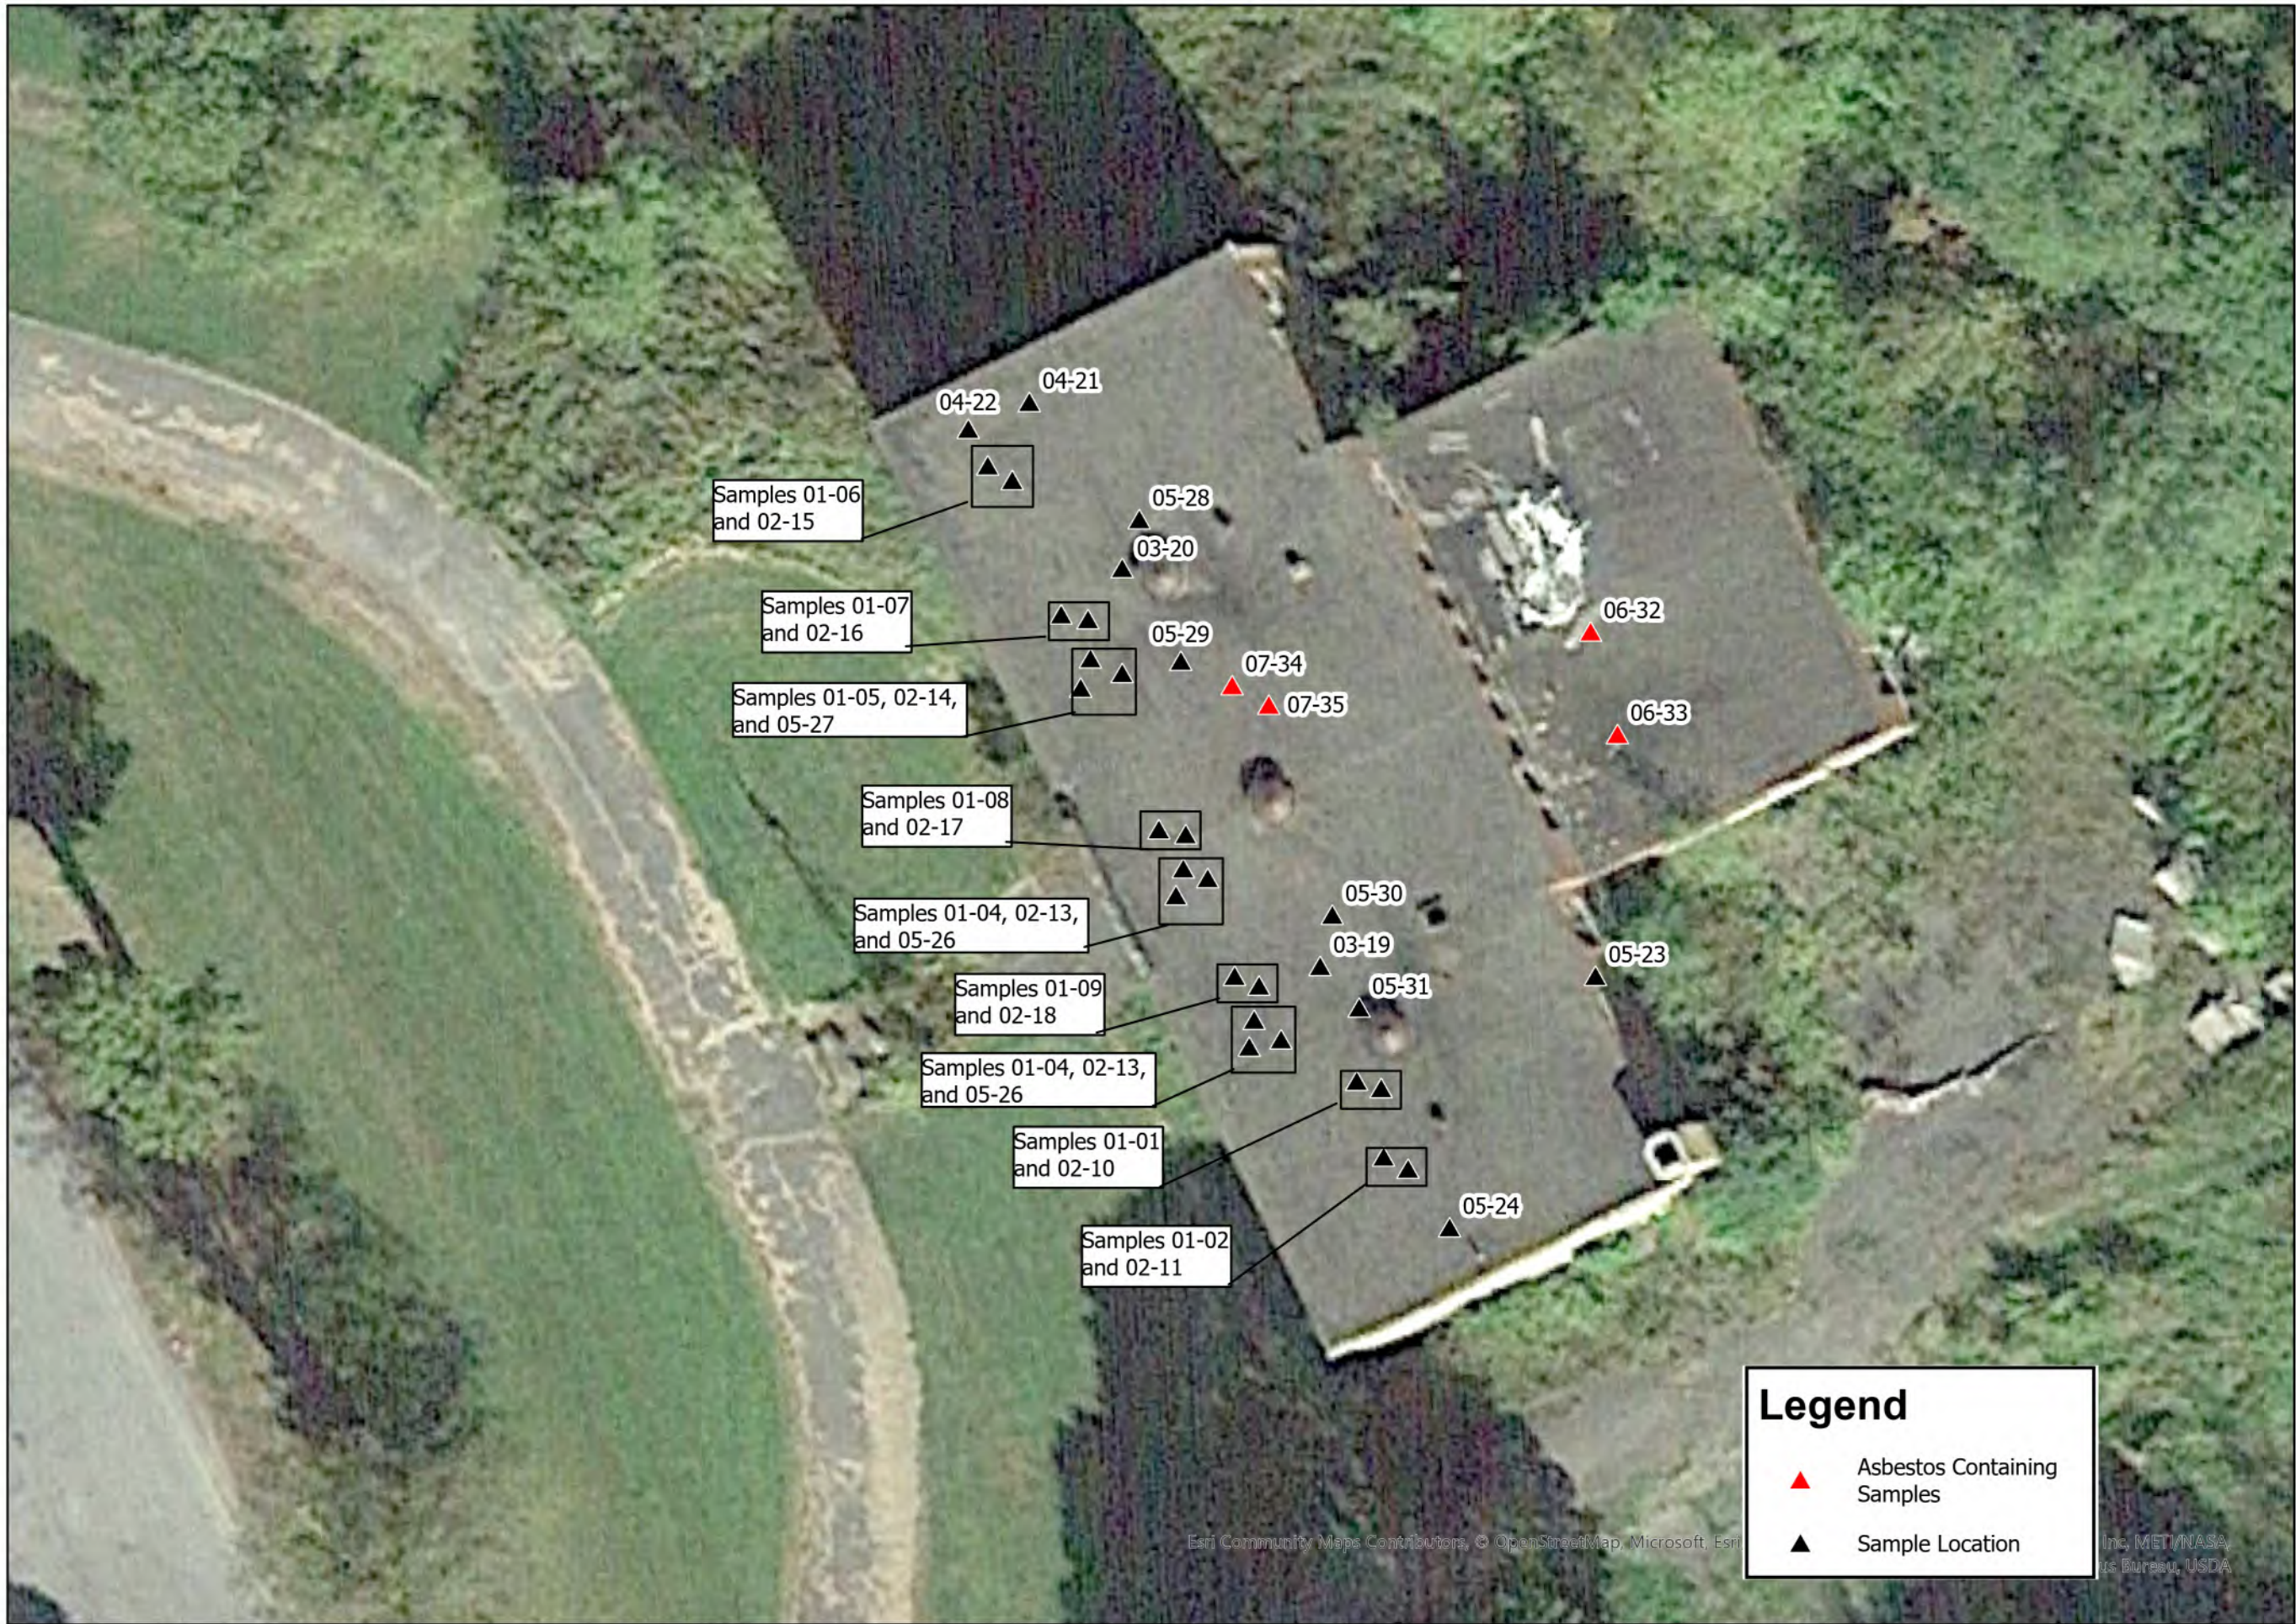
Figure No.
1

- Black built up roof above auditorium (third floor) – 3.9% Chrysotile (Sample #06-32, #06-33)
- White pipe insulation (second floor) – 28.6% Chrysotile (Sample #07-34 through #07-36). Based on the lack of access in the building, pipe insulation throughout the building should be presumed to be an ACM, or further assessed by an asbestos building inspector following the removal of debris from the building.
