RE: REPORT OF ASBESTOS SURVEY, FORMER REMINGTON ARMS, 14 HOEFLER AVENUE, ILION, NEW YORK (HRP PROJECT TUR3500.BA)

Project Dates: December 13, 2024 – January 17, 2025

Former Remington Arms
14 Hoefler Ave
Ilion NY 13357

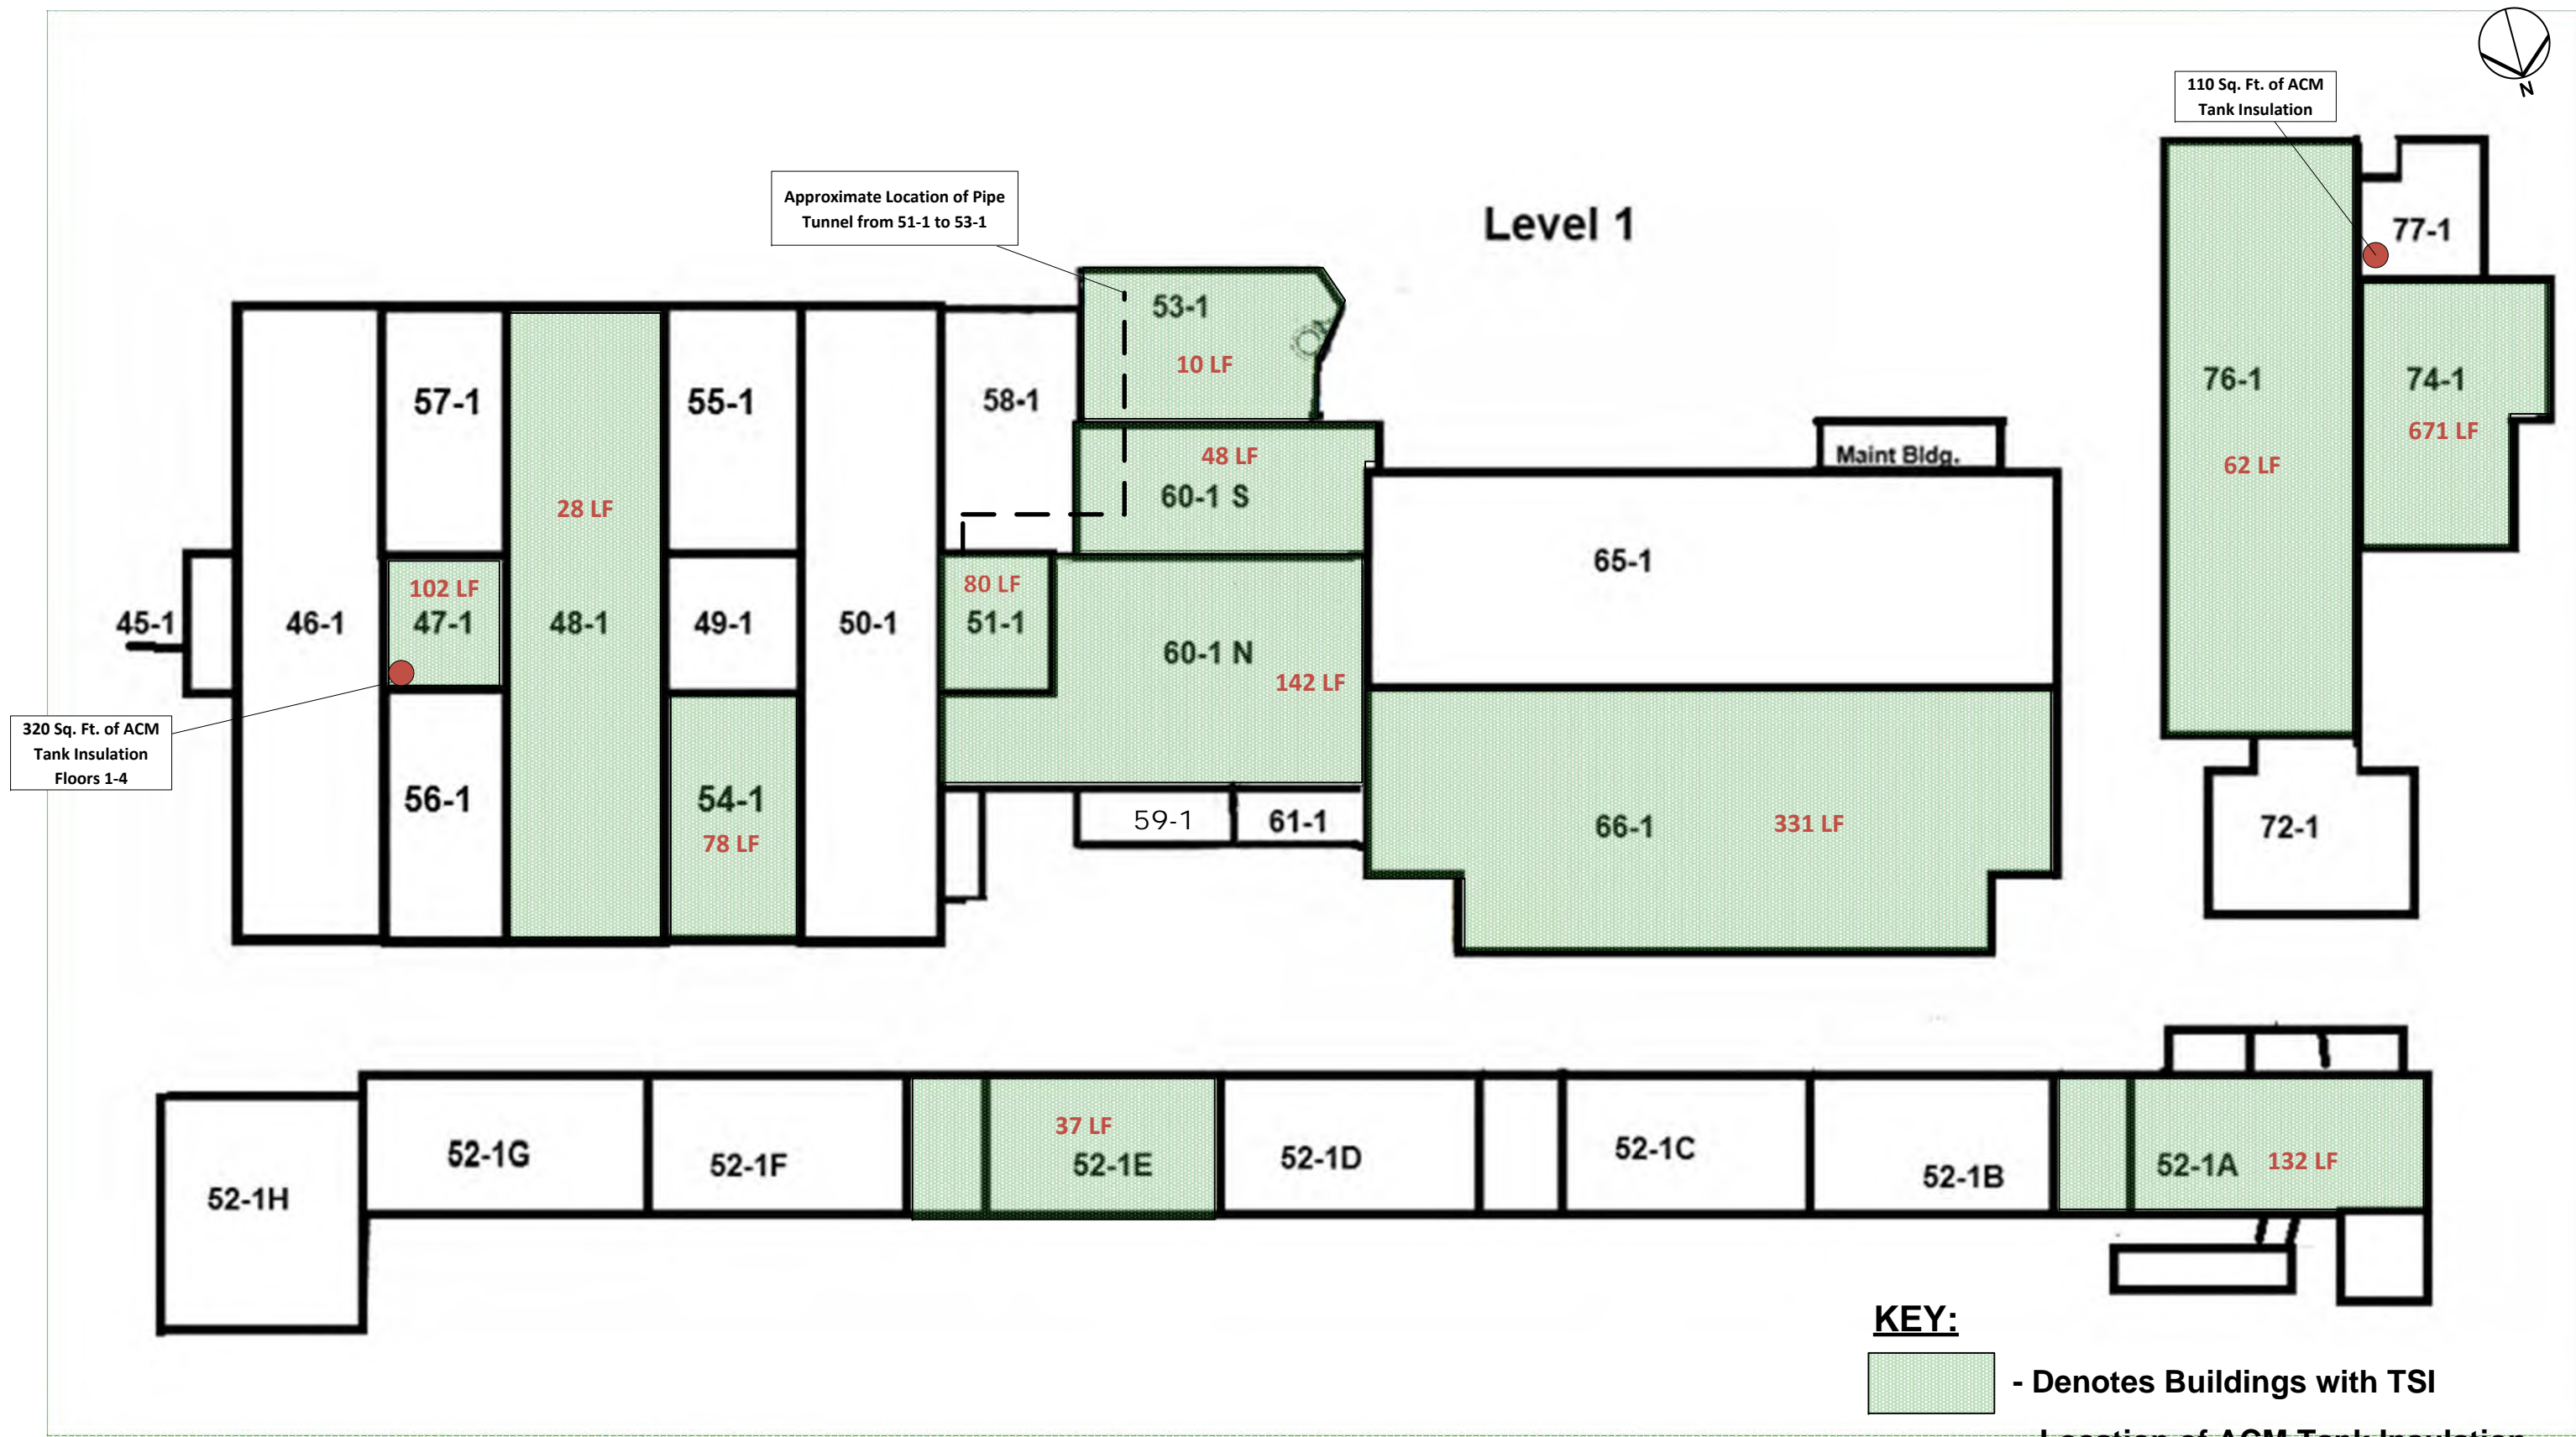
Level 1

- Denotes Buildings with TSI
- Location of ACM Tank Insulation (Refer to Summary of ACM Table 2.0)
- Approx. Location of Pipe Tunnel

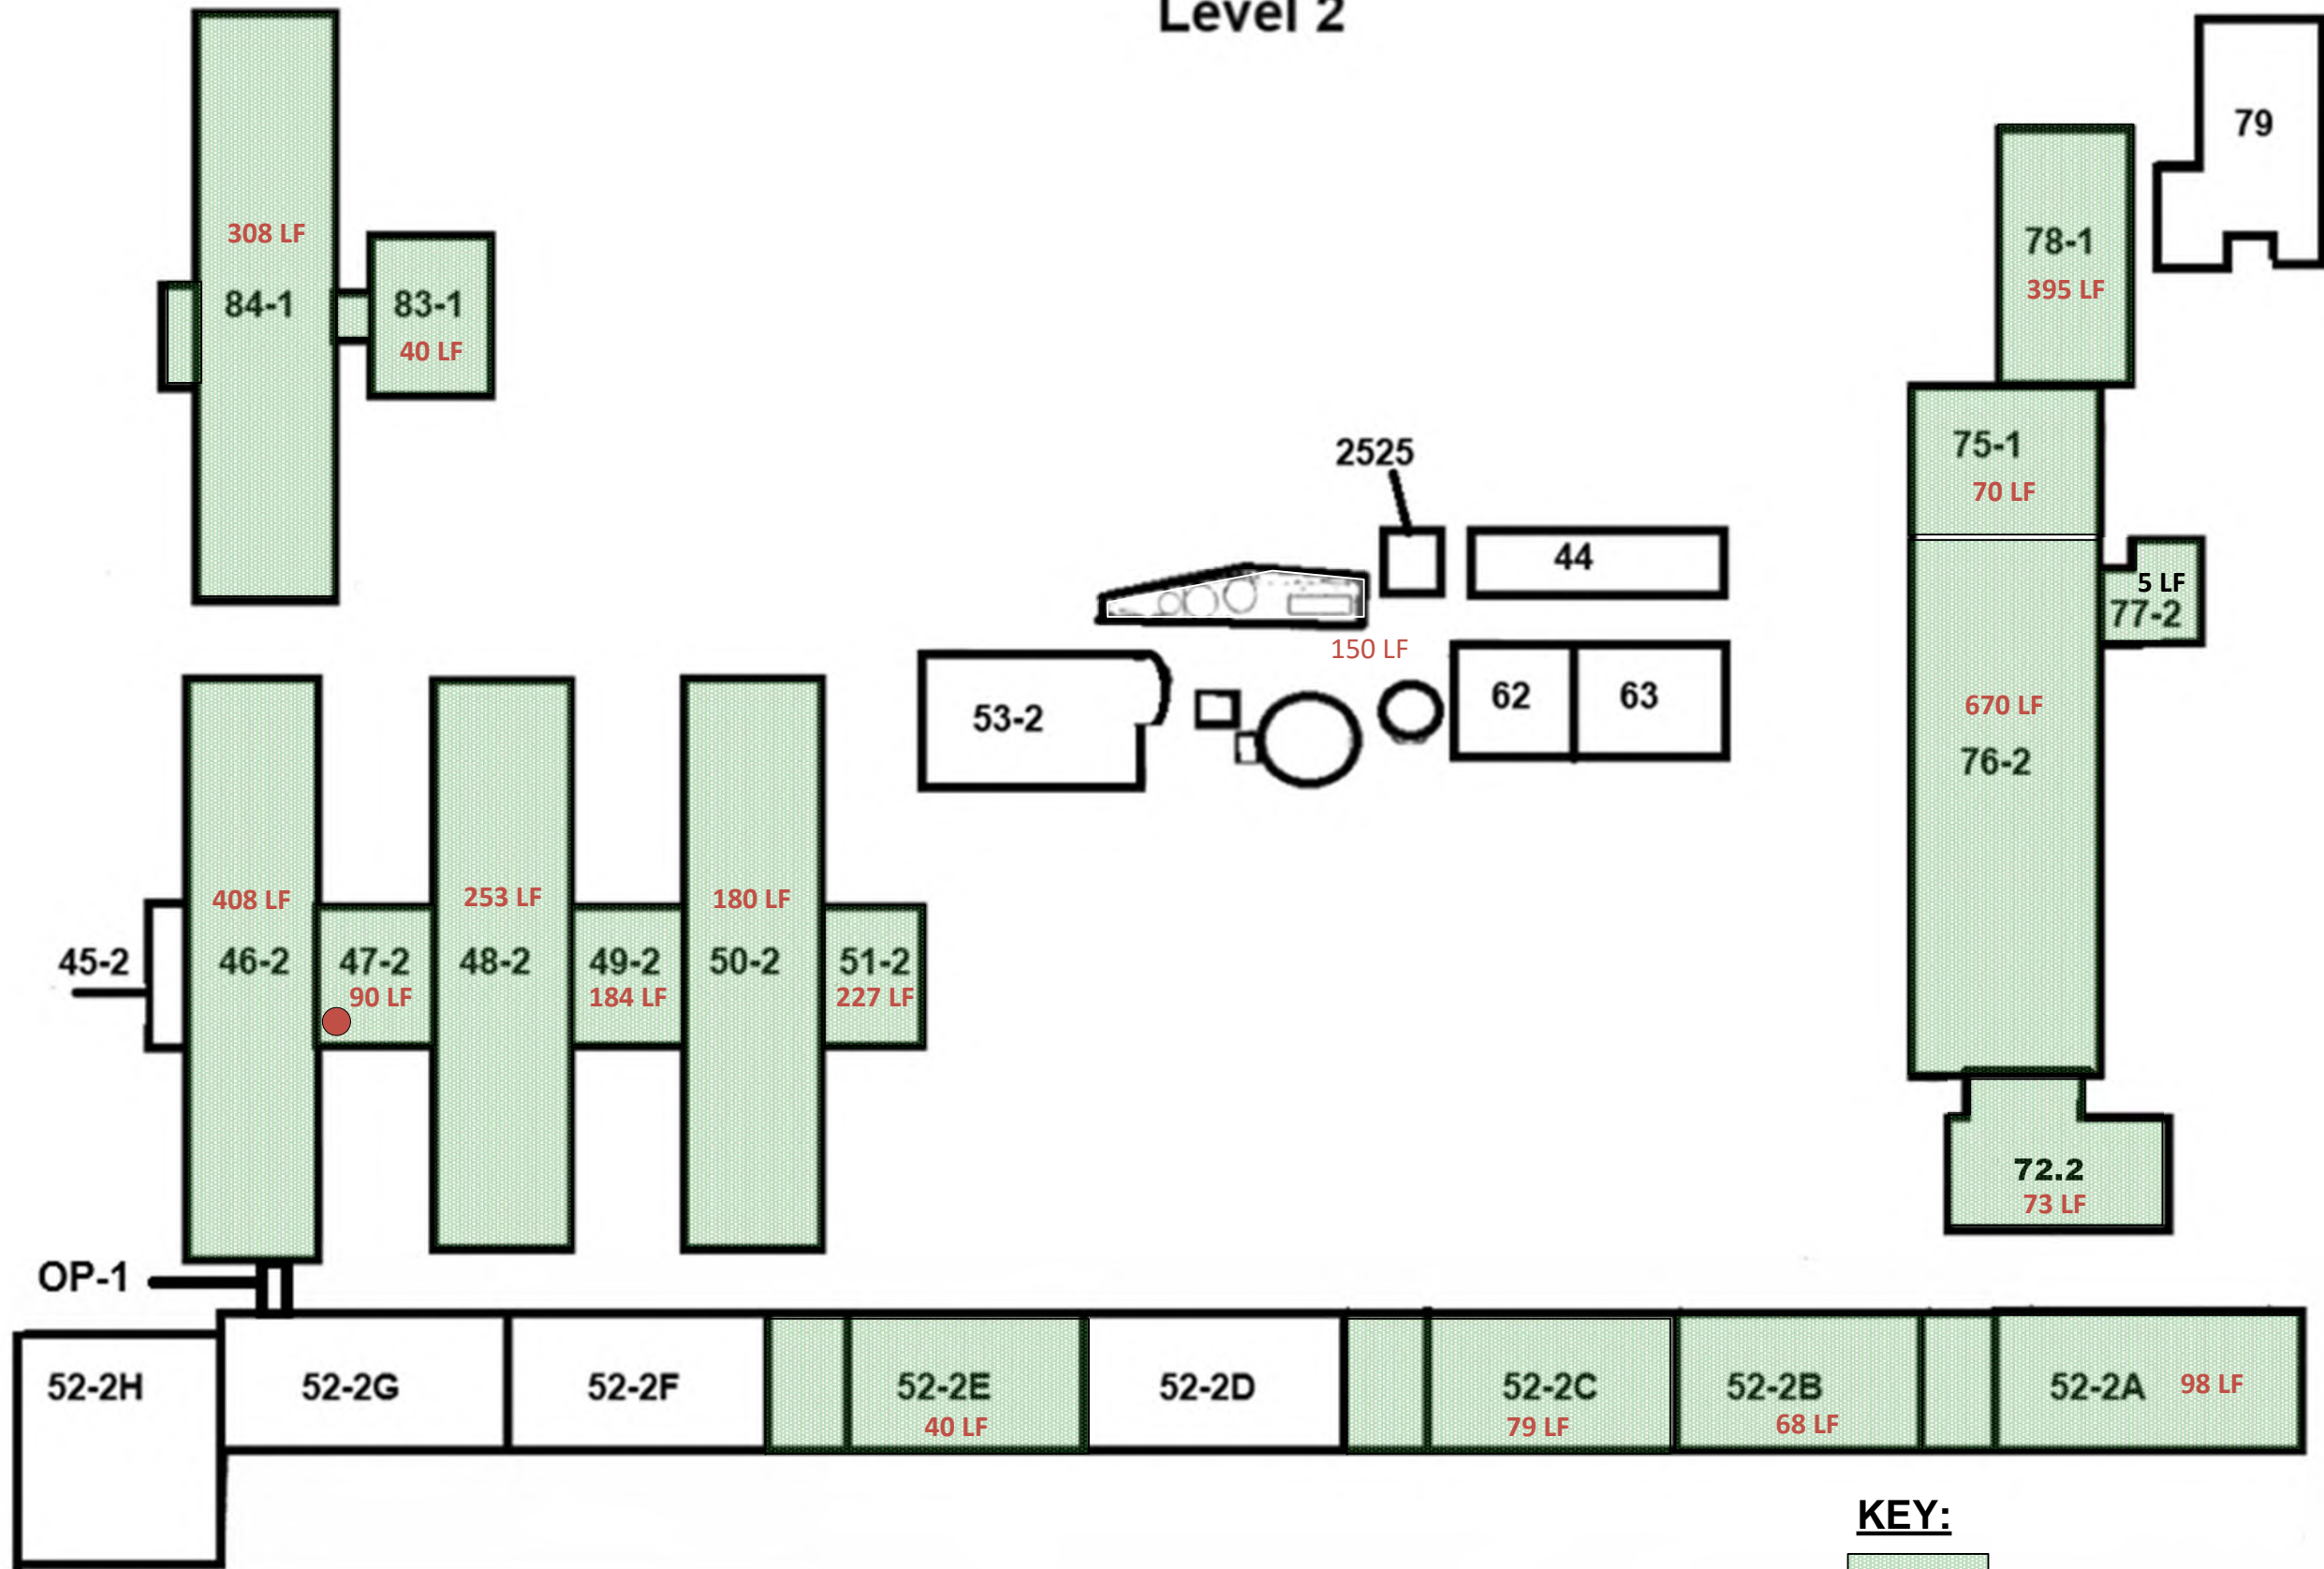
Level 2

- Denotes Buildings with TSI
- Location of ACM Tank Insulation (Refer to Summary of ACM Table 2.0)

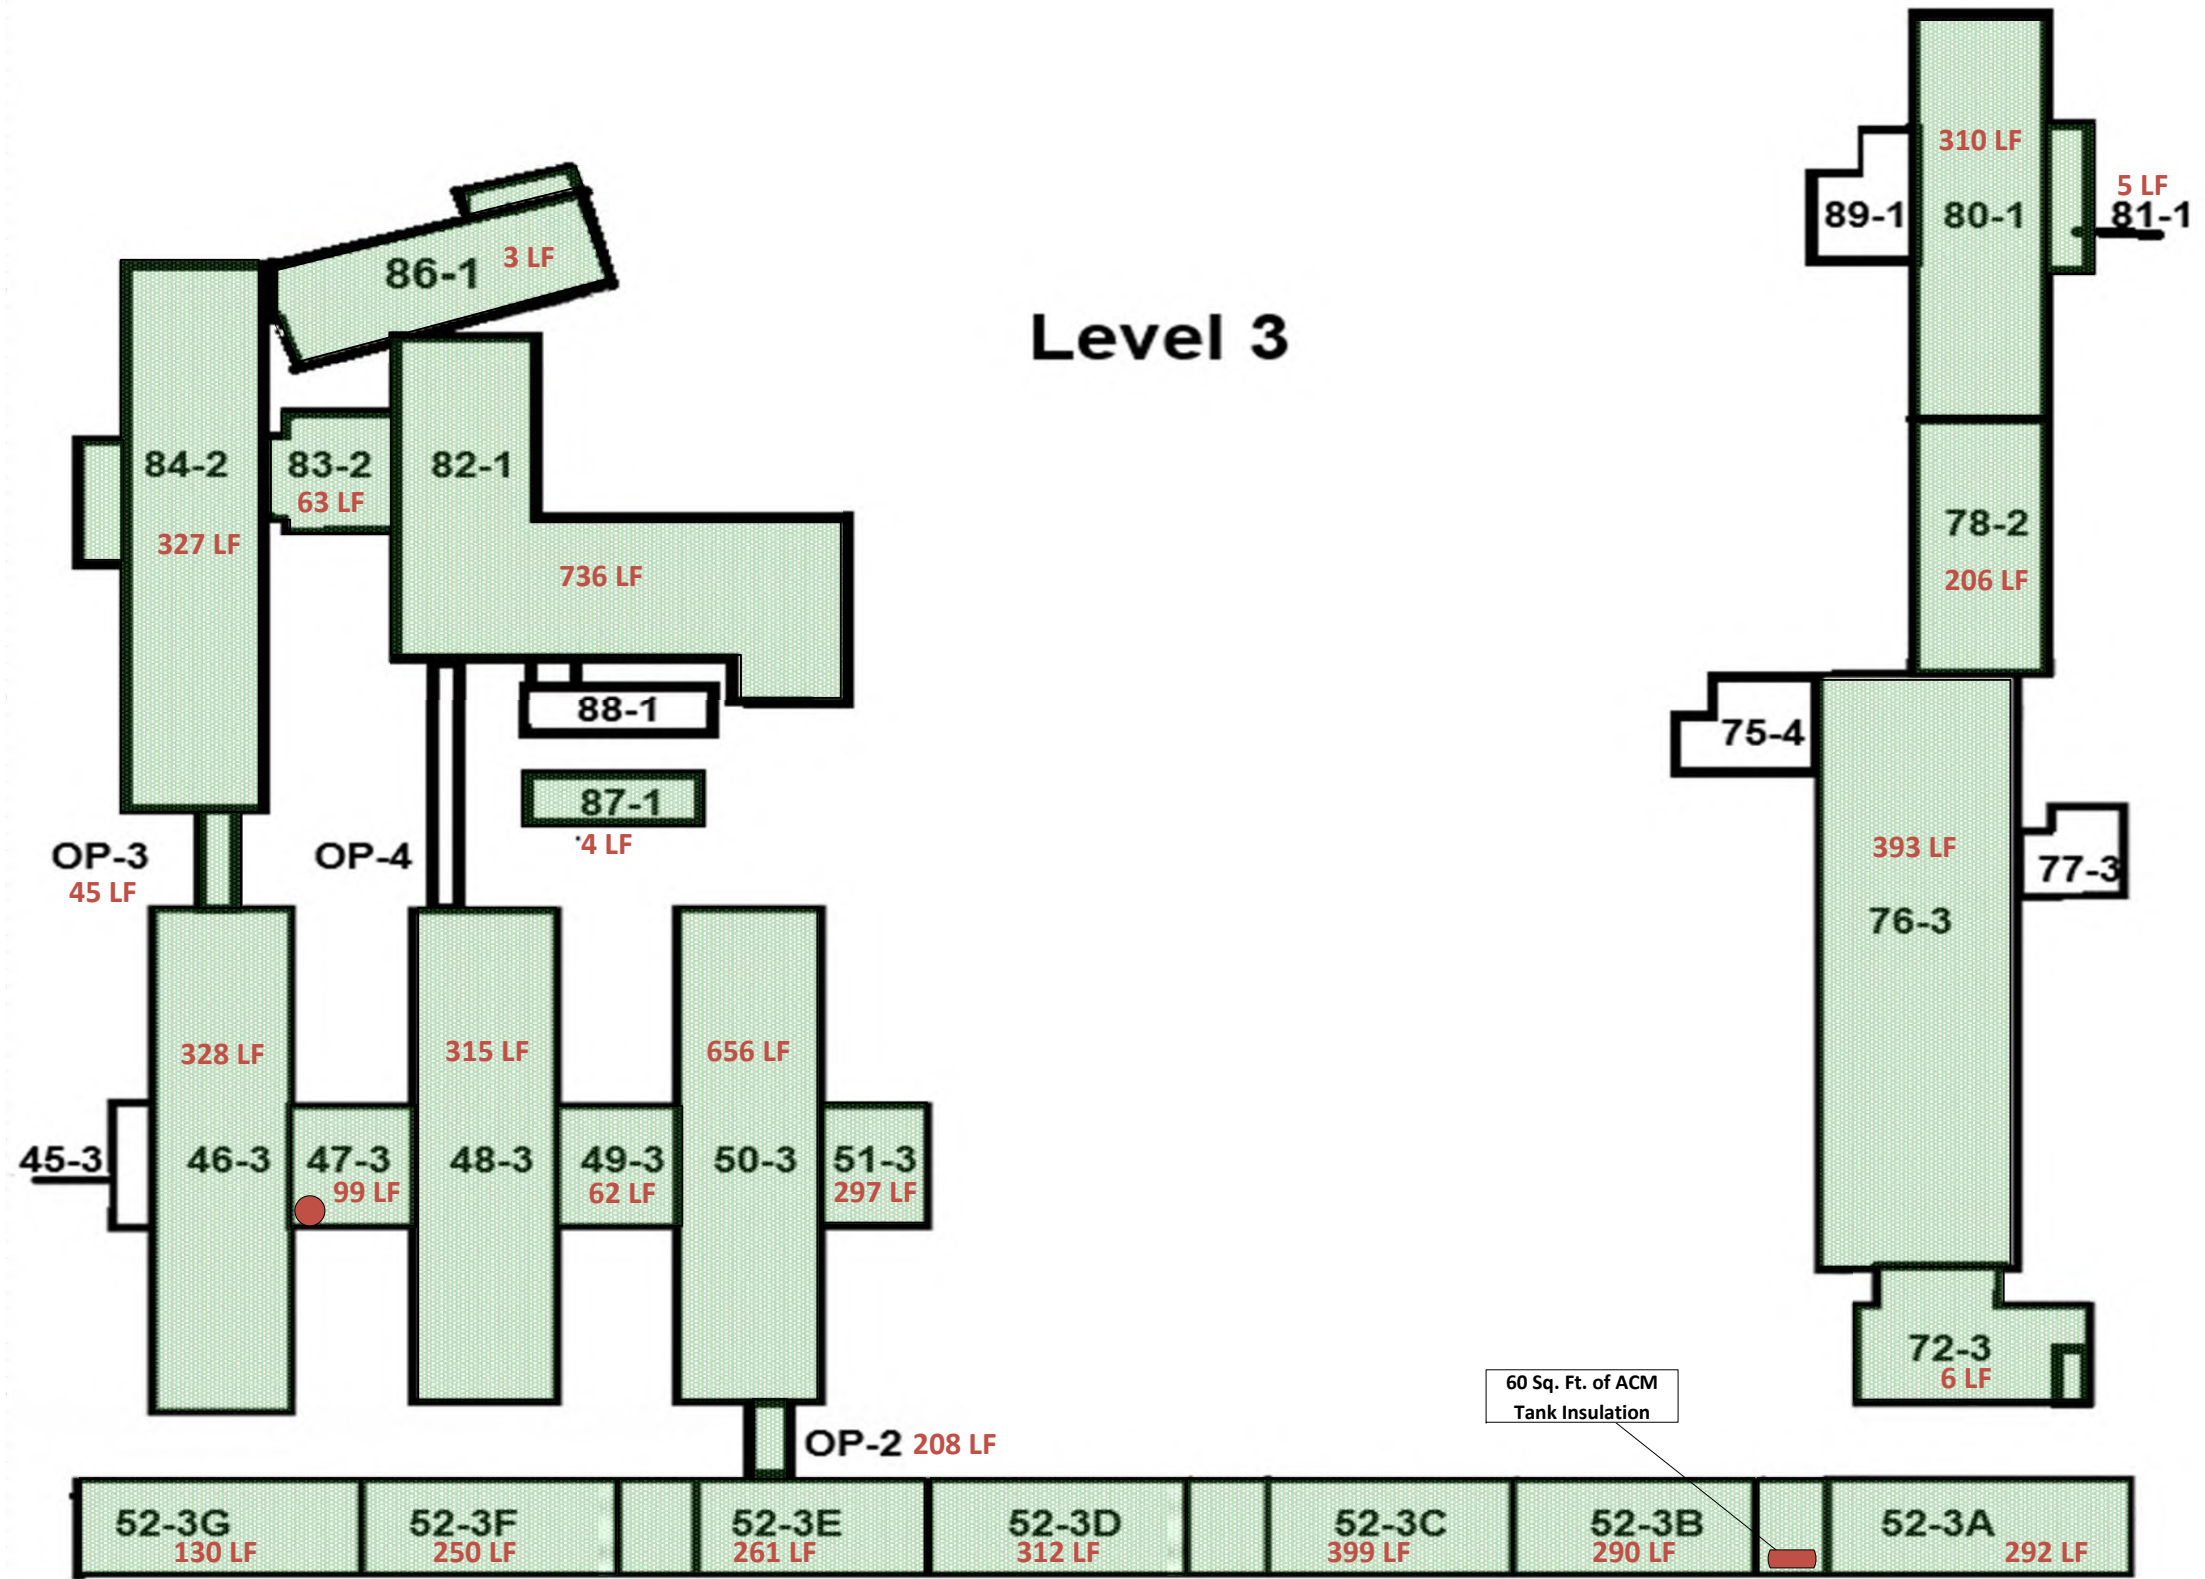
Level 3

60 Sq. Ft. of ACM Tank Insulation

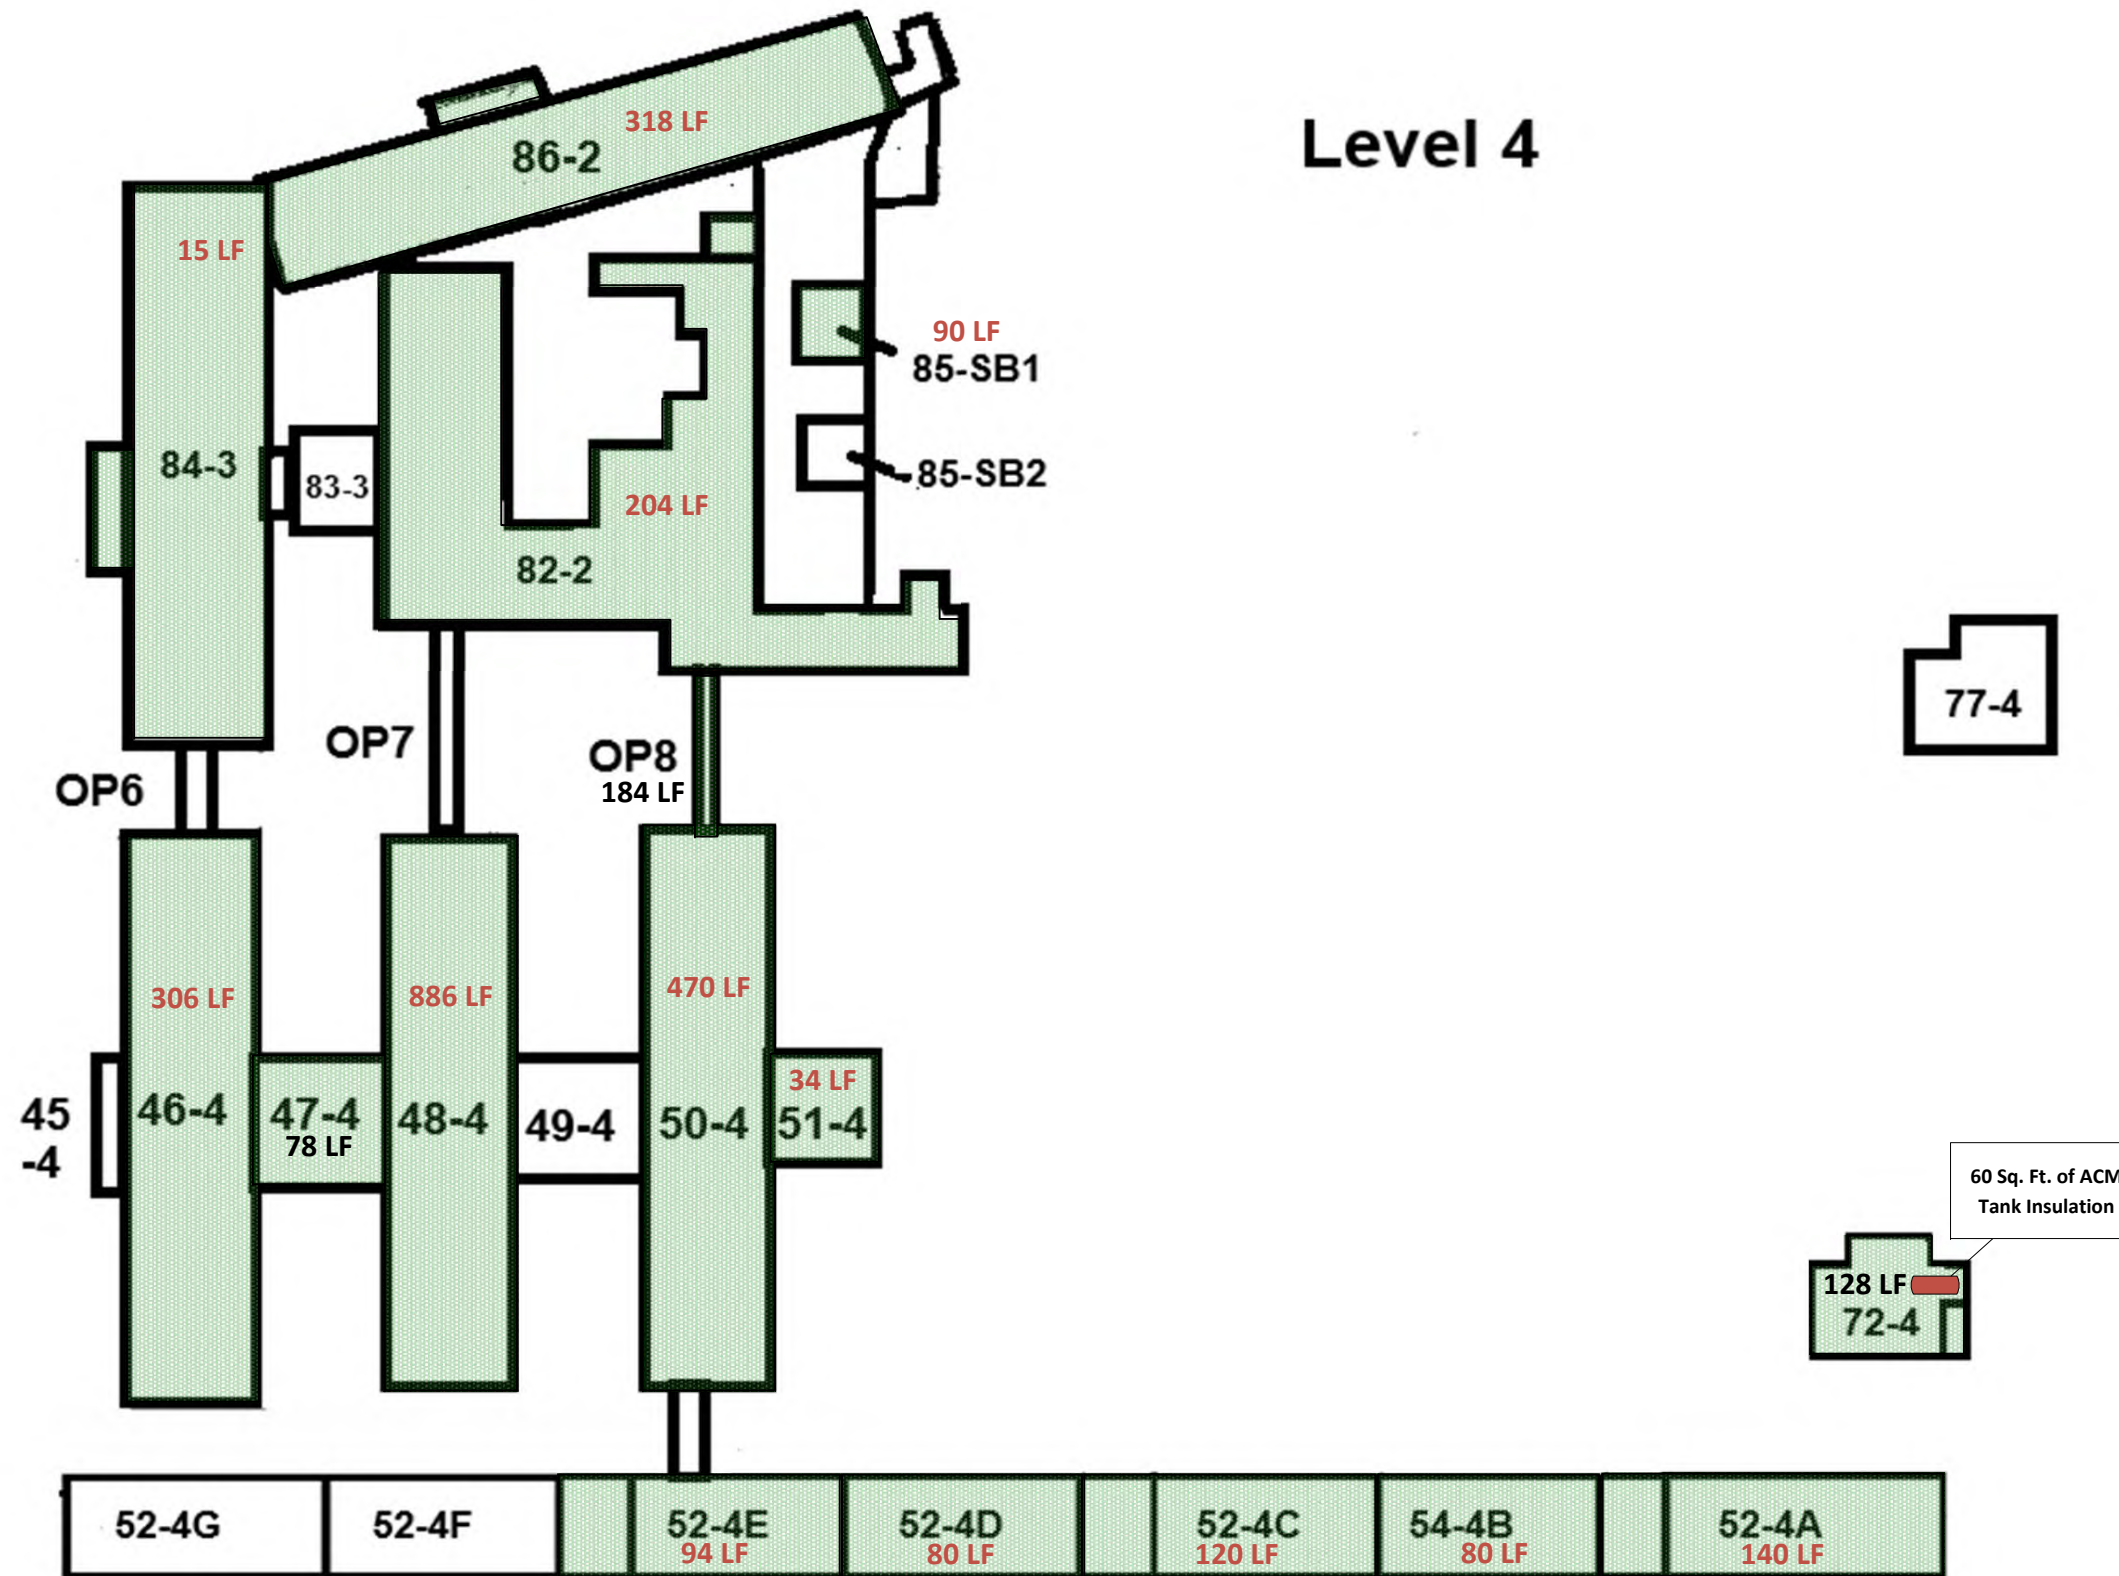
Level 4

- Denotes Buildings with TSI
- Location of ACM Tank Insulation (Refer to Summary of ACM Table 2.0)

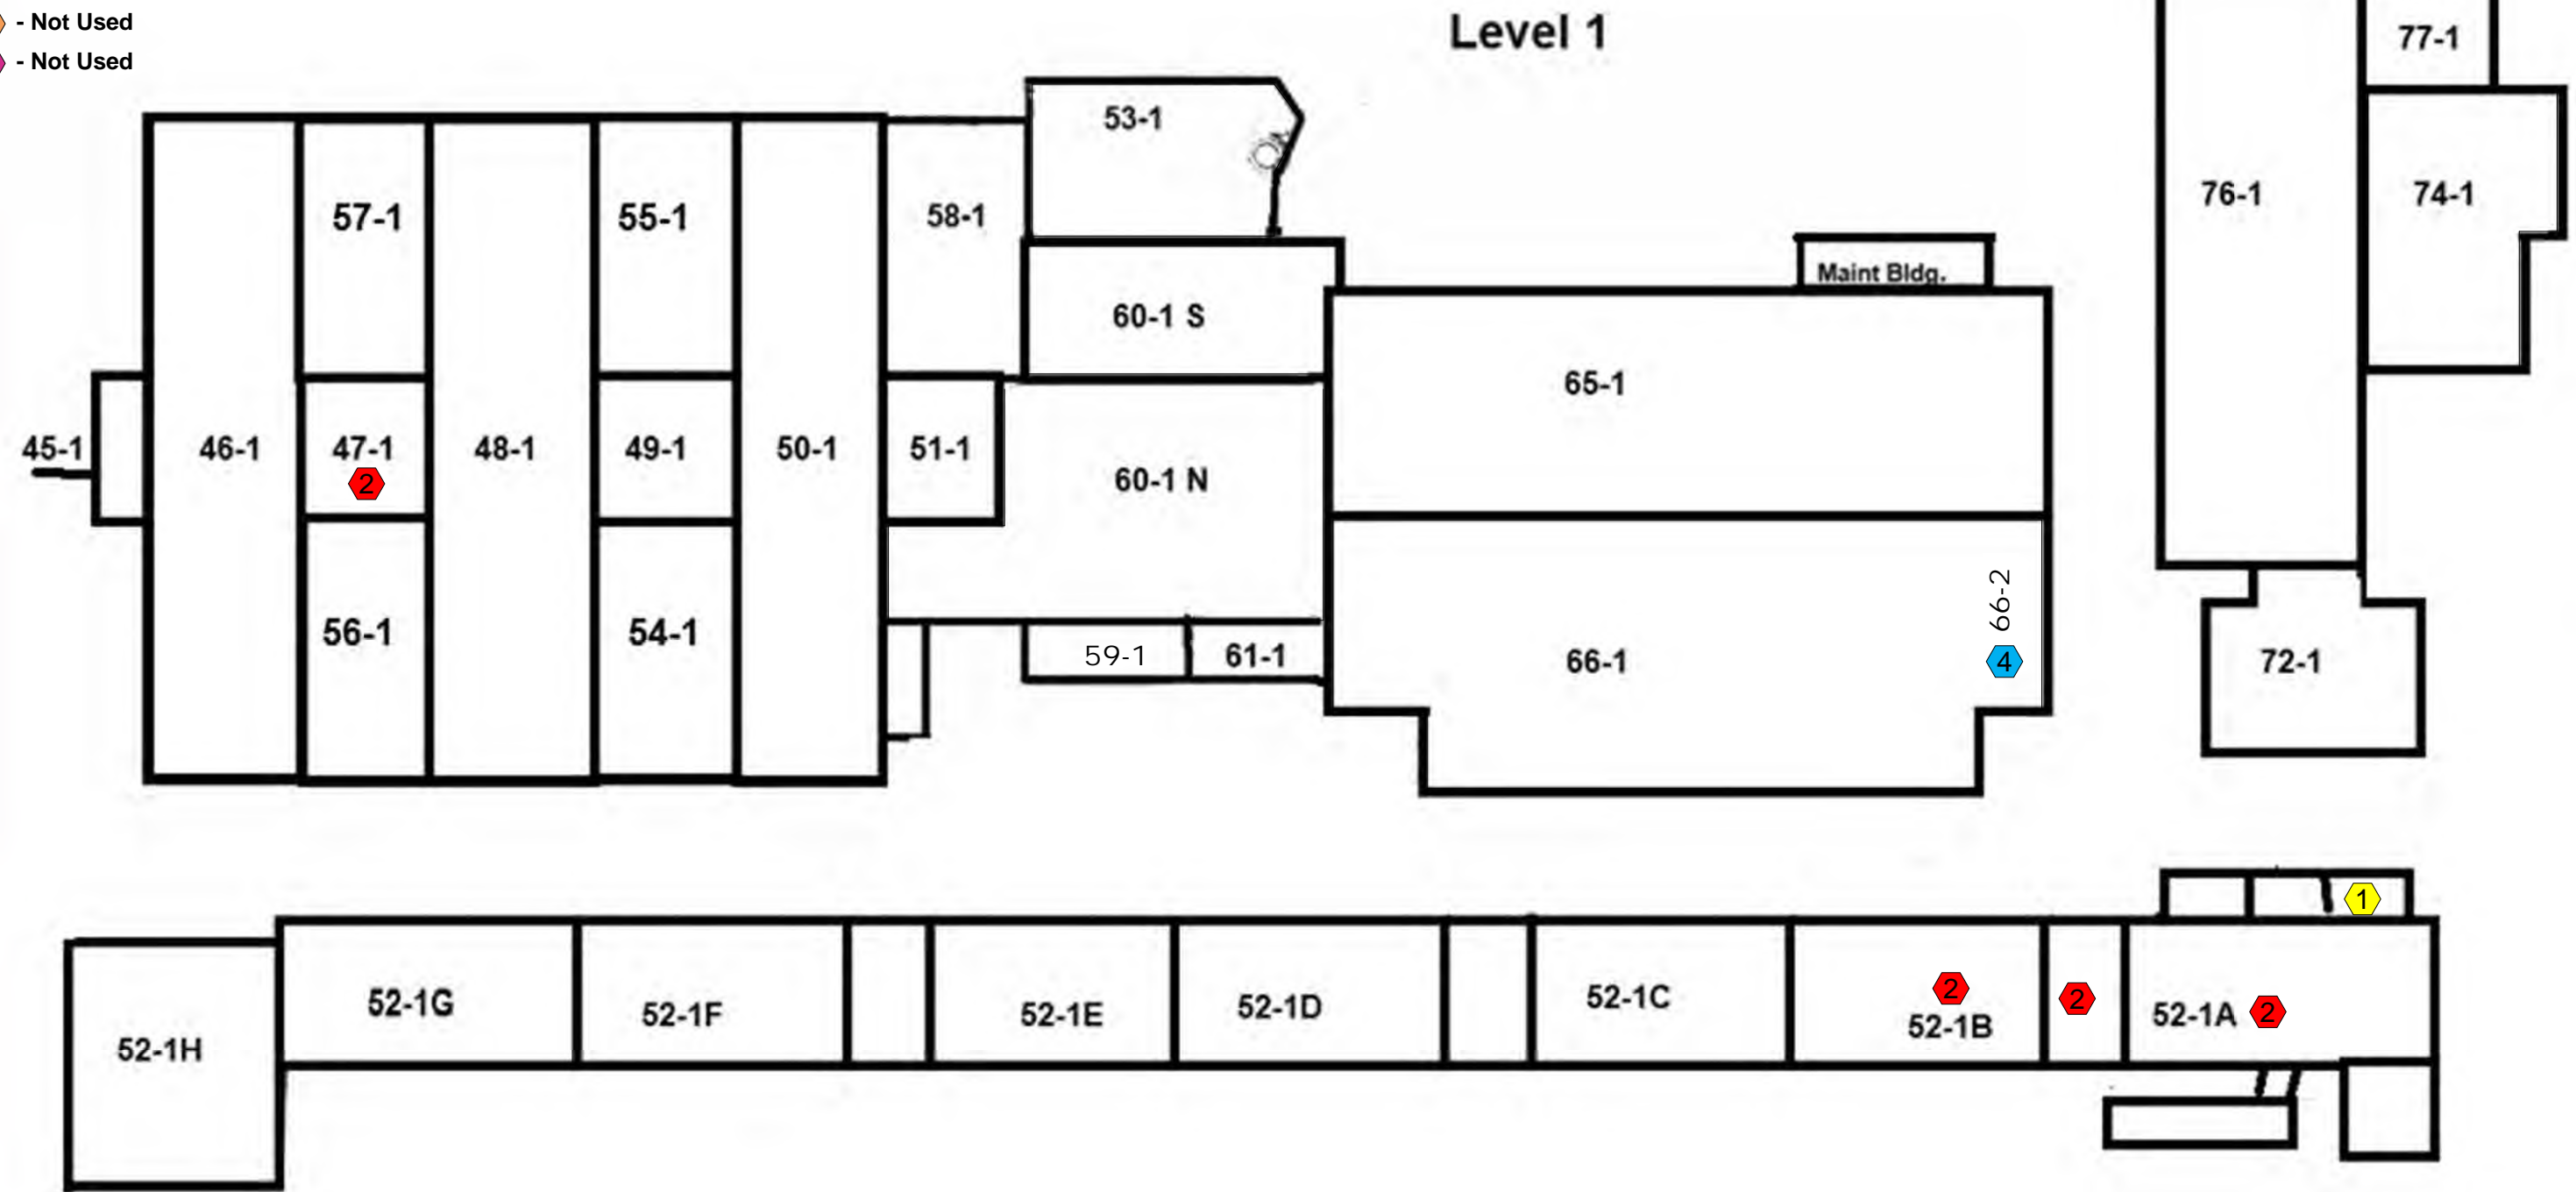
- 1 - Acoustic Panel Glue
- 2 - 12"x12" Vinyl Asbestos Floor Tile
- 3 - 9"x9" Vinyl Asbestos Floor Tile
- 4 - Black Floor Tile Mastic under 12"x12" Tile
- 5 - Not Used
- 6 - Not Used
- 7 - Not Used
- 8 - Not Used
- 9 - Not Used
- 10 - Not Used

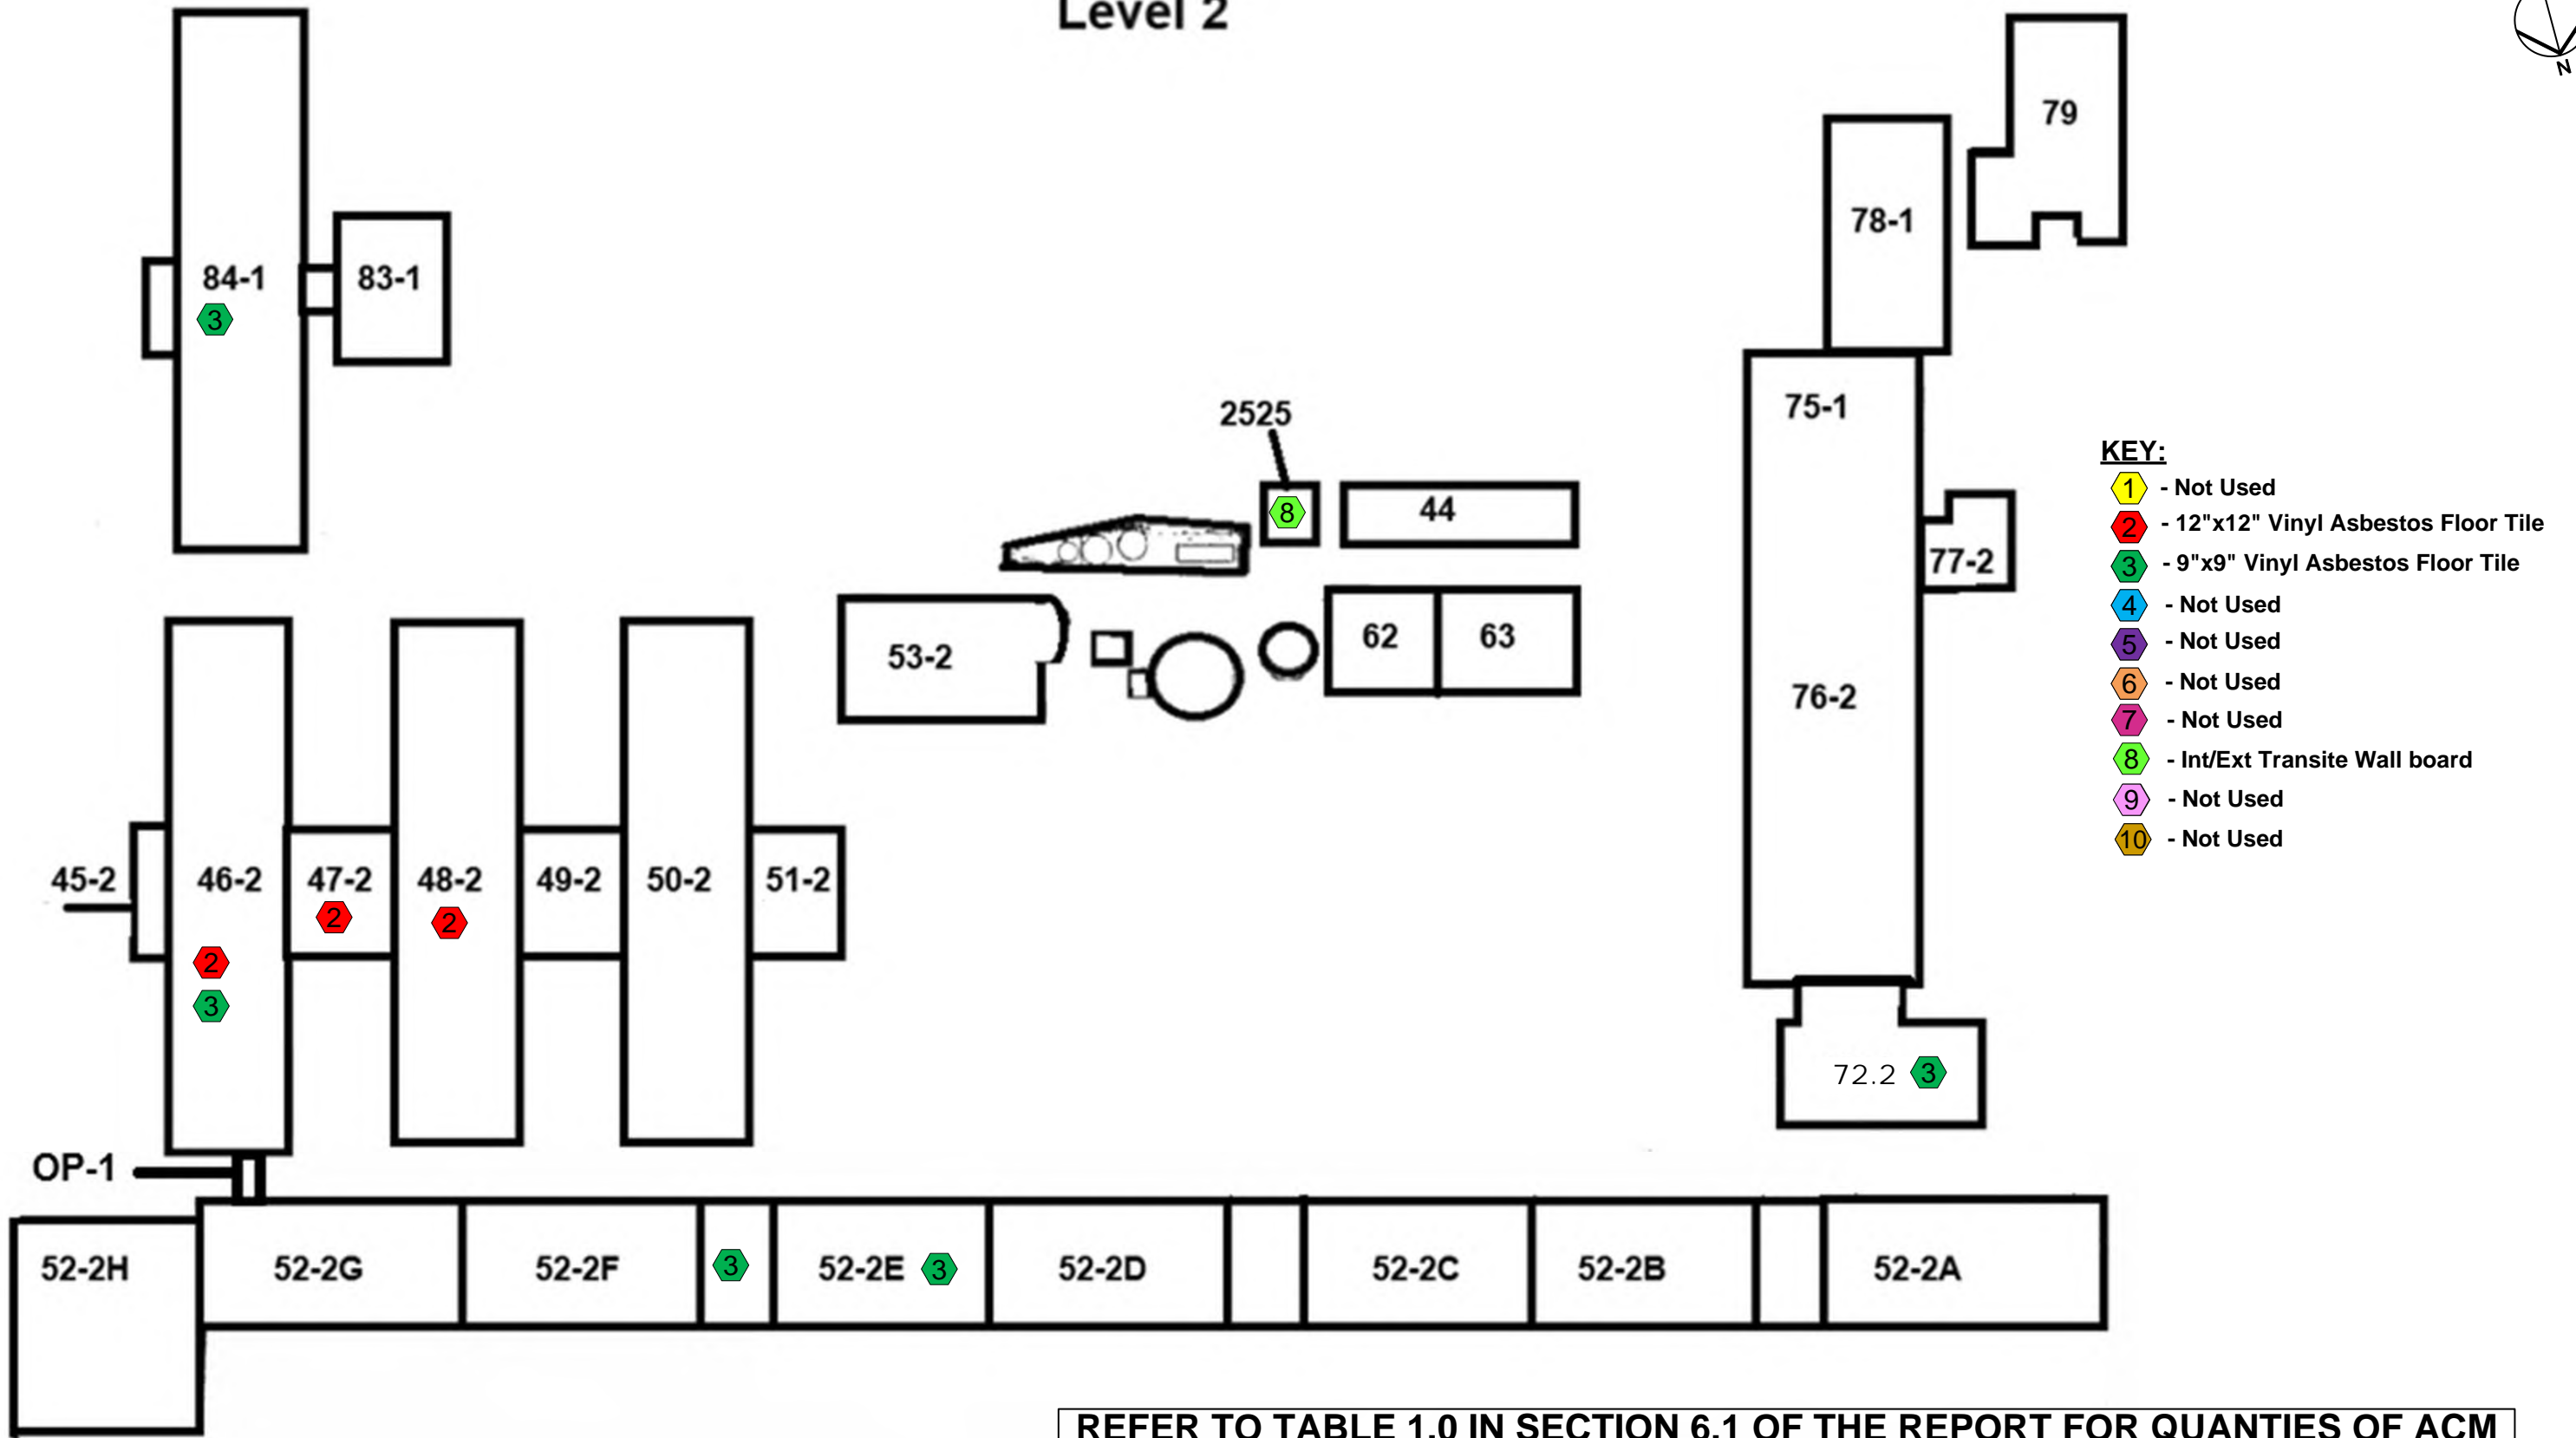
Level 2

- KEY:**
- 1 - Not Used
 - 2 - 12"x12" Vinyl Asbestos Floor Tile
 - 3 - 9"x9" Vinyl Asbestos Floor Tile
 - 4 - Not Used
 - 5 - Not Used
 - 6 - Not Used
 - 7 - Not Used
 - 8 - Int/Ext Transite Wall board
 - 9 - Not Used
 - 10 - Not Used
