RE: REPORT OF ASBESTOS SURVEY, FORMER REMINGTON ARMS, 14 HOEFLER AVENUE, ILION, NEW YORK (HRP PROJECT TUR3500.BA)

Project Dates: December 13, 2024 – January 17, 2025

Former Remington Arms
14 Hoefler Ave
Ilion NY 13357

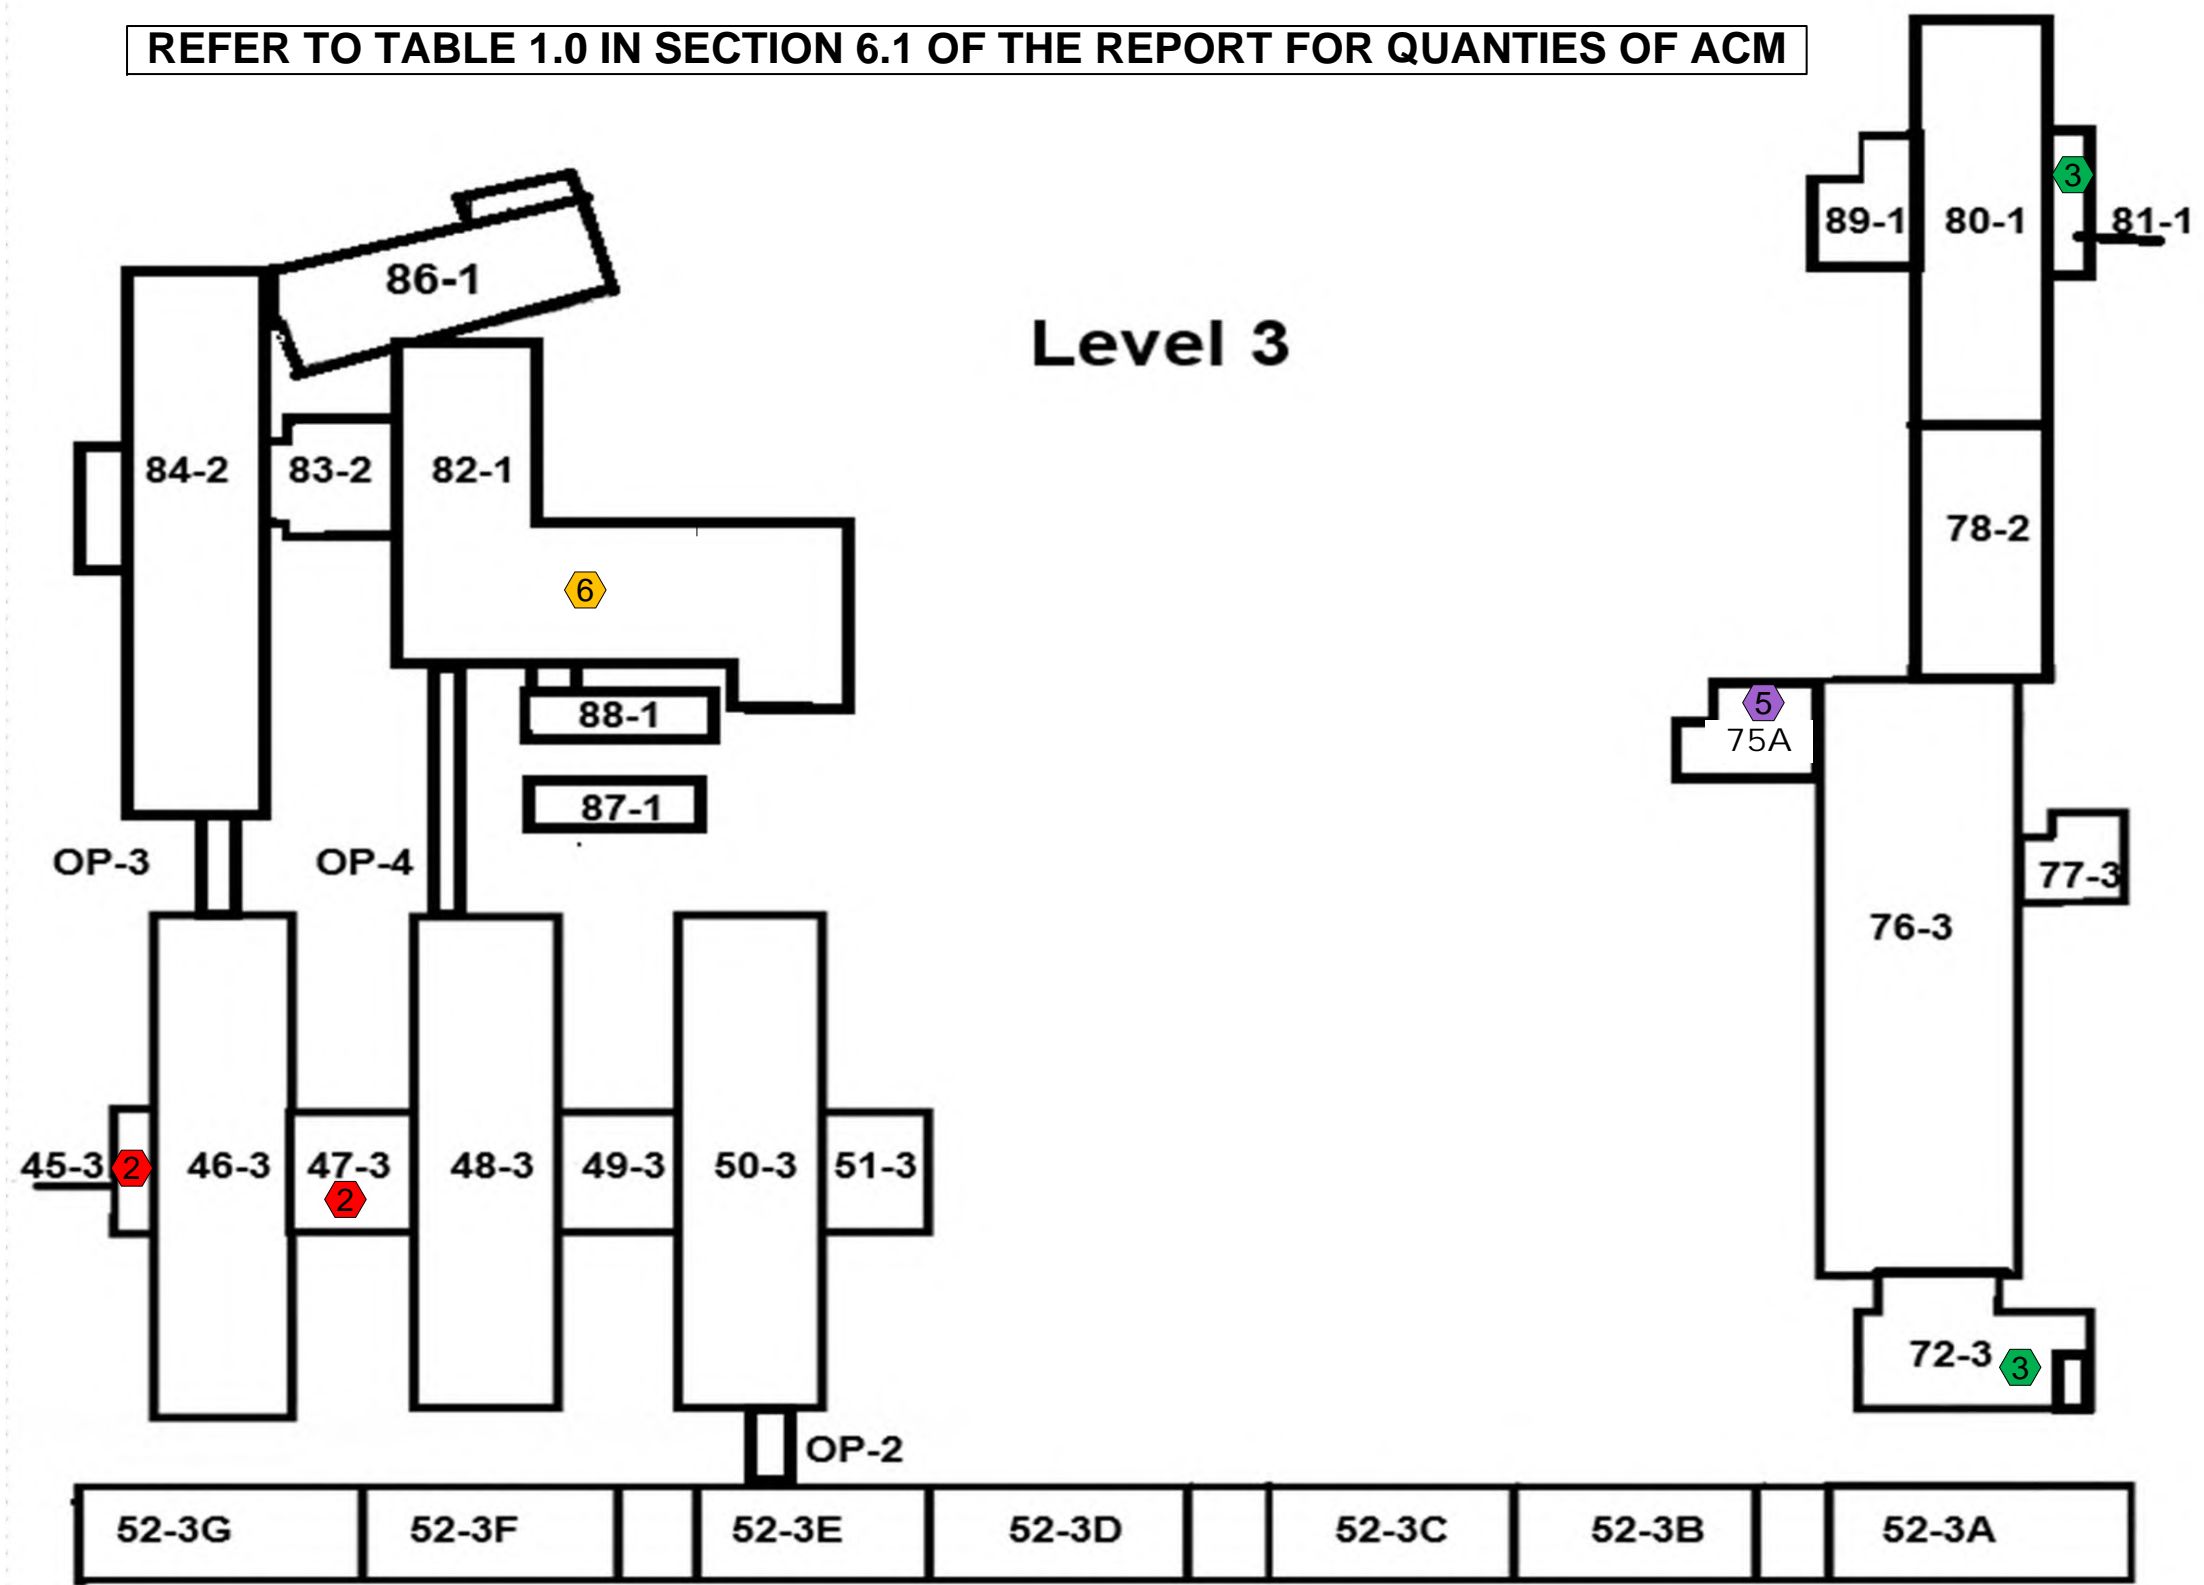
Level 3

- KEY:**
- ◆ 1 - Not Used
 - ◆ 2 - 12"x12" Vinyl Asbestos Floor Tile
 - ◆ 3 - 9"x9" Vinyl Asbestos Floor Tile
 - ◆ 4 - Not Used
 - ◆ 5 - Joint Compound and Gypsum Wallboard
 - ◆ 6 - Round Metal Duct Joint Tape
 - ◆ 7 - Not Used
 - ◆ 8 - Not Used
 - ◆ 9 - Not Used
 - ◆ 10 - Not Used

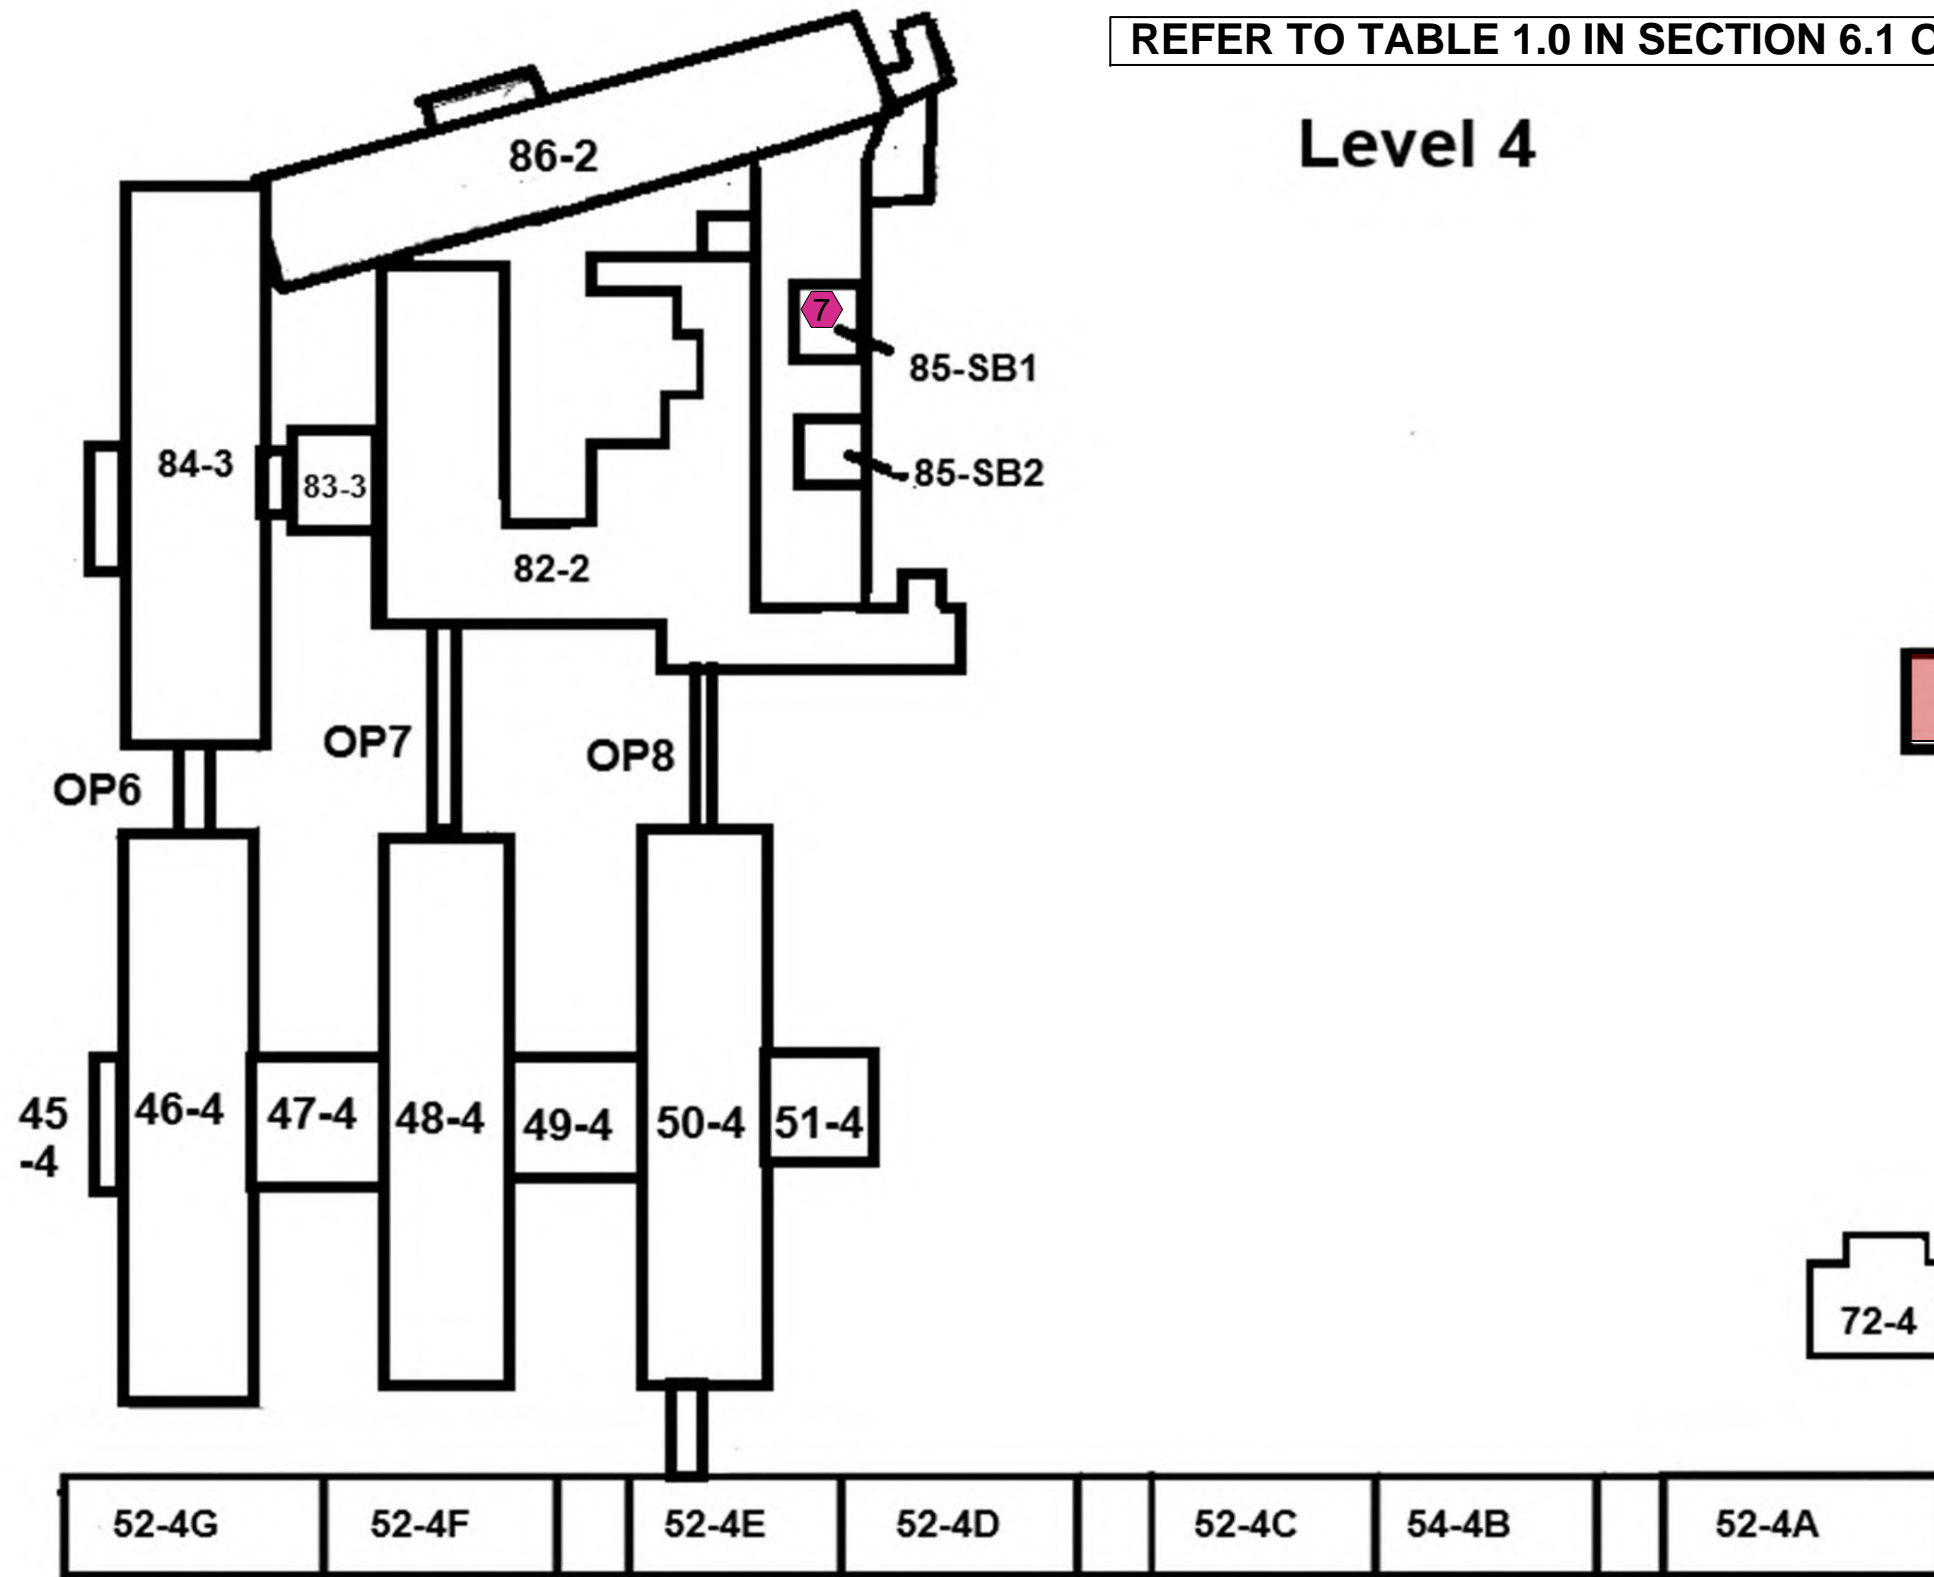
Level 4

- KEY:**
- 1 - Not Used
 - 2 - Not Used
 - 3 - Not Used
 - 4 - Not Used
 - 5 - Not Used
 - 6 - Not Used
 - 7 - Transite Panels on Mechanical Equipment
 - 8 - Not Used
 - 9 - Not Used
 - 10 - Not Used
 - Red Square - No Access, High Voltage Area

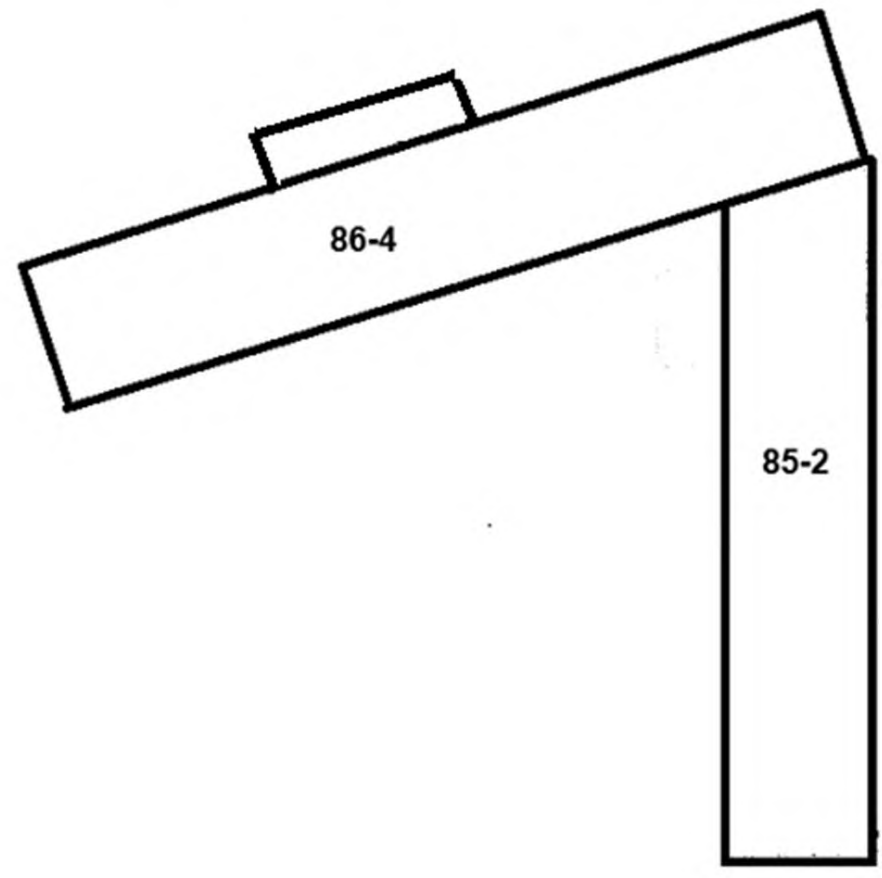
Level 6

- KEY:**
- 1 - Not Used
 - 2 - Not Used
 - 3 - Not Used
 - 4 - Not Used
 - 5 - Not Used
 - 6 - Not Used
 - 7 - Not Used
 - 8 - Not Used
 - 9 - Machine Insulation
 - 10 - Machine Door Gaskets
