PROPERTY INSPECTION REPORT

12345 Your Home Dr., Los Angeles, CA 90039

DATE OF INSPECTION: 3/4/2025

VILLA PROPERTY INSPECTIONS
www.inspectaproperty.com

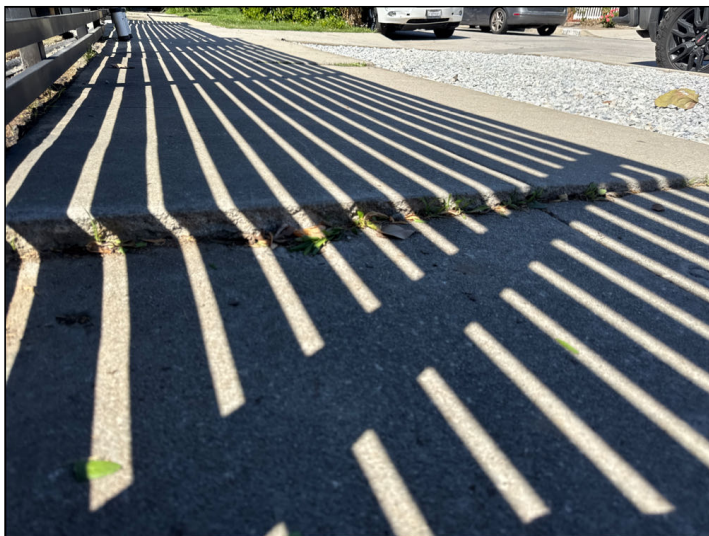
Sidewalk surface is raised or settled and poses a trip hazard. Repair or replacement is recommended.

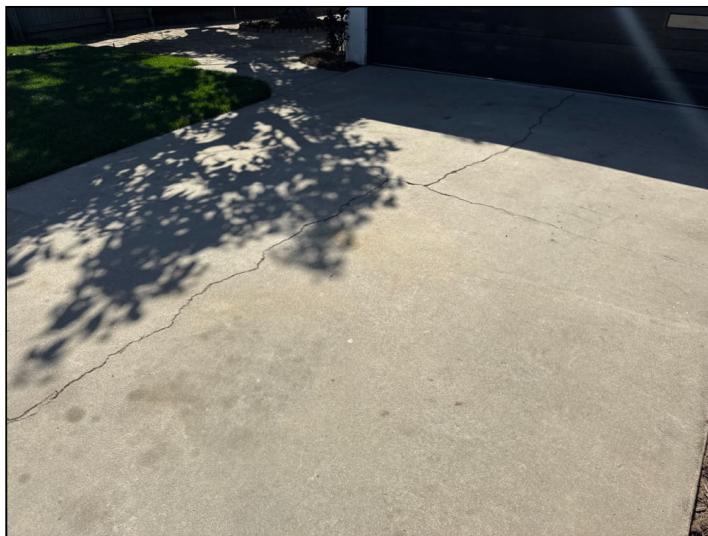
Moderate cracks noted on the driveway at time of inspection.

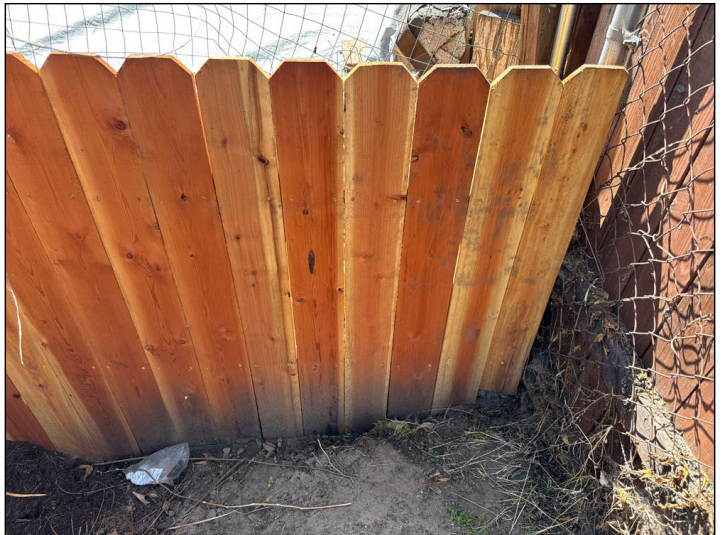
Earth to wood contact observed at the wood fence. A minimum 6 inch separation is recommended between the soil and the bottom of the fence to prevent moisture penetration and damage.

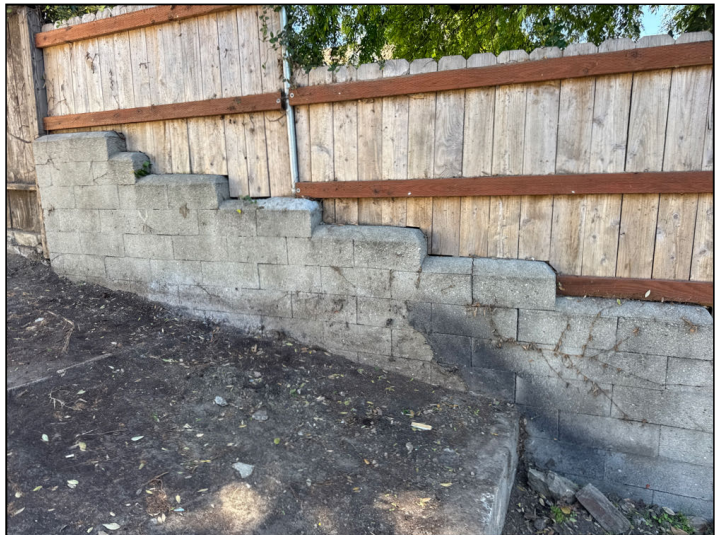
Moderate cracks noted on the block wall.

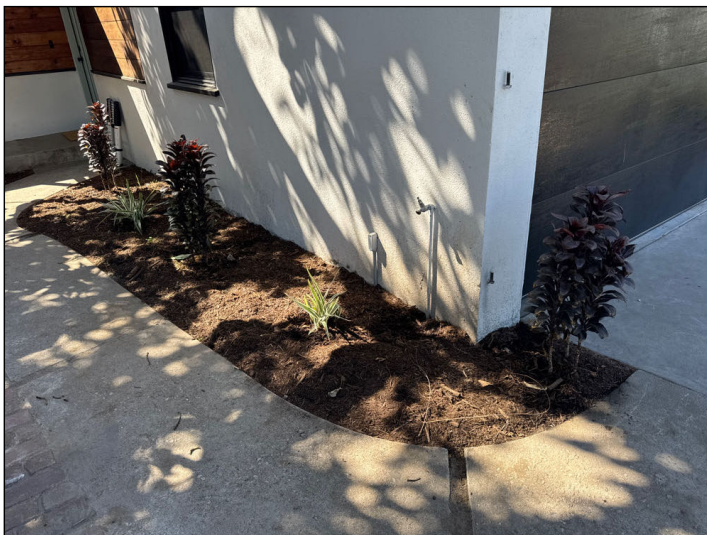
Planter areas near the house do not have a drainage system installed and retain water when it rains. This excess moisture, near the foundation of the house, can cause damage. Installation of a drainage system is recommended.

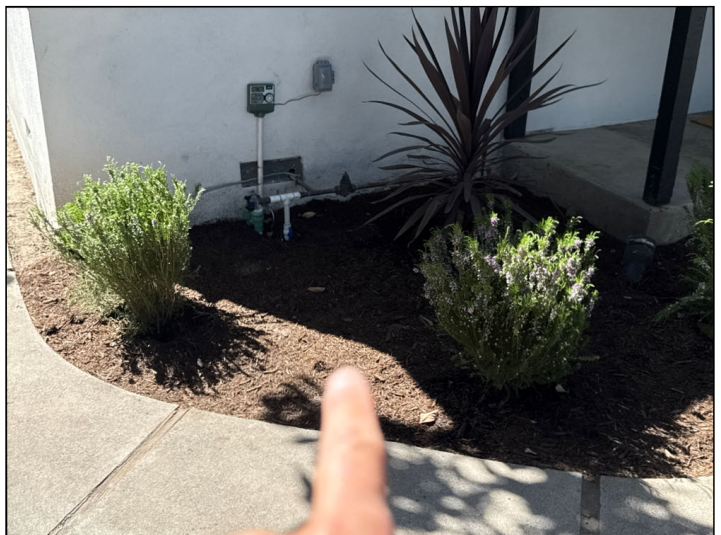
Improper soil slope toward foundation. Slope should fall away from the foundation at a minimum of 1/2 inch per foot and extend at least 10 feet away from the foundation.

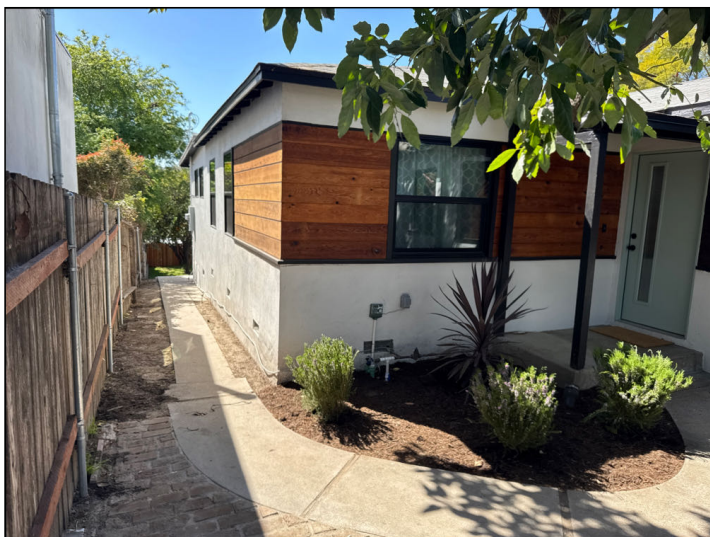
You should consider installing roof gutters to aid with site drainage.

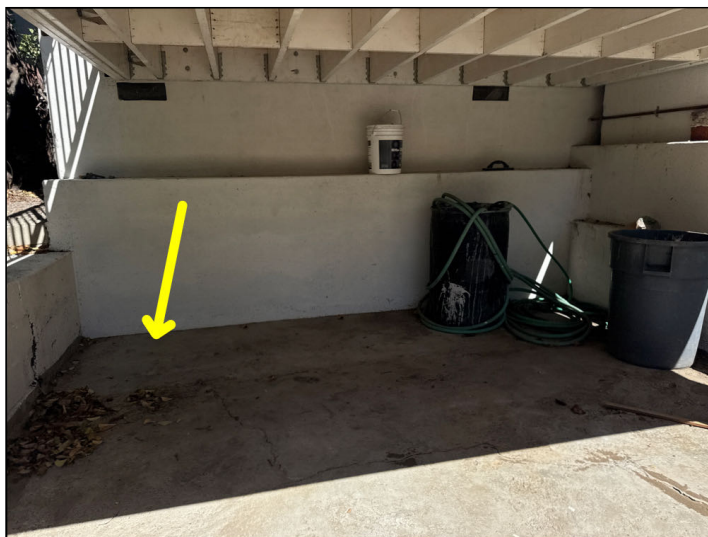
Evidence of pooling water was observed at time of inspection.

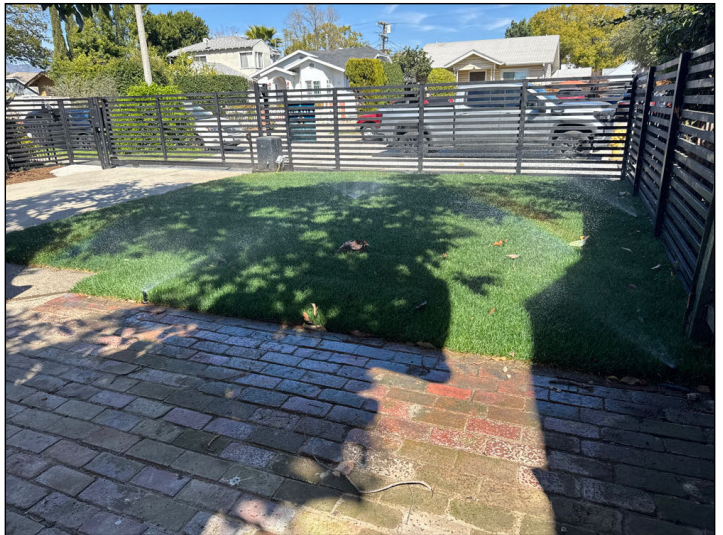
Adjust spray away from structures, sidewalks or fences to prevent moisture penetration and damage.

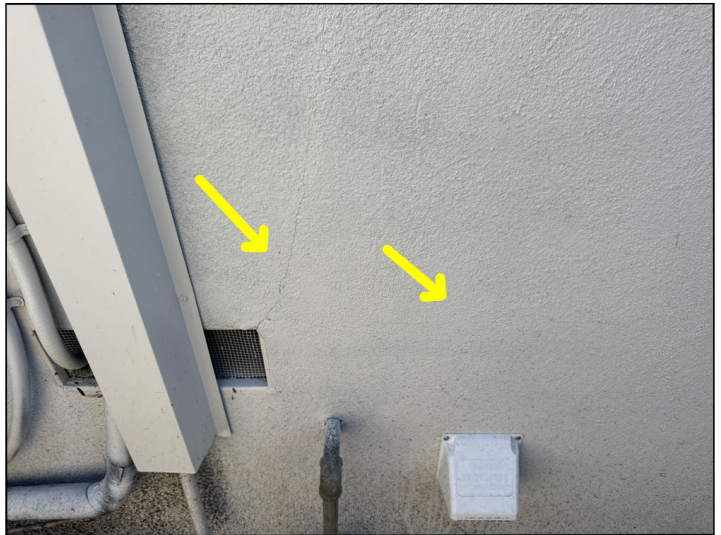
Cracks are typical and not structurally significant.

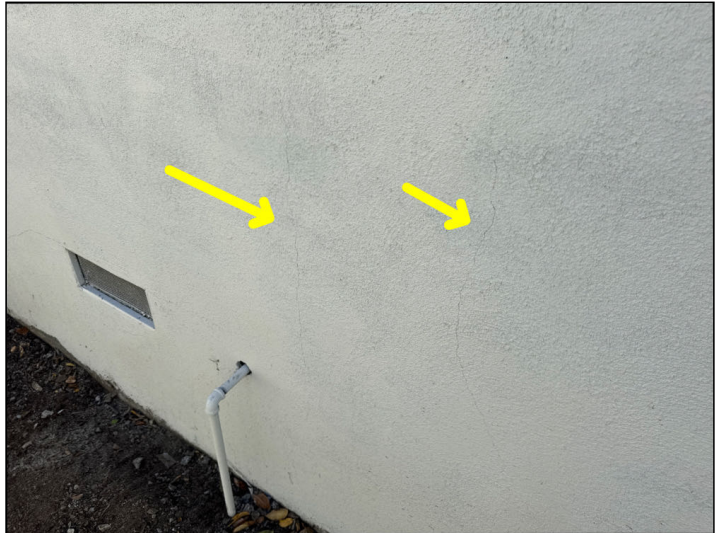
Cracks were noted on the walls.

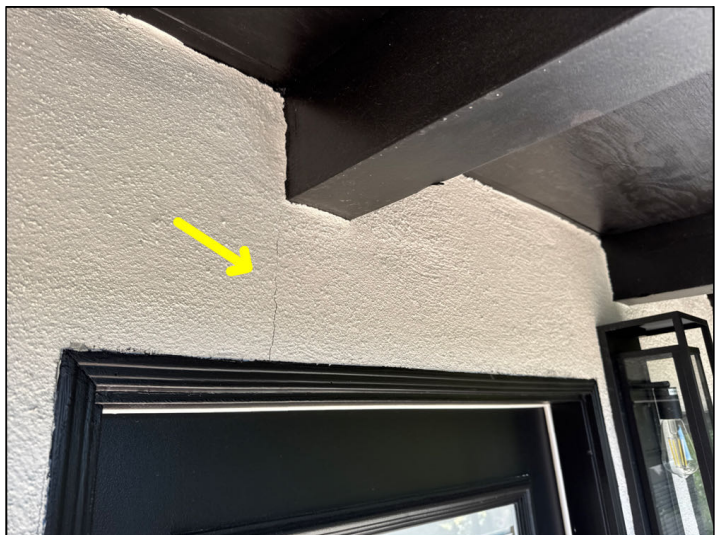
Cracks are typical and not structurally significant.

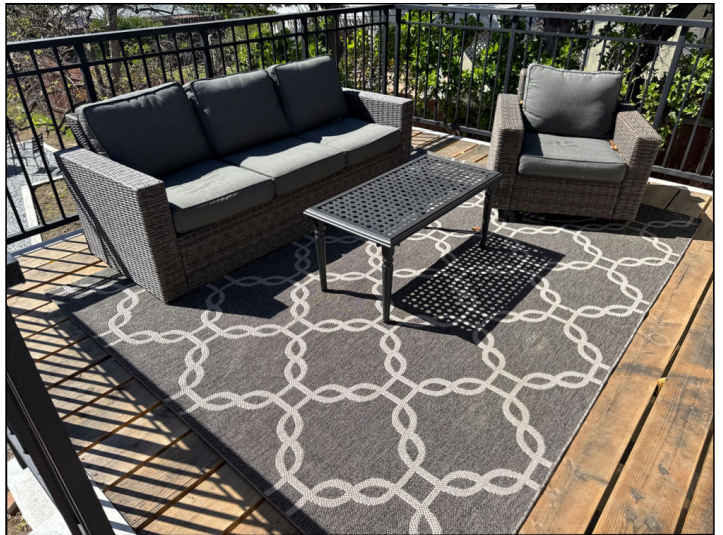
Unable to fully view the deck due to occupants' belongings.

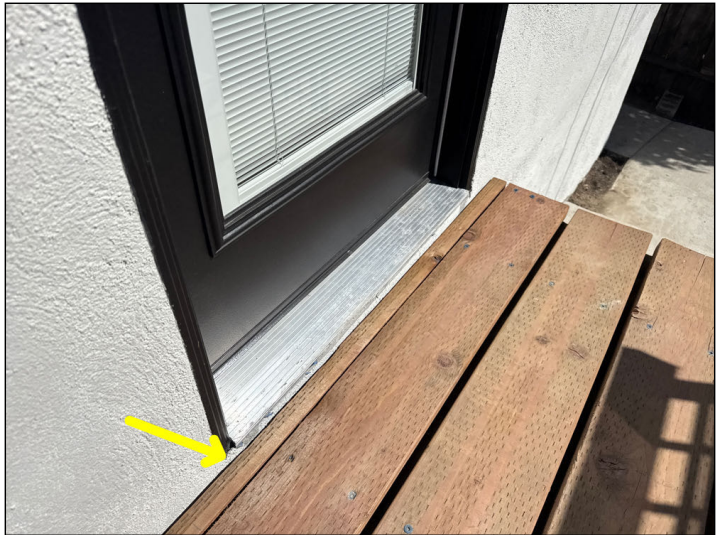
Flashings are not properly sealed at the floor to wall junction and may allow moisture penetration and damage.

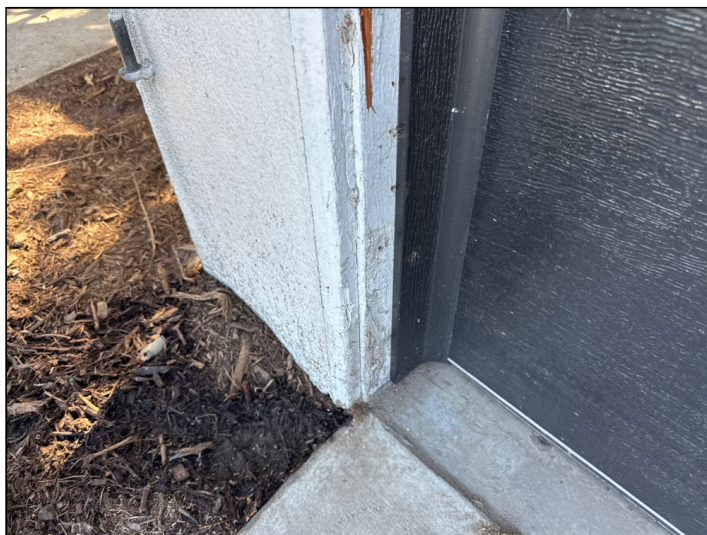
Paint finish is flaking or deteriorated. Repainting is recommended.

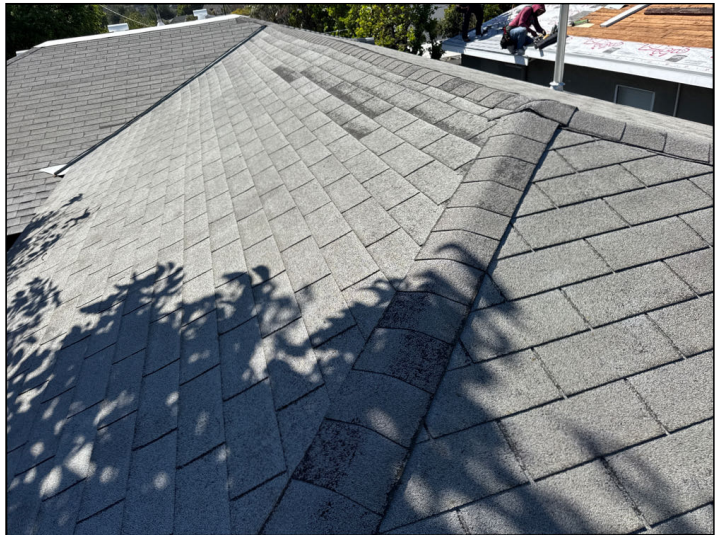
Roofing material appears to be at or near the end of its useful life. A licensed roof contractor should be contacted for further evaluation and repairs or replacement.

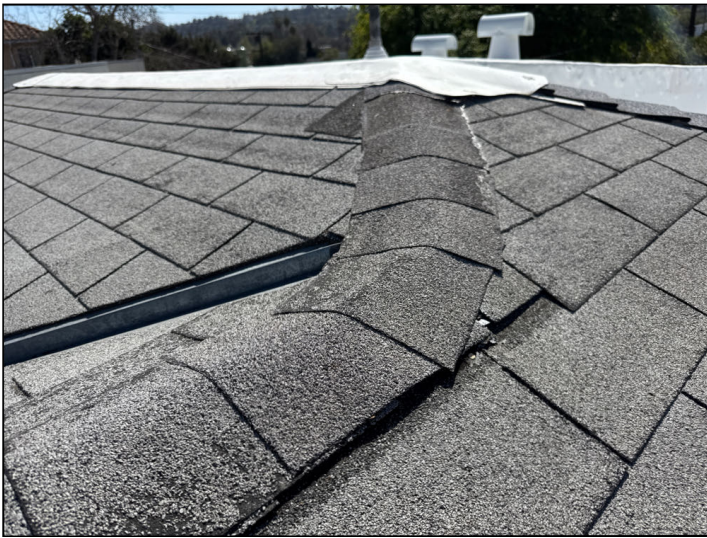
Damaged or missing shingles noted. Repair or replacement is needed.

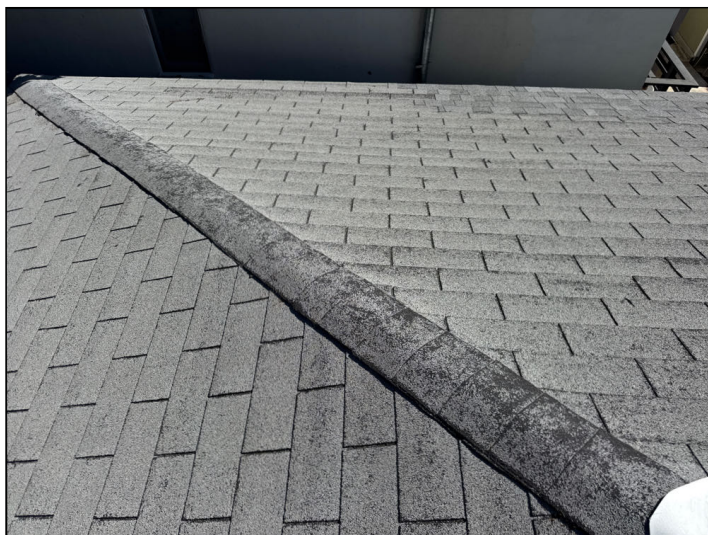
The roofing material appears to have moderate deterioration (granular loss) at time of inspection. Periodic monitoring and regular maintenance is recommended.

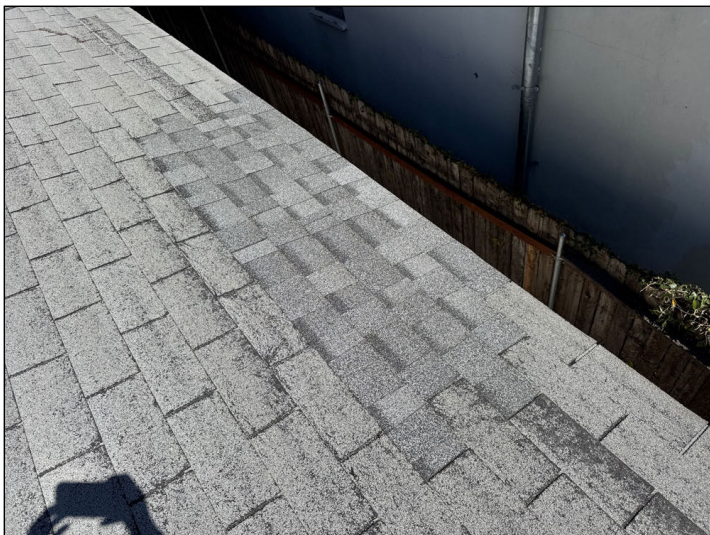
Evidence of prior patching and/or repairs was noted at time of inspection.

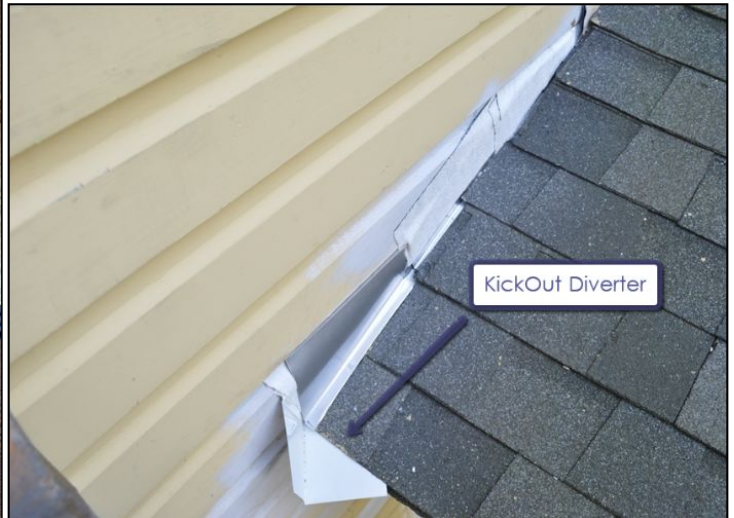
Kick out flashing is not installed at the wall to roof edge connection. Kick out flashing diverts water from cascading down a wall from a roof edge.
See sample photo.

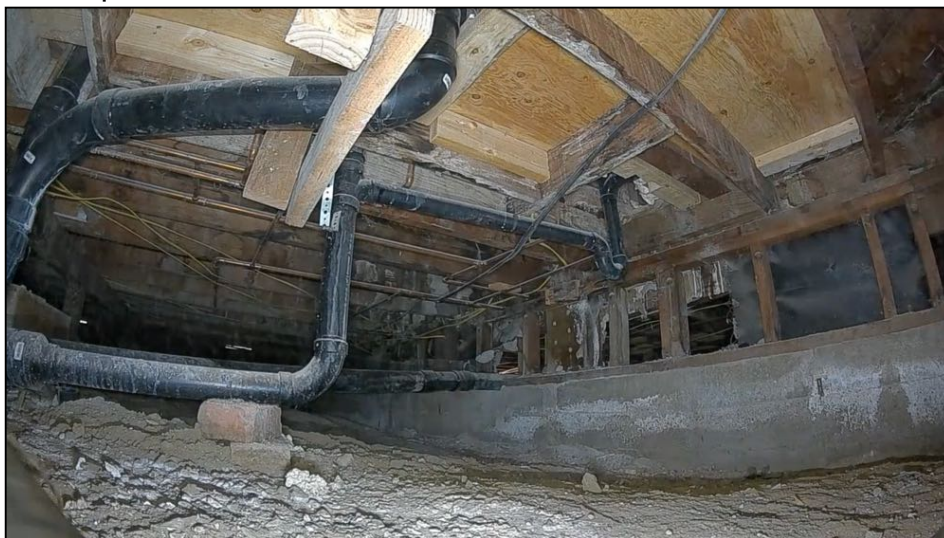
Pipes lack proper support under the house.

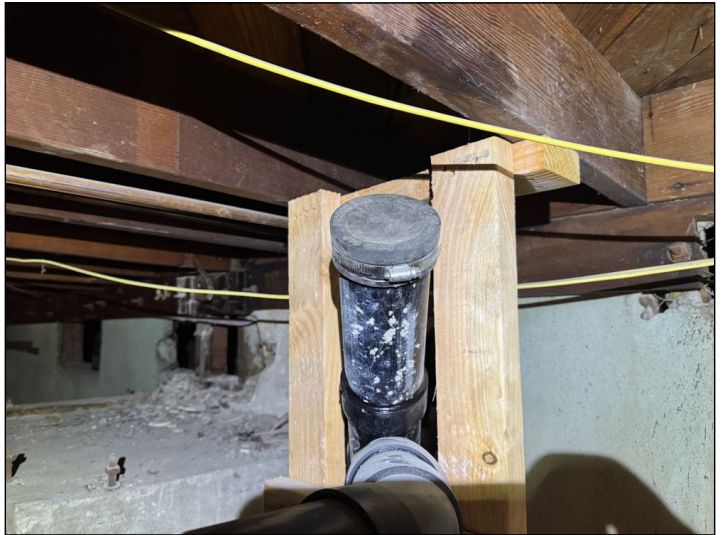
Drain line clean out is not readily accessible.
Installation of an extension on the pipe is recommended for easier access for inspection, maintenance and repairs of the sewer lines.

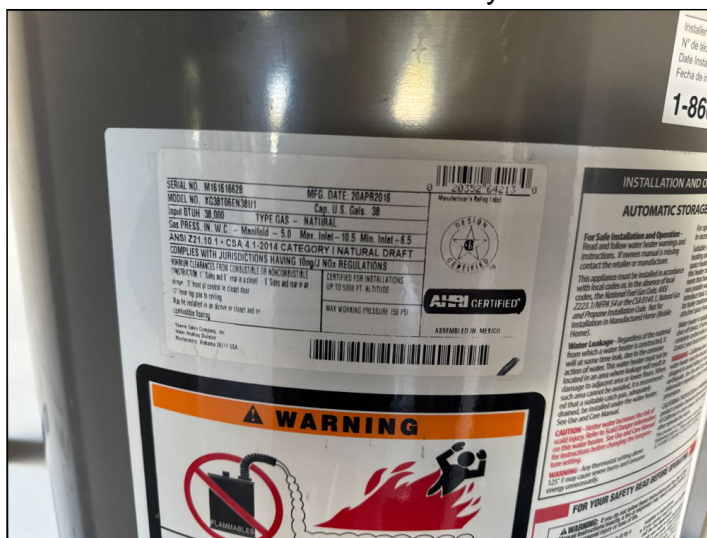
7-10 Years old. Unit is reaching the end of it's useful life. Although no problems may exist at time of inspection, the lifespan of a water heater is normally between 5 to 12 years. You may want to consider replacing with a newer unit for increased efficiency.

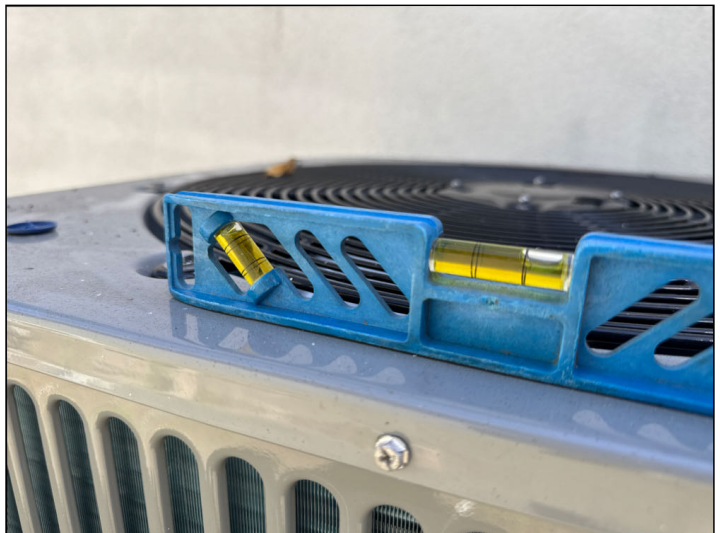
Condenser unit is visibly unlevel and may not allow proper operation of the refrigeration pump. Leveling is recommended.

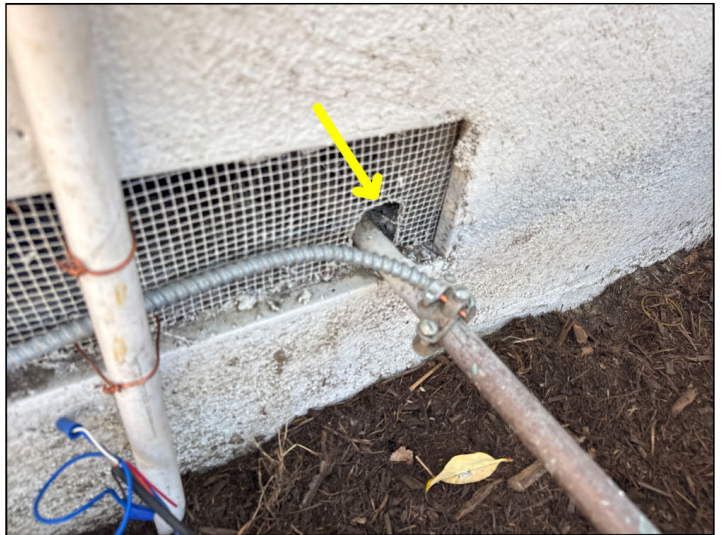
Ventilation screens are damaged or missing.
Repair or replacement is recommended.

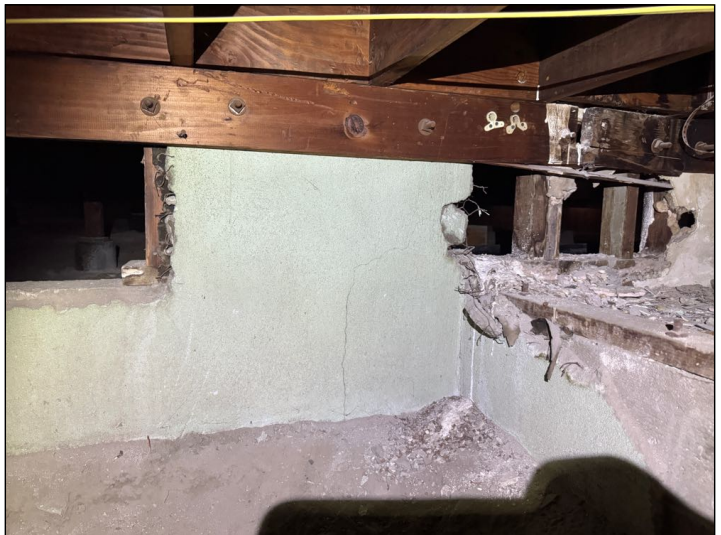
Moisture stains/damage observed at time of inspection.

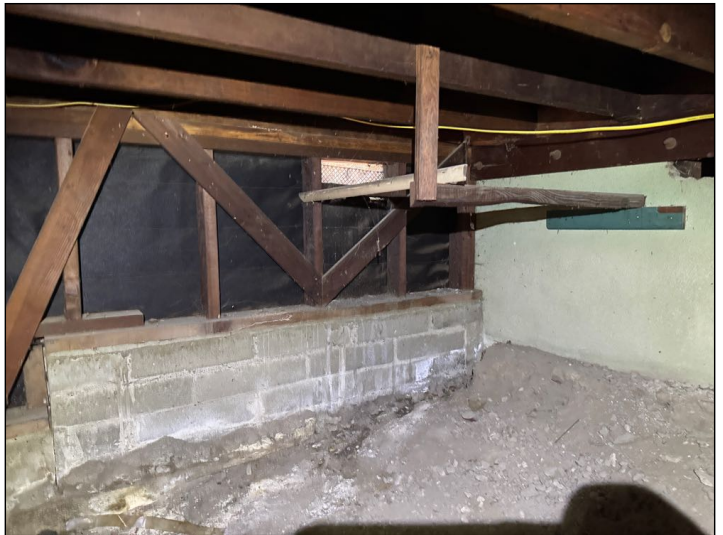
Evidence of prior water penetration is noted.

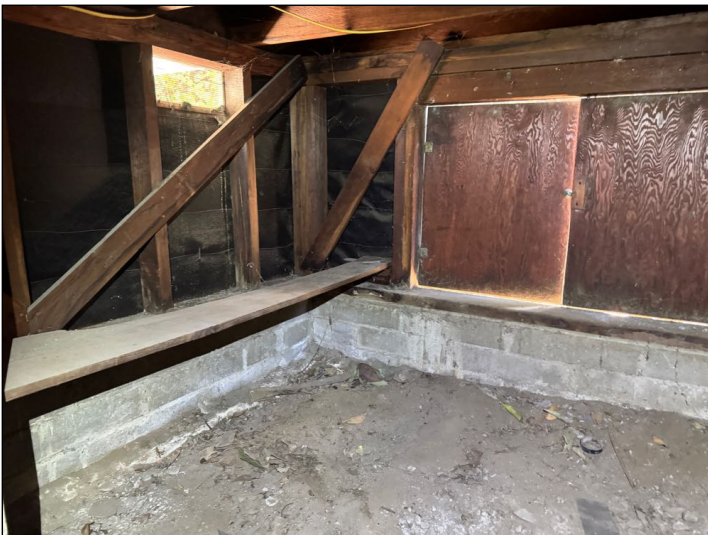
Cripple walls are present, but not braced. Reinforcement is recommended but may not be required.

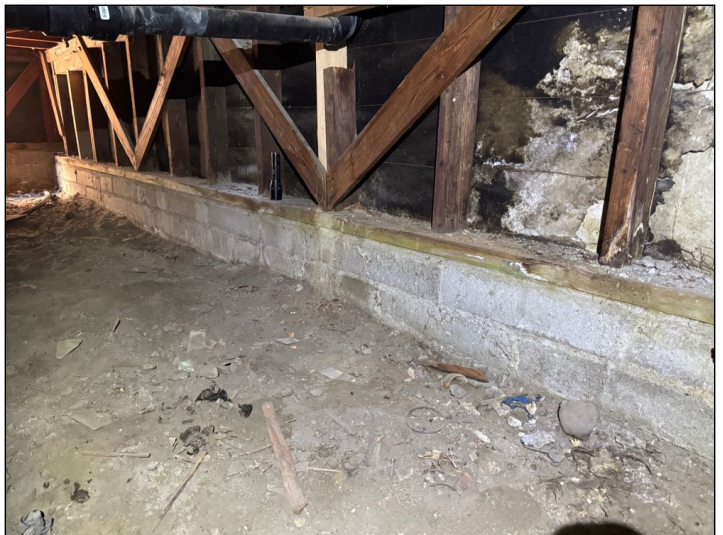
Efflorescence observed on walls indicates the presence of periodic moisture.

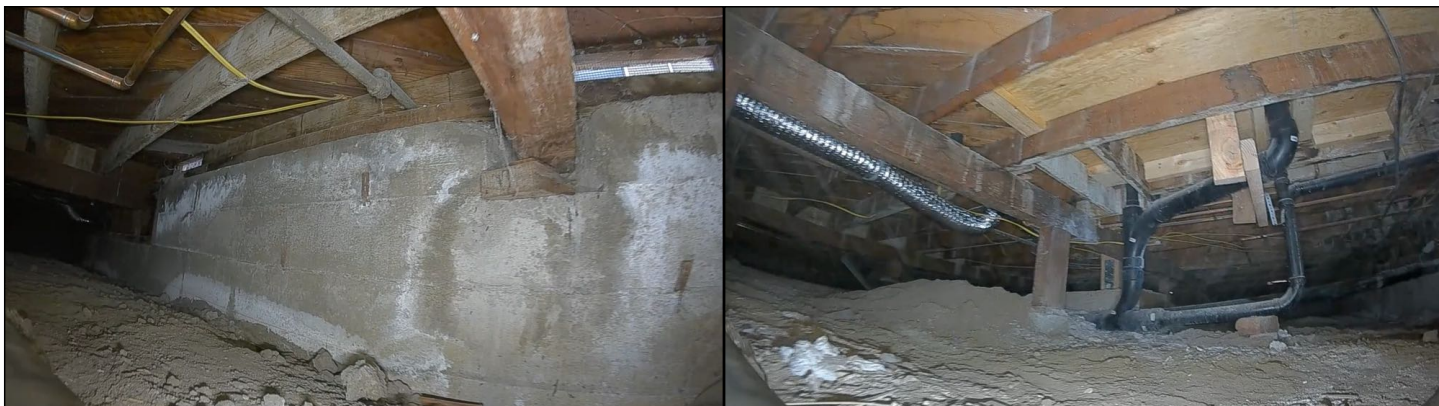
Poor end bearing of the beam was observed.
Installation of additional supports is recommended.

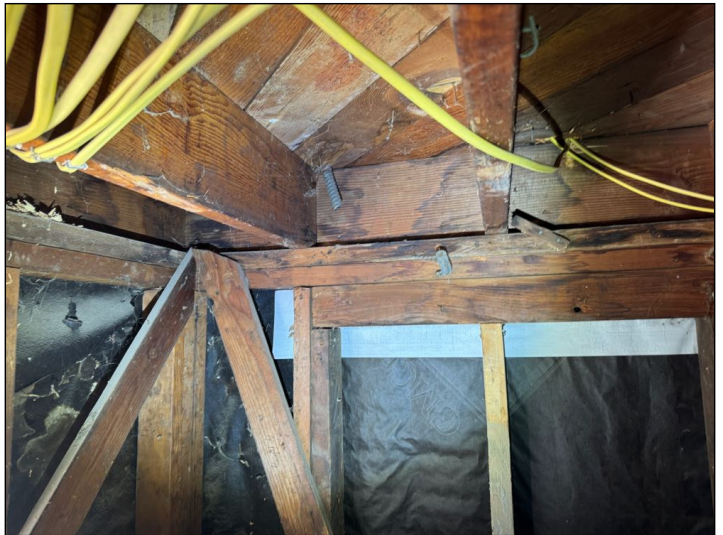
Moisture, rot or termite-like damage noted under the floor joists.

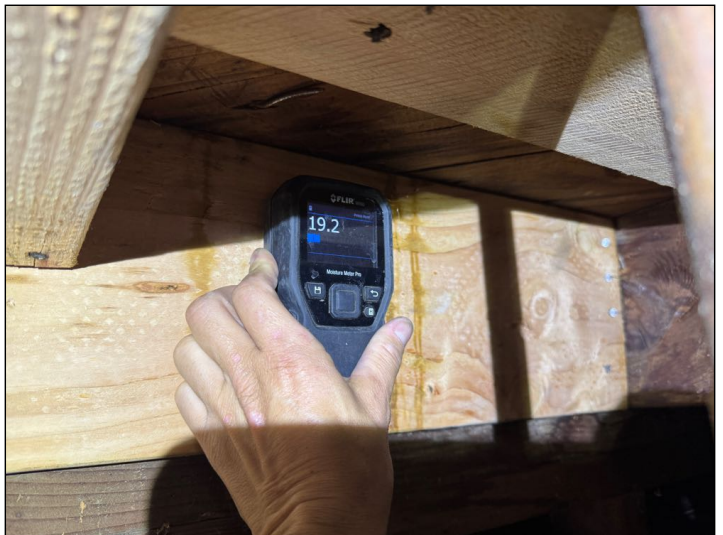
Active moisture intrusion into the building by materials was confirmed at the time of inspection with the use of a moisture meter. Building materials with a moisture content above 20% will allow for mold spores to reproduce. Recommend further evaluation and mold sampling by a qualified contractor prior to the close of your transaction.

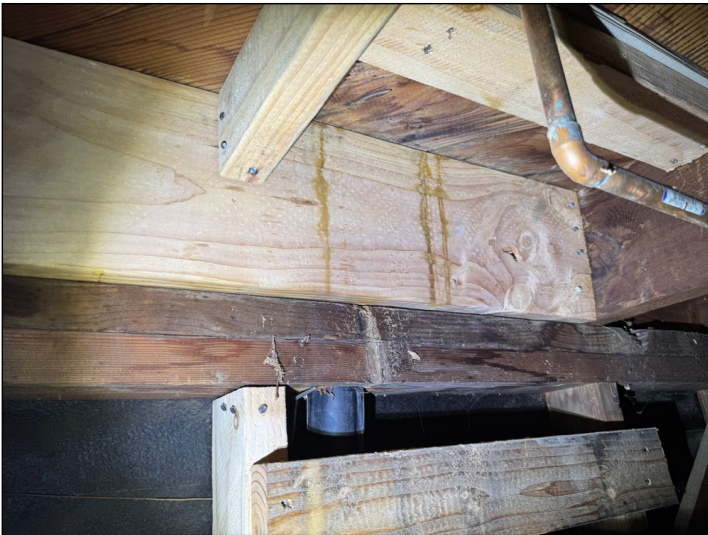
Moisture, rot or termite-like damage noted under the bathroom.

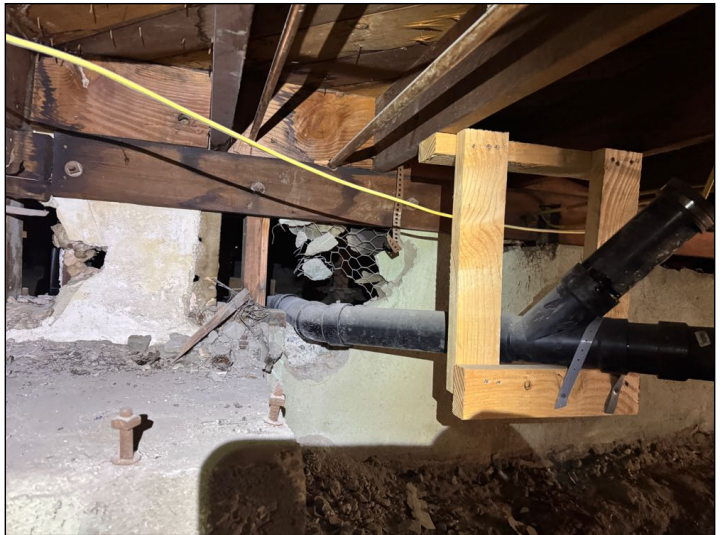
Damage is minor.

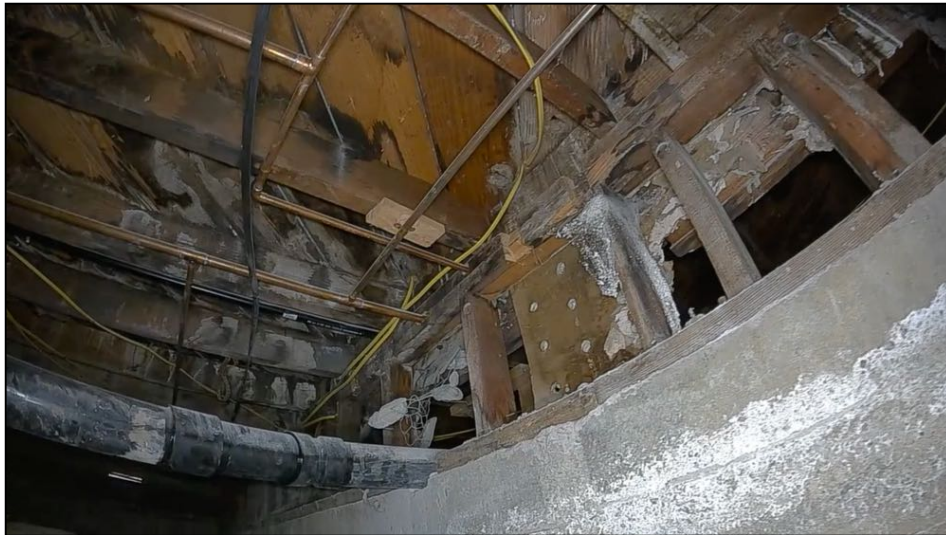
Moisture, rot or termite-like damage noted under the bathroom.

Inspection and repairs by a licensed termite inspector is recommended prior to the close of your transaction.

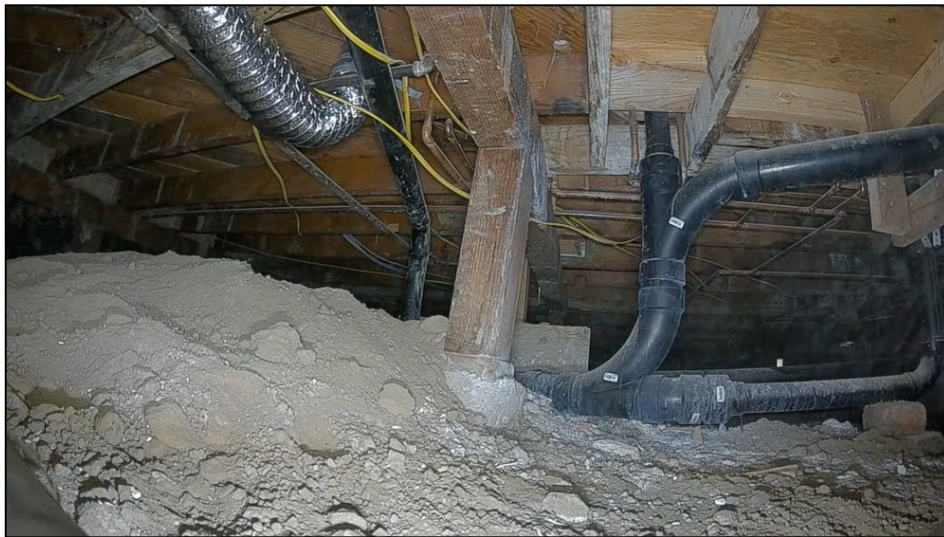
One of more of the wooden posts supporting the floor frame is leaning and or not providing adequate support. Proper installation is necessary to prevent unlevelled floors.

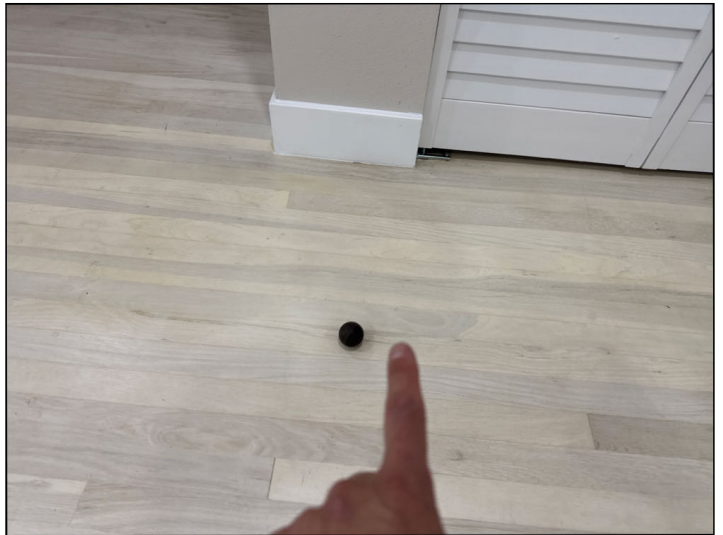
Floor is visibly unlevel. Further evaluation is recommended.

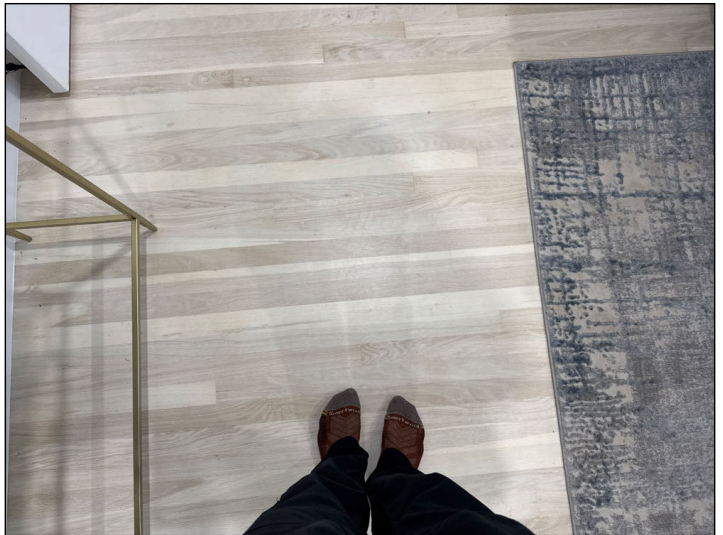
Floor boards are loose and noisy. Repairs are needed.

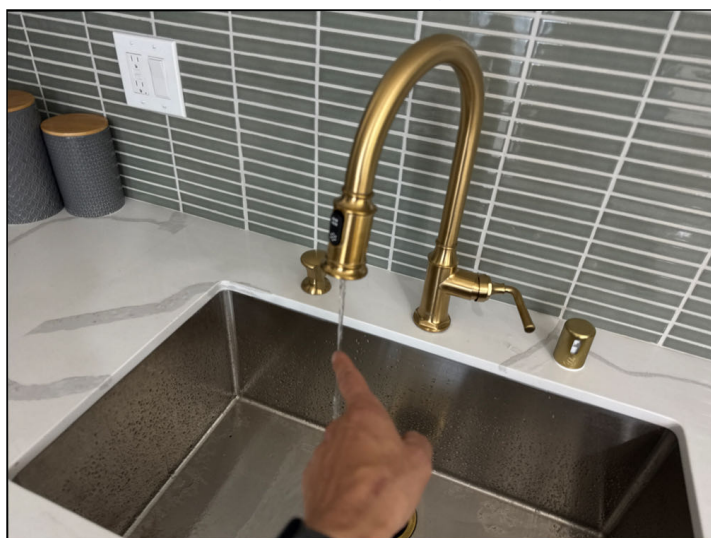
Low water pressure/flow was observed at the faucet at time of inspection. Further evaluation and repairs by a licensed plumbing contractor are recommended prior to the close of your transaction.

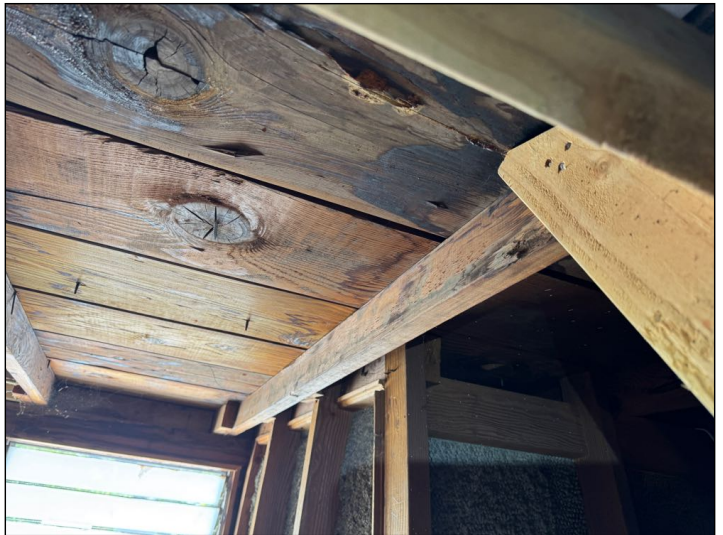
Minor staining was noted on the wood surfaces in the attic, indicating a possible roof leak.

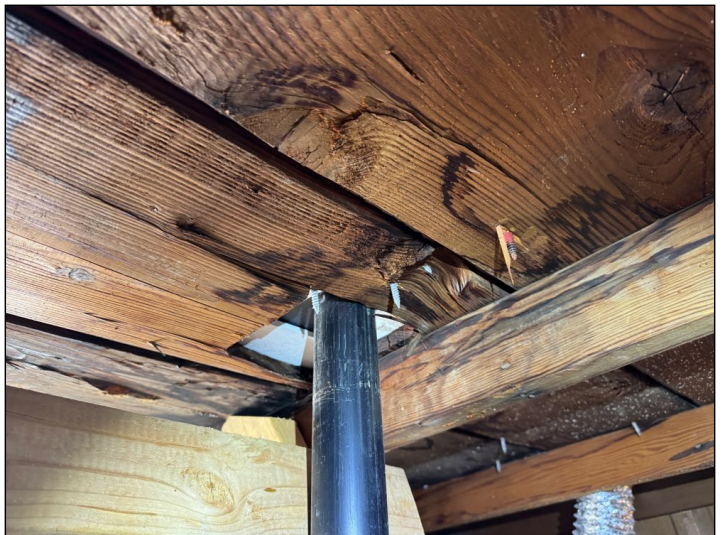
Moisture stains observed at the vent pipes.

Unable to determine the status of the stains.
Active leakage may be present.

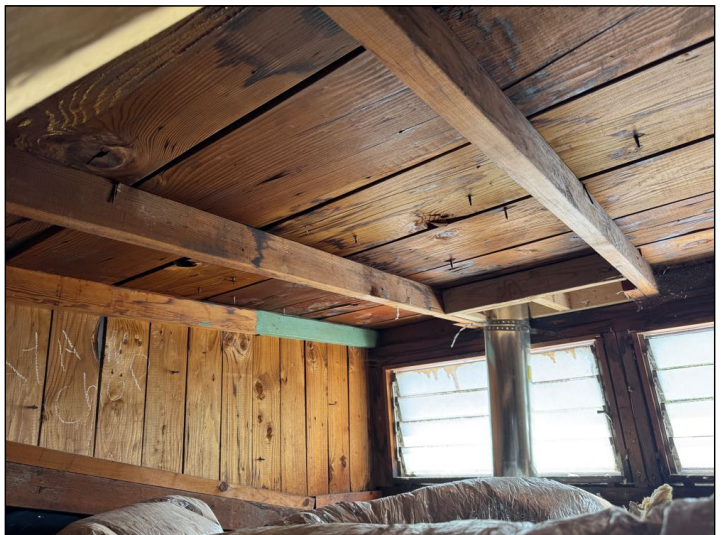
Minor staining was noted on the wood surfaces in the attic, indicating a possible roof leak.

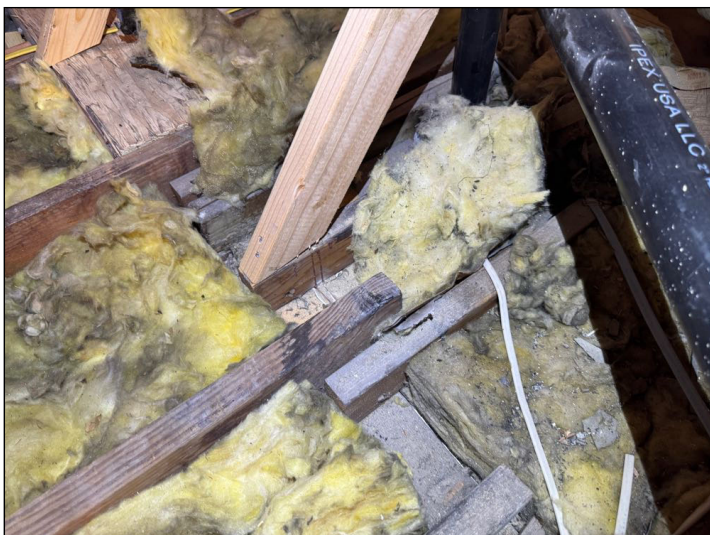
Evidence of rodent activity was noted. You may wish to have treatment carried out by a licensed exterminator.

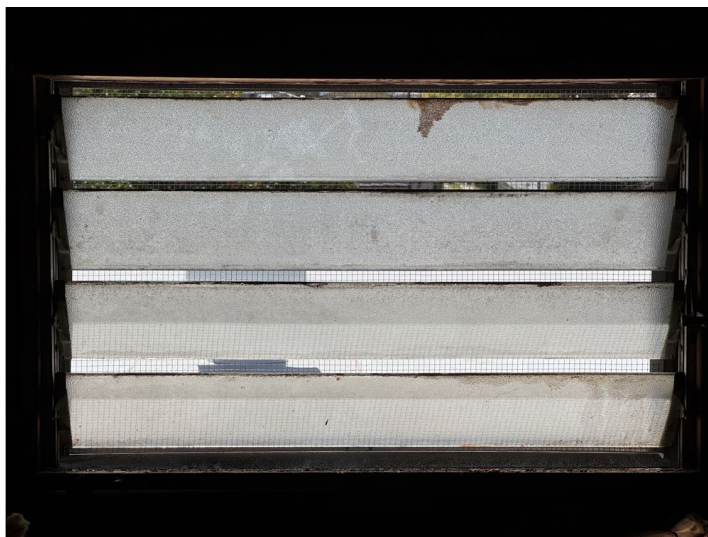
Ventilation screens are damaged and may allow birds or animals into the attic. Proper installation of ventilation screens is recommended.
