# Villa Home Inspections

## Property Inspection Report

12345 Commercial Lane, Los Angeles, CA 90001  
Inspection prepared for: John Doe  
Real Estate Agent: - -

Date of Inspection: 7/30/2019 Time: 11:00 a.m.

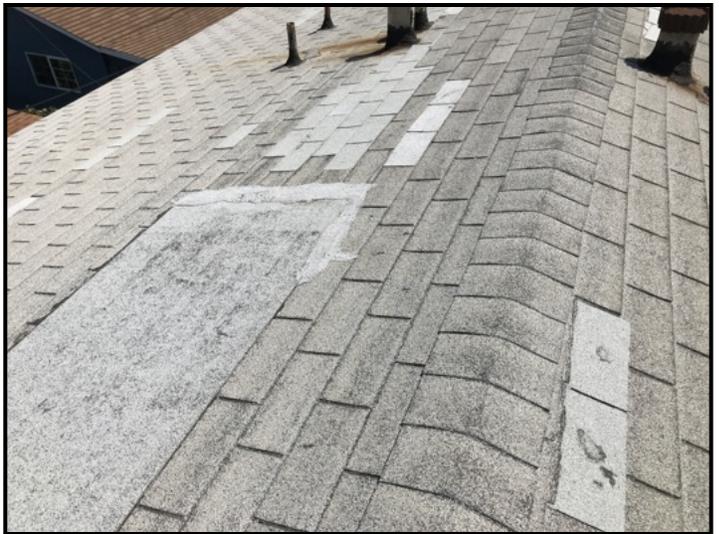
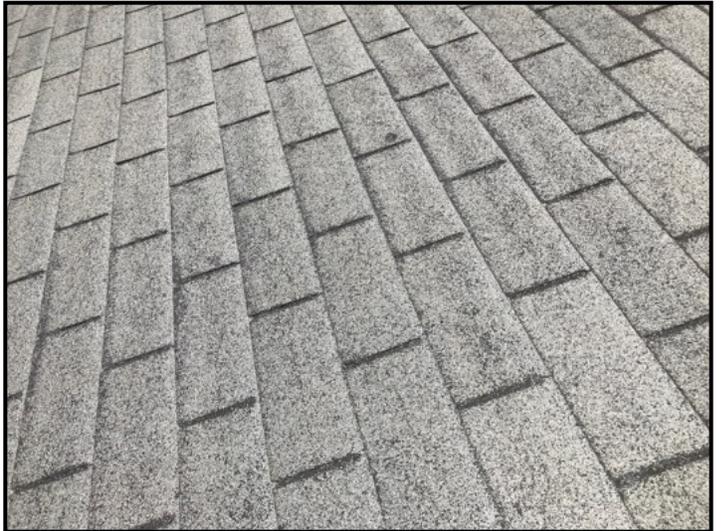
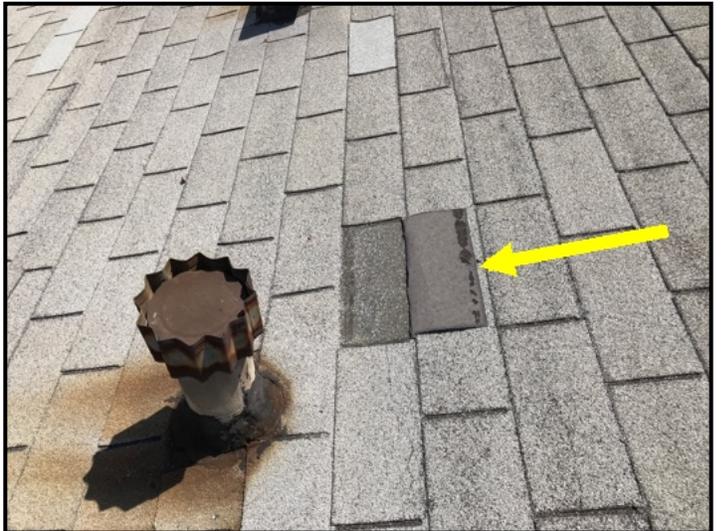
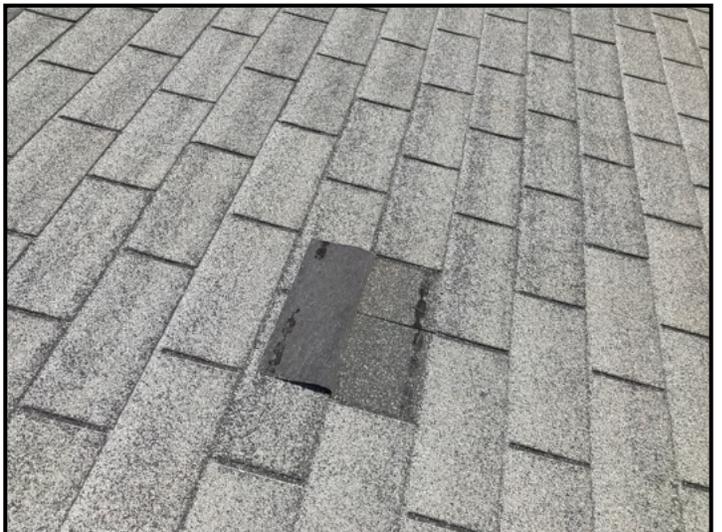
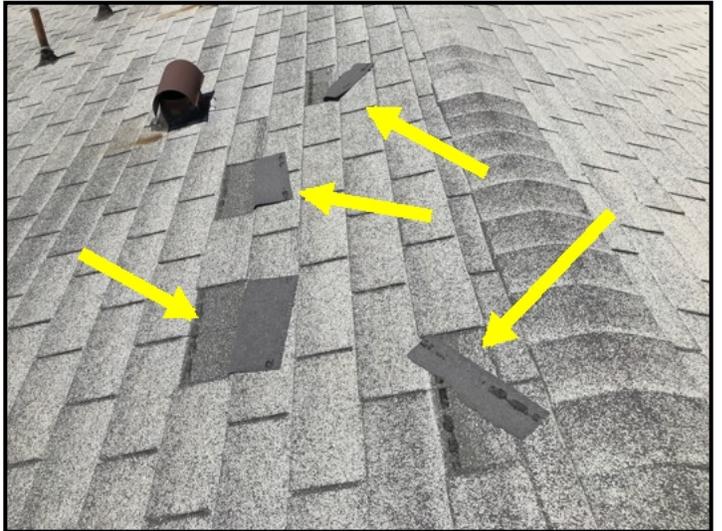
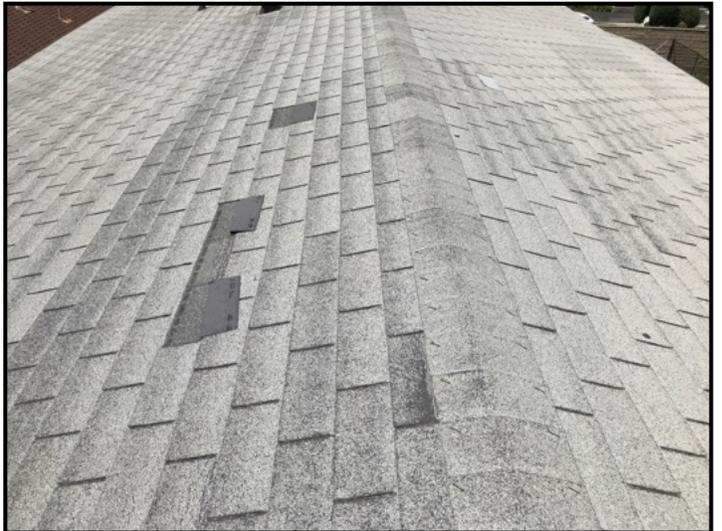
## 4. Covering Condition

- Roofing material appears to be at or near the end of it's useful life.
- Moderate to significant deterioration of the roofing material was noted at time of inspection.
- Evidence of significant prior patching and/or repairs was noted at time of inspection.
- Evidence of improper roof drainage observed on the roof surface. Pooling water can cause deterioration of the roofing material and leaks. See photos.
- Damaged or missing shingles noted. Repair or replacement is needed.
- A licensed roofing contractor should be called to make further evaluation and repairs as needed.
- See photos.

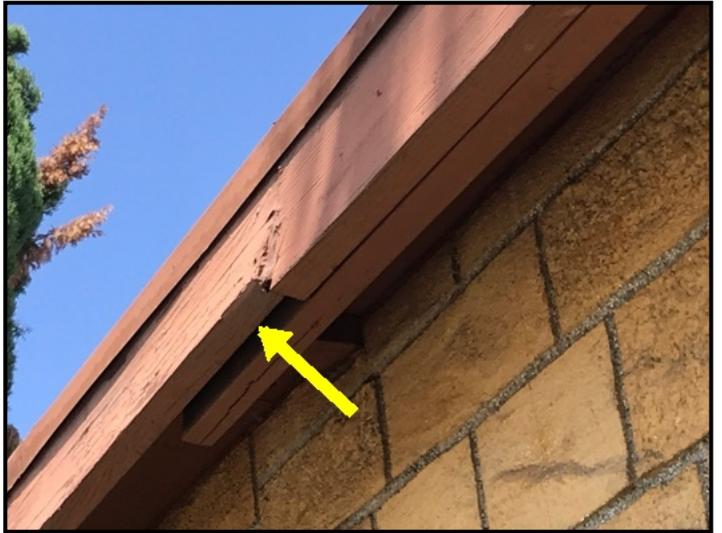
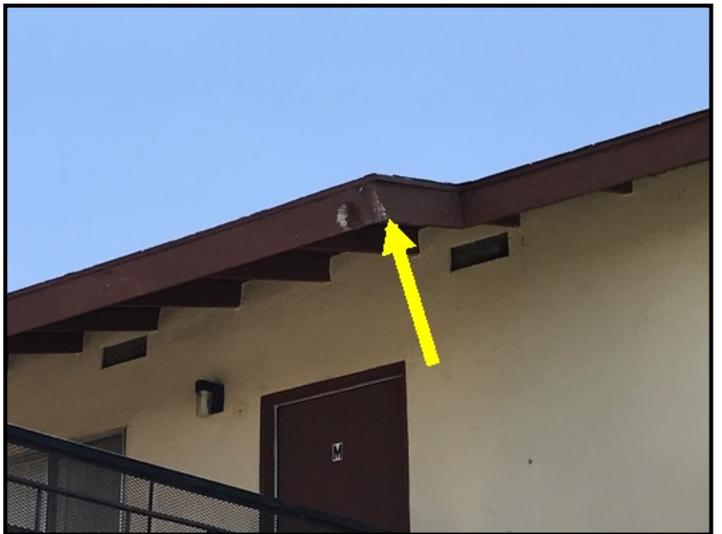
## 5. Roof Eaves Condition

- Moisture, rot or termite-like damage observed at the roof eave boards.
- Fascia boards are twisted and loose. See photo. Repair or replacement is recommended.
- Damage appears to be significant and will most likely require replacement of wood boards.
- Fascia boards are loose and or damaged. Repair or replacement is recommended.
- Further evaluation by a licensed termite inspector is recommended.
- See photos.

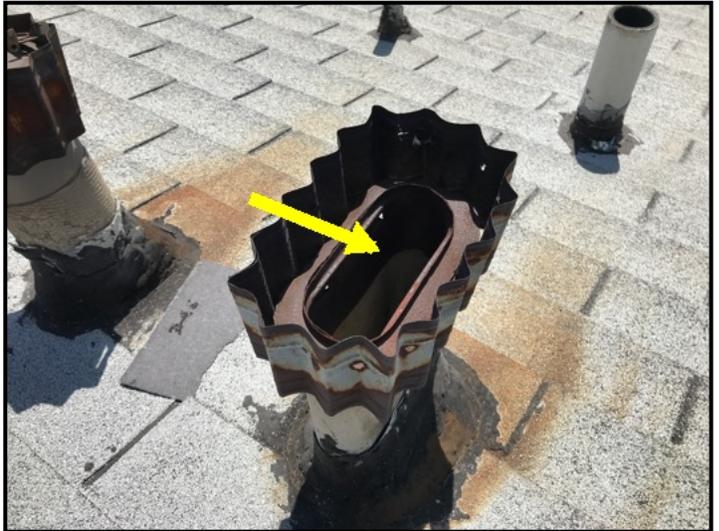
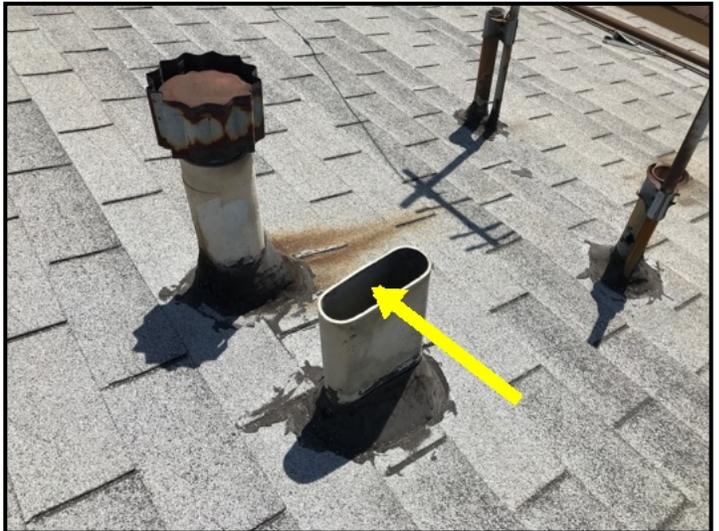
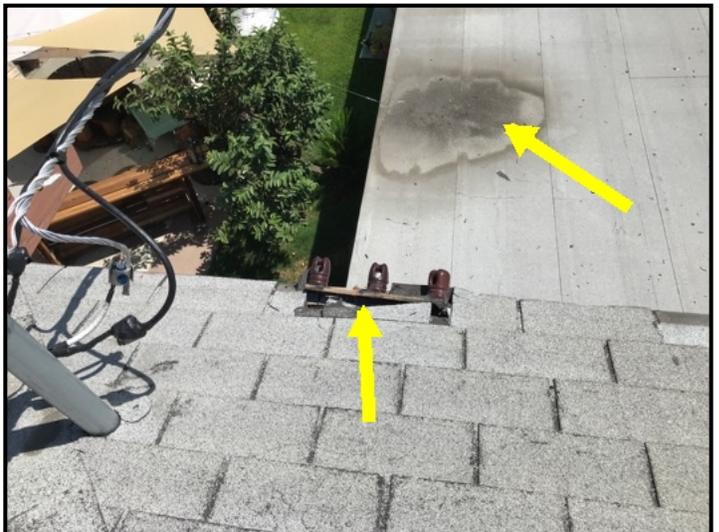
## 6. Flashings Condition

- Rusty flashing is noted.
- Flashing is not installed at the electrical service entrance mast.
- Flashings do not appear to be properly sealed at the vent pipes.
- Vent caps are missing on the heater vent pipes throughout the roof. Installation is recommended to prevent moisture penetration.
- A licensed roofing contractor should be called to make further evaluation and repairs as needed.
- See photos.

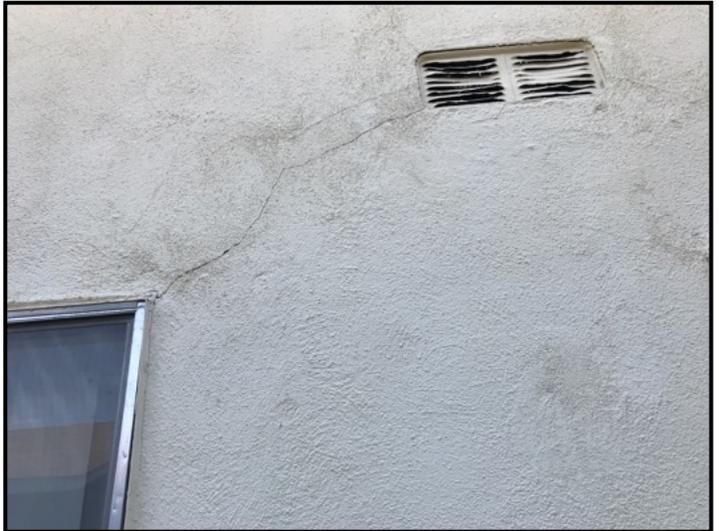
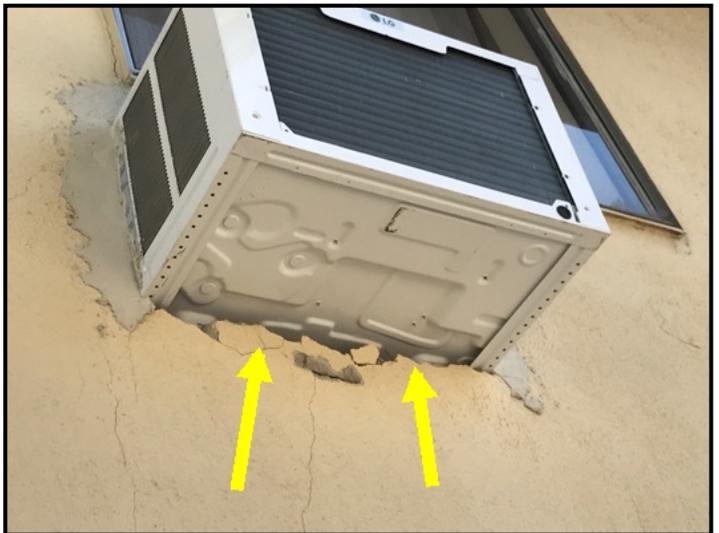
- Cracks are typical and not structurally significant.
- Cosmetic damage observed on the walls at time of inspection. Patching and re-painting is recommended.
- Wall is damaged and not properly sealed at the east side of the building due to a couple wall air conditioners installed. See photo. Proper patching is necessary to prevent moisture penetration and damage.

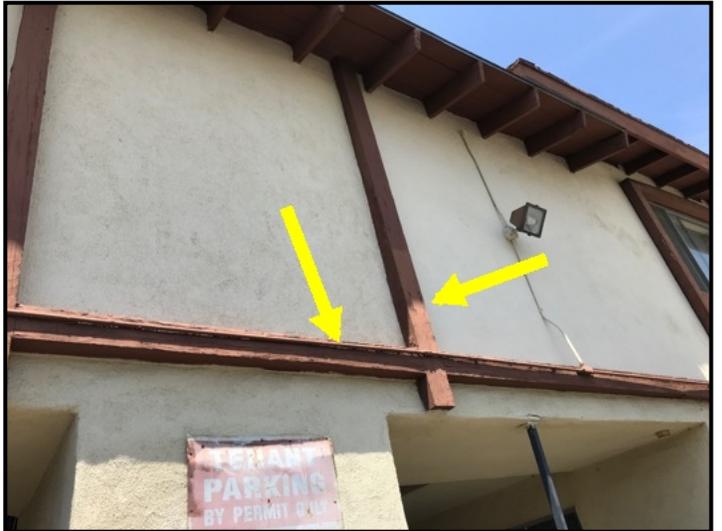
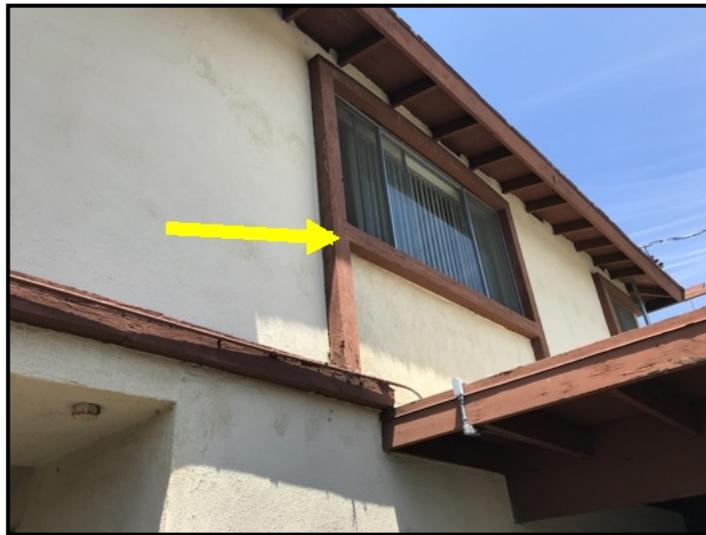
### 7. Wall Trim Condition

- Caulking is needed at the trim, windows or doors to prevent moisture penetration and damage.
- Paint finish is deteriorated or flaking. Repainting is recommended to prevent moisture damage.

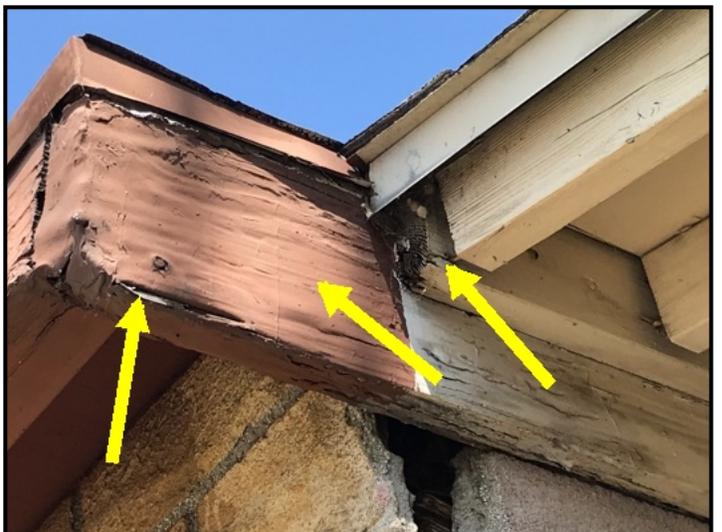
### 8. Miscellaneous

- Termite-like damage observed at the trash area wood structure. See photo. Further evaluation by a licensed termite inspector is recommended.

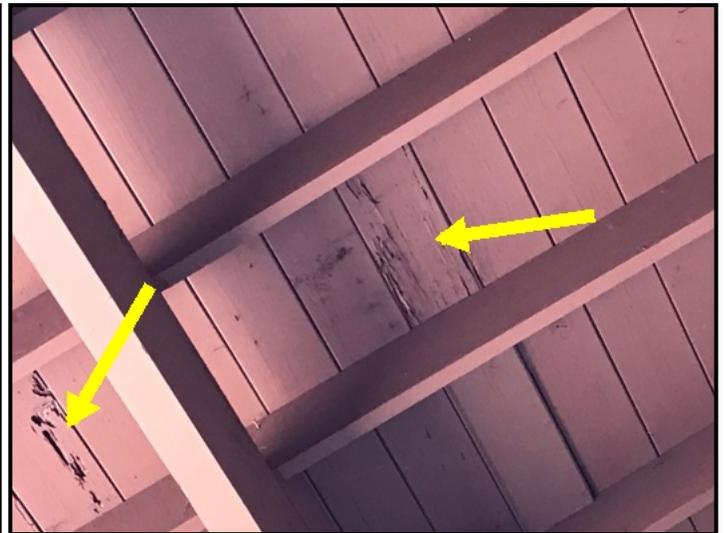
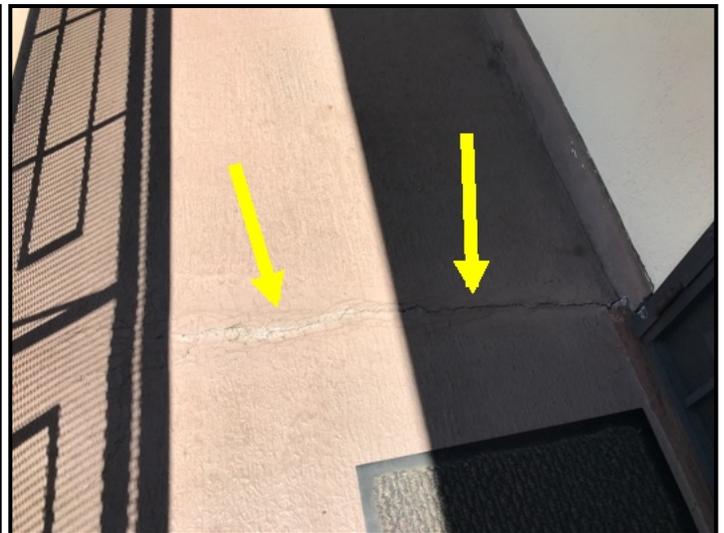
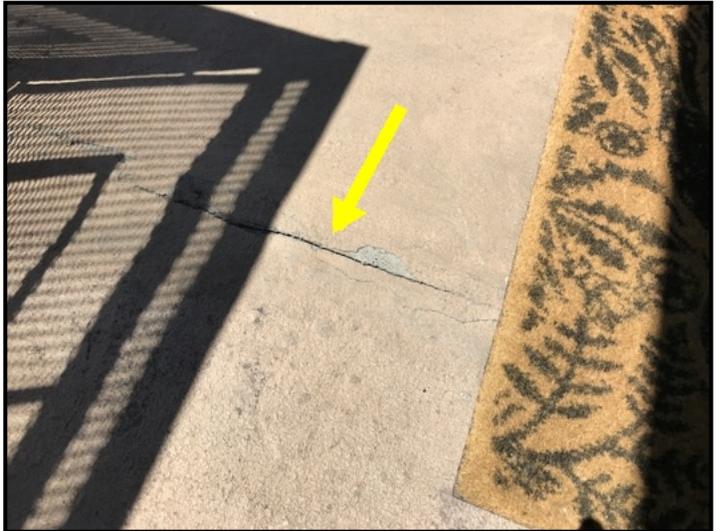
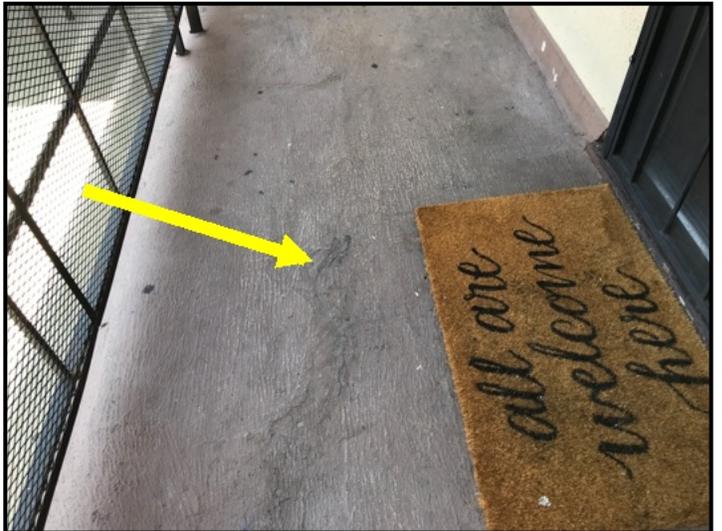
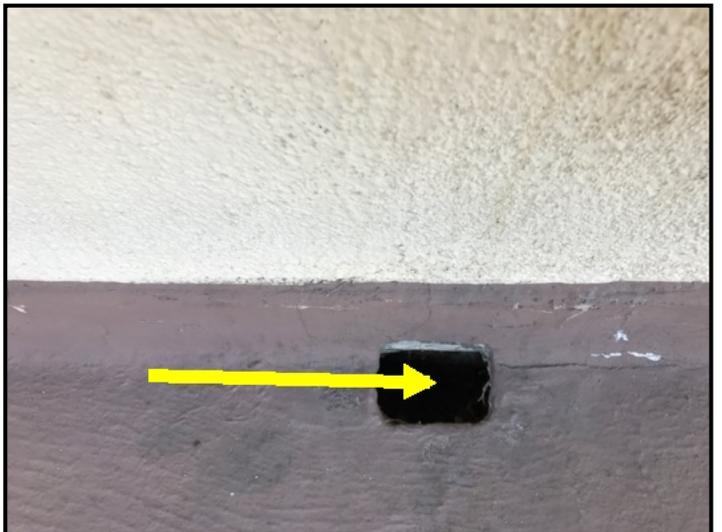
- **Floor Condition:**
- Significant cracks and deterioration observed at the balcony floor throughout the building. See photos. Resurfacing is recommended.
- Floor drains throughout the balcony do not have downspouts below. This can cause water damage on the floor system below. See photos.
- Further evaluation by a licensed contractor is recommended.
- See photos.
- **Cover Condition:**
- Rot, termite or moisture damage observed. Further evaluation by a licensed termite inspector is recommended.

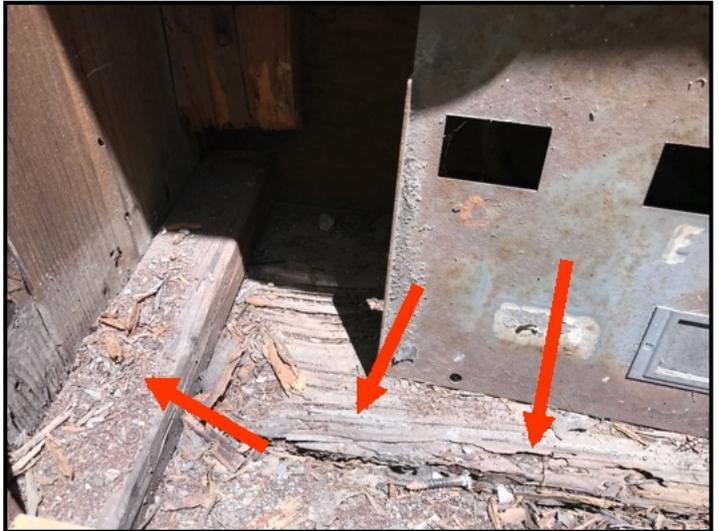
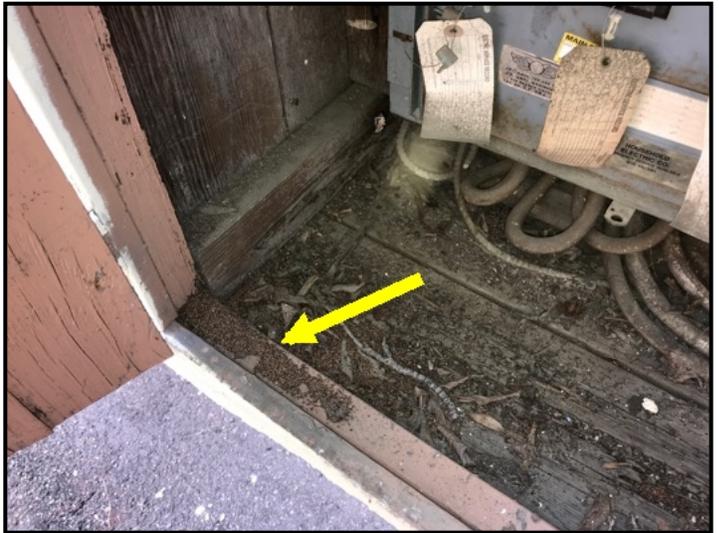
- Wood enclosures surrounding the main shut offs rot and termite damage. Inspection and or repair and replacement by a licensed termite and or general contractor is recommended.

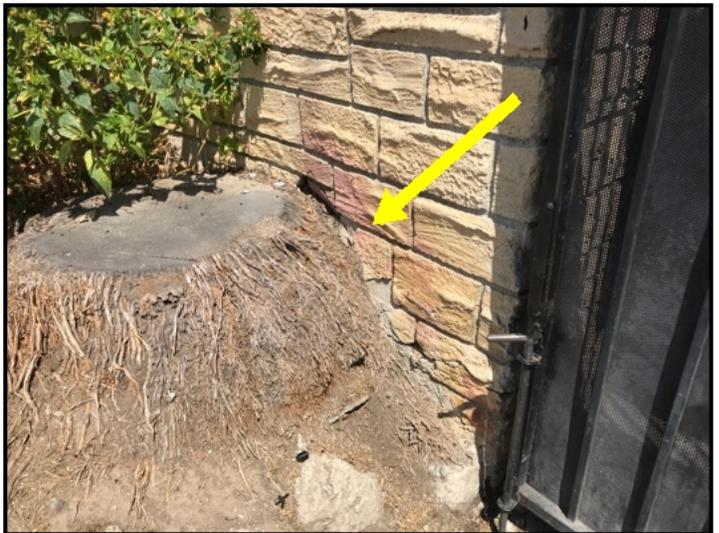
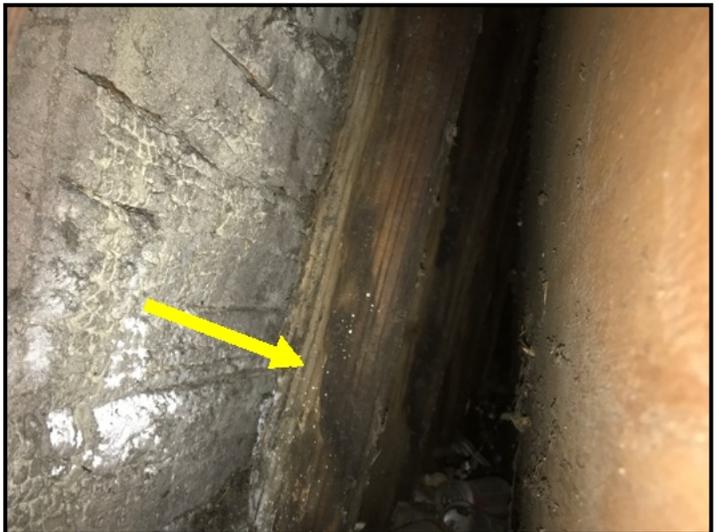
## 3. Walls & Ceiling

Observations:  
• Tree root damage observed at the south east carport wall. See photo. Removal of the tree stump is recommended  
• Significant termite like activity observed at the east carport wall. Wall is not fully visible due to plywood paneling. However, plywood paneling is loose and falling off. See photos.

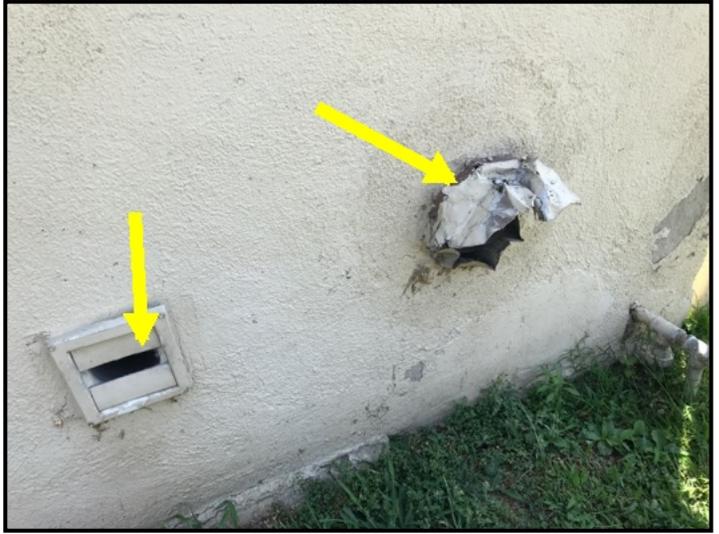
- Gas service pipe is provided.
- Dryer venting is damaged. Replacement is necessary.
- Drain line does not have a P-trap installed and may allow sewer gases to escape.

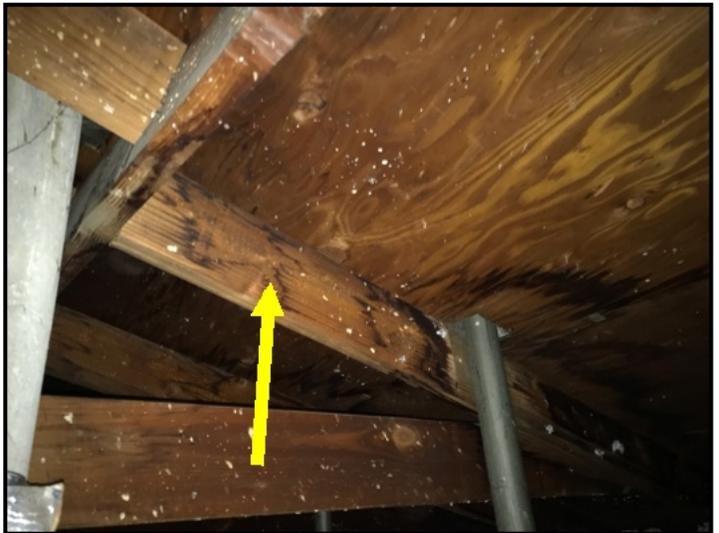
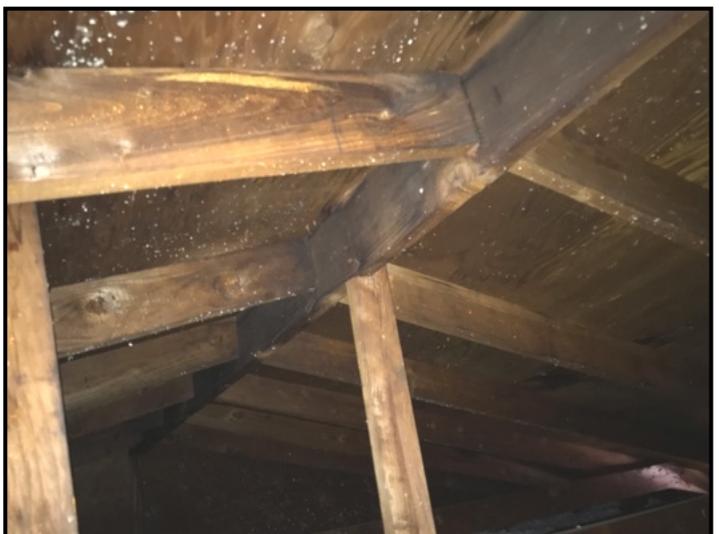
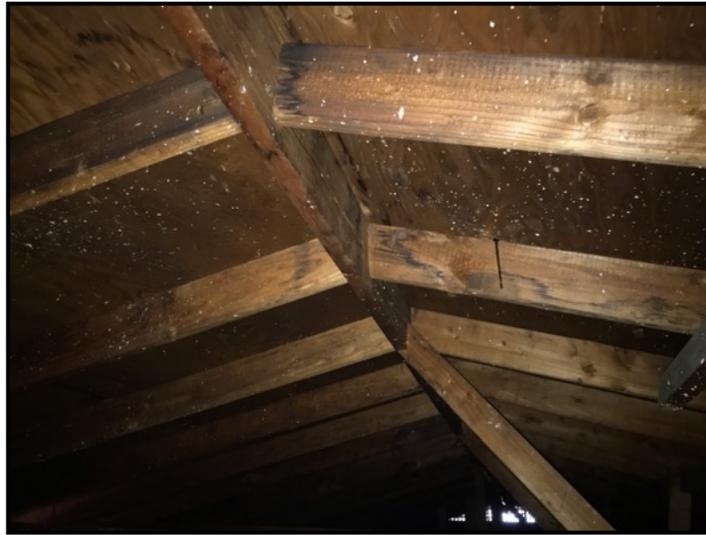
- No visible structural problems noted at time of inspection.
- Attic is accessible from more than one dwelling and there is no partition inside the attic. This poses a security problem to the occupants. It is recommended that locking hardware be installed on all attic access panels as a security enhancement.
- Moisture stains observed at the vent pipes.
- Unable to determine the status of the stains. Active leakage may be present.
- Termite-like activity observed in the attic area at time of inspection. Further evaluation by licensed termite inspector is recommended.
- Recommend further evaluation by a licensed roofing contractor.
- See photos.

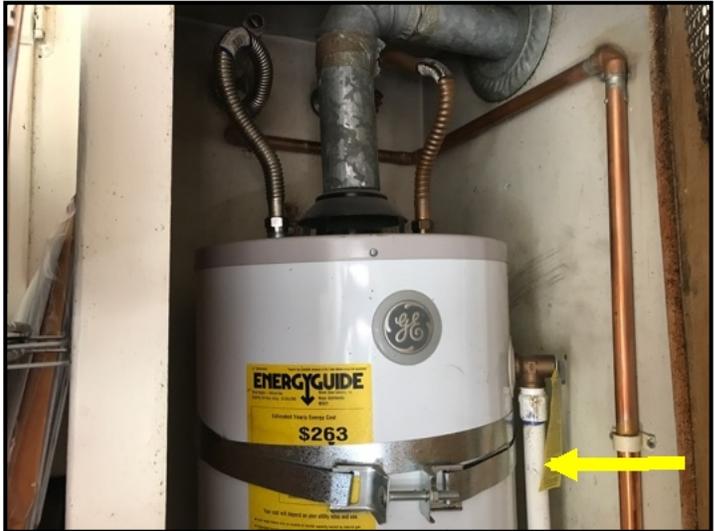
- Operated properly at time of the inspection.
- Temperature pressure relief valve discharge line is not installed. This is a potential hazard. Installation is required.

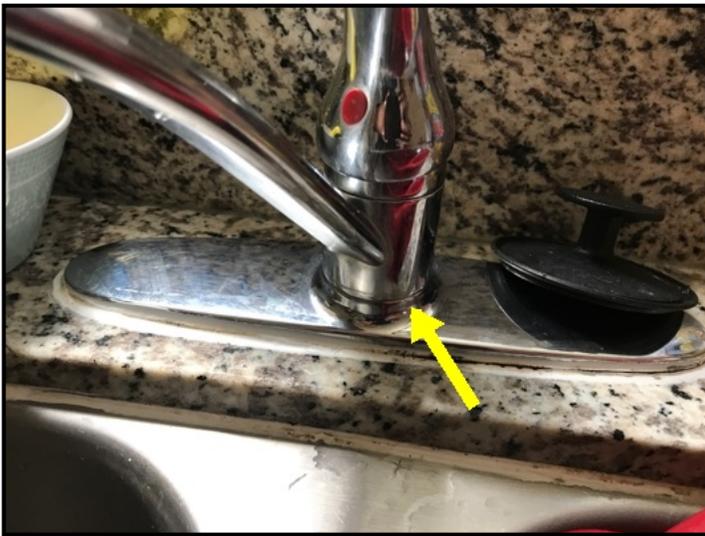
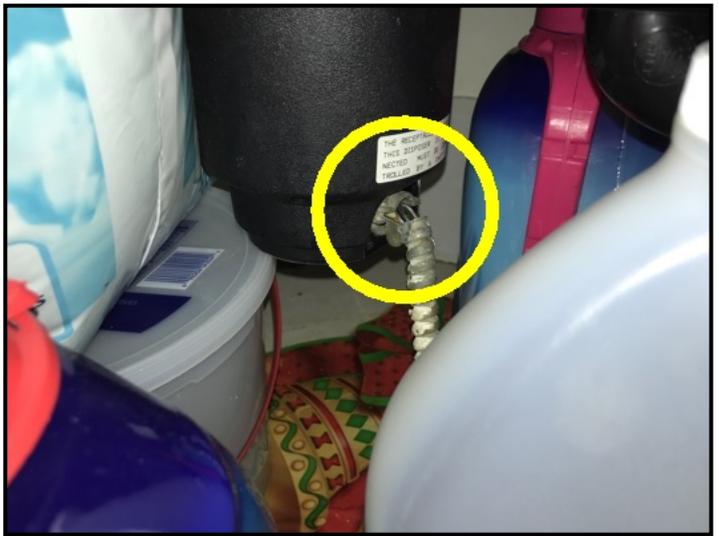
- No visible problems noted at the counters and cabinets at time of inspection.
- Windows and doors operated properly at time of inspection.
- Walls and ceiling appeared functional at time of inspection.
- No visible problems noted at the floor at time of inspection.
- **Faucet is loose. Proper installation is necessary.**
- **Exhaust fan did not operate.**
- **Exposed wiring observed at the garbage disposal. This is a potential hazard. Proper installation is required.**

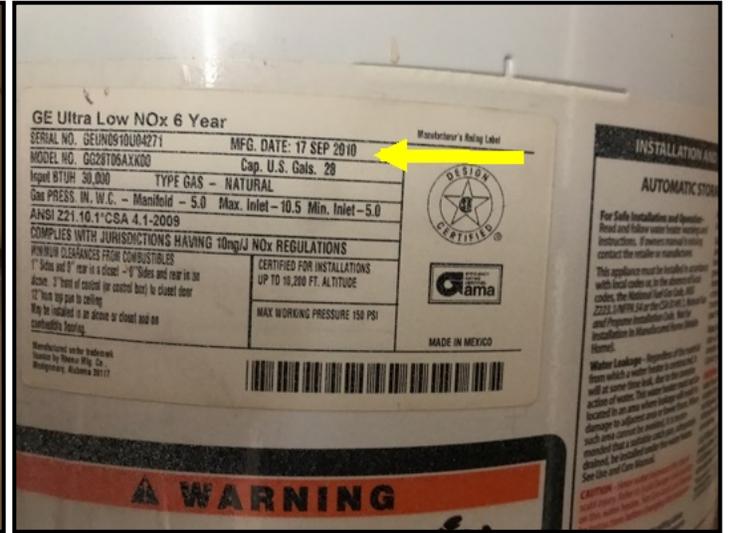
- Operated properly at time of the inspection.
- Temperature pressure relief valve discharge line is not installed. This is a potential hazard. Installation is required.

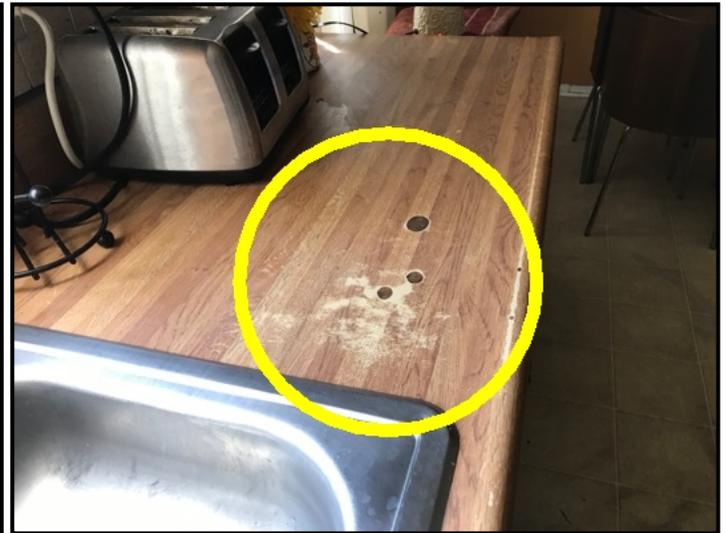
- Walls and ceiling appeared functional at time of inspection.
- A representative number of outlets, switches and fixtures was operated and found to be in operable condition at time of inspection.
- Minor to moderate wear and or damage observed on the kitchen counter top. Repair or replacement is recommended.
- Drawers are damaged or difficult to operate.
- Flooring is damaged or deteriorated. Repair or replacement is recommended.
- Exposed wiring observed at the garbage disposal. This is a potential hazard. Proper installation is required.
- See photos.

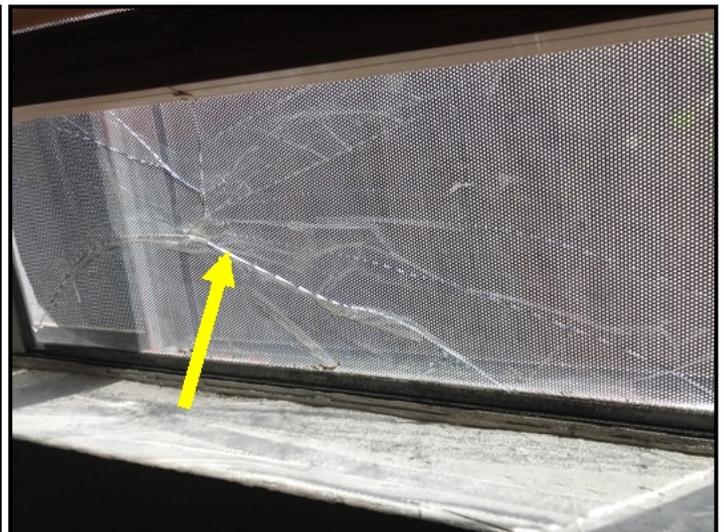
- Windows and doors operated properly at time of inspection.
- Walls and ceiling appeared functional at time of inspection.
- No visible problems noted at the floor at time of inspection.
- A representative number of outlets, switches and fixtures was operated and found to be in operable condition at time of inspection.
- **Smoke detector is not installed. A smoke detector is required in every bedroom, adjacent hallway and every level of the dwelling prior to the close of escrow.**
- **Window glass is cracked or broken. Replacement is required.**
- **Closet doors are fallen off the tracks. Proper installation is recommended.**
- **Improper installation of a light fixture on the ceiling. See photo. Proper installation or removal is required.**

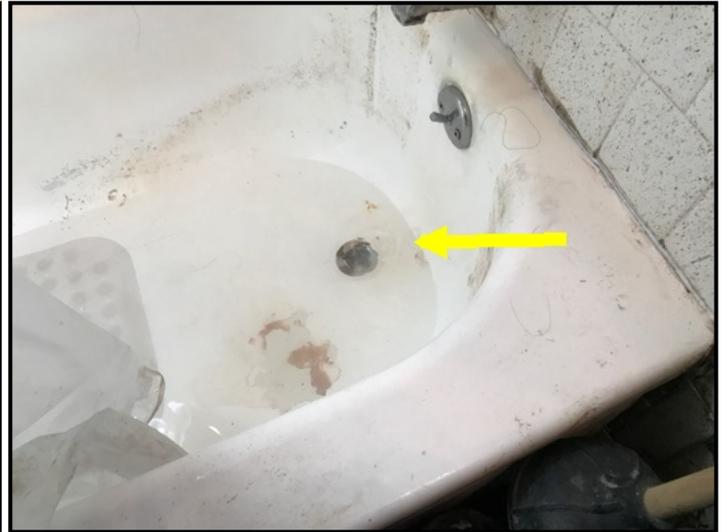
## 6. Bathrooms

- Windows and doors operated properly at time of inspection.
- Walls and ceiling appeared functional at time of inspection.
- No visible floor problems noted at time of inspection.
- No visible electrical problems observed at time of inspection.
- **Tub faucet leaks when operated.**
- **Tub does not drain properly.**
- **Further evaluation and repairs as needed by a plumbing contractor is recommended.**
- **Caulking is recommended at the tub or shower areas to prevent moisture penetration and damage behind the walls.**
- **Ground Fault Circuit Interrupter (GFCI) outlets are recommended for installation.**

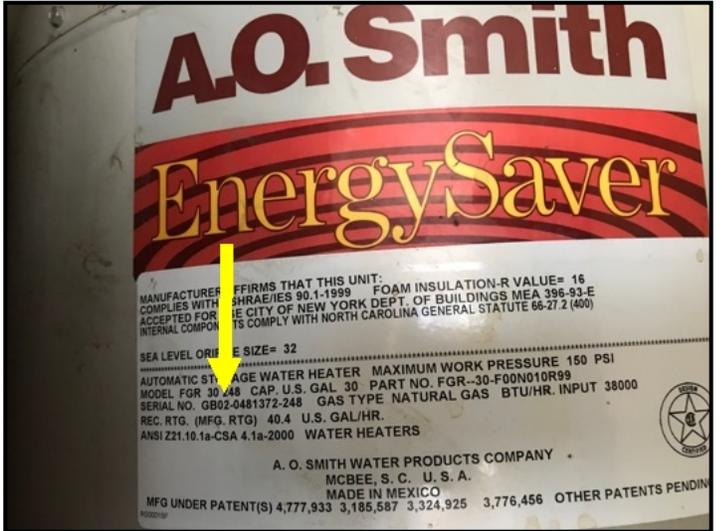
## 7. Heating System Condition

- Operated properly at time of the inspection.
- **Seismic straps are not installed on the heater. Installation of approved straps is required prior to the close of escrow.**
- **Temperature pressure relief valve discharge line is not installed. This is a potential hazard. Installation is required.**
- **Further evaluation and repairs by a plumbing contractor is recommended.**
- **See photo.**

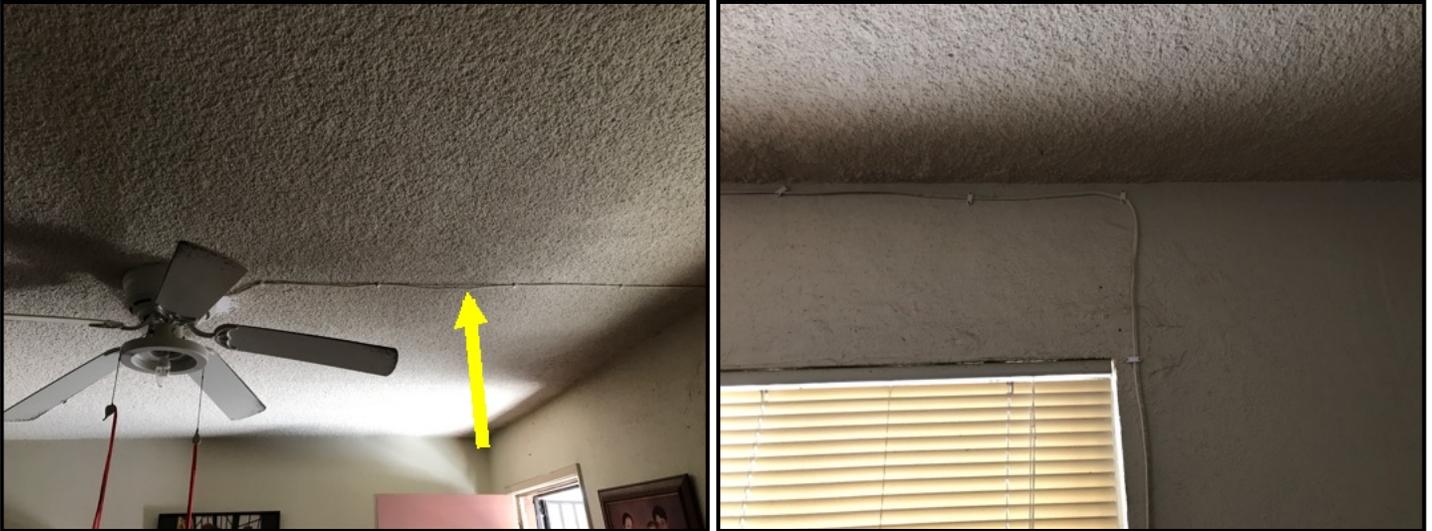
### 1. Living & Dining Room

- Windows and doors operated properly at time of inspection.
- Walls and ceiling appeared functional at time of inspection.
- No visible problems noted at the floor at time of inspection.
- A representative number of outlets, switches and fixtures was operated and found to be in operable condition at time of inspection.
- **Improperly installed light fixture observed at the ceiling and wall. Proper installation or removal is necessary.**

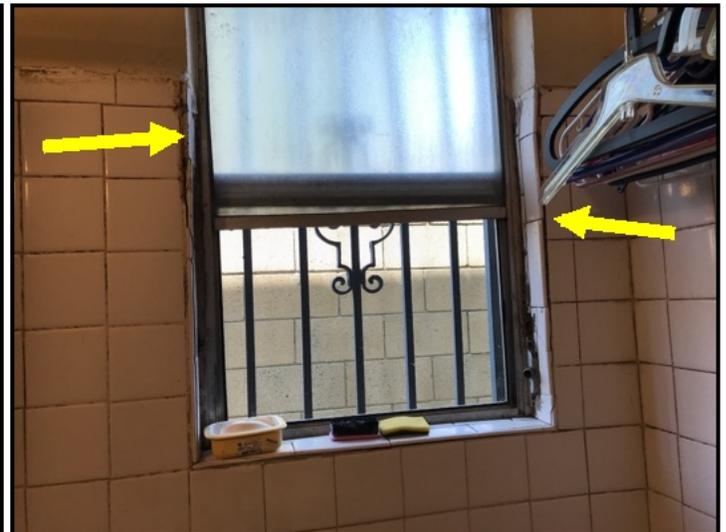
- No visible plumbing problems noted at time of inspection.
- Windows and doors operated properly at time of inspection.
- Walls and ceiling appeared functional at time of inspection.
- No visible floor problems noted at time of inspection.
- No visible electrical problems observed at time of inspection.
- Tub surround wall tiles are loose and or damaged. Repair or replacement is recommended.
- Ground Fault Circuit Interrupter (GFCI) outlets are recommended for installation.

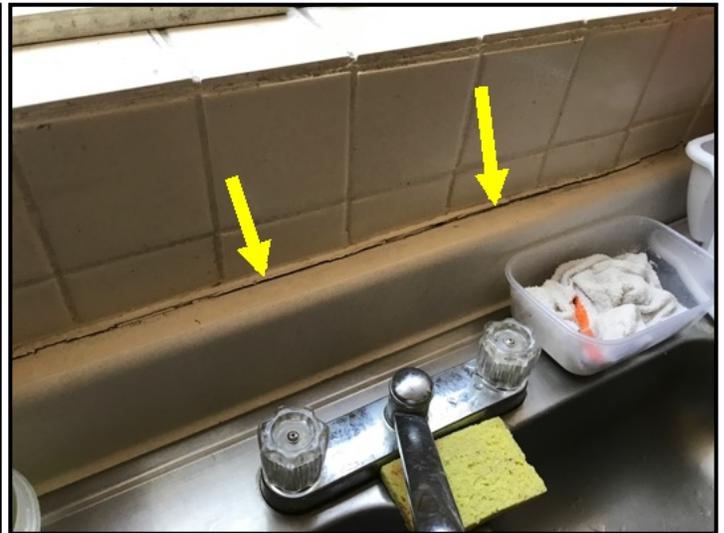
- **A licensed plumbing contractor should be called to make necessary repairs.**
- **See photos.**

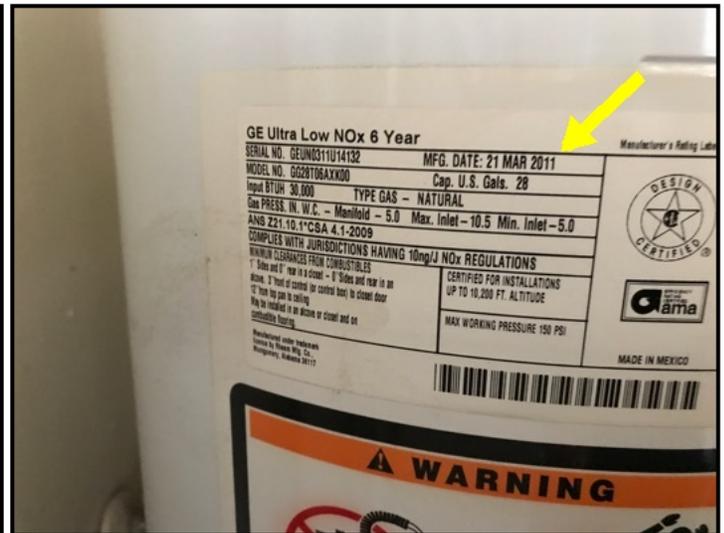
- Operated properly at time of the inspection.
- **Temperature pressure relief valve discharge line is not installed. This is a potential hazard. Installation is required.**

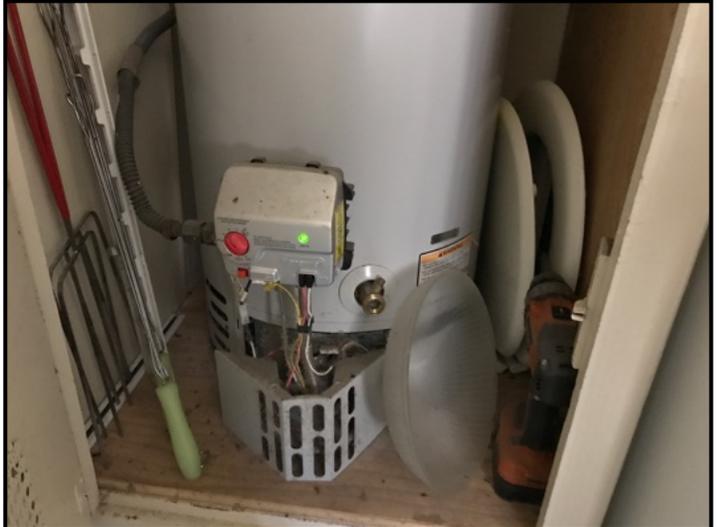
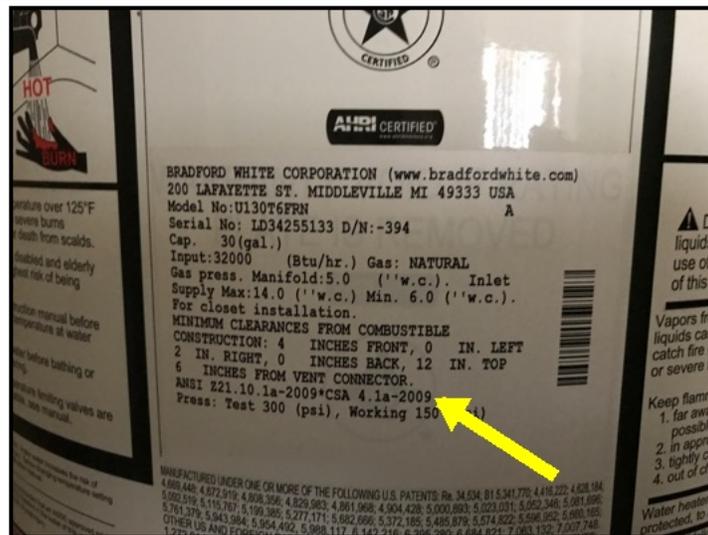
- Operated properly at time of the inspection.
- **Temperature pressure relief valve discharge line is not installed. This is a potential hazard. Installation is required.**

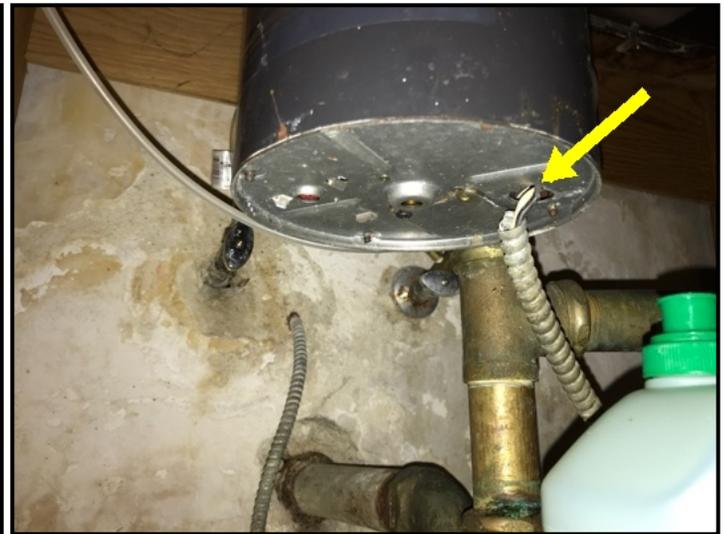
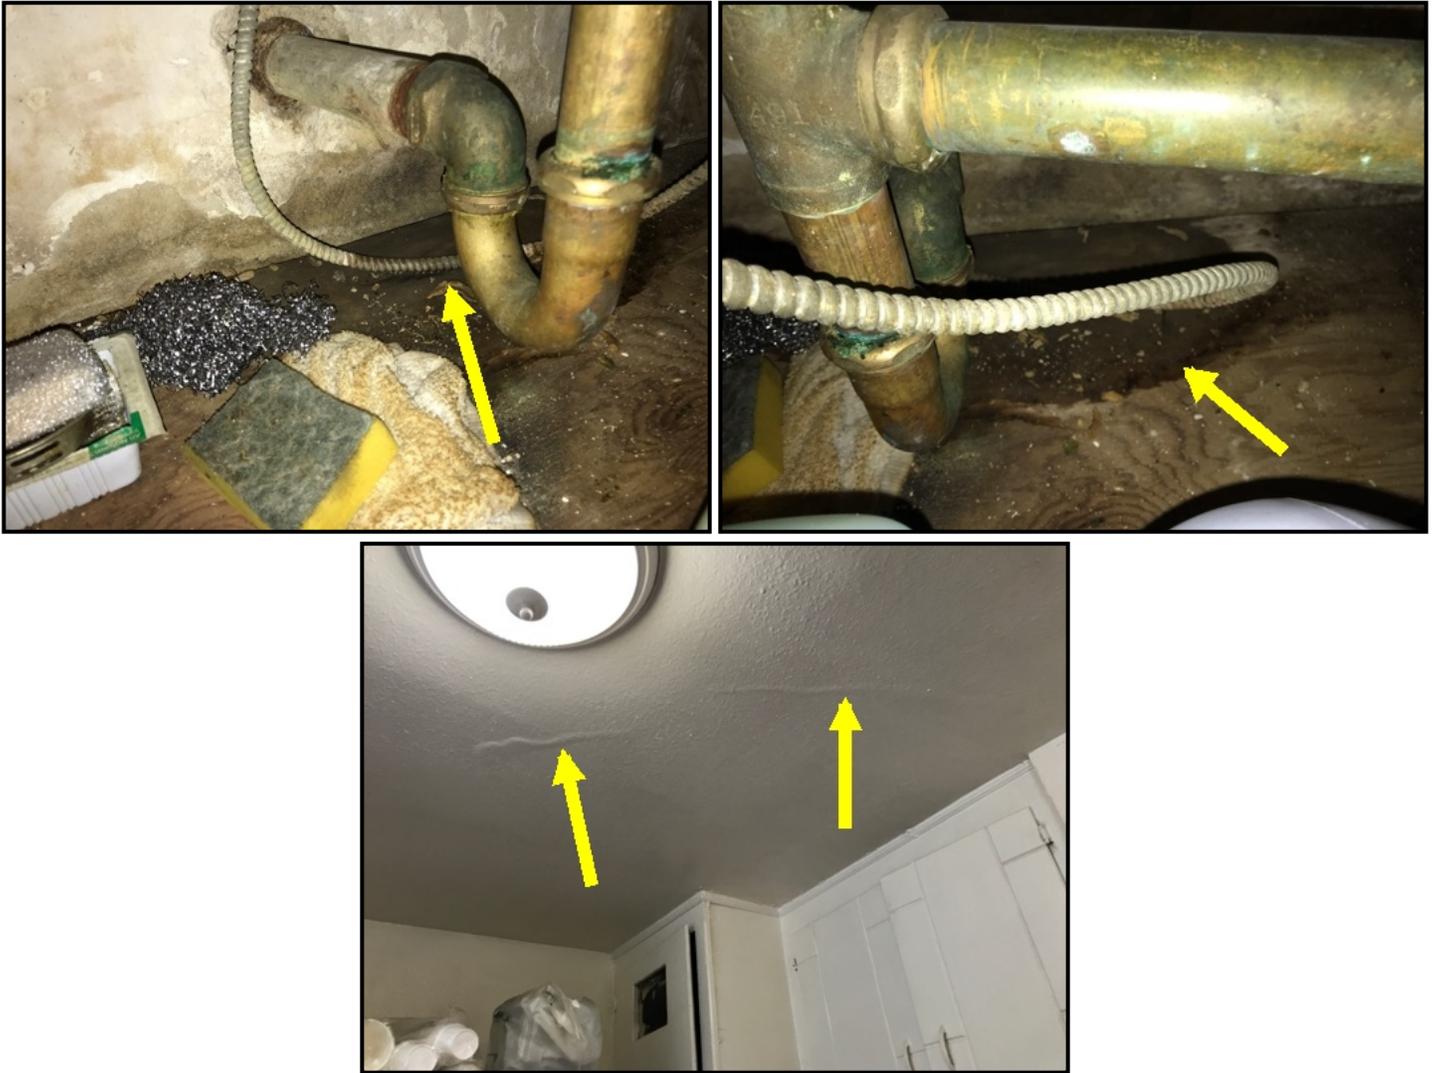
- No visible problems noted at the counters and cabinets at time of inspection.
- Windows and doors operated properly at time of inspection.
- No visible problems noted at the floor at time of inspection.
- A representative number of outlets, switches and fixtures was operated and found to be in operable condition at time of inspection.
- Leaks noted at the faucet at time of inspection.
- Drain lines leak under the sink.
- A licensed plumbing contractor should be called to make necessary repairs.
- Moisture stains and/or damage viewed on the ceiling.
- Possible plumbing leak from dwelling above. Further evaluation by a plumbing contractor is recommended.
- Ground Fault Circuit Interrupter (GFCI) outlets are recommended for installation.

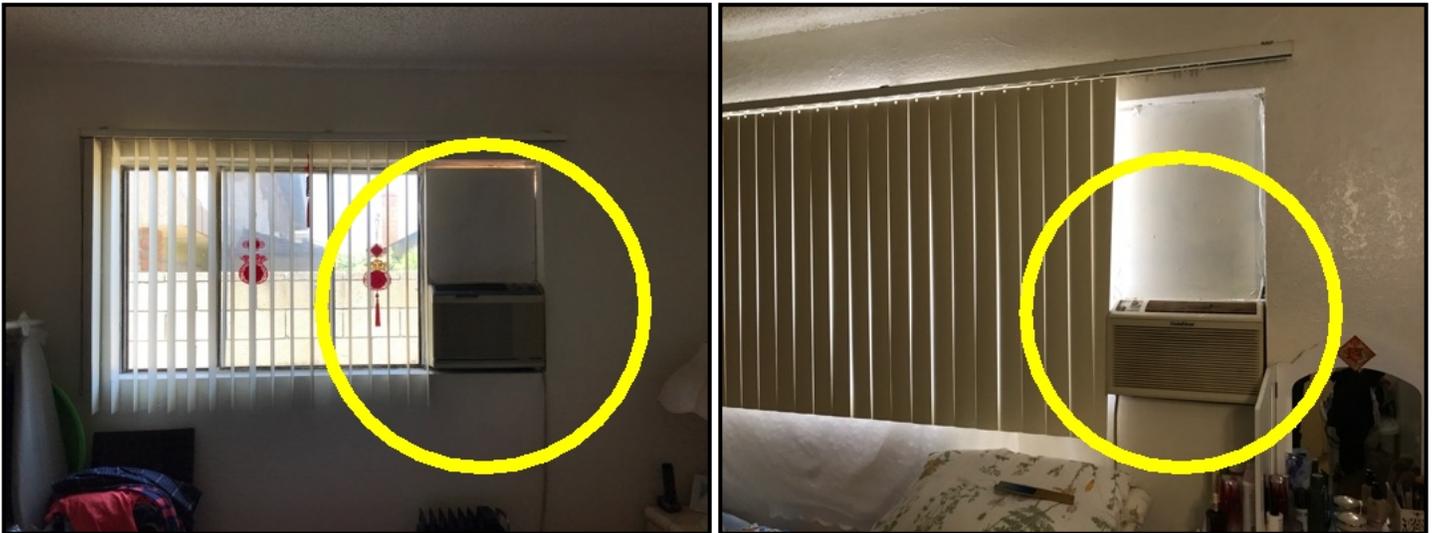
#### 4. Bedrooms

- Windows and doors operated properly at time of inspection.
- Walls and ceiling appeared functional at time of inspection.
- No visible problems noted at the floor at time of inspection.
- A representative number of outlets, switches and fixtures was operated and found to be in operable condition at time of inspection.
- **Smoke detector is not installed. A smoke detector is required in every bedroom, adjacent hallway and every level of the dwelling prior to the close of escrow.**
- **Closet doors are fallen off the tracks. Proper installation is recommended.**
- **Inadequate egress observe that bedroom. Air-conditioner is installed in the only bedroom window. This is not allowed by code. Removal is required.**

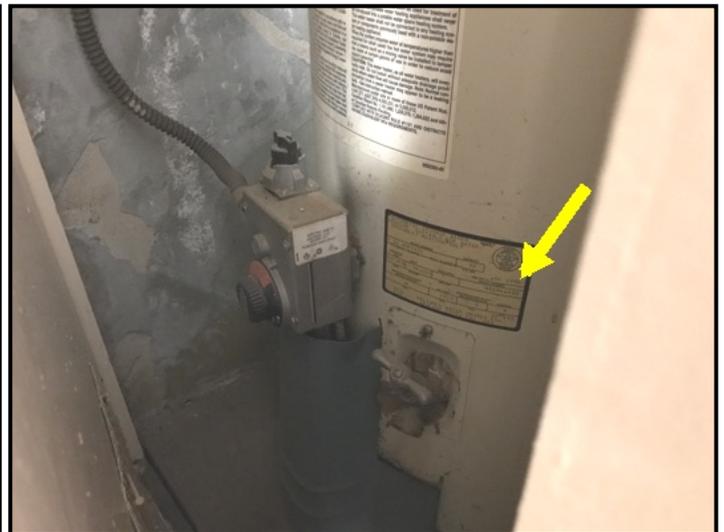
- Operated properly at time of the inspection.
- Seismic straps are not installed on the heater. Installation of approved straps is required prior to the close of escrow.
- Temperature pressure relief valve discharge line is not installed. This is a potential hazard. Installation is required.
- Heater is over 15 years old. Unit has exceeded it's useful life. Although no problems may exist at time of inspection, the lifespan of a water heater is normally between 5 to 12 years. You may want to consider replacing with a newer unit for increased efficiency.
