# Villa Home Inspections

## Property Inspection Report

12345 Commercial Lane, Los Angeles, CA 90001  
Inspection prepared for: John Doe  
Real Estate Agent: - -

Date of Inspection: 7/30/2019 Time: 11:00 a.m.

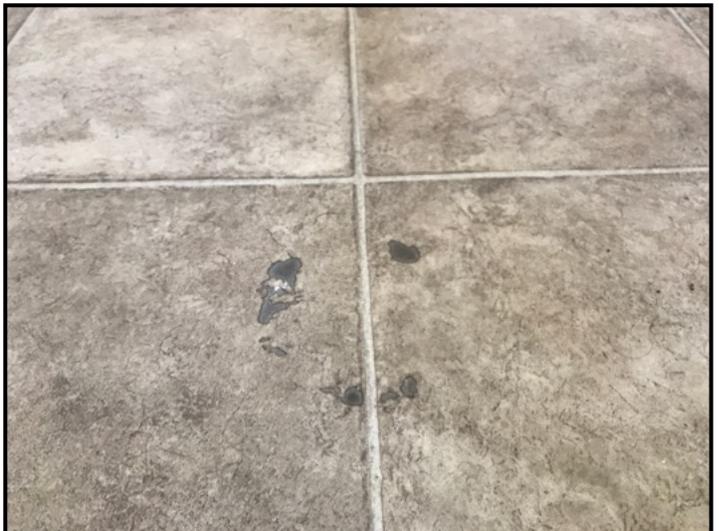
- Plumbing lines are functional at time of inspection.
- Drawers are damaged or difficult to operate.
- Caulking is recommended at the sink and backsplash areas to prevent moisture penetration and damage.
- Window is difficult to operate. Repair or replacement is recommended.
- Moisture stains and/or damage viewed on the ceiling.
- Possible roof leak. Further evaluation by a roofing contractor is recommended.
- Flooring is damaged or deteriorated. Repair or replacement is recommended.

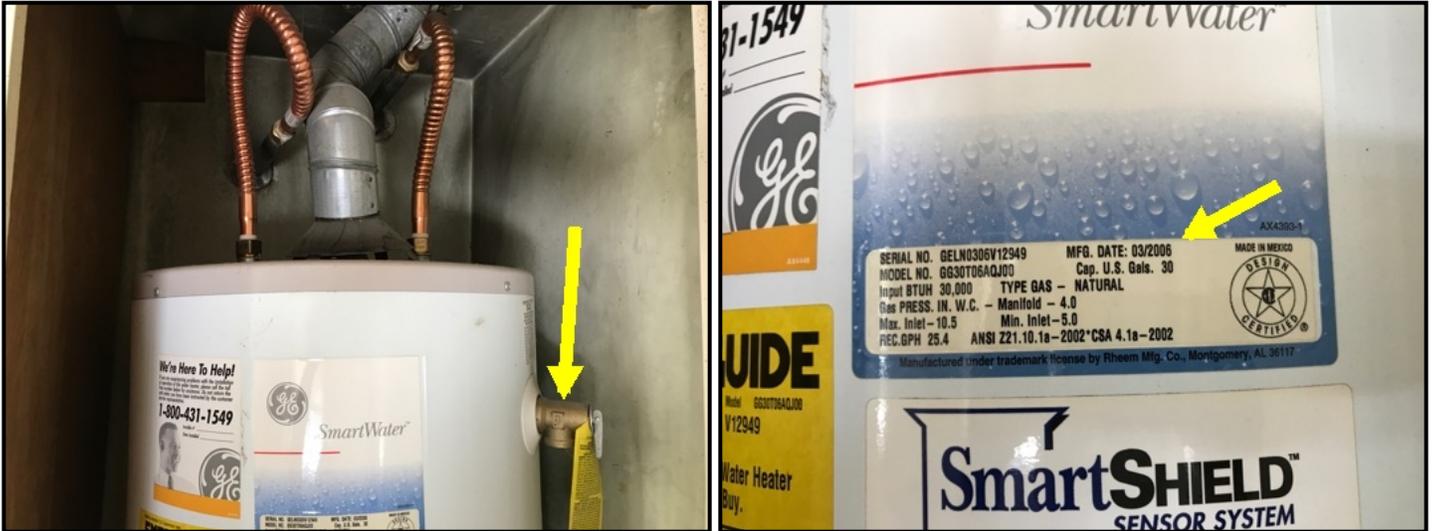
- Operated properly at time of the inspection.
- **Seismic straps are not installed on the heater. Installation of approved straps is required prior to the close of escrow.**
- **Temperature pressure relief valve discharge line is not installed. This is a potential hazard. Installation is required.**

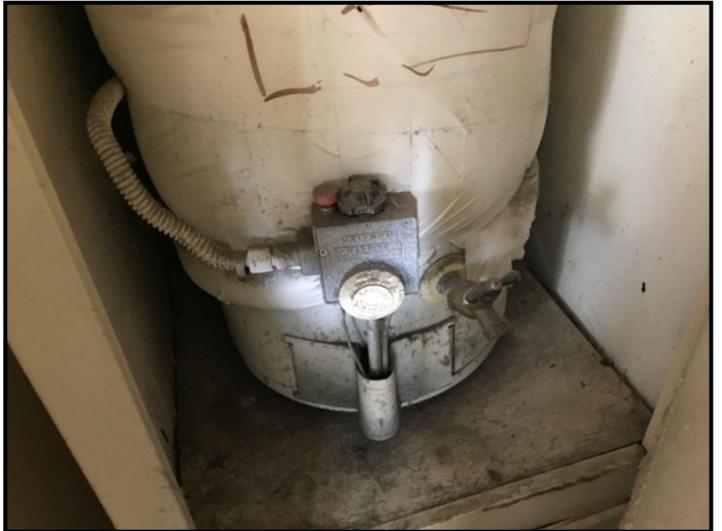
- Operated properly at time of the inspection.
- Seismic straps are not installed on the heater. Installation of approved straps is required prior to the close of escrow.
- Heater is over 15 years old. Unit has exceeded it's useful life. Although no problems may exist at time of inspection, the lifespan of a water heater is normally between 5 to 12 years. You may want to consider replacing with a newer unit for increased efficiency.
- Temperature pressure relief valve discharge line is not installed. This is a potential hazard. Installation is required.

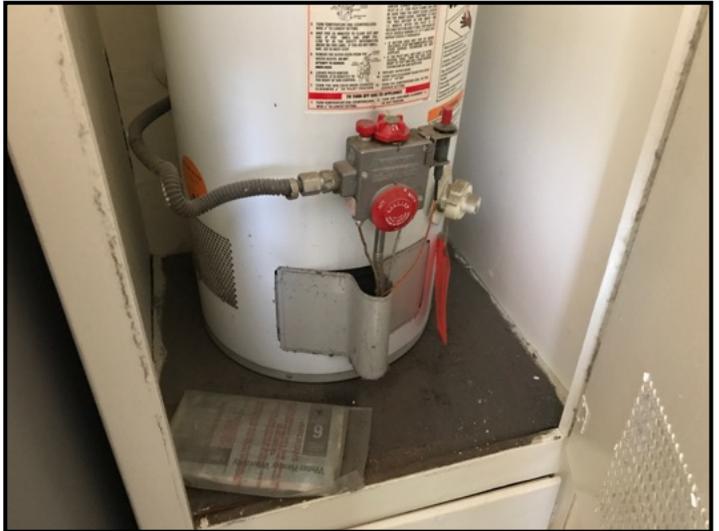
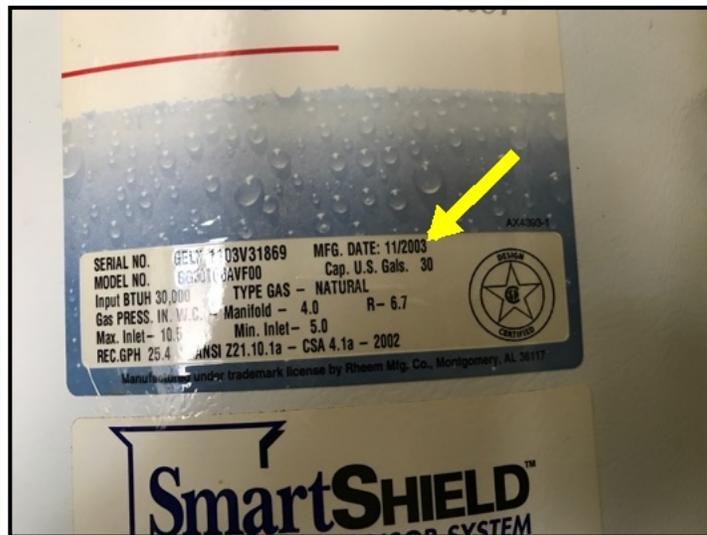
- Operated properly at time of the inspection.
- Seismic straps are not installed on the heater. Installation of approved straps is required prior to the close of escrow.
- Heater is over 15 years old. Unit has exceeded its useful life. Although no problems may exist at time of inspection, the lifespan of a water heater is normally between 5 to 12 years. You may want to consider replacing with a newer unit for increased efficiency.
- Temperature pressure relief valve discharge line is not installed. This is a potential hazard. Installation is required.
- See photo.

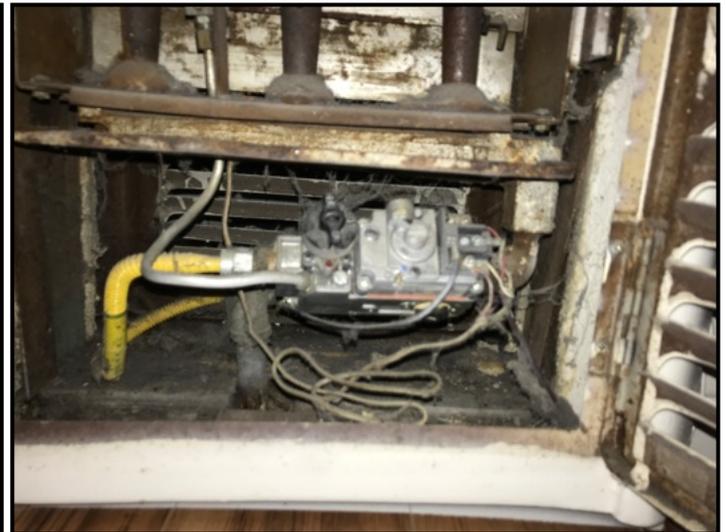
- Rust damage at the burners
- Recommend cleaning the system thoroughly before using.
- Pilot light was not lit at time of inspection. Unable to inspect. Further evaluation by gas company is recommended.

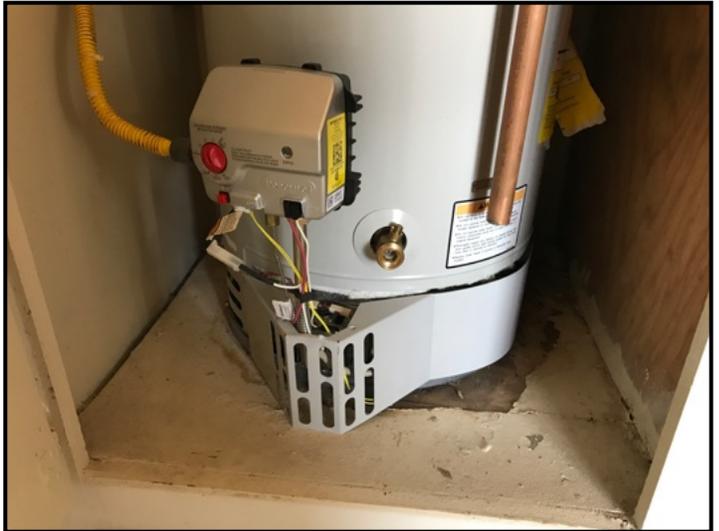
- Operated properly at time of the inspection.
- Leaks note at the water supply lines.
- Further evaluation and repairs by a plumbing contractor is recommended.
- See photo.

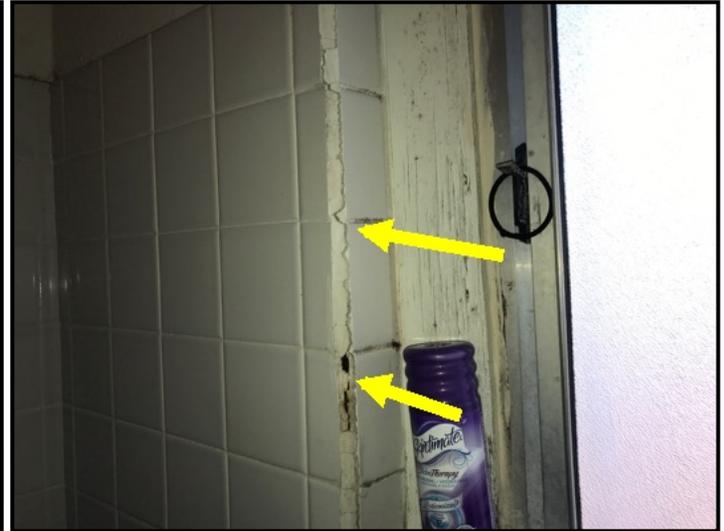
- No visible plumbing problems noted at time of inspection.
- Windows and doors operated properly at time of inspection.
- Walls and ceiling appeared functional at time of inspection.
- No visible floor problems noted at time of inspection.
- No visible electrical problems observed at time of inspection.
- Tub surround wall tiles are loose and or damaged. Repair or replacement is recommended.
- Caulking is recommended at the tub or shower areas to prevent moisture penetration and damage behind the walls.
- Ground Fault Circuit Interrupter (GFCI) outlets are recommended for installation.

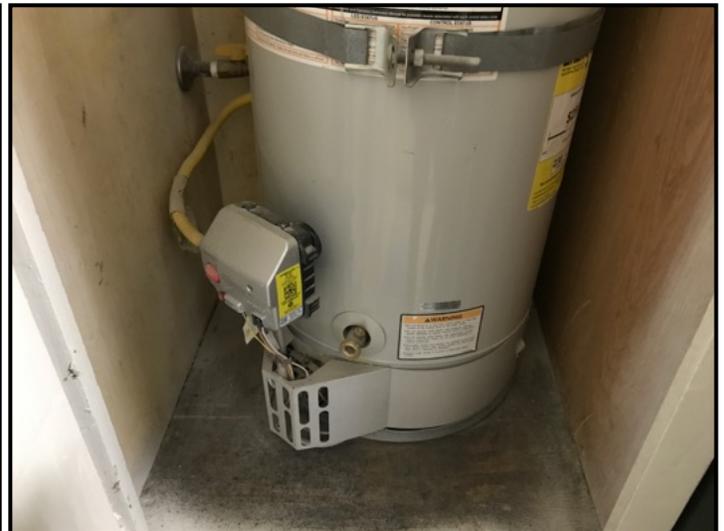
- Operated properly at time of the inspection.
- Temperature pressure relief valve discharge line is not installed. This is a potential hazard. Installation is required.
- Moisture stains and damage observed on the ceiling surrounding the vent pipe. Possible roof leak. Further evaluation by a roofing contractor is recommended.
- Further evaluation and repairs by a plumbing contractor is recommended.
- See photo.

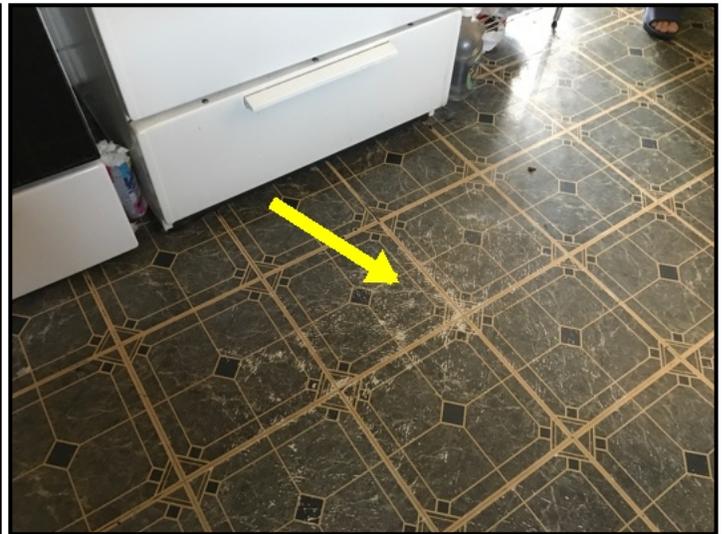
- Plumbing lines are functional at time of inspection.
- No visible problems noted at the counters and cabinets at time of inspection.
- Walls and ceiling appeared functional at time of inspection.
- Flooring is damaged or deteriorated. Repair or replacement is recommended.
- A representative number of outlets, switches and fixtures was operated and found to be in operable condition at time of inspection.
- Window is difficult to operate. Repair or replacement is recommended.
- Ground Fault Circuit Interrupter (GFCI) outlets are recommended for installation.
- See photos.
- Exposed wiring at the garbage disposal

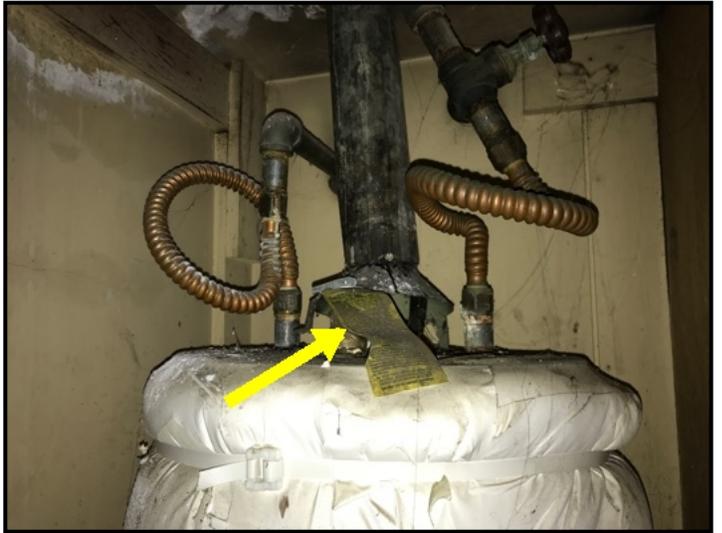
- Operated properly at time of the inspection.
- **Seismic straps are not installed on the heater. Installation of approved straps is required prior to the close of escrow.**
- **Temperature pressure relief valve discharge line is not installed. This is a potential hazard. Installation is required.**
- **Moisture stains and damage observed on the ceiling surrounding the vent pipe. Possible roof leak. Further evaluation by a roofing contractor is recommended.**
- **Further evaluation and repairs by a plumbing contractor is recommended.**
- **See photo.**
