PROPERTY INSPECTION REPORT

12345 Main St, Los Angeles, CA 9100

DATE OF INSPECTION: 11/20/2022

VILLA HOME INSPECTIONS

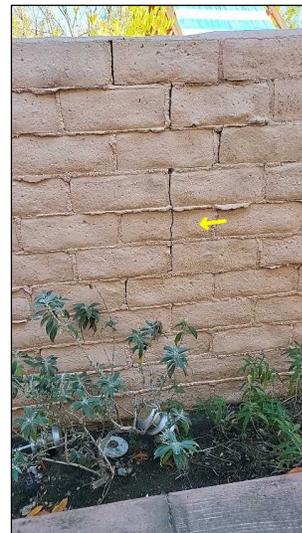
- Moderate cracks noted on the block wall.

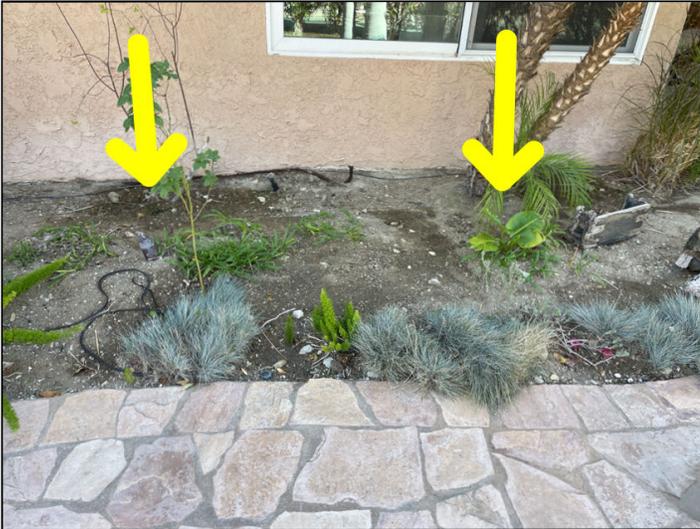
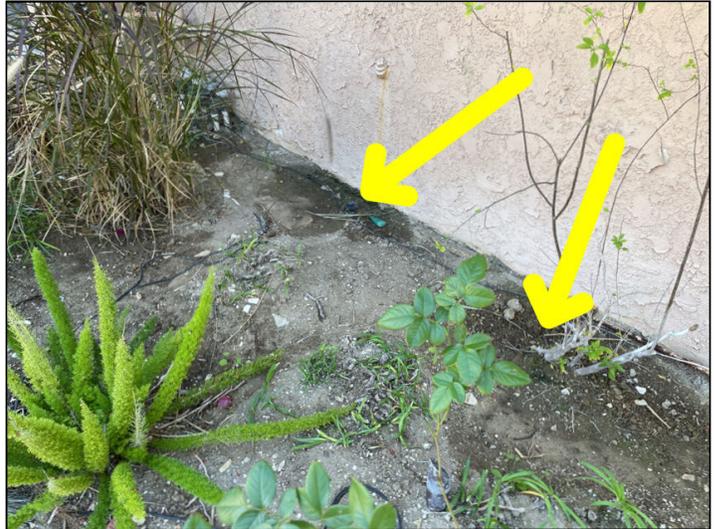
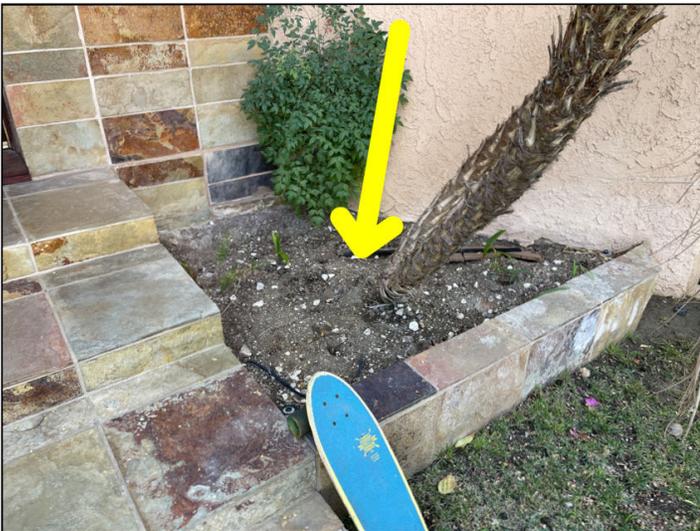
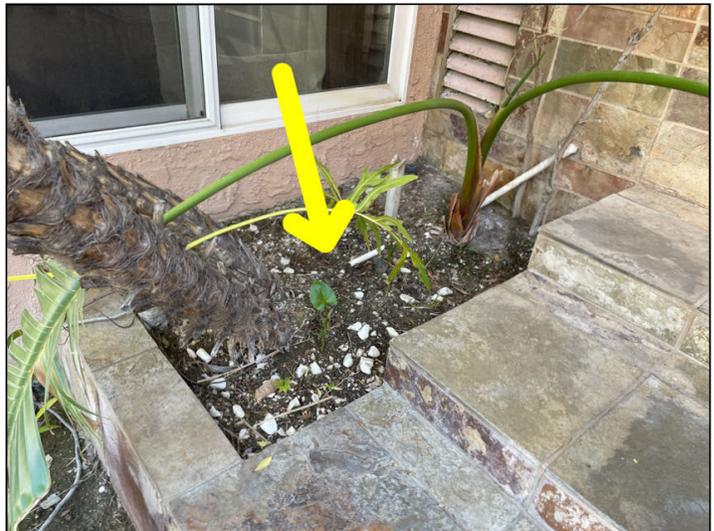
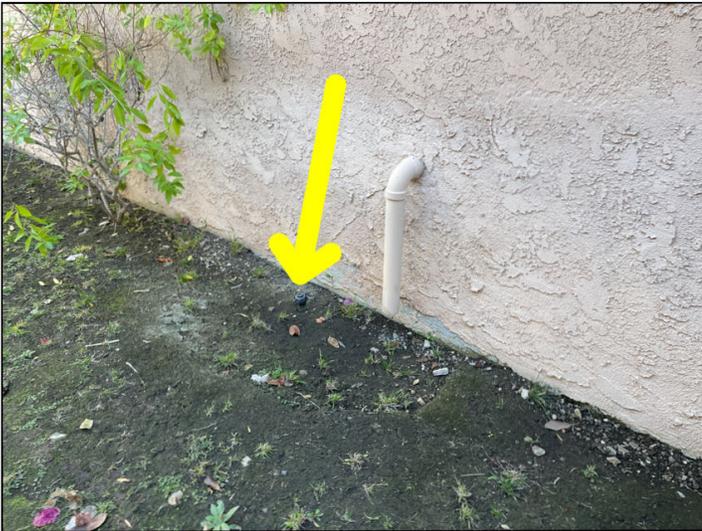
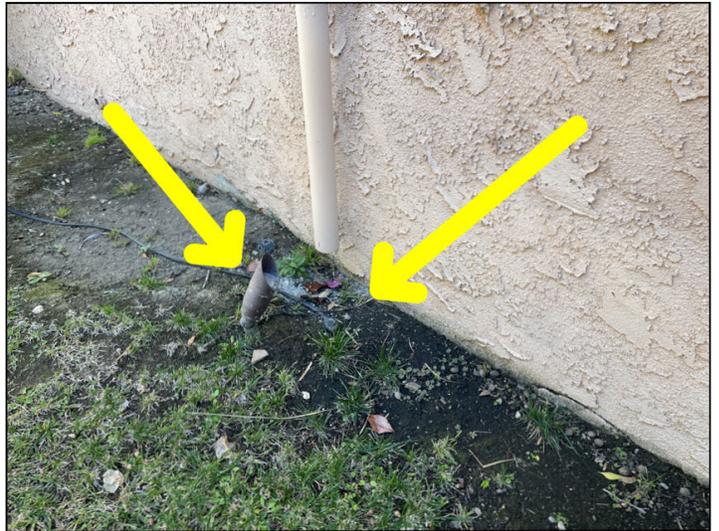
- Signs of poor drainage observed at the West side of the property.
- Evidence of pooling water was observed at time of inspection.
- Planter areas near the house do not have a drainage system installed and retain water when it rains. This excess moisture, near the foundation of the house, can cause damage. Installation of a drainage system is recommended.
- See photos.

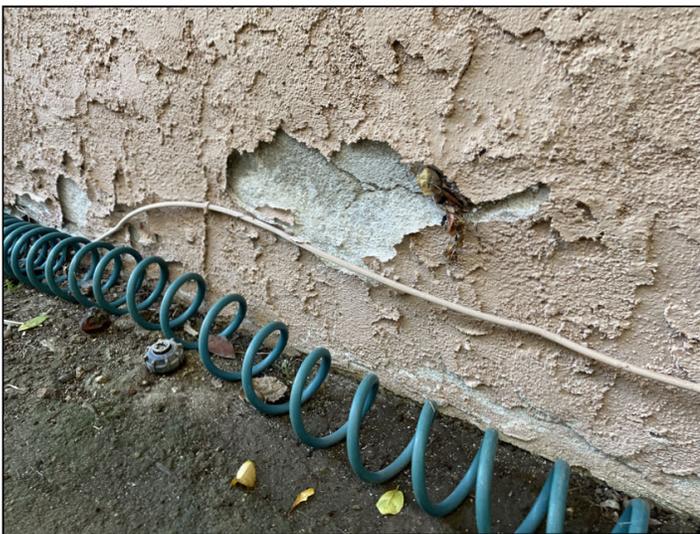
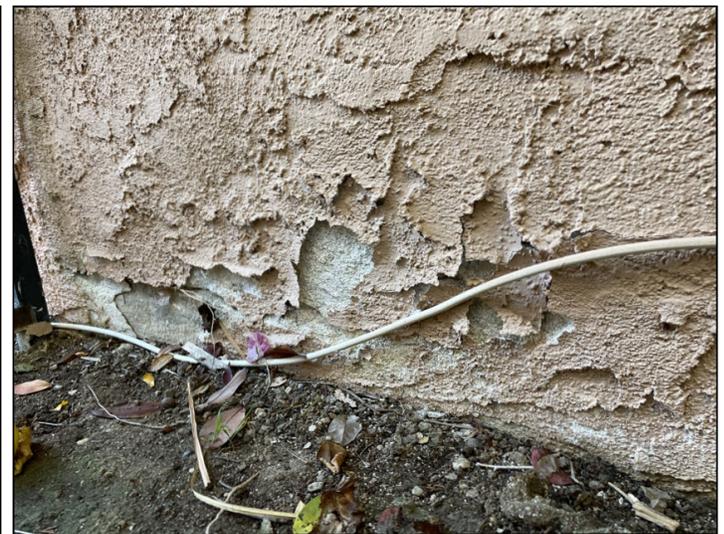
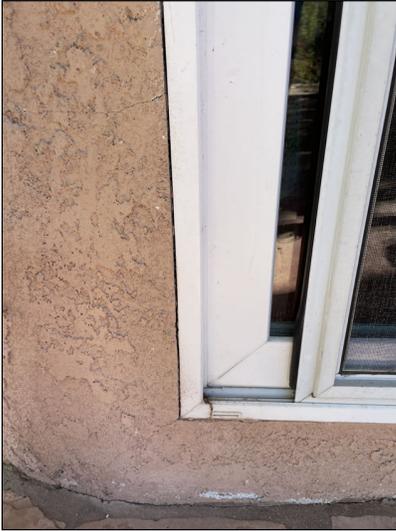
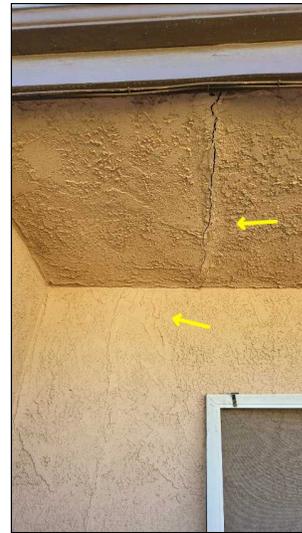
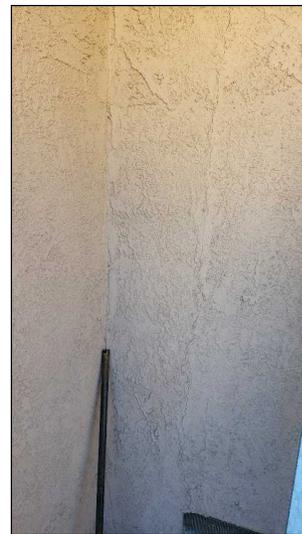
- Cracks noted are moderate and may indicate foundation movement due to seismic activity or settlement.
- Cracks were noted on the walls.
- Paint finish is deteriorated or flaking. Repainting is recommended to prevent moisture damaged.
- Evidence of continual splashing was observed on the walls, due to lack of roof gutters. Over time, this may cause moisture damage and penetration.
- See photos.

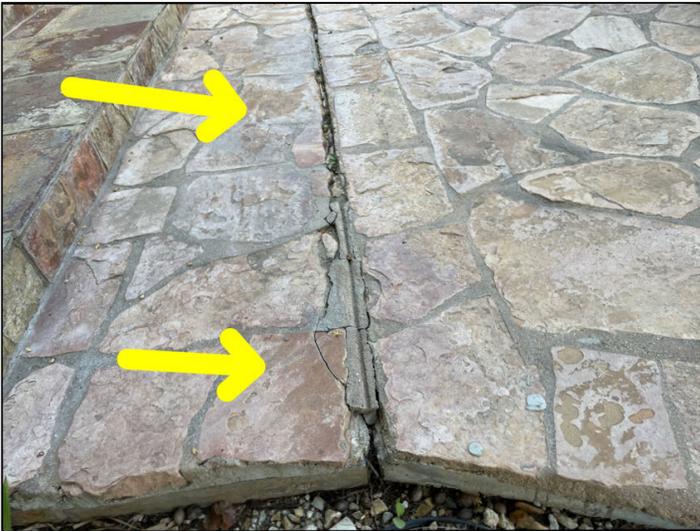
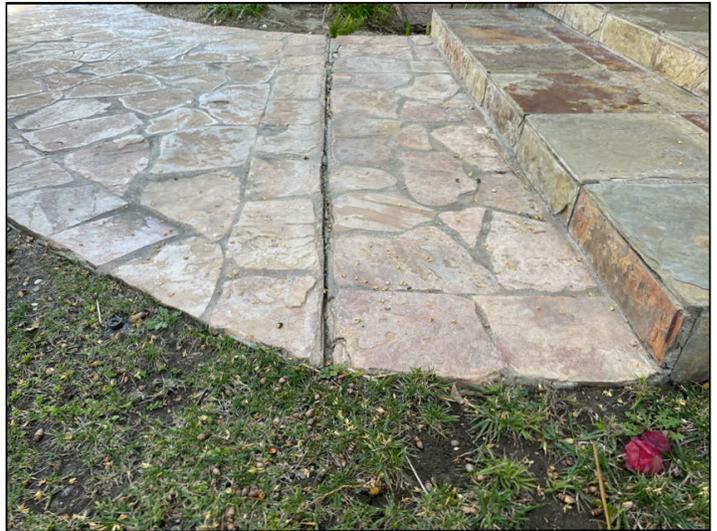
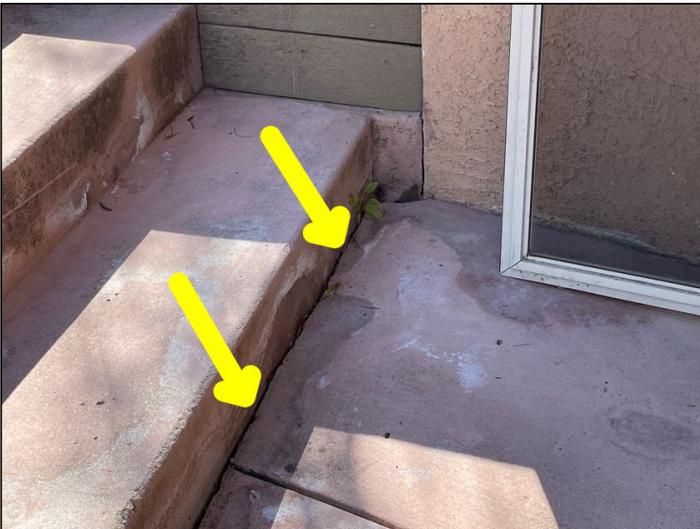
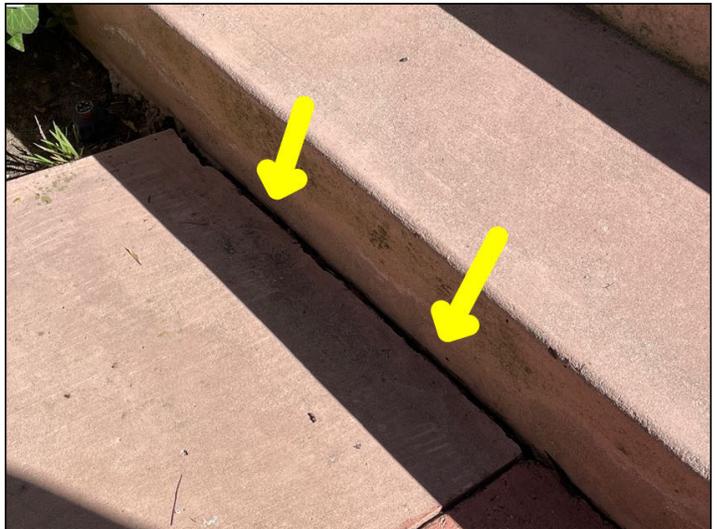
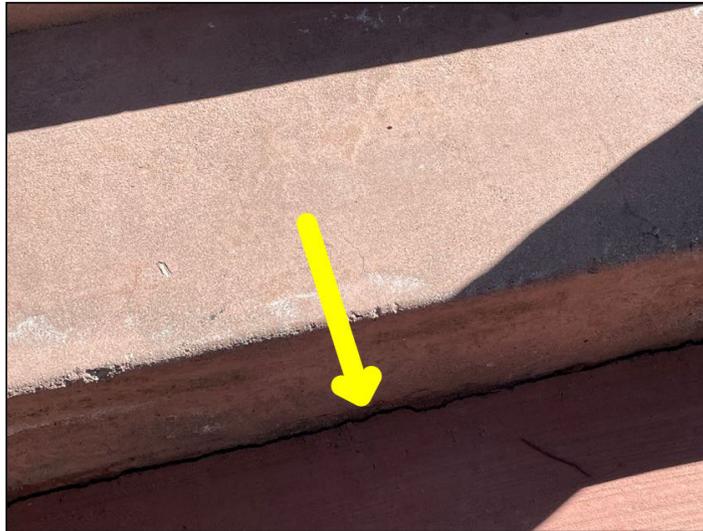
- Cover Condition:
- No visible problems observed at time of inspection.
- Floor Condition:
- Minor settlement noted.
- See photos.

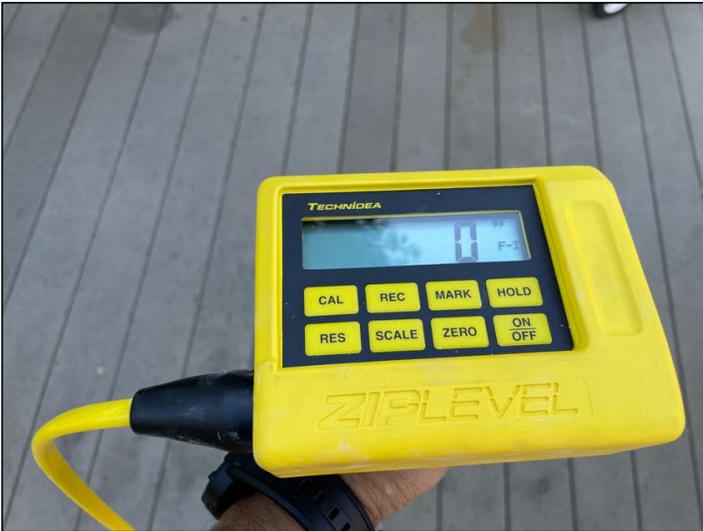
- 1) Significant floor settlement was measured at the north east side of the deck.
- 2) General practice for a cantilevered section of deck/balcony is for the cantilever to be no more than 1/4 the length of the full span of the deck or balcony. In this case, the deck span at the north side of the property is 16 feet. The span of the cantilever is 6 ft. this is the area that has significant floor settlement. The most span this area should have is approximately 3 feet. See photos.

Zero base.

Further evaluation by a licensed structural engineer is recommend.

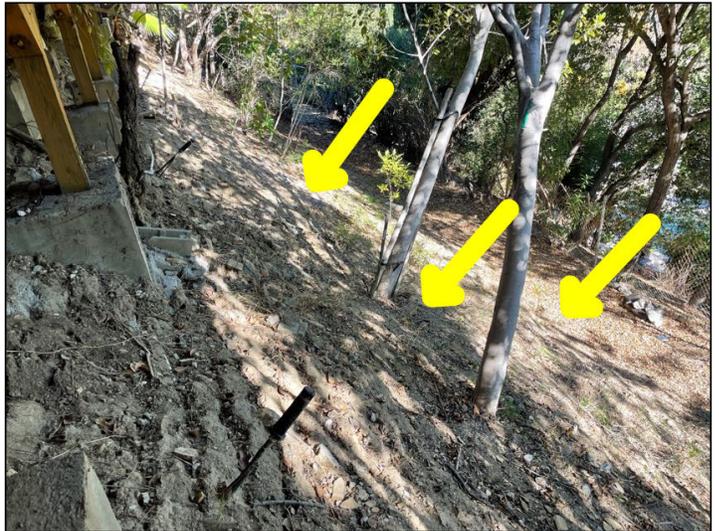
- 7) Significant soil erosion was observed on the east hillside, under the deck. Wooden boards have been installed under the deck to prevent soil erosion. However, these measures are grossly inadequate and the boards have collapsed. Erosion is likely caused by the lack of vegetation cover.

Inadequate hillside coverage. Evidence of significant soil erosion

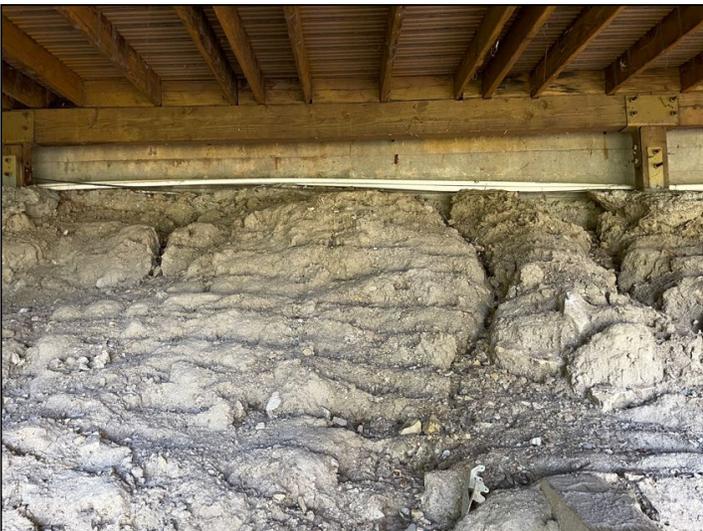
- 8) Soil has eroded significantly under the several concrete piers. One pier and post are visibly leaning.
- 9) Structural beams are inadequately secured to the concrete base and are only secured to the adjacent beam with a metal strap.

Significant soil erosion under the deck at the supports.

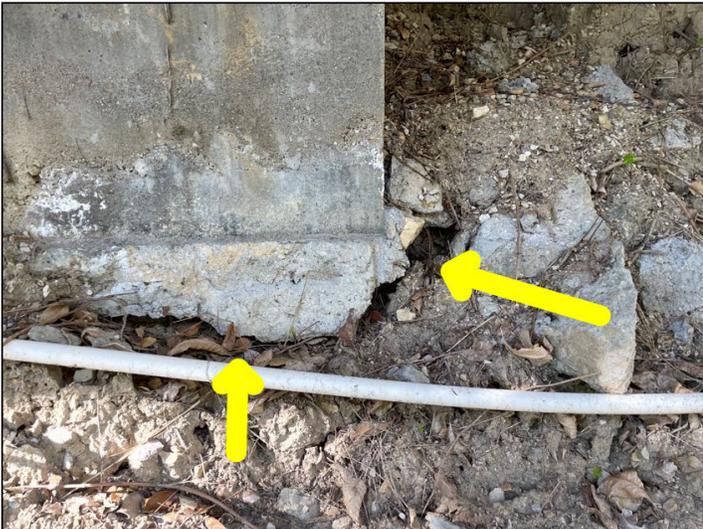
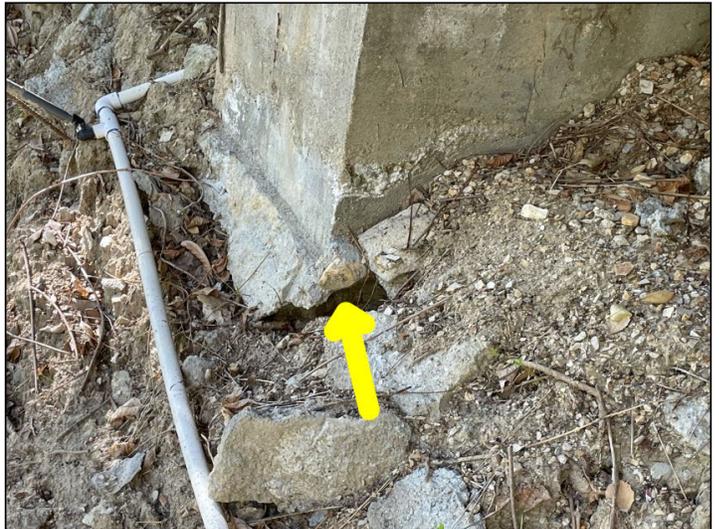
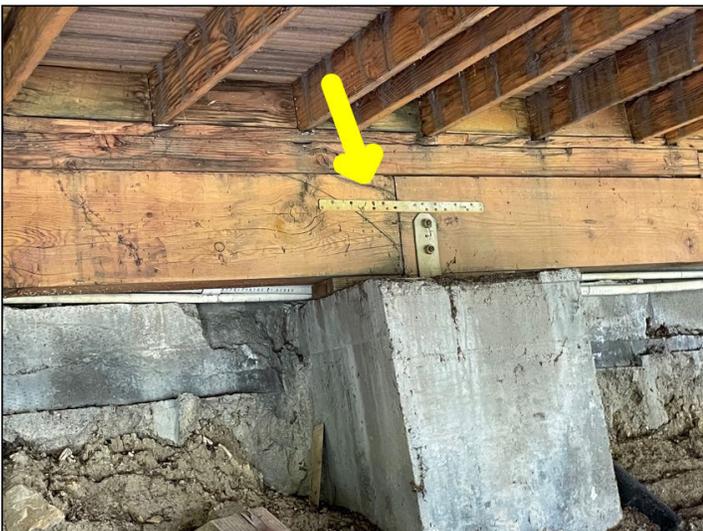
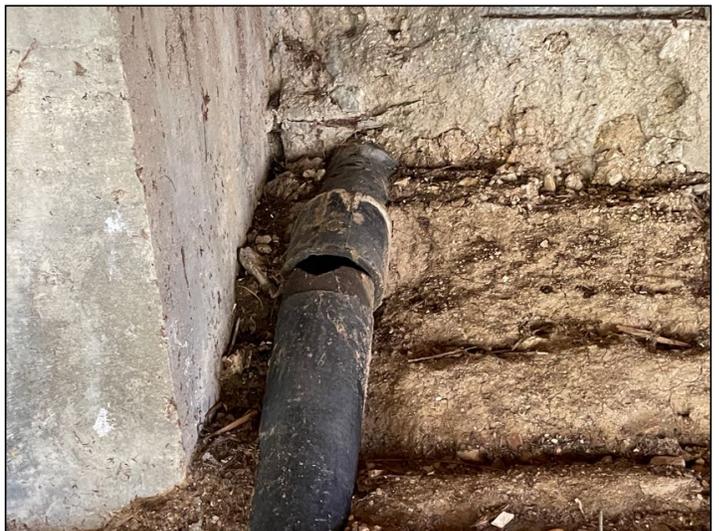
Inadequate connection to concrete support

Disconnected site drainage pipe

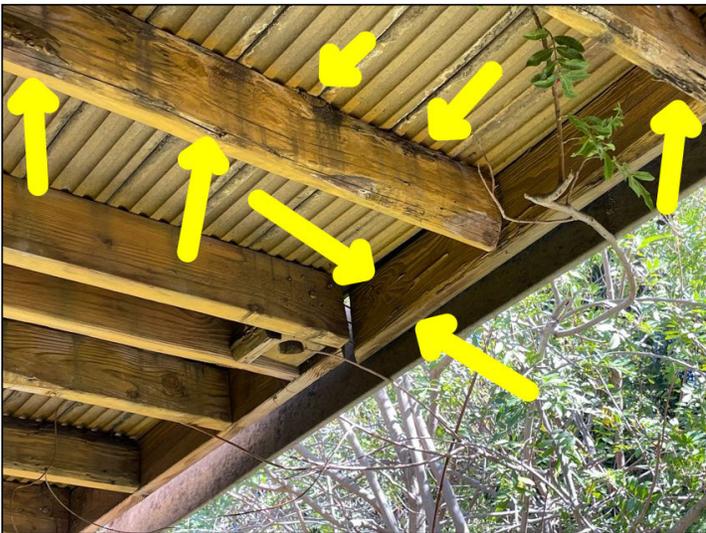
- 3) Moderate to significant moisture damage was observe on the floor joists throughout the underside of the deck from lack of regular maintenance.
- 4) The rim joist at the north side of the deck is loose and falling off.

Rot damage. Rim joist is falling off.

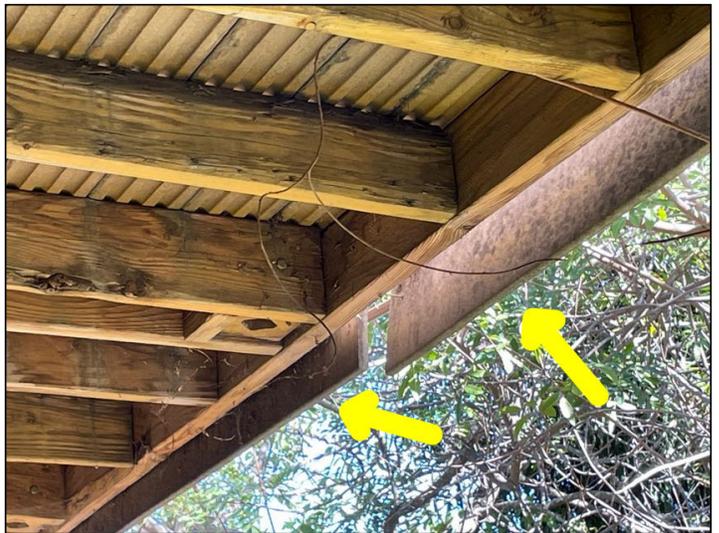
Fascia boards falling off

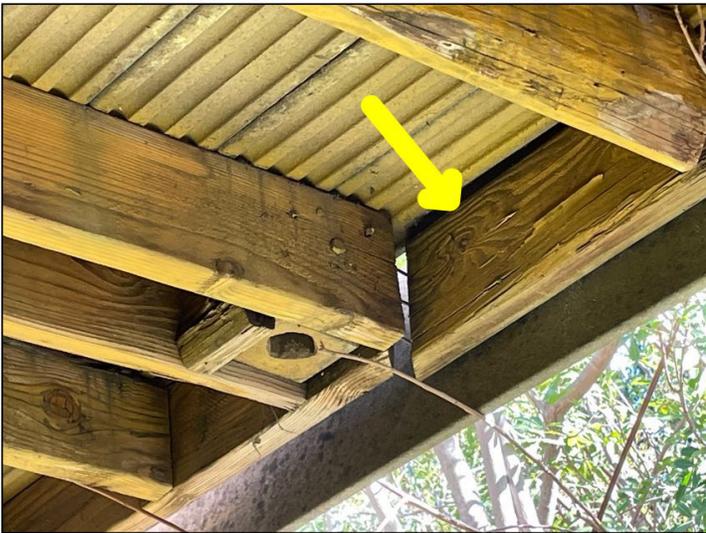
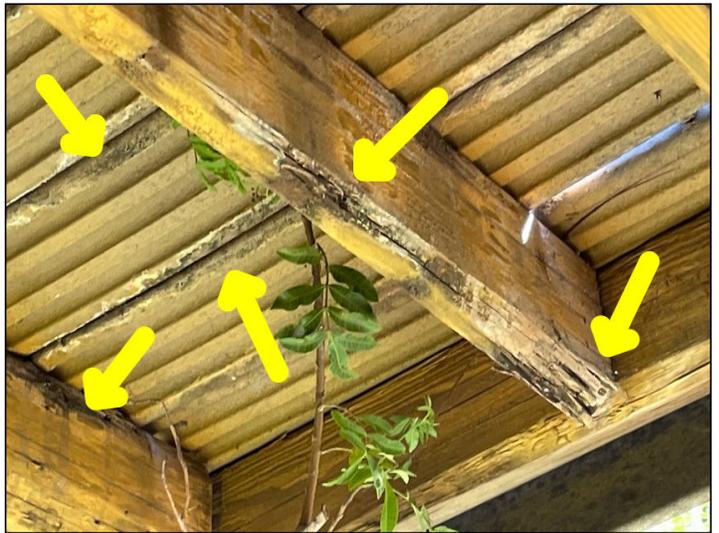
Moisture & rot damage

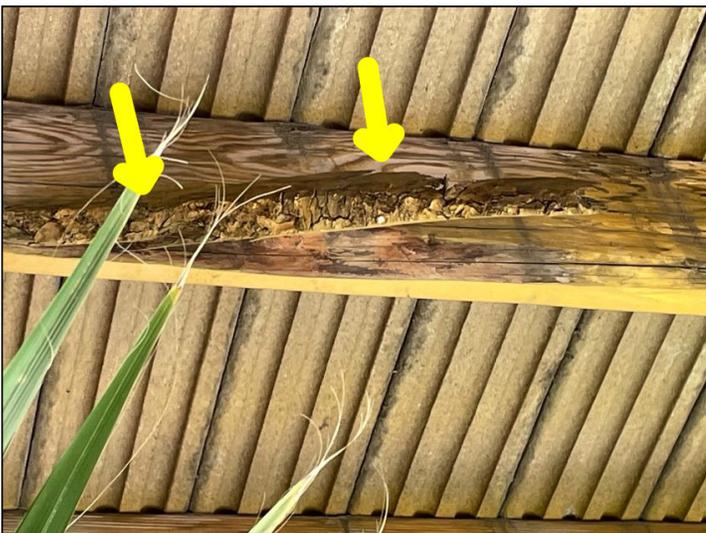
Moisture & rot damage

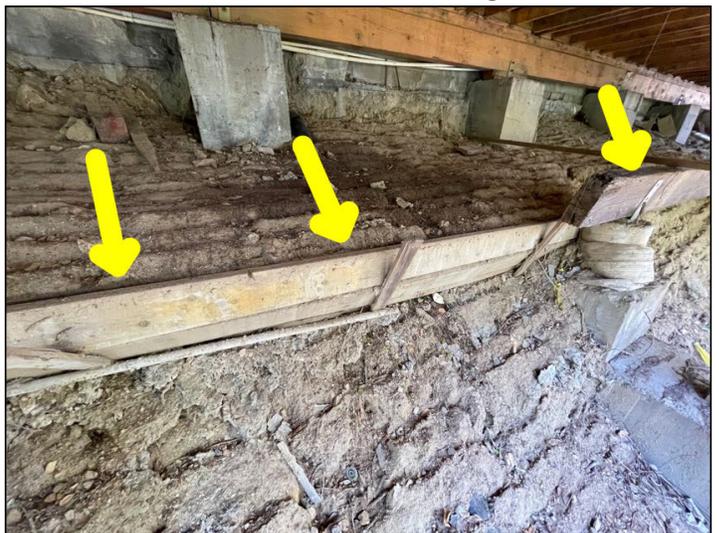
Soil erosion prevention boards collapsed.

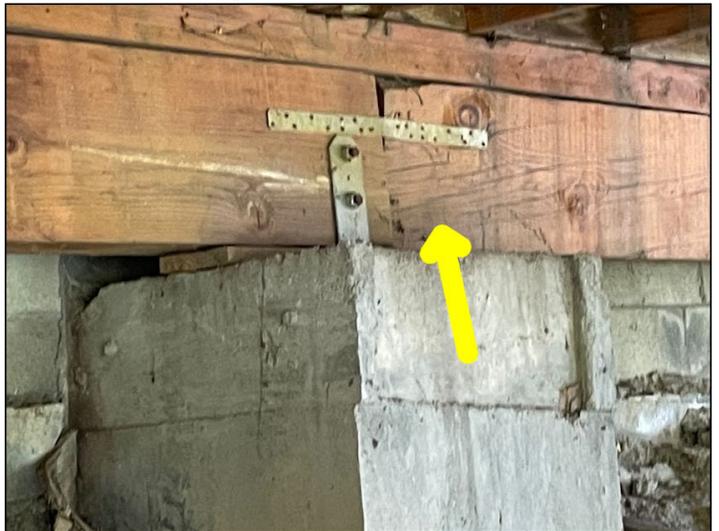
Inadequate connection to concrete support

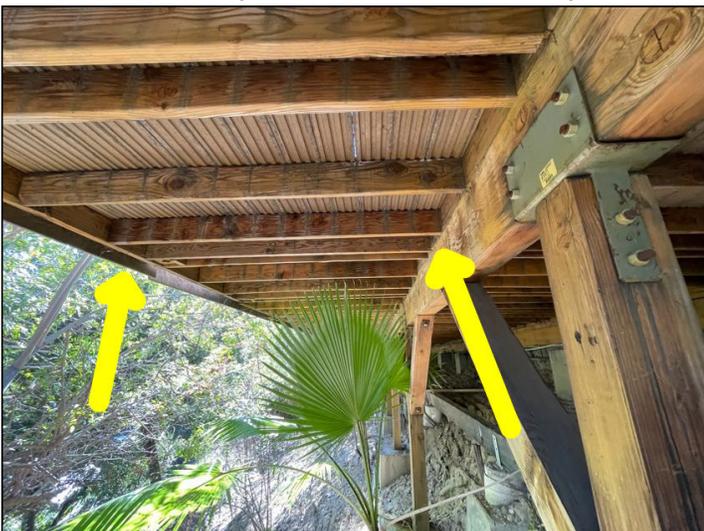
Improper 6 ft cantilever

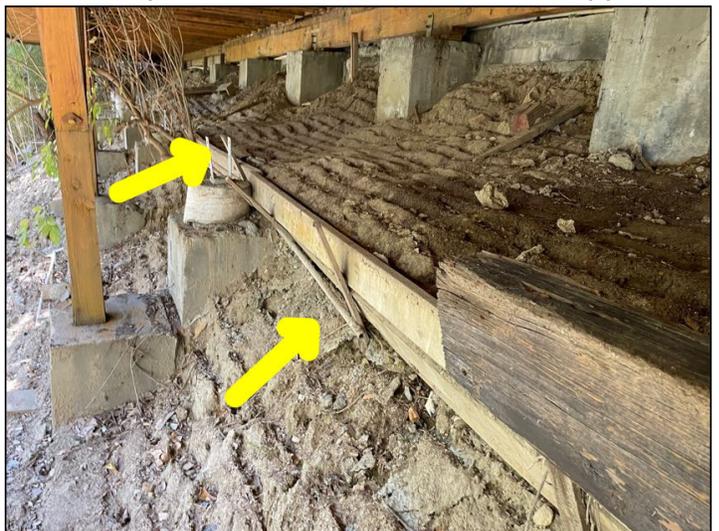
Improper soil erosion prevention measures

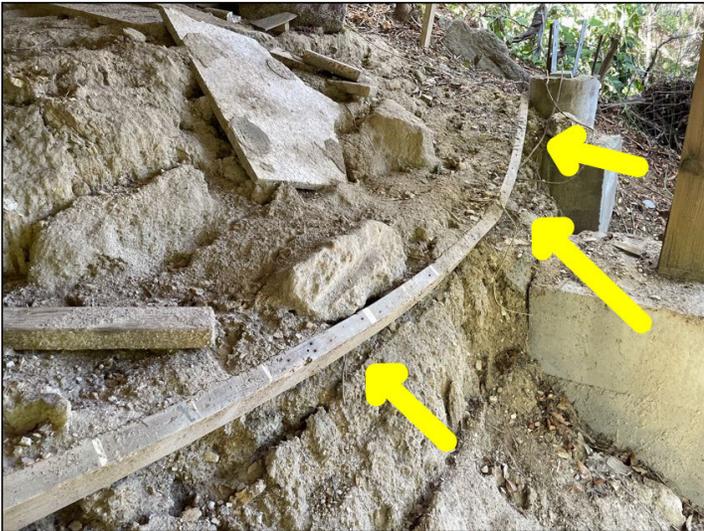
Soil erosion prevention boards collapsed.

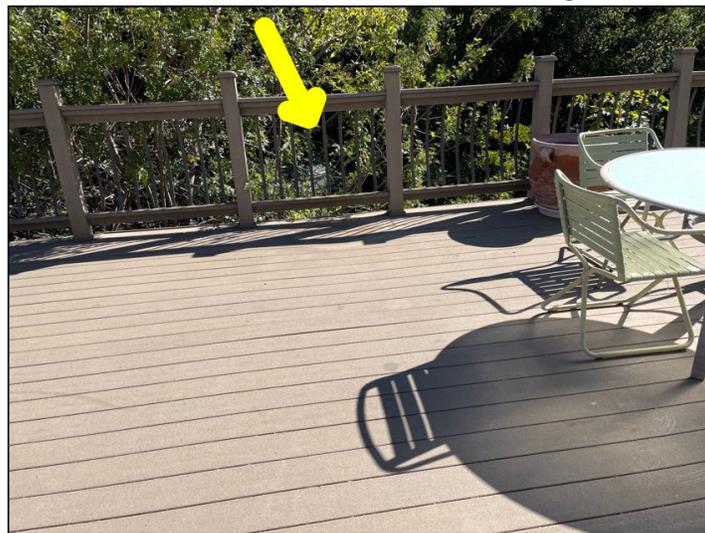
- 5) The hand railings at the north side of the deck are visibly loose.
- 6) The railing **balusters** are too far apart and may allow a small child or pet to fall through. Current standards are for the balusters to be no more than 4 inches apart.

Loose railings

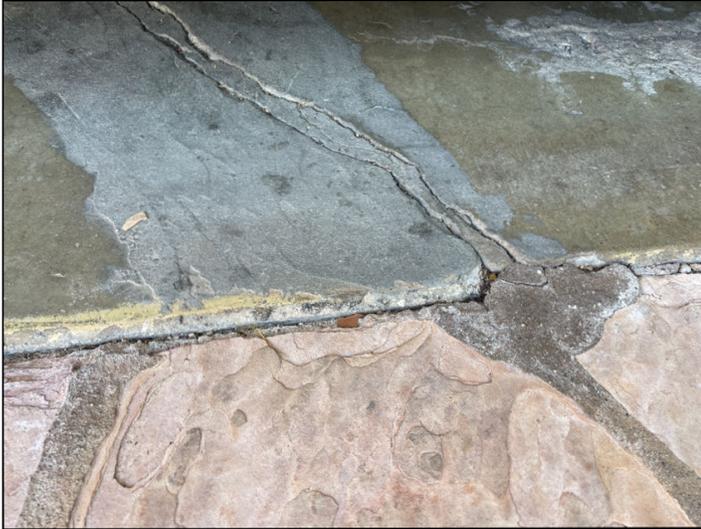
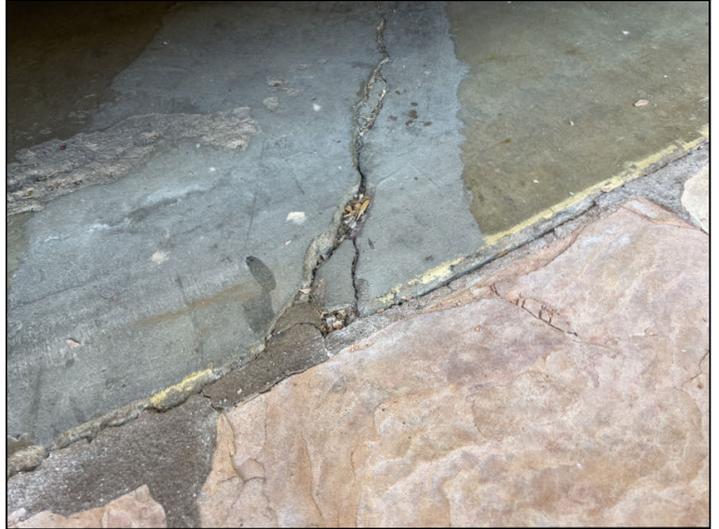
- Moderate cracks noted on the floor at time of inspection.
- Minor settlement of the floor was noted at time of inspection.
- See photos.

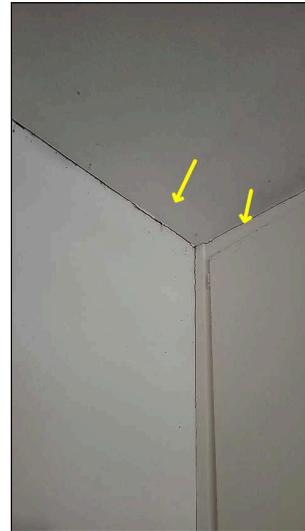
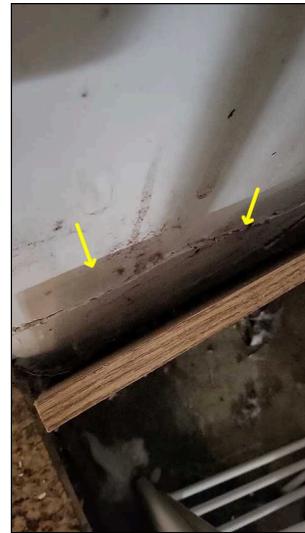
- Walls have been covered with drywall.
- Cracks are moderate. Periodic monitoring is recommended.
- See photos.

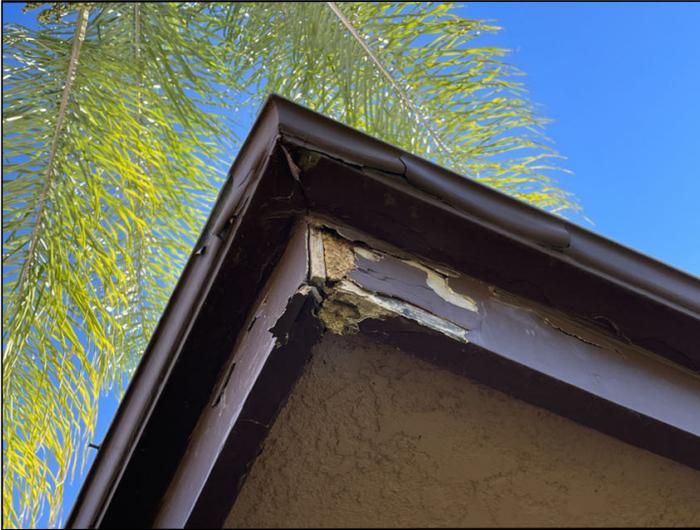
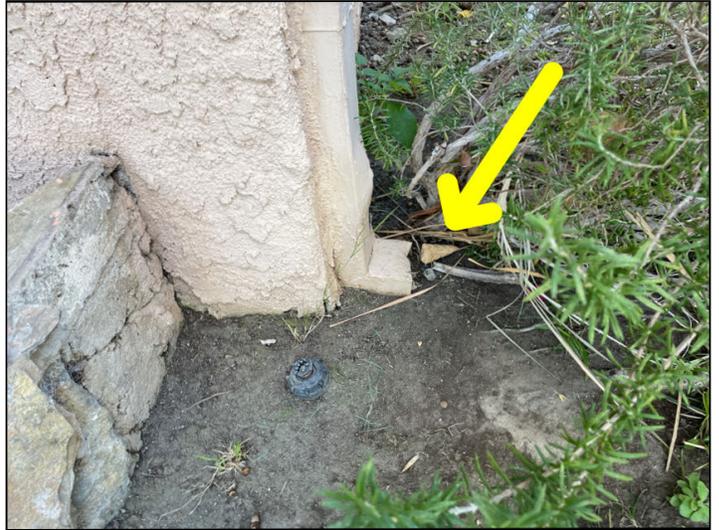
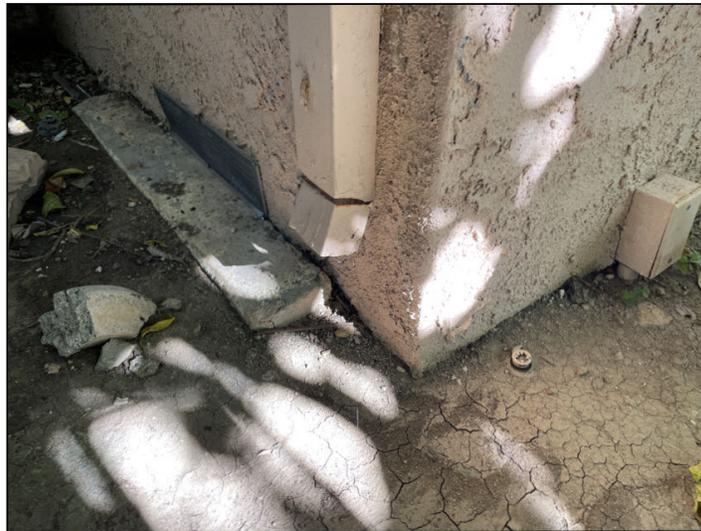
- Rust damage observed on the metal roof gutters.
- Gutters appear to be leaking at the seams.
- Recommend re-routing the downspouts to drain away from the building. Excess moisture near the foundation may cause settlement and foundation problems.
- See photos.

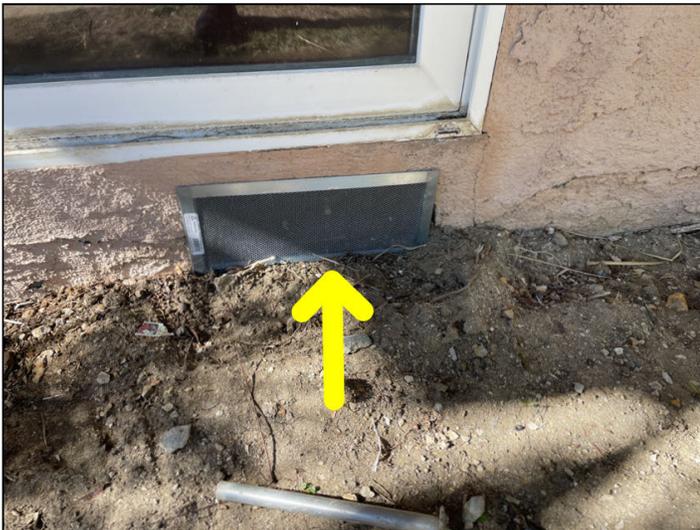
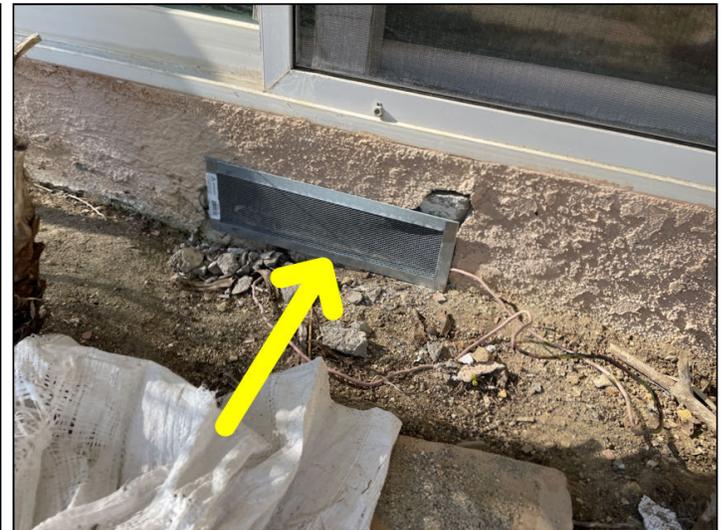
- It should be mentioned that at least one of the foundation vent openings is even with adjacent grade. This could be a source of water entry into the crawl area. Suggest improvements. Damaged screens noted at foundation opening. Install at this time to prevent animal entry.
- See photos.

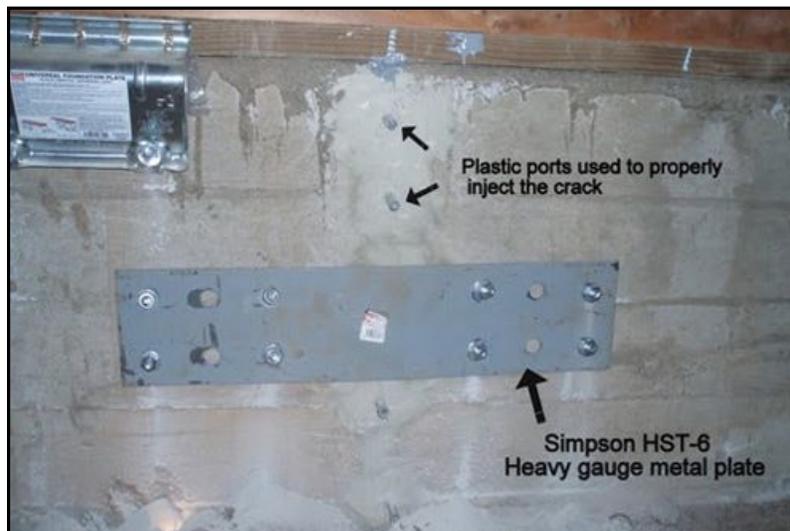
- Anchor bolts are not visible due to the type of floor framing. Unable to determine the presence of anchor bolting.
- Moderate to significant settlement cracks noted on the foundation stem walls at one or more location. Cracks do not appear to be significant at this time.

- Evidence of present water penetration is noted.
- Evidence of prior water penetration is noted.
- **eflorescence** observed on walls indicates the presence of periodic moisture.

- A Structural Engineer should be called to make further evaluation and recommendations as needed prior to the close of your transaction.
- Approved sealant should be applied properly to all foundation cracks (see sample photo). For a FREE foundation retrofit guide, go to: <https://inspectaproperty.com/downloads>

- Metal strapping should be considered foundation cracks (see sample photo) for additional structural support. For a FREE foundation retrofit guide, go to: <https://inspectaproperty.com/downloads>

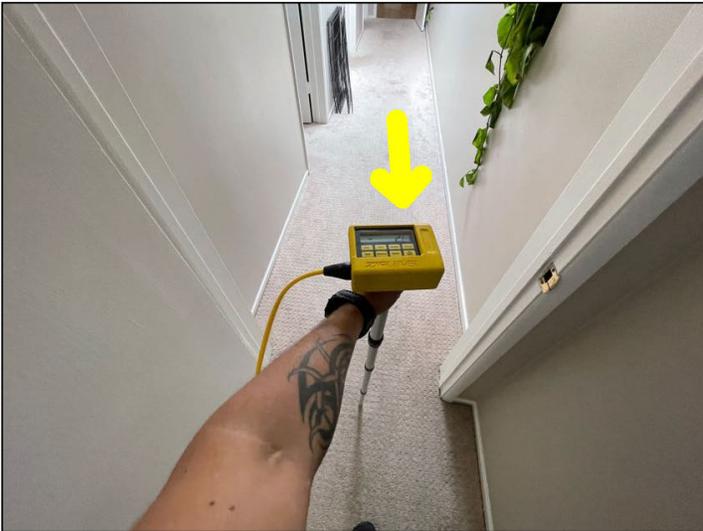
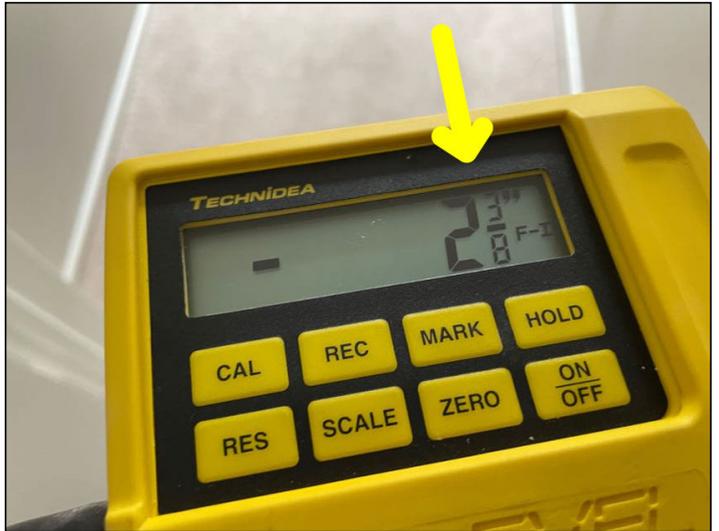
- Floor/foundation settlement was measured throughout the house using a ZipLevel Pro altimeter at time of inspection. See photo. There appears to be significant settlement of the floor/foundation at the east side of the house, at the living room/family room and south bedroom areas. Normal settlement is generally between 0-3/4 inches within a 10 foot span from zero/base. In this case, settlement of up to 2 5/8 inches was measured. Cracks were also observed throughout the walls and ceilings in the same areas of the settlement. Further evaluation by a licensed structural engineer is recommended.
- Expansive soils appear to be present in this property. Movement of the house structure should be expected during excessively wet or dry periods of weather. You can read more about expansive soils at: <https://inspectaproperty.com/blog/expansive-soil-what-you-should-know>

Significant settlement within 10 foot from zero.

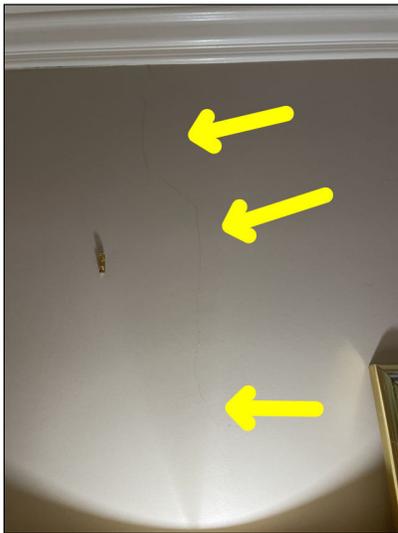
Master

- Significant cracks noted at time of inspection.
- Typical cracks noted.
- Cracks above doors and/or windows noted.
- See Photos.

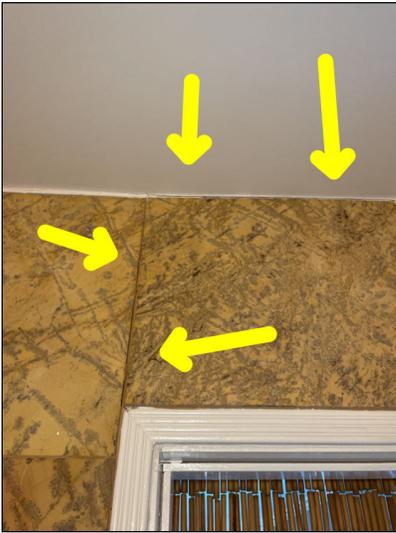
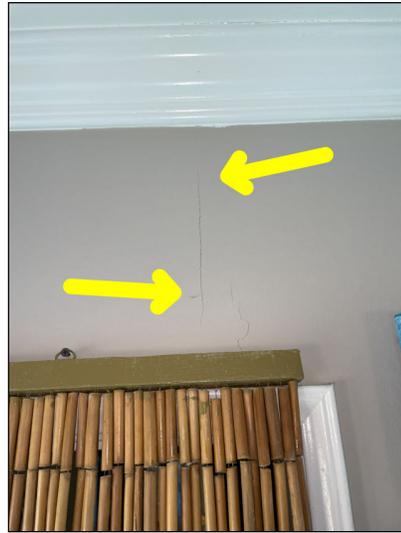
- Typical cracks noted.
- See Photos.

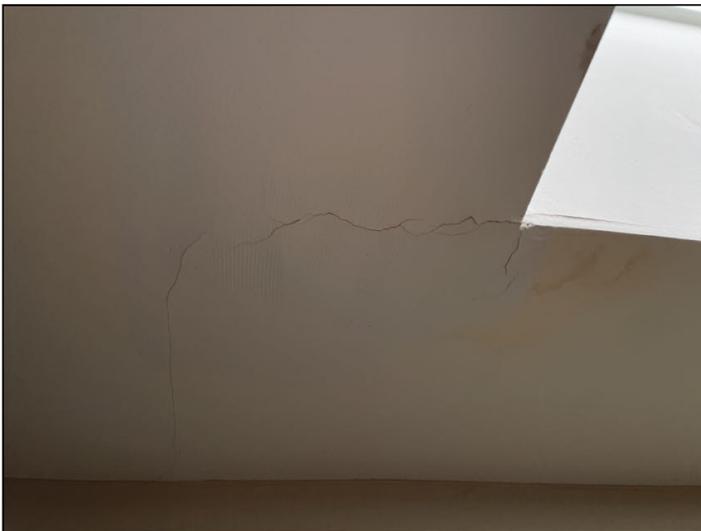
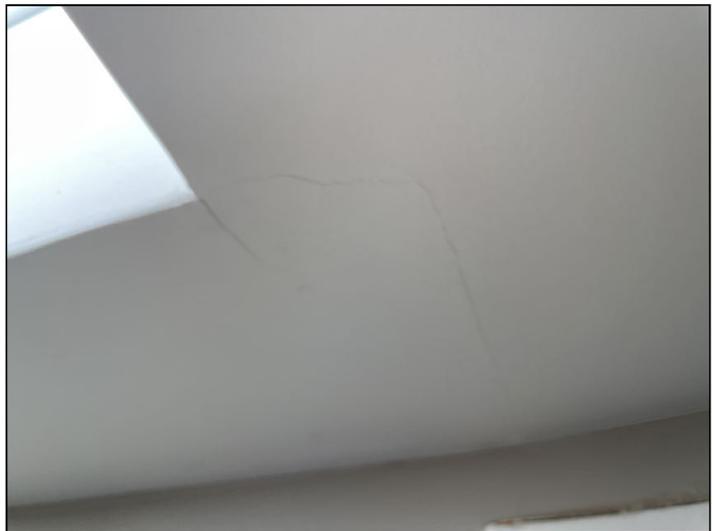
- Significant cracks noted at time of inspection.
- Cracks above doors and/or windows noted.
- See Photos.

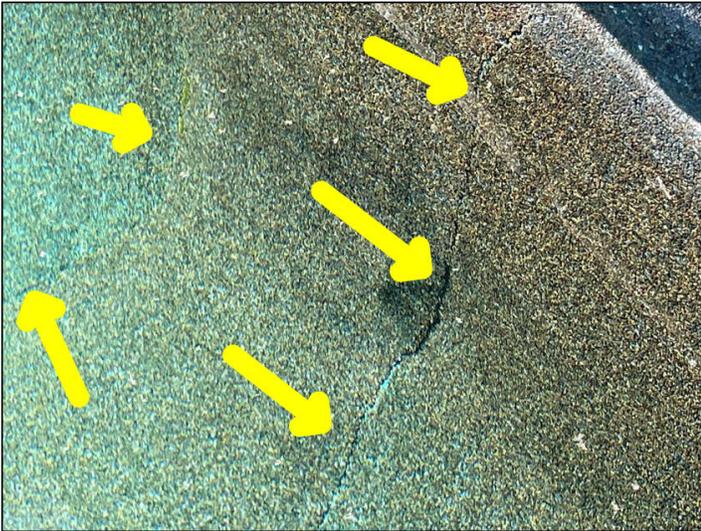
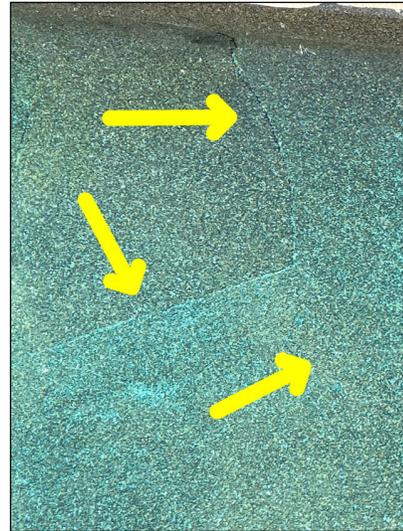
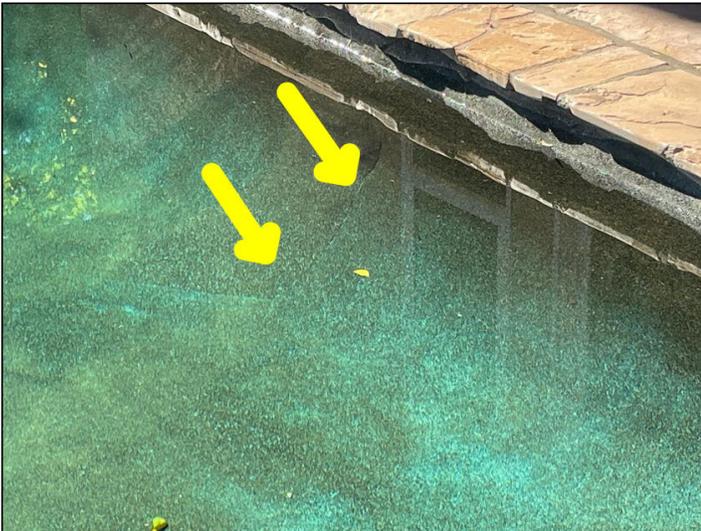
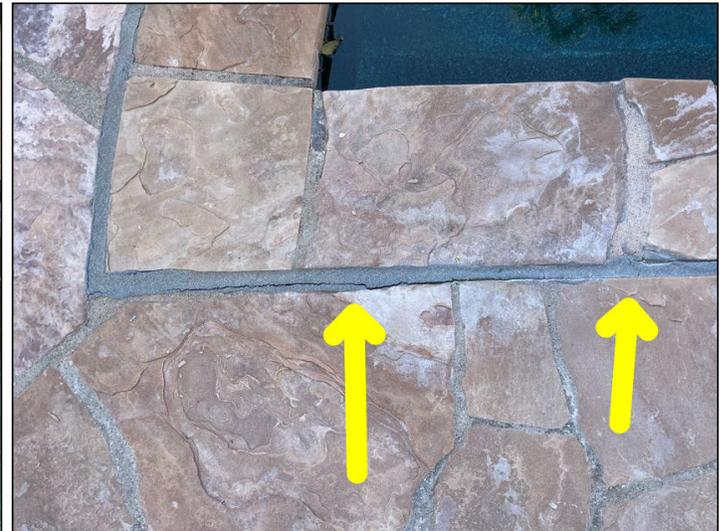
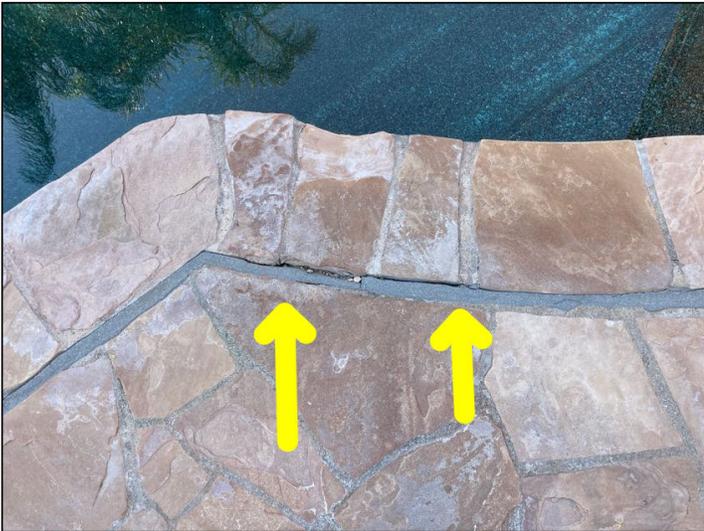
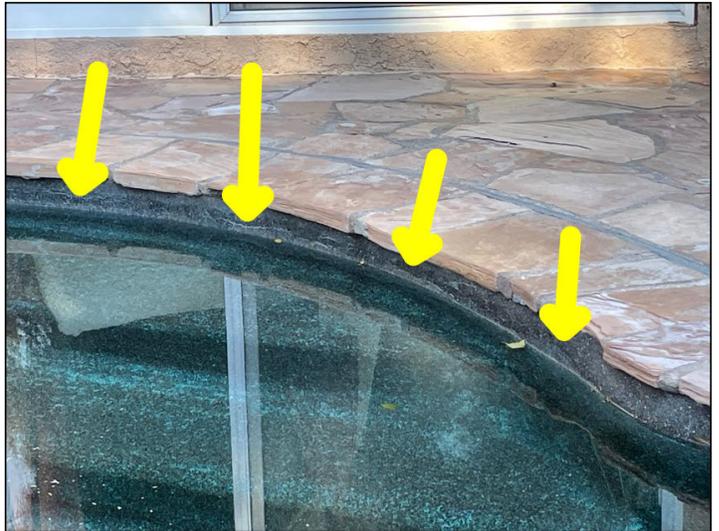
- Cracks noted on the pool surface.
- Cracks appear significant and may be caused by soil settlement due to inadequate hillside coverage and significant hillside soil erosion. See deck comments and photos. Determining underground leaks is beyond the scope of this inspection. Further evaluation by a licensed pool contractor is recommended.
