PROPERTY INSPECTION REPORT

12345 Main Street, Anytown, CA 90001

DATE OF INSPECTION: 12/9/2022

VILLA HOME INSPECTIONS

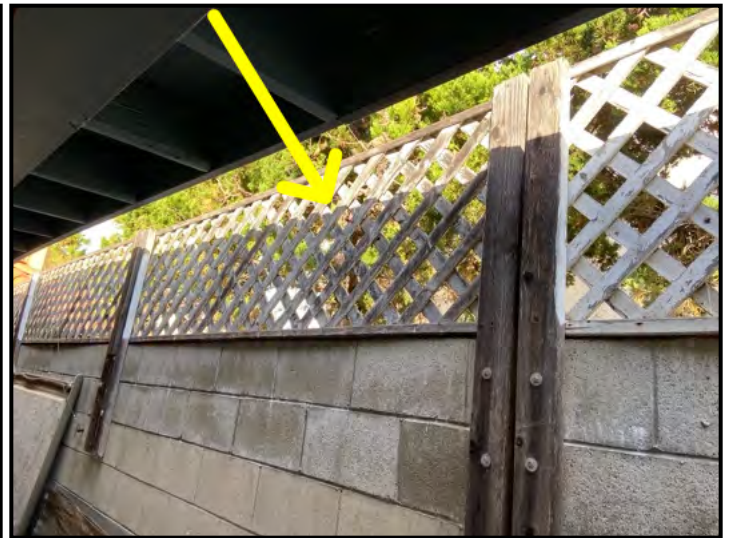
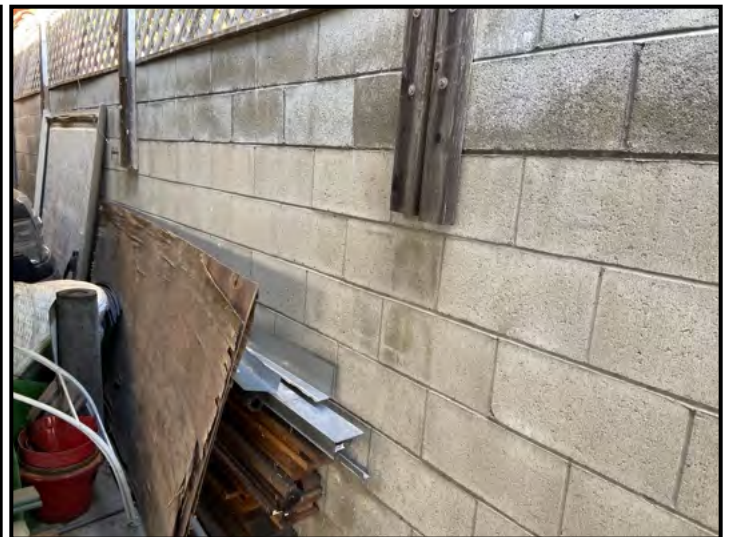
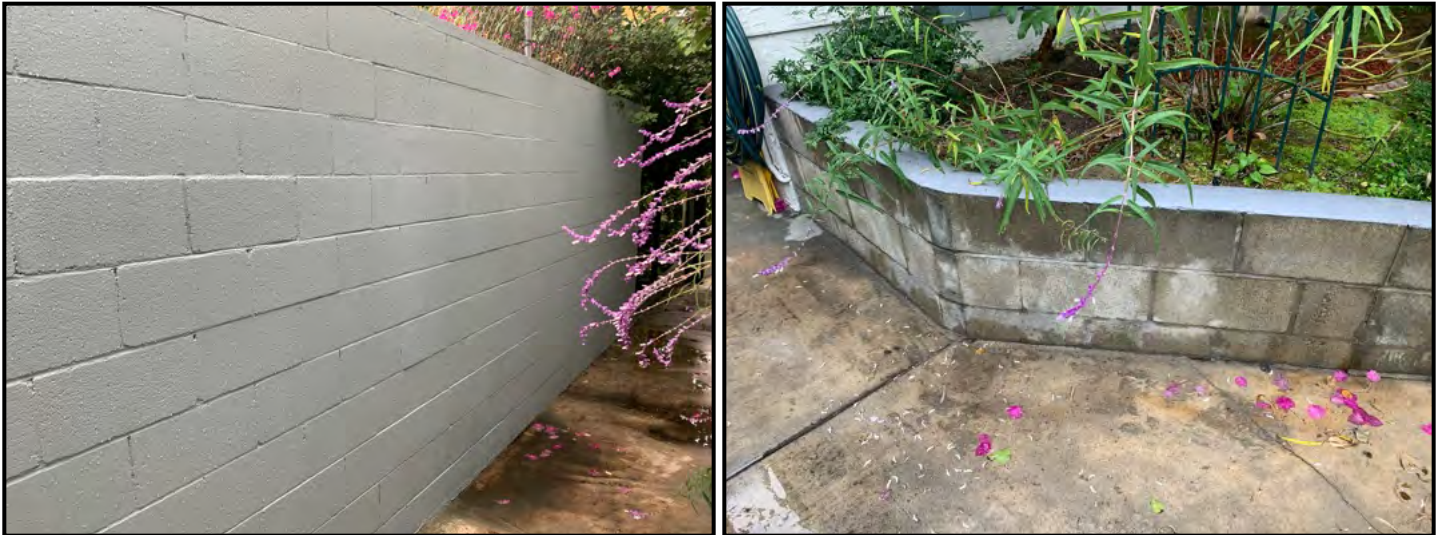
- Fencing appears functional.
- Common cracks noted on the block walls.
- See photos.
- Fence is leaning or falling. Repair or replacement is recommended.
- Paint finish is deteriorated or flaking. Repainting is recommended to prevent moisture damage.
- See photos.

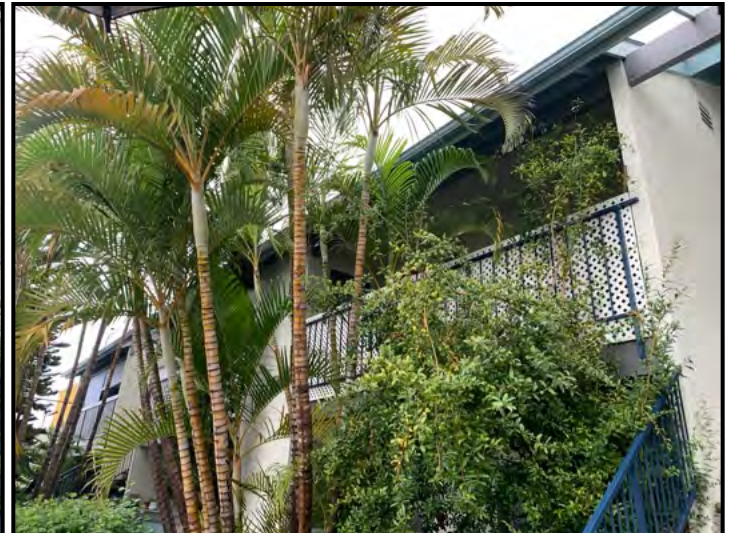
- Landscaping appears adequately maintained.
- Trimming plants away from the structure is recommended to prevent damage and rodent infestation.
- Trees are within 6 feet of foundation. Monitor for potential root damage.
- Trees or other vegetation are touching or overhanging the roof. Damage is possible. Vegetation on the roof is also a source for rodent activity on the roof and the attic. Recommend trimming all vegetation or trees away from the roof structure.
- Brush growth is too close to the structure (under 100 ft.). Removal is recommended for fire safety.
- Tree branches overhanging roof and/or against siding. Trim trees that are in contact or proximity to home, as branches can abrade siding and damage roofing.
- See photos.

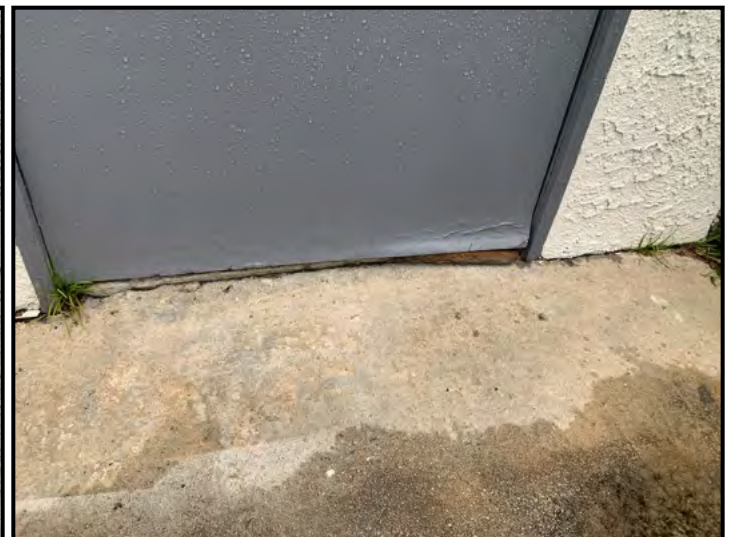
- Glass is cracked or broken. Replacement is required.
- Some windows are hard to operate or painted closed.
- One or more doors are delaminated or have moisture damage. Repair or replacement is recommended.
- Exterior door is improper type. All exterior doors must be solid type.
- See photos.

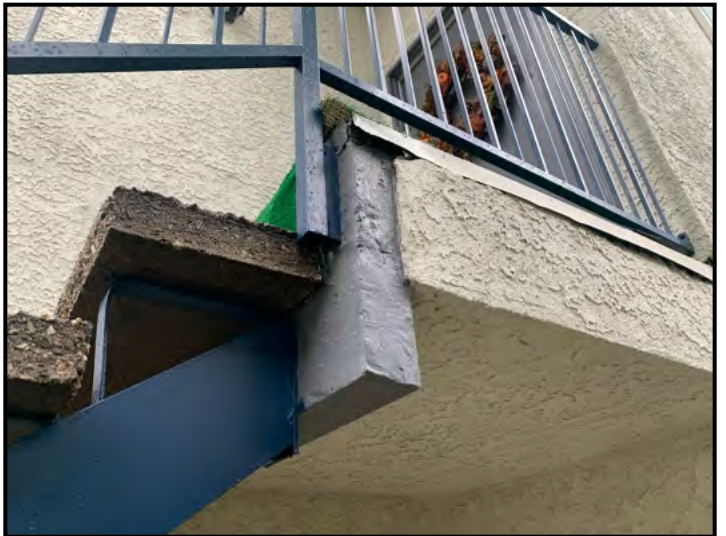
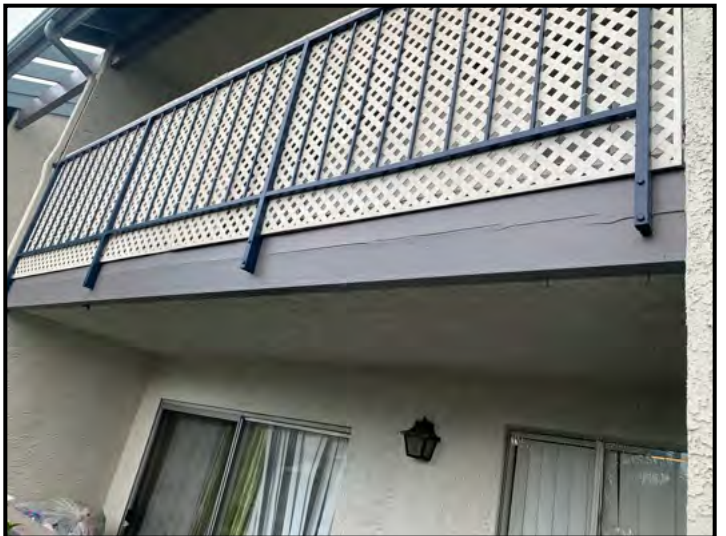
- Deck underside is not accessible for inspection. Further evaluation may be necessary.
- Balcony underside is covered with wood or stucco and is not accessible for inspection. Further evaluation may be necessary.
- Carpet restricts viewing and inspection of the balconies, stair landings and patio floors. See exterior stairs comments and photos. Further evaluation is recommended, and may necessitate the removal of the carpet.
- Wood beams on some of the decks appear to have some rot/termite damage and moderate size cracking. See photos.
- Most decks and porches have been covered with synthetic turf material which holds moisture and causes significant amount of rock damage underneath. See photos.
- See photos.

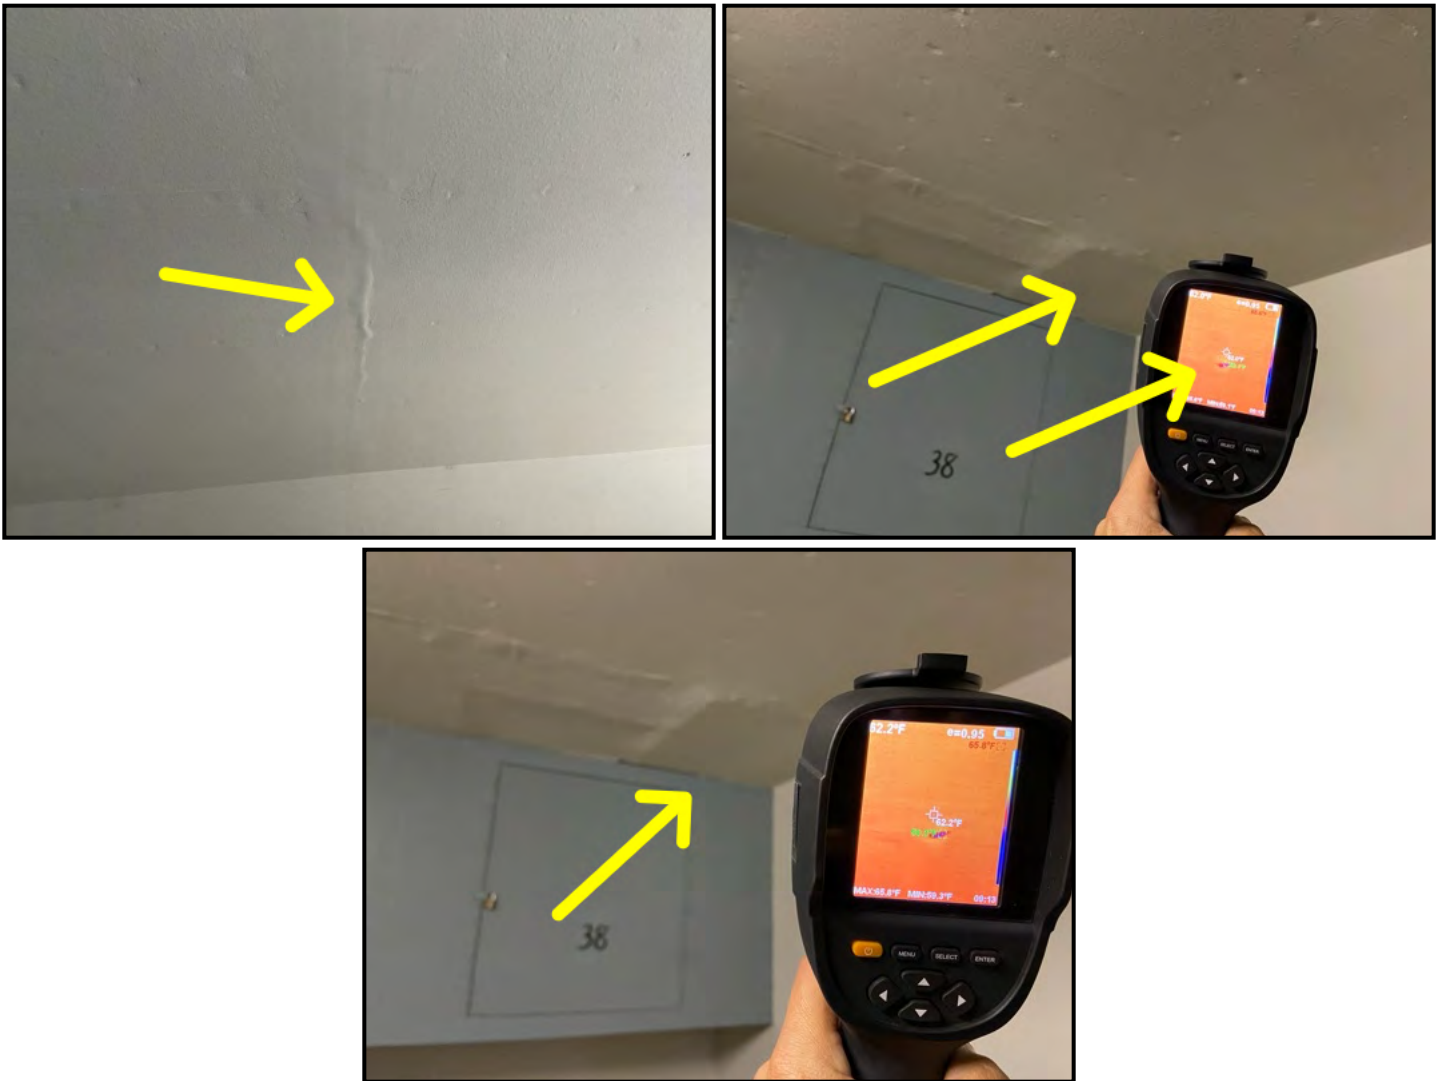
- Moisture stains or damage observed on the garage ceiling.
- Possible plumbing leak. Further evaluation by a plumbing contractor is recommended.
- See photos.

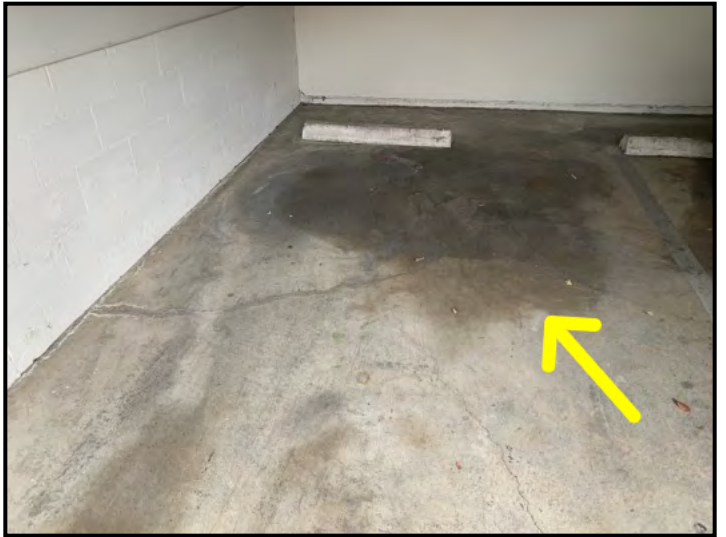
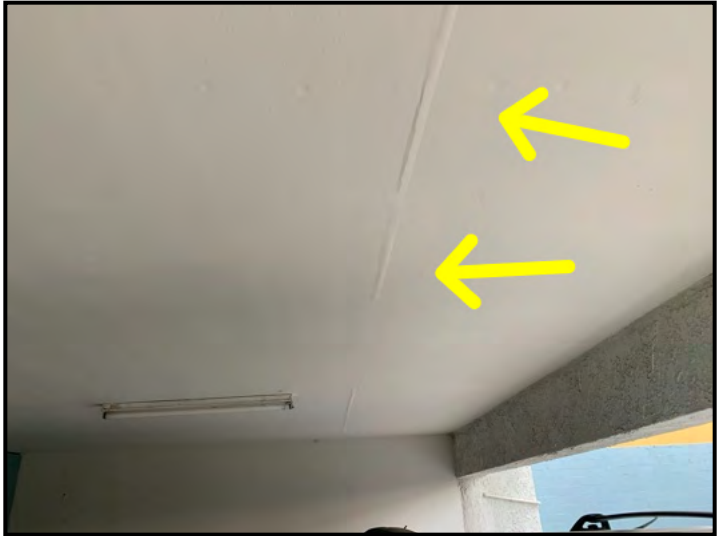
- Moisture, rot or termite damage observed at the East fascia boards.
- Fascia boards are twisted and loose. See photo. Repair or replacement is recommended.
- Further evaluation by licensed termite inspector is recommended.
- Paint finish is deteriorated or flaking. Repainting is recommended to prevent moisture penetration and damage.
- Moisture penetration and or damage observed on the roof structure. Further evaluation by roofing contractor is recommended.
- See photos.
- Improper slope or low areas in carport causing in adequate drainage noted. See photos.
- Some damaged drywall inside carport area noted. See photos.

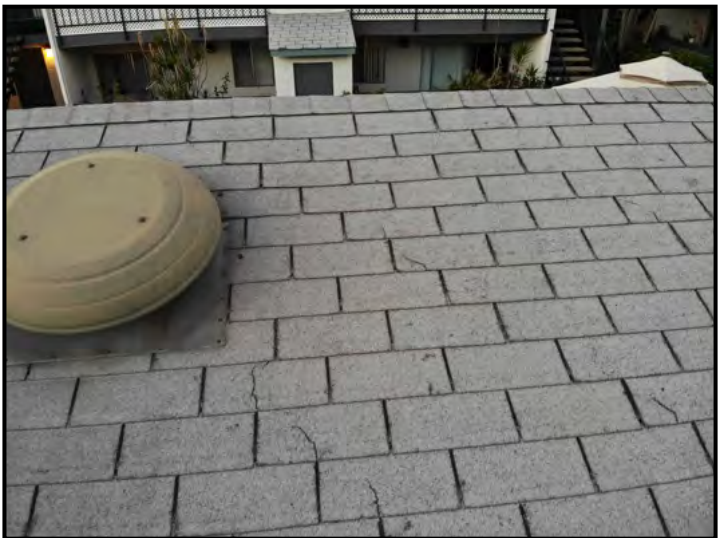
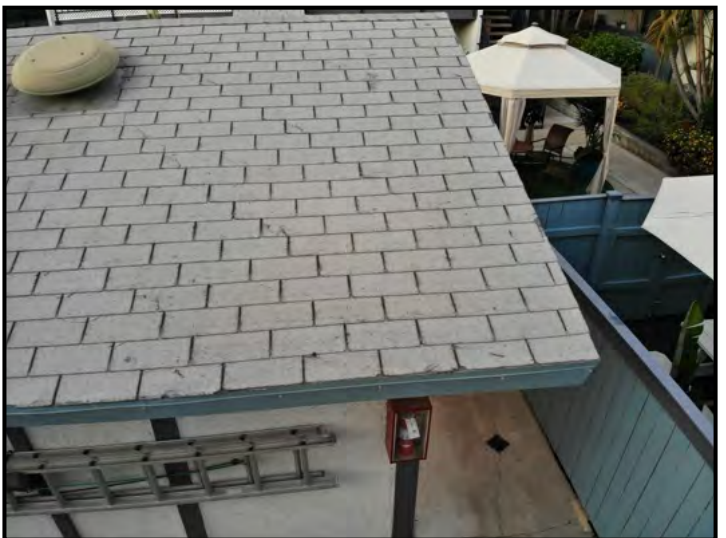
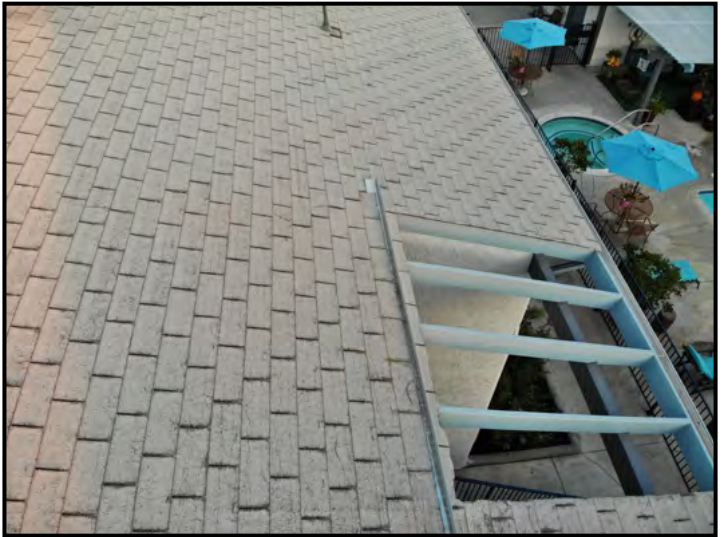
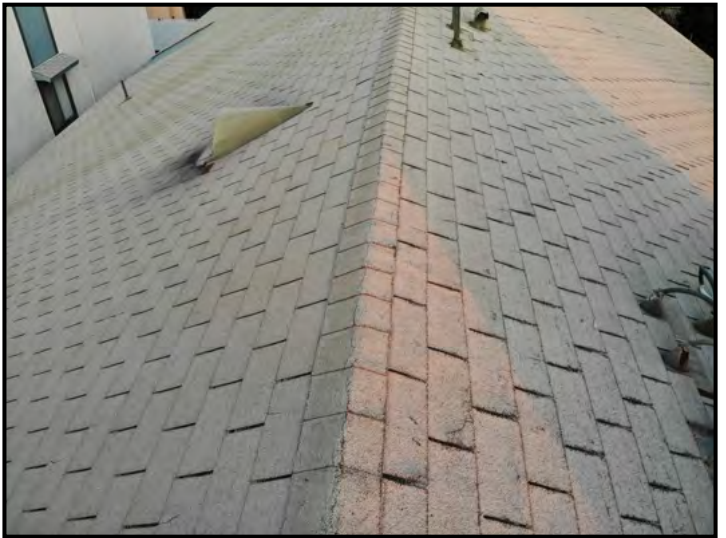
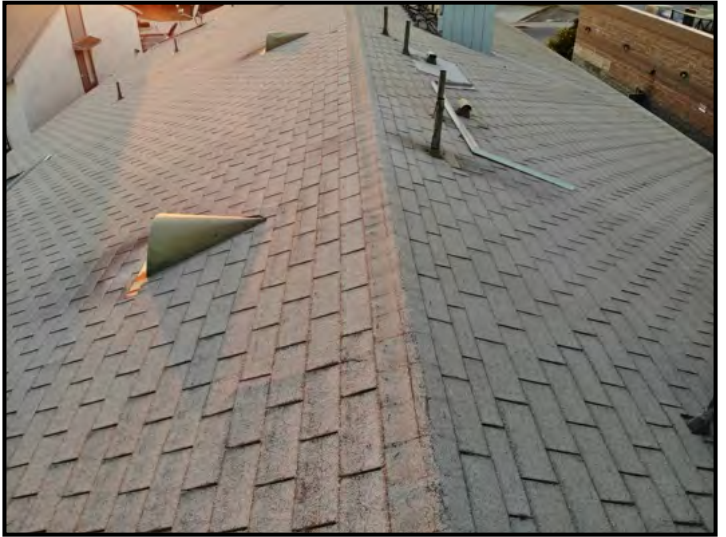
- Moderate deterioration of the roofing material was noted at time of inspection.
- Moderate to significant cracking and clawing of the roofing shingles observed throughout the roofs at time of inspection. Cracking and clawing of shingles are the result of long term weathering and an advanced shingle age.
- A licensed roofing contractor should be called to make further evaluation and repairs as needed.
- See photos.

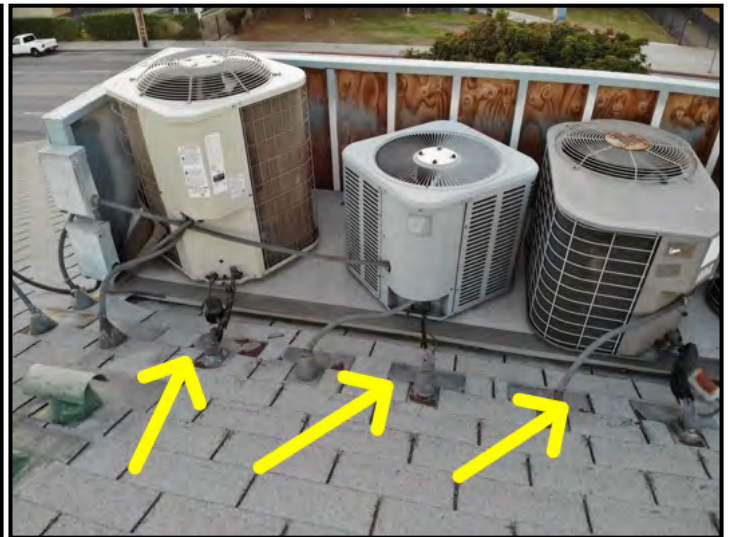
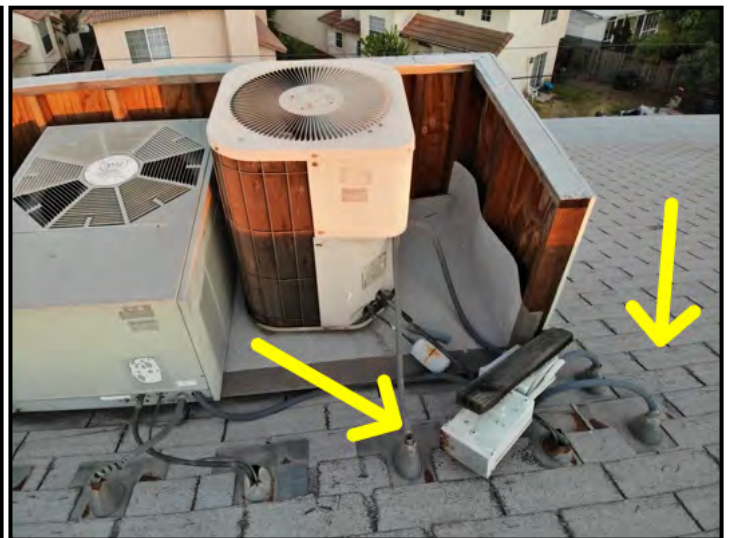
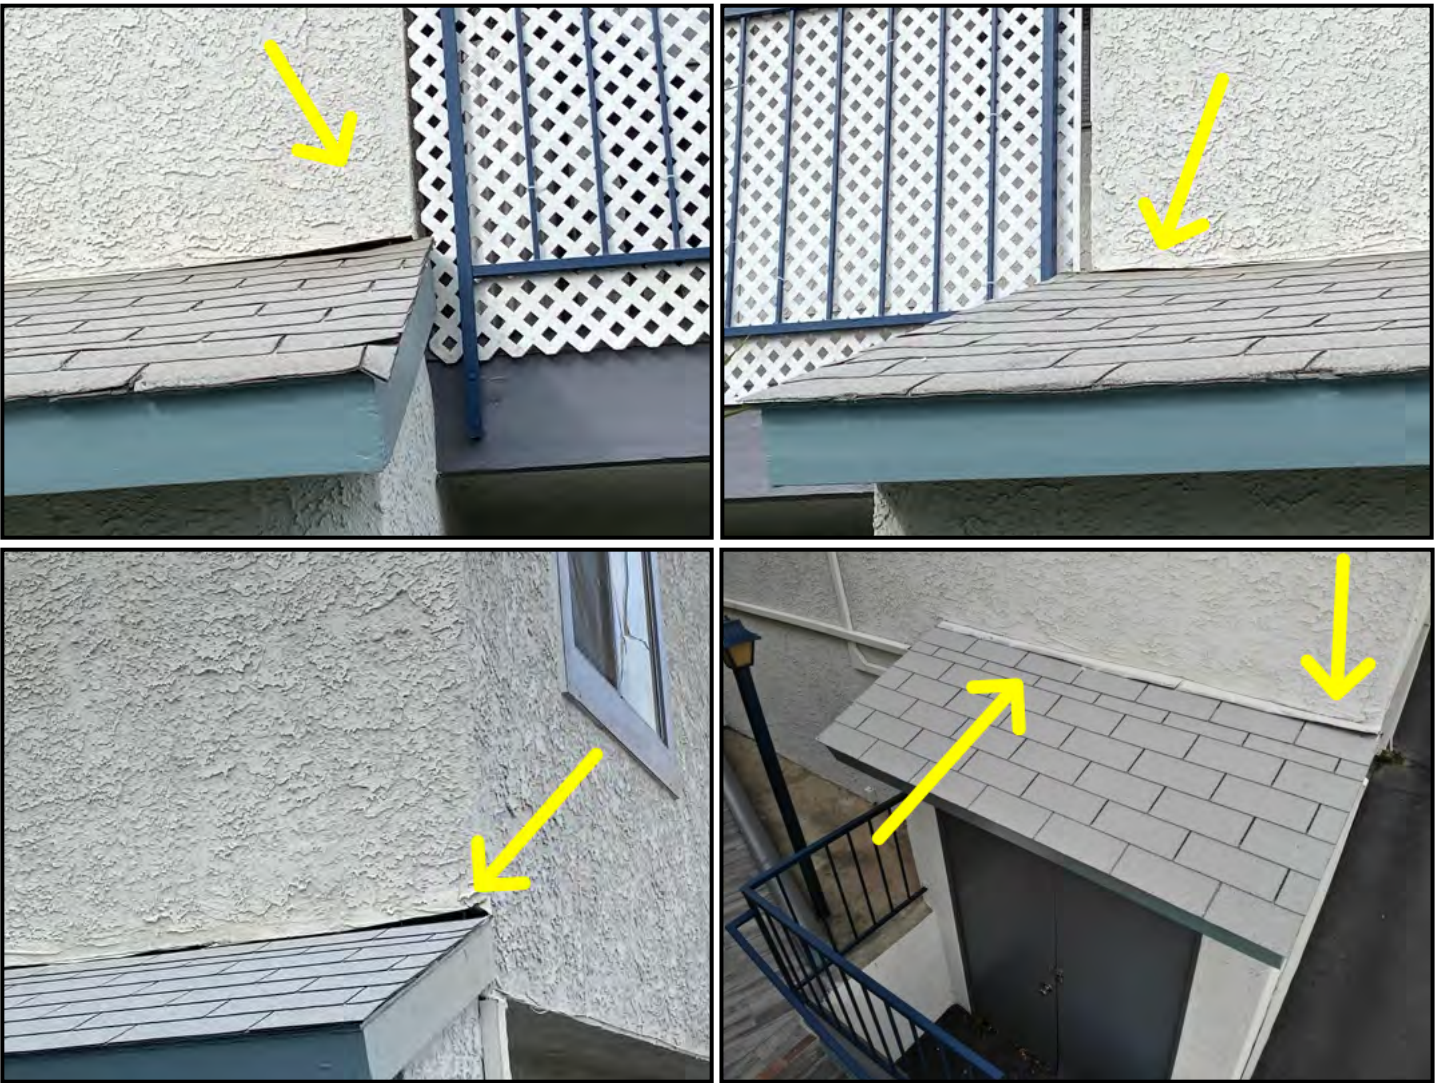
- Flashings do not appear to be properly sealed at the wall junctions.
- Flashings do not appear to be properly sealed at the vent pipes.
- Flashings do not appear to be properly sealed at the HVAC systems throughout the roofs.
- Typical maintenance is recommended.
- See photos.

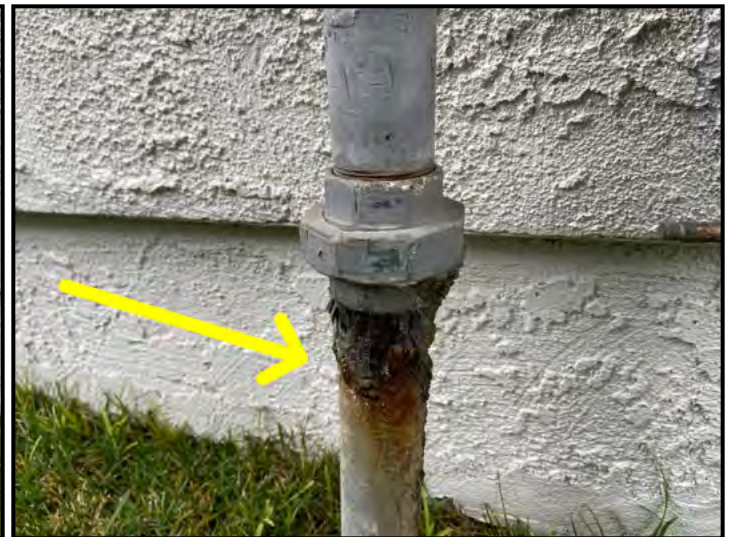
- Excessive corrosion is observed on or near the main water shut off valve.
- Meter box was flooded at time of inspection. Unable to determine which side of the meter is leaking. Further evaluation by plumbing contractor is recommended.
- A licensed plumbing contractor should be called for further evaluation and repairs.
- See photos.

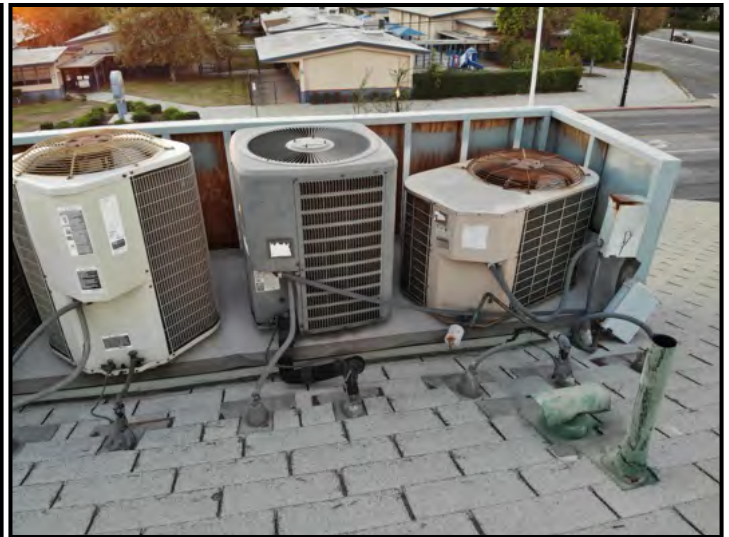
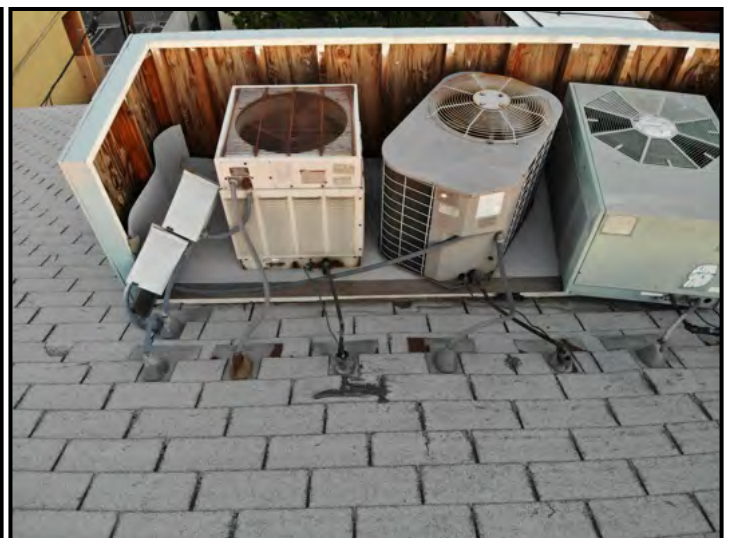
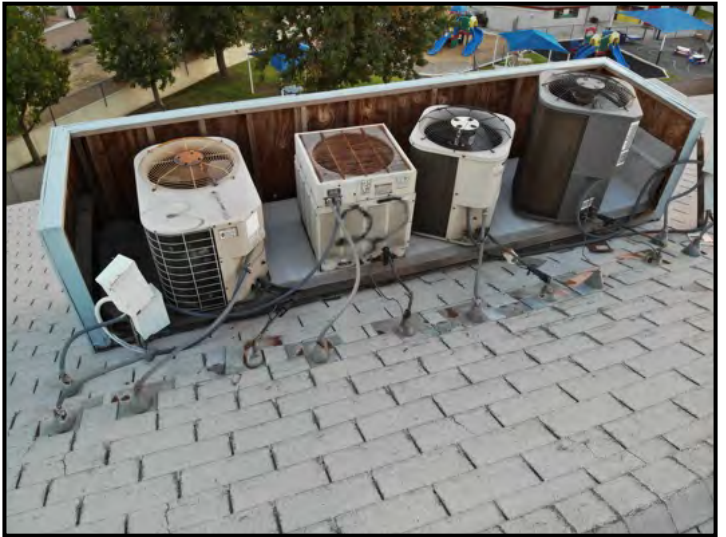
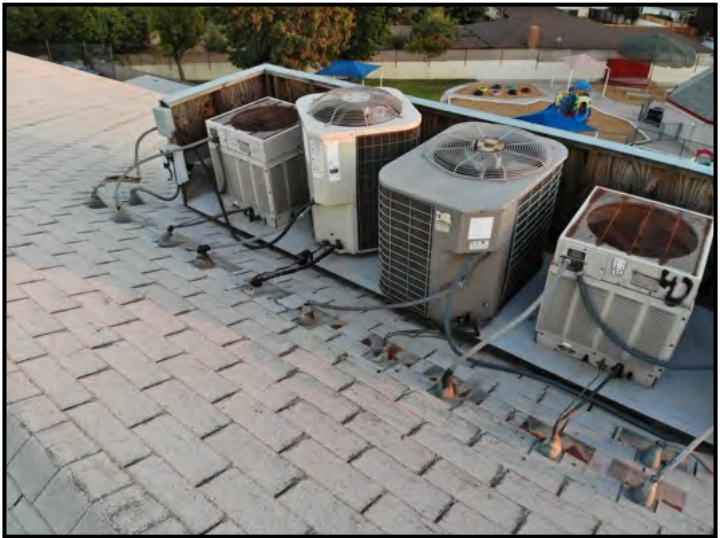
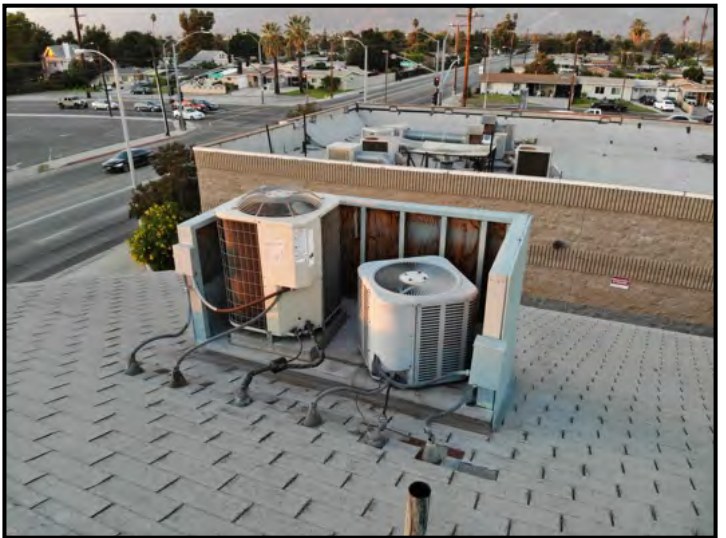
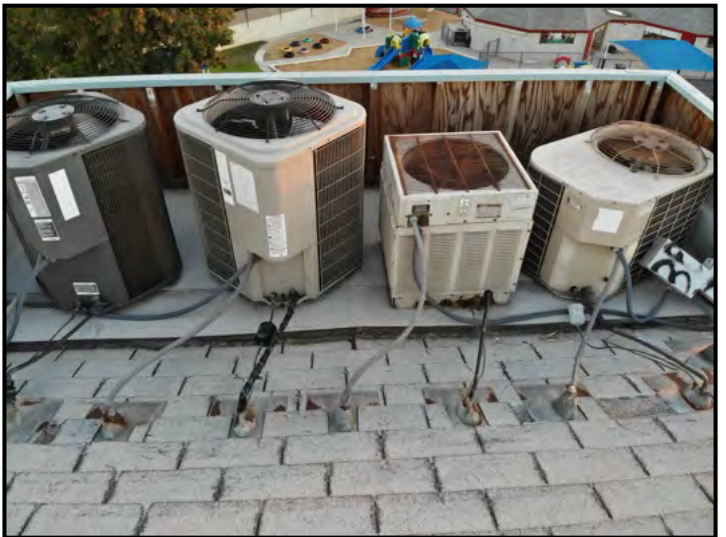
- Condenser units are dirty throughout the property and in need of cleaning and maintenance.
- Insulation on the refrigeration lines of the condensers is deteriorated or missing throughout the property. Repair or replacement is recommended.
- A licensed HVAC contractor should be called to make further evaluation and repairs as needed.
- See photos.

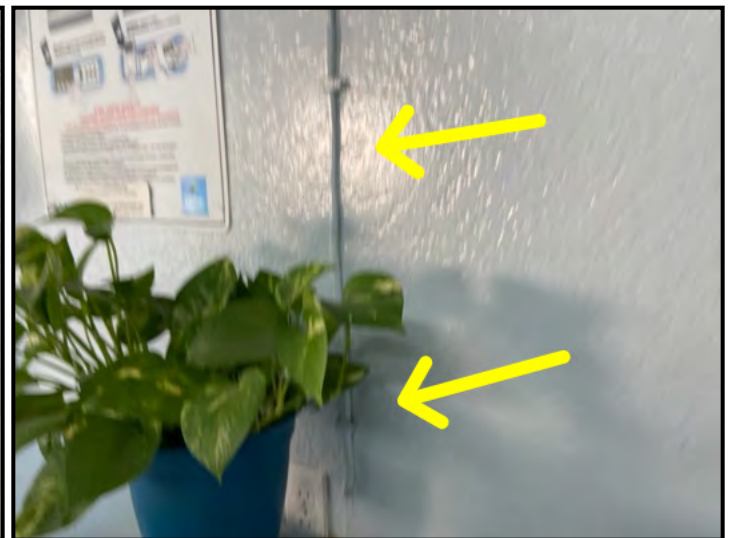
- A representative number of outlets, switches and fixtures was operated and found to be in operable condition at time of inspection.
- Improperly installed, exposed and unsafe romex wiring observed in the laundry room. See photos. Proper Installation or removal is necessary.

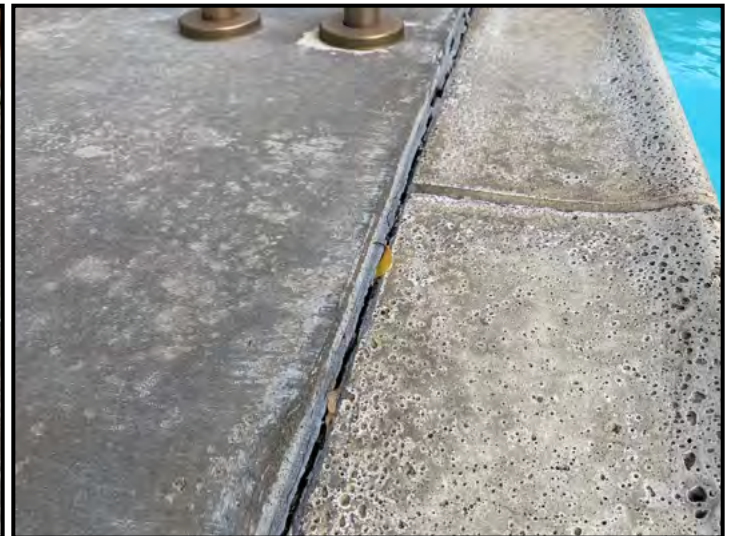
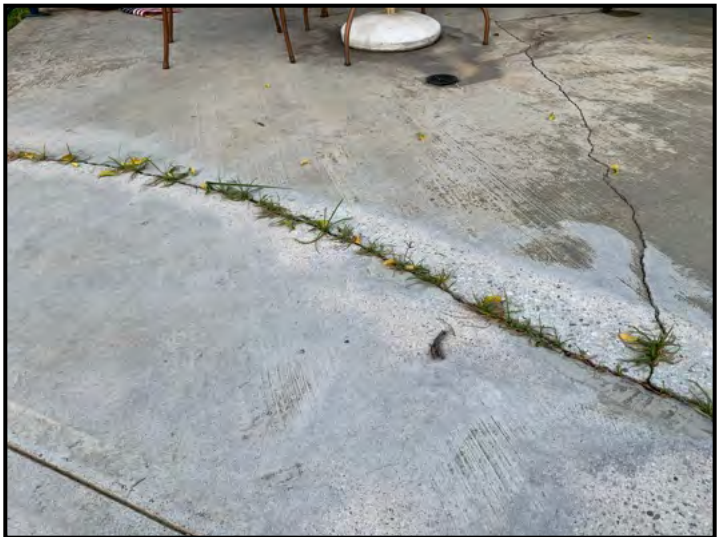
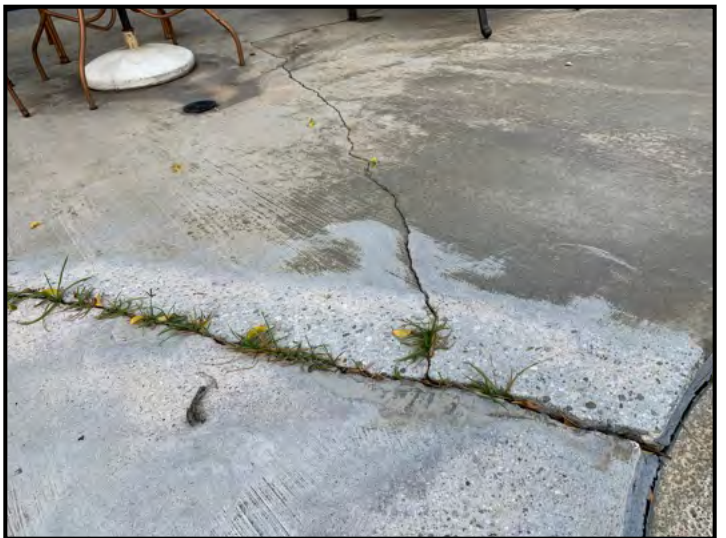
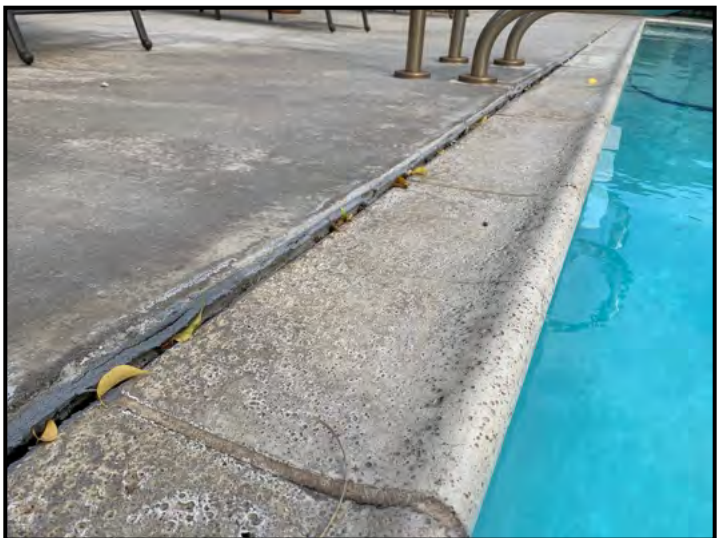
- Coping is not sealed properly. Application of sealant is recommended to prevent moisture penetration behind pool walls.
- Cracks observed on the coping around the pool. This is an indication of rusted steel reinforcement (rebar) inside the bond beam (structural support around the top of the pool walls) and may be a structural concern in the future if not repaired.
- Concrete deck has moderate cracks and may need further evaluation by a masonry or pool contractor.
- North west corner of the pool decking appears to have been lifted up and is no longer level with the pool. See photos
- See photos.

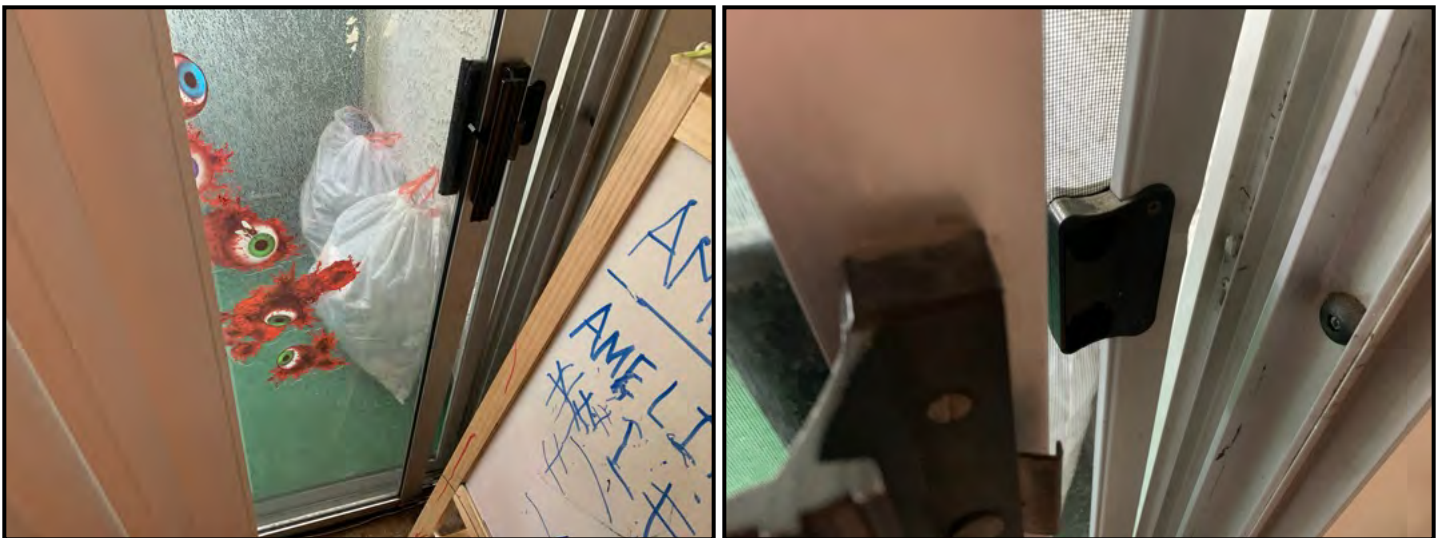
- Walls and ceiling appeared functional at time of inspection.
- No visible problems noted at the closet at time of inspection.
- No visible problems noted at the floor at time of inspection.
- A representative number of outlets, switches and fixtures was operated and found to be in operable condition at time of inspection.
- Evidence of moisture penetration observed at the window. Window may need caulking or sealant application on the exterior.
- Window is difficult to operate. Repair or replacement is recommended.
- Sliding glass door screen is damaged or missing. Repair or replacement is recommended
- See photos.
- Sliding glass door is difficult to operate

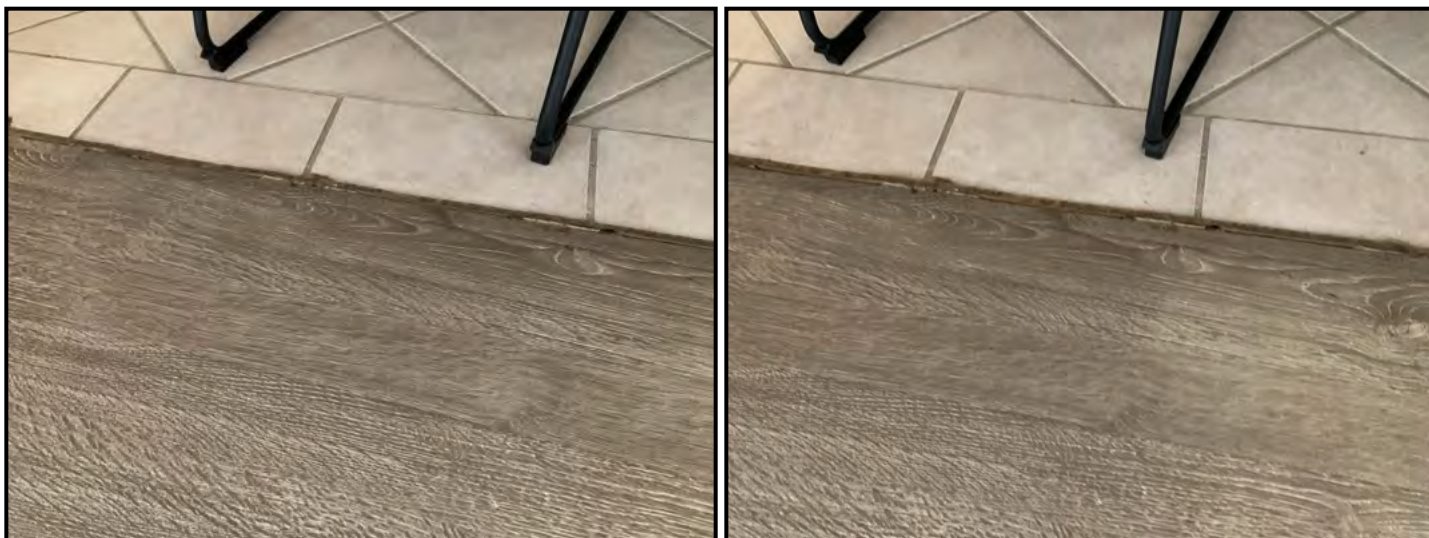
- Windows and doors operated properly at time of inspection.
- Walls and ceiling appeared functional at time of inspection.
- A representative number of outlets, switches and fixtures was operated and found to be in operable condition at time of inspection.
- **Flooring is damaged or deteriorated. Repair or replacement is recommended.**

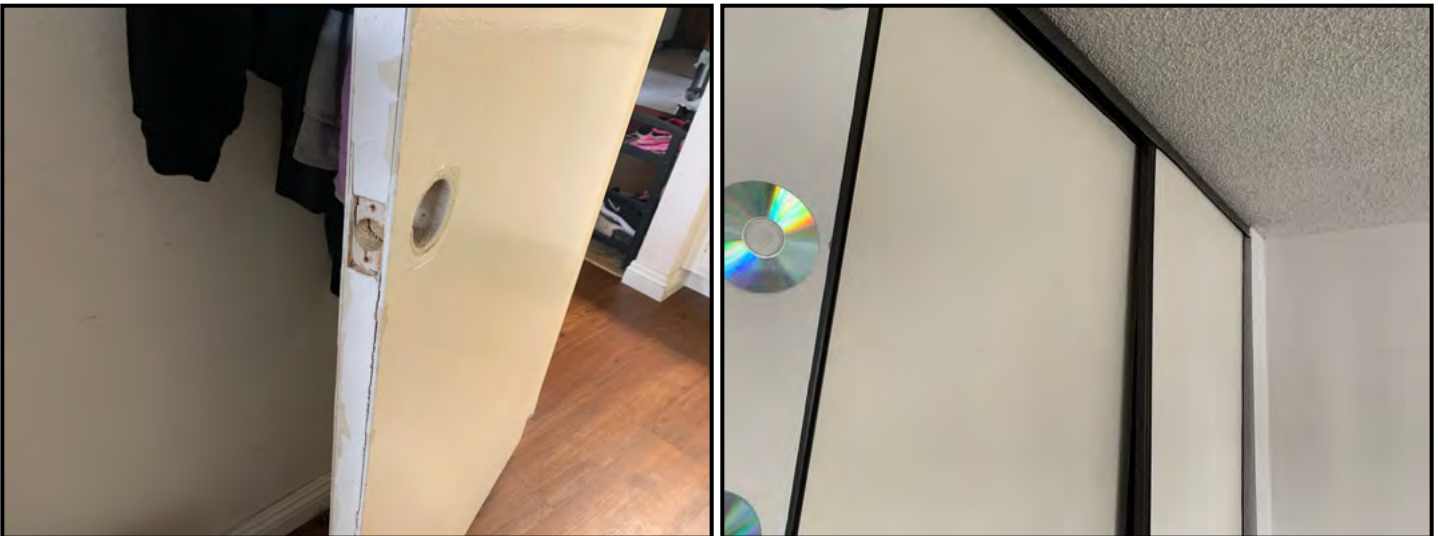
- Walls and ceiling appeared functional at time of inspection.
- No visible problems noted at the floor at time of inspection.
- A representative number of outlets, switches and fixtures was operated and found to be in operable condition at time of inspection.
- **Smoke detector is not installed. A smoke detector is required in every bedroom, adjacent hallway and every level of the dwelling prior to the close of escrow.**
- **See photos.**
- **Closet doors are fallen off the tracks. Proper installation is recommended.**
- **See photos.**
- **Closet doors do not operate properly in and falling off tracks.**
- **Bedroom door is damaged and missing hardware**

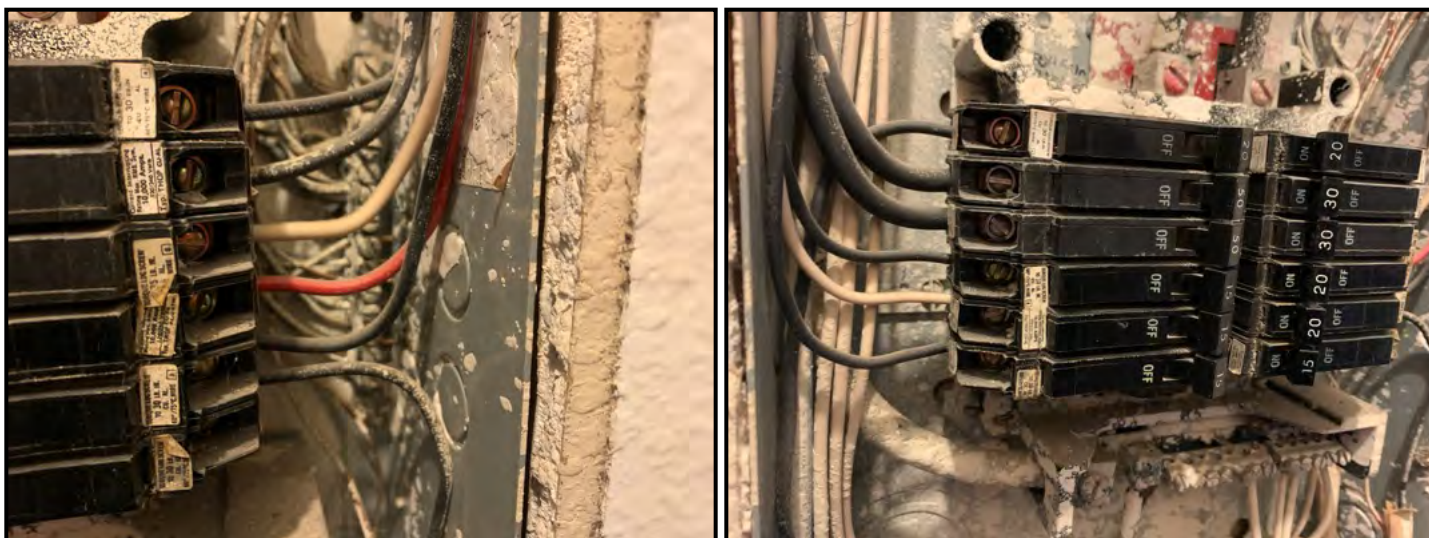
- Circuit and wire sizing correct so far as visible.
- Grounding system is present.
- See photos.
- **Electrical panel is located in bedroom closet which is not allowed**

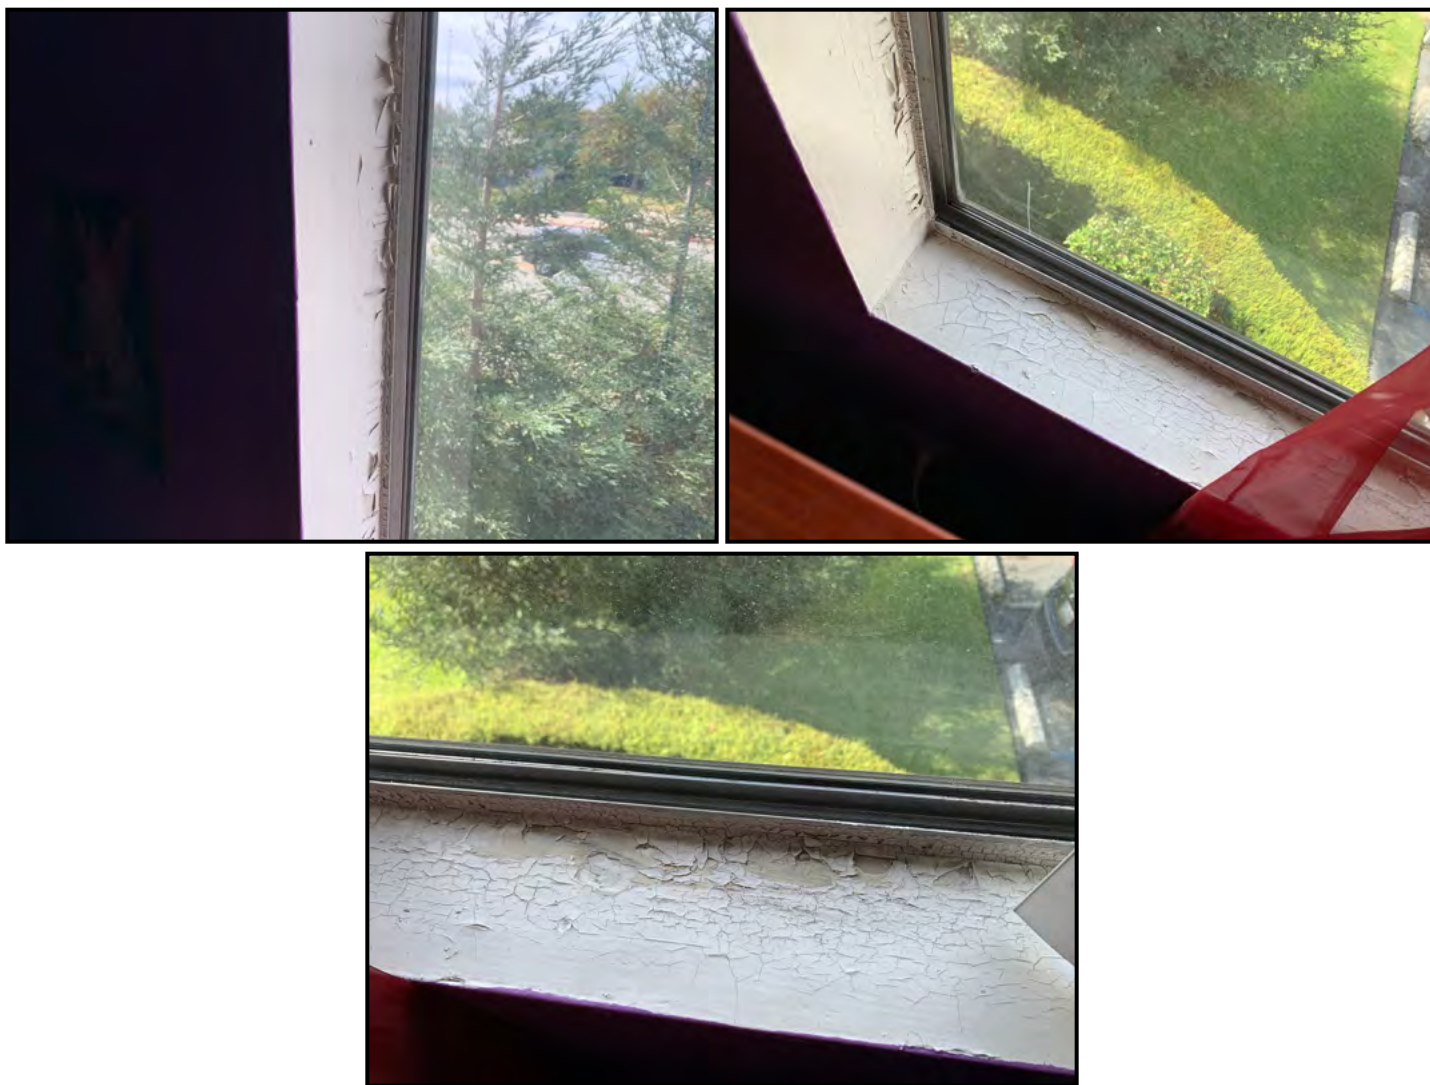
- Windows and doors operated properly at time of inspection.
- Walls and ceiling appeared functional at time of inspection.
- No visible problems noted at the closet at time of inspection.
- No visible problems noted at the floor at time of inspection.
- A representative number of outlets, switches and fixtures was operated and found to be in operable condition at time of inspection.
- **Smoke detector is not installed. A smoke detector is required in every bedroom, adjacent hallway and every level of the dwelling prior to the close of escrow.**
- **Evidence of moisture penetration observed at the window. Window may need caulking or sealant application on the exterior.**

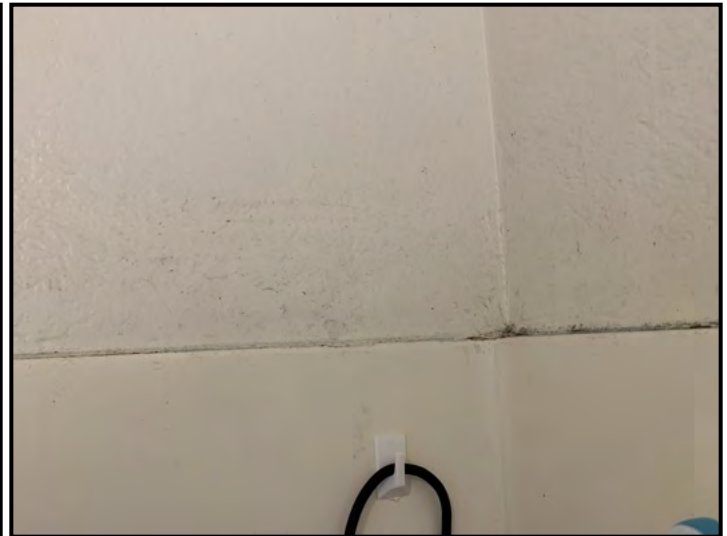
- No visible plumbing problems noted at time of inspection.
- No visible problems noted at the sink and vanity at time of inspection.
- No visible problems noted at the tub/shower area at time of inspection.
- No visible problems observed at the doors and windows at time of inspection.
- No visible floor problems noted at time of inspection.
- **Moisture stains and/or damage viewed on the walls.**
- **See photos.**
- **Ground Fault Circuit Interrupter (GFCI) outlets are recommended for installation.**
- **See photos.**

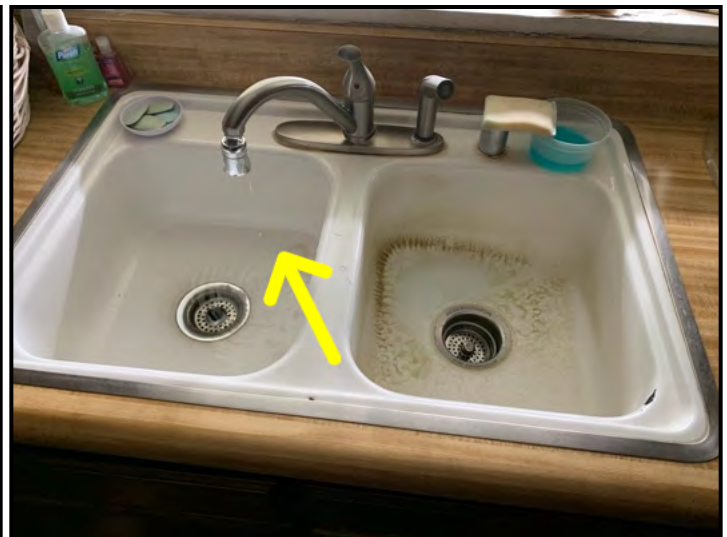
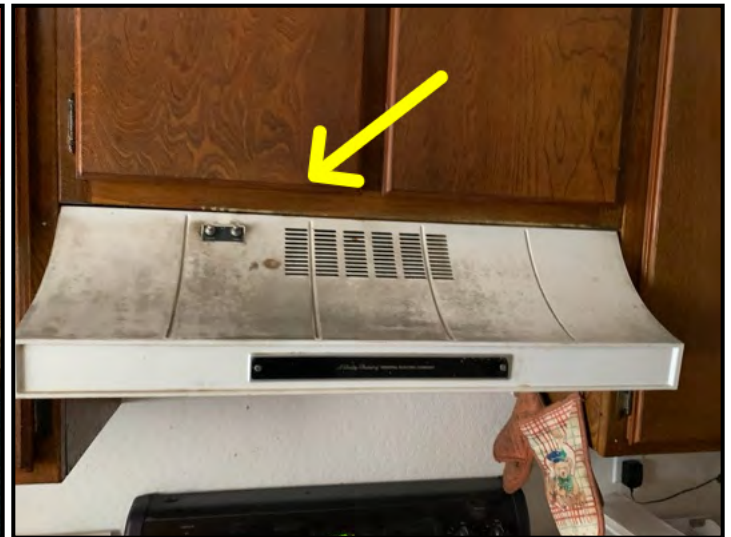
- Windows and doors operated properly at time of inspection.
- Walls and ceiling appeared functional at time of inspection.
- No visible problems noted at the floor at time of inspection.
- A representative number of outlets, switches and fixtures was operated and found to be in operable condition at time of inspection.
- Low water pressure was noted at the faucet.
- Dishwasher did not operate at time of inspection.
- Sink surface is damaged or worn. Repair or resurfacing is recommended.
- Moisture damage noted on the cabinets. Repair or replacement is recommended.
- See photos.
- Dishwasher is original older appliance needs to be replaced.
- Range fan is original and his damaged and needs to be replaced
