PROPERTY INSPECTION REPORT

12345 Main Street, Anytown, CA 90001

DATE OF INSPECTION: 12/9/2022

VILLA HOME INSPECTIONS

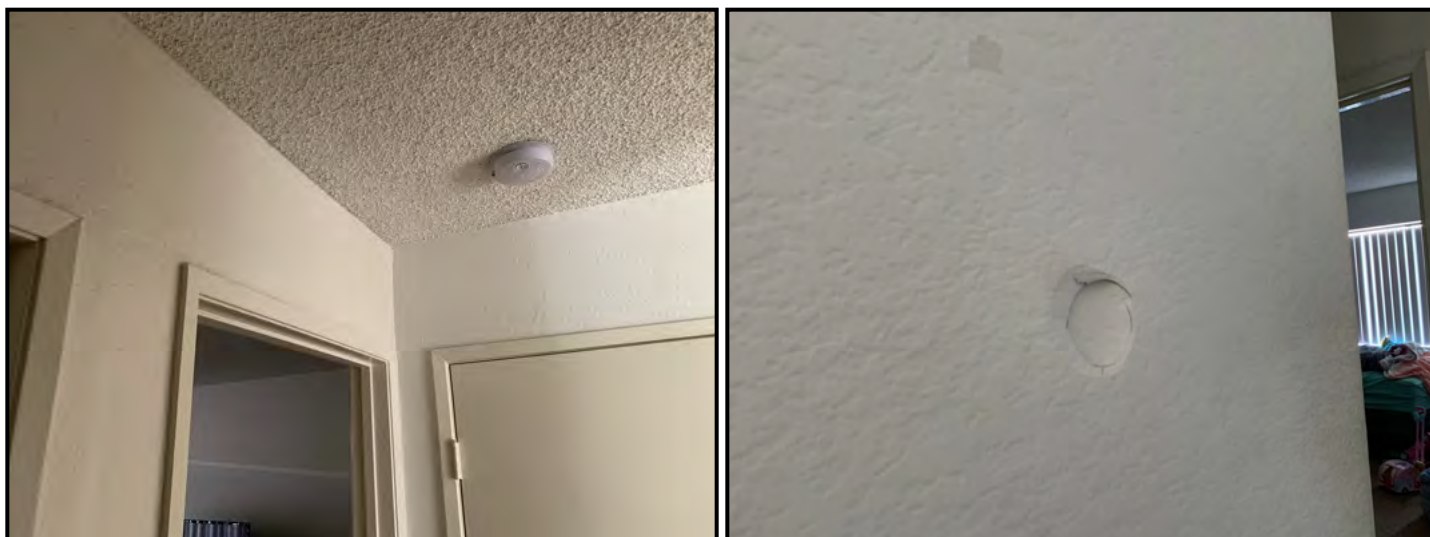
- Smoke detector is installed.
- Windows and doors operated properly at time of inspection.
- No visible problems noted at the closet at time of inspection.
- No visible problems noted at the floor at time of inspection.
- A representative number of outlets, switches and fixtures was operated and found to be in operable condition at time of inspection.
- No carbon monoxide alarm installed in the dwelling. Installation is required near the sleeping rooms when any gas burning appliance is present.
- Moisture stains and/or damage viewed on the walls.

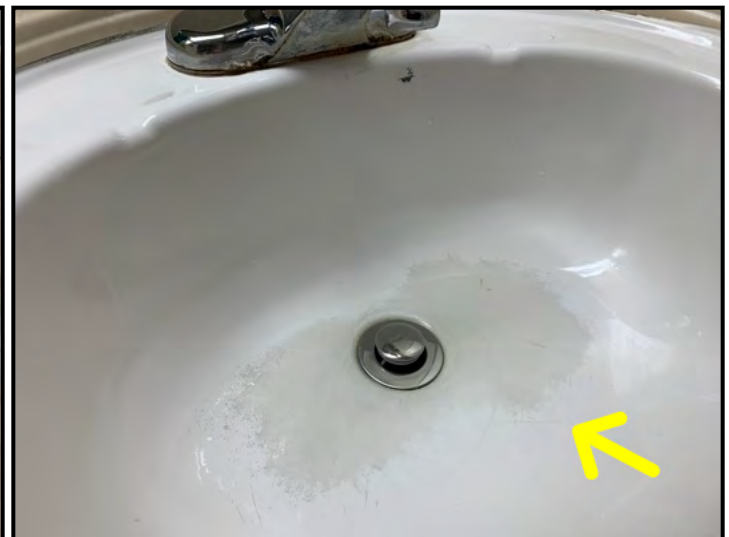
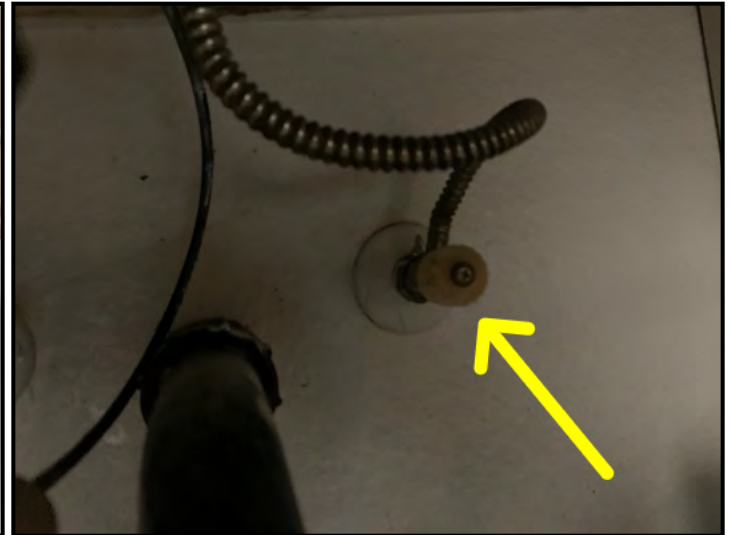
- No visible problems noted at the sink and vanity at time of inspection.
- No visible problems noted at the tub/shower area at time of inspection.
- No visible problems observed at the doors and windows at time of inspection.
- Walls and ceiling appeared functional at time of inspection.
- No visible floor problems noted at time of inspection.
- No visible electrical problems observed at time of inspection.
- **Sink does not drain properly.**
- **See photos.**
- **See photos.**
- **Bathroom sink surface is damaged**
- **Bathroom faucet has corrosion and is damaged**
- **Supply valve is older style has significant amount of corrosion and does not work properly.**

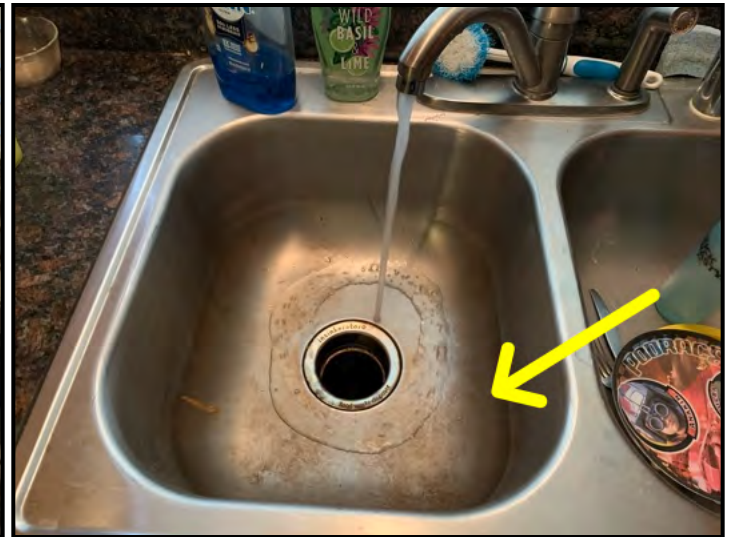
- No visible plumbing problems noted at time of inspection.
- Walls and ceiling appeared functional at time of inspection.
- No visible problems noted at the floor at time of inspection.
- A representative number of outlets, switches and fixtures was operated and found to be in operable condition at time of inspection.
- Sink surface is damaged or worn. Repair or resurfacing is recommended.
- Moisture damage noted on the cabinets. Repair or replacement is recommended.
- Evidence of moisture penetration observed at the window. Window may need caulking or sealant application on the exterior.
- Window is difficult to operate. Repair or replacement is recommended.

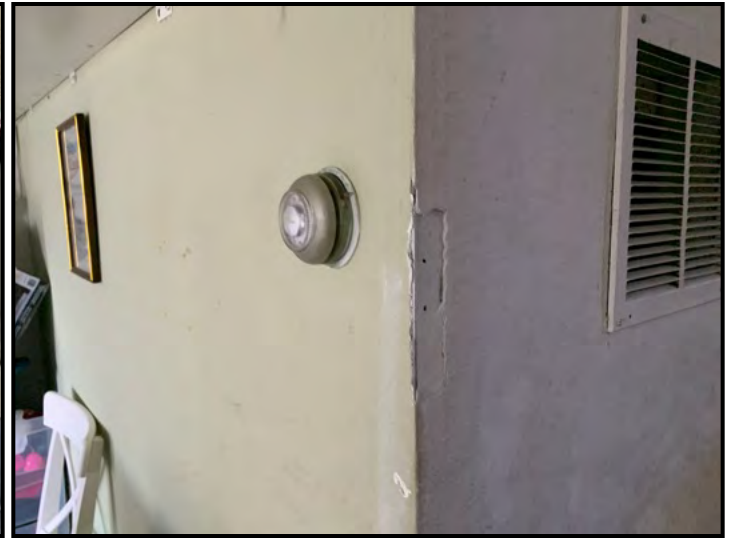
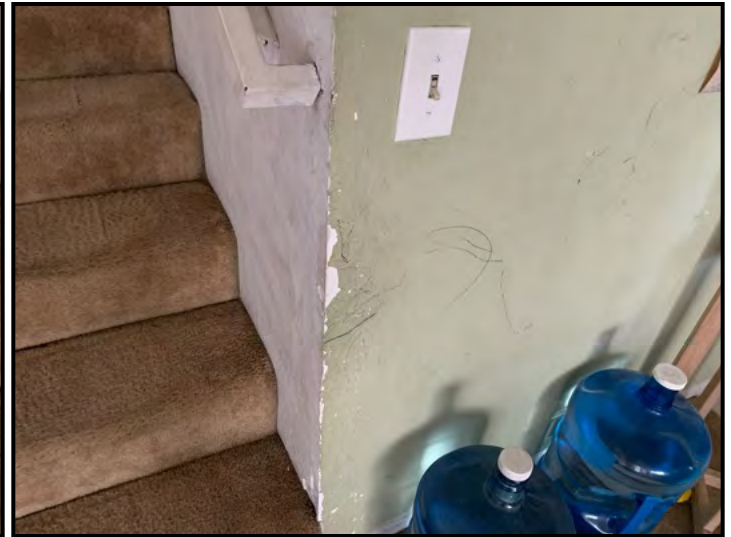
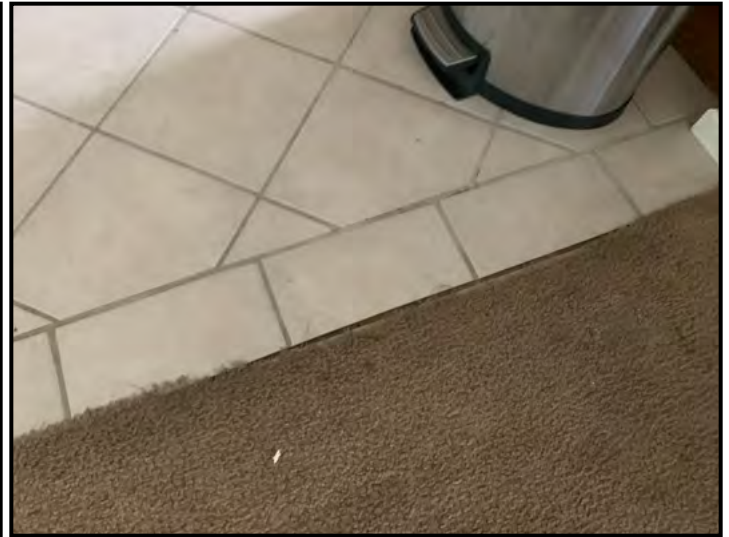
- Windows and doors operated properly at time of inspection.
- A representative number of outlets, switches and fixtures was operated and found to be in operable condition at time of inspection.
- **Moisture stains and/or damage viewed on the ceiling.**
- **Moisture stains and/or damage viewed on the walls.**
- **Flooring is damaged or deteriorated. Repair or replacement is recommended.**

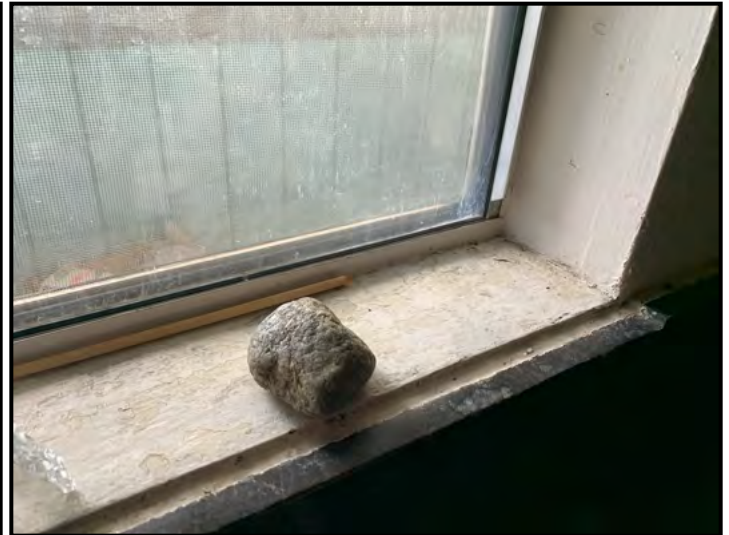
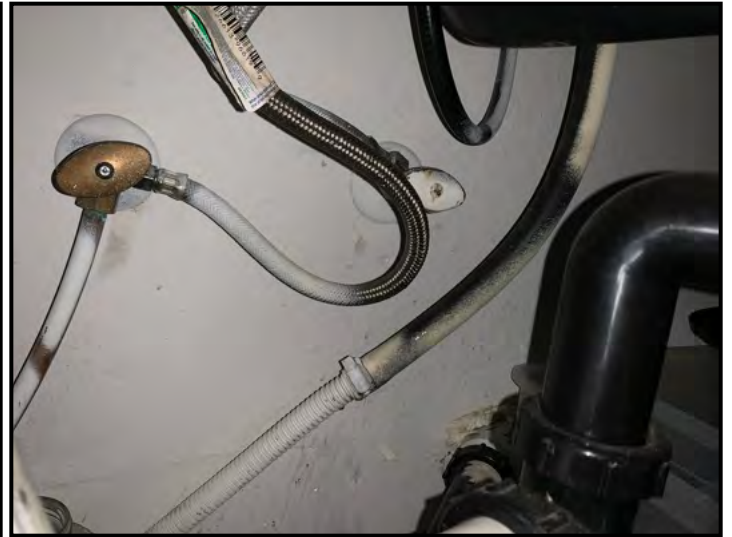
- No visible problems noted at the counters and cabinets at time of inspection.
- Windows and doors operated properly at time of inspection.
- Walls and ceiling appeared functional at time of inspection.
- No visible problems noted at the floor at time of inspection.
- A representative number of outlets, switches and fixtures was operated and found to be in operable condition at time of inspection.
- **Low water pressure was noted at the faucet.**
- **See photos.**
- **Little to no flow on hot water side in kitchen**
- **Supply line valves underneath kitchen sink are old and frozen I need to be replaced**

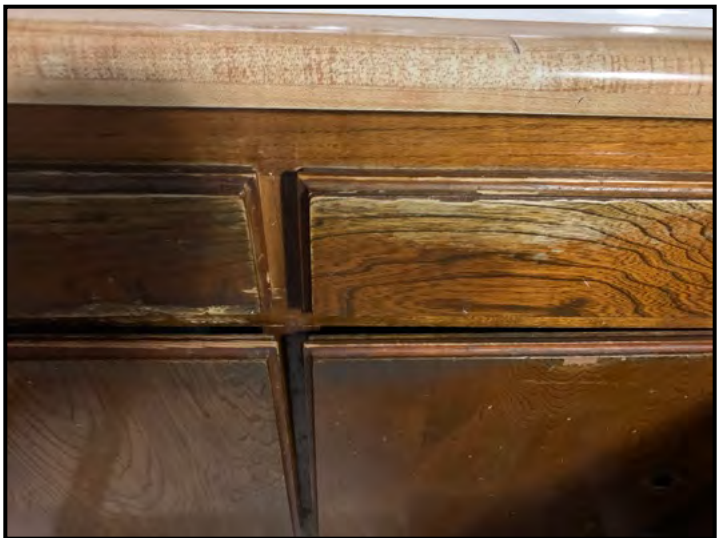
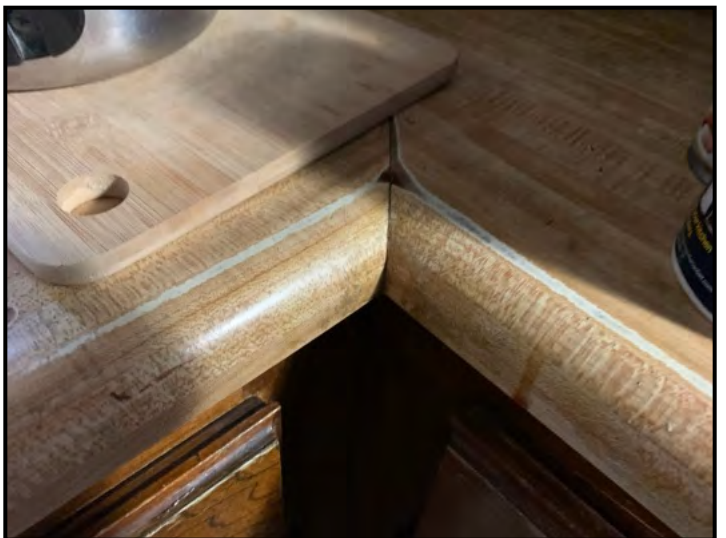
- No visible plumbing problems noted at time of inspection.
- Windows and doors operated properly at time of inspection.
- Walls and ceiling appeared functional at time of inspection.
- A representative number of outlets, switches and fixtures was operated and found to be in operable condition at time of inspection.
- **Minor to moderate wear and or damage observed on the kitchen counter top. Repair or replacement is recommended.**
- **Moisture damage noted on the cabinets. Repair or replacement is recommended.**
- **Flooring is damaged or deteriorated. Repair or replacement is recommended.**
- **See photos.**

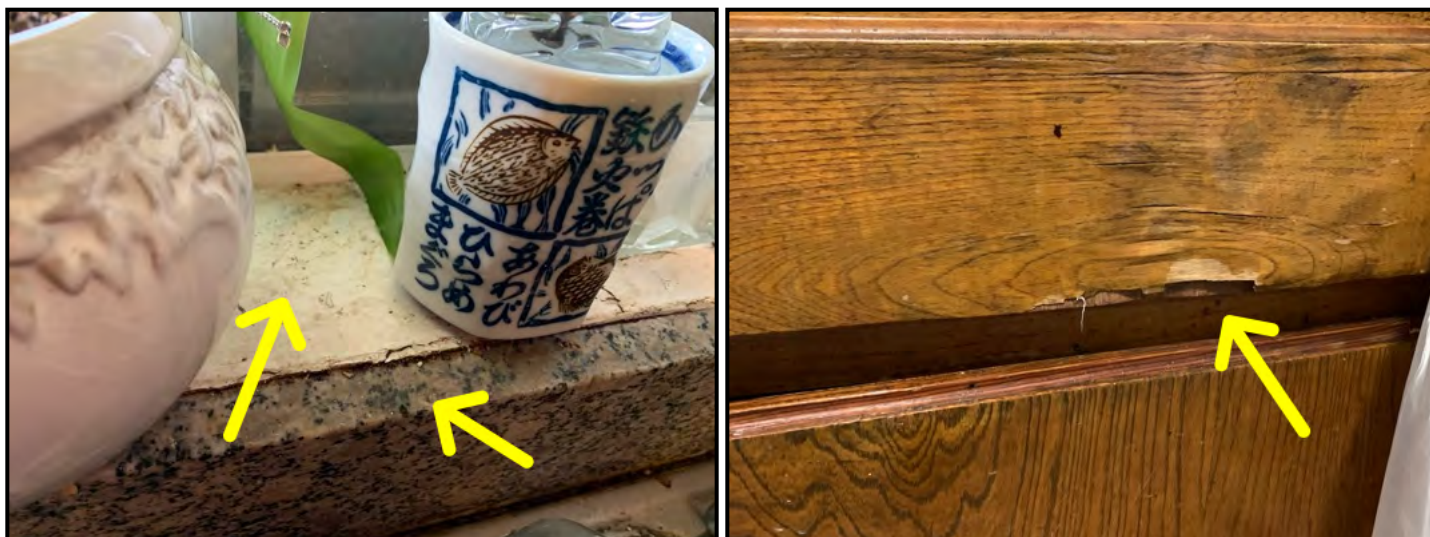
- Windows and doors operated properly at time of inspection.
- Walls and ceiling appeared functional at time of inspection.
- No visible problems noted at the floor at time of inspection.
- A representative number of outlets, switches and fixtures was operated and found to be in operable condition at time of inspection.
- **Leaks noted at the faucet at time of inspection.**
- **Rust and corrosion observed on the water supply valves under the sink.**
- **Moisture damage noted on the cabinets. Repair or replacement is recommended.**

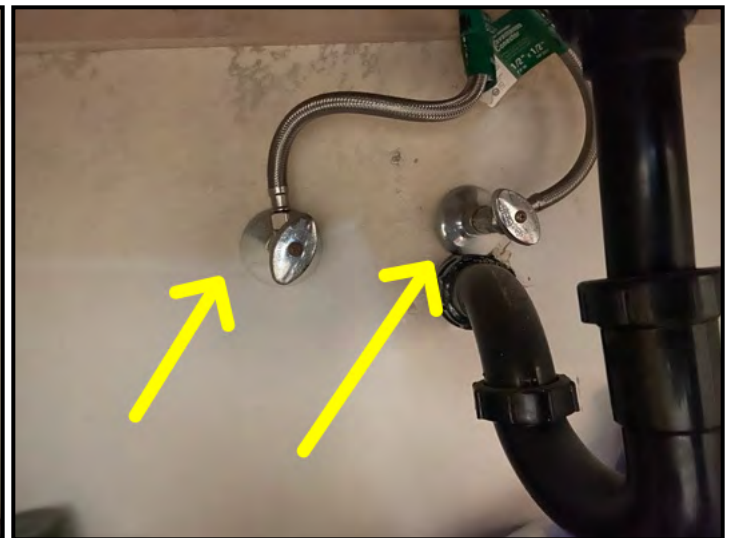
- **Leaks noted at the faucet at time of inspection.**
- **Leaks noted at the supply lines under the sink at time of inspection.**
- **Further evaluation and repairs as needed by a plumbing contractor is recommended.**
- **See photos.**

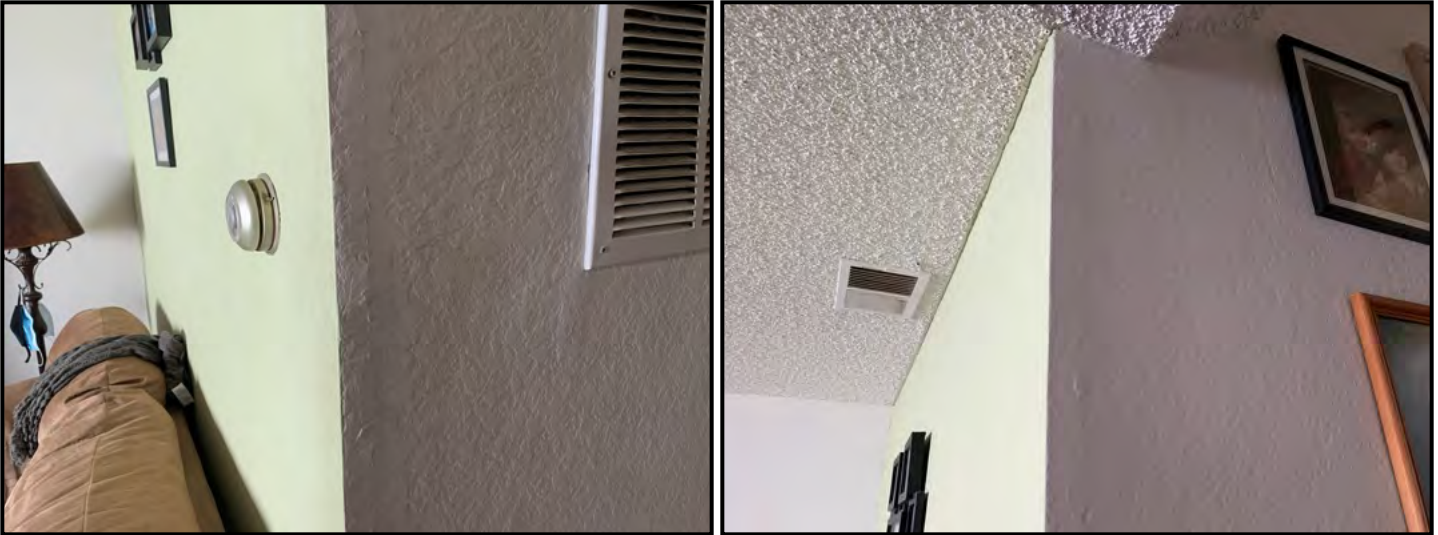
- Windows and doors operated properly at time of inspection.
- No visible problems noted at the floor at time of inspection.
- A representative number of outlets, switches and fixtures was operated and found to be in operable condition at time of inspection.
- **Moisture stains and/or damage viewed on the walls.**
- **See photos.**
- **Minor damage and patchwork noted in the living room on walls near hallway**

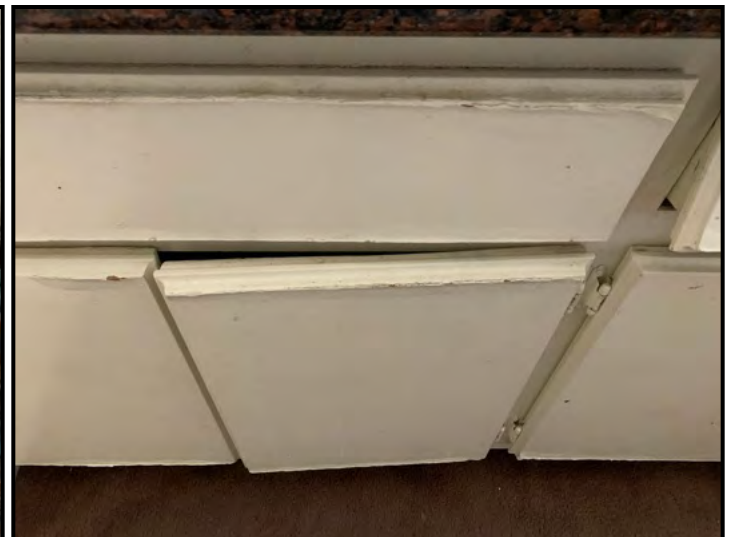
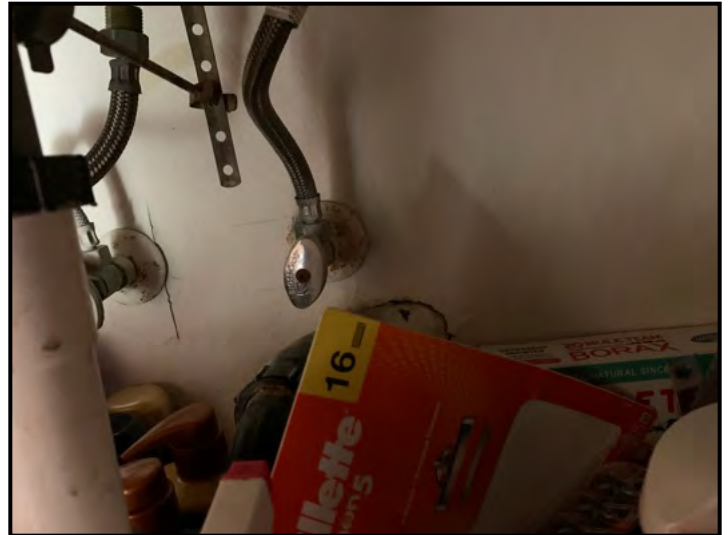
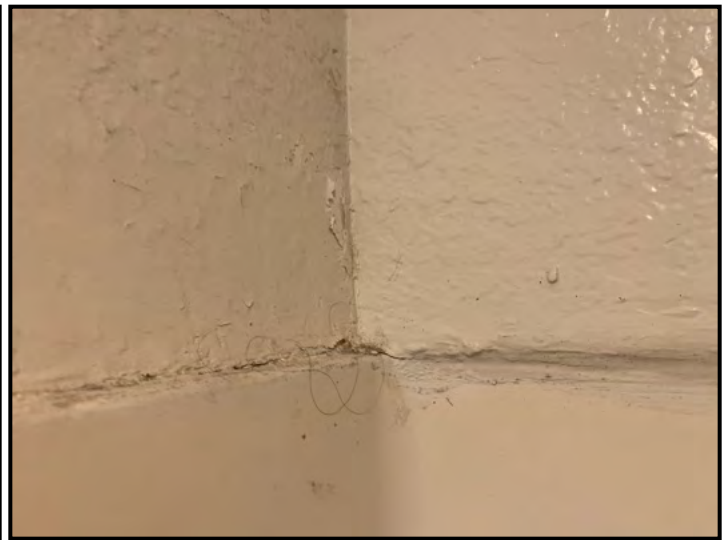
- No visible plumbing problems noted at time of inspection.
- No visible problems observed at the doors and windows at time of inspection.
- No visible floor problems noted at time of inspection.
- **Rust and corrosion observed on the water supply valves**
- **Vanity door or drawer is damaged or broken. Repair or replacement is recommended.**
- **Caulking is recommended at the tub or shower areas to prevent moisture penetration and damage behind the walls.**
- **Moisture stains and/or damage viewed on the walls.**
- **Ground Fault Circuit Interrupter (GFCI) outlets are recommended for installation.**

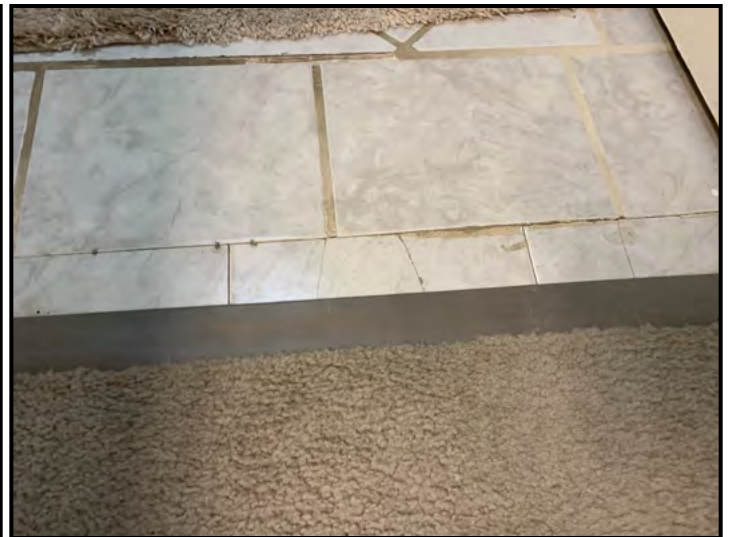
- No visible plumbing problems noted at time of inspection.
- No visible problems noted at the sink and vanity at time of inspection.
- No visible problems observed at the doors and windows at time of inspection.
- Walls and ceiling appeared functional at time of inspection.
- **Tub surface is damaged. Repair and or resurfacing is recommended.**
- **Caulking is recommended at the tub or shower areas to prevent moisture penetration and damage behind the walls.**
- **Floor tiles are damaged or loose. Repair or replacement is recommended.**
- See photos.
- **Ground Fault Circuit Interrupter (GFCI) outlets are recommended for installation.**
- See photos.

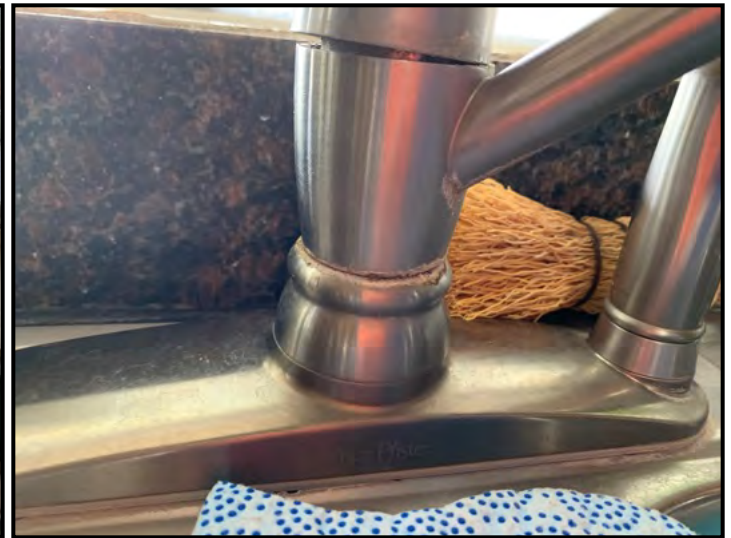
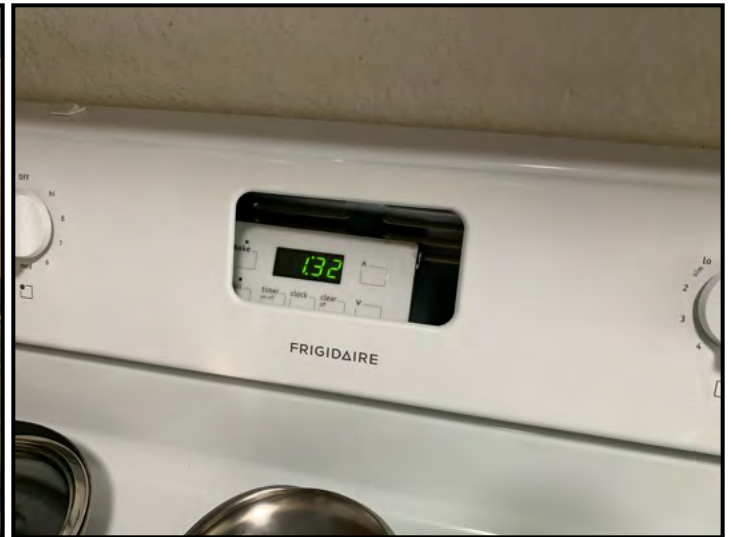
- No visible plumbing problems noted at time of inspection.
- Windows and doors operated properly at time of inspection.
- Walls and ceiling appeared functional at time of inspection.
- No visible problems noted at the floor at time of inspection.
- A representative number of outlets, switches and fixtures was operated and found to be in operable condition at time of inspection.
- **Moisture damage noted on the cabinets. Repair or replacement is recommended.**
- **Evidence of moisture penetration observed at the window. Window may need caulking or sealant application on the exterior.**
- **See photos.**
- **Kitchen stove is damaged and needs to be repaired or replaced**
