PROPERTY INSPECTION REPORT

1234 Sunny Lane, Anytown, CA 91001

DATE OF INSPECTION: 3/15/2020

VILLA HOME INSPECTIONS

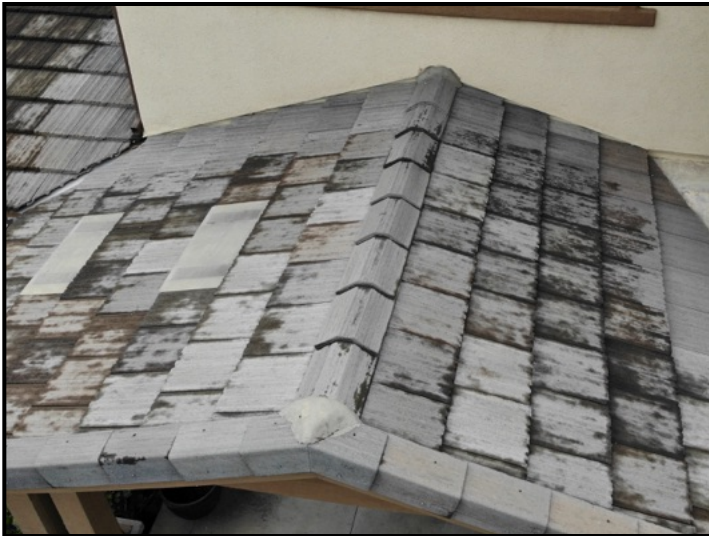
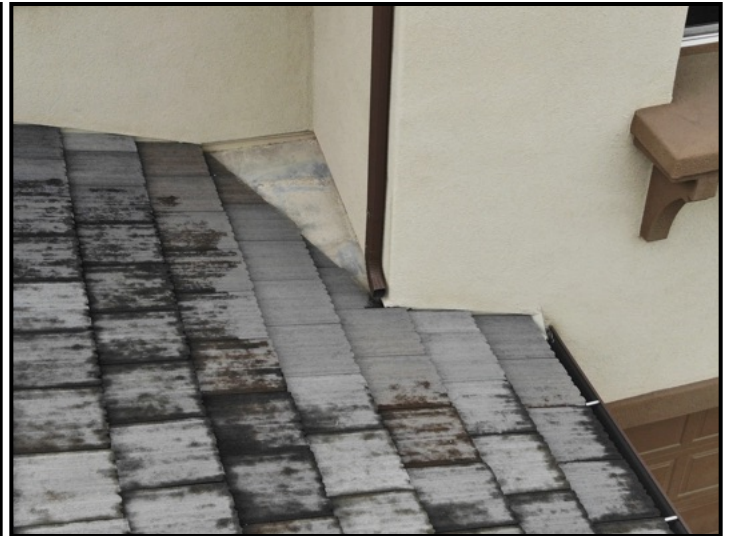
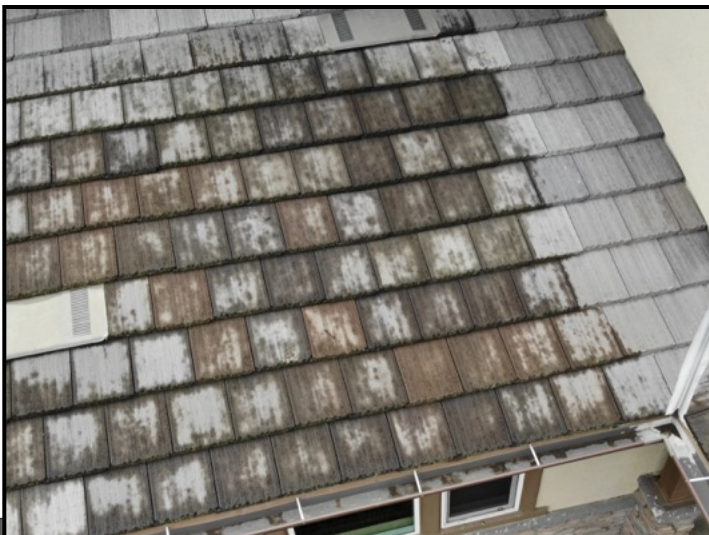
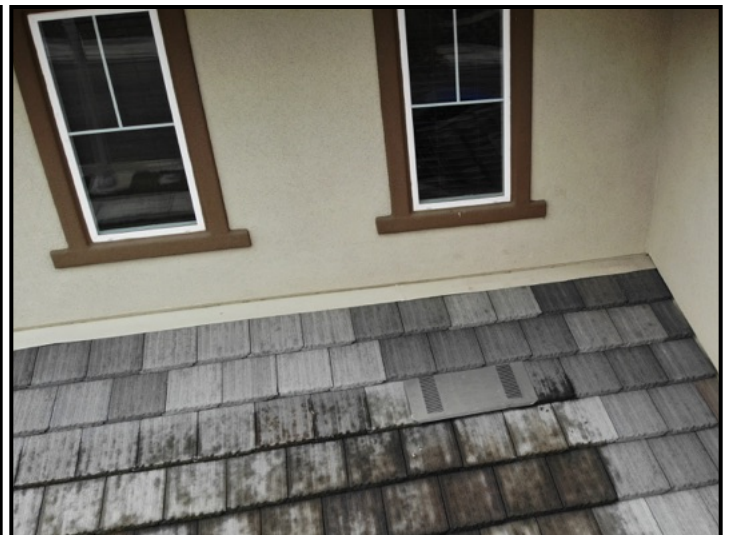
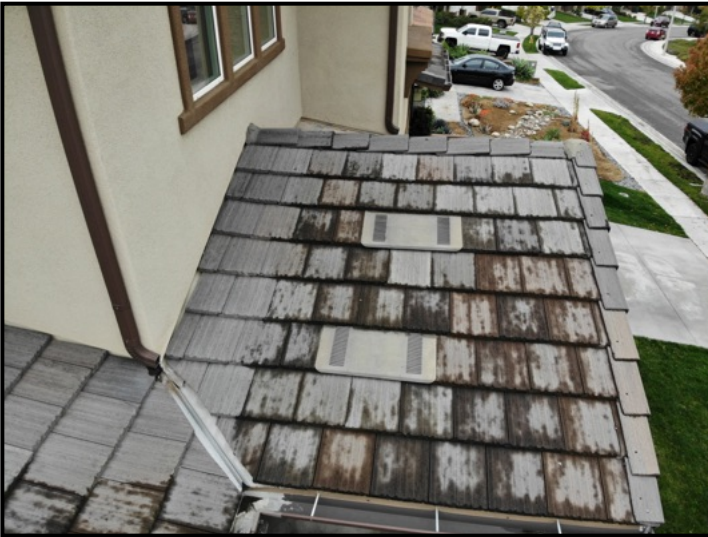
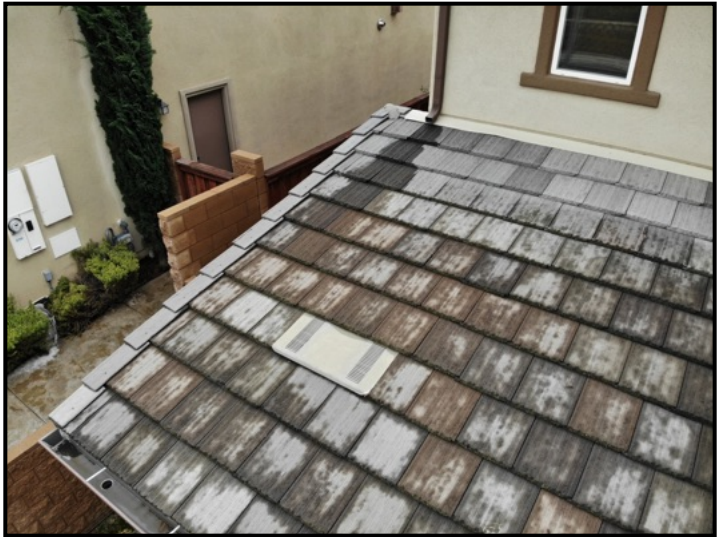
4. Covering Condition

- Roofing material appears to be within it's useful life.
- **Cracked or broken tiles observed.**
- **TYPICAL MAINTENANCE IS RECOMMENDED.** This usually consists of repair or replacement of damaged or missing shingles or tiles. This maintenance should help insure the weather tightness of the building and should be performed on a regular basis.
- See photos.

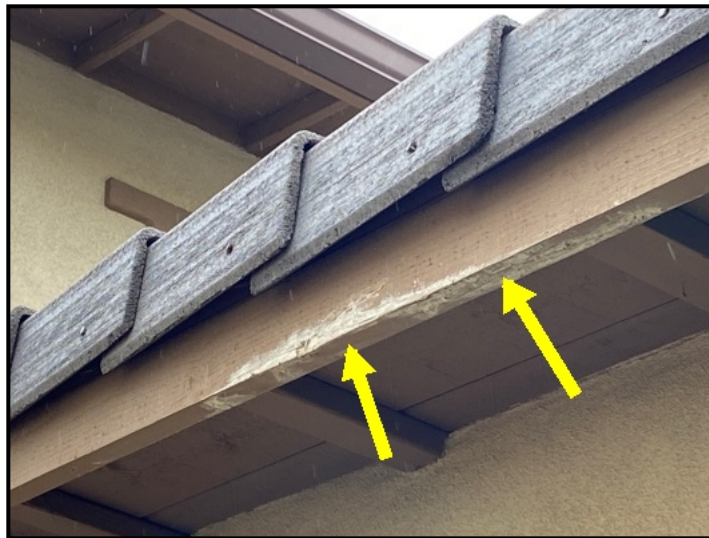
5. Roof Eaves Condition

- Moisture, rot or termite-like damage observed on the fascia boards (roof edge board).
- Damage appears to be minor and will most likely need minor repairs.

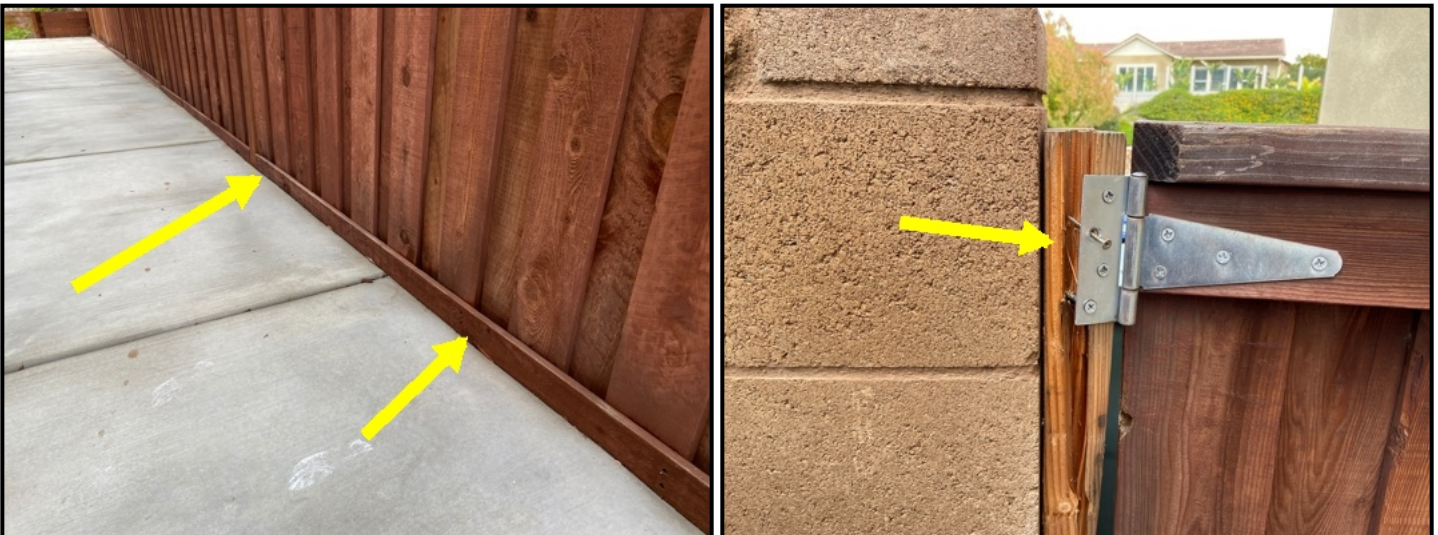
2. Fence & Walls Condition

- Fencing appears functional.
- **Gates are falling off the hinges. Repair or replacement is needed.**
- **Earth to wood contact observed at the wood fence. A minimum 6 inch separation is recommended between the soil and the bottom of the fence to prevent moisture penetration and damage.**
- **Repair or replacement is recommended.**
- **See photos.**

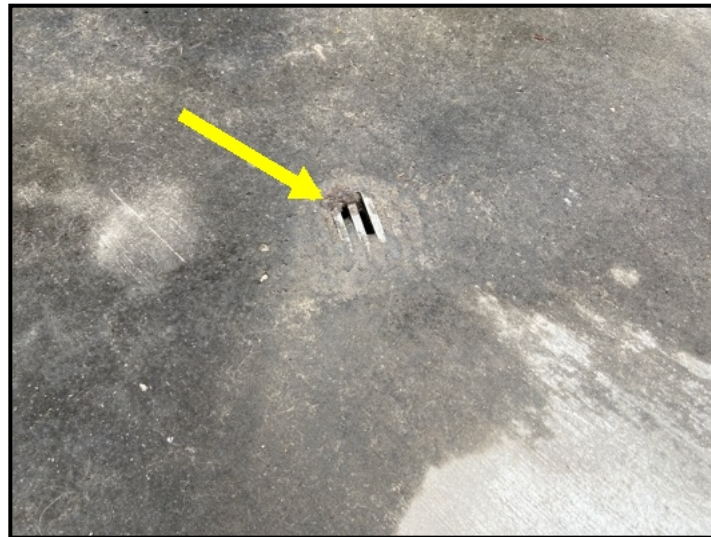
3. Grading & Site Drainage

- Site drainage throughout the property appeared adequate and functional at time of inspection.
- **Floor drains are filled with debris and may not allow adequate drainage. Further evaluation on clearing off all underground drains is recommended.**

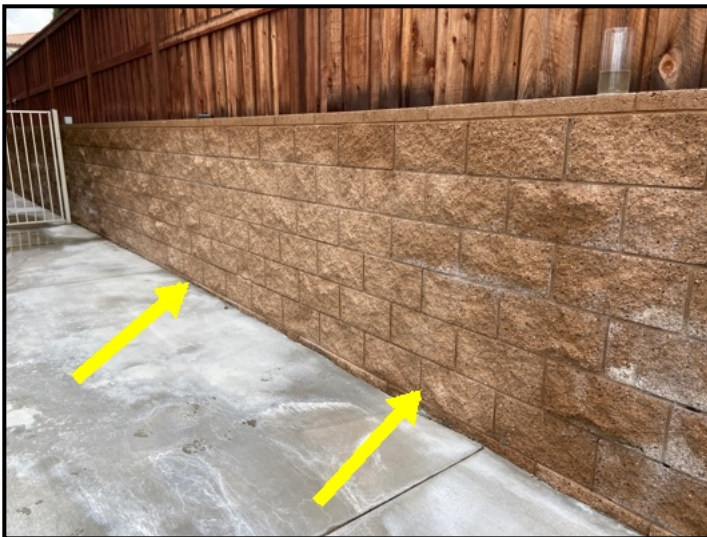
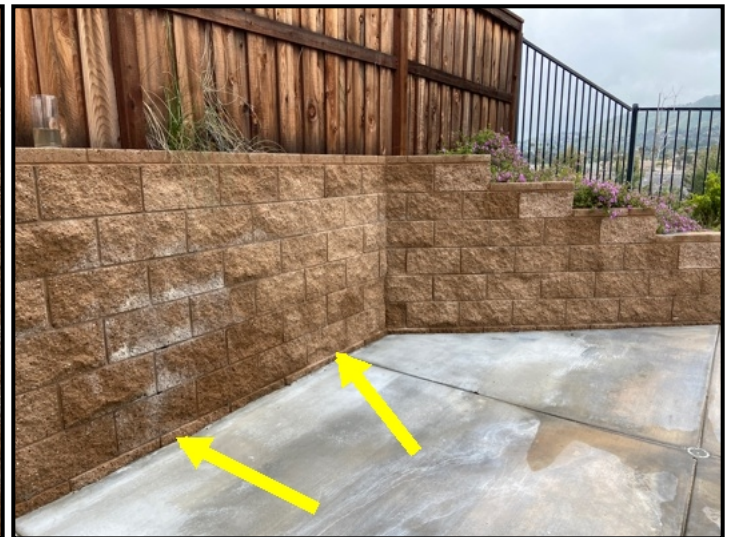
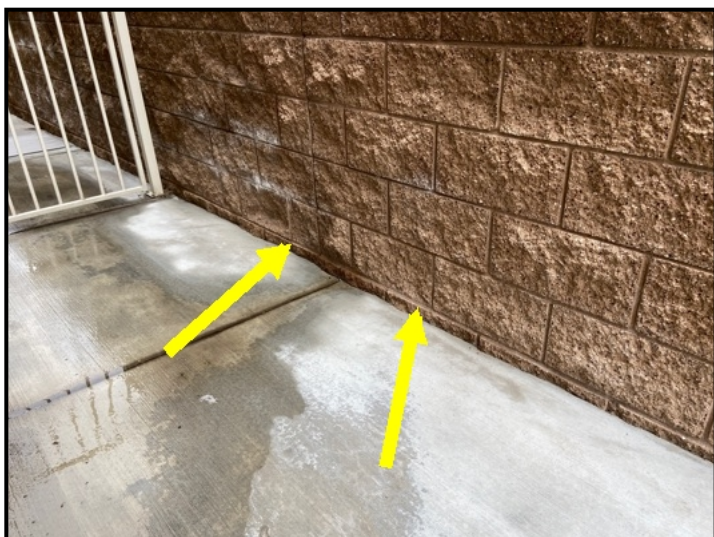
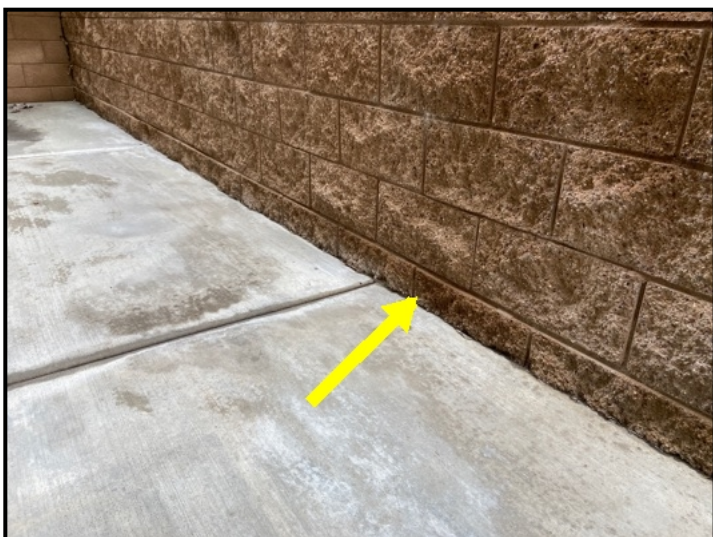
4. Retaining Wall Observations

- Retaining walls appear functional at time of inspection.
- **No drainage weep holes are installed at the bottom of the wall. Improper drainage behind the wall can cause damage and eventual failure. Installation of a drainage system is recommended.**

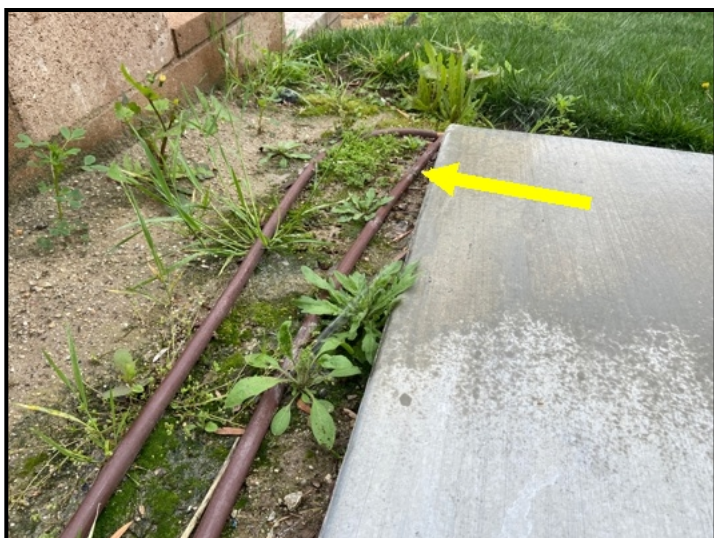
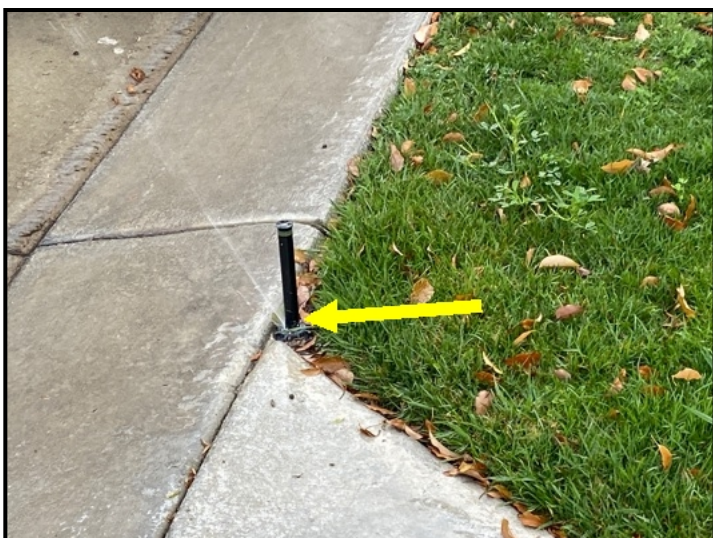
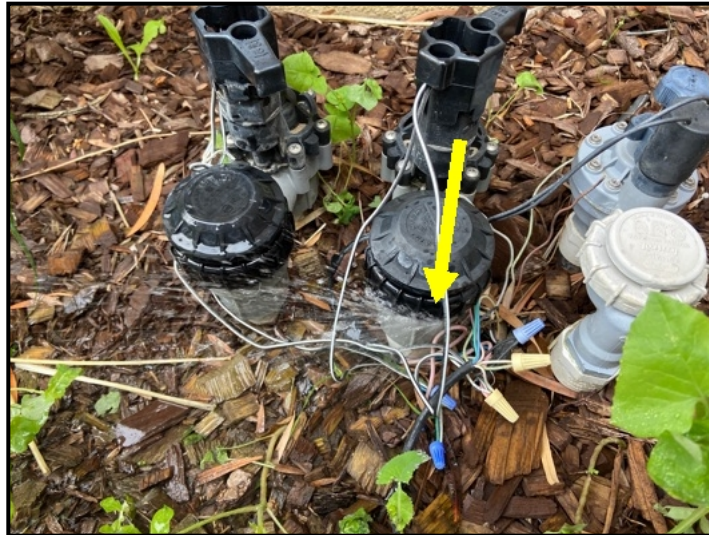
- Control valves leak when operated.
- Damaged or missing sprinkler heads observed.
- Adjust spray away from structures, sidewalks or fences to prevent moisture penetration and damage.
- Repair or replacement is recommended.

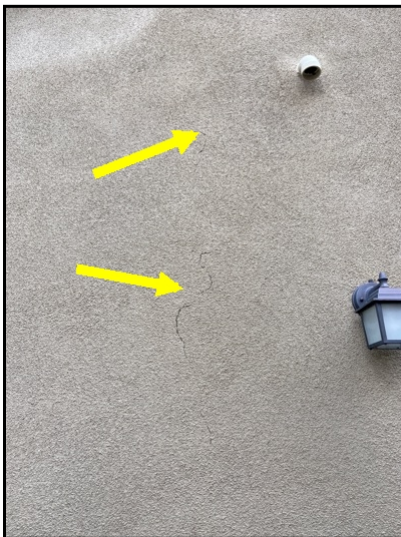
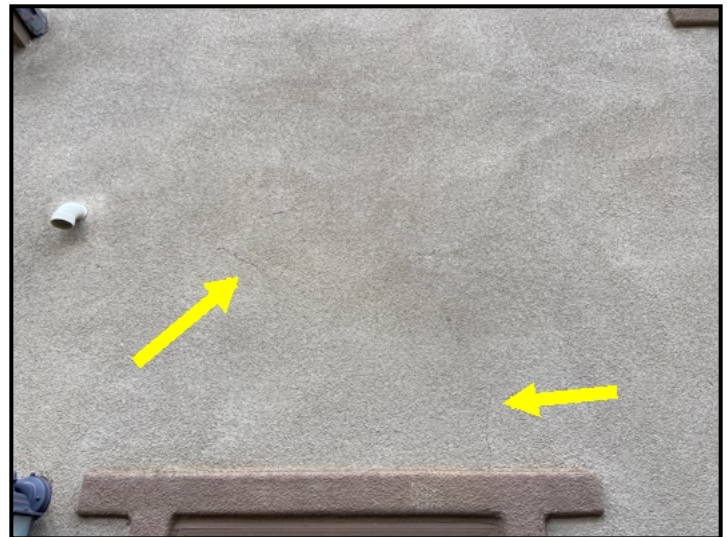
7. Exterior Wall Condition

- Cracks noted are moderate and may indicate foundation movement due to seismic activity or settlement.

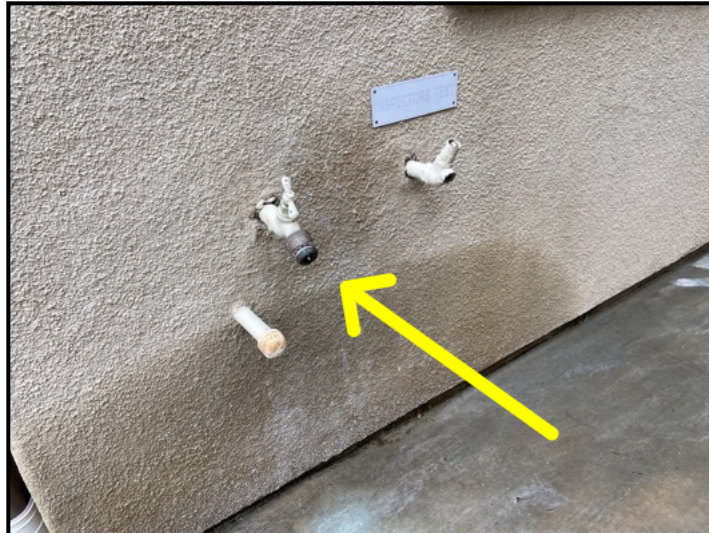
- One or more of the hose faucets was inoperative at time of inspection. Repair or replacement is recommended.
- Recommend further evaluation by a plumbing contractor.
- See photos.

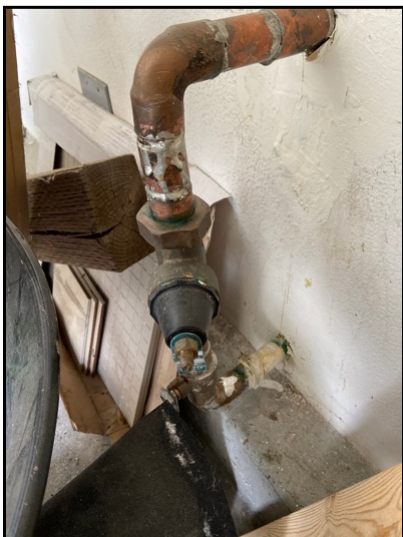
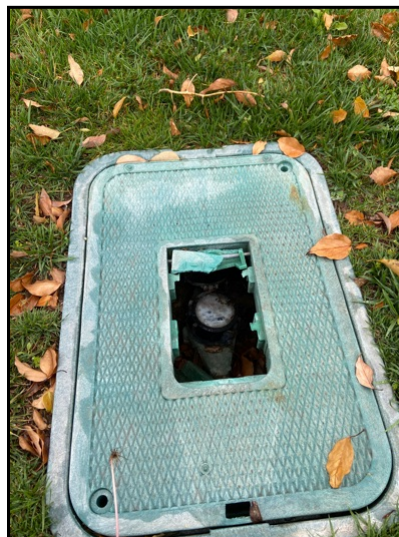
6. Main Line Condition

- No visible problems observed at time of inspection.
- **Water meter cover is broken. Replacement is recommended.**

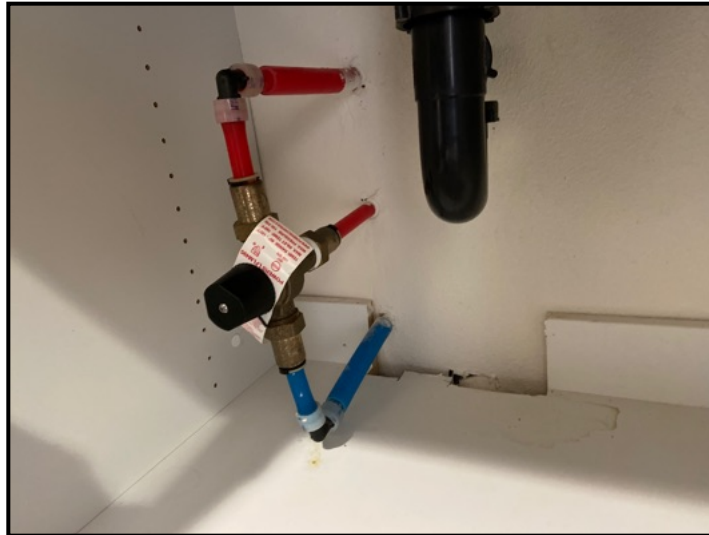
7. Supply Lines Condition

- Water lines appear to be within their useful life.
- Water lines were not fully visible at time of inspection or underground. Only the visible portions of the plumbing system are inspected and a part of this report.
- **One or more water shut off valves under the sinks throughout the house are frozen and do not operate in either direction. This is usually due to not being used over time. However, this is also an indication of a dry o-ring seal which will likely crack and cause a leak when operated. Replacement of the frozen shut off valves is recommended.**

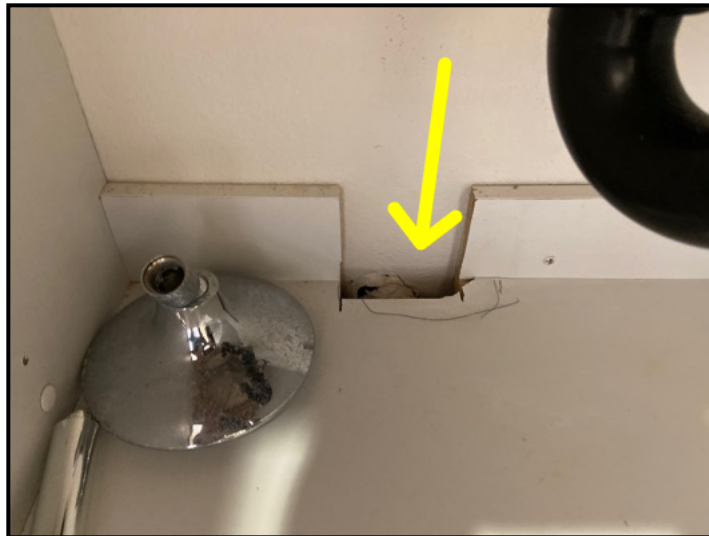
8. Waste Lines Condition

- No visible problems noted at time of inspection.
- Waste lines not fully visible at time of inspection or underground. Only the visible portions of the plumbing system are inspected and a part of this report.
- **Clean out for the drain line at the master bathroom is blocked by the vanity cabinet. See photo.**

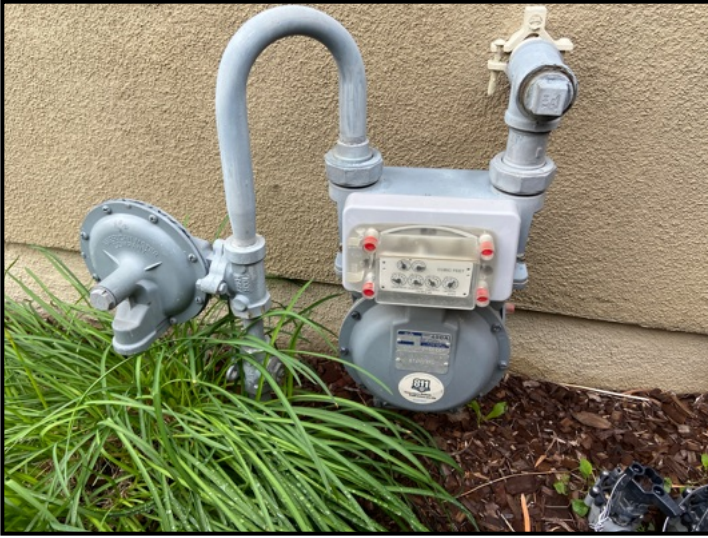
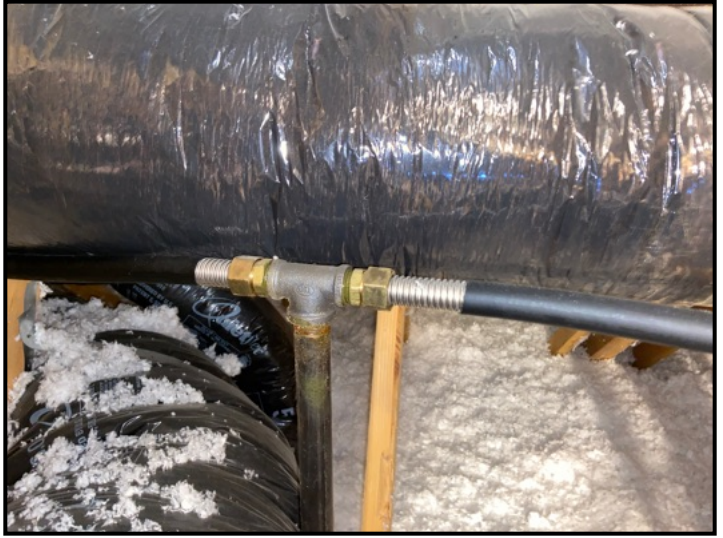
9. Fuel System Condition

- Meter appears functional at time of inspection.
- **Per SB-998, known as the "Proper Bonding and Grounding of Corrugated Stainless Steel Tubing Act", because **CSSI** was observed in this dwelling, the following advisory is required:**

"Manufacturers of yellow corrugated stainless steel tubing believe that yellow corrugated stainless steel tubing is safer if properly bonded and grounded as required by the manufacturer's installation instructions. Proper bonding and grounding of this product can only be determined by a licensed electrical contractor."

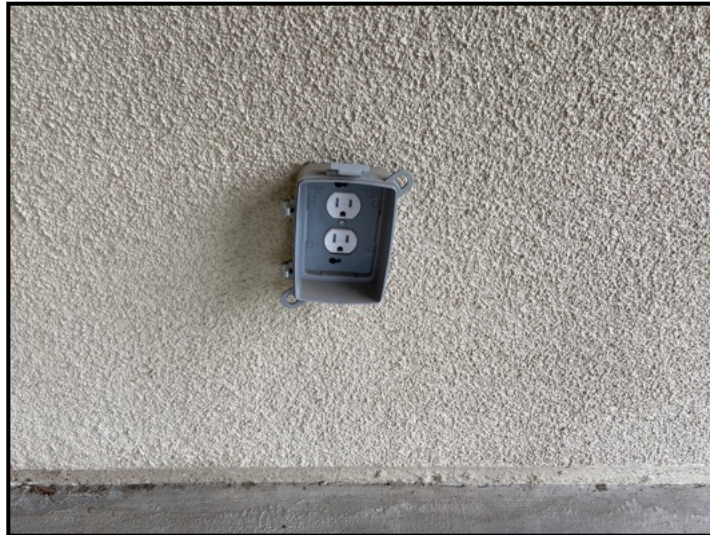
- One or more exterior electrical outlets are not **GFCI** protected. All exterior outlets are required to be protected. Replacement of the outlet by a qualified electrician is necessary.

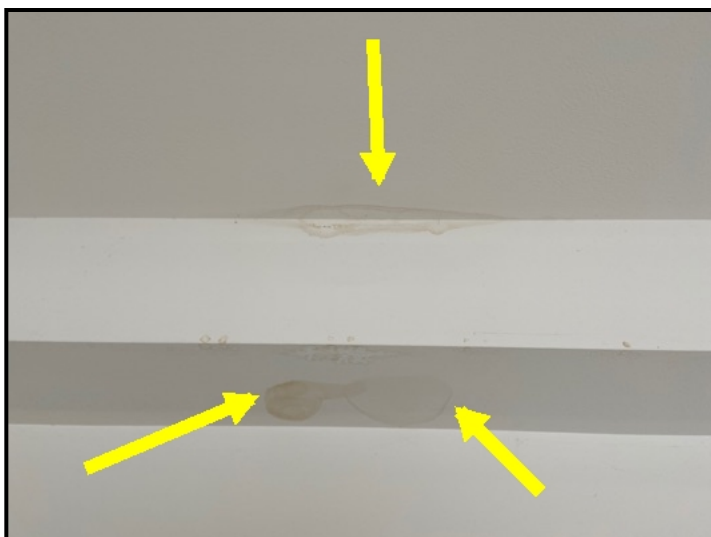
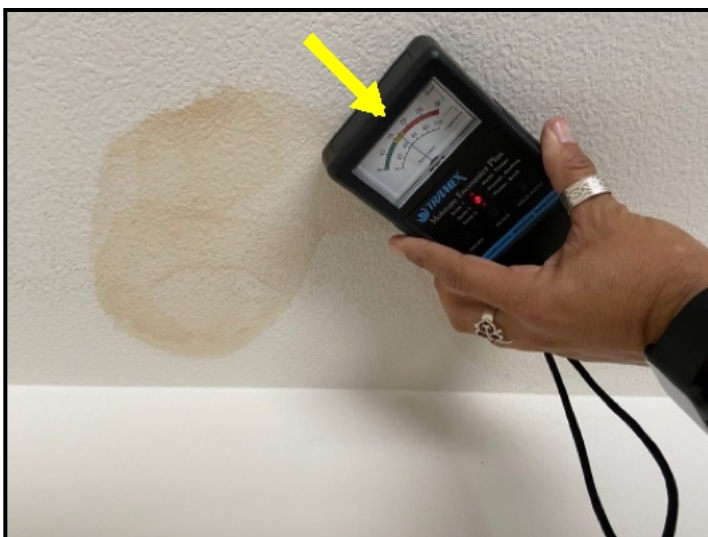
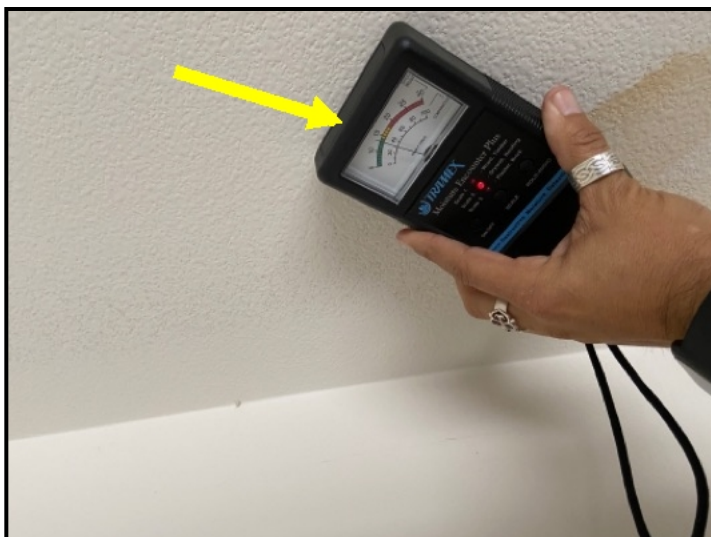
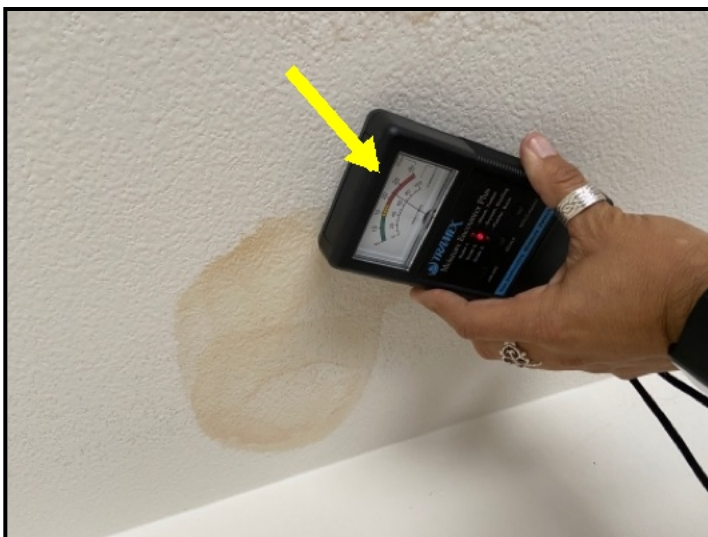
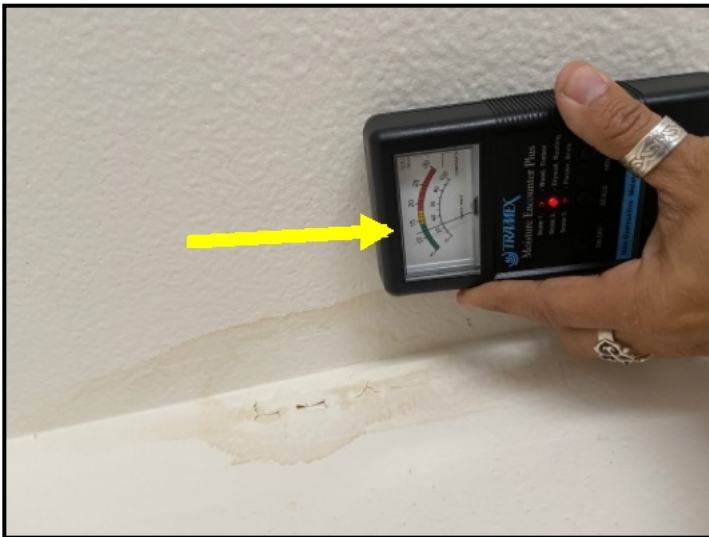
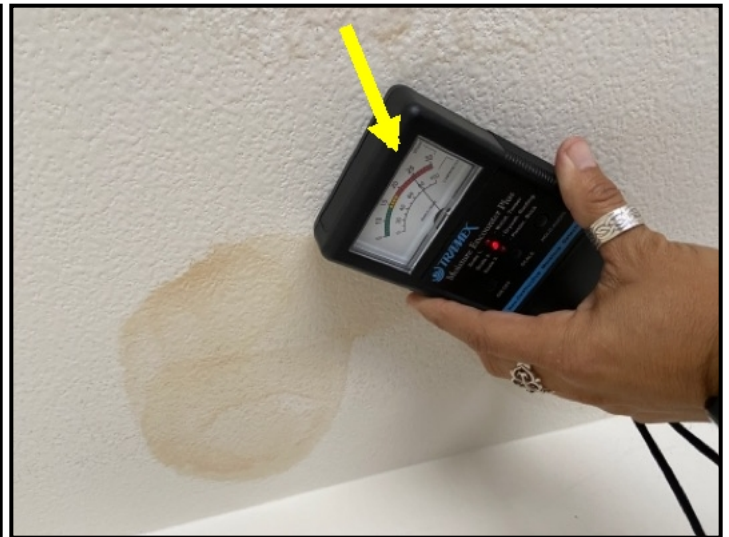
- **Moisture stains or damage observed on the garage ceiling.**
- **Possible plumbing leak. Further evaluation by a plumbing contractor is recommended.**
- **See photos.**

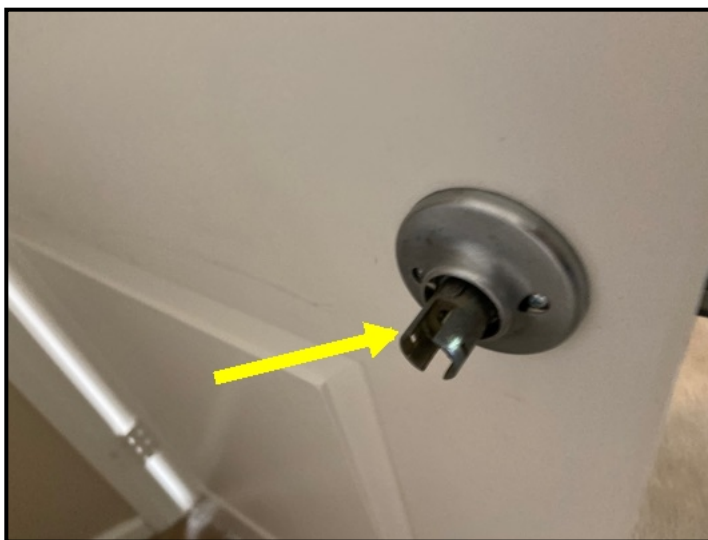
2. Doors & Windows Condition

- Windows operated properly at time of inspection.
- Doors operate properly.
- **Door handle is fallen off at the west bedroom door. See photo. Repair or replacement is recommended.**

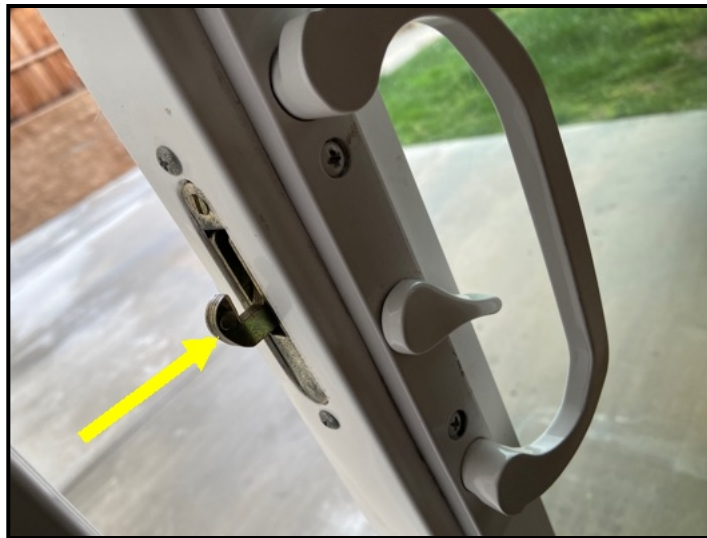
1. Doors & Windows Condition

- Windows operated properly at time of inspection.
- Door won't latch properly and does not stay closed. Adjustments are recommended.
- See photos.

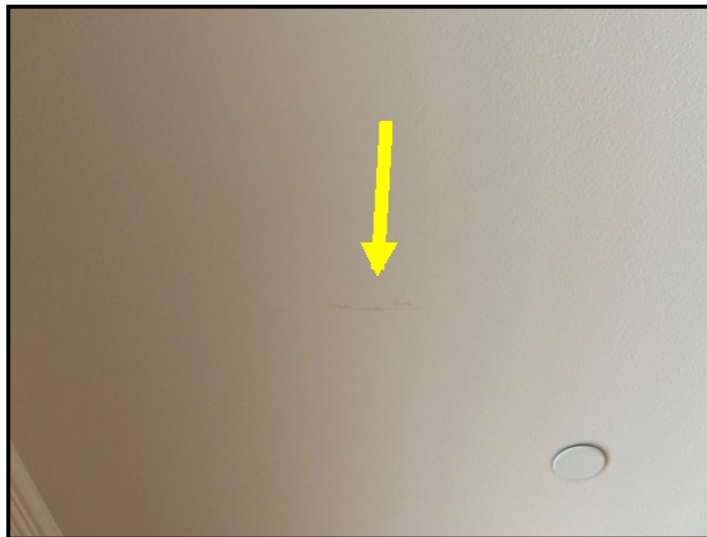
2. Walls & Ceilings Condition

- Walls and ceiling appeared functional at time of inspection.
- Moisture stains and/or damage viewed on the ceiling. No moisture was detected with a moisture meter at time of inspection.
- See Photos.

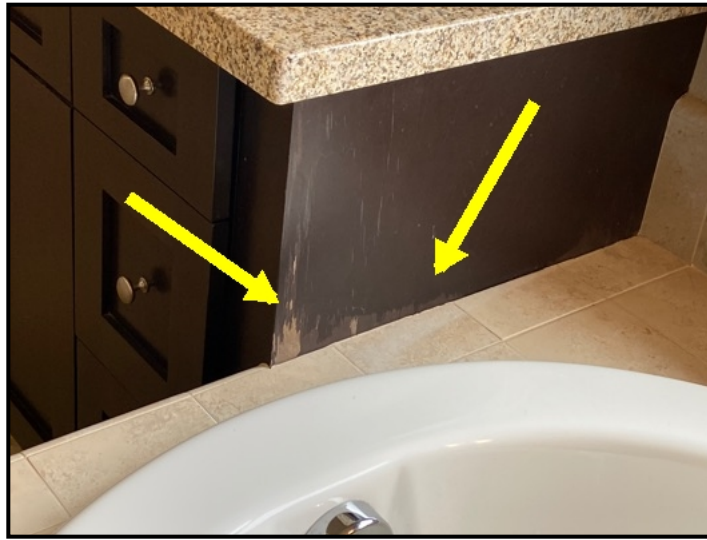
2. Sink & Vanity Condition

- Sink and counter areas are in functional condition.
- Counters/cabinets appear serviceable.
- Sink cabinet(vanity) has moisture damage. Repair or replacement is recommended.

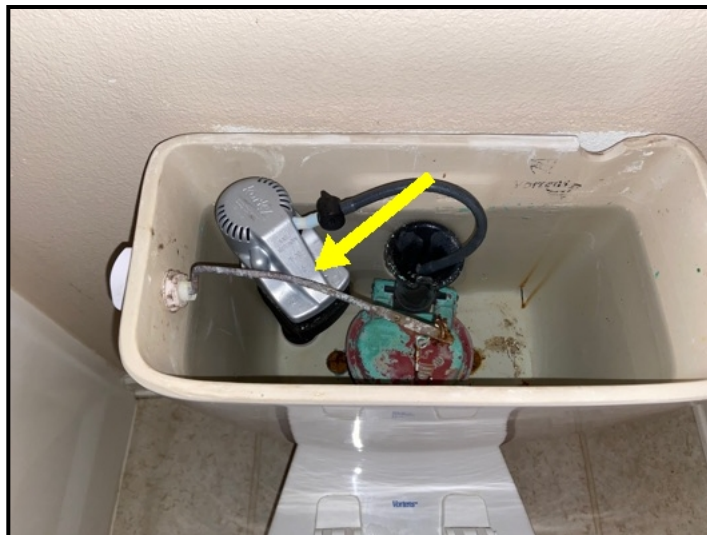
4. Toilet Condition

- Toilet is low flow type.
- Toilet does not flush properly and needs repair.
- A licensed plumber should be called to make further evaluation and repairs as needed.
- See photos.

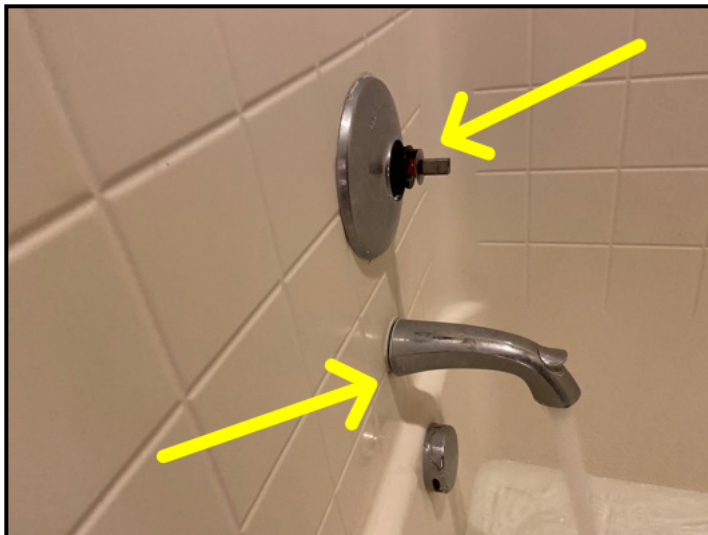
5. Tub & Shower Fixtures

- Plumbing fixtures operated properly at time of inspection.
- Drain appears serviceable.
- Leakage is noted at faucet handles.
- Tub faucet handle at the first floor bathroom has fallen off. See photo.
- A licensed plumber should be called to make further evaluation and repairs as needed.
- See photos.

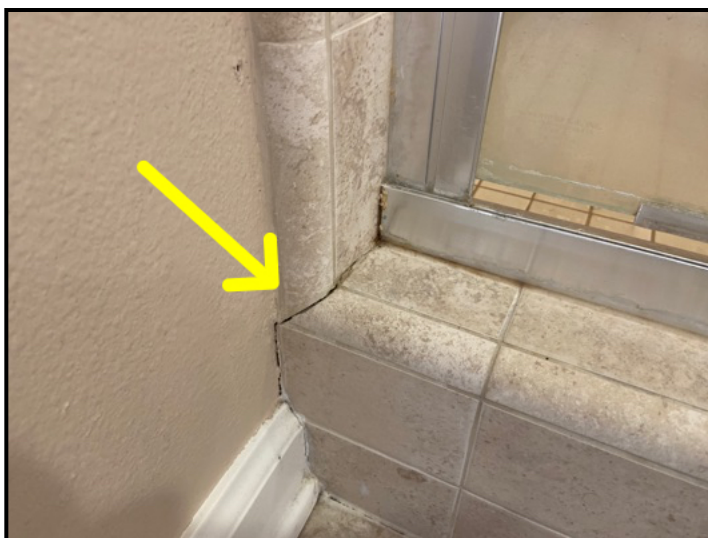
6. Tub & Shower Walls

- Tub and shower areas appear serviceable.
- Caulking and/or re-grouting at the tub surround walls is needed to prevent water penetration and moisture damage.

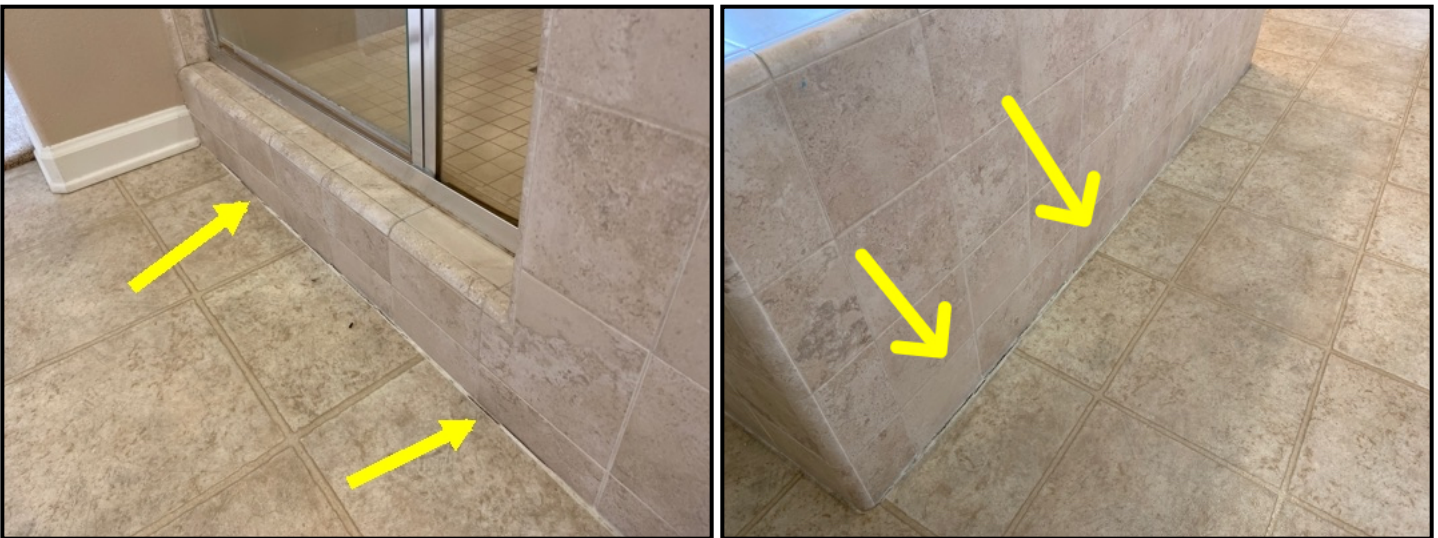
10. Floor Condition

- No visible problems noted at time of inspection.
- **Caulking is needed at the floor junction to the bathtub and shower. See photos.**

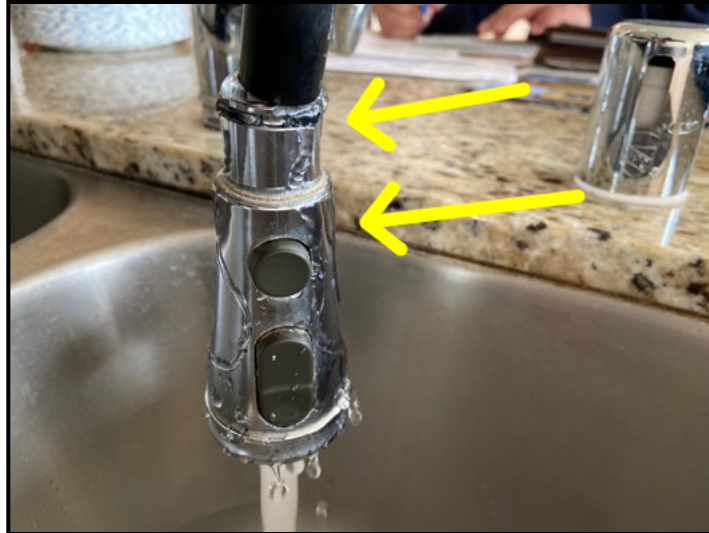
1. Sink & Fixtures Condition

- TYPE OF SINK:
 - Stainless Steel.
 - Faucet operated properly at time of inspection.
 - Drain lines under the sink appear functional.
 - **Hand sprayer was leaking at time of inspection. Repair or replacement is needed.**

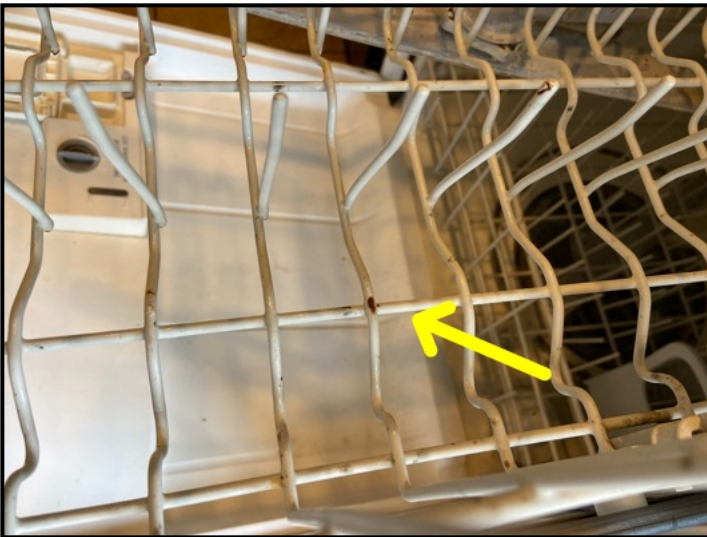
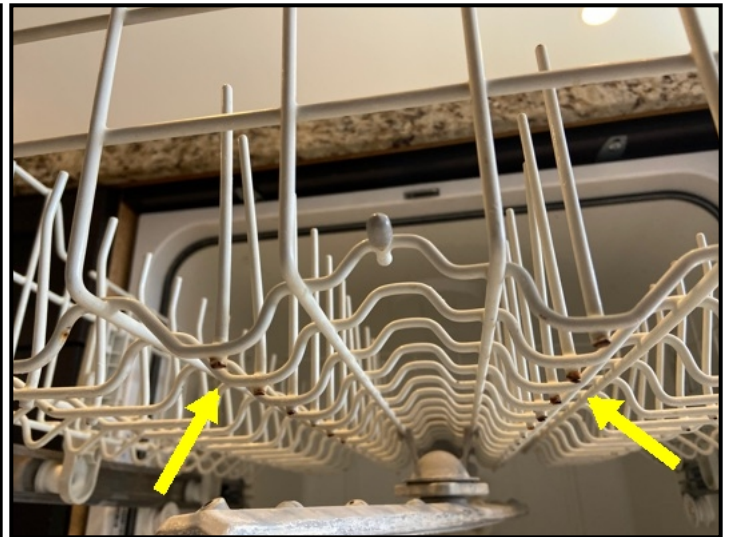
5. Appliance Condition

- Oven operated properly.
- Dishwasher operated properly at time of inspection.
- Microwave operated properly at time of inspection.
- One or more range burners are not functional. Further evaluation by an appliance repair technician is recommended.
- Older model appliance. Unit is near the end of its useful life.
- Rusting is noted inside the dishwasher. Repair or replacement is recommended.
- Repair or replacement is recommended.
- Electric igniter for the range would not shut off at time of inspection. Repair or replacement is necessary.
- See Photos.

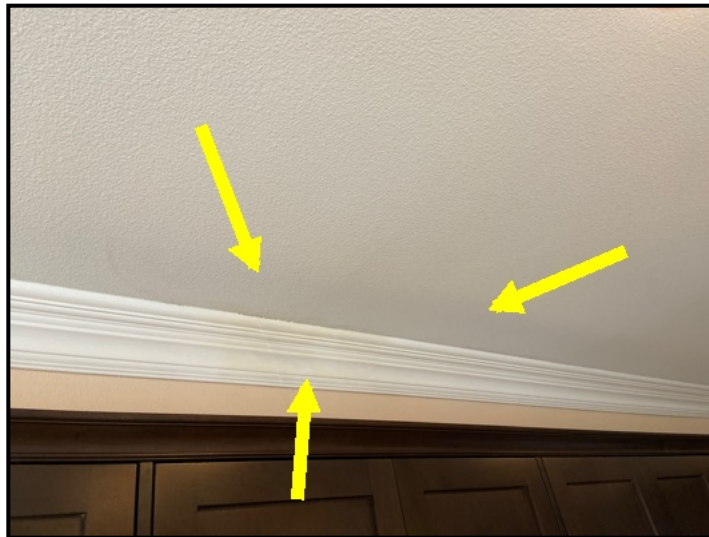
7. Walls & Ceilings Condition

- Moisture stains and/or damage viewed on the ceiling. No moisture was detected with a moisture meter at time of inspection.
- Possible plumbing leak from dwelling above. Further evaluation by a plumbing contractor is recommended.
- See Photos.

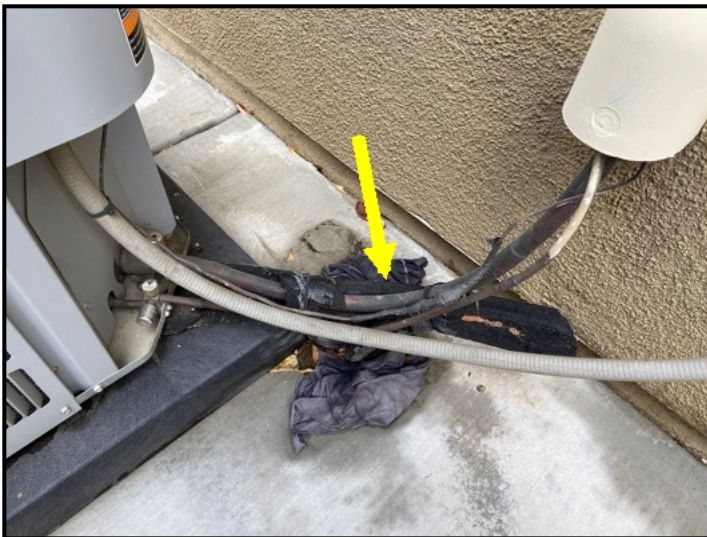
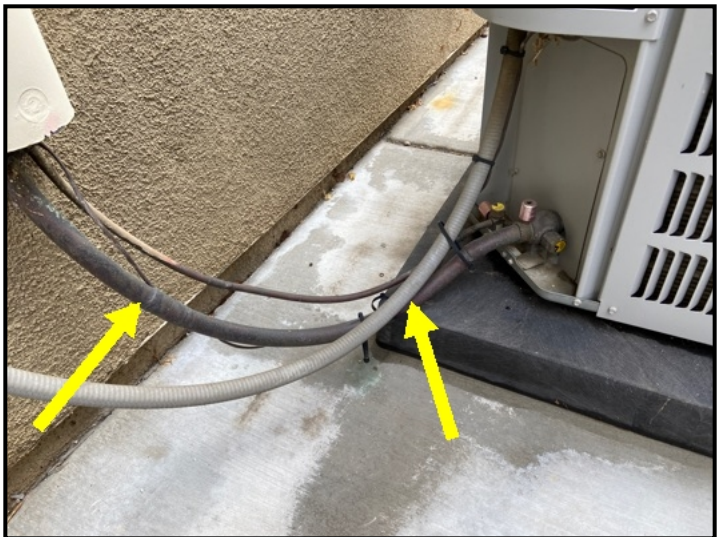
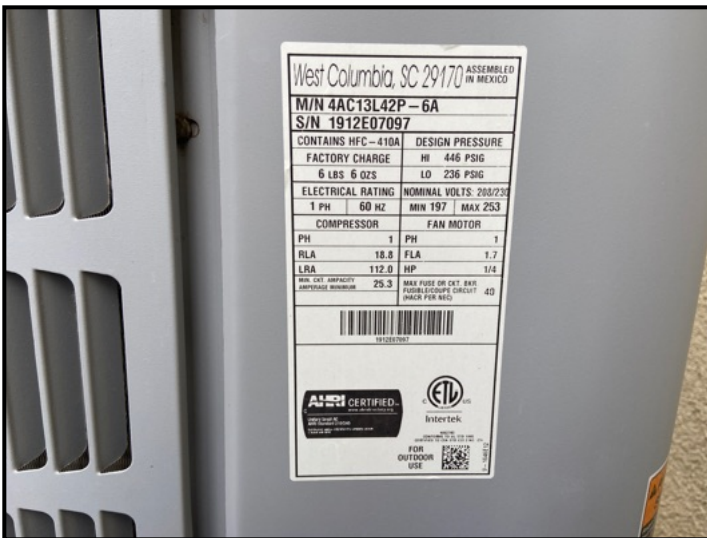
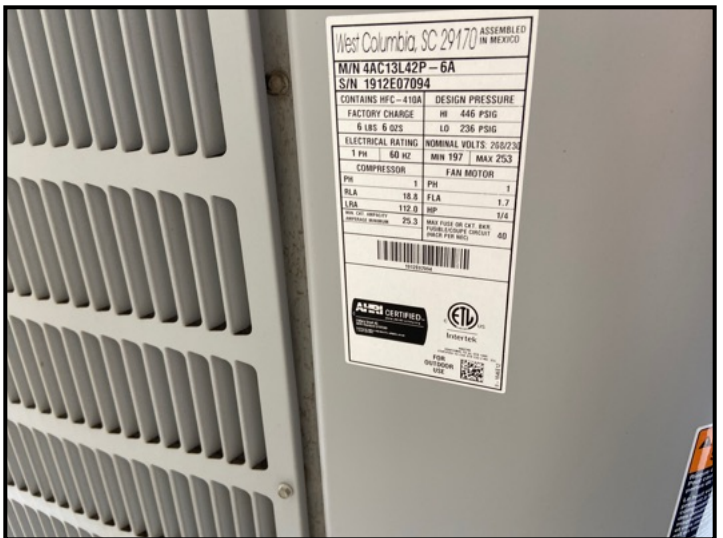
- Condenser units are dirty. Cleaning/maintenance is recommended.
- Insulation on the refrigeration lines is deteriorated or missing at the condenser unit. Repair or replacement is recommended.
- See photos.
