**APPROVED**  
**Board of Directors**  
**Wynola Water District and**  
**Wynola Estates Fire Safe Council**  
**July 13, 2024, 9:00 a.m.**  
**22135 CA – 79 Santa Ysabel CA 92070**

**9. Report by WWD Water Operator: Tim Guishard**

**Notes from the June 21, 2024, investigation, with Buddy leading the way:**

**Notes from the investigation on July 2, 2024, with Albert or Jack accompanying me, are as follows:**

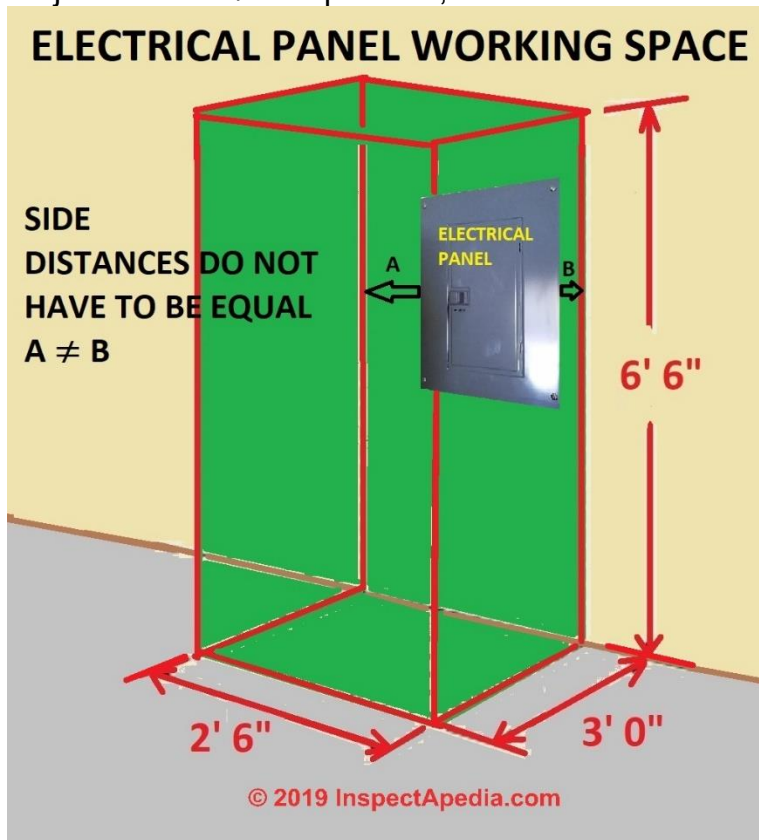
- 1. The condition of the pump house.
  - a. A pump house should not be a storage room for anything other than pumps and their related pump repair parts. Tools should not even be in this room, because the room is so small.
  - b. The OSHA/CEC required clear space in front of many of the electrical enclosures, has been encroached into with piping, valves, pumps, storage of equipment, etc.
- 2. There is supposed to be nothing in front of any electrical enclosure that needs "adjustment and/or inspection", from the floor to above an operator's head.

- a. Wynola WD needs a dedicated storage space for all the items that are loose in this room, especially items that would be damaged by water and vermin.

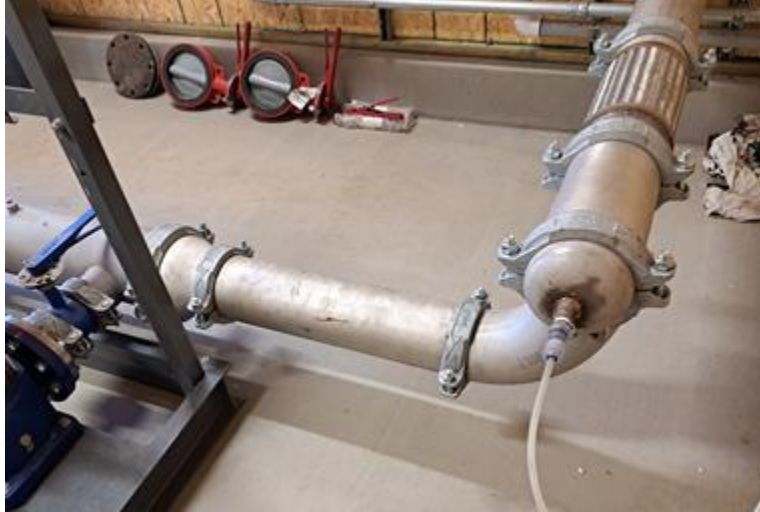
- c. The booster pump logbook had also not been updated in about a year.
14. The headers on the booster pumps will need to be replaced soon to correct the many leaks and corrosion issues that are present. While conversing with Albert, it was revealed this piping was welded without a purge gas (Argon) being introduced into the pipe during the welding process. It is questionable if the welds were properly passivated after the welds were completed. The lack of corrosion

protection during and after the welding processes has compromised the welds and probably piping near the welds.

An example of grooved stainless-steel pipe with related fittings at a different water system.

- a. I would recommend that the headers be completely re-piped, still with stainless steel, but using grooved and flanged connections. With this connection process, a single pipe failure can easily be mitigated by replacing a small section of pipe or fitting.

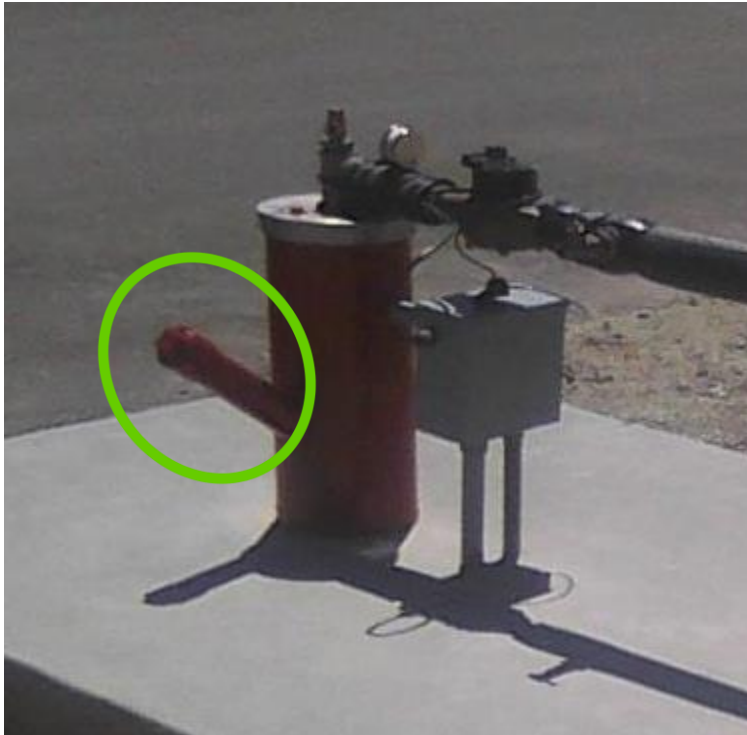
- b. They are also utilized while disinfecting the well itself.
  26. None of the wells are properly equipped with facilities to make it easy to disinfect the well.

The fitting on the side of this casing is used when disinfecting the well.

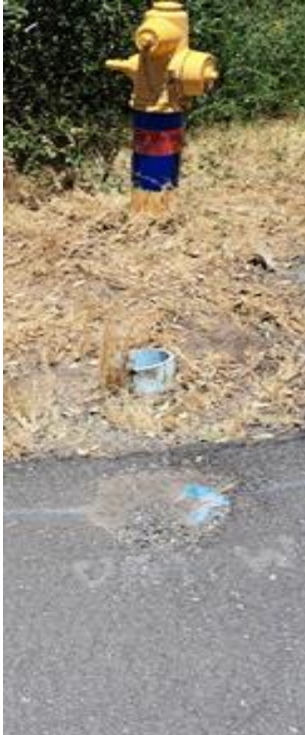
This is hydrant # 14.

I think the valve in the asphalt is from the loop that extends from Oakforest, although the paint on the asphalt indicates otherwise.

I think the valve that has no cover is what shuts off the hydrant.

Note that the valve with no cover is a hazard:

1) in that someone could trip on it because it is so high.

2) in that someone could twist an ankle if part of their foot were to enter the open hole.

3) to small animals that might fall into it.

- a. Yellow is for an open line valve in the distribution or transmission system.
- b. Red is for a closed line valve in the distribution or transmission system.
- c. White indicates that the valve only closes service to a fire hydrant.
- d. I noted that there is a missing gate cap near hydrant #14.

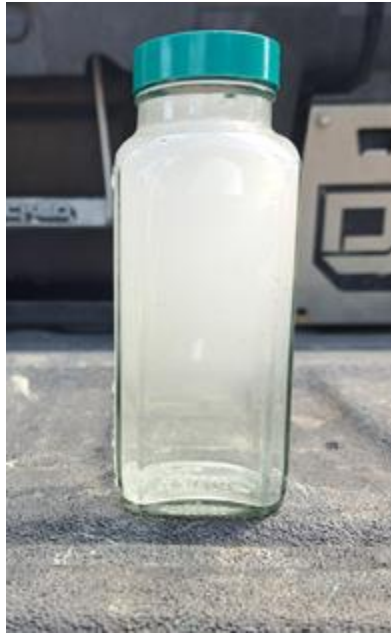
63. While collecting water samples at well 9 and 11, the water was milky white with lots of tiny air bubbles.
- This suggests that the wells are being pumped a bit too hard, and water is cascading either in the well bore or out in the formation.
  - This caused issues when trying to fill a very small sample bottle that can have no air in it.

The water near the top of this container, is what the water in the entire container looked like when the sample was first collected.

The water is clearing near the bottom of the container after about 45 seconds.

The entire container was clear after about 2 minutes. The water level had dropped about 3/8" in the container after the water was clear.
