<u>Reservoir</u>	<u>Utility Name</u>	<u>Date</u>
<u>Dive Control/Supervisor</u>	<u>Diver/Inspector</u>	<u>Tender</u>

Inspection Supplemental Report and Additional Information

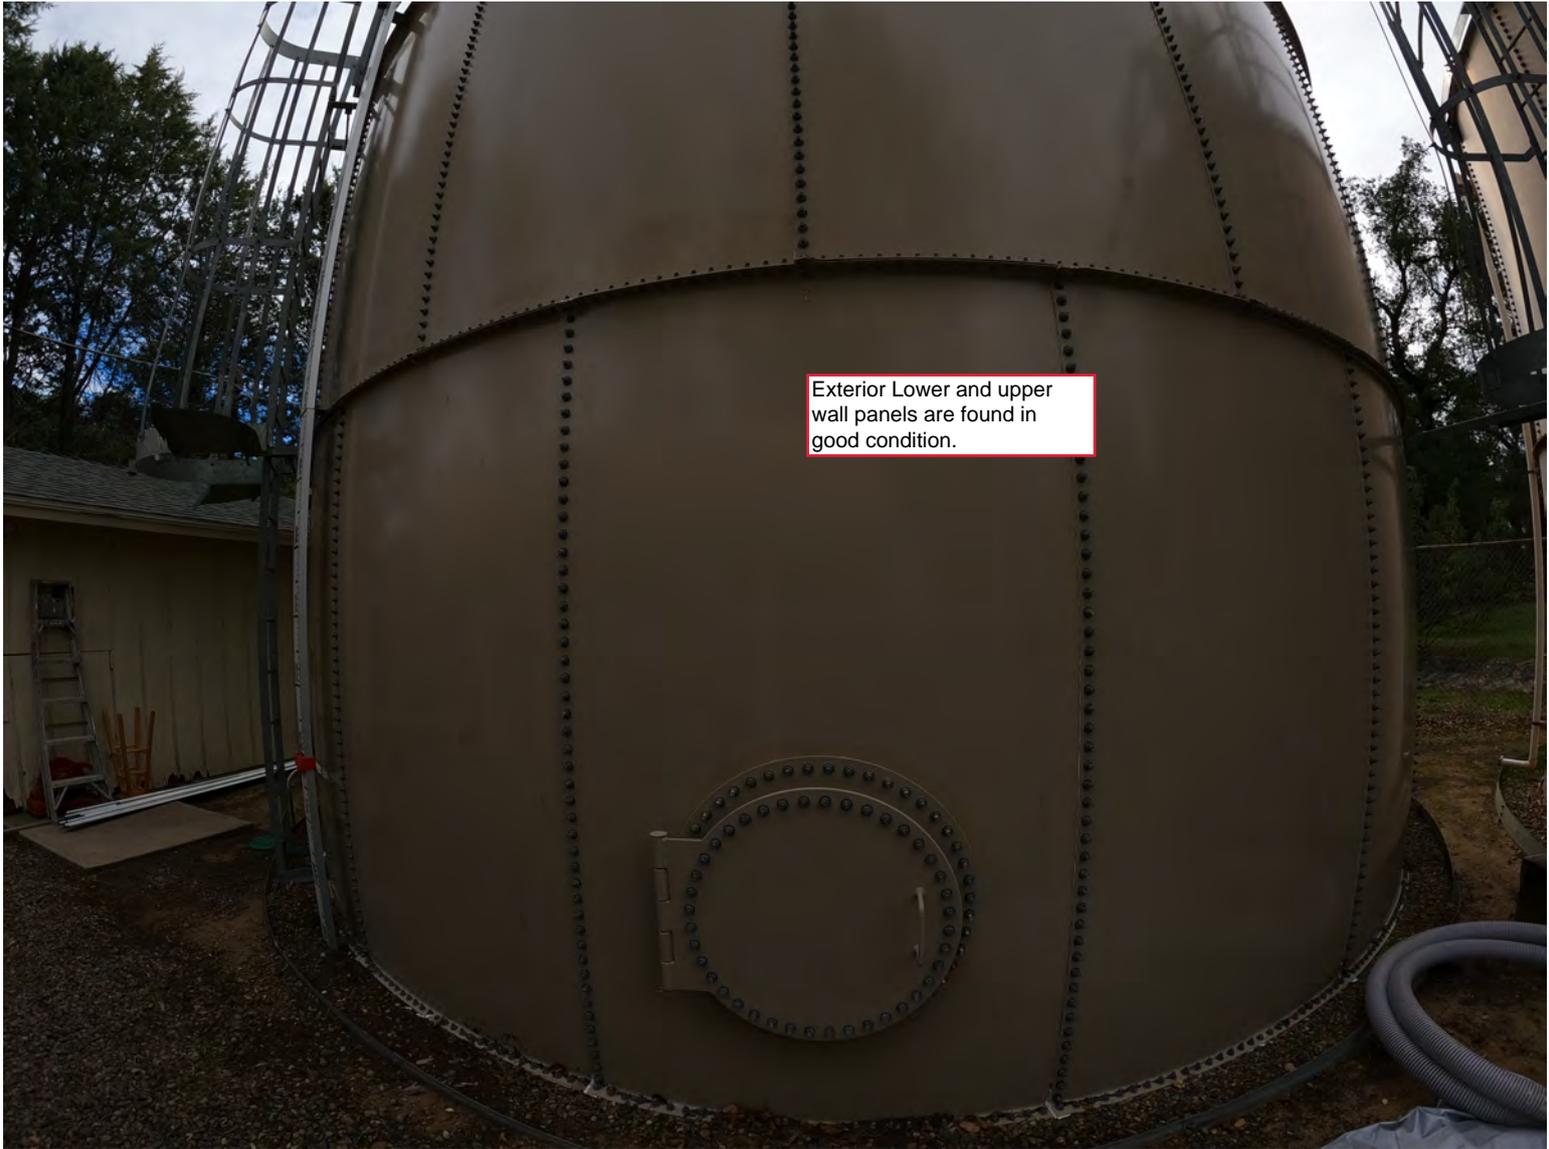
Exterior Lower and upper wall panels are found in good condition.

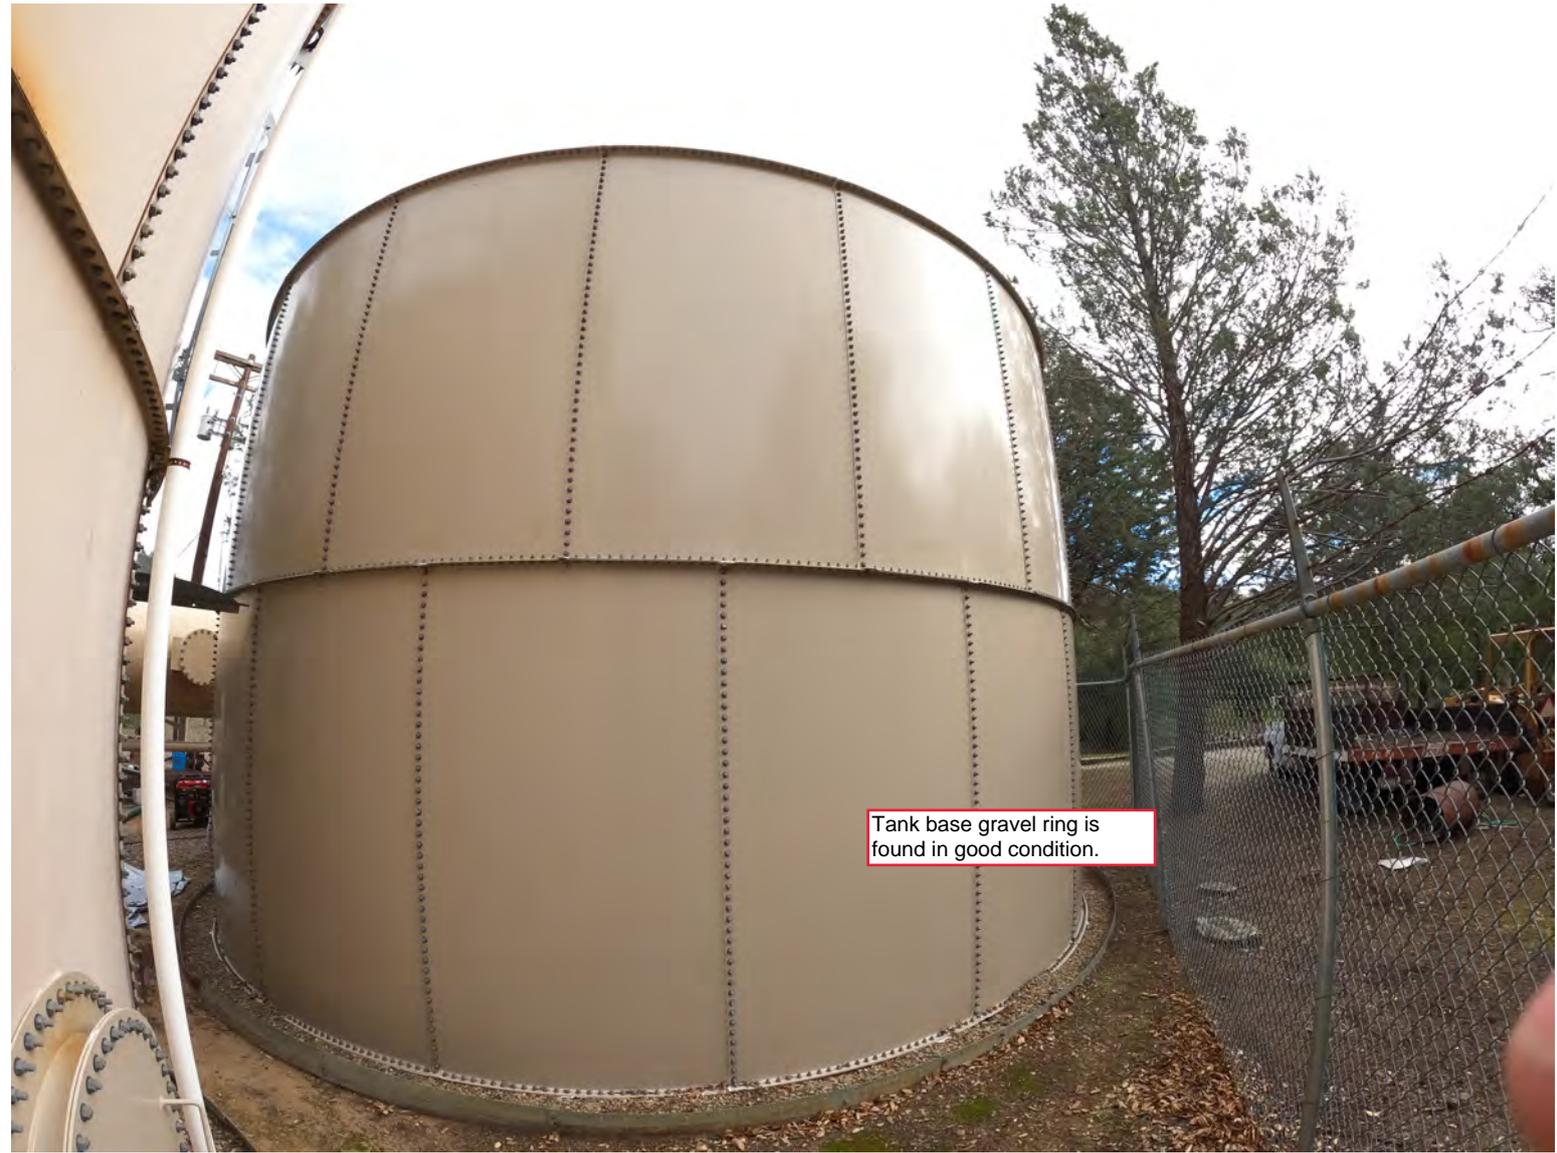
Tank base gravel ring is found in good condition.

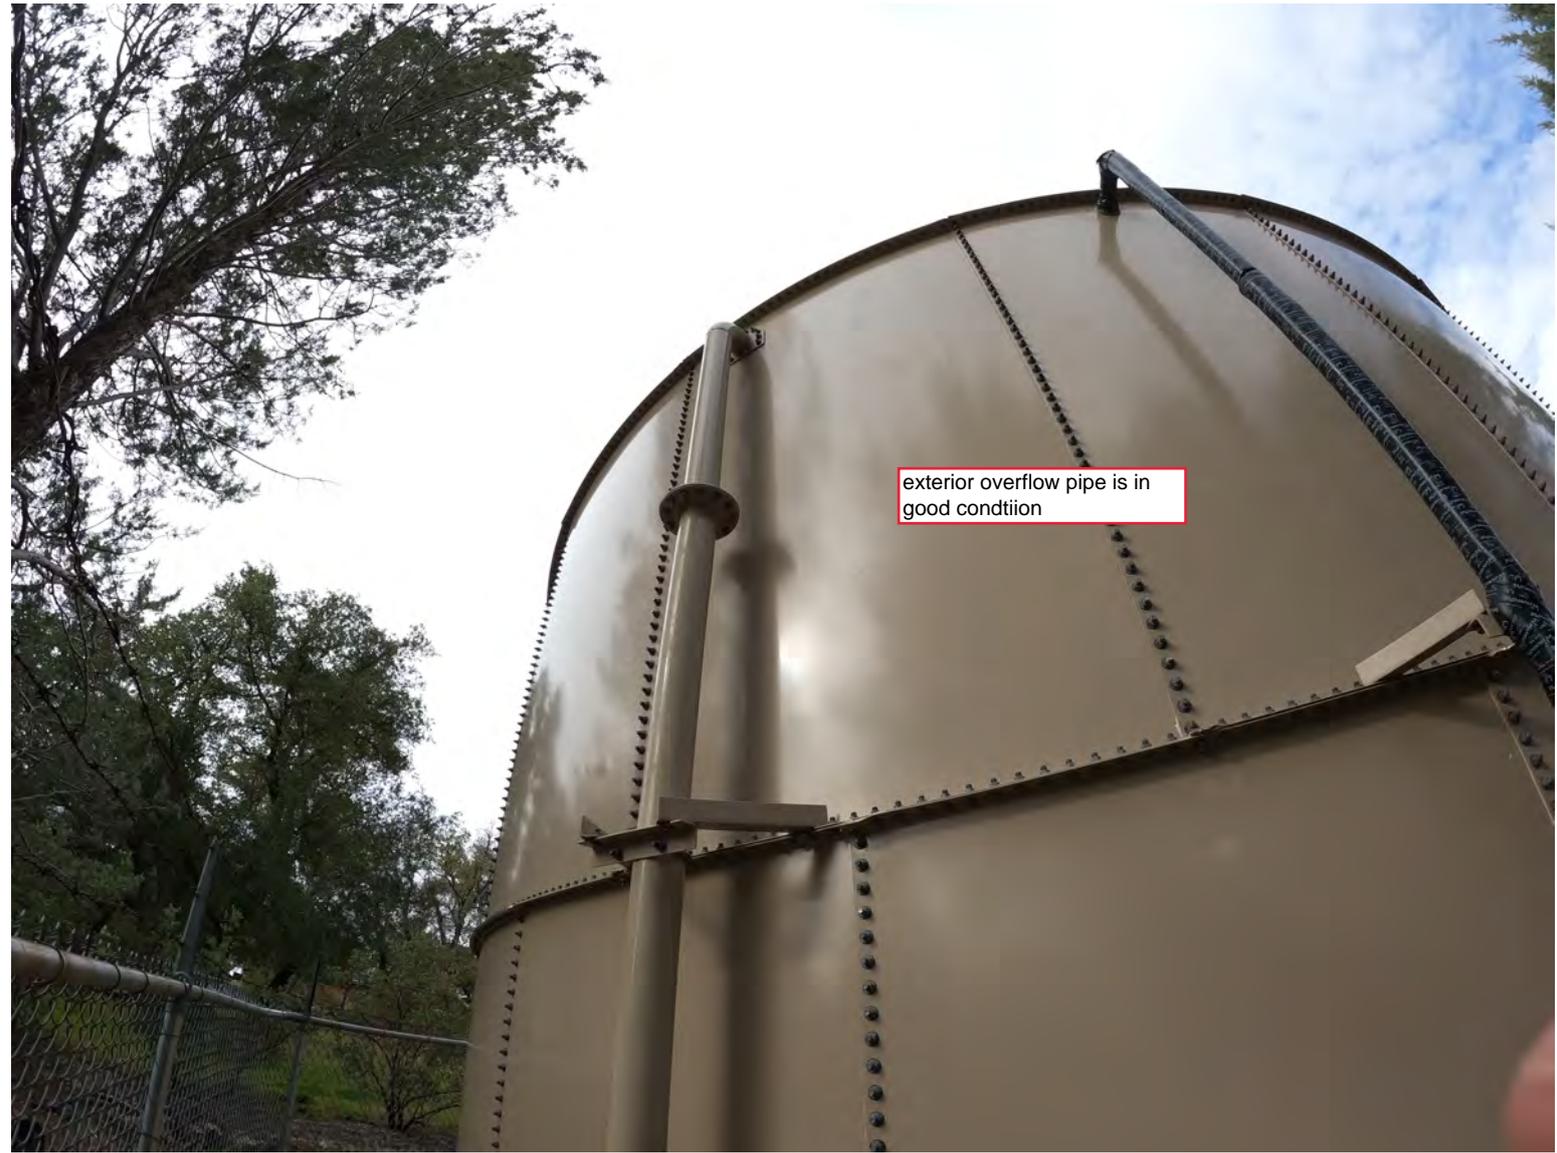
exterior overflow pipe is in good condition

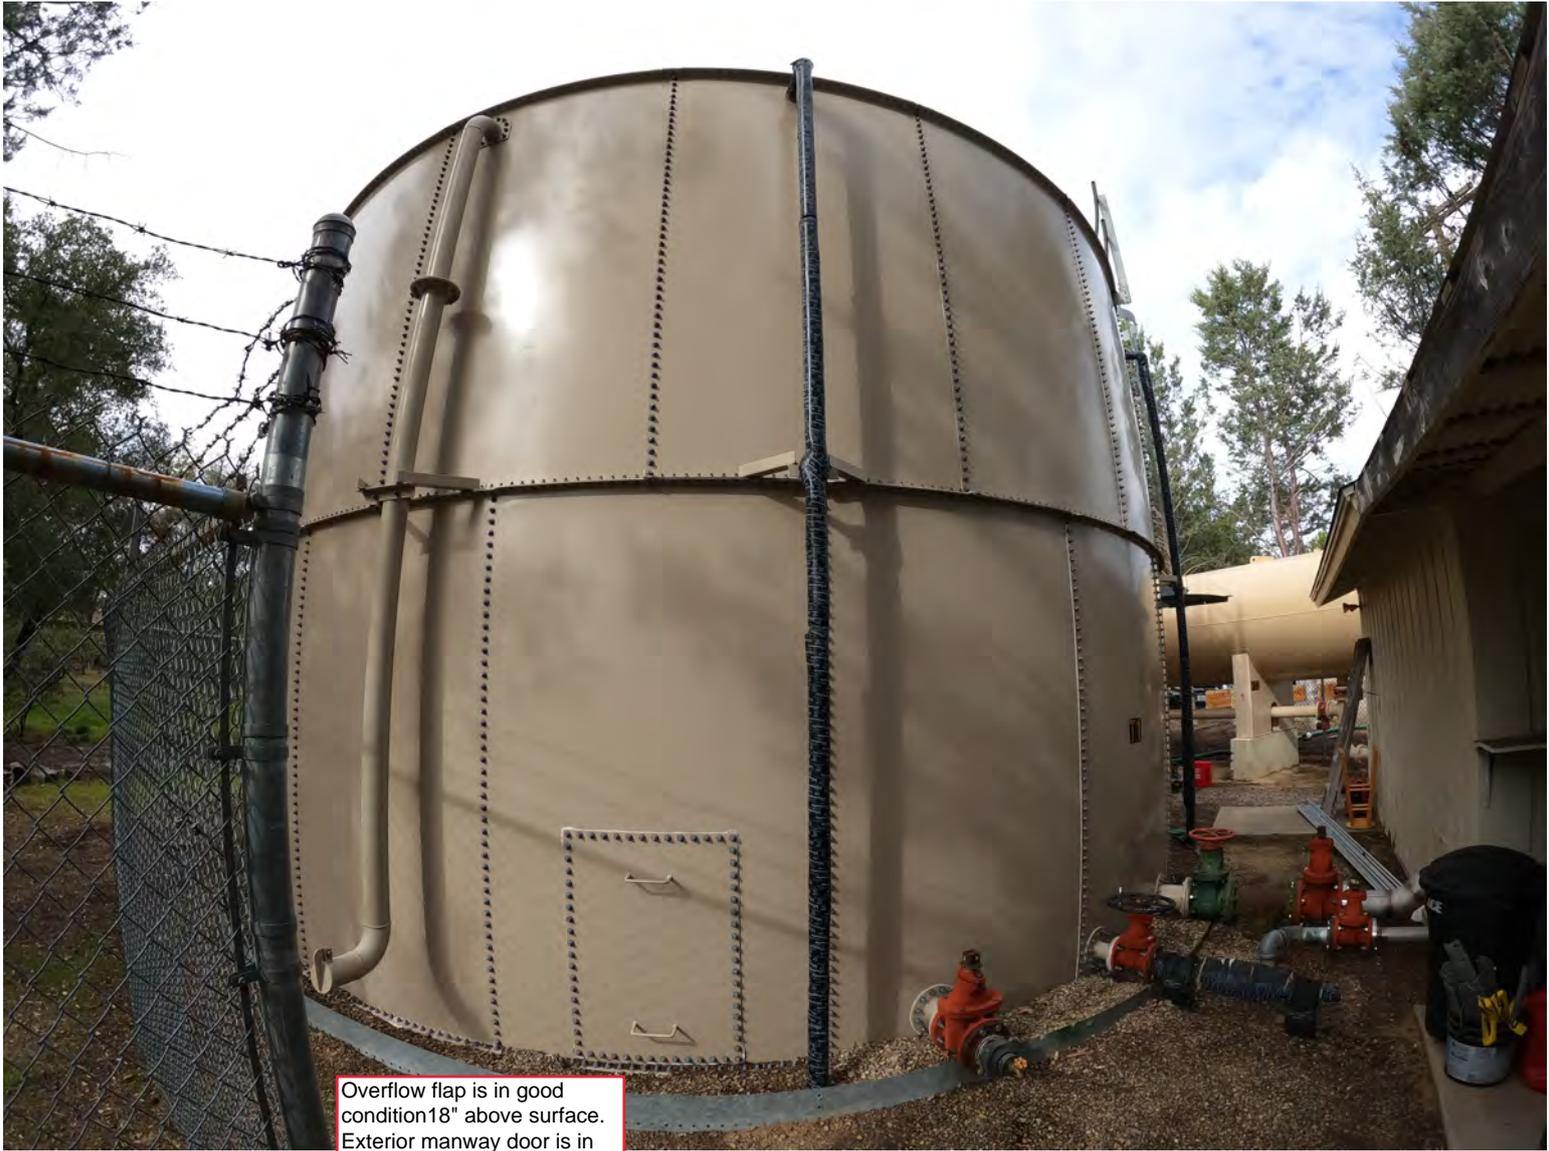
Overflow flap is in good condition 18" above surface. Exterior manway door is in good condition.

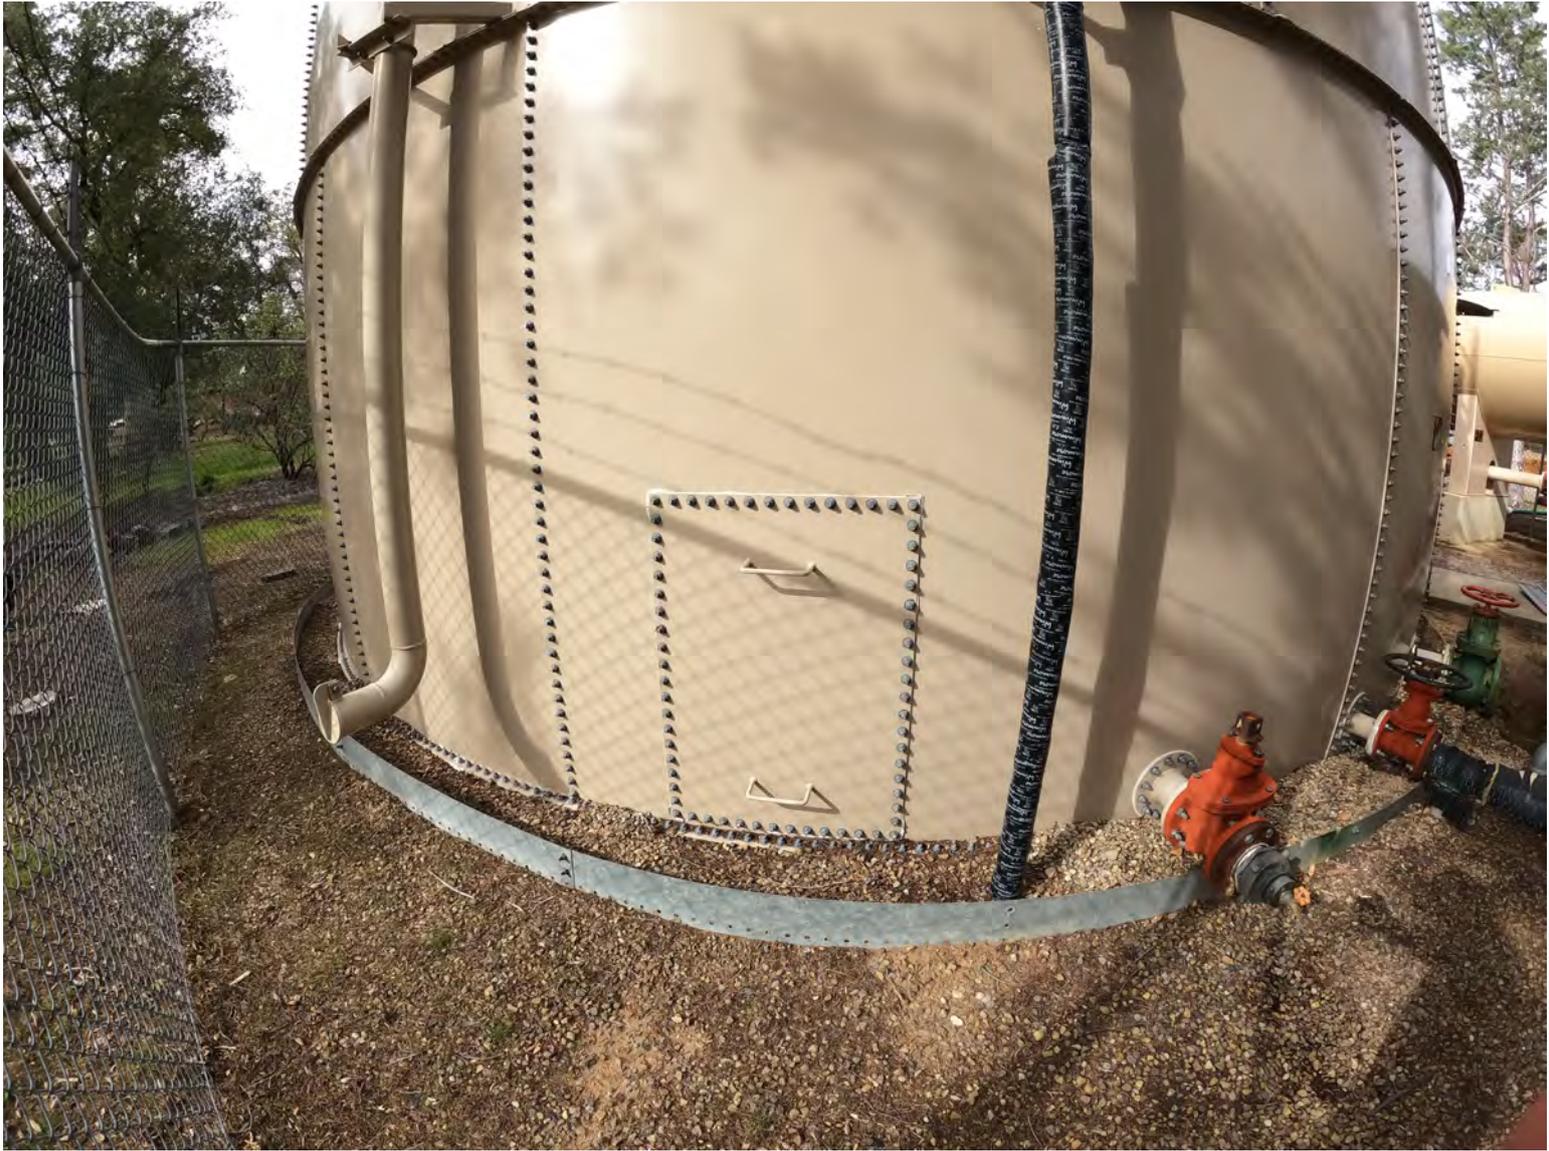
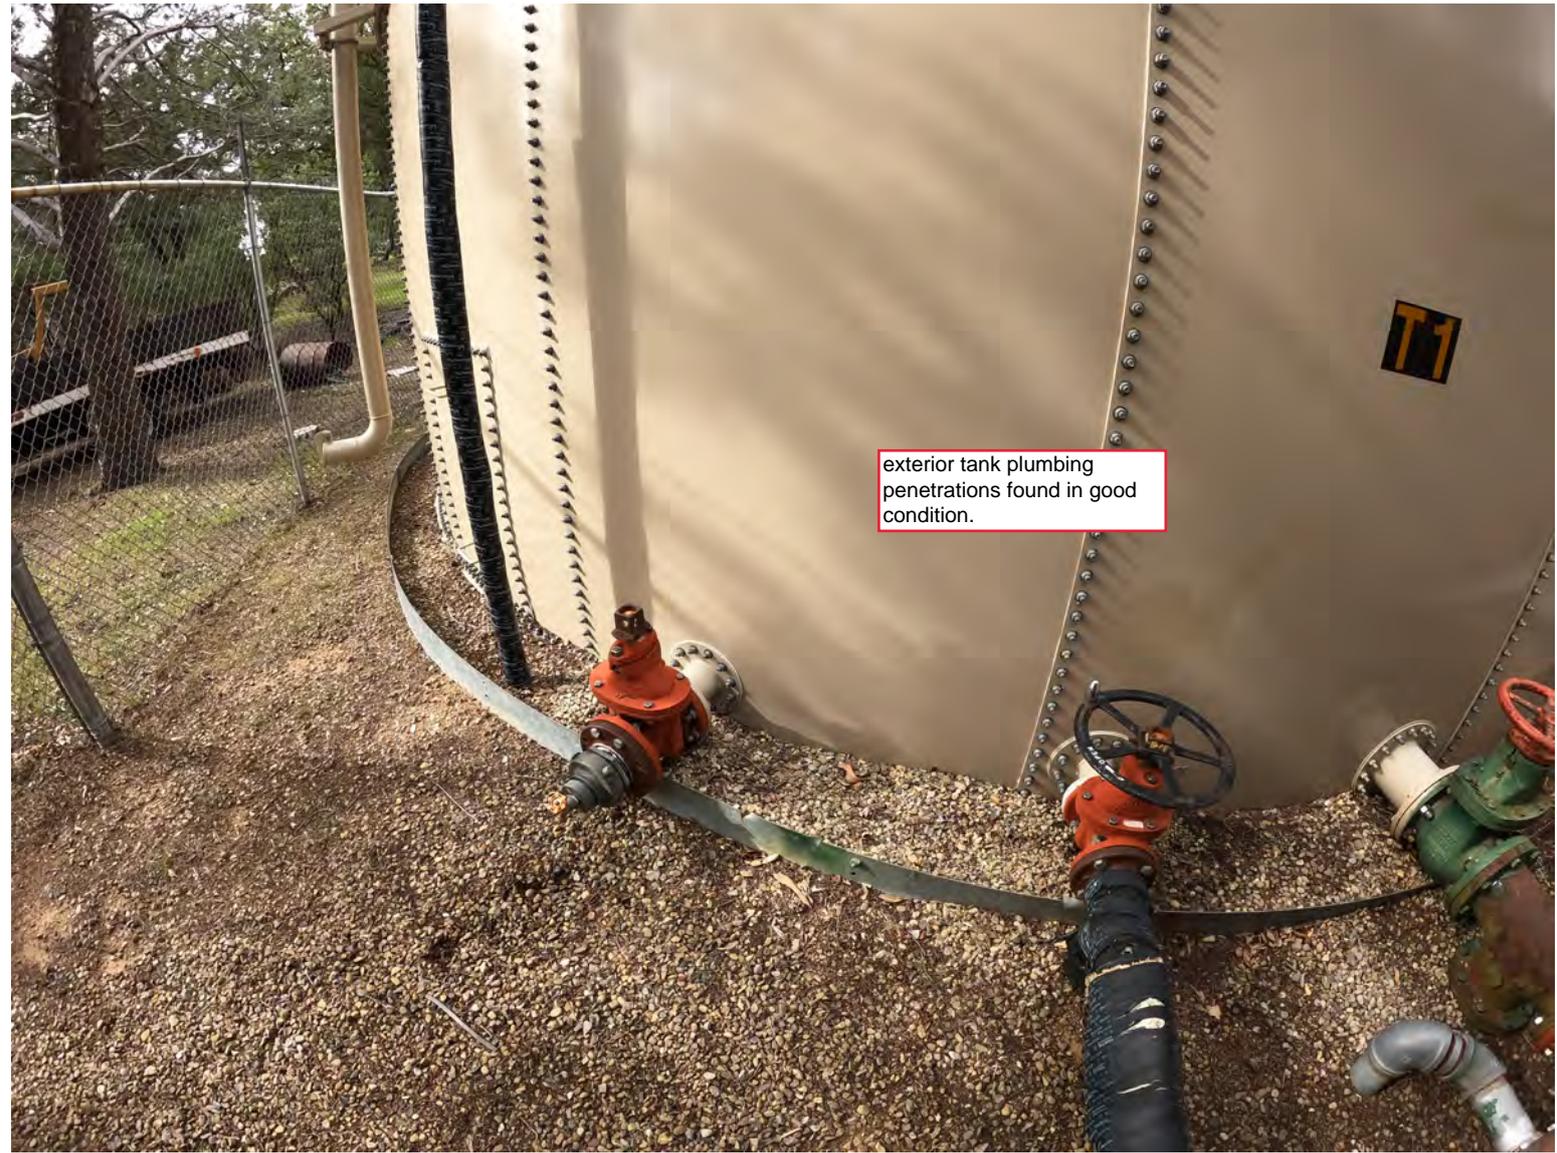
exterior tank plumbing penetrations found in good condition.

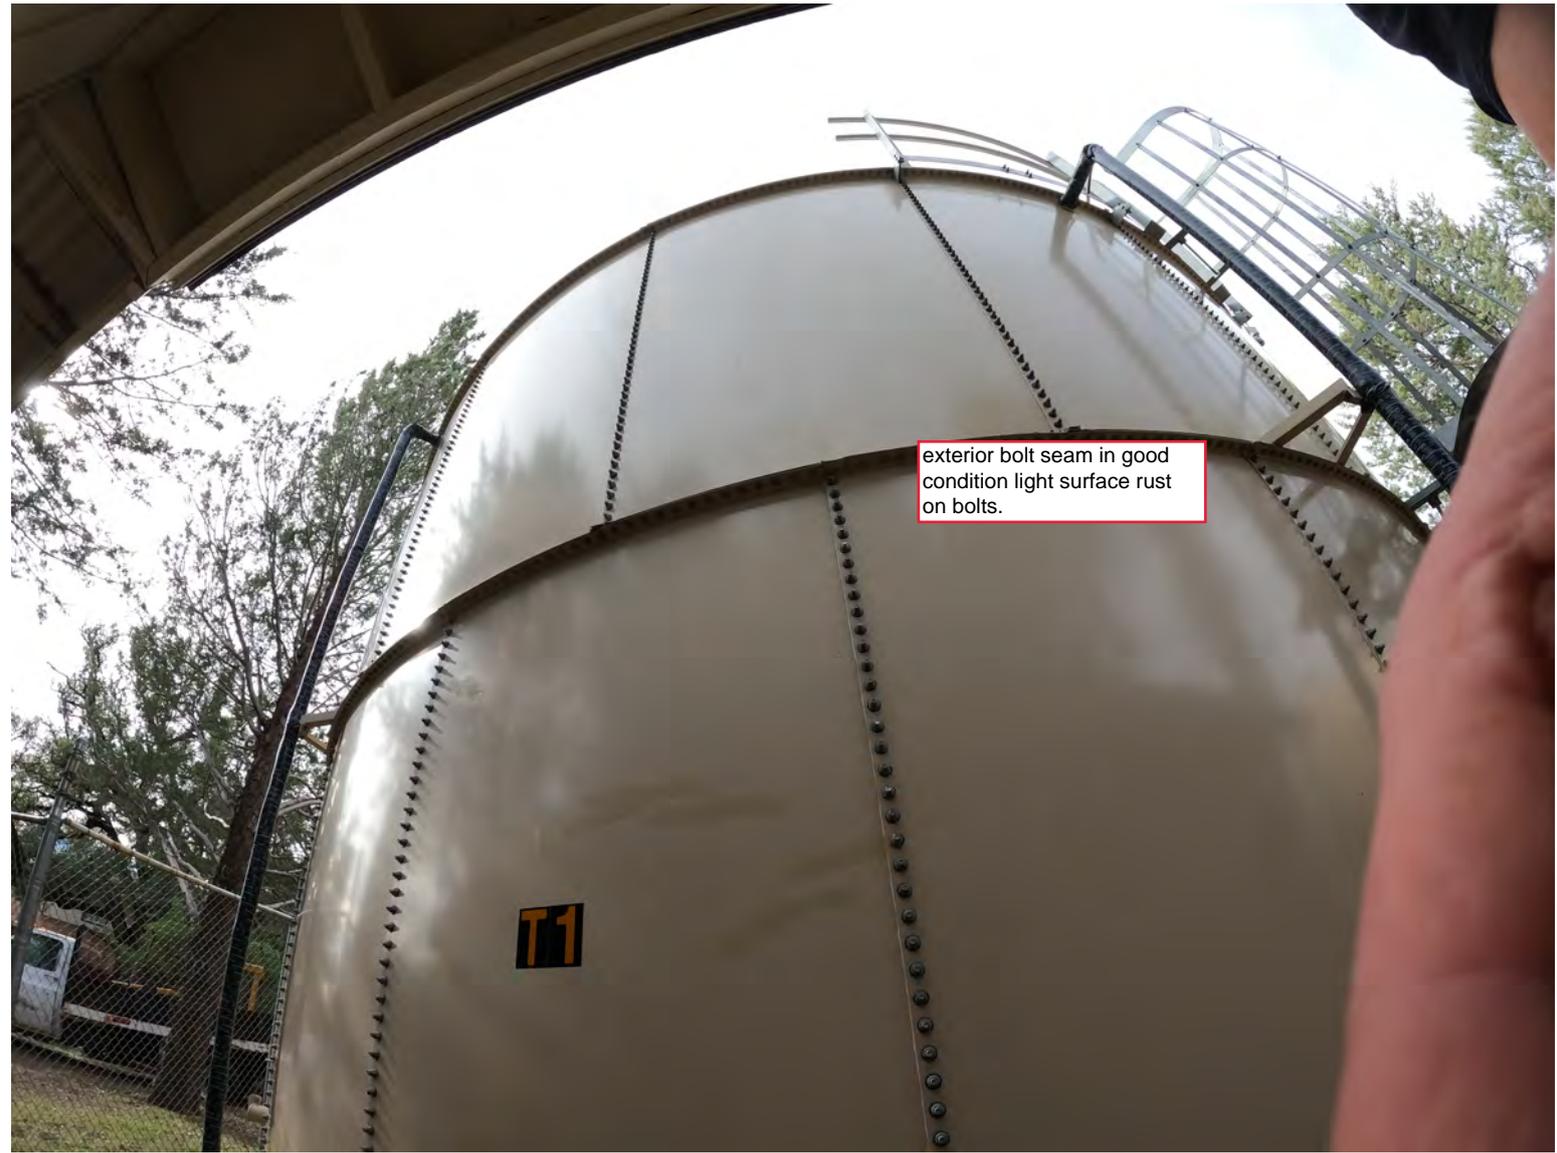
exterior bolt seam in good condition light surface rust on bolts.

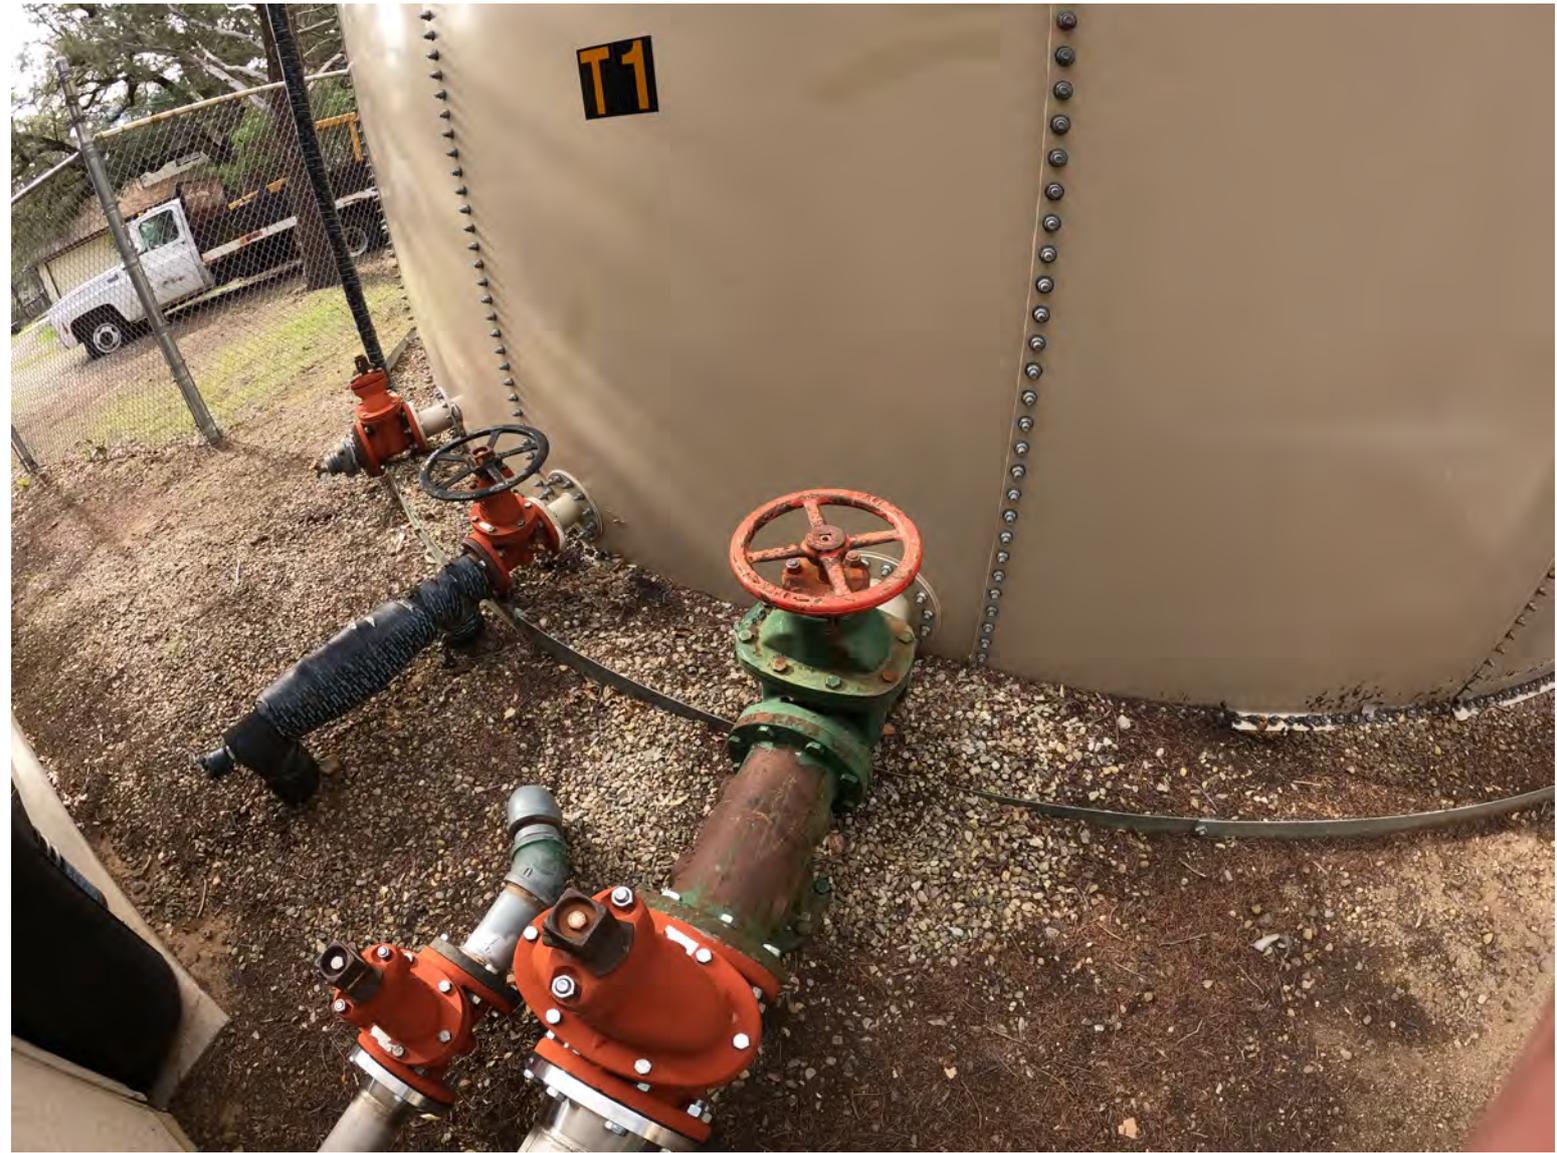
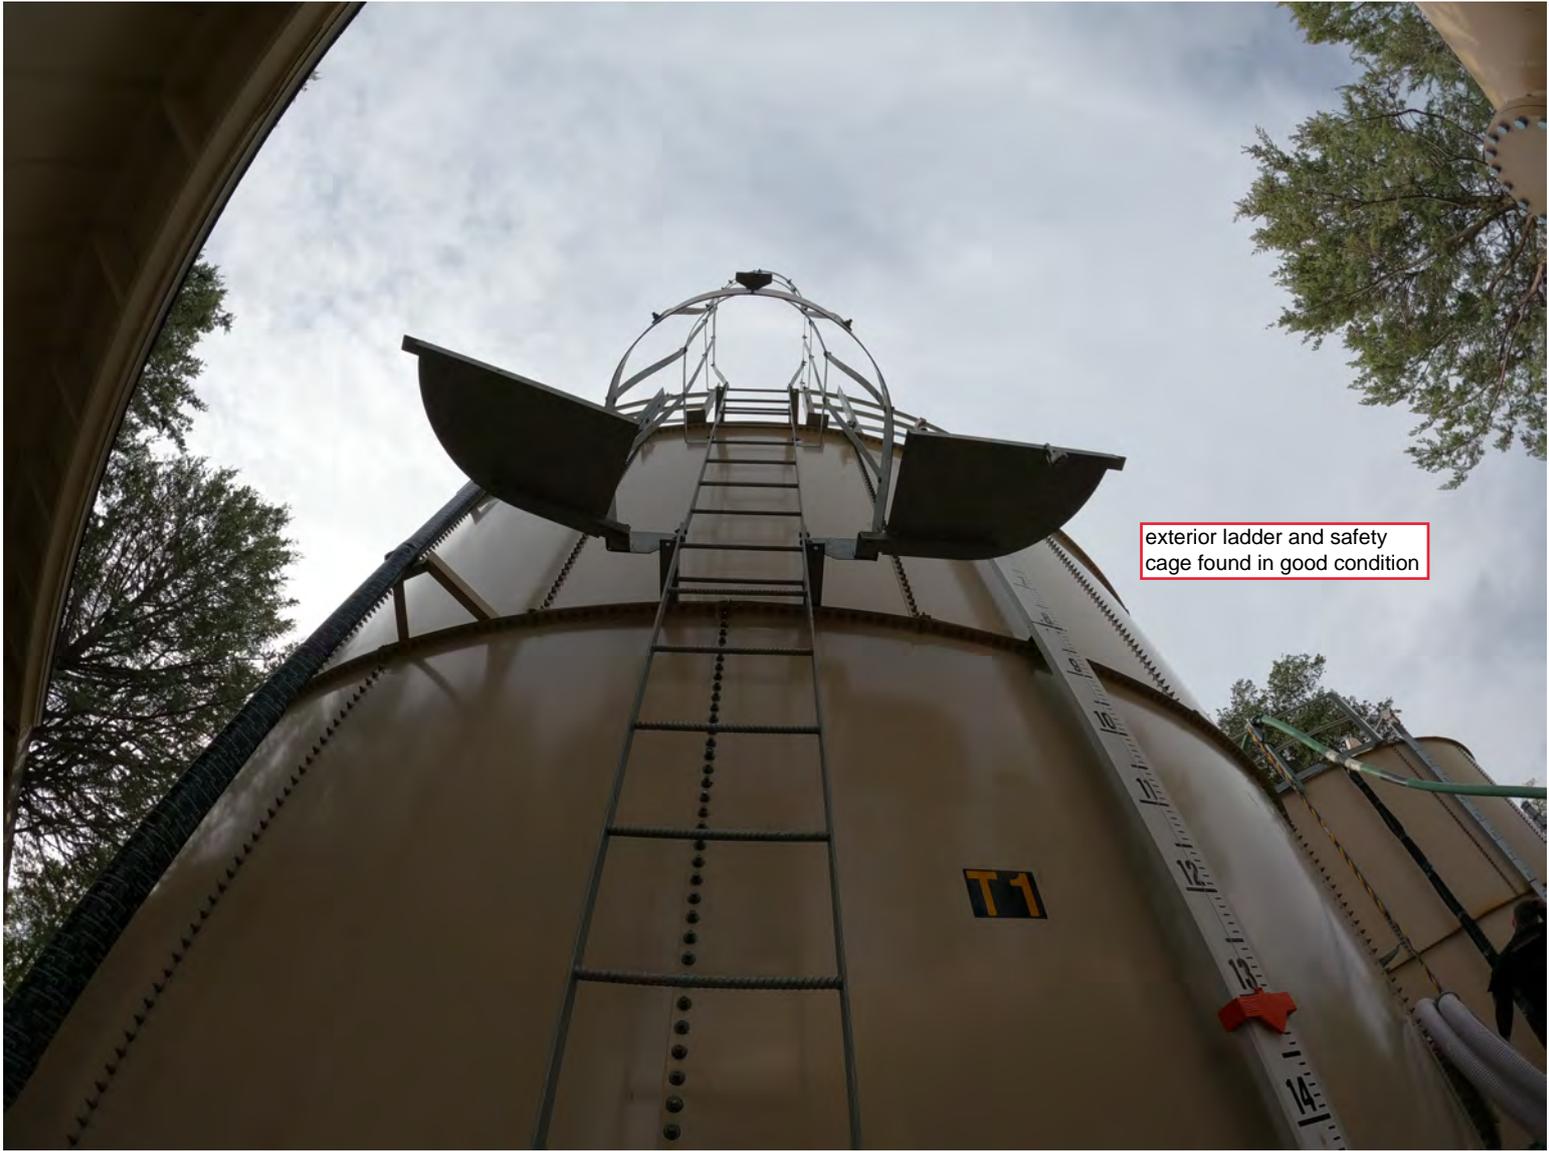
exterior ladder and safety cage found in good condition

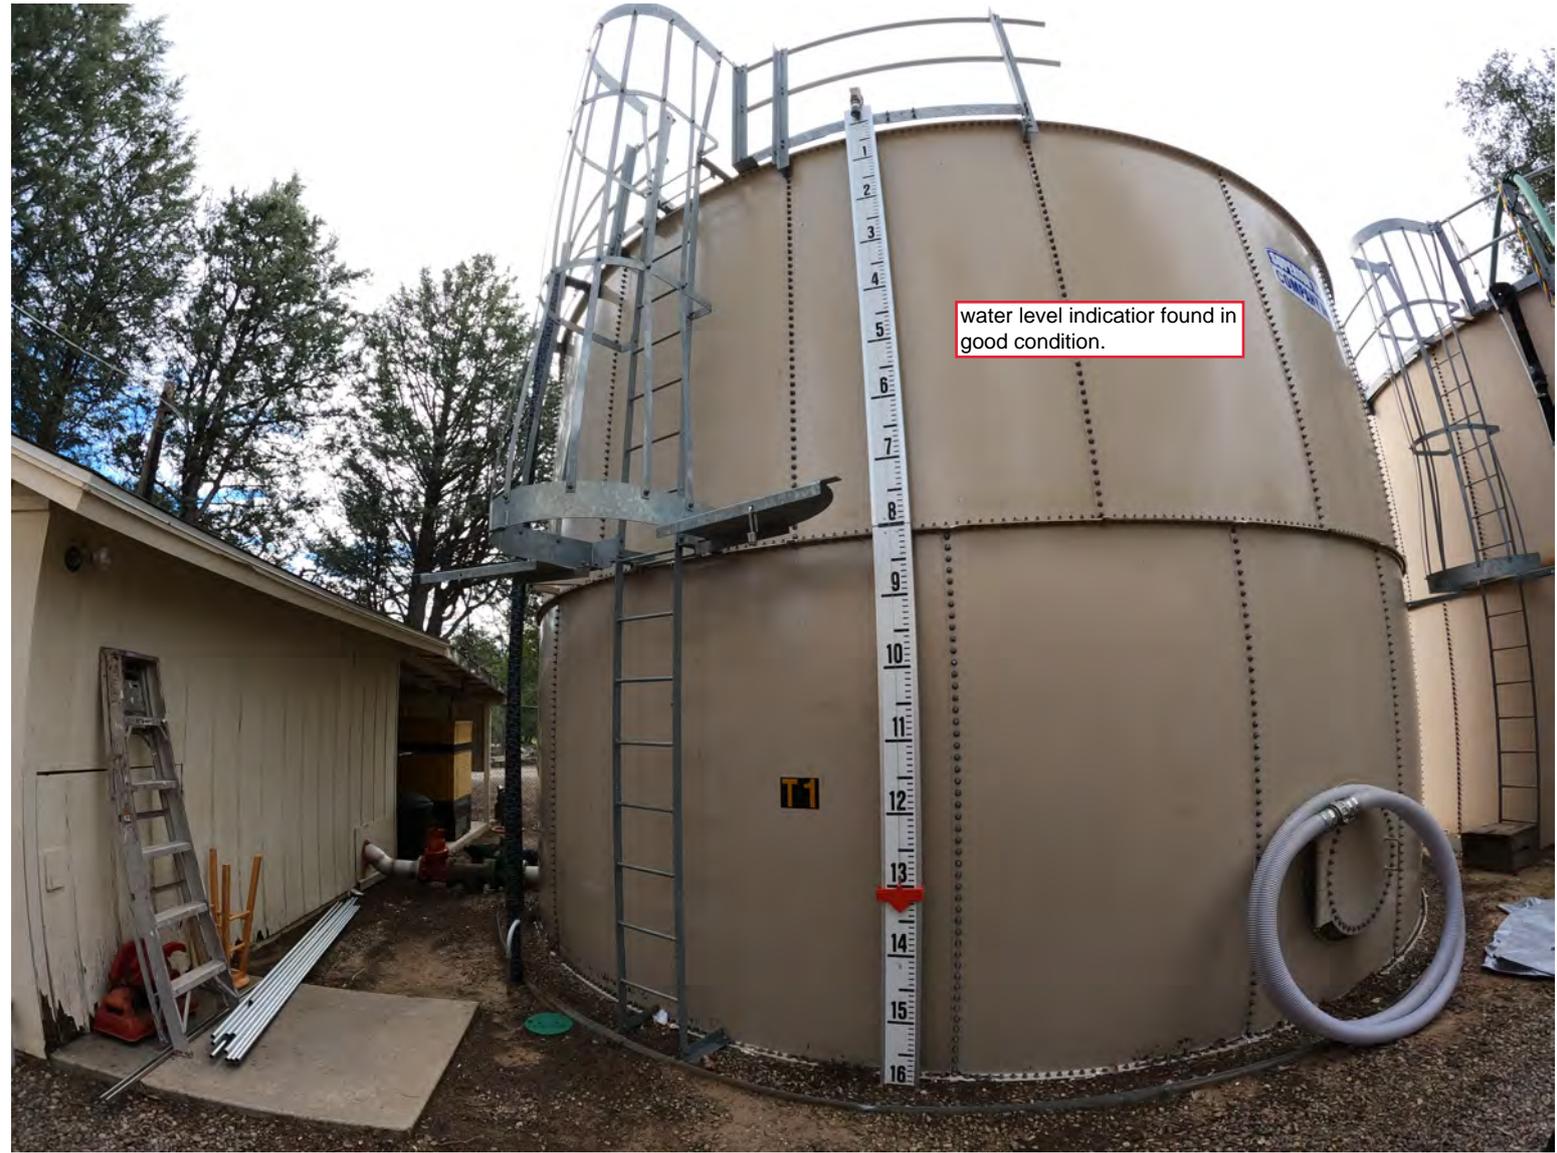
water level indicator found in good condition.

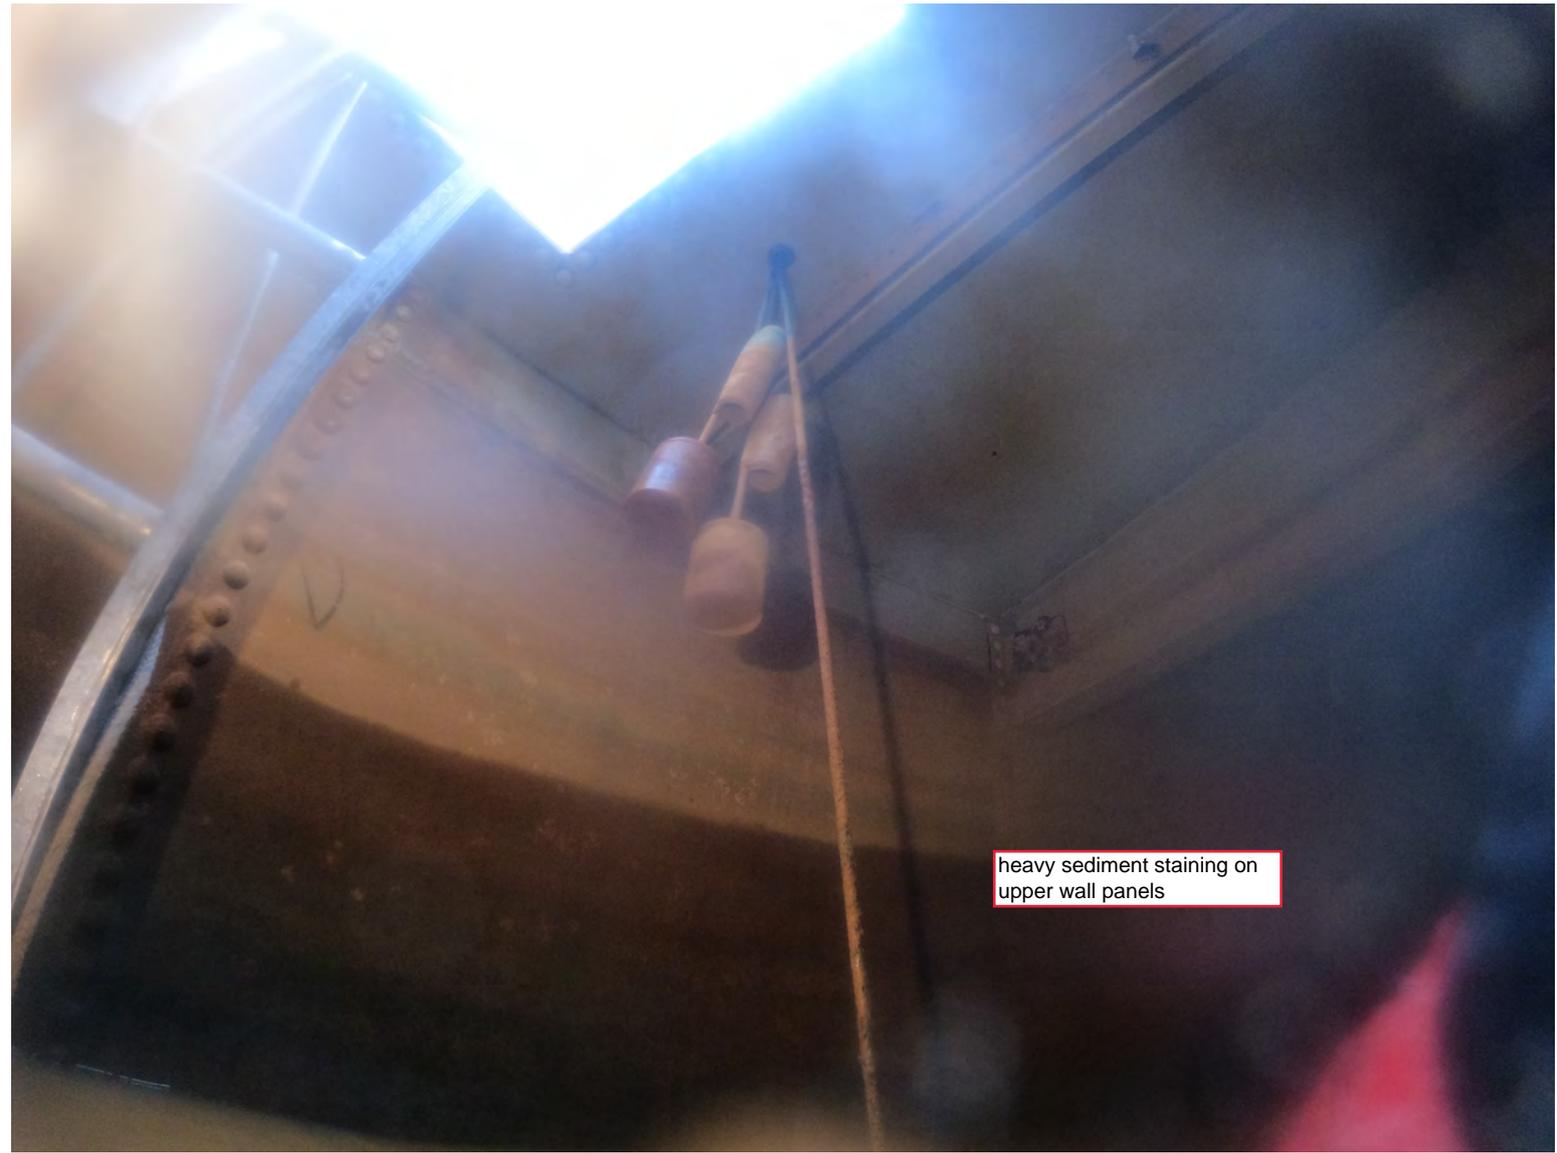
heavy sediment staining on upper wall panels
