Reservoir 45 kg on-grade steel bolted	Utility Name Wynola Water District	Date 1/12/2022
Dive Control/Supervisor Cody Clark	Diver/Inspector Dalton Chea	Tender Tyler Cote

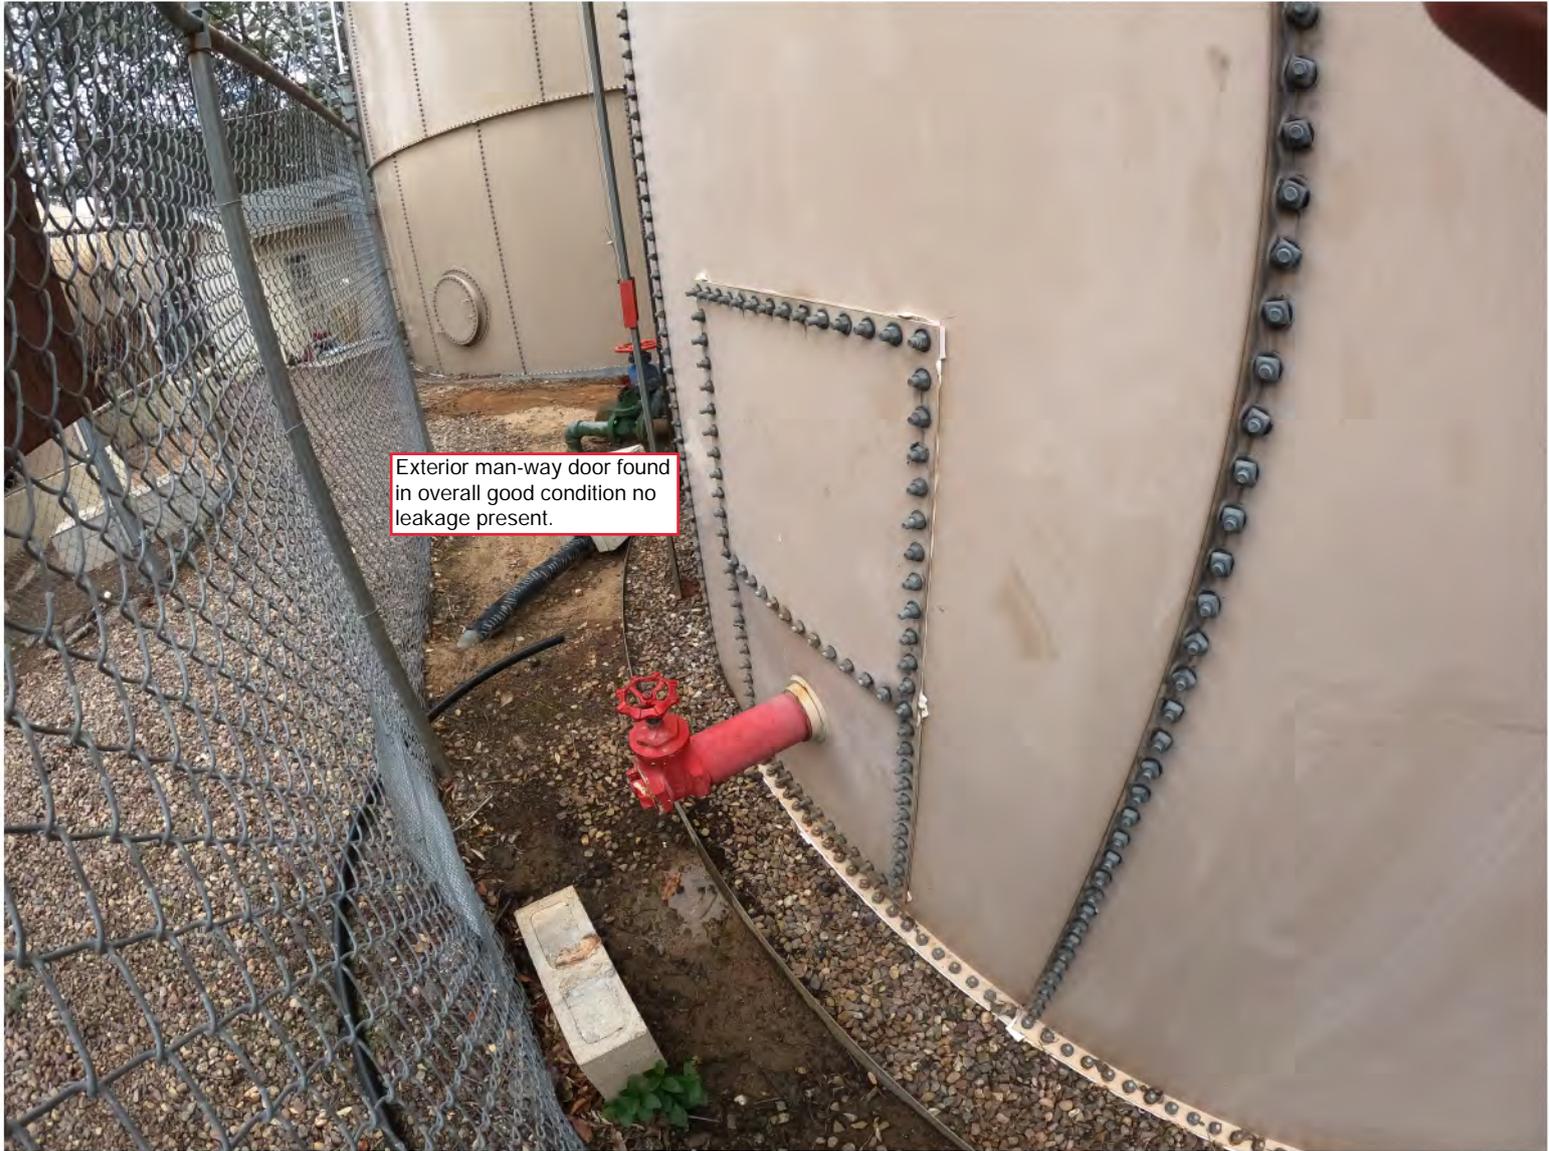
Exterior man-way door found in overall good condition no leakage present.

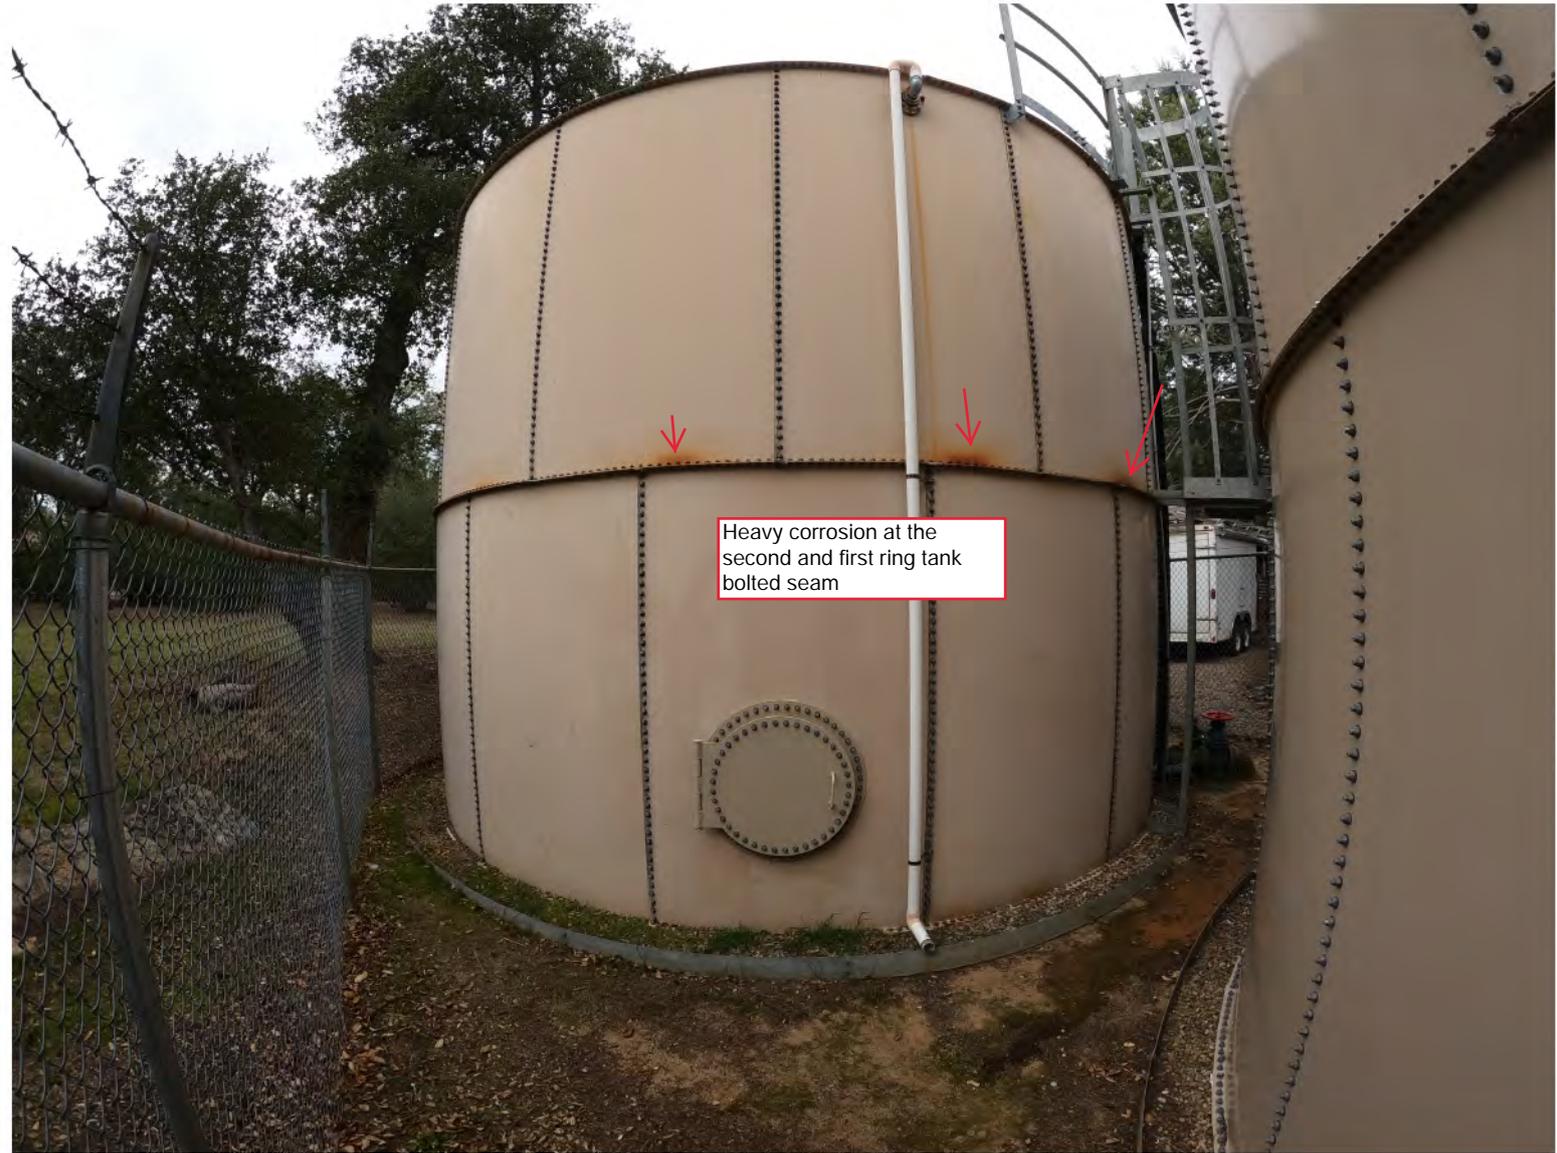
Heavy corrosion at the second and first ring tank bolted seam

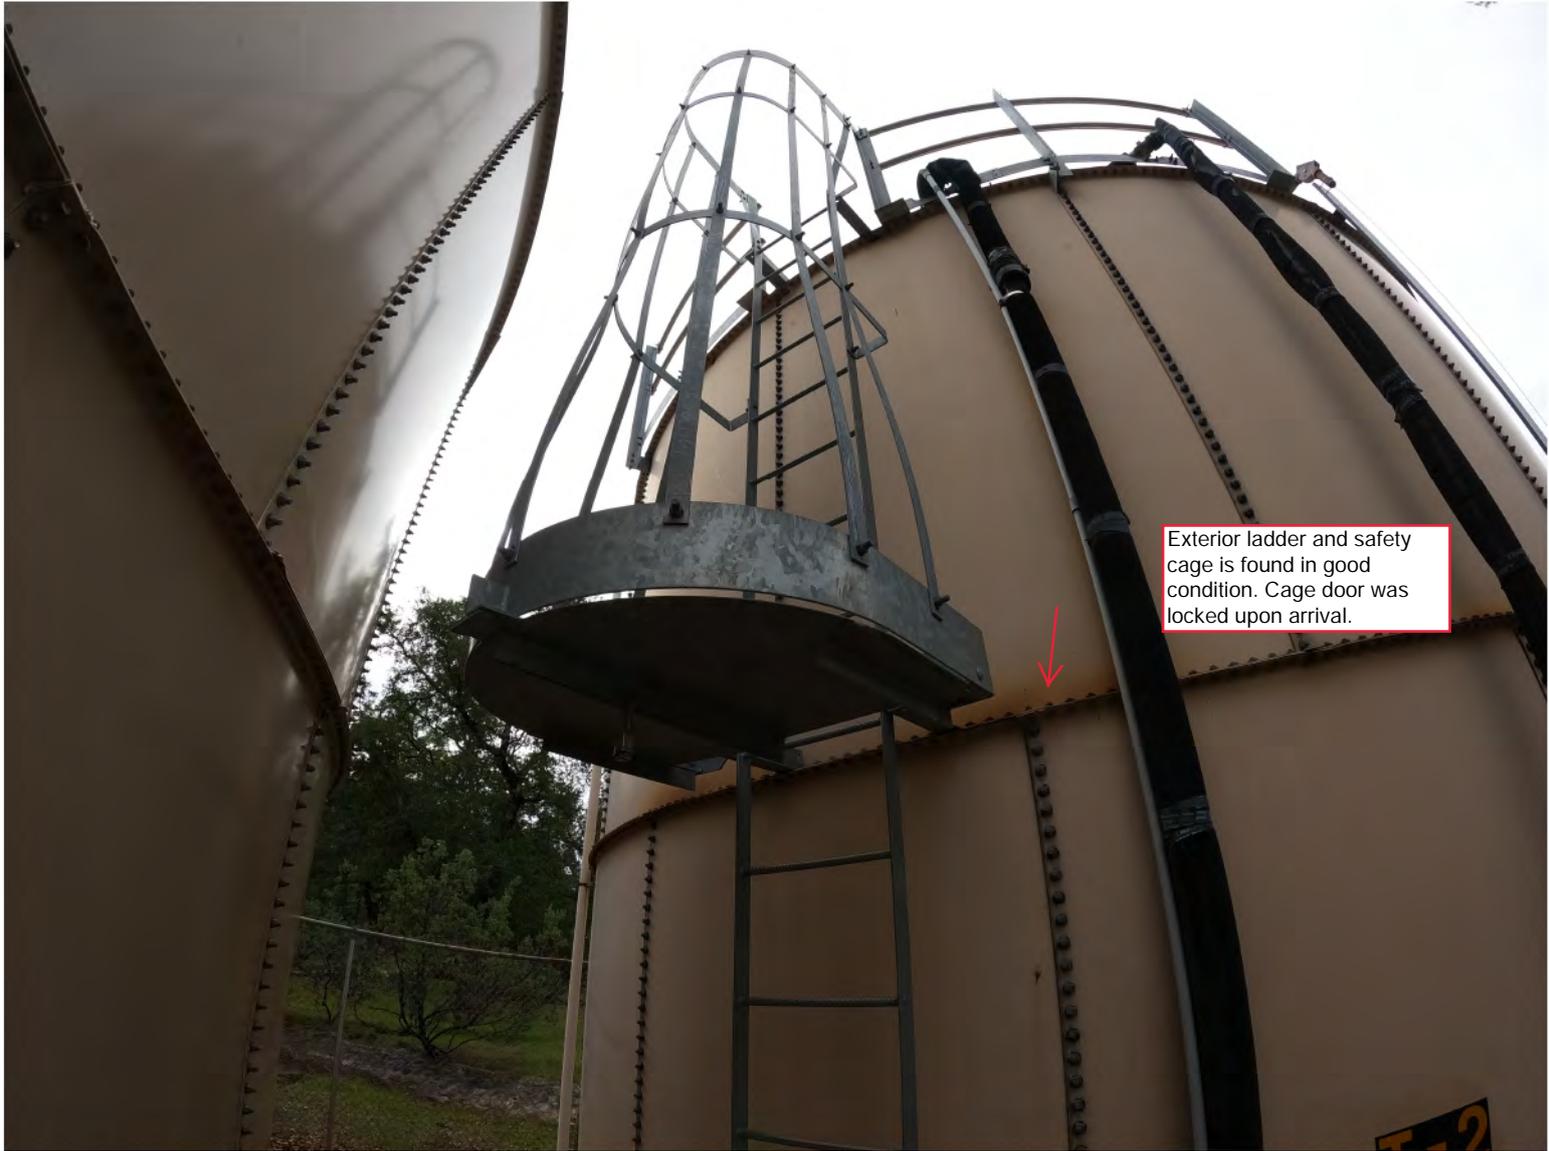
Exterior ladder and safety cage is found in good condition. Cage door was locked upon arrival.

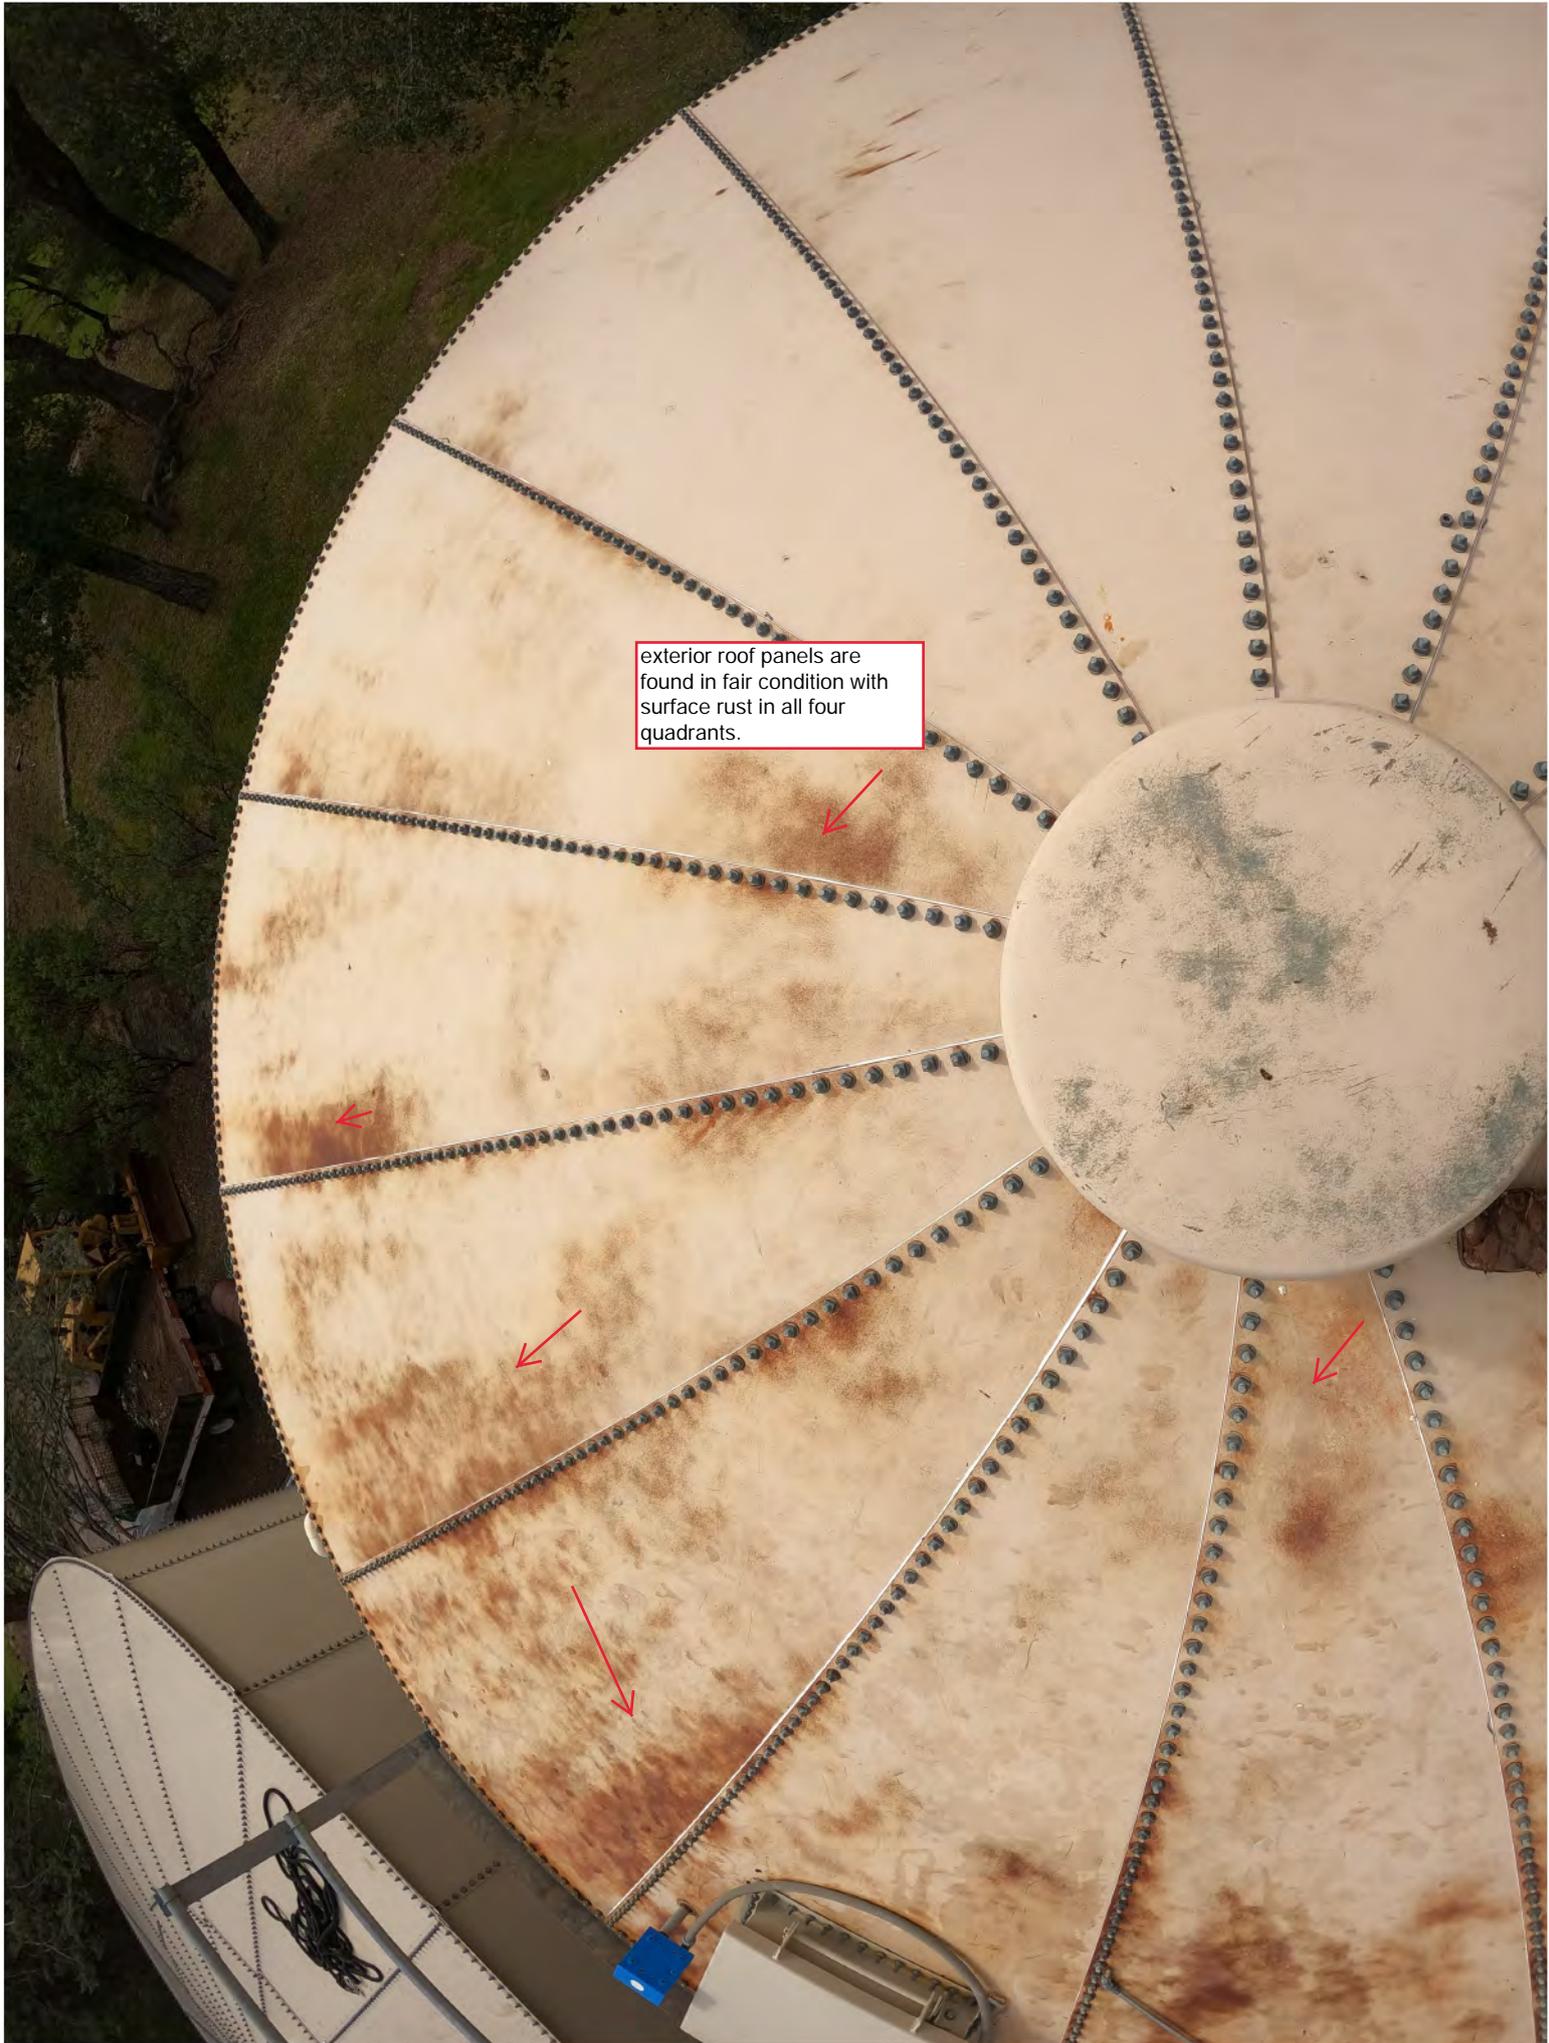
exterior roof panels are found in fair condition with surface rust in all four quadrants.

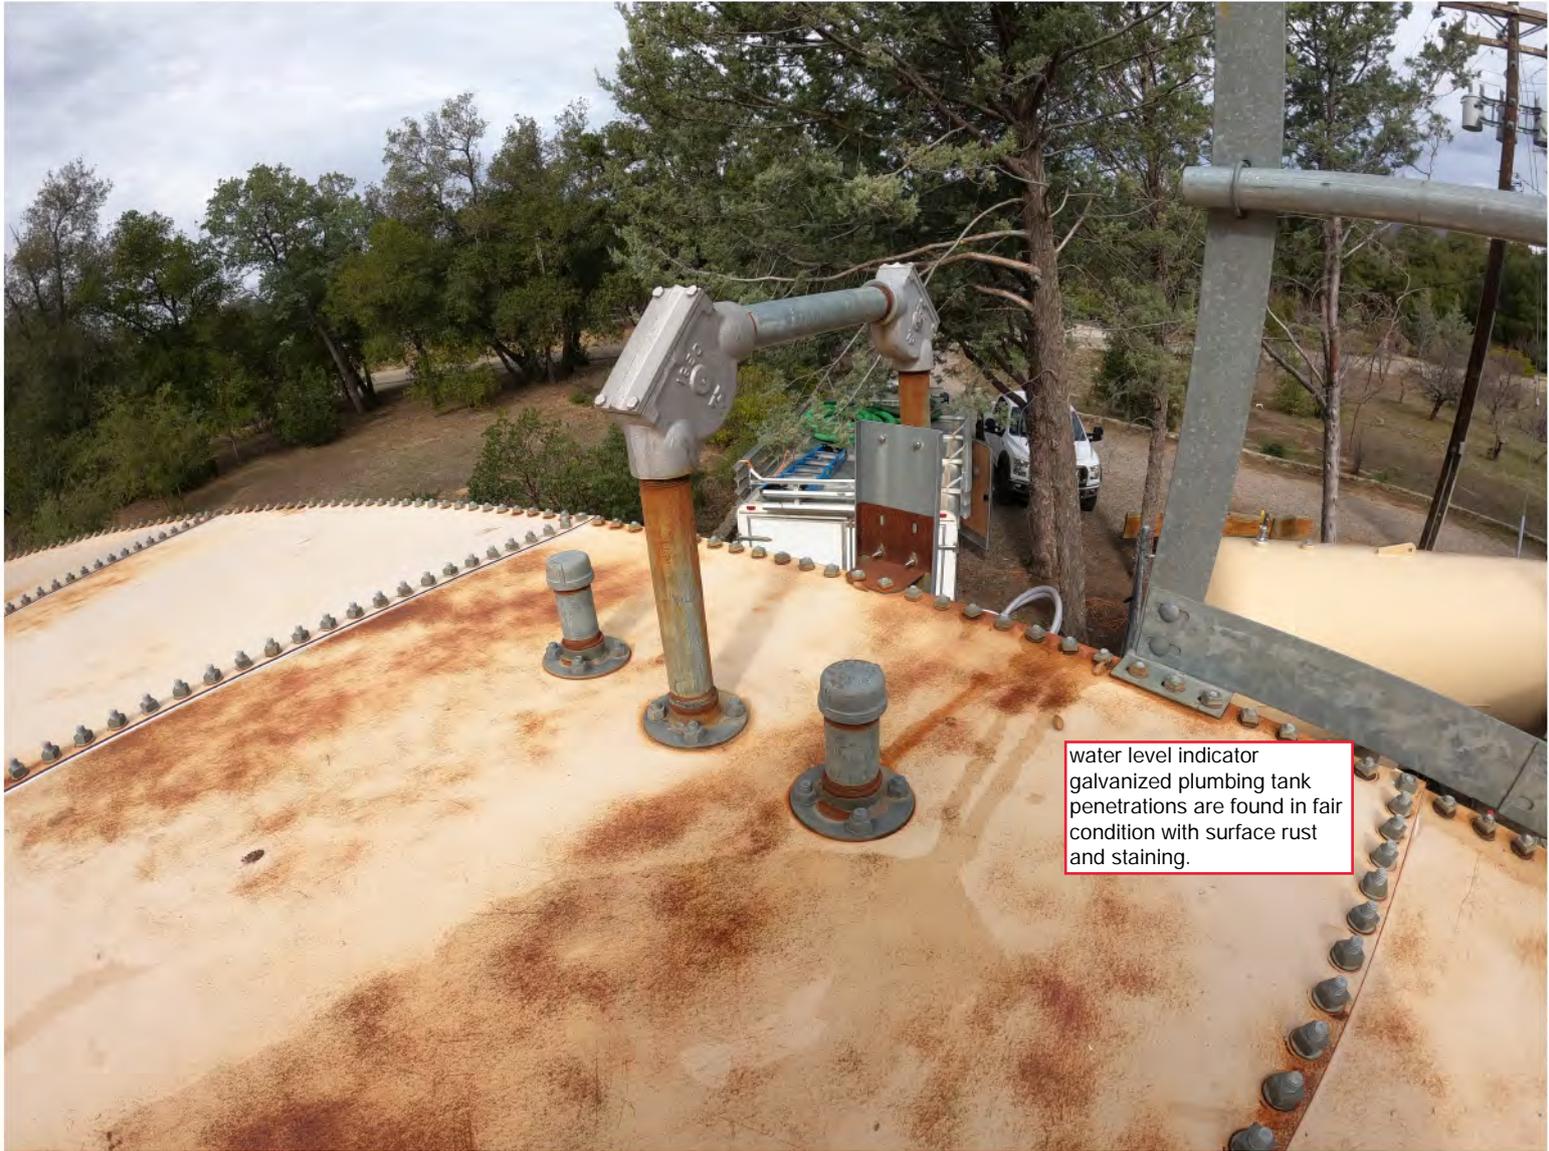
water level indicator
galvanized plumbing tank
penetrations are found in fair
condition with surface rust
and staining.

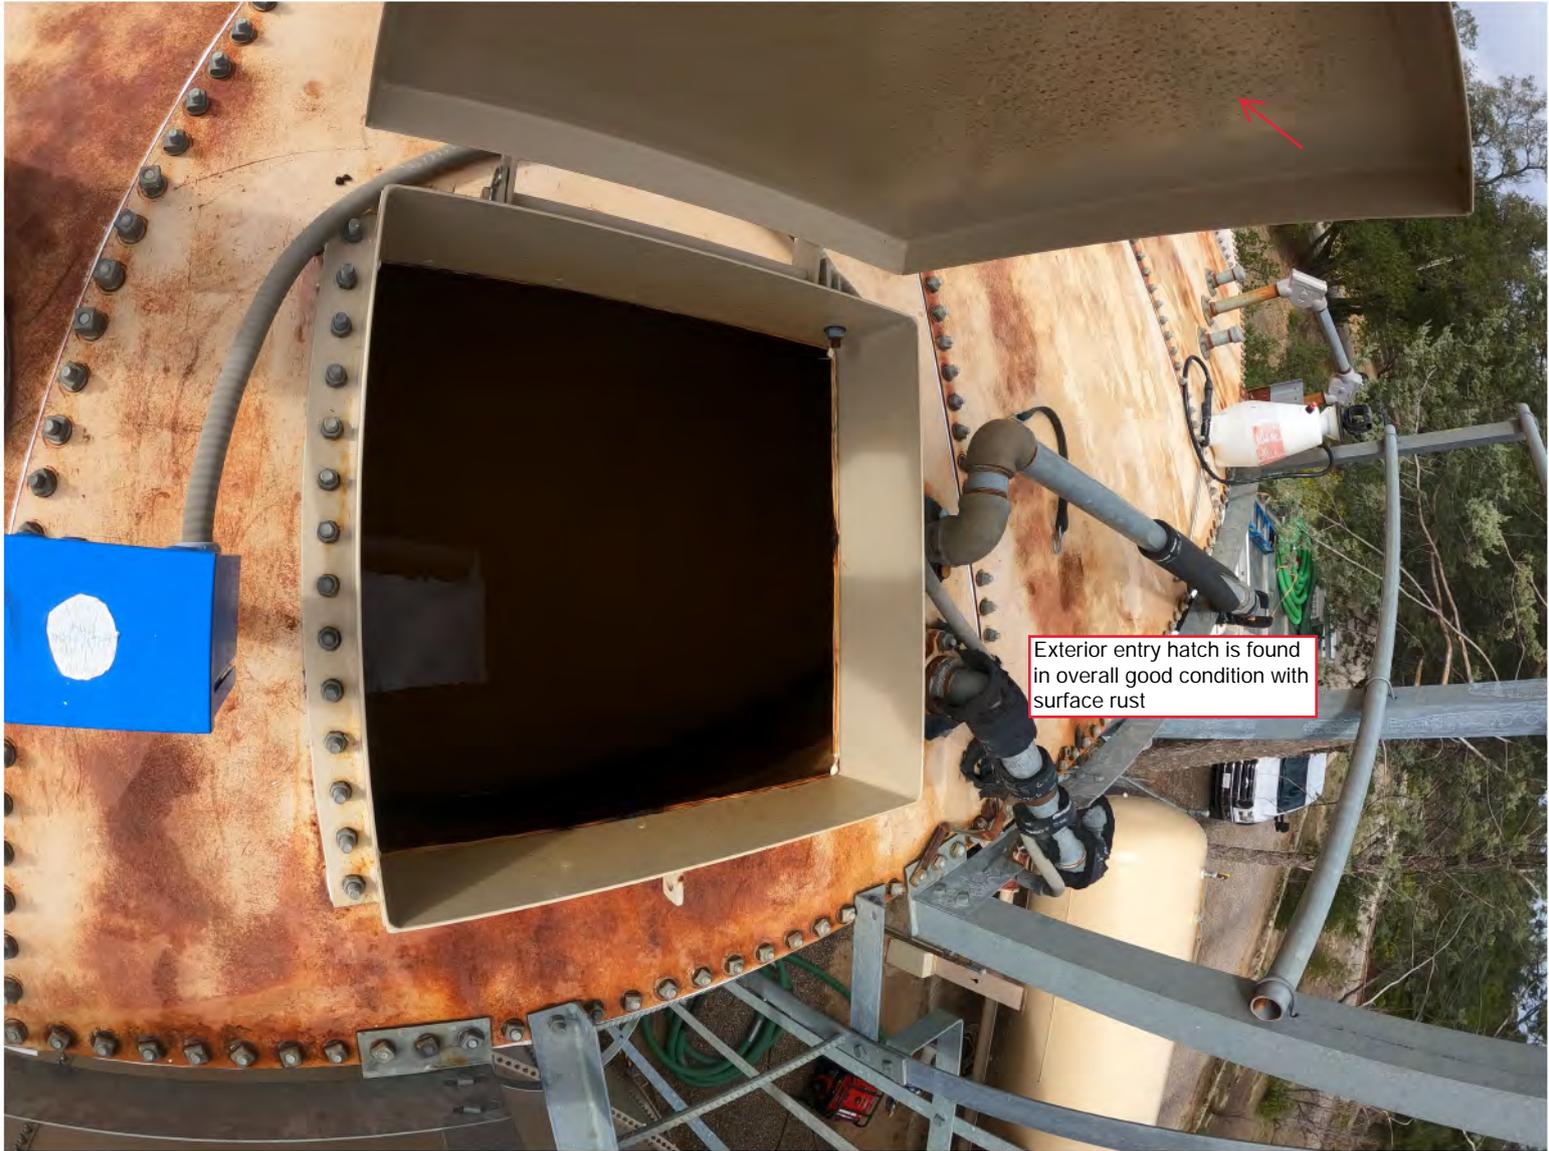
Exterior entry hatch is found in overall good condition with surface rust

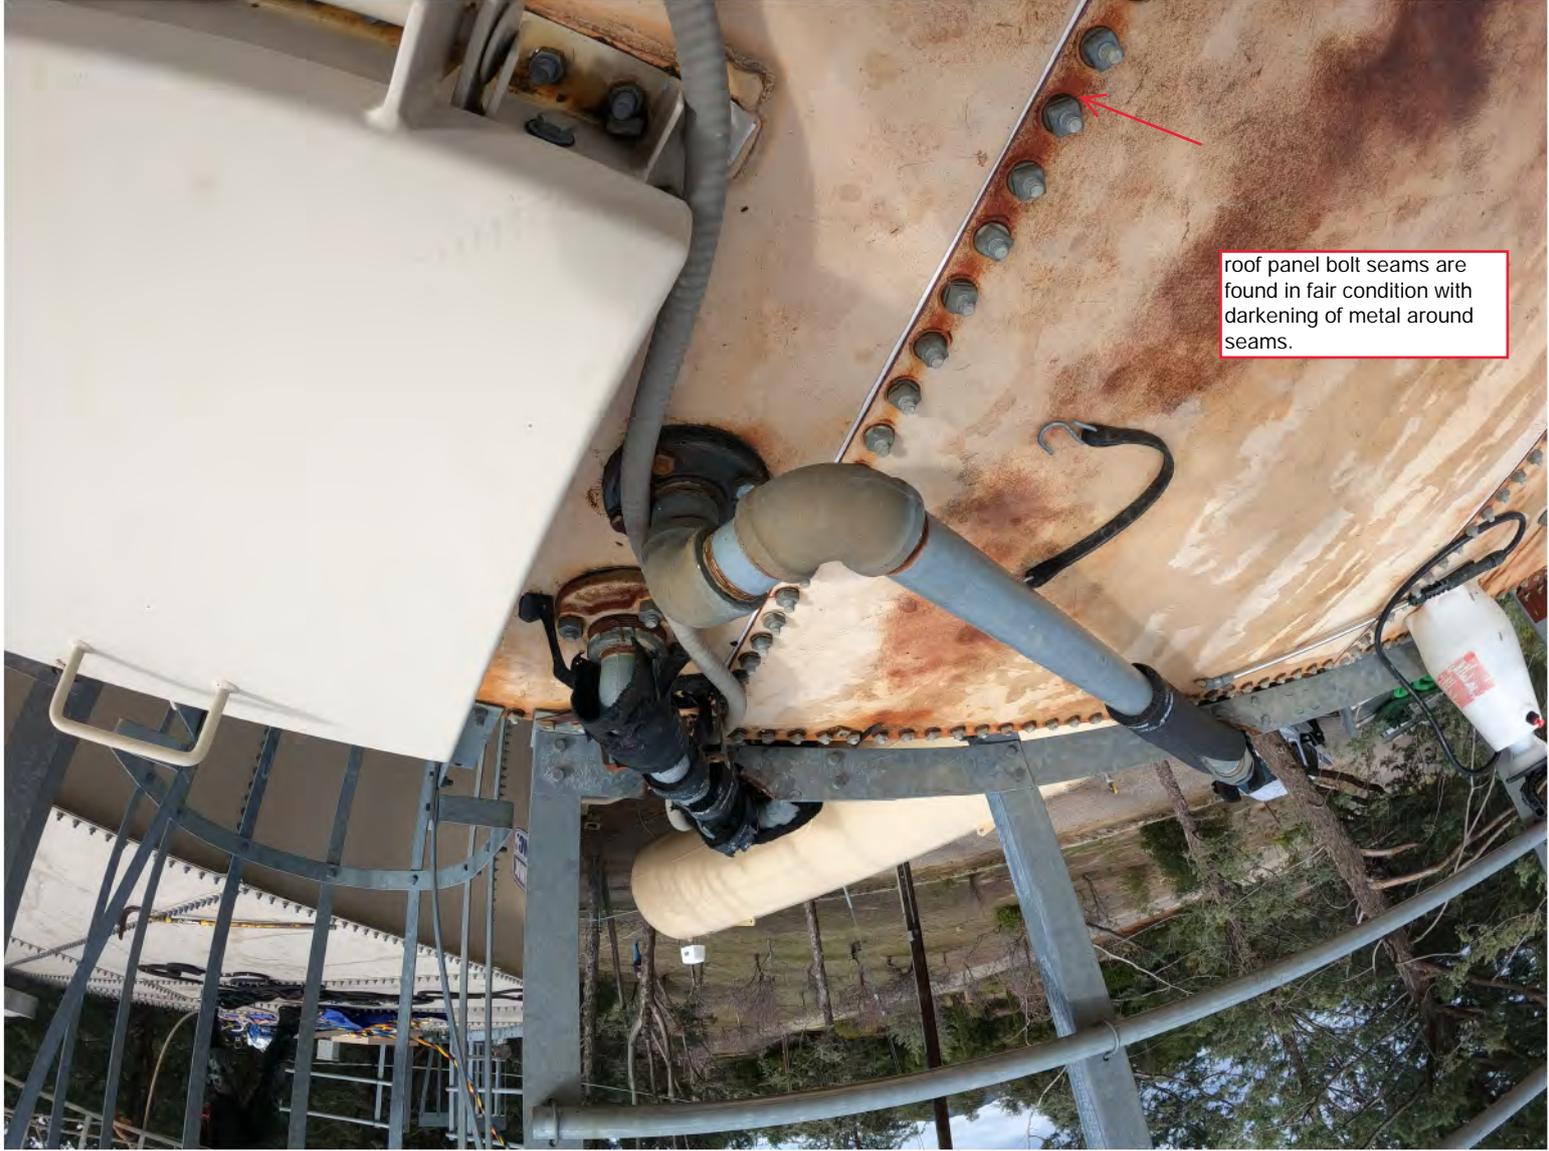
roof panel bolt seams are found in fair condition with darkening of metal around seams.

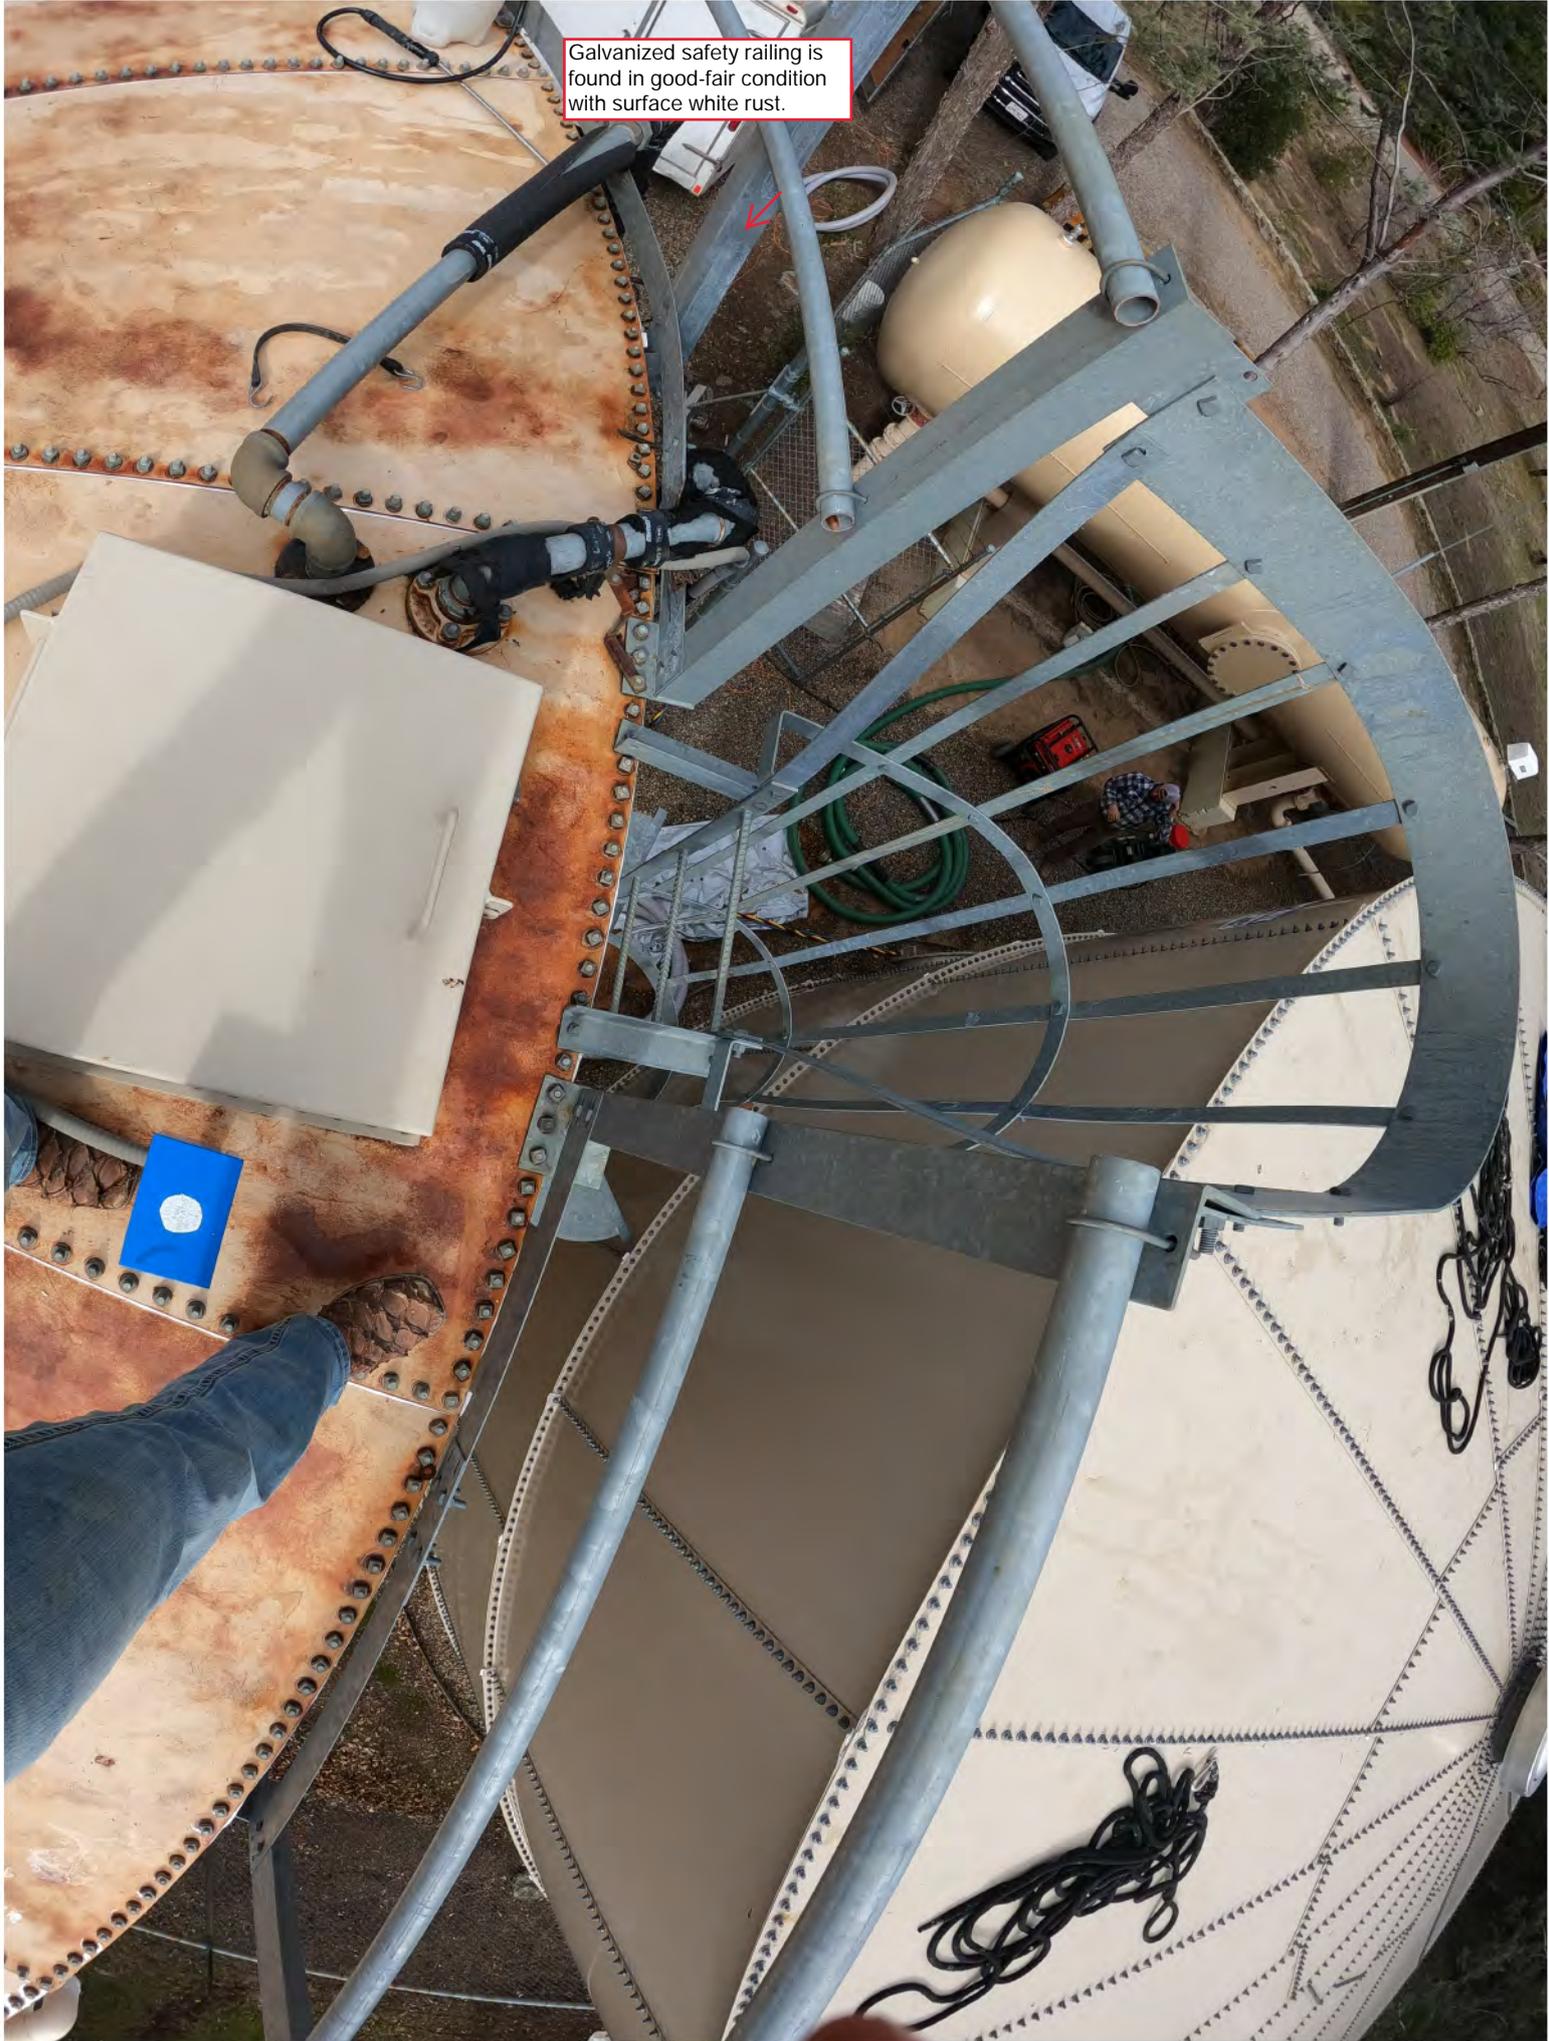
Galvanized safety railing is found in good-fair condition with surface white rust.

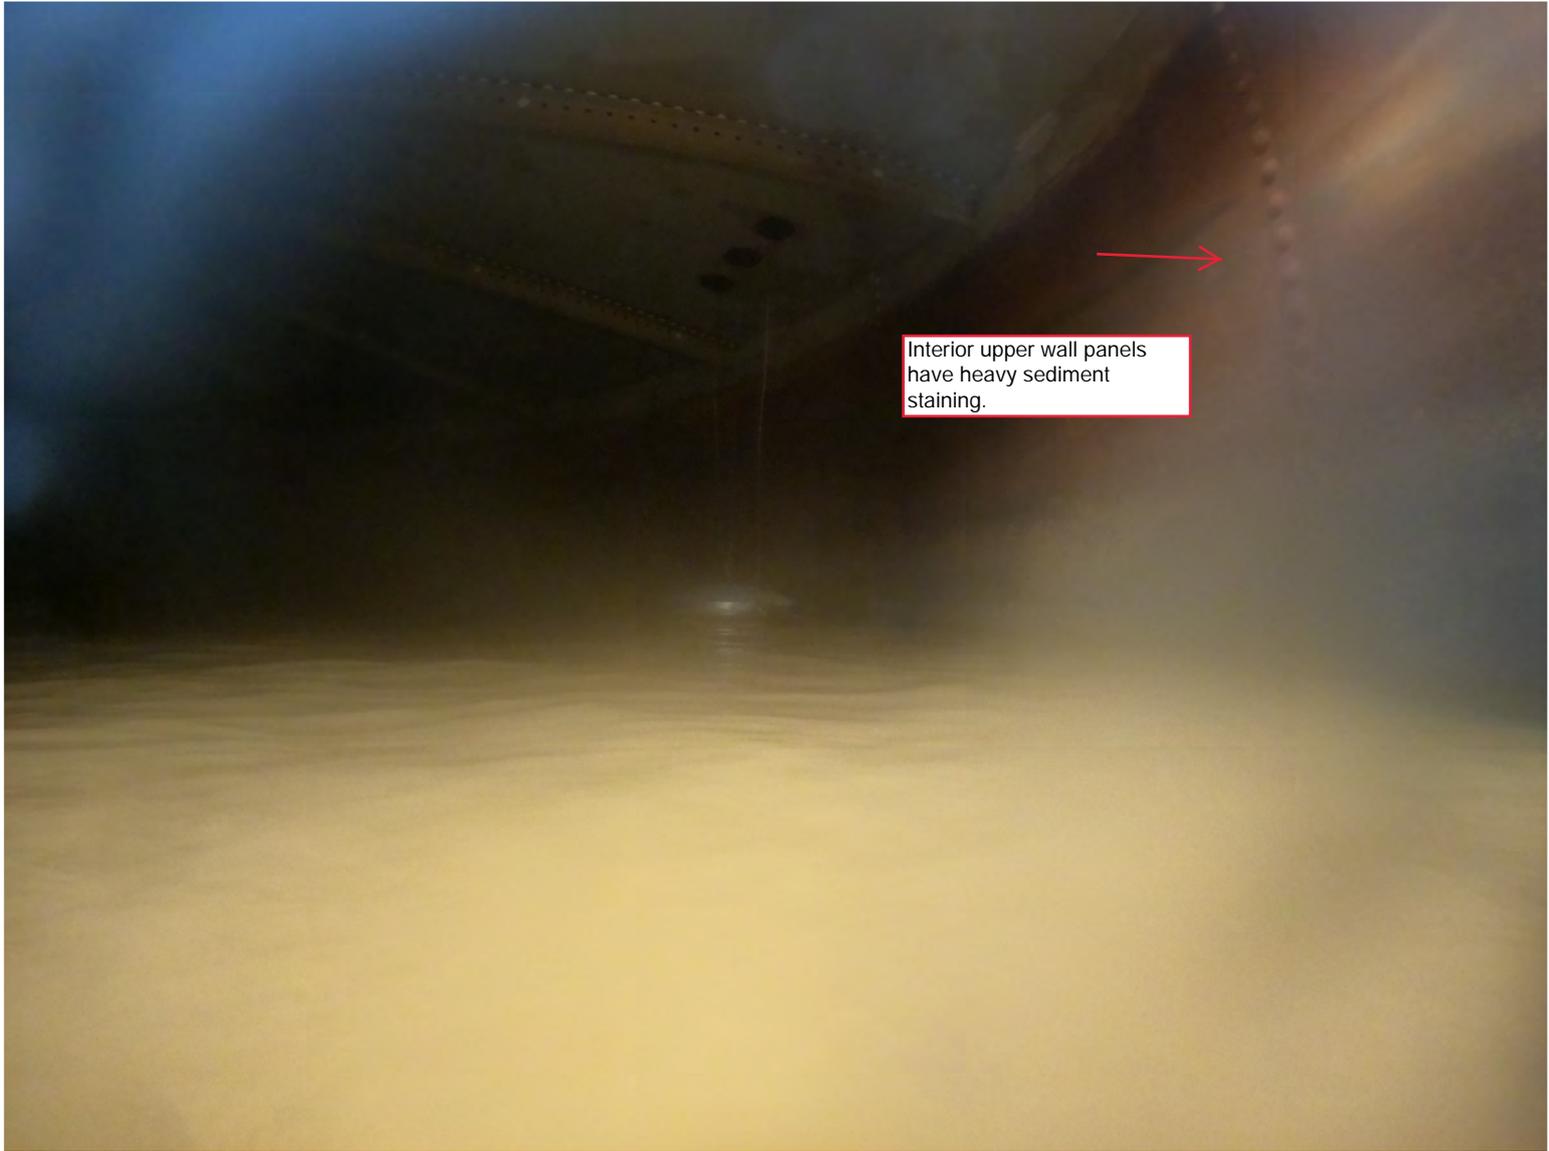
Interior upper wall panels
have heavy sediment
staining.

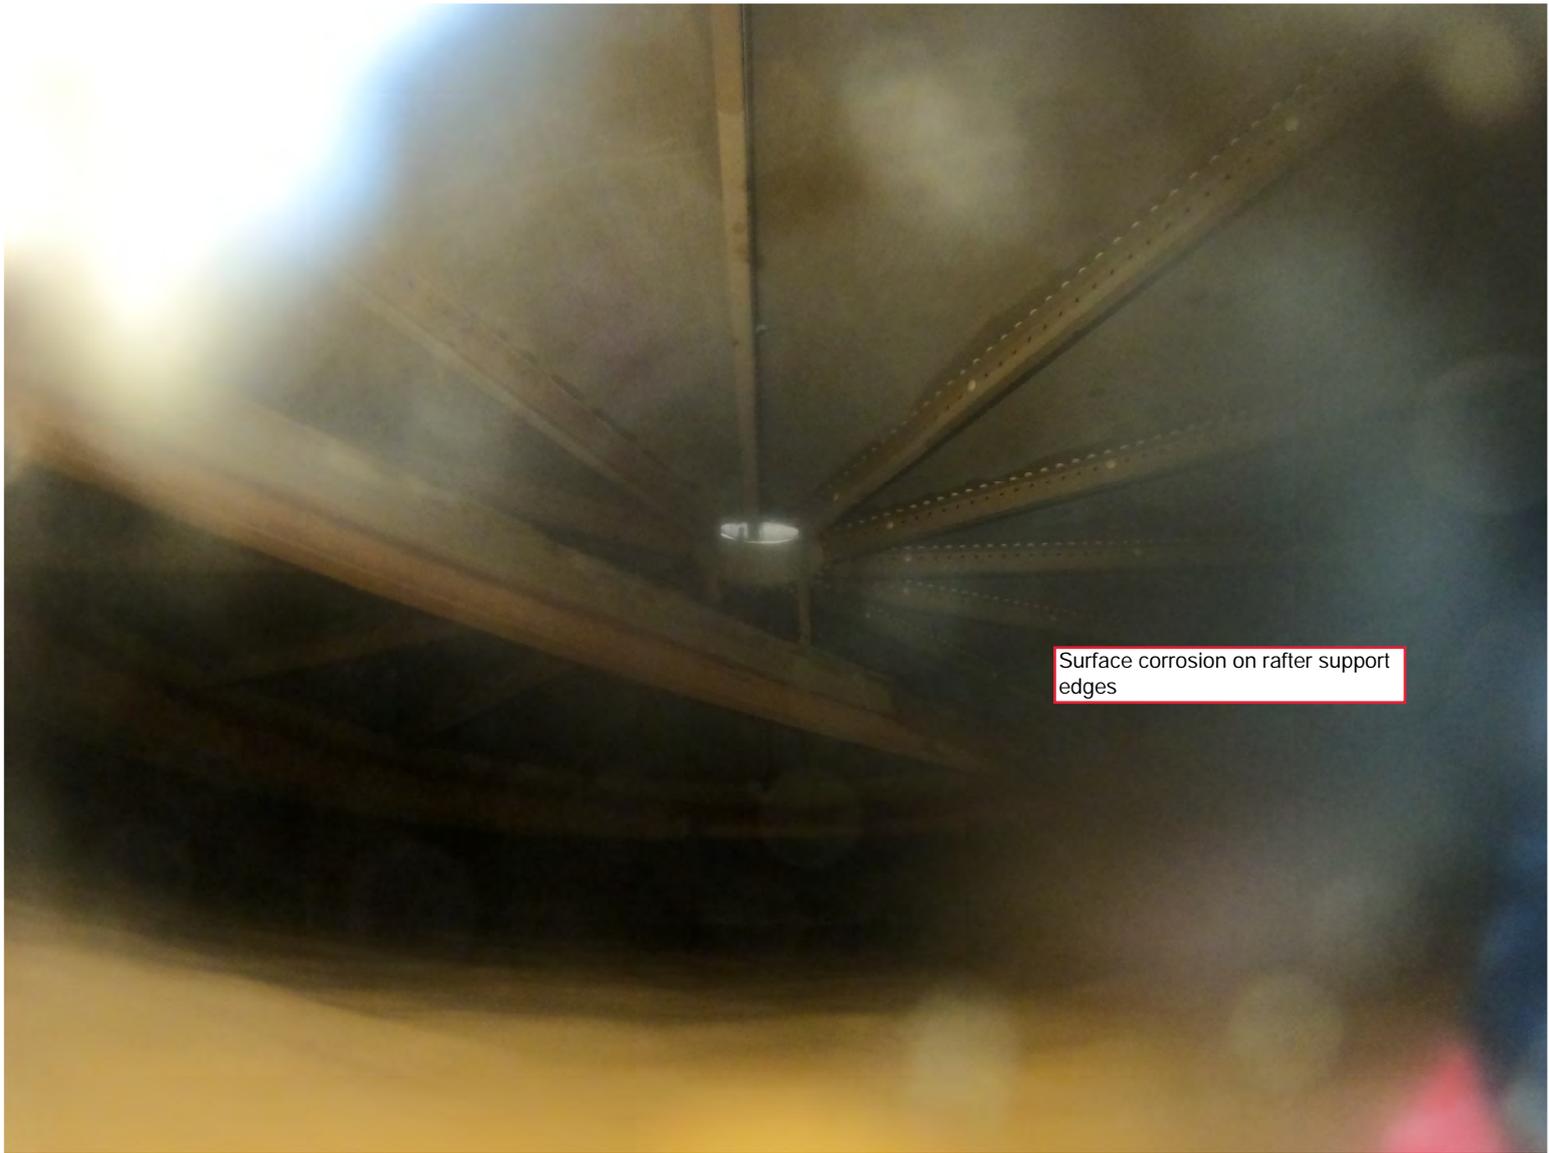
Surface corrosion on rafter support edges
