Sewerage System Performance Review

Date	09-05-2023
Customer Name	Ed May
Address	12174 Hodgkins Rd
City	Other
City	Lake Errock
Phone Number	(604) 621-5200
Email Address	Klammer9500@shaw.ca

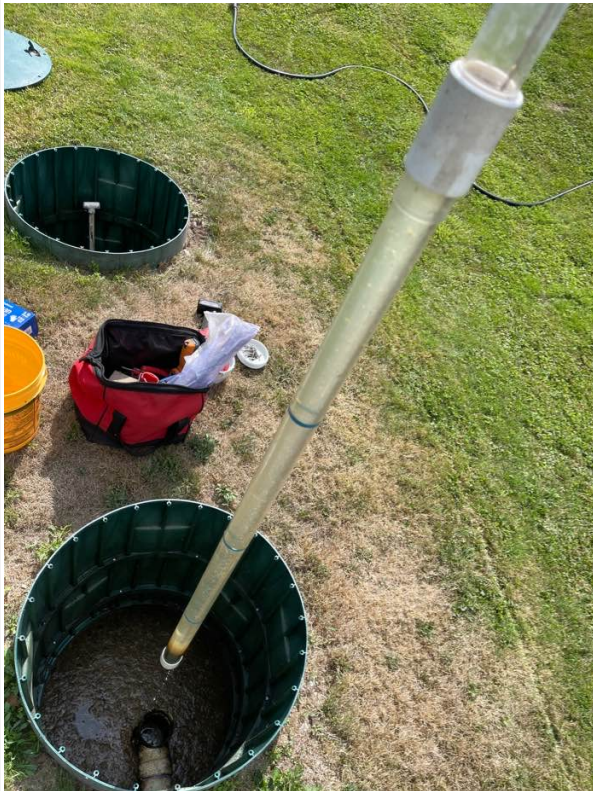
<p>Sludge judge of septic tank inlet.</p>
Effluent Surface Temperature in Septic Tank (F)	74
Pump out required?	1 - No pump out required

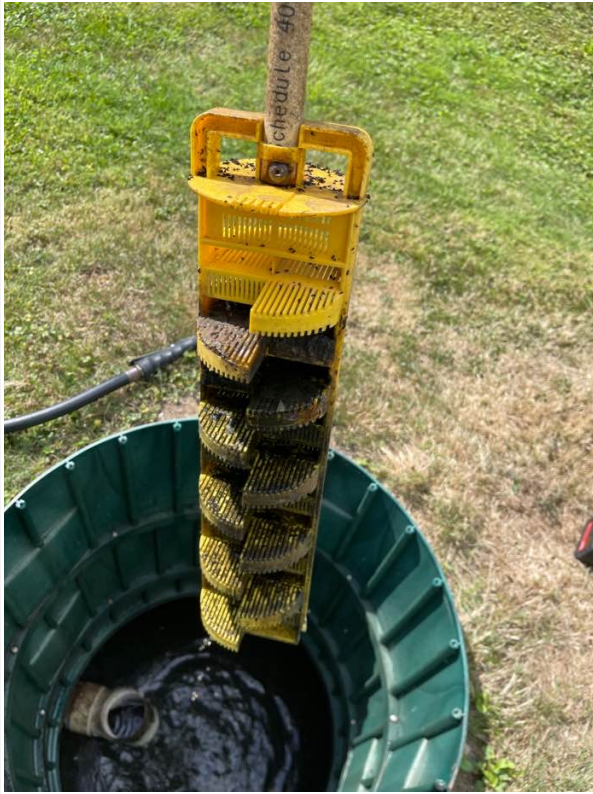
<p>Effluent filter prior to cleaning.</p>

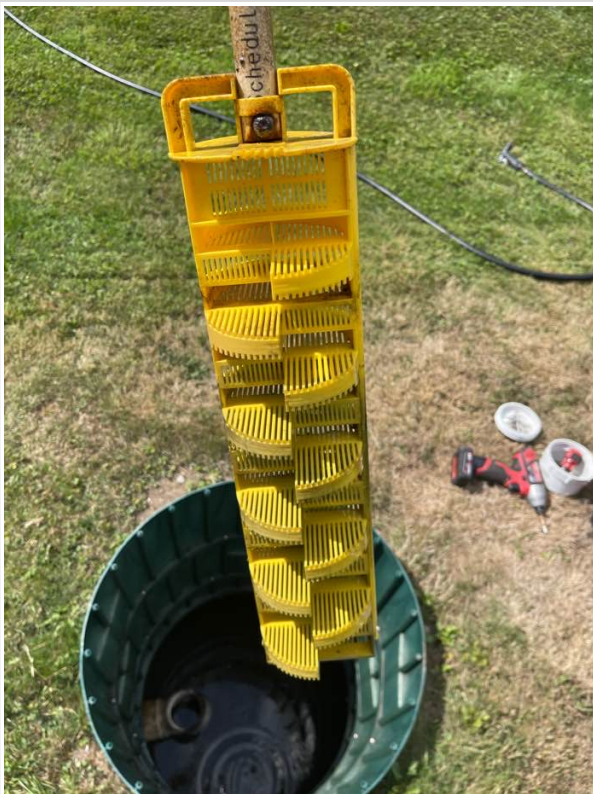
<p>Effluent filter after cleaning.</p>

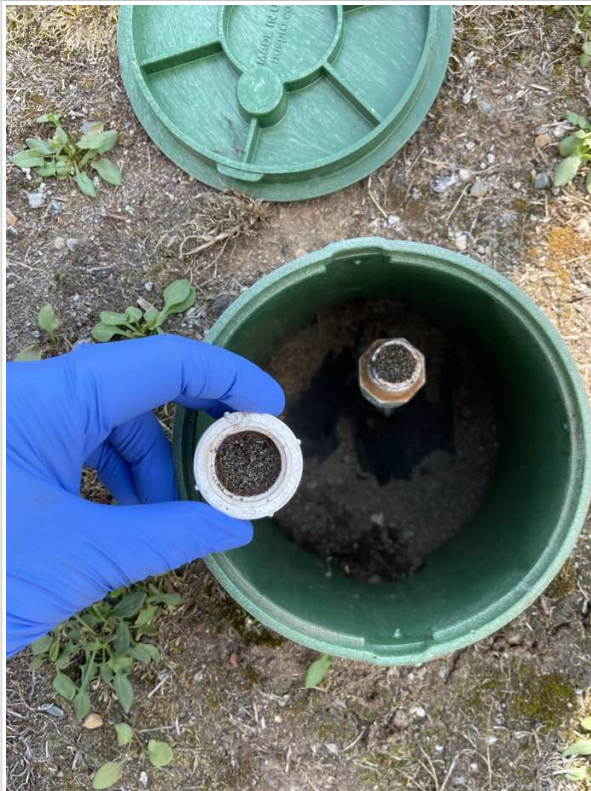
Lateral appears to have a slight sand blockage.

SUMMARY OF SYSTEM PERFORMANCE & RECOMMENDATIONS	<ul style="list-style-type: none">- A second lateral appears to have sand infiltration; this lateral was flushed successfully. It is likely that the sand infiltration is due to incorrect orifice shields used for the pipe size of 3/4". The orifice shields used are designed to fit 1" and larger pipe and will be loose and can shift off of the orifices on 3/4" pipe.- Repaired & flushed exposed lateral at this time, installed missing orifice shield under the bottom hole as required. <p>Tanks do not require pump out at this time. Please let us know if you have any questions or concerns.</p>
NEXT REVIEW DUE:	September 2024

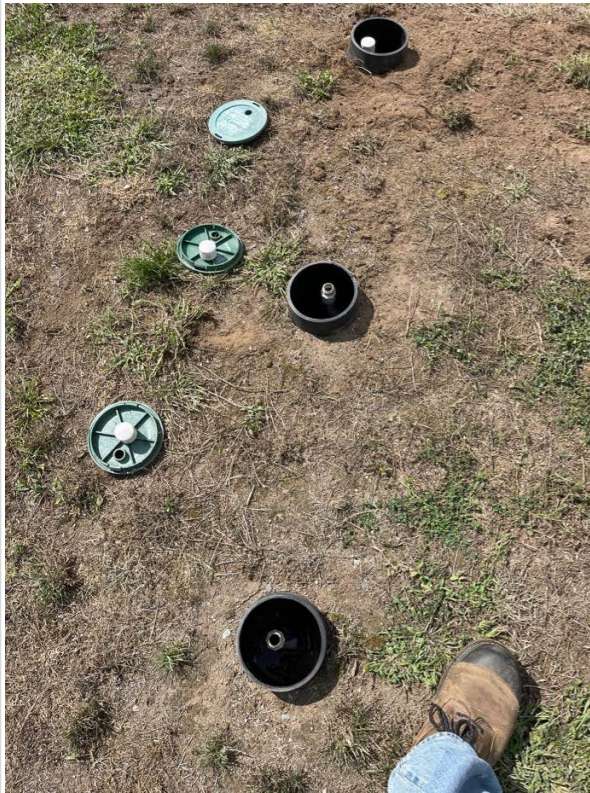
Laterals flushing.

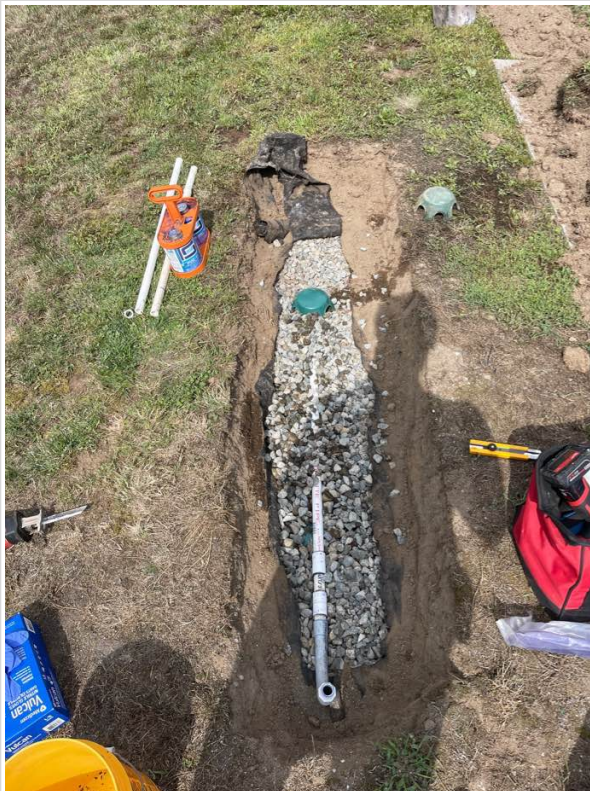
Bottom facing orifice appears to have a missing orifice shield.
Orifice shield has been placed.

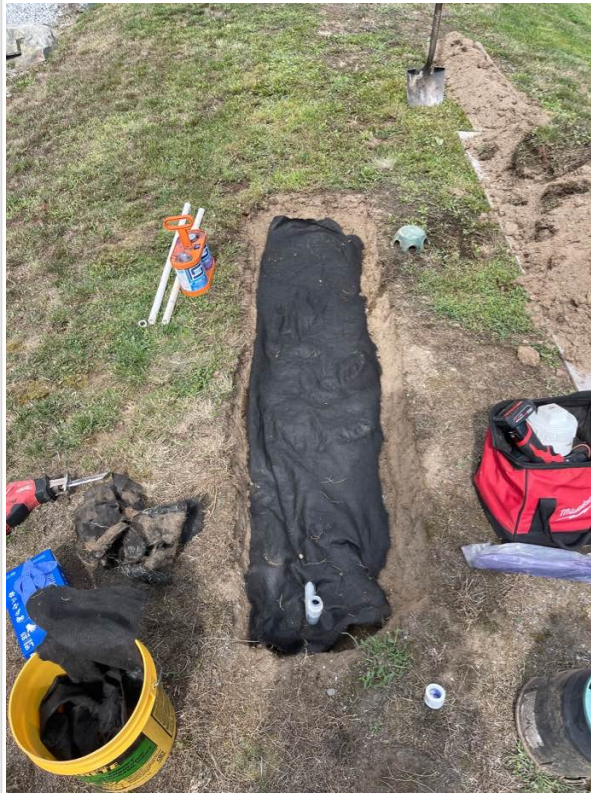
Lateral after filter cloth has been placed.

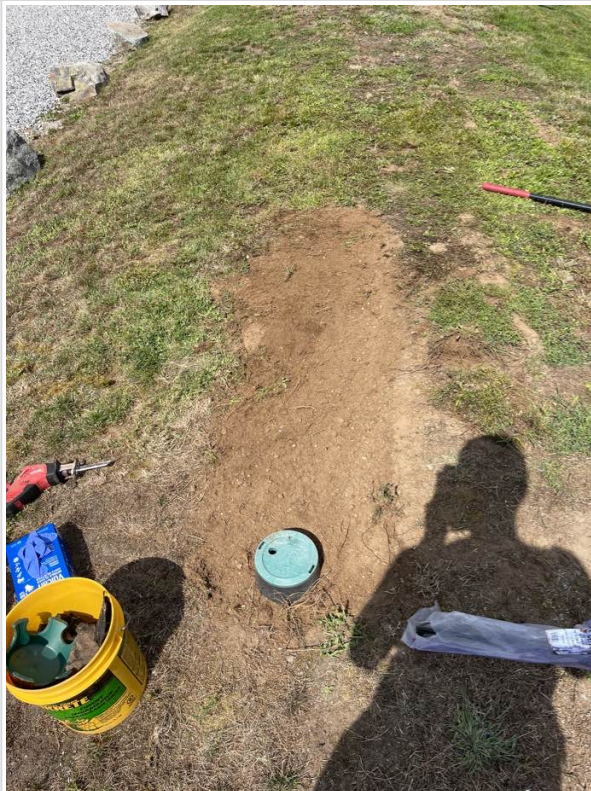
Lateral after backfill.
