# **RV Inspection Report**

2020 Gulf Stream Conquest 6238

WE RV SERVICES, LLC David Patty 256-605-0706 david@wervservices.com

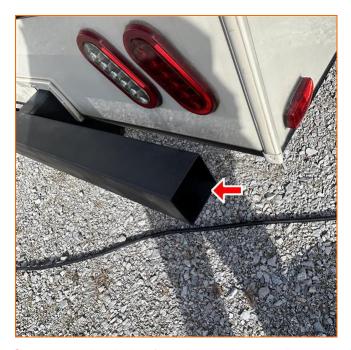
## **Rear Bumper Condition**

One end cap is missing from the rear bumper. Recommend replacement.

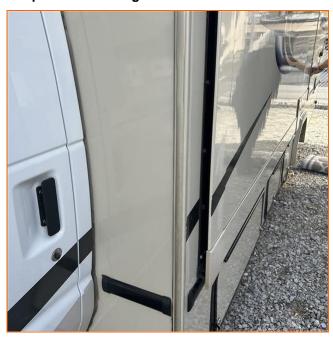
# **Slideout Operation and Alignment**

The bottom of the slideout is not pulled in tight. Recommend evaluation by a qualified service technician to determine whether it needs adjusted.

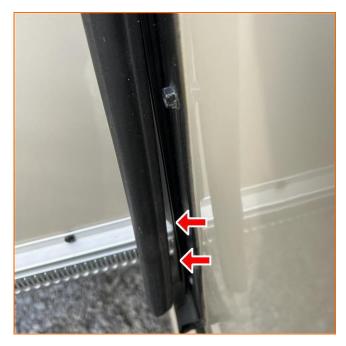
# **Slideout T-Molding Trim**

A portion of the bulb seal is detached. Recommend repair.

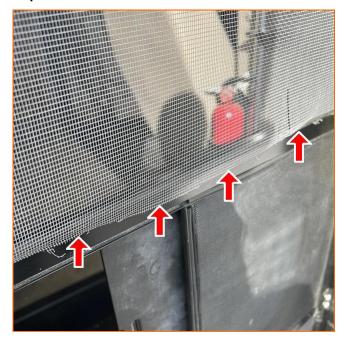
# **Screen Operation and Condition**

A one-foot section of the screen is detached. Recommend reattaching the screen.

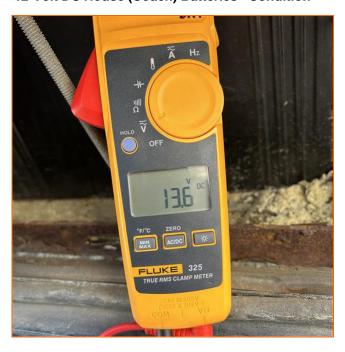
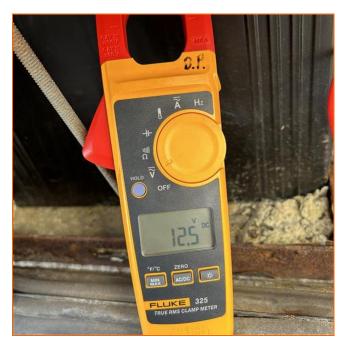
#### 12-Volt DC House (Coach) Batteries - Condition

Battery voltage was 13.6 while plugged into shore power, and was 12.5 when unplugged from shore power. There should a voltage drop when unplugged from shore power and the converter kicks in. However, a drop of this amount indicates the battery may be weakening. Recommend evaluation of the battery.

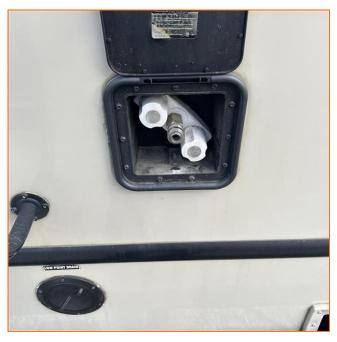
# **Outside Shower - Condition and Operation**

The outside shower hose is missing.

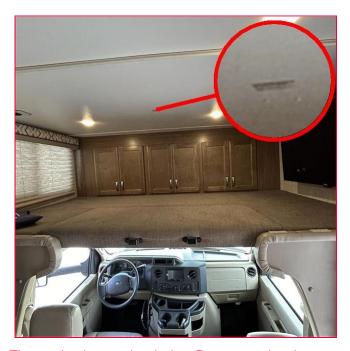
#### **Smoke Detector**

The smoke detector is missing. Recommend replacement before the RV is occupied.

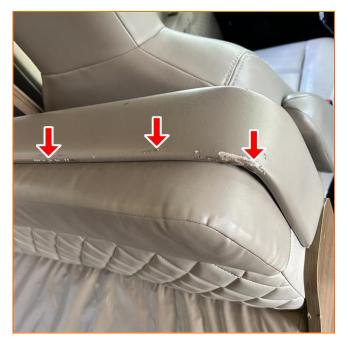
## **Dinette - Booth Seats / Chairs**

Some blemishes were observed on the dinette booth seat.

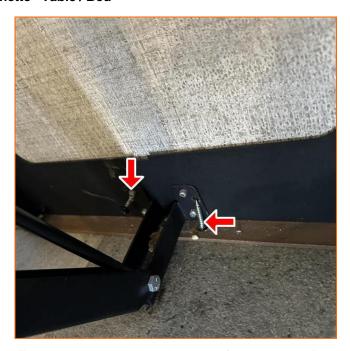
## Dinette - Table / Bed

Two screws are loose at the base of the table leg. Recommend tightening screws.

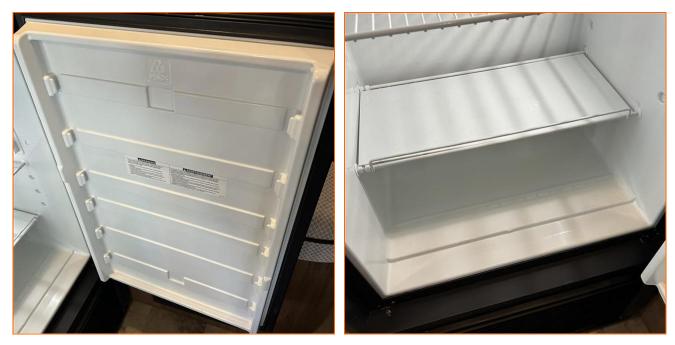
The drawer and door bins are missing from the refrigerator.

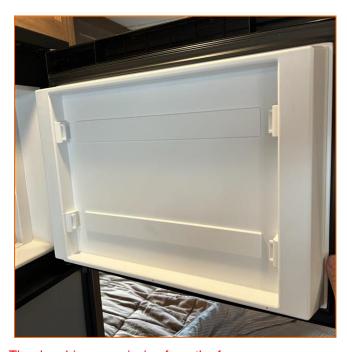
${\bf Freezer \hbox{-} Shelves, Racks, Trays, Drawers \hbox{-} Poor}$

The door bins are missing from the freezer.

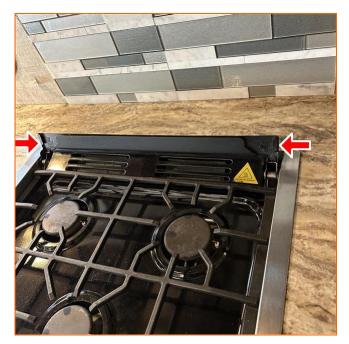
# **Cooktop - Burner Grate/Cover Condition**

The cooktop cover is missing. Recommend replacement.

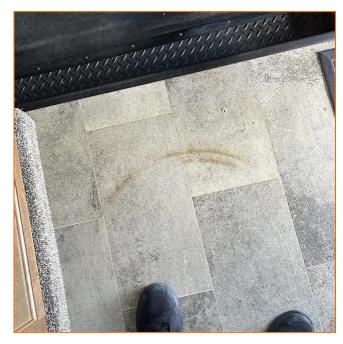
# Flooring

There is a stained spot on the kitchen floor. Recommend cleaning.

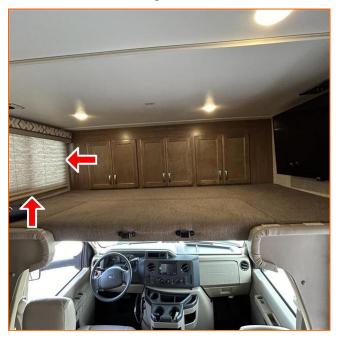
## **Window Blinds/Coverings**

The blind in the loft area will not raise. Recommend repair.

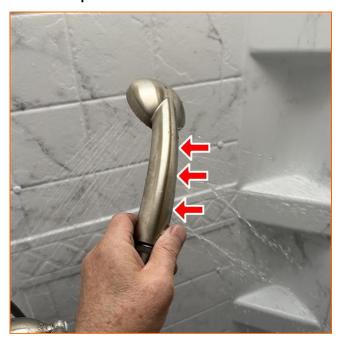
# Shower / Tub - Operation and Condition

The shower head handle is cracked and spraying water. Recommend replacement.

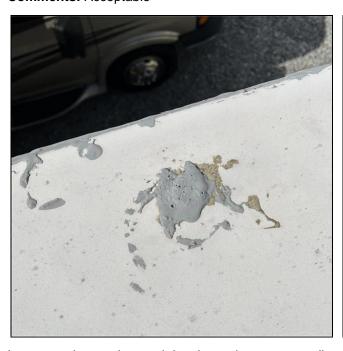
# 2.0 General Roof Condition Comments: Acceptable

Inspector observed a repair has been done on a small portion of the roof. It appears the repair is acceptable to prevent any water intrusion.

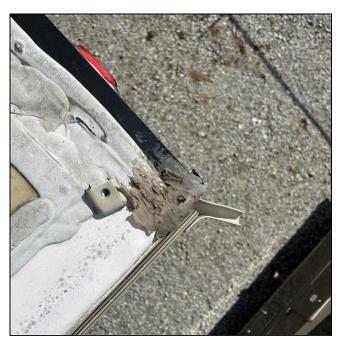
2.3 Rear Cap, Joints and Seals

Both rear cap corners have been repaired, but the wrong kind of sealant was used. Recommend evaluation by a qualified service technician.

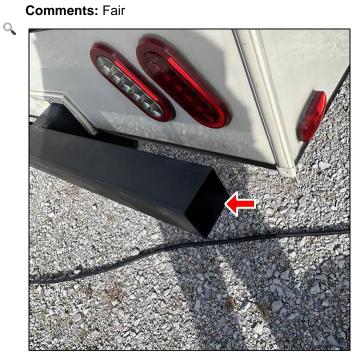
5.3 Rear Bumper Condition

One end cap is missing from the rear bumper. Recommend replacement.

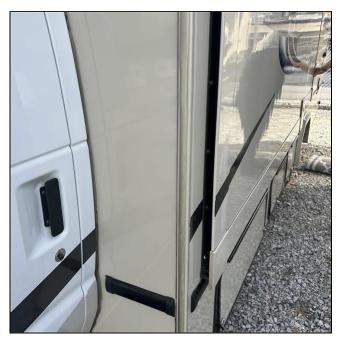
The bottom of the slideout is not pulled in tight. Recommend evaluation by a qualified service technician to determine whether or not it needs adjusted.

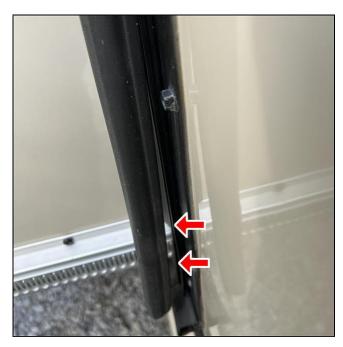
A portion of the bulb seal is detached. Recommend attaching.

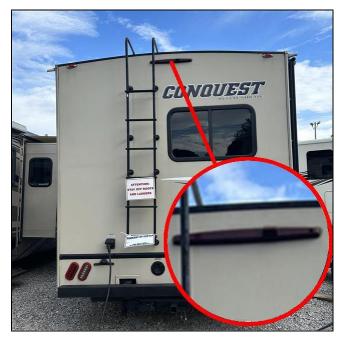
11.7 Brake Lights
Comments: Fair

This light does not operate. Recommend repair or replacement.

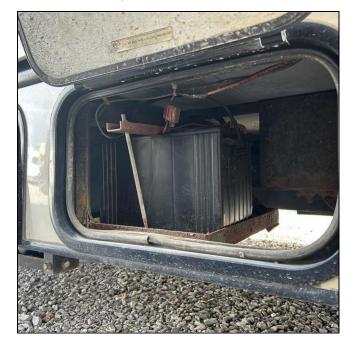
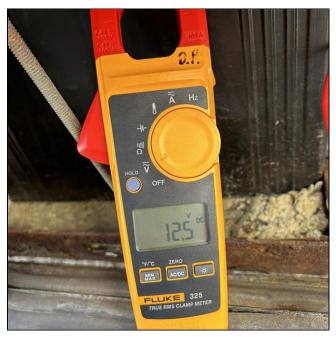
# 12.30 12-Volt DC House (Coach) Batteries - Condition

Battery voltage was 13.6 while plugged into shore power, and was 12.5 when unplugged from shore power. There should a voltage drop when unplugged from shore power and the converter kicks in. However, a drop of this amount indicates the battery may be weakening. Recommend evaluation of the battery.

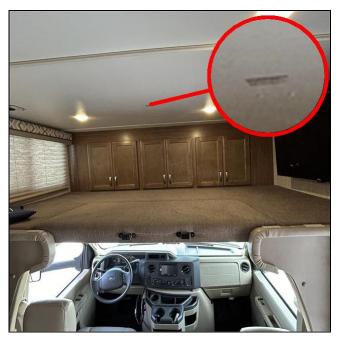
The smoke detector is missing. Recommend replacement before the RV is occupied.

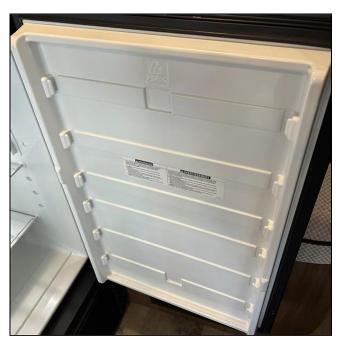
The drawer and door bins are missing from the refrigerator.

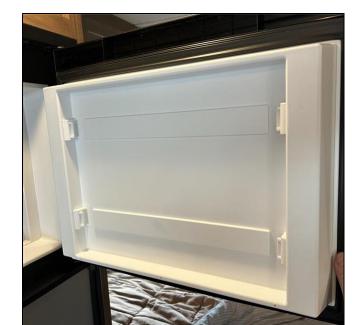
The door bins are missing from the freezer.

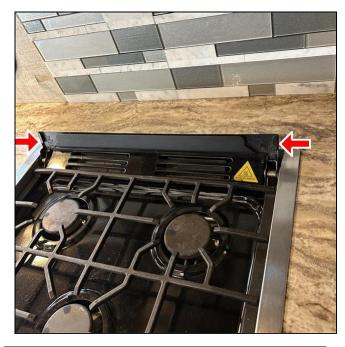
15.13 Cooktop - Burner Grate/Cover Condition

The cooktop cover is missing. Recommend replacement.

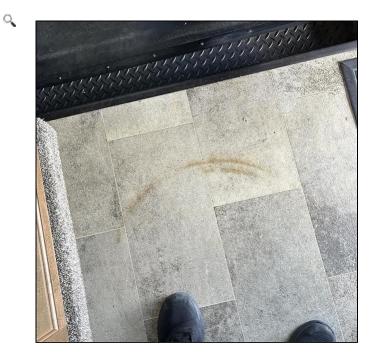
18.9 Flooring

There is a stained spot on the kitchen floor. Recommend cleaning.

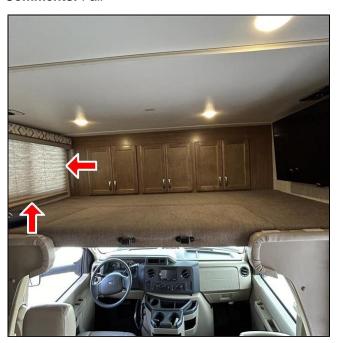
The blind in the loft area will not raise. Recommend repair.

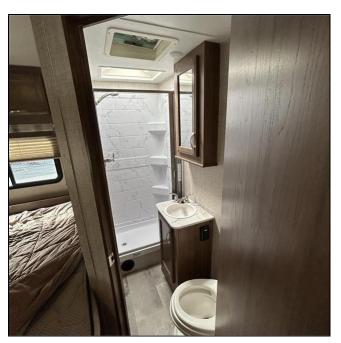
19.6 Shower / Tub - Operation and Condition

The shower head handle is cracked and spraying water. Recommend replacement.
