# **SOUTH FLORIDA WATER MANAGEMENT DISTRICT**

## **Memorandum**

**Subject:** Investigation of Complaints Re: ERP Permit for Sierra Ranch - Project # 24-07

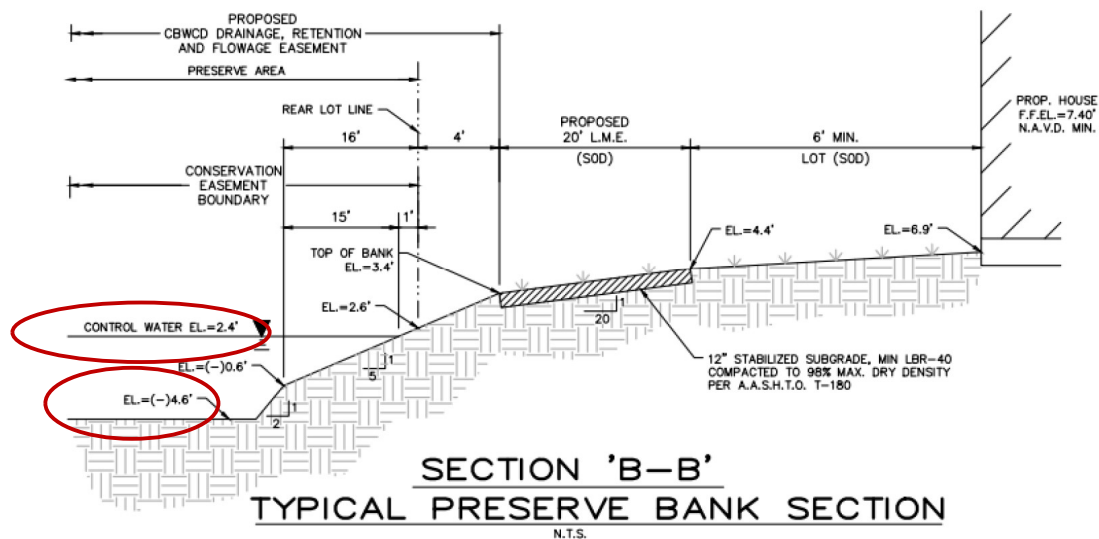
To address the allegation as to whether the design contains conflicting cross-sections regarding the open water channel (with one showing a 7-foot depth and another a 10-foot depth) we compared the indicated elevation shown on the Section B-B Typical Preserve Bank Section (shown below) to the elevations indicated on other typical drawings in the same set of plans. The drawings state that all elevations are shown in **NGVD 1929 DATUM**.

The above cross section shows the bottom of the open-water channel elevation at -4.6 feet and the Control Water Elevation at +2.4 feet. Based to this cross section, the bottom of the open water channel was designed to be 7 feet below the Control Water Elevation. The design documents also contained the following drawing. (The A & B cross-sections are shown on the following page.)

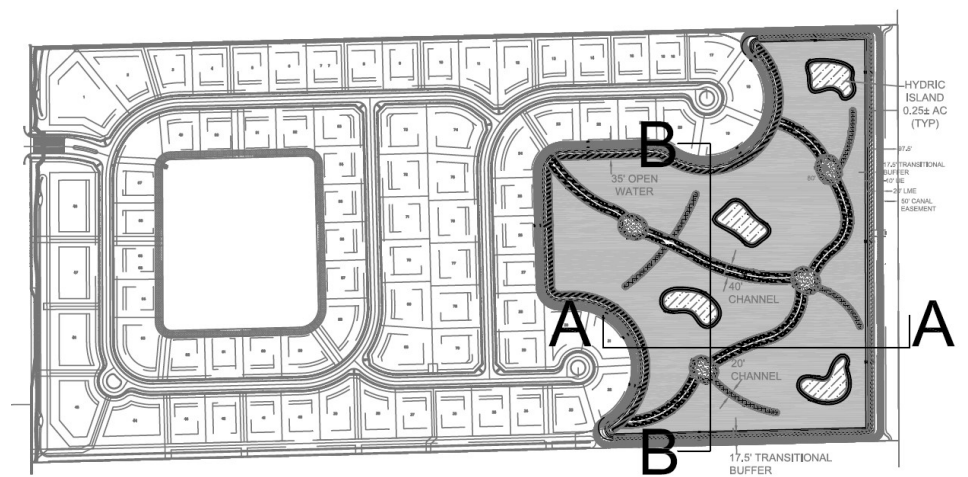
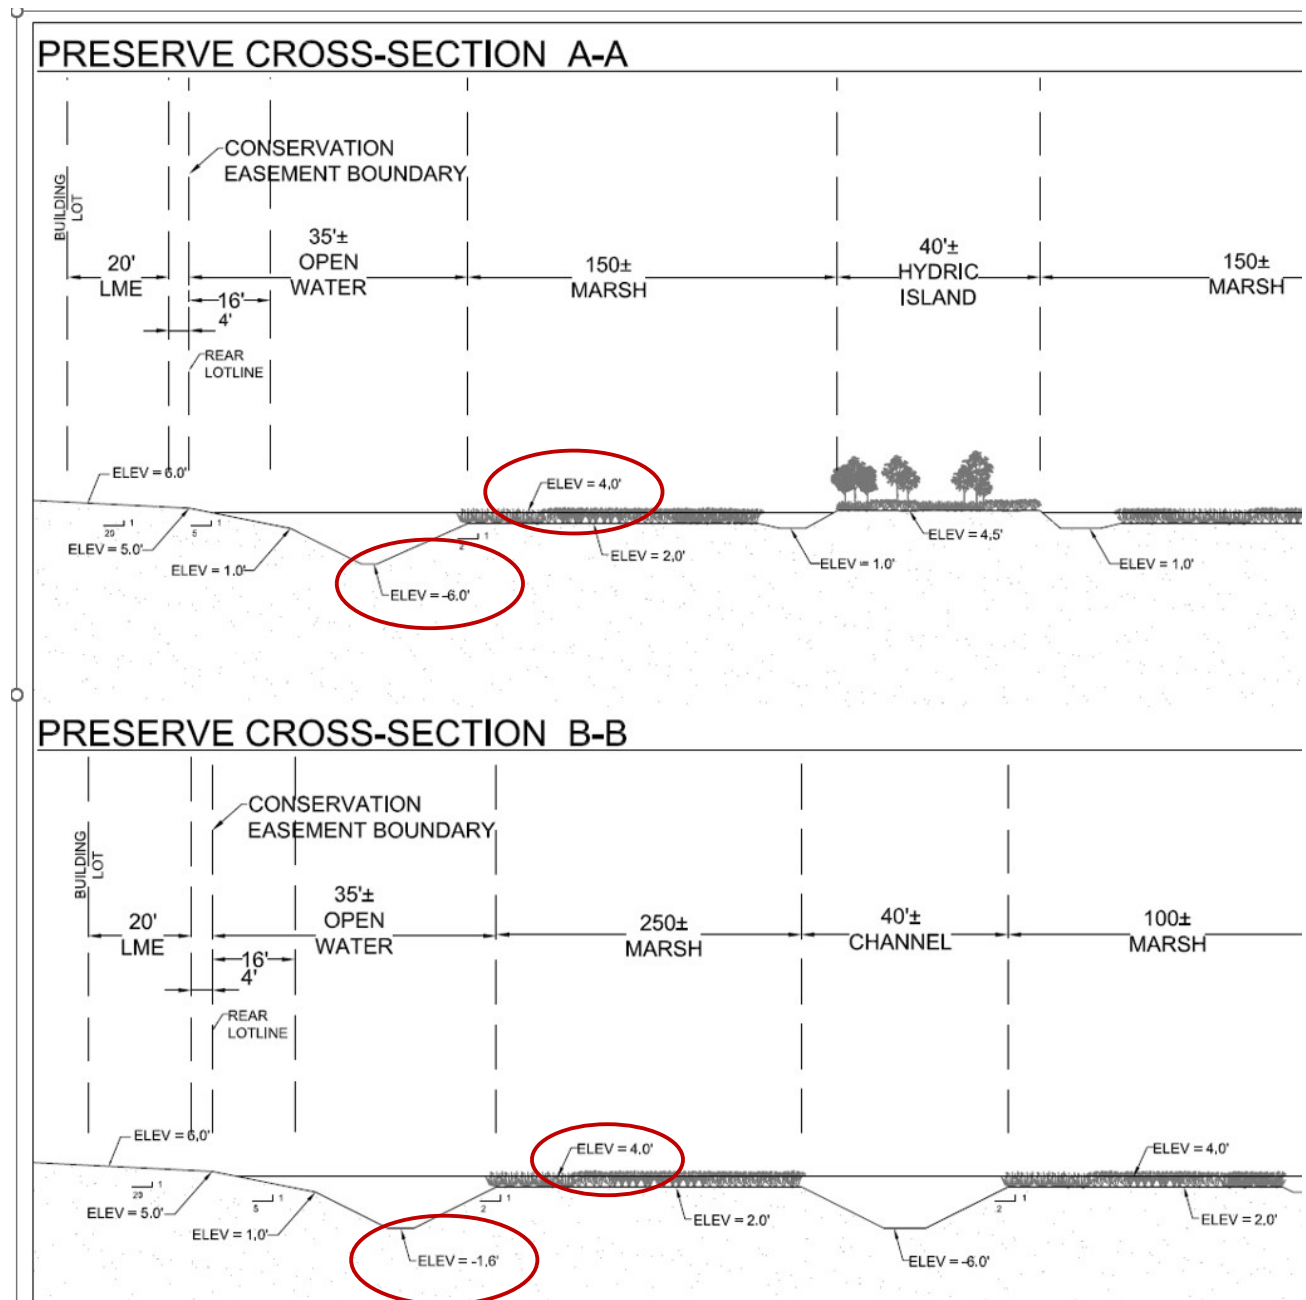
The Preserve Cross-Section A-A above shows the open water channel elevation at -6.0 feet and a line that appears to be the Control Water Elevation at +4.0 feet; thus, indicating a designed water depth of 10 feet. Additionally, the Preserve Cross-Section B-B above shows the open-water channel elevation at -1.6 feet and a line that appears to be the Control Water Elevation at +4.0 feet; thus, indicating a designed water depth of 5.6 feet.

The line presumed to be the Control Water Elevations on both of the “Preserve Cross-Section” on page 8 are not labeled and may represent something else; therefore, we cannot definitively determine whether the differences between the drawings represents discrepancies. The as-built plans show the open-water channel was constructed with a base elevation of -4.6 feet NGVD, which is consistent with the cross section shown on page 7. Considering that the Control Water Elevations are not labeled on the apparent conflicting drawings there is insufficient evidence to prove or disprove this allegation; thus, the allegation is Not Sustained.

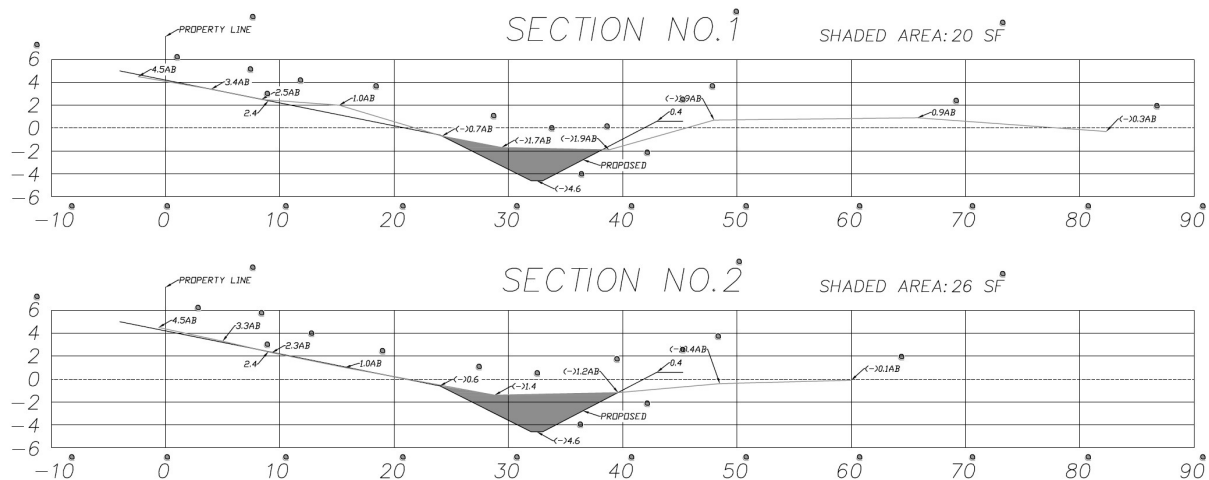
Following is a sample of the 16 cross-sections:

- The width of the open-water channel in certain locations was less than 20 feet, compared to the design width of 35 feet.
- The survey results revealed that little to no channel currently exists compared to the original approved plans and the as-builts provided by the developer.
- The bottom of the proposed channel was found to be filled in.
- Wetland plants were observed propagating within the open-water channel when little to no wetland plants should exist due to the prescribed depths of this area (7' or 10').
- The estimated amount of excavation to bring the open-water channel back to conformity of the plans, utilizing the 7' depth, was ~41,000 Cubic Feet of material; and about three times that amount utilizing the 10' depth.

Using the cross section details in the Consultant's report, we calculated that the average open-water channel depth of the elevations at the lowest points of the 16 cross section surveyed. The result showed the actual average depth is 2.1 NAVG, for a total depth of 4.5 feet, or 2.5 feet less than the 7-foot depth shown in the as-built surveys.

The Consultant's drawings shows that the open-water channel depth is shallower than the depth shown in the as-built survey that was submitted to the CBWCD with a sign-off date of 8/9/2023. The Consultant's report states that their field survey took place on September 22<sup>nd</sup> and 25<sup>th</sup>, 2023, only 44 to 47 days later. However, the as-built survey states that "this drawing reflects our findings per a field survey performed on 12/01/2021", approximately 20 months prior to the sign-off date. It should be noted that, although both surveys do show very different results, both were performed by license professionals and any conclusions reached by us are limited to comparing the results of the two surveys. We do not represent to have the proficiencies to assess the credibility of one survey over the other; however, we do offer the following observations:
