Inspection Report

Mr. Fuller RV Services

(7) 2009 Tiffin Phaeton 42QBH Floorplan

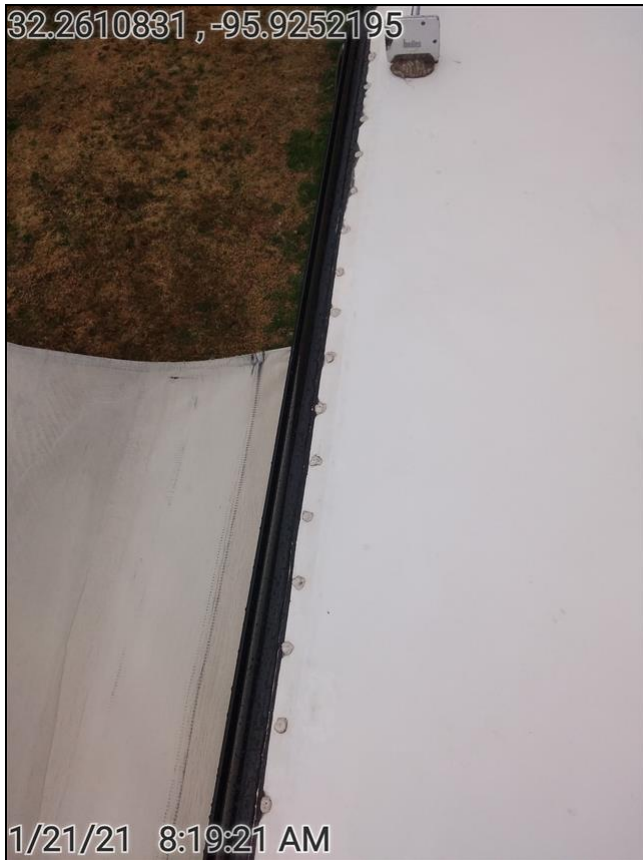
Trim rail Streetside

The inspector observed that the awning slide topper on the streetside large slide sags.

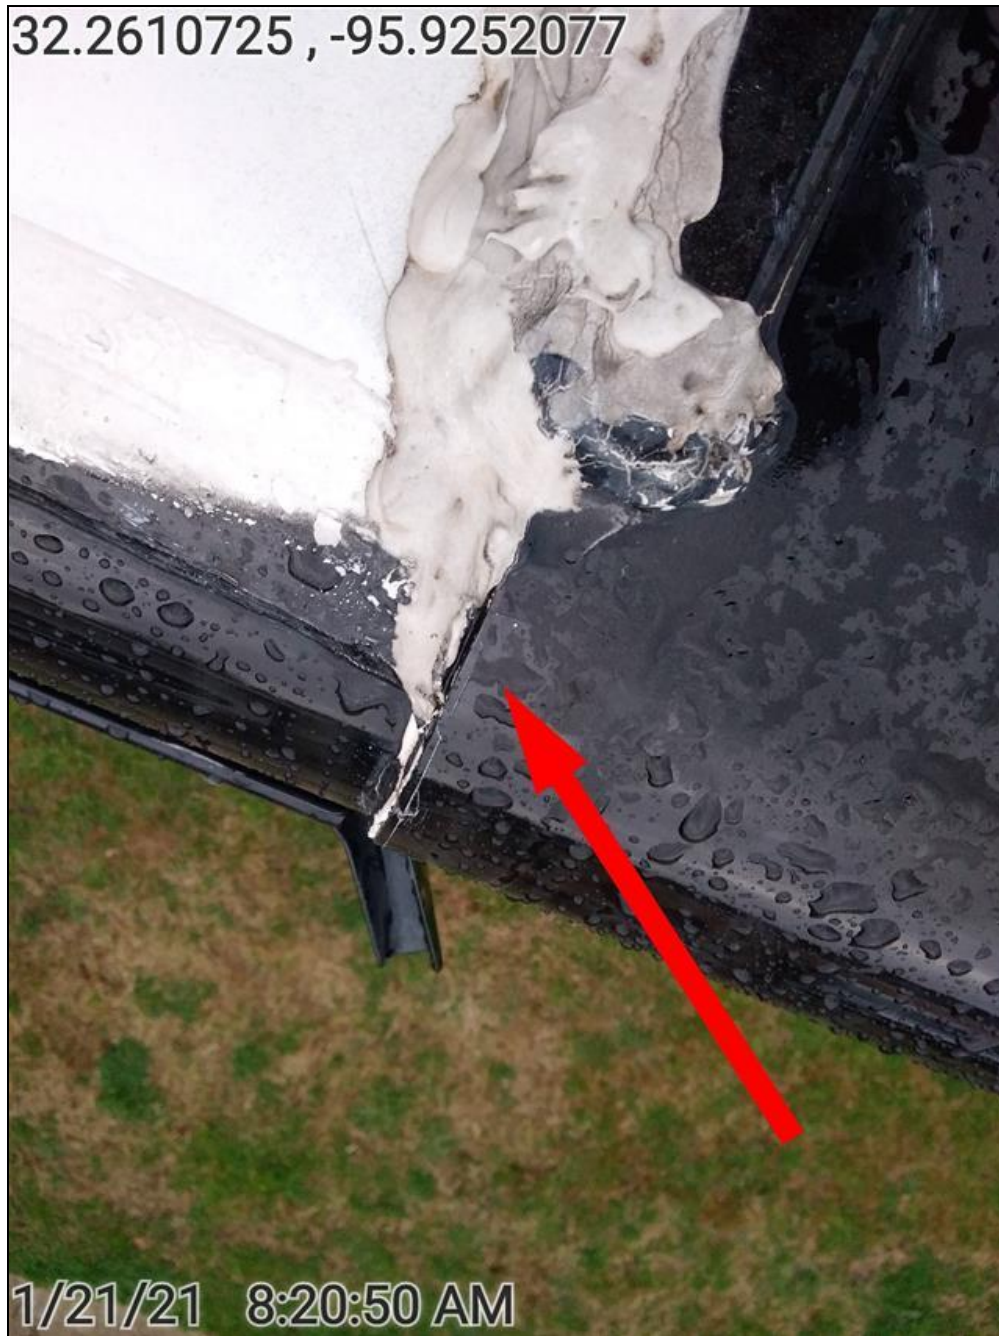
Streetside rear cap meets roof

The inspector observed that a sealant crack exists where the rear cap meets the roof on the streetside. It is recommended that a qualified RV repair technician repair the sealant to prevent possible future water intrusion.

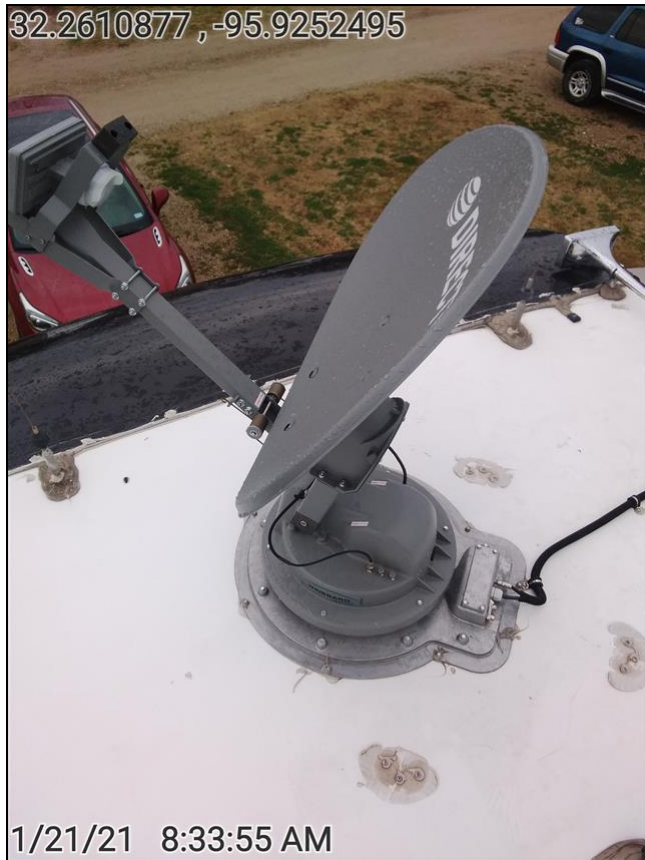
Satellite Antenna

The inspector observed that the King Dome satellite dish was removed. The location where the King Dome was removed have been patched by silicone and are sealed to the weather.

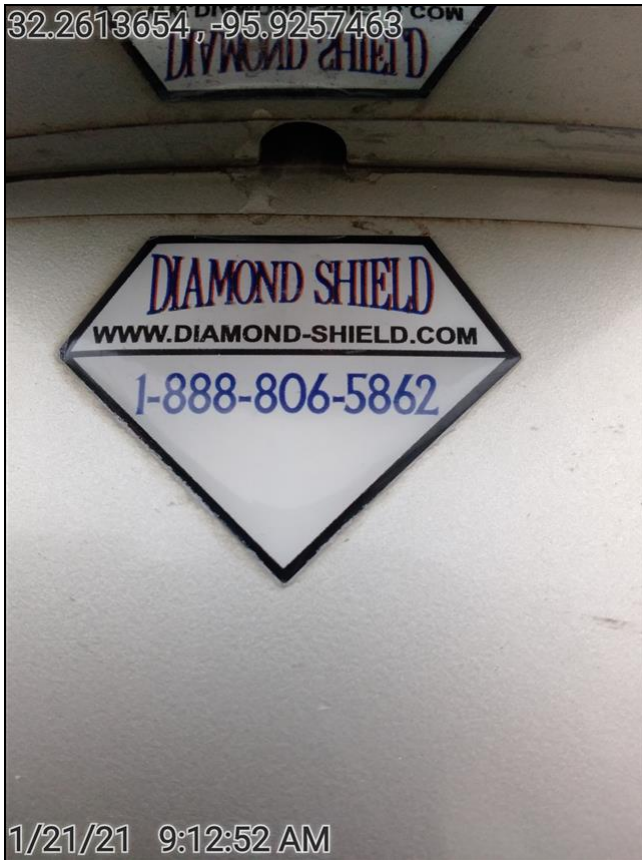
Diamond Shield information

The front cap is protected by a plastic coating. The inspector observed that the edges of the plastic coating show signs of deterioration. It is recommended that the plastic coating be replaced/renewed by a qualified technician.

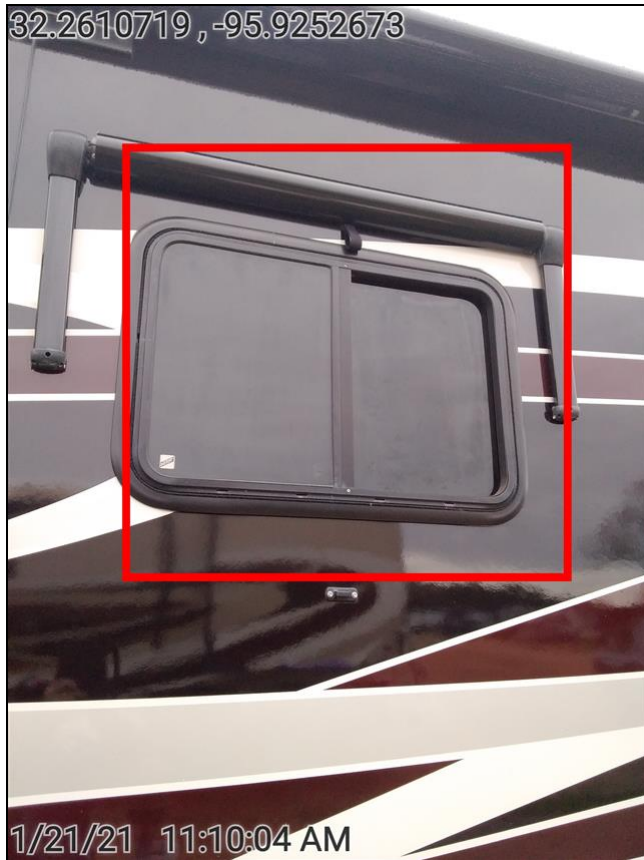
Bedroom streetside window

(1) The inspector observed that the window in the bedroom has lost it's seal. It is recommended that the glass be replaced by a qualified RV technician.

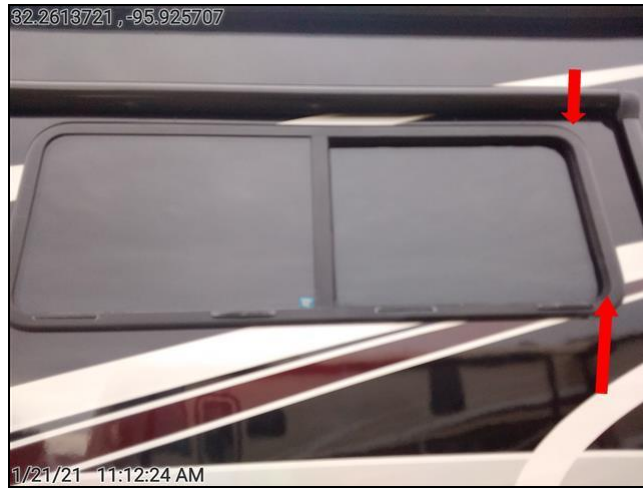
Dining are window

(2) Edges of the window trim in the streetside dining area window are showing a small gap that could allow water penetration in the future. It is recommended that the window trim be repaired.

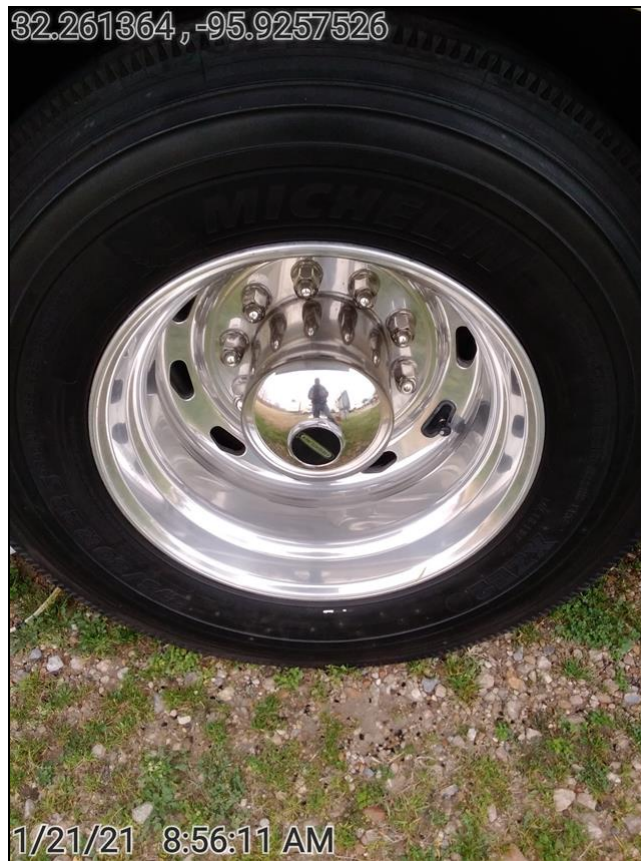
Curbside Drive

NOTE: The National Transportation Safety Board (NTSB) and some tire manufacturers are recommending that all tires older than six years should be replaced, regardless of their condition.

The inspector recommends that the tire be replaced as the DOT code 0313 indicates that the tire is eight years old and past the recommended NTSB replacement interval of 6 years.

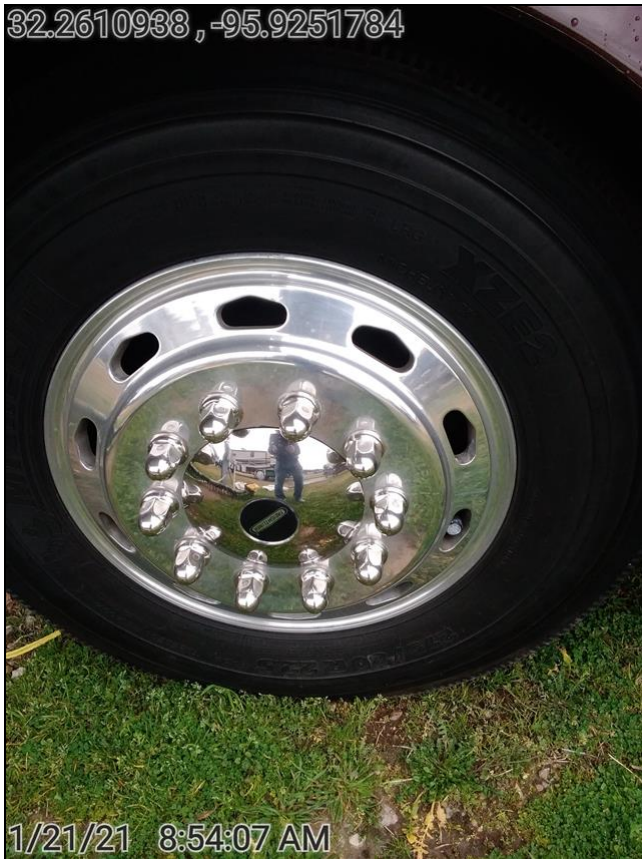
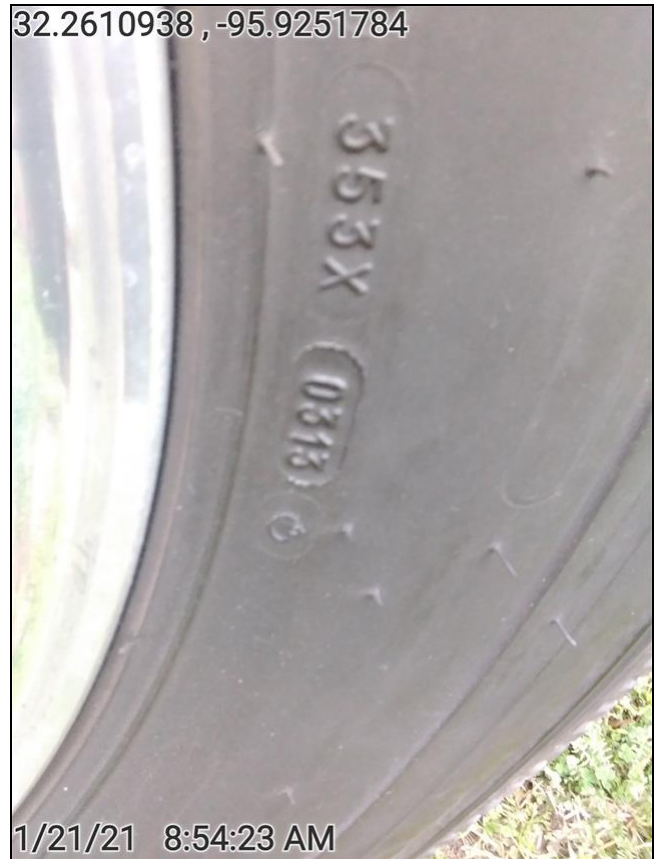
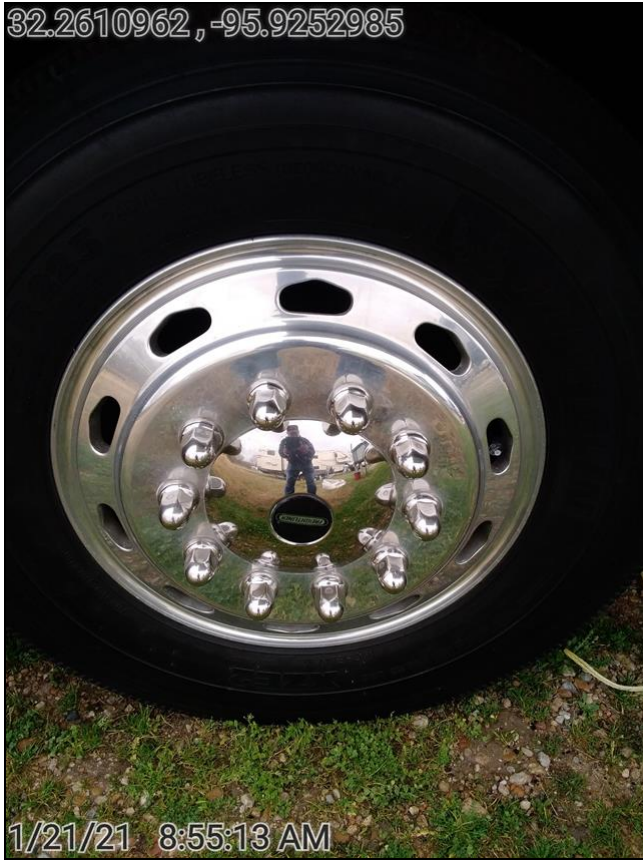
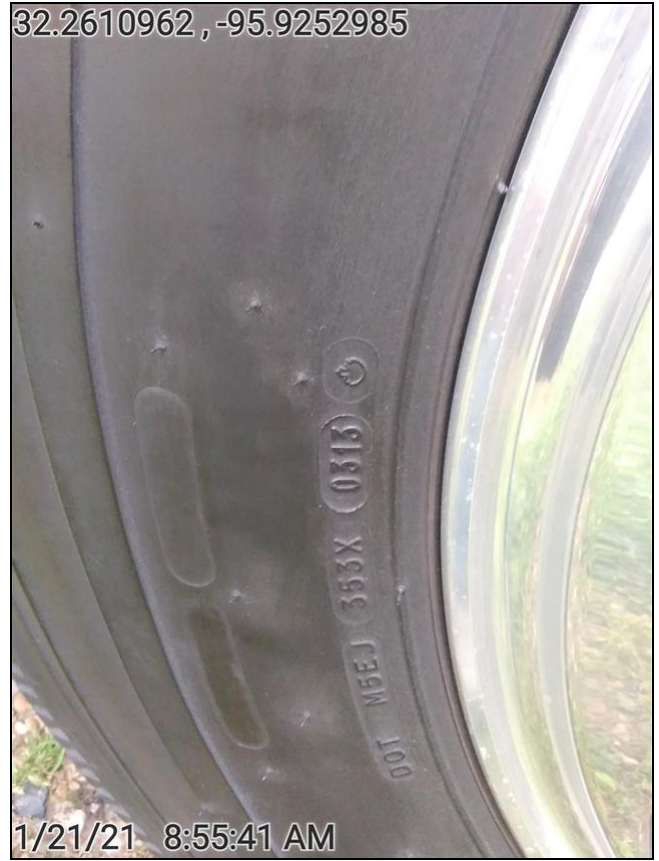
The inspector recommends that the tire be replaced as the DOT code 0313 indicates that the tire is eight years old and past the recommended NTSB replacement interval of 6 years.

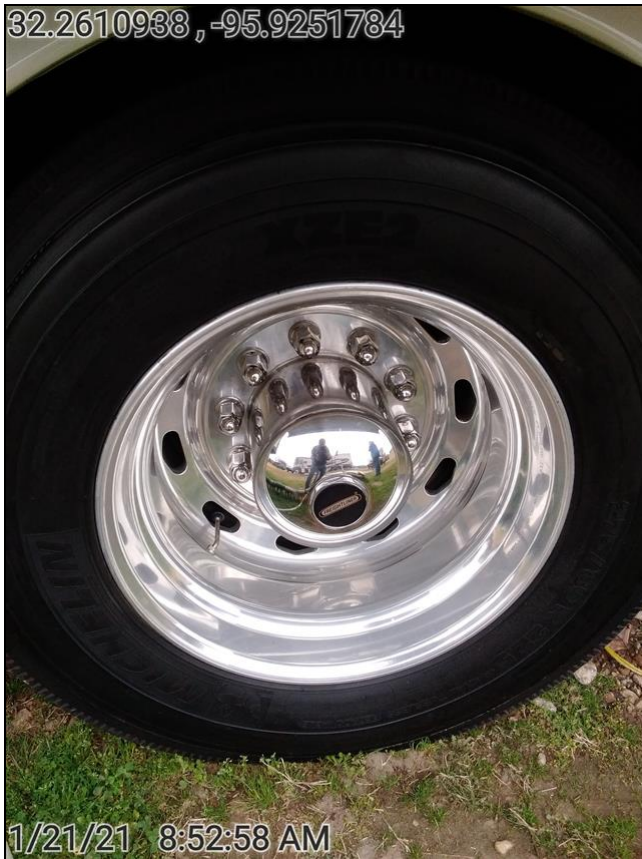
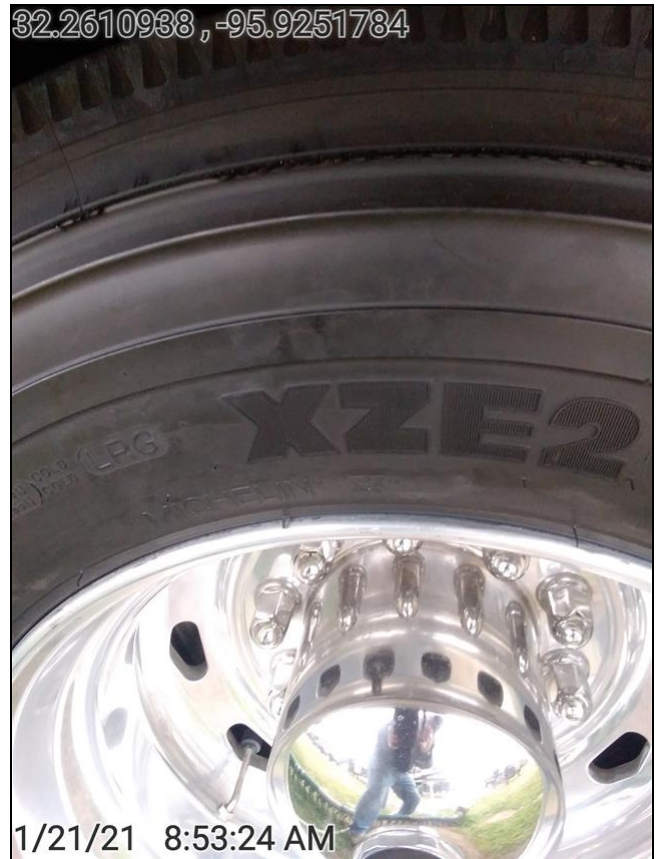
Streetside drive

The inspector recommends that the tire be replaced as the DOT code 0313 indicates that the tire is eight years old and past the recommended NTSB replacement interval of 6 years.

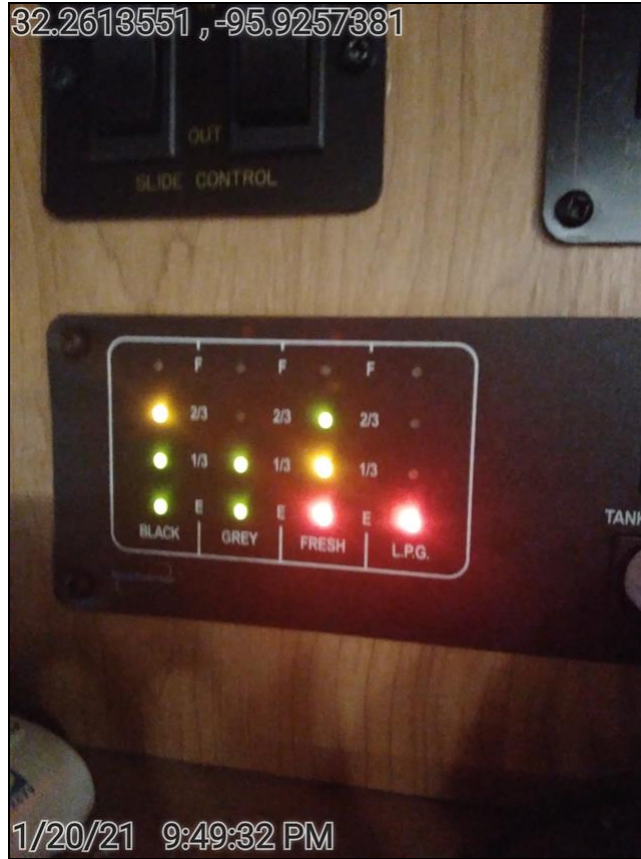
Tank Monitors

The inspector observed that the gray black and propane tank monitors have level indicator lights but they do not accurately reflect the actual contents of the tanks they monitor. It is recommended that the tanks be cleaned and flushed by a qualified RV technician.

The freshwater tank monitor does reflect the water level in the freshwater tank.

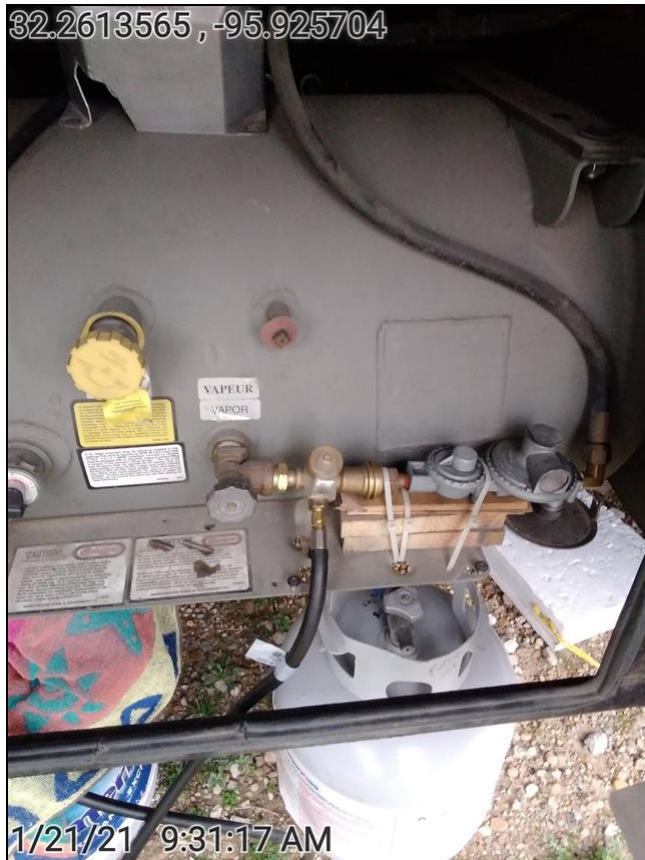
Propane tank

Inspector noted that the propane regulator was mounted horizontally and needs to be tilted to down 45 degrees. It is recommended that the regulator mounting system be repaired by a qualified RV technician.

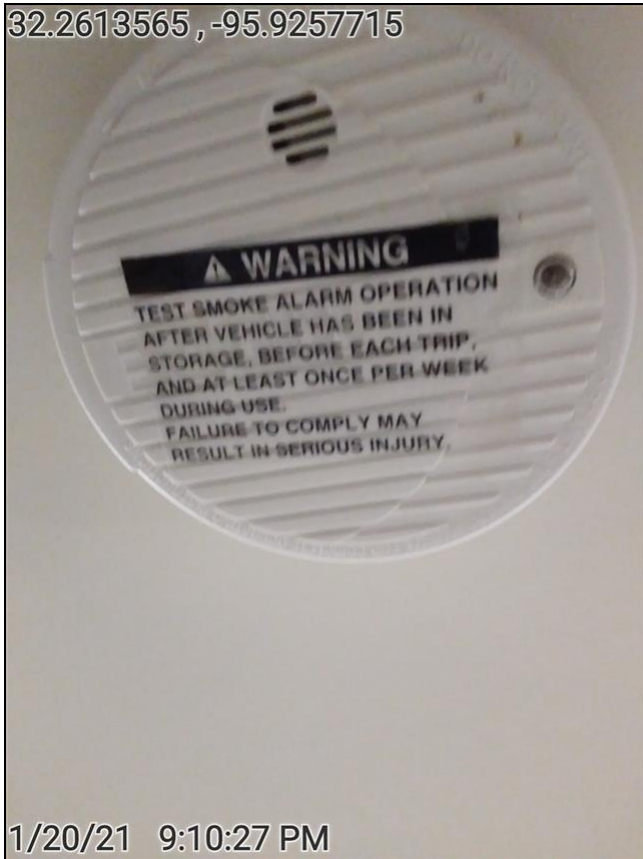
Smoke Detector

The smoke detector born on date is indicated to be March 14th 2008 and is past the recommended replacement interval. It is strongly recommended that the smoke detector be replaced before the RV is occupied.

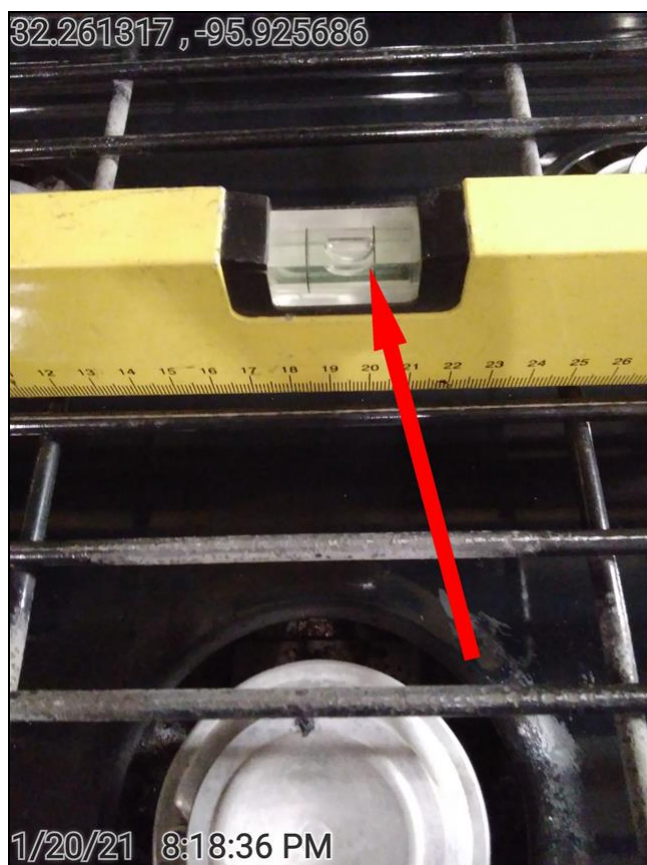
The inspector noted that the stove top is out of level in two directions. This is consistent with owner comments. It is recommended that the stove top installation be repaired by a qualified RV technician.

Stove top high on the rear most direction.

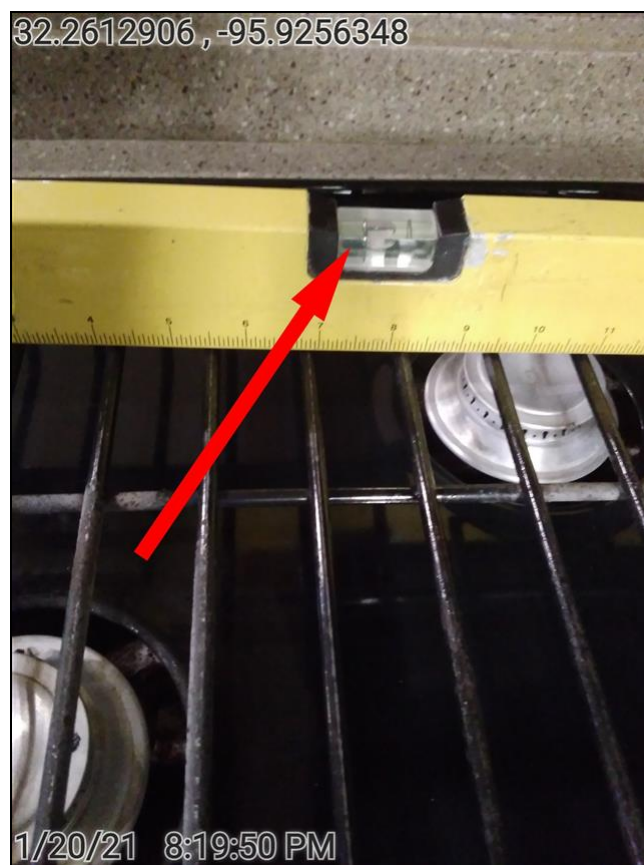
Stovetop out of level and high on drivers side.

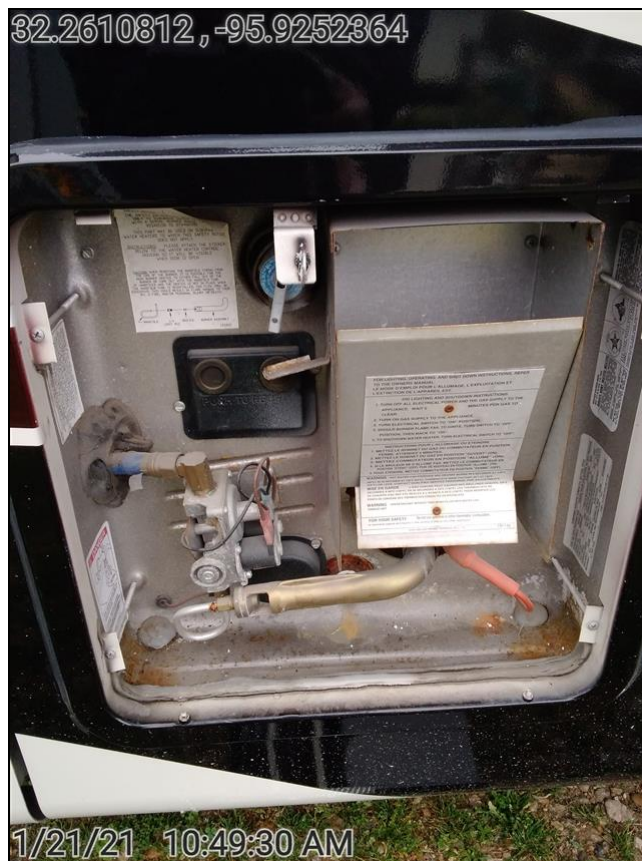
Water heater

Inspector notice some surface stress in the lower left and right corners of the water heater Bay
