FIELD RECONNAISSANCE REPORT – MAY 30, 2023

SAND FLOWER SUBDIVISION

SEMI-ANNUAL FIELD INSPECTION

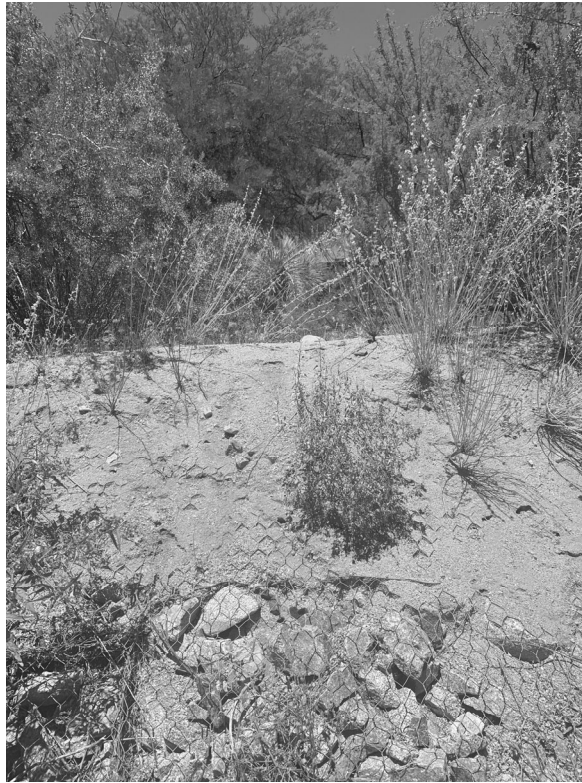
- The riprap embankment along the stagecoach wash, as shown in **fig 3**, looks intact with no concerns at this time.
- The improved wash banks along the Stagecoach downstream face of Windmill Rd looks good and is of no concern. A short distance downstream of that location, a portion of the bank had a small bank failure, as shown in **fig 6**. It is not a concern but will keep an eye on it for the next inspection.

Figure 3: Facing north, intact structure observed.

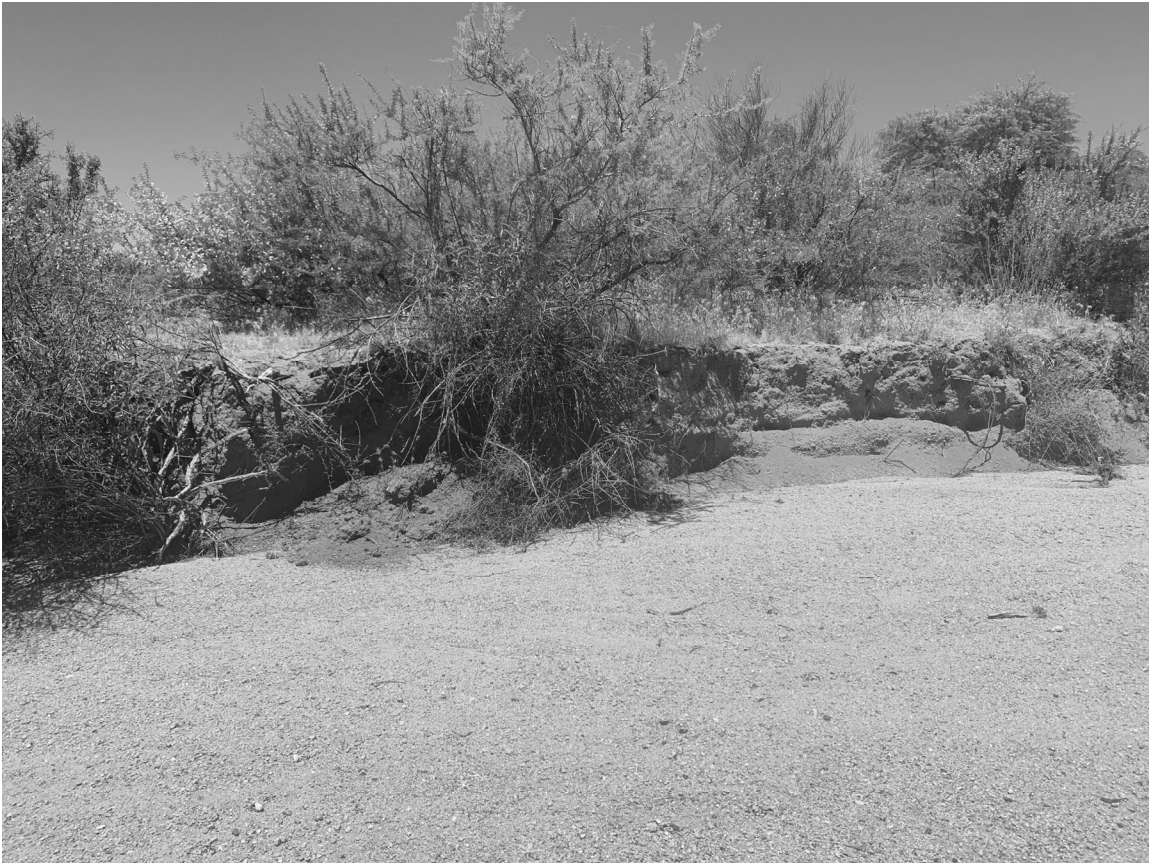
Figure 6: Facing south about 25 feet east of N Windmill Rd

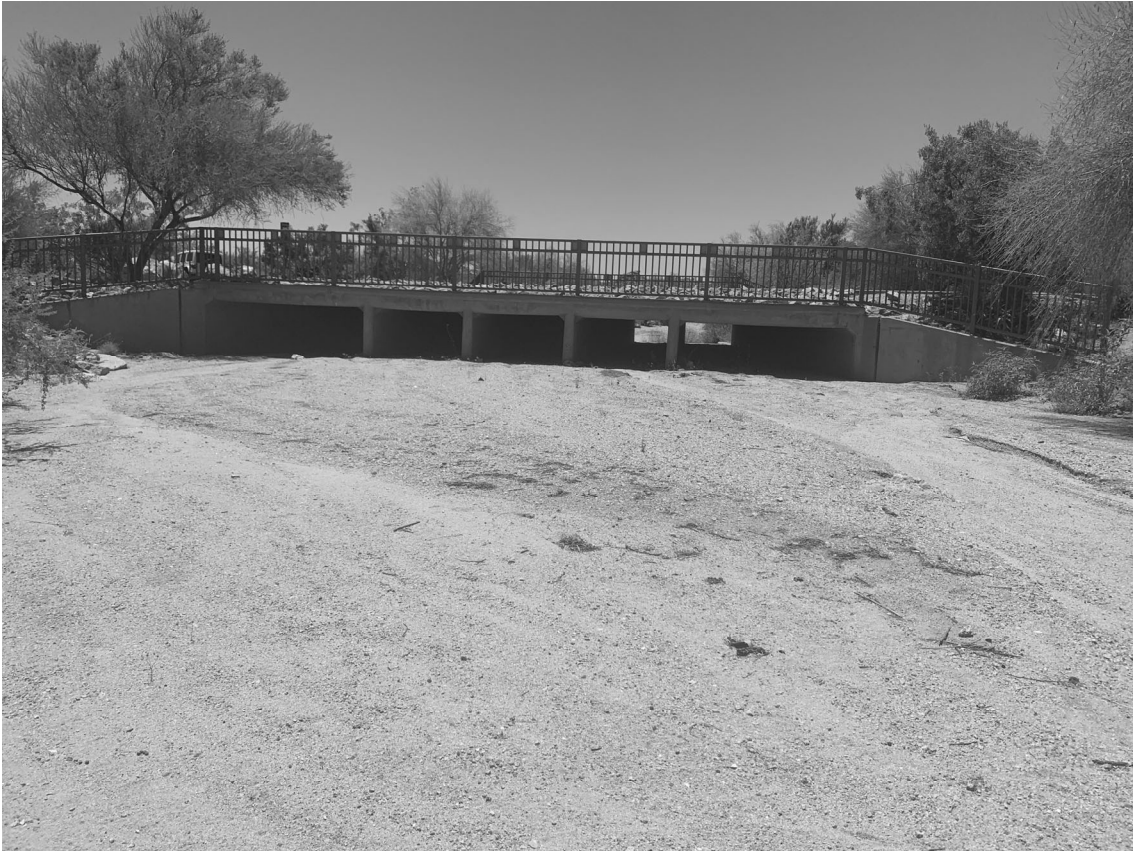
Figure 15: Facing Southwest, 25 ft from 81st St. Waterways are clear of debris and brush.
