IMPORTANT SAFETY WARNING

Pre-July 2019, 11-Speed HOLLOWTECH II Road Cranksets Inspection Notice

Shimano starts inspection and replacement program.

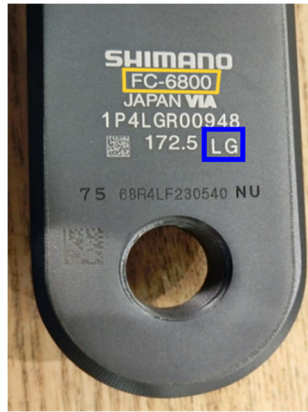
The affected products are DURA-ACE and ULTEGRA branded cranksets with the following model numbers: **ULTEGRA FC-6800, FC-R8000 and DURA-ACE FC-9000, FC-R9100 and FC-R9100-P**. The model numbers are stamped on the inside of the crank arm near the bottom of the arm (see yellow square in the image below).

A manufacturing code is stamped on the inside of the crank arm near the bottom of the arm (see the blue square in the image above). The affected models are pre-July 2019 production and have the following two-letter production codes: KF, KG, KH, KI, KJ, KK, KL, LA, LB, LC, LD, LE, LF, LG, LH, LI, LJ, LK, LL, MA, MB, MC, MD, ME, MF, MG, MH, MI, MJ, MK, ML, NA, NB, NC, ND, NE, NF, NG, NH, NI, NJ, NK, NL, OA, OB, OC, OD, OE, OF, OG, OH, OI, OJ, OK, OL, PA, PB, PC, PD, PE, PF, PG, PH, PI, PJ, PK, PL, QA, QB, QC, QD, QE, QF, QG, QH, QI, QJ, QK, QL, RA, RB, RC, RD, RE, and RF.

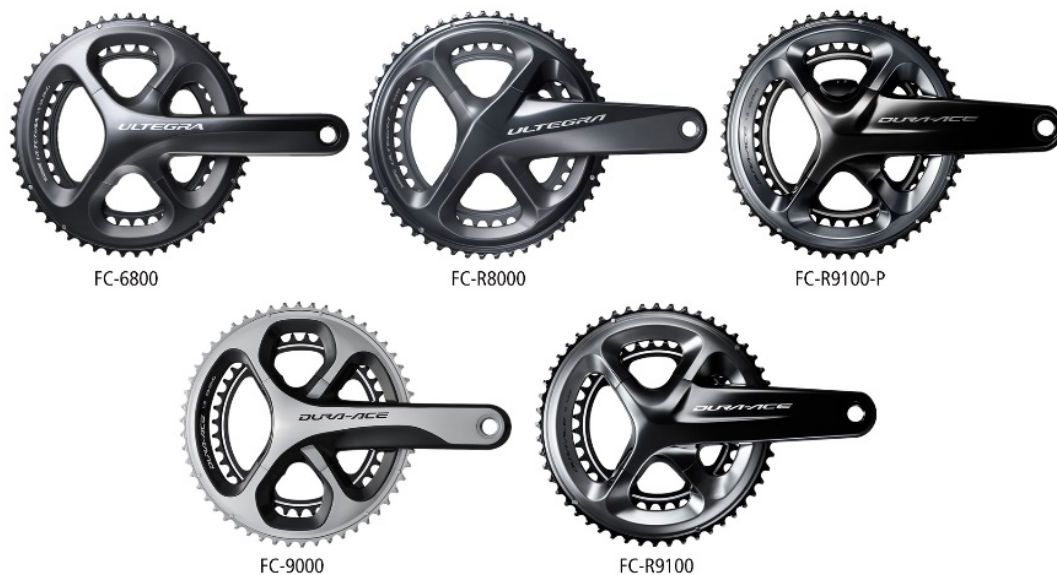
This specifically concerns the Shimano ULTEGRA FC-6800, DURA-ACE FC-9000, ULTEGRA FC-R8000, DURA-ACE FC-R9100 and FC-R9100-P 11-Speed Bonded HOLLOWTECH II Road Cranksets in Australia. Reports received by Shimano indicate that the bonded parts of the crank arm could separate and break, posing potential fall and crash hazards to consumers.

Reports received by Shimano indicate that the outer cover of the crank arm may start to separate from the main crank arm body, posing potential fall and crash hazards to consumers.

Figure 1. Image of the cranksets that might be subject to inspection.

To remedy this situation, Shimano will have any applicable crankset inspected. Shimano will replace any crank arm that fails the inspection process.

Consumers whose cranksets show signs of bonding separation or delamination during the inspection will be provided a free replacement crankset from Shimano that the dealer will professionally install. If your crankset needs replacement following the inspection, please do not use it. If a replacement crankset is temporarily unavailable, Shimano will notify you through your dealer when the replacement is ready.
