CAPITAL RESERVE STUDY

KEG File: 18RS-0562
June 27, 2018

*Cape Haze Resort Community
Association, Inc.
8401 Placida Road
Cape Haze, FL 33946*

Re: ***Cape Haze Resort Community Association, Inc.
KEG Project No. 18RS-0562
Professional Engineering Services – Capital Reserve Study***

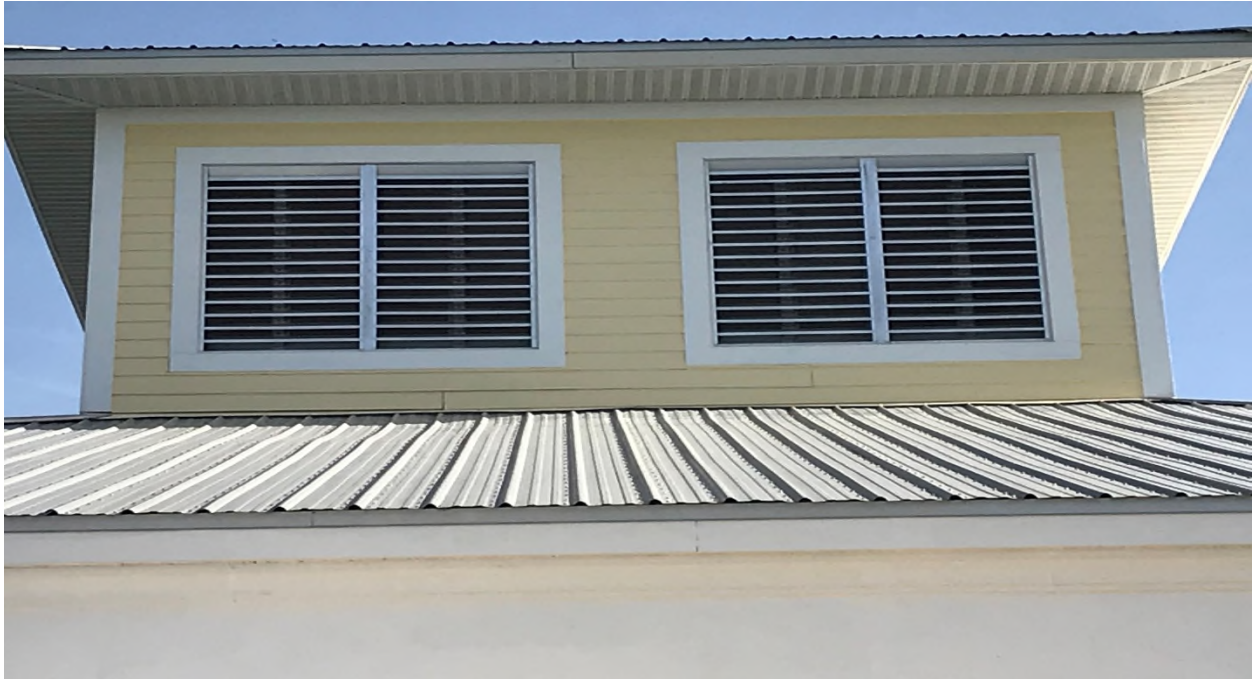
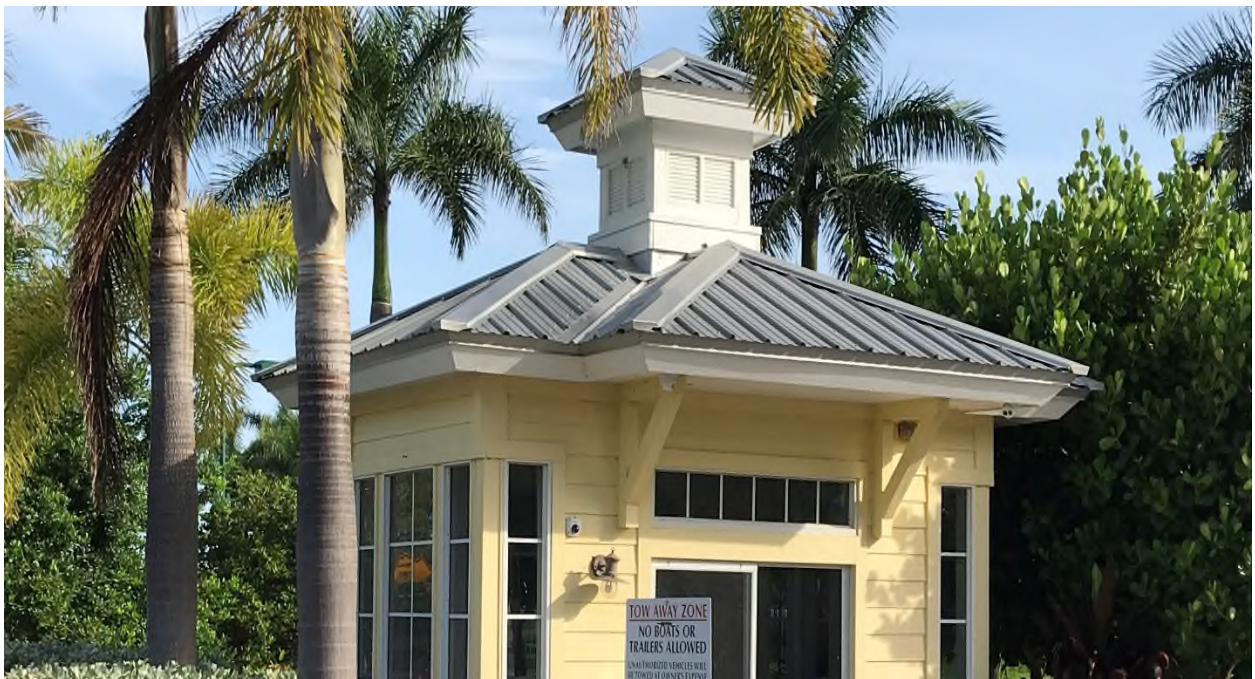
The roofing systems at the club house as well as the guardhouse both appear to be comprised of a standing-seam metal roof. The existing roofs appear to be in above average condition. The roofs should be kept clean and free of debris with routine inspections, and foot traffic should be kept to a minimum.

The expected useful life for the 9,300 total square foot standing-seam metal roofs is 40 years
Assuming the roof was installed when the association was developed, the expected remaining useful life is 29 years.
The estimated replacement cost is anticipated in 2047 for \$220,000.07.

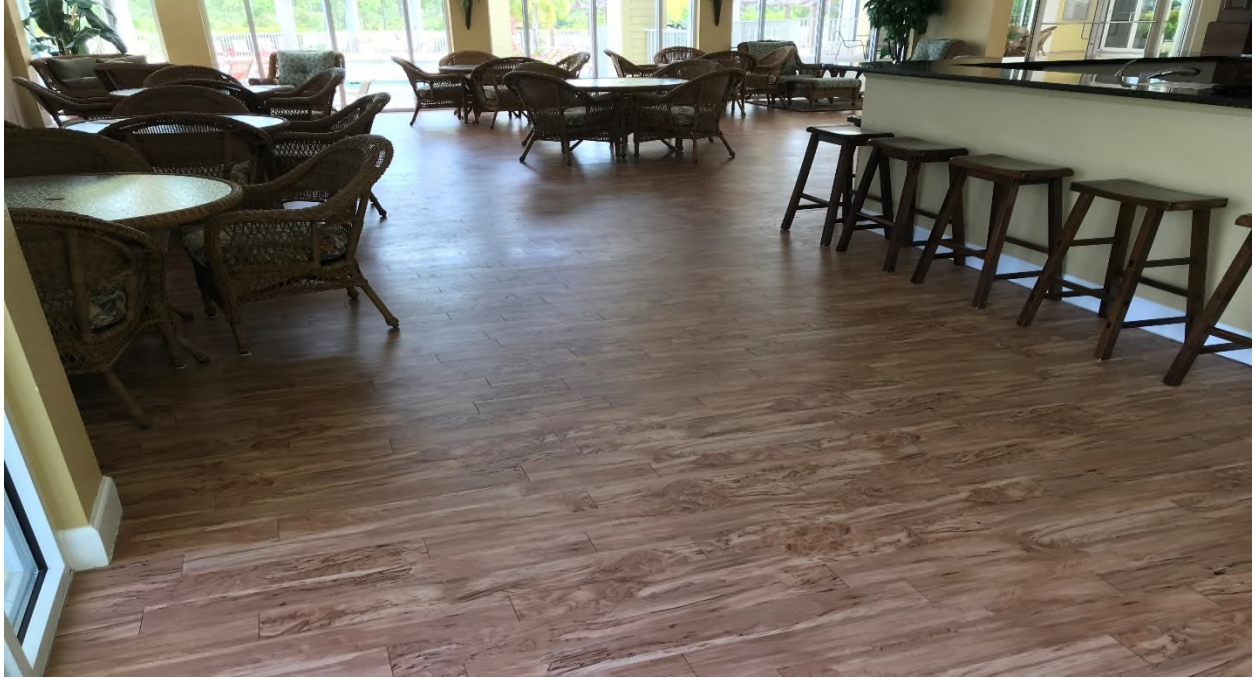
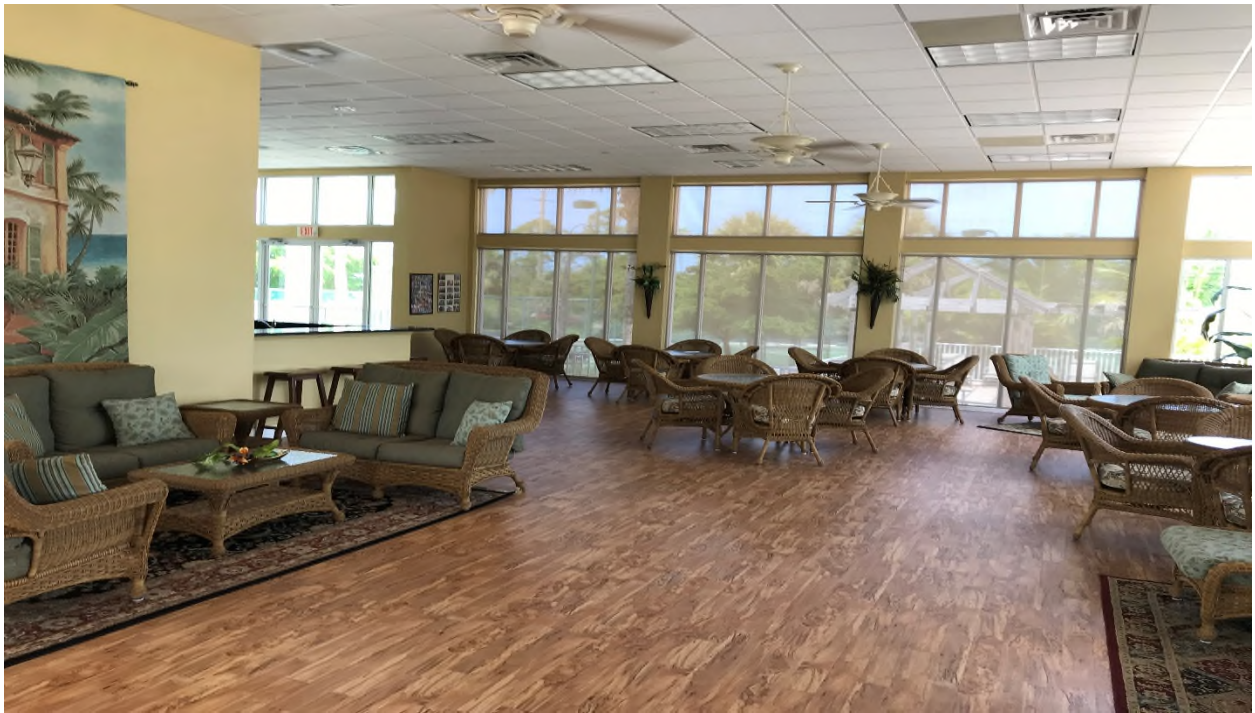
The clubhouse consists of various pieces of furniture that makes up its interior and all is in good condition. There are many different factors that contribute to the useful life of the furniture. Periodic inspections and addressing deficiencies will prolong the useful life of the furniture.

The expected useful life for various piece of wicker furniture along with the bar furniture is 20 years
The expected remaining useful life is 9 years.
The estimated replacement cost is anticipated in 2027 for \$33,548.77.

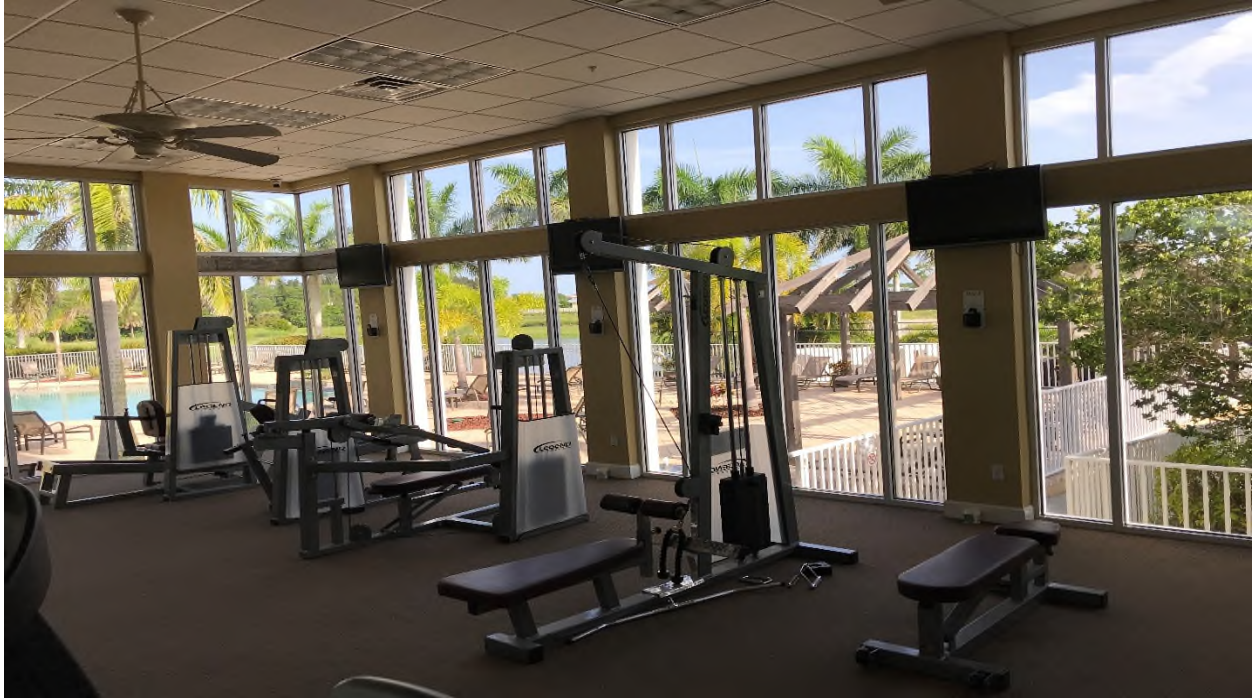
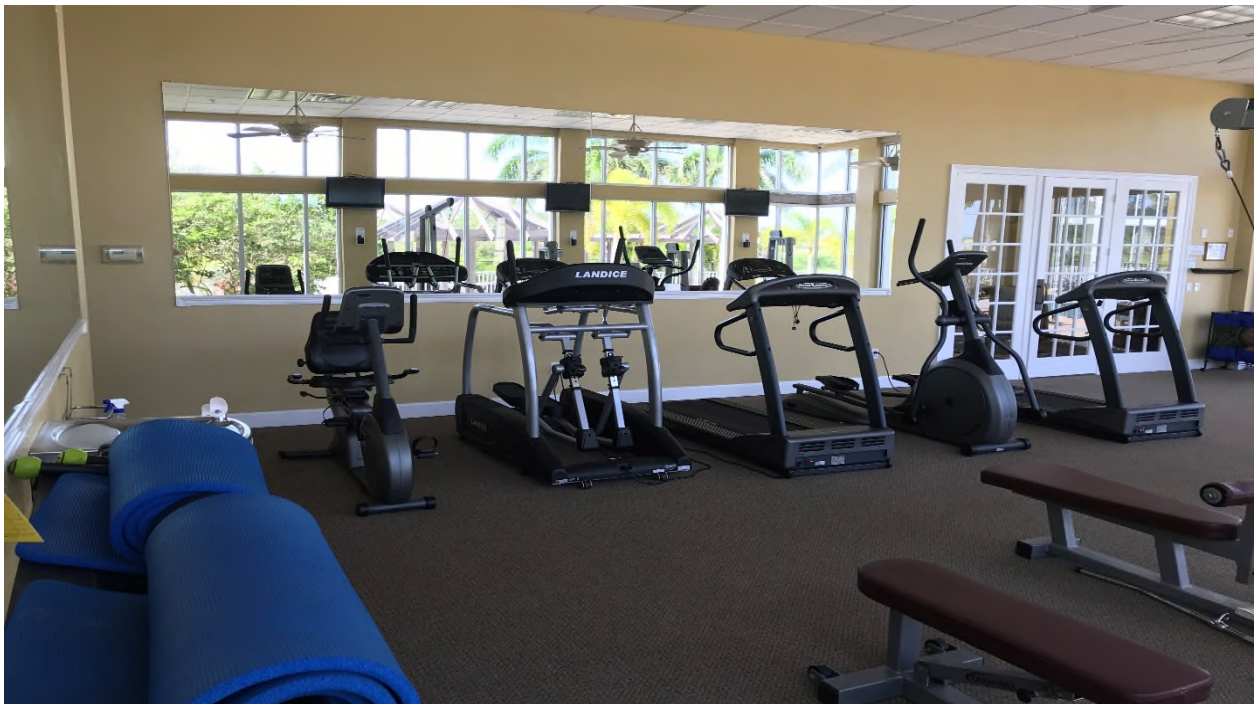
The 9 pieces of exercise equipment are in average condition and has a projected useful life of 7 to 12 years. Equipment that gets excessive use or isn't properly maintained will fall on the low end of the range. Equipment that is used sparingly and gets regular maintenance may last well beyond its projected lifespan which appears to be the case at Cape Haze Resort, therefore piecewise replacement is recommended. KEG was informed that one of the pieces of the equipment was replaced within the last year, and Cape Haze Resort suggested piecewise replacement of the machines rather than wholesale replacement.

The expected useful life for the 7 pieces of exercise equipment is 12 years
The expected remaining useful life is 9 years.
The estimated replacement cost is anticipated \$28,000 in today's dollars.

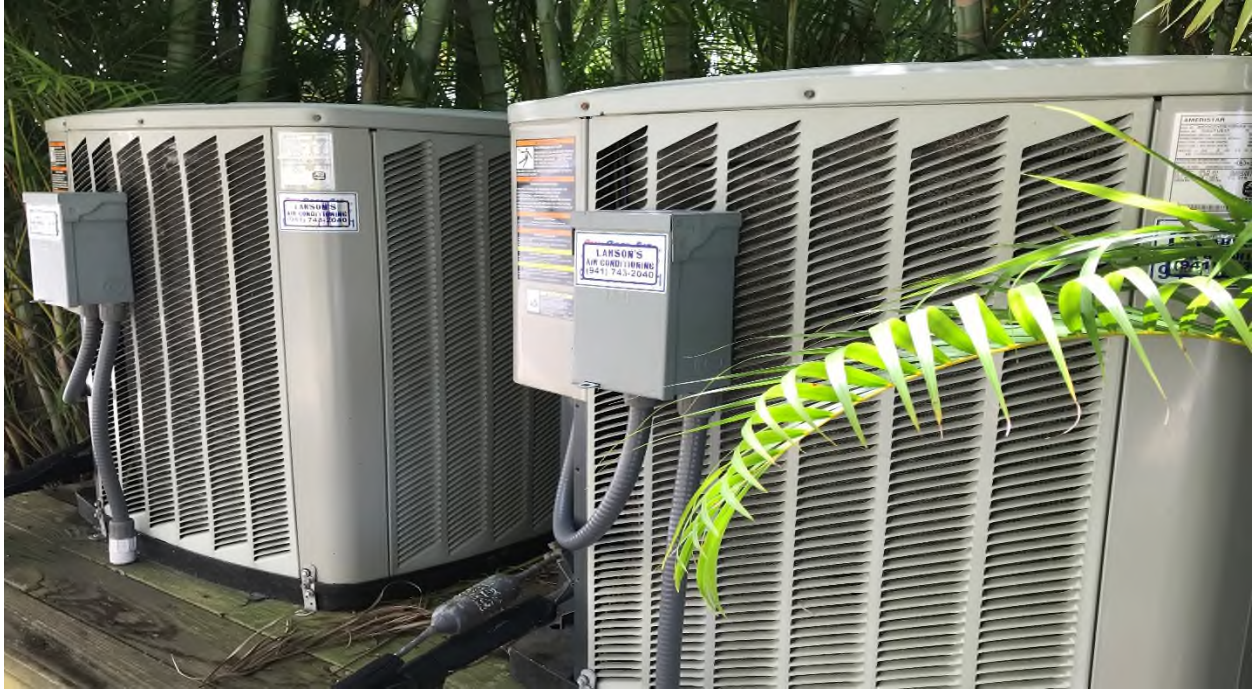
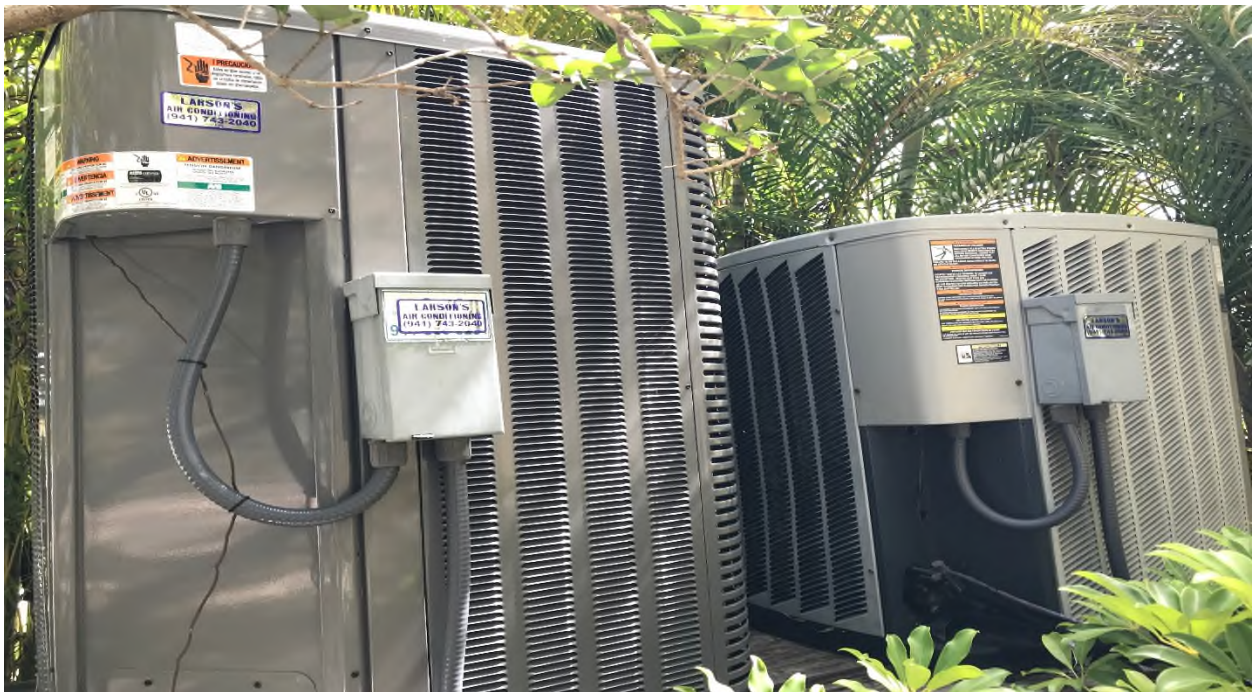
The HVAC systems should last ten years with service recommend every six months to extend the expected useful life. The Association has four AC systems for the common areas. Two systems were recently replaced, one located on the office side of the clubhouse along with one on the function hall side.

The expected useful life for the four systems is 10 years.
The expected remaining useful life for the units;
10 years for Office A/C System #1
0 years for Office A/C System #2
10 years for Function Hall A/C System #3
0 years for Function Hall A/C System #4
The estimated replacement cost is \$6,600 in today's dollars each.

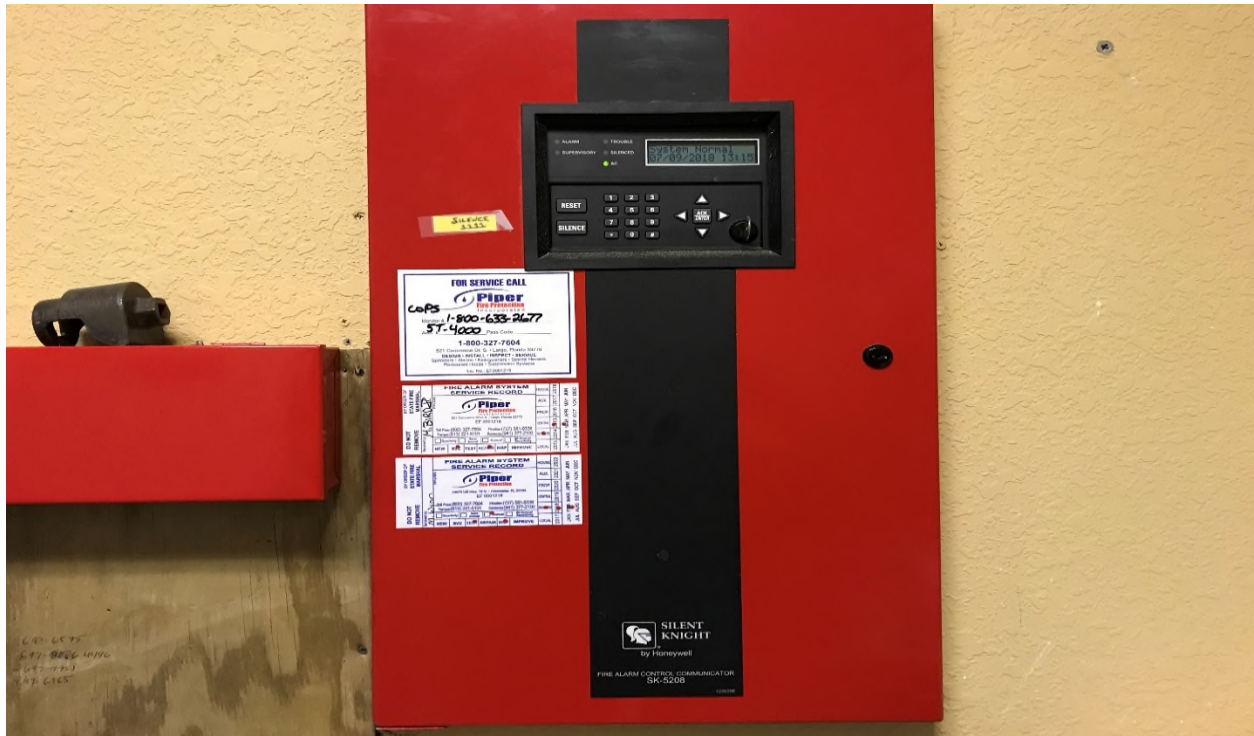
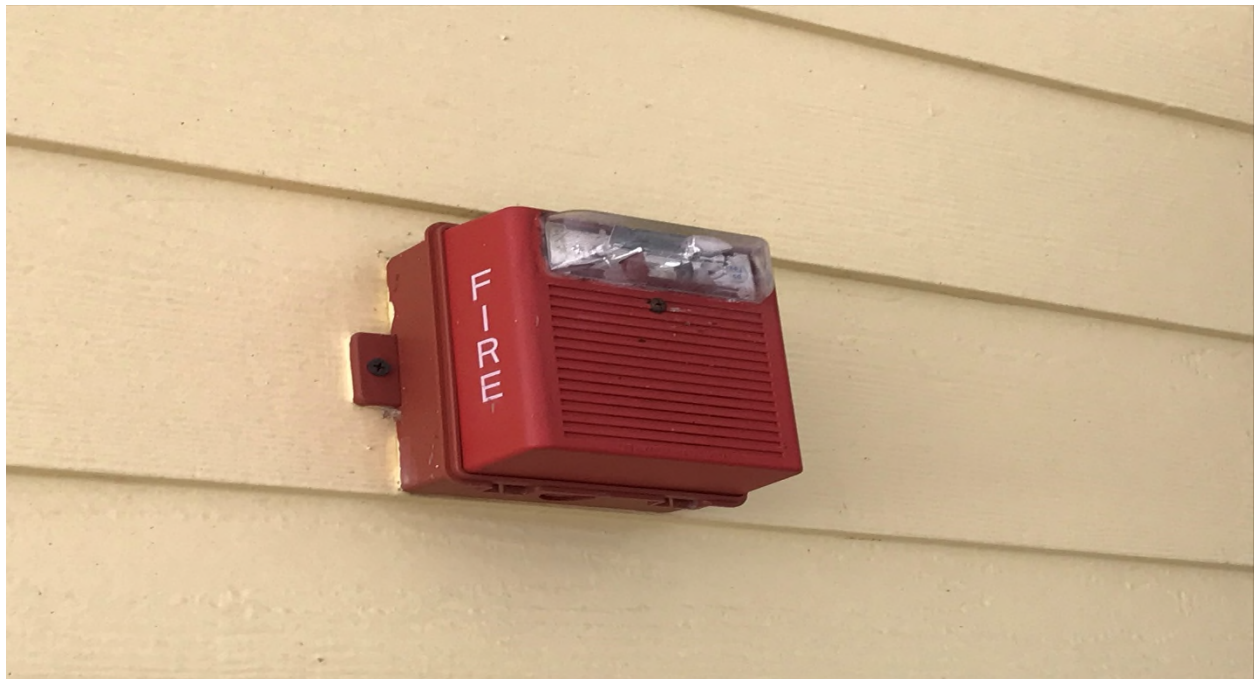
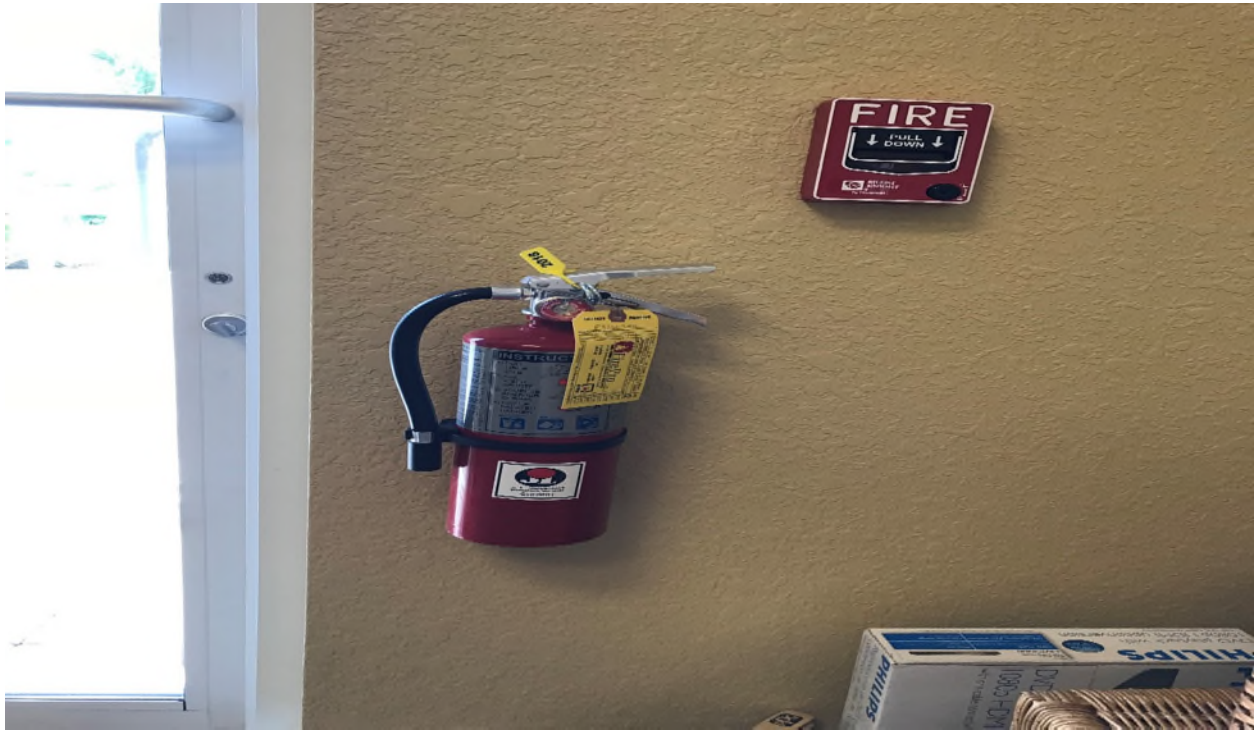
The fire protection system appears to be in good working condition and are required to have scheduled inspections and testing as required by the State. A service contract with routine maintenance should be in place.

The expected useful life for the fire alarm panel is 20 years.
The expected remaining useful life is 9 years.
The estimated replacement cost is \$10,000 in today's dollars.

The expected useful life for the fire alarm pull stations is 25 years.
The expected remaining useful life is 14 years.
The estimated replacement cost is \$1,400 in today's dollars.

The expected useful life for the fire alarm strobes is 25 years.
The expected remaining useful life is 14 years.
The estimated replacement cost is \$3,080 in today's dollars.

The expected useful life for the fire extinguishers is 15 years.
The expected remaining useful life is 4 years.
The estimated replacement cost is \$375 in today's dollars.

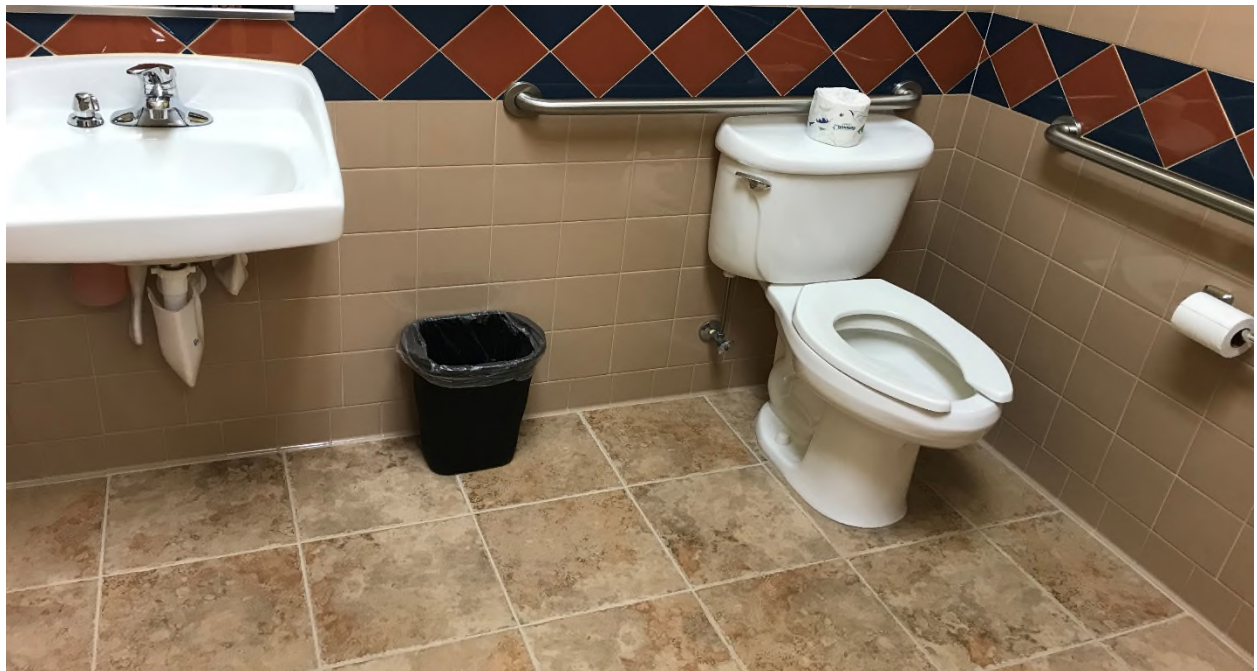
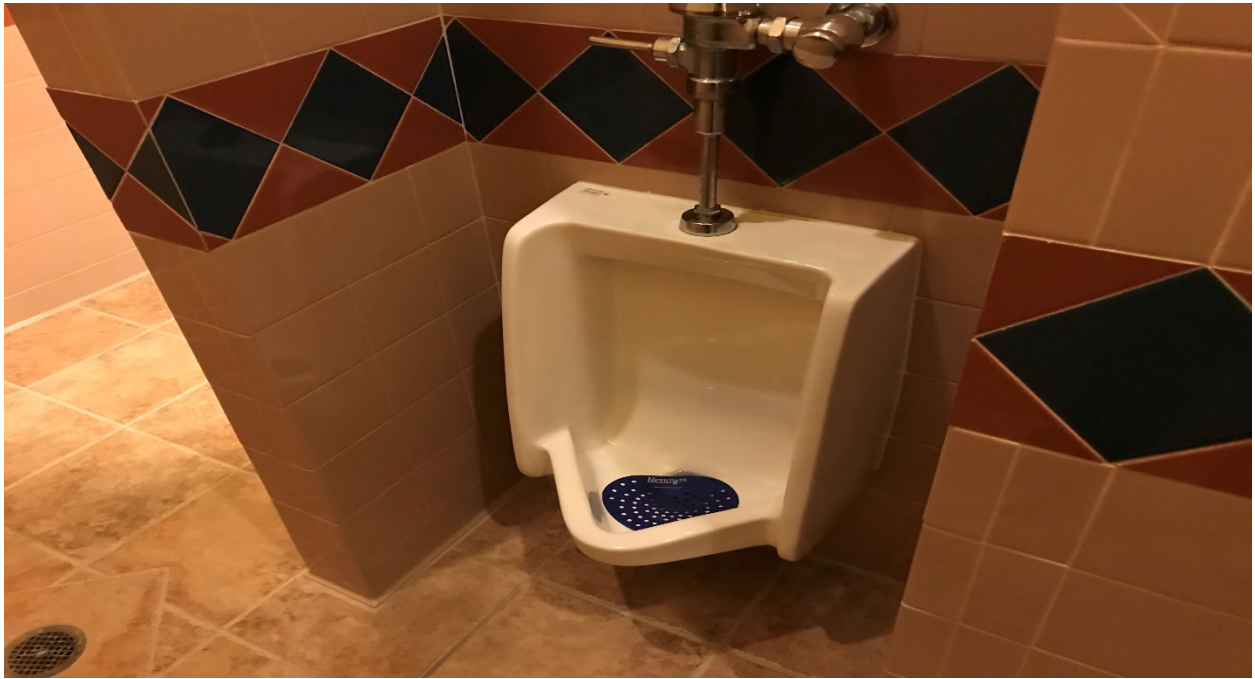
Two restrooms located in the office portion of the clubhouse, along with two restrooms in the function hall are utilized by workers, residents, and guests are in good condition. The restrooms are assumed to be original in 2007 including new fixtures and finishes.

The expected useful life for the 4 total restrooms is 20 years
The expected remaining useful life is 9 years.
The estimated remodeling cost is anticipated in 2027 for \$31,312.18.

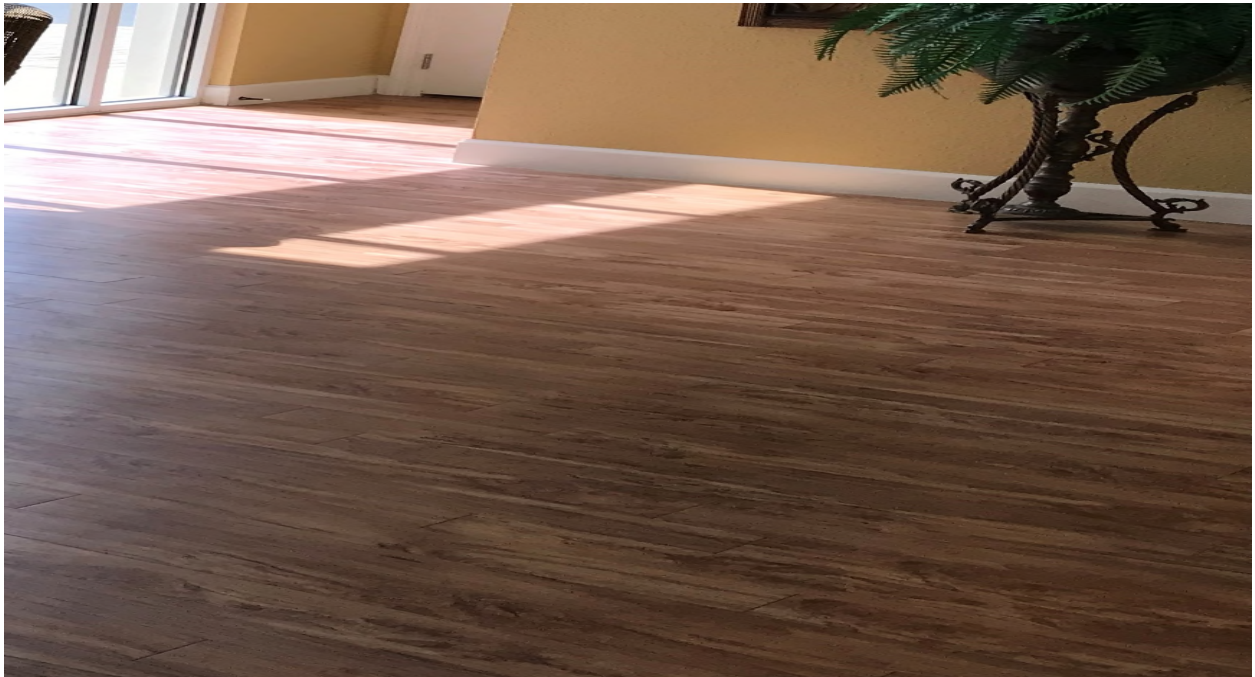
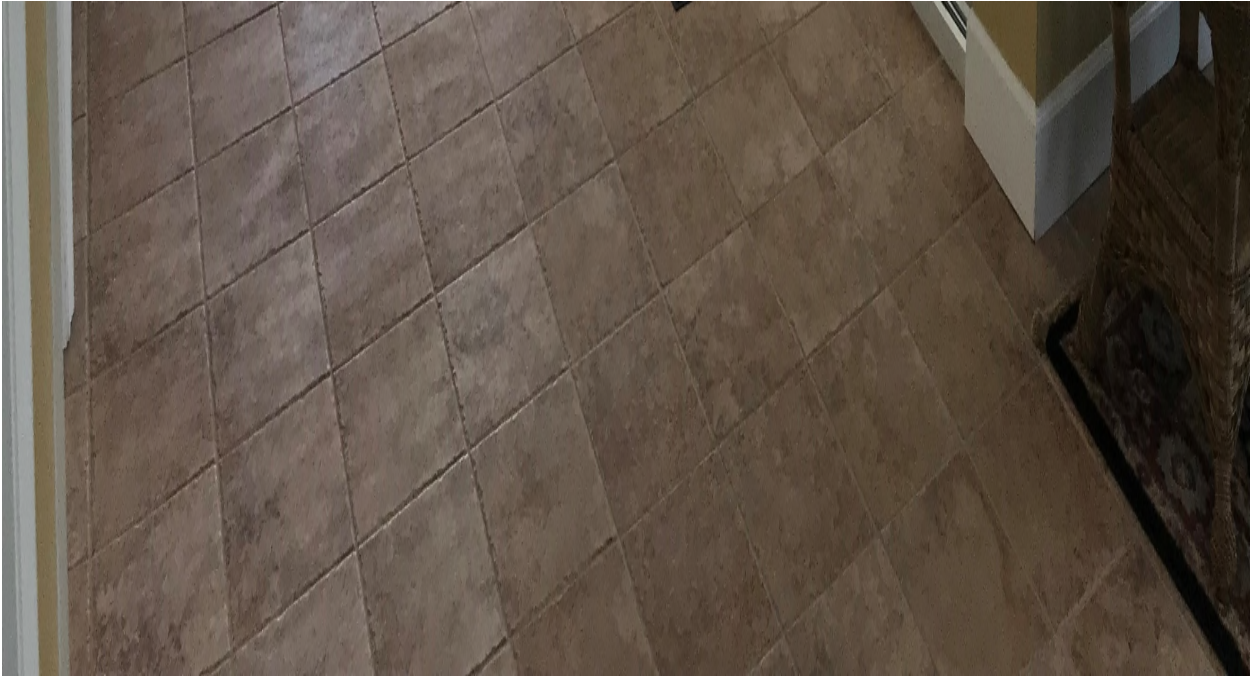
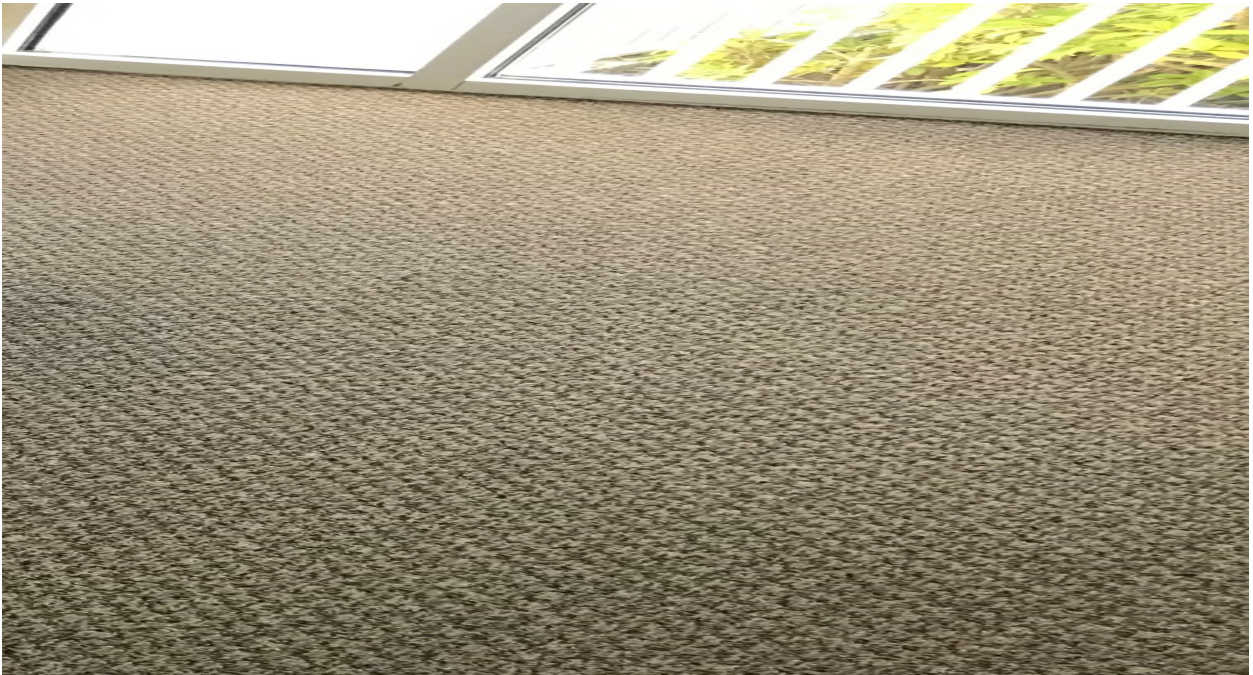
The floor coverings located within the clubhouse includes wood, ceramic tile, and carpet finishes. All the finishes appear to be in like new condition. Each finish has its own useful life.

The expected useful life for the 2,250 total square foot of wood flooring is 30 years.
The expected remaining useful life is 19 years.
The estimated replacement cost is anticipated in 2037 for \$18,518.32.

The expected useful life for the 1,230 total square foot of ceramic tile is 50 years.
The expected remaining useful life is 39 years which is out of the scope of this report.
The estimated replacement cost is \$12,300 in today's dollars.

The expected useful life for the 170 total square yard of carpet is 14 years due to lack of heavy foot traffic.
The expected remaining useful life is 7 years
The estimated replacement cost is anticipated in 2025 for \$8,159.56.

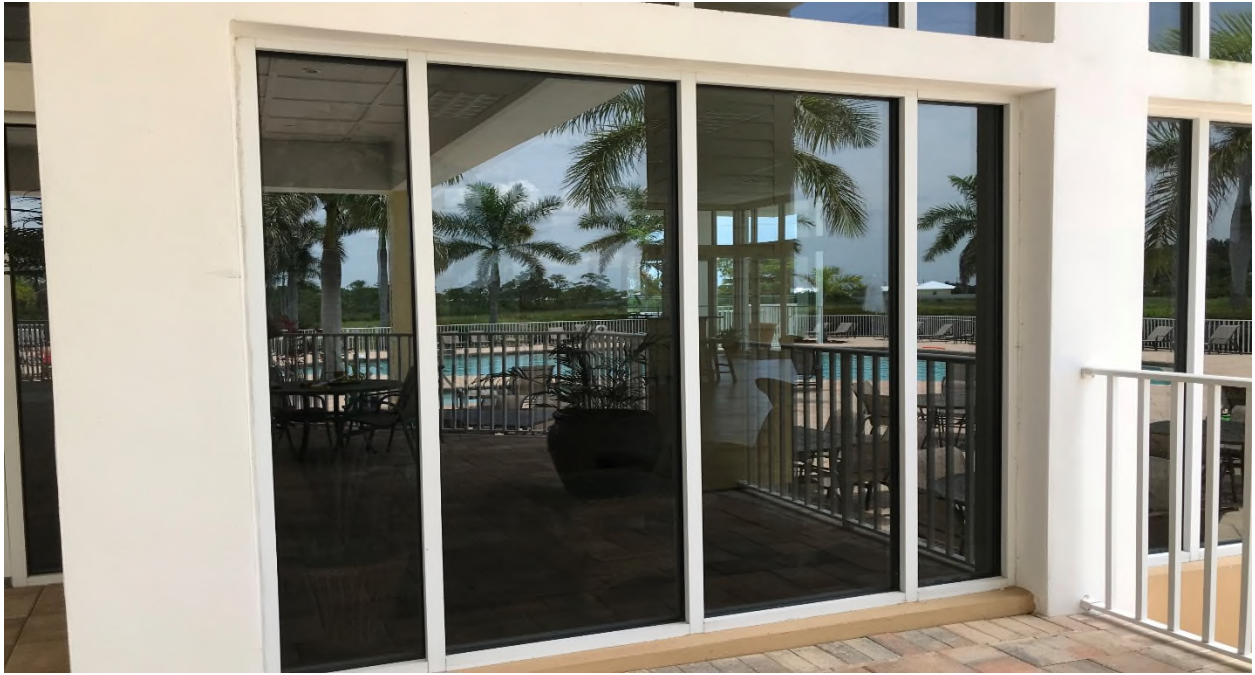
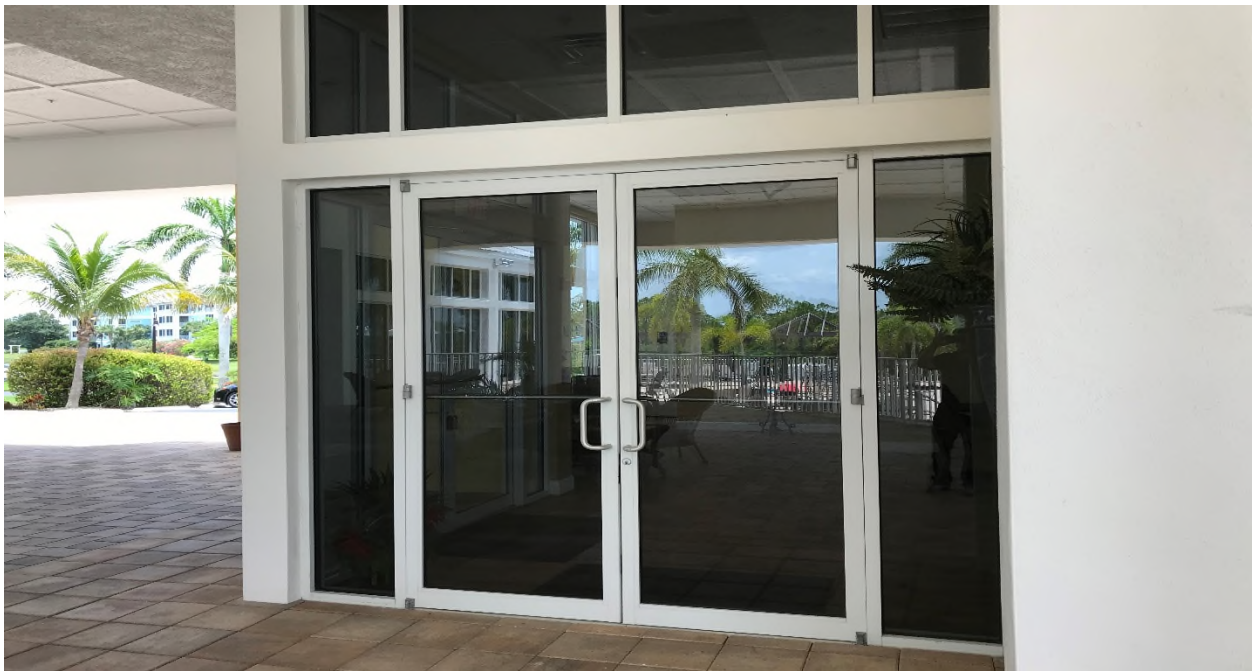
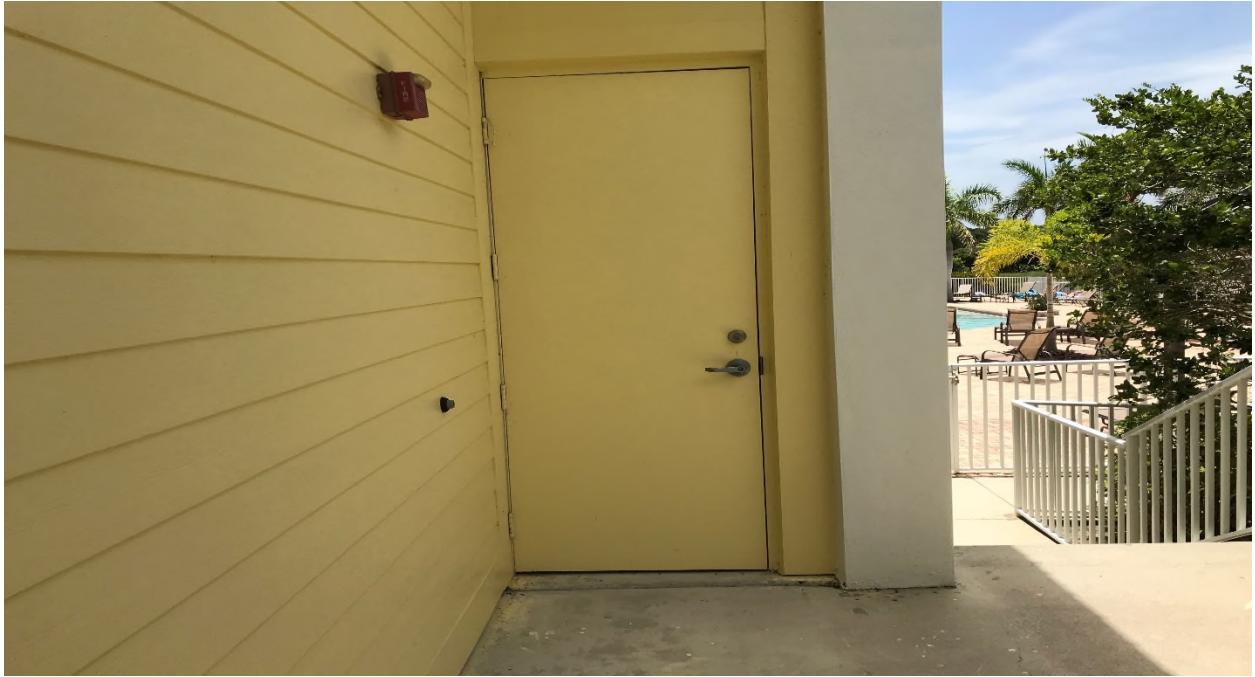
The fixed windows, and storefront and service doors located at the clubhouse along with the gatehouse appear to be in like new condition. Each component has its own unique useful life while assuming the window and doors were originally set in 2007 when the association project was constructed.

The expected useful life for the 205-total fixed windows is 30 years.
The expected remaining useful life is 19 years.
The estimated replacement cost is anticipated in 2037 for \$428,295.40.

The expected useful life for the 13-total storefront doors is 30 years.
The expected remaining useful life is 19 years.
The estimated replacement cost is anticipated in 2037 for \$36,213.59.

The expected useful life for the 4-total number of service doors 25 years.
The expected remaining useful life is 14 years.
The estimated replacement cost is anticipated in 2032 for \$51,049.06.

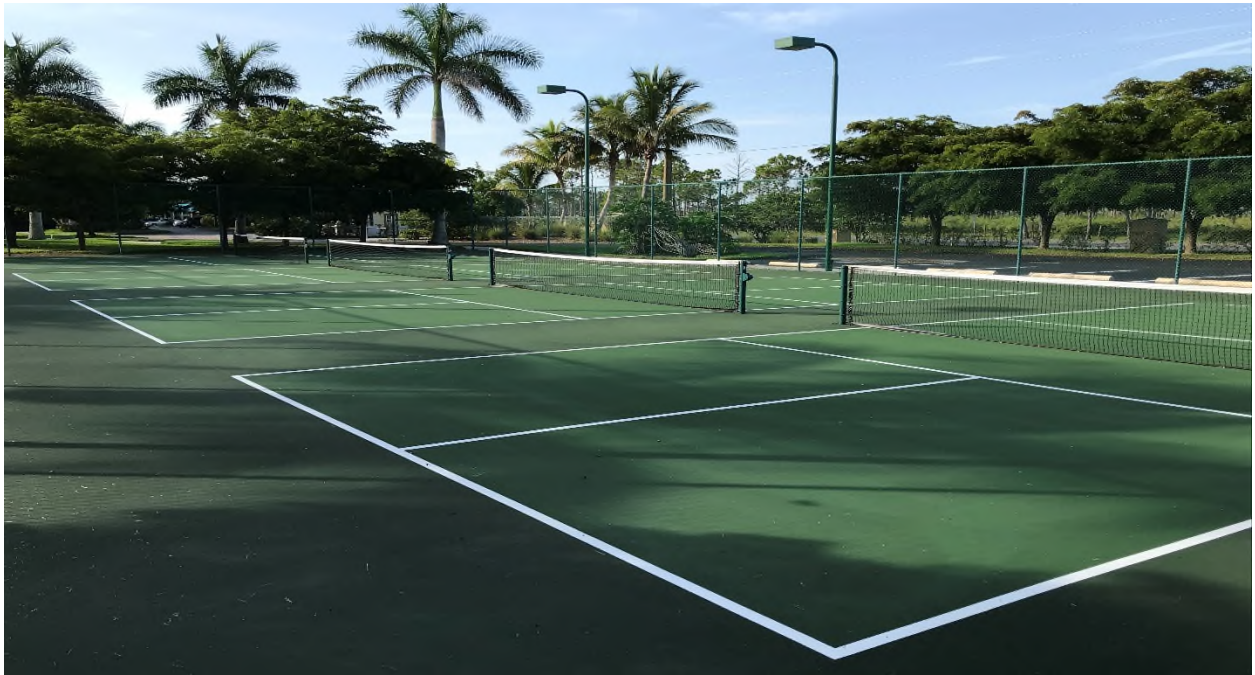
Figure20 - Pickleball Courts

The Har-Tru tennis court and four pickleball courts are in very good condition and were resurfaced and reconditioned in 2017. Both tennis courts and pickleball courts are enclosed by a chain link fence and is also in very good condition.

The expected useful life for the tennis and pickleball court surfaces is 12 years.
The expected remaining useful life is 11 years.
The estimated resurfacing cost is anticipated in 2029 for \$22,928.48.

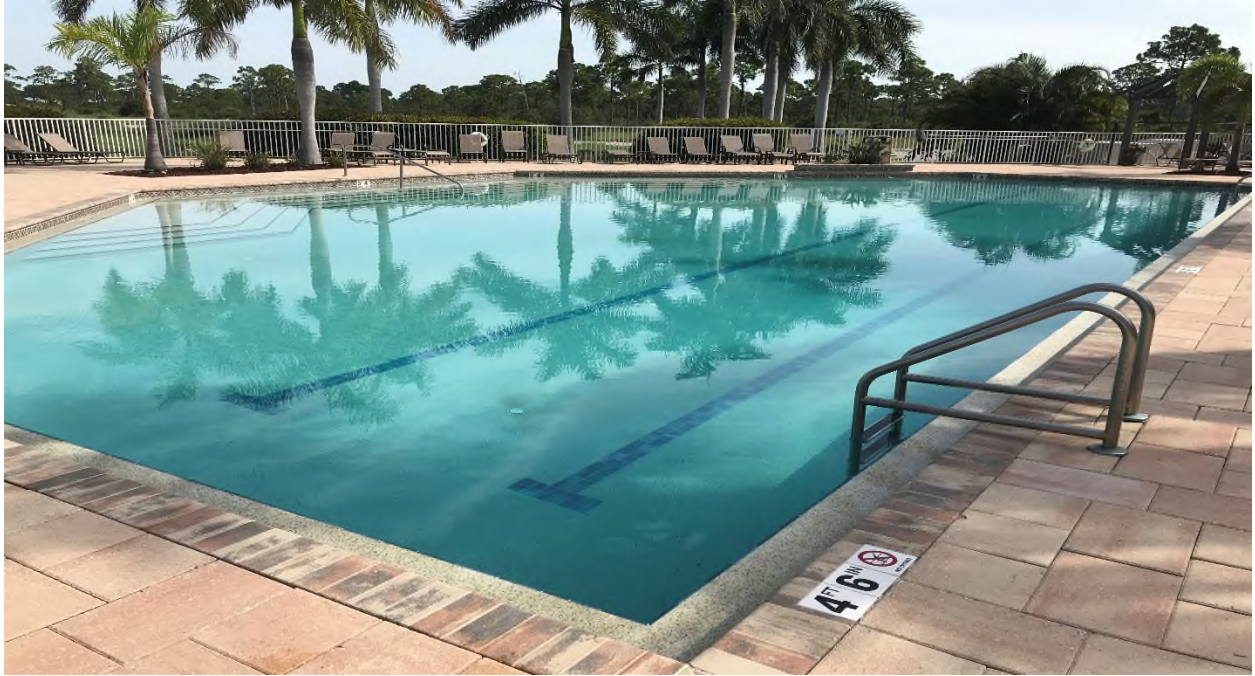
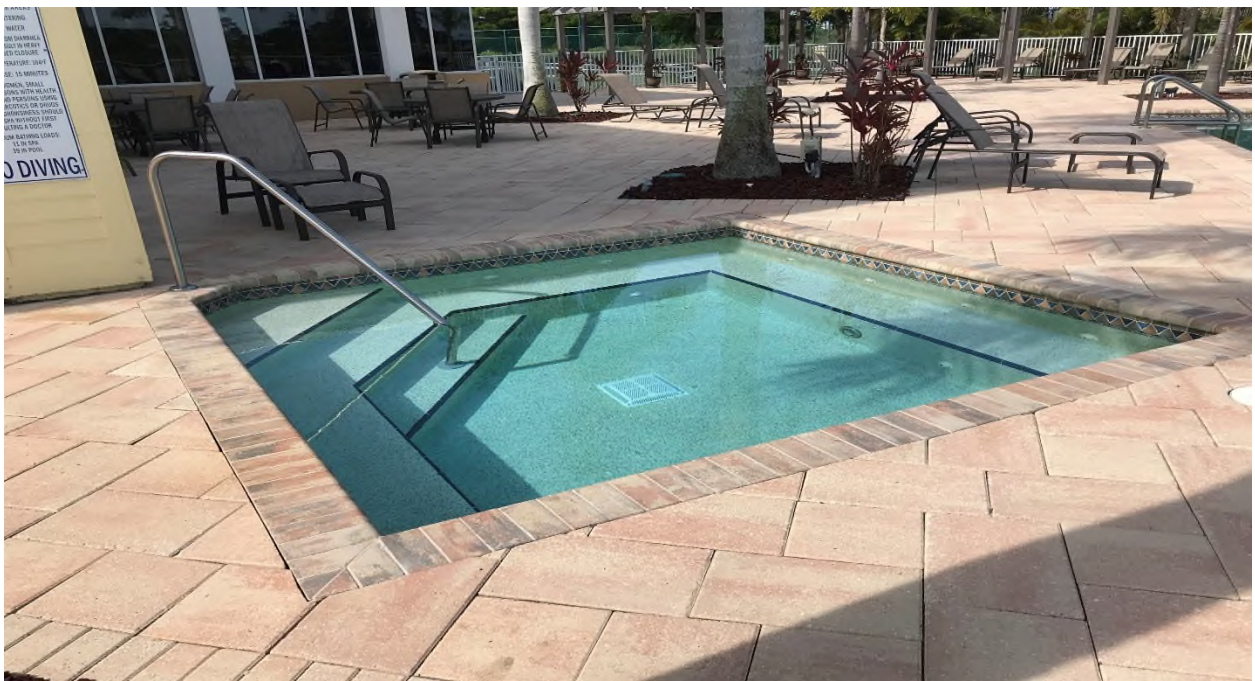
The pool and equipment should be serviced and inspected as required by the Florida Building Code. The pool, spa, and related elements appear to be in like new conditions with little signs of wear aside from the pool finish which appears to be reaching the end its useful life.

The expected useful life for the 2770 square feet of the exposed aggregate pool and spa finish is 12 years.
The expected remaining useful life is 1 years.
The estimated refinishing cost is anticipated in 2019 at a cost of \$18,230.06.

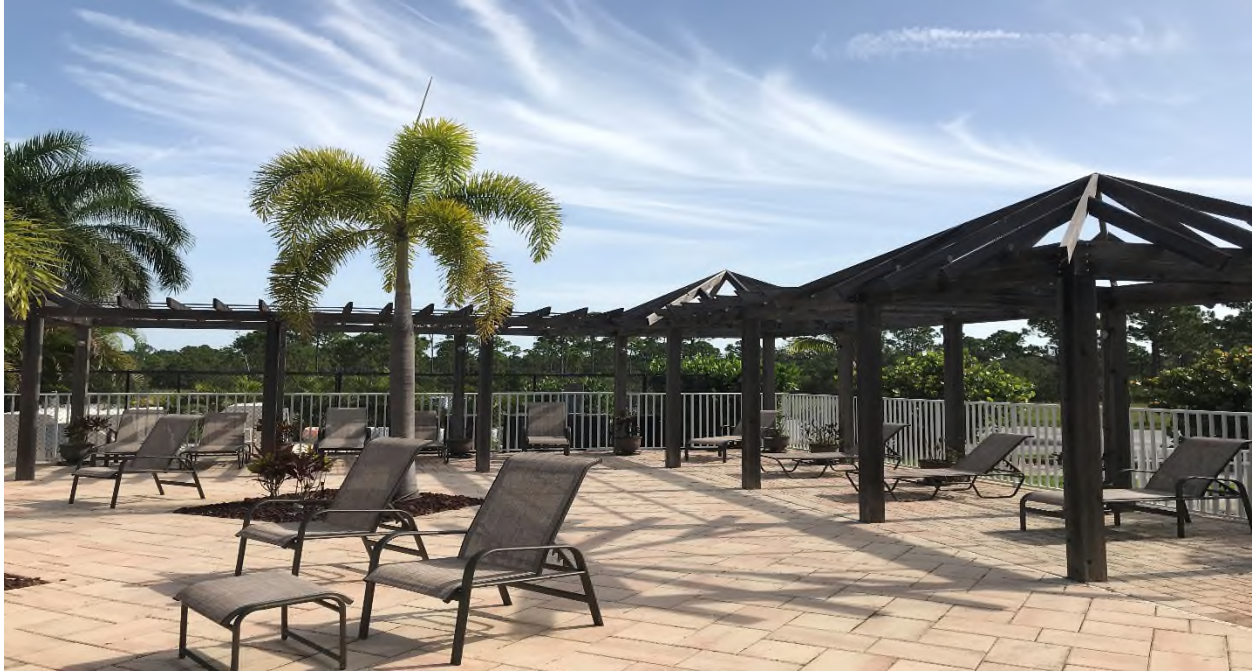
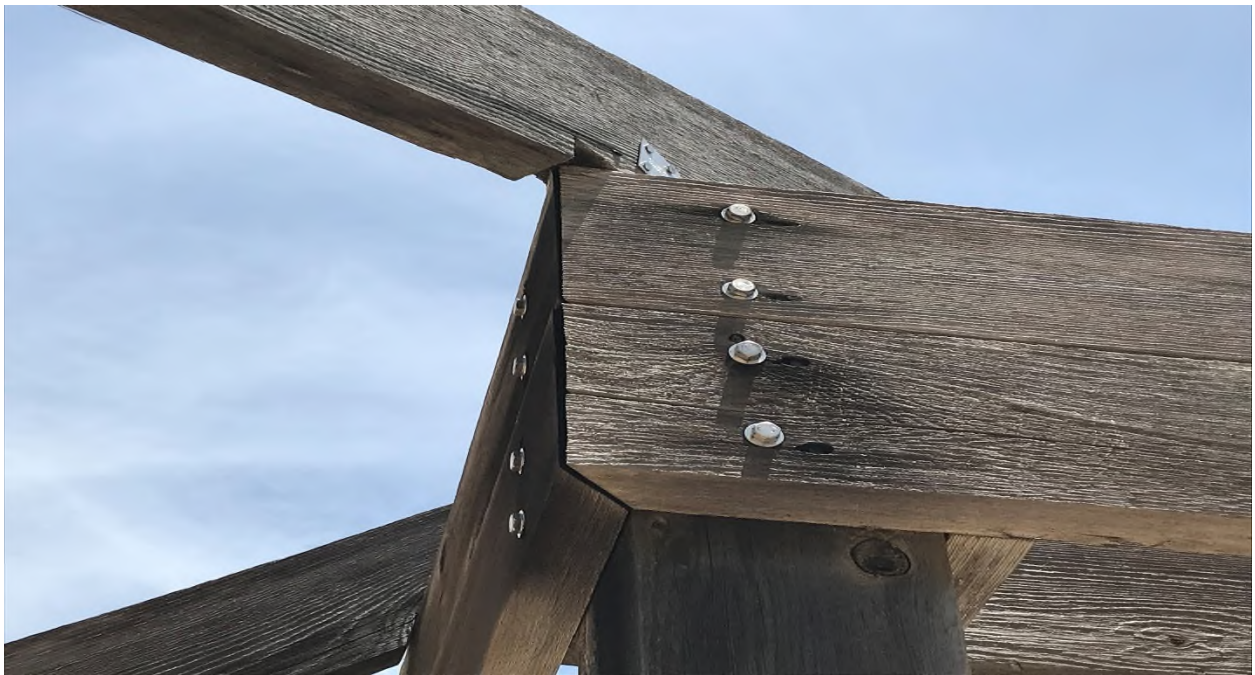
The expected useful life for the 128 linear feet of pergola is 15 years.
The expected remaining useful life is 4 years.
The estimated replacement cost is \$6,800 in today's dollars.
