CAPITAL RESERVE STUDY

KEG File: 18RS-0562
June 27, 2018

*Cape Haze Resort Community
Association, Inc.
8401 Placida Road
Cape Haze, FL 33946*

Re: ***Cape Haze Resort Community Association, Inc.
KEG Project No. 18RS-0562
Professional Engineering Services – Capital Reserve Study***

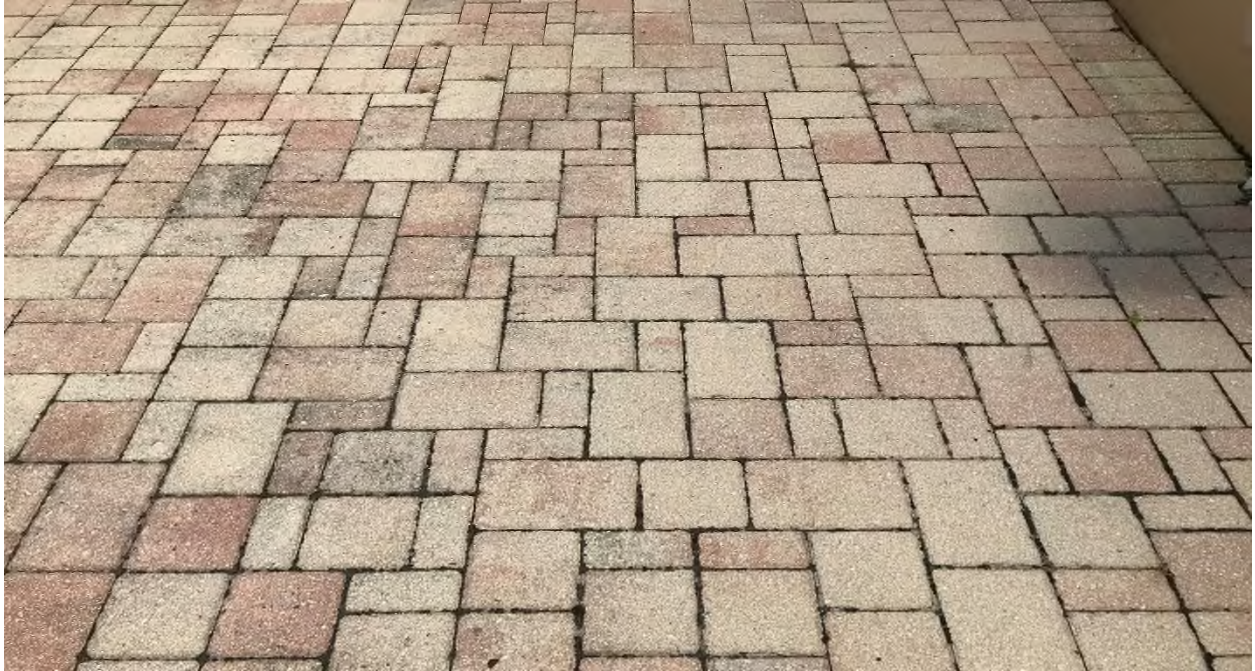
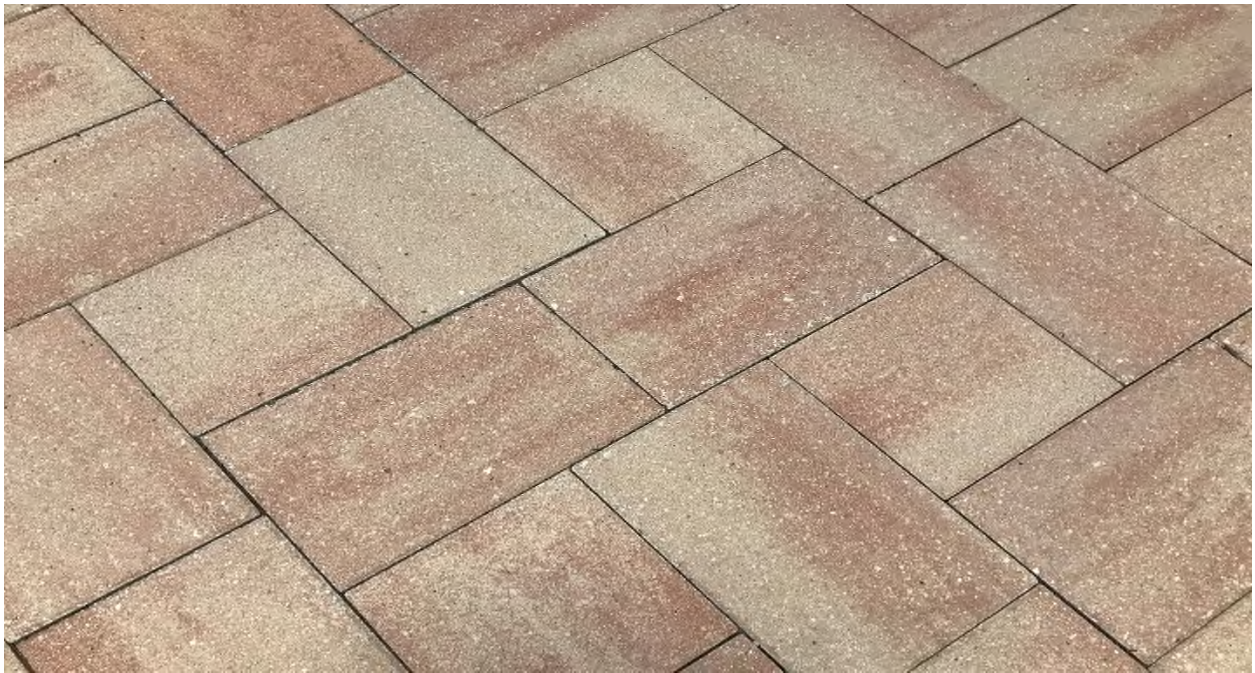
The expected useful life for the 12,880 square feet of pool deck/clubhouse walkway pavers is 40 years.
The expected remaining useful life is 29 years.
The estimated replacement cost is \$76,653.00 in today's dollars.

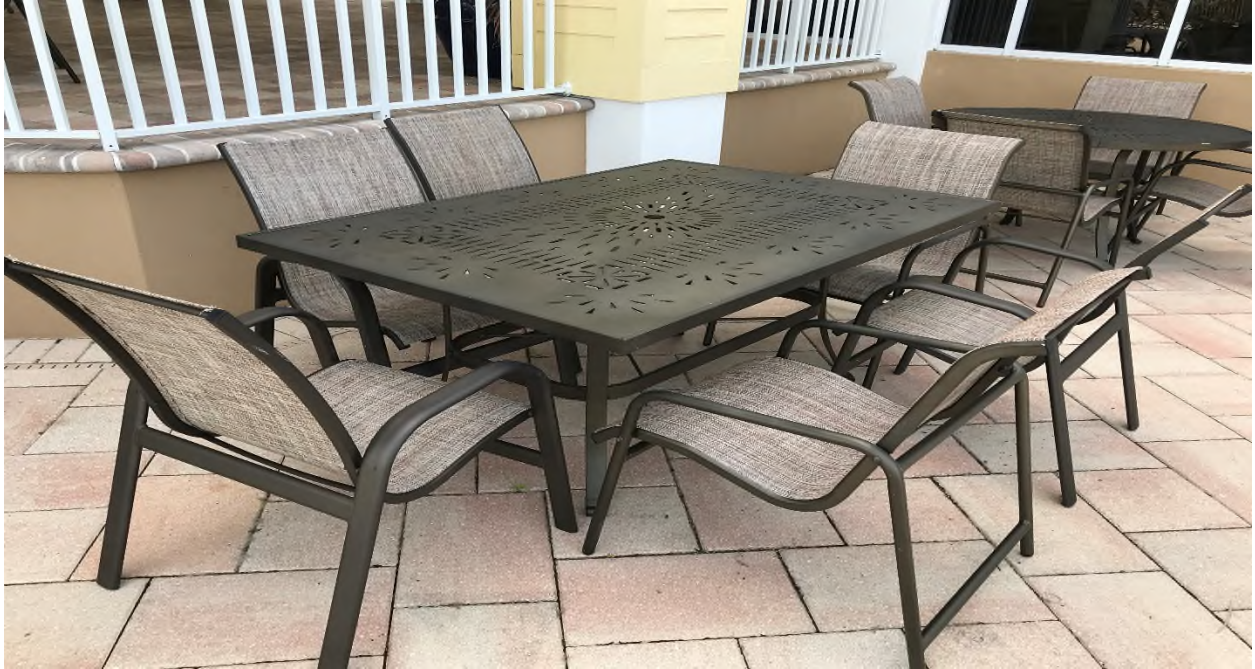
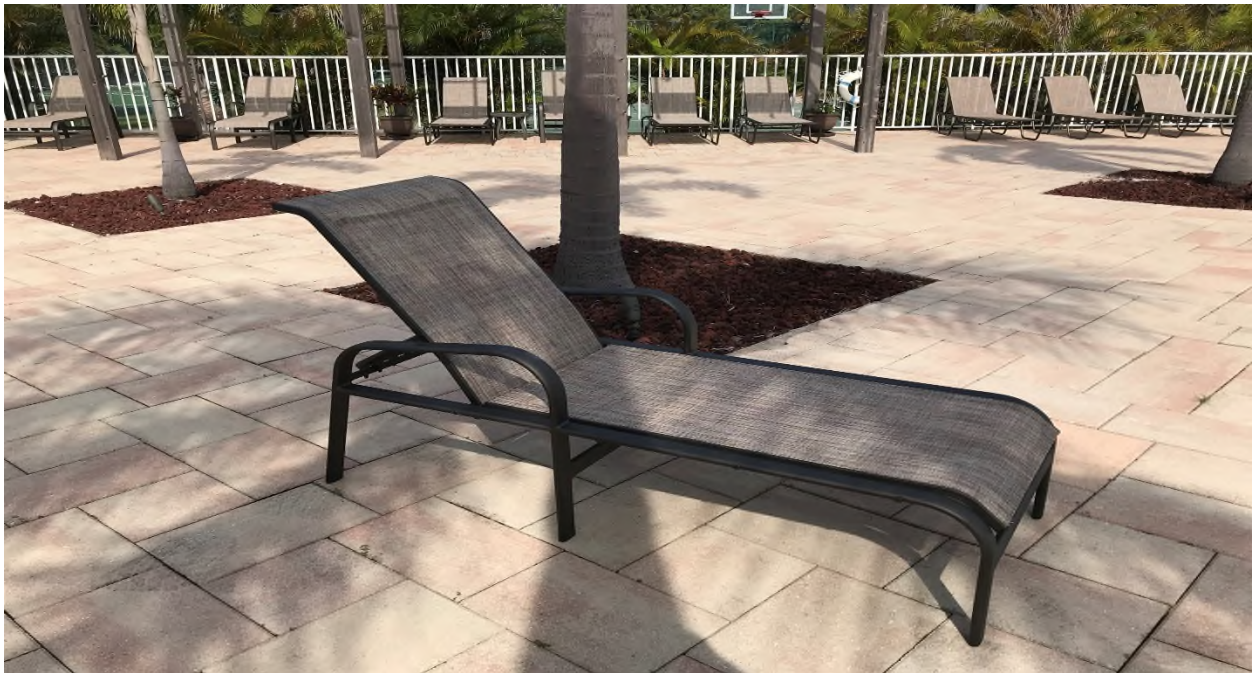
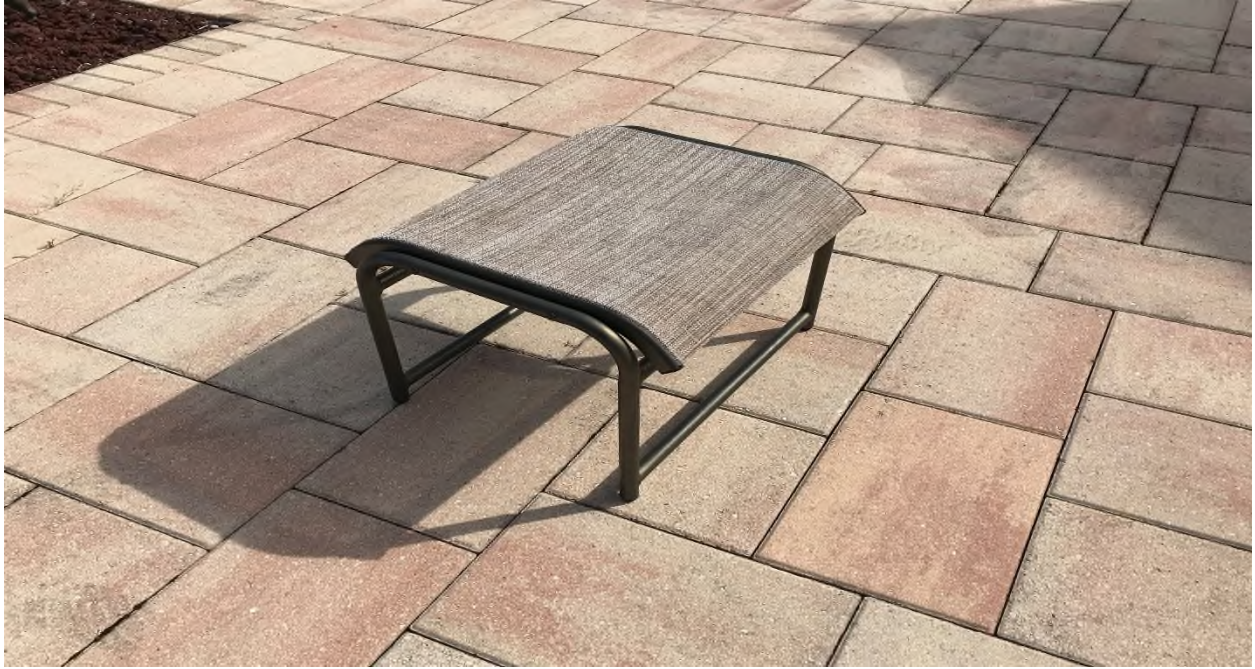
The expected useful life for the pool furniture is 5 years.
The expected remaining useful life is 4 years.
The estimated replacement cost is \$44,000 in today's dollars.

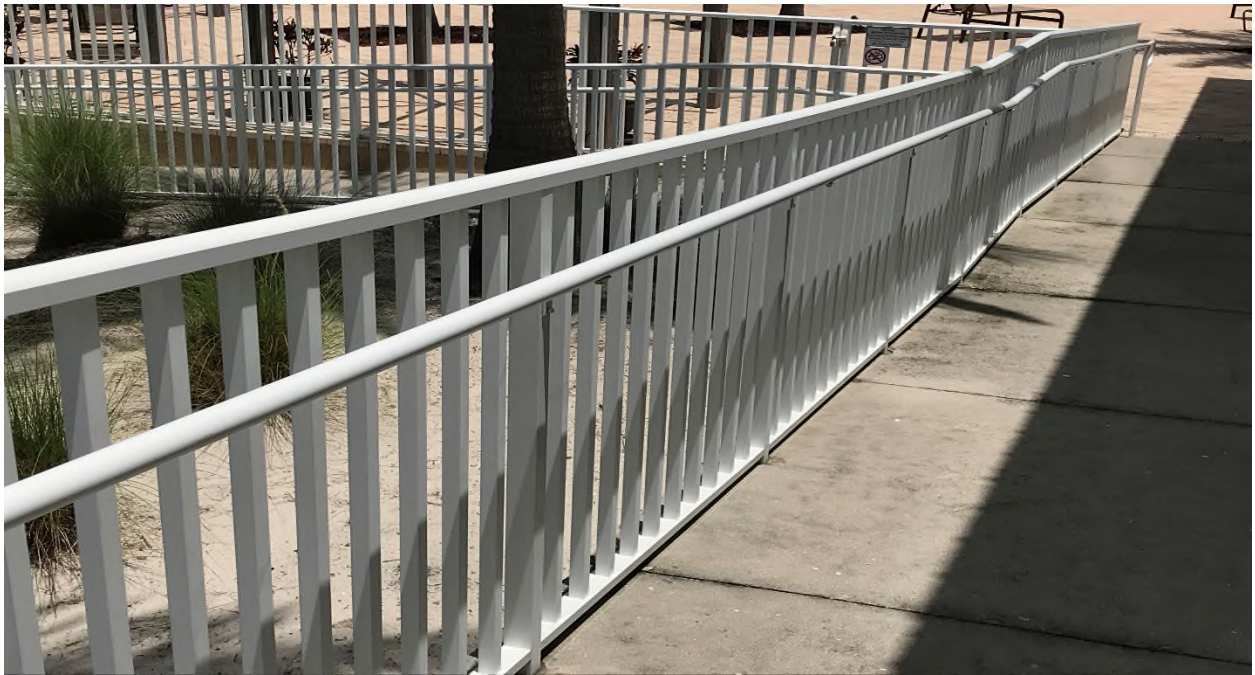
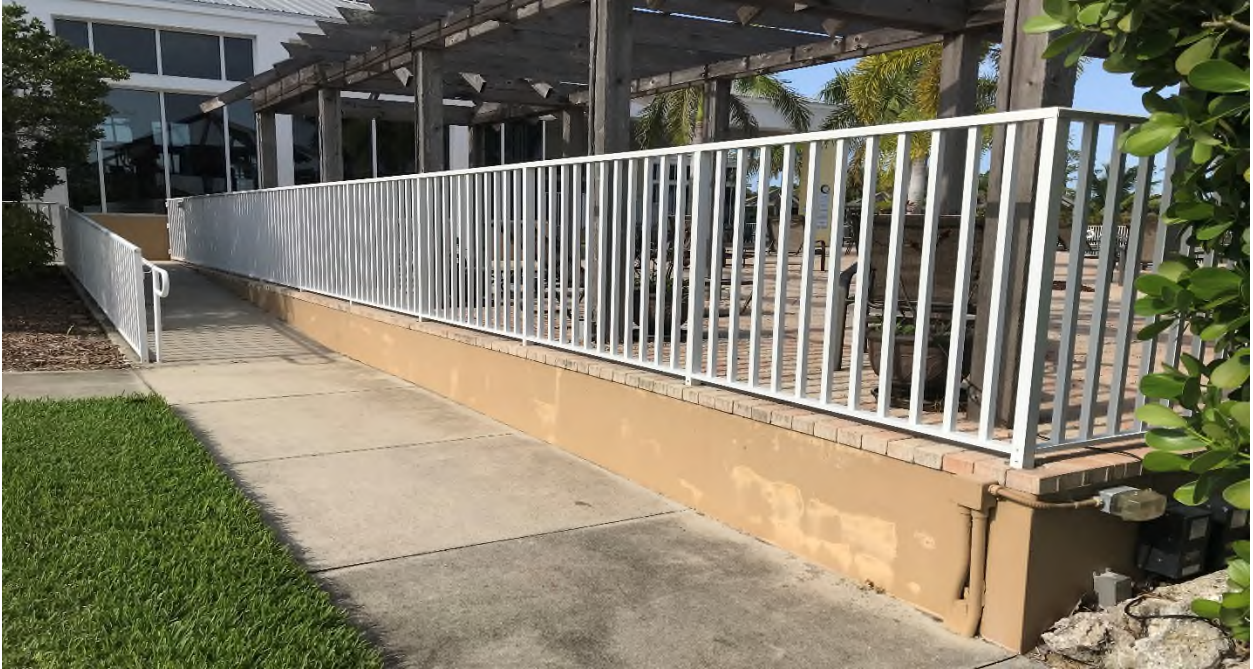
The expected useful life for the 750 linear feet aluminum railing at all areas of the clubhouse is 20 years
The expected remaining useful life is 9 years.
The estimated replacement cost is \$46,875 in today's dollars.

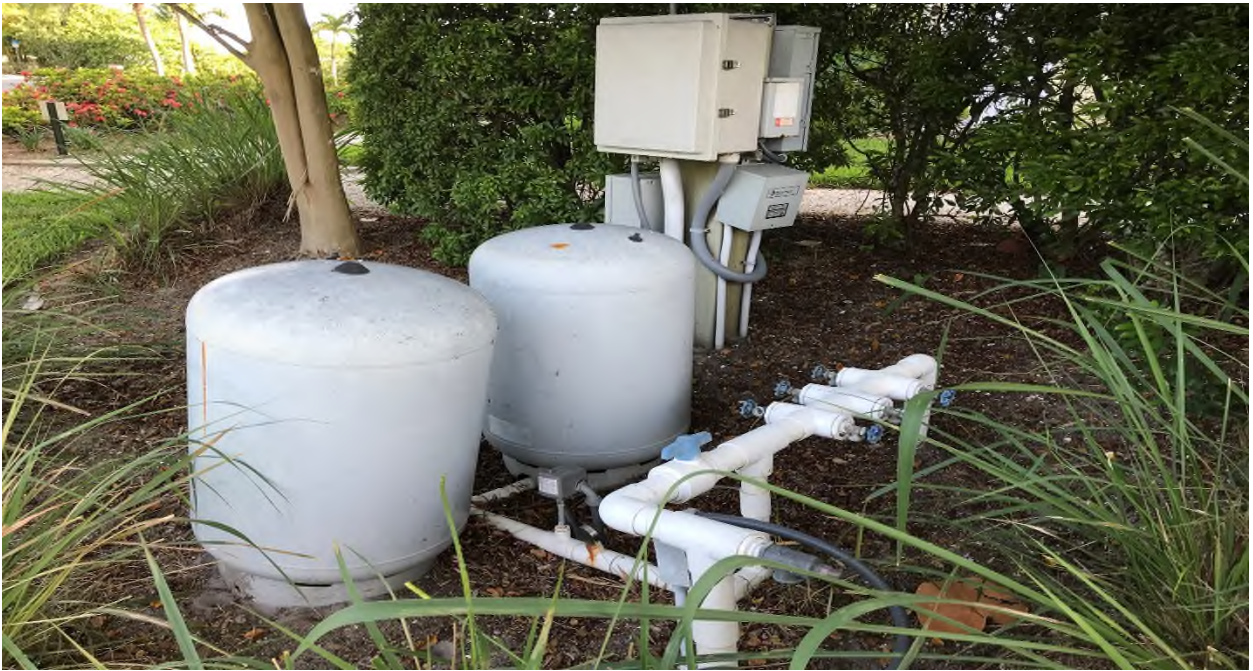
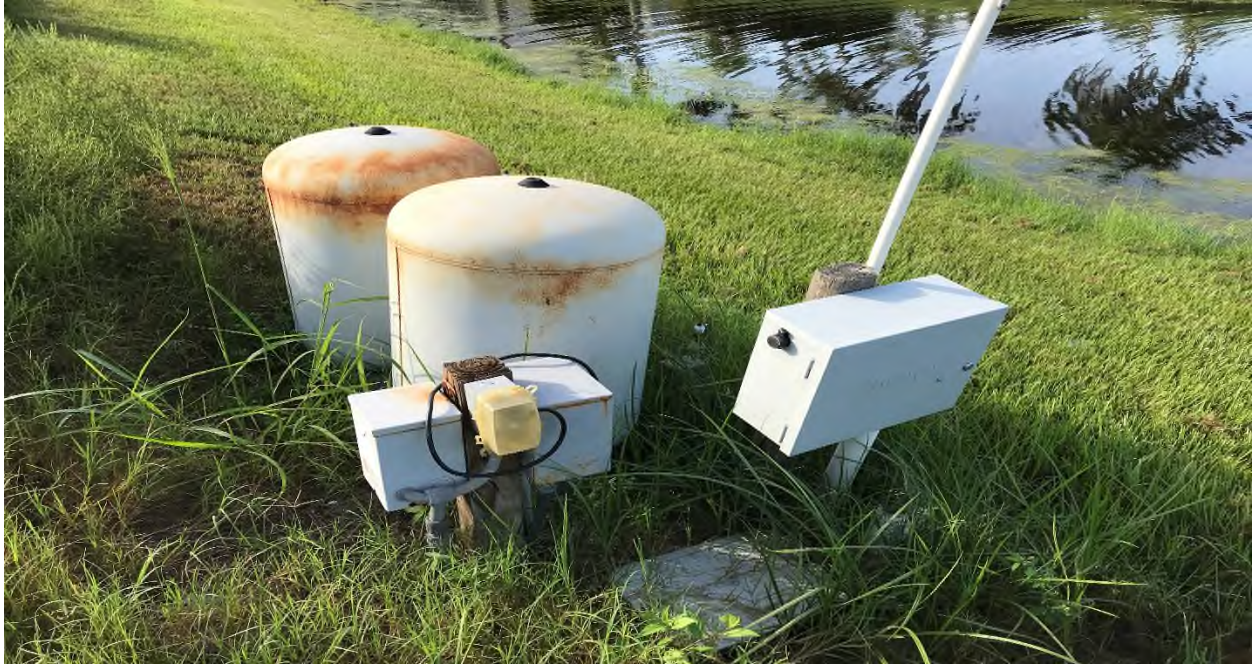
The accessible irrigation components to be in good condition. KEG recommends an irrigation pump replacement project be planned for. In addition, KEG recommends heads and low volume components be replaced as needed, as part of a maintenance schedule, during the life of the pumps.

The expected useful life for the irrigation system is 15 years.
The expected remaining useful life is 4 years.
The estimated replacement cost is anticipated in 2022 for \$21,018.19.

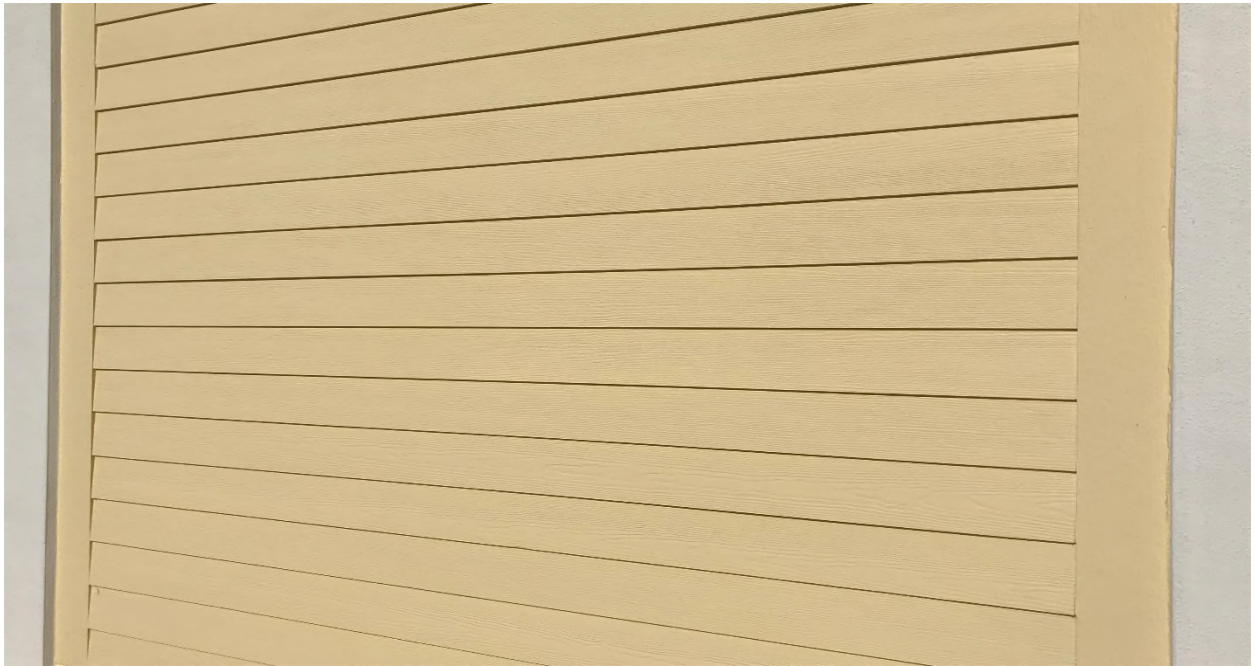
Figure 38 - Clubhouse Exterior Painting

A premium coating system should last ten years with cleaning and inspection at every 5 years. A mid-grade paint system should last 7 years with cleanings and inspections every three and a half years. KEG noted no chalking and the paint should perform as expected.

The expected useful life for the coating system for the gatehouse and clubhouse is 7 years.
The expected remaining useful life is 5 years.
The estimated replacement cost is anticipated in 2022 for \$9,195.77.

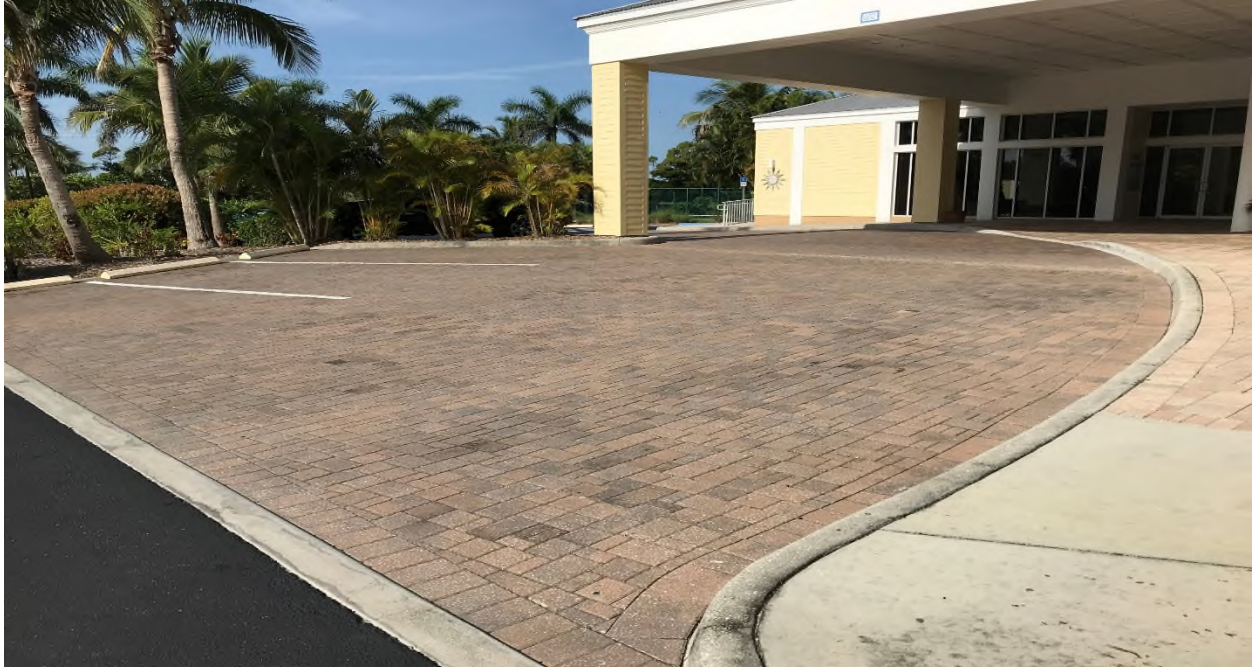
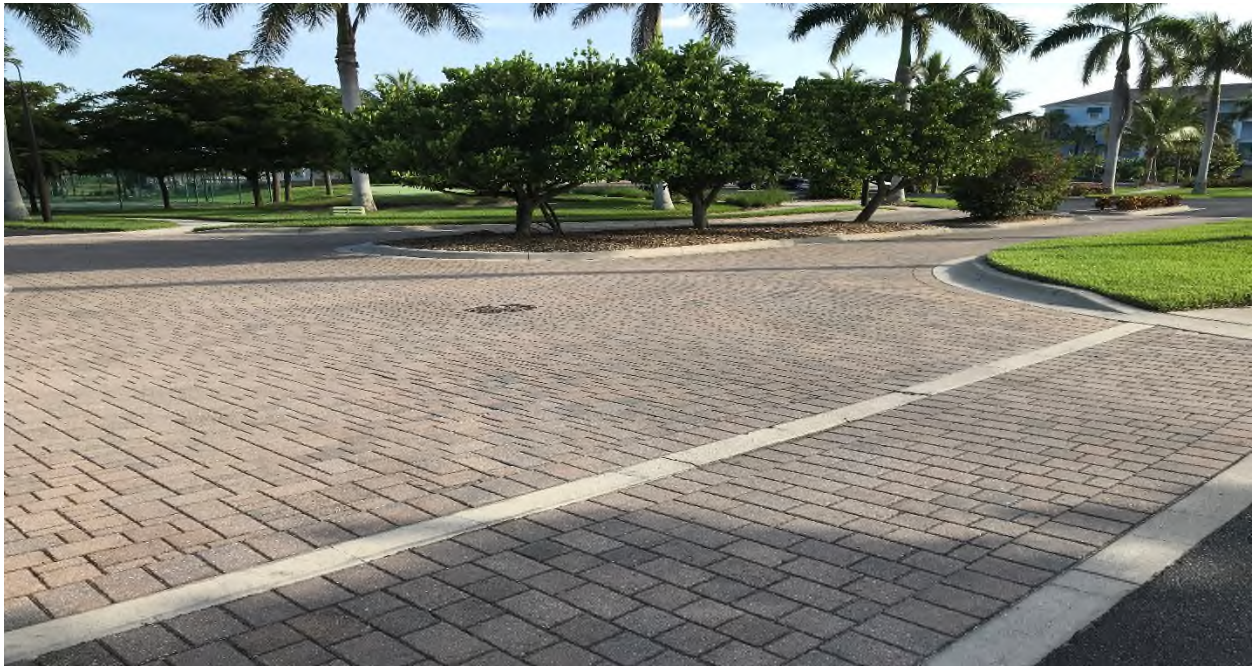
The expected useful life for the 9,018 square feet of vehicular pavers is 40 years.
The expected remaining useful life is 29 years.
The estimated replacement cost is anticipated in 2047 for \$109,896.81.

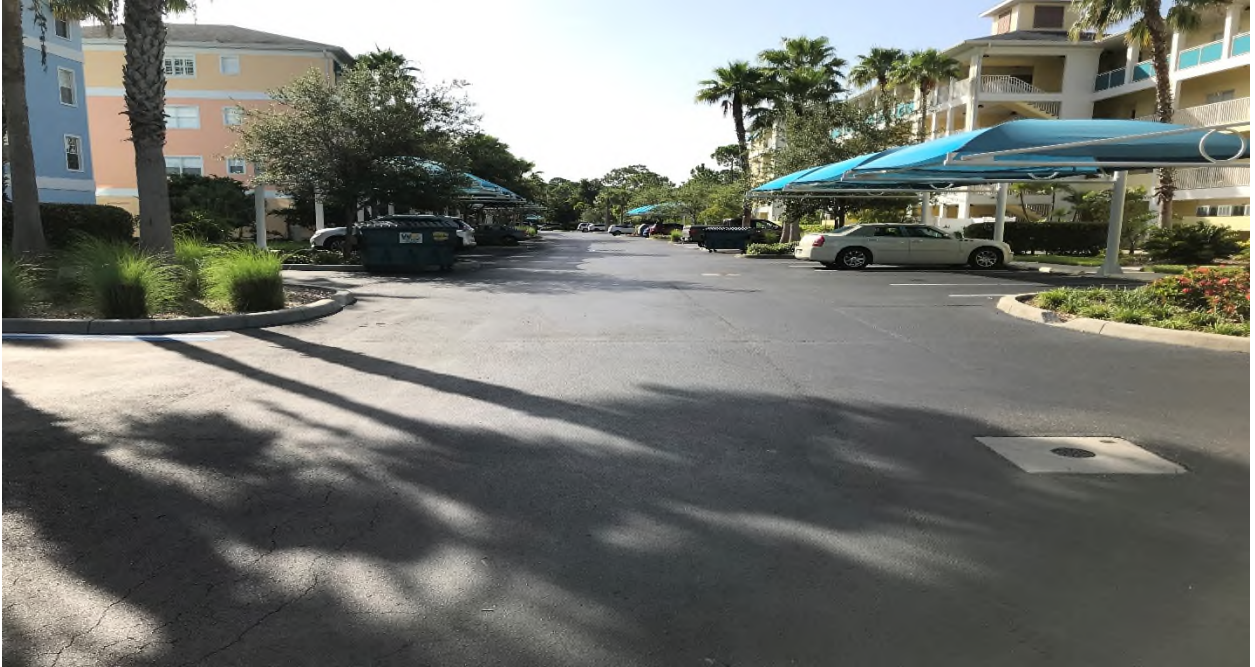
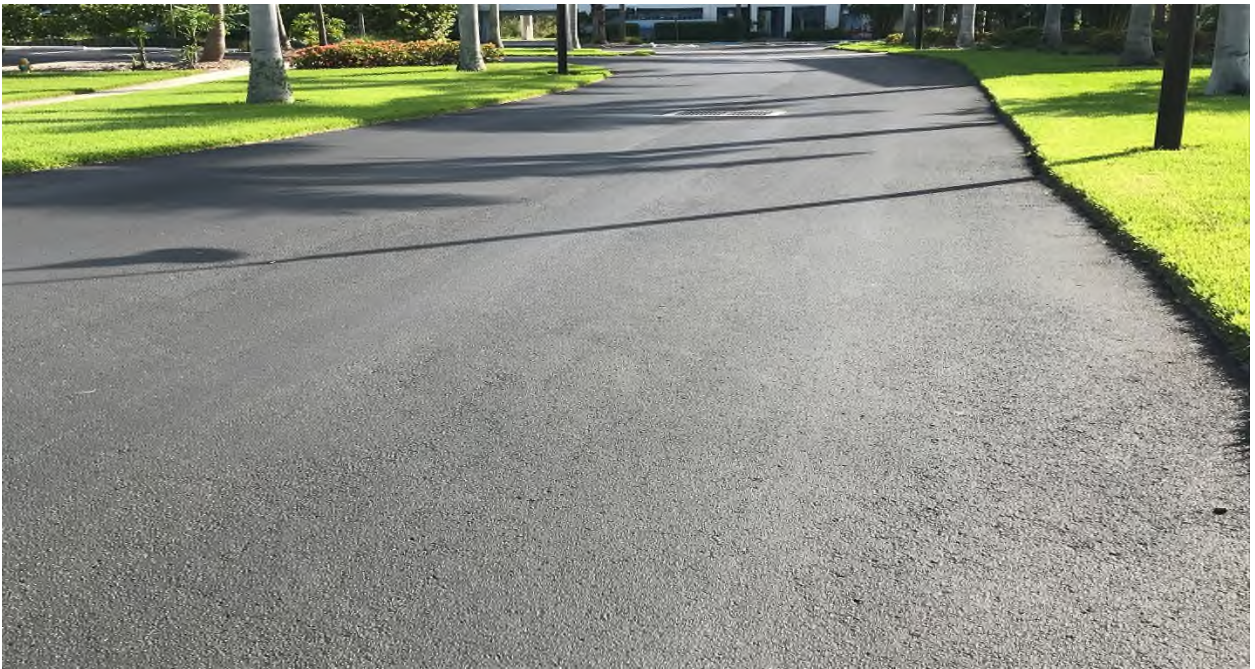
The expected useful life for the developed portion of 11,360 square yard asphalt 1-1/2-inch overlay is 20 years.
The expected remaining useful life is 9 years.
The estimated replacement cost is \$154,382.40 in today's dollars.
The Association has budgeted for sealcoat application and restriping every 5 years with the next application due in 2022 at an estimated cost of \$11,246.40 in today's dollars.

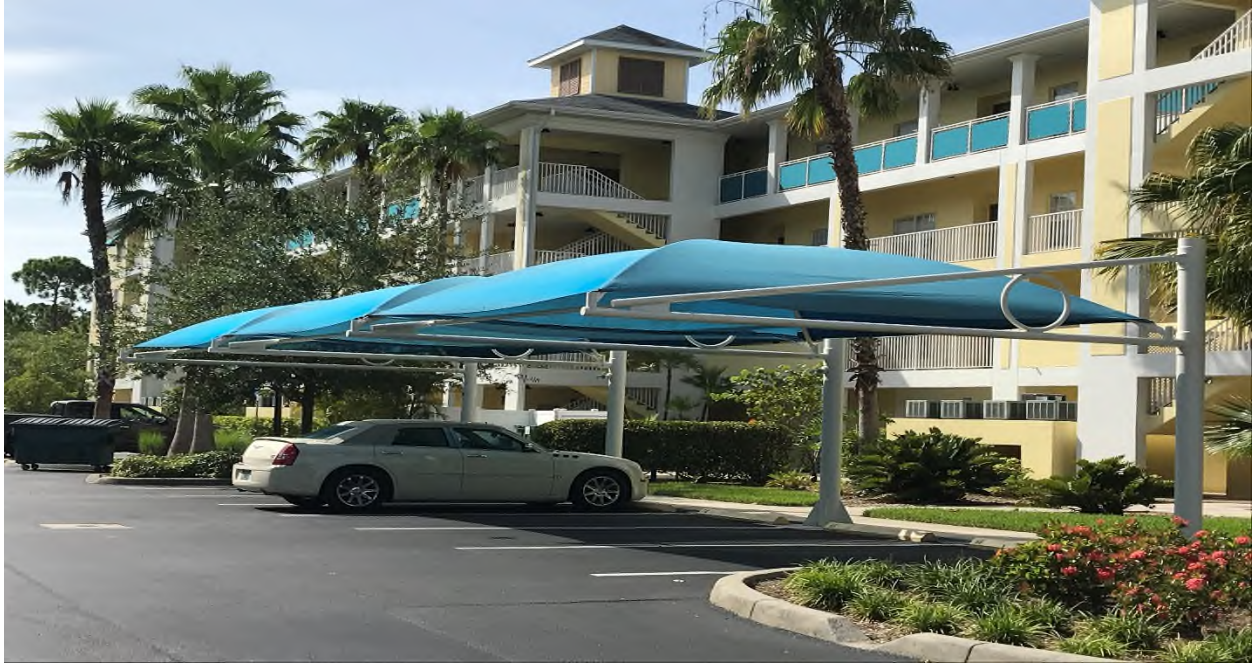
Figure 43 - Carports within Cape Haze Resort (Typical)

The expected useful life for the "Duraport" Carport Systems is 20 years.
The expected remaining useful life is 9 years.
The estimated replacement cost is \$60,000 in today's dollars.

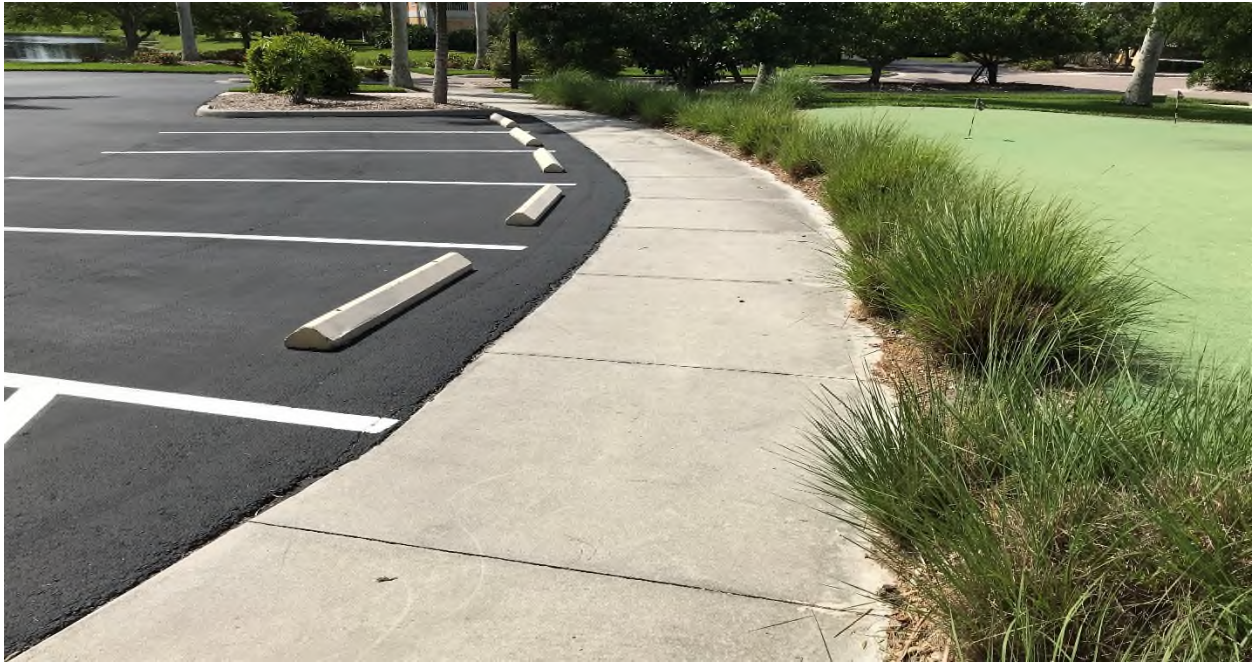
Figure 44 - Section of Walkway

The expected useful life for the 4925 linear feet of sidewalk is 50 years.
The expected remaining useful life is 39 years.
The estimated replacement cost is \$71,412.50 in today's dollars.

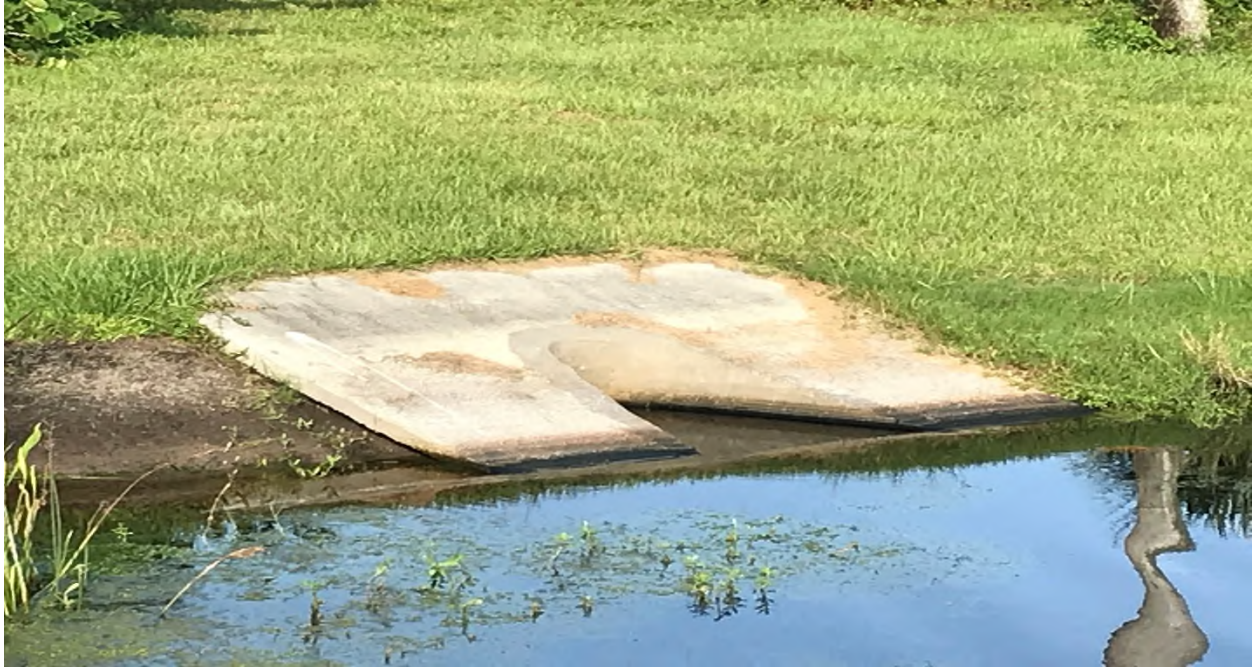
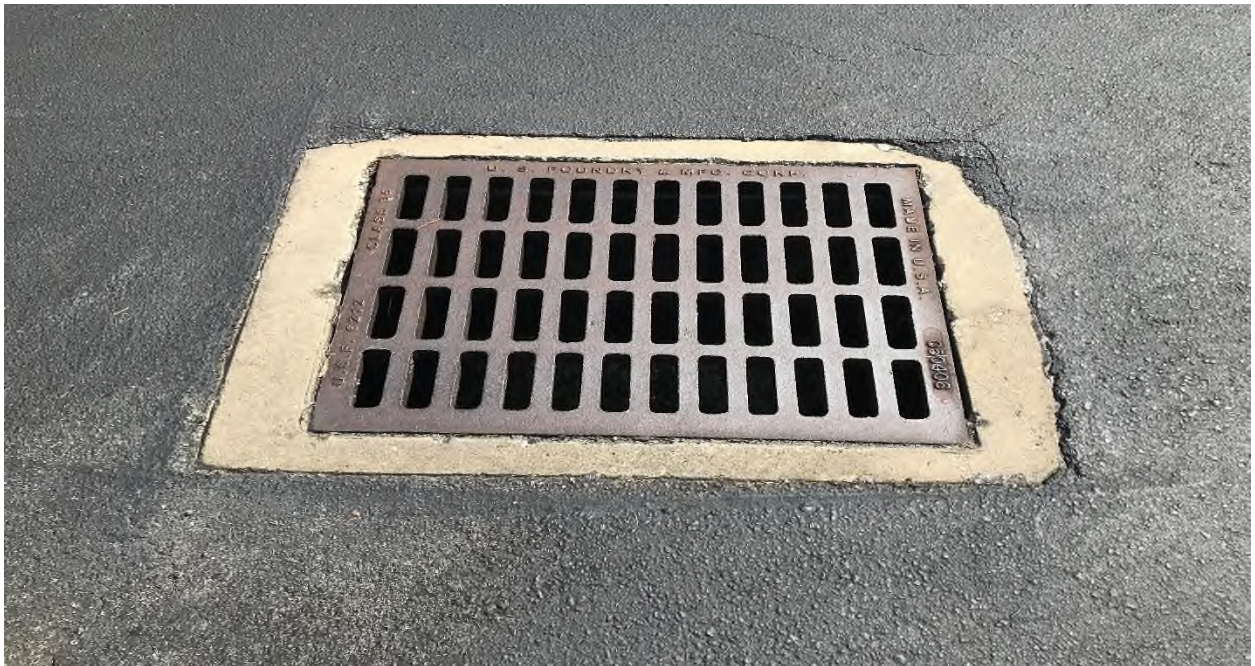
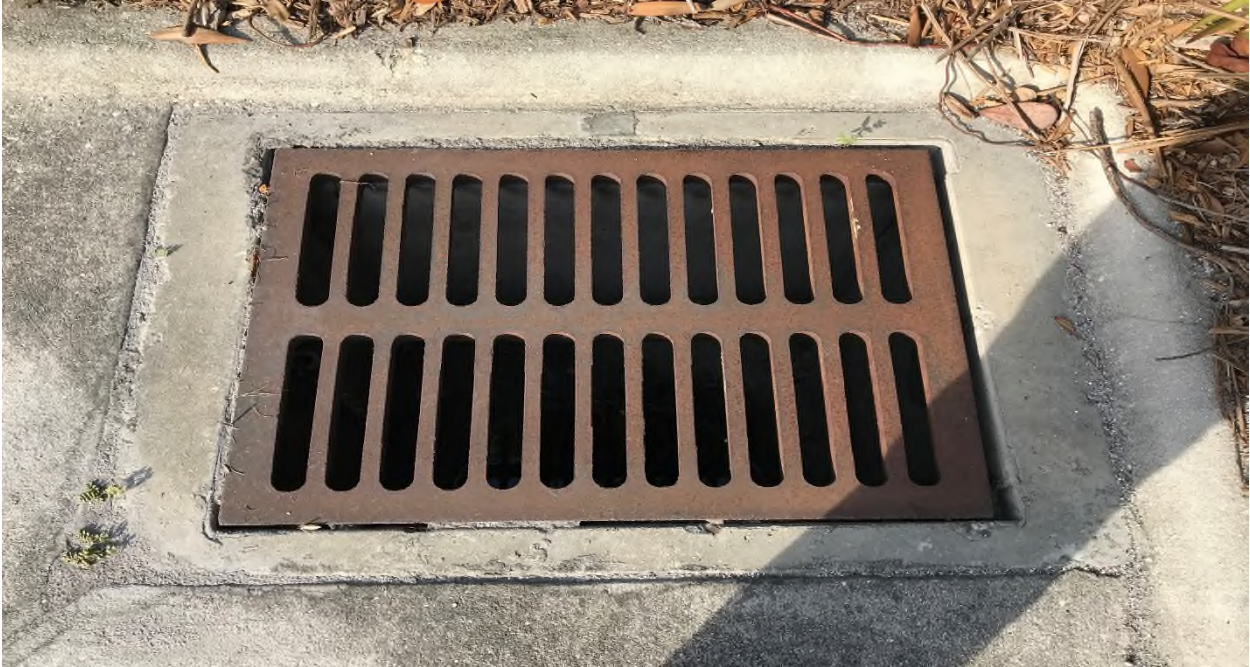
The drainage system at Cape Haze combines over land sheet flow, drainage inlets, underground piping network and a flow-controlled pond. Elements available for observation appeared to be in good working condition. Drainage structures and underground piping have an estimated useful life is 50 years. The estimated remaining life is 40 years with replacement anticipated in 2058 and is beyond the scope of this report.

The expected useful life for the storm pipe network and related structures is 50 years.

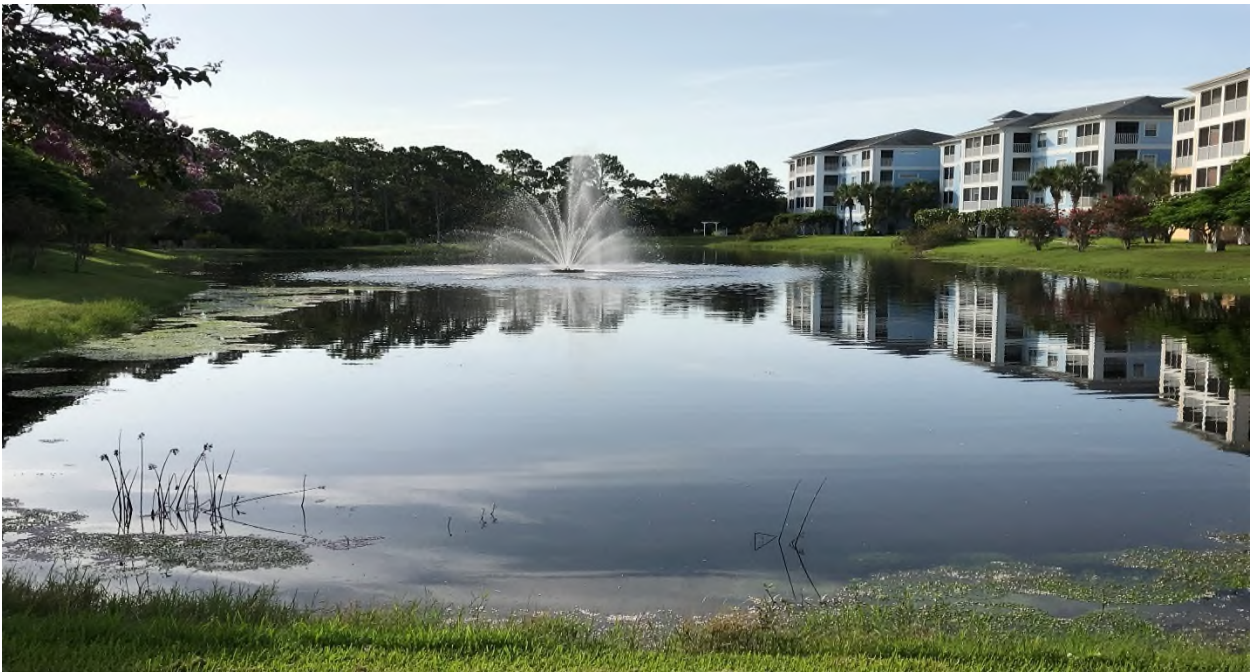
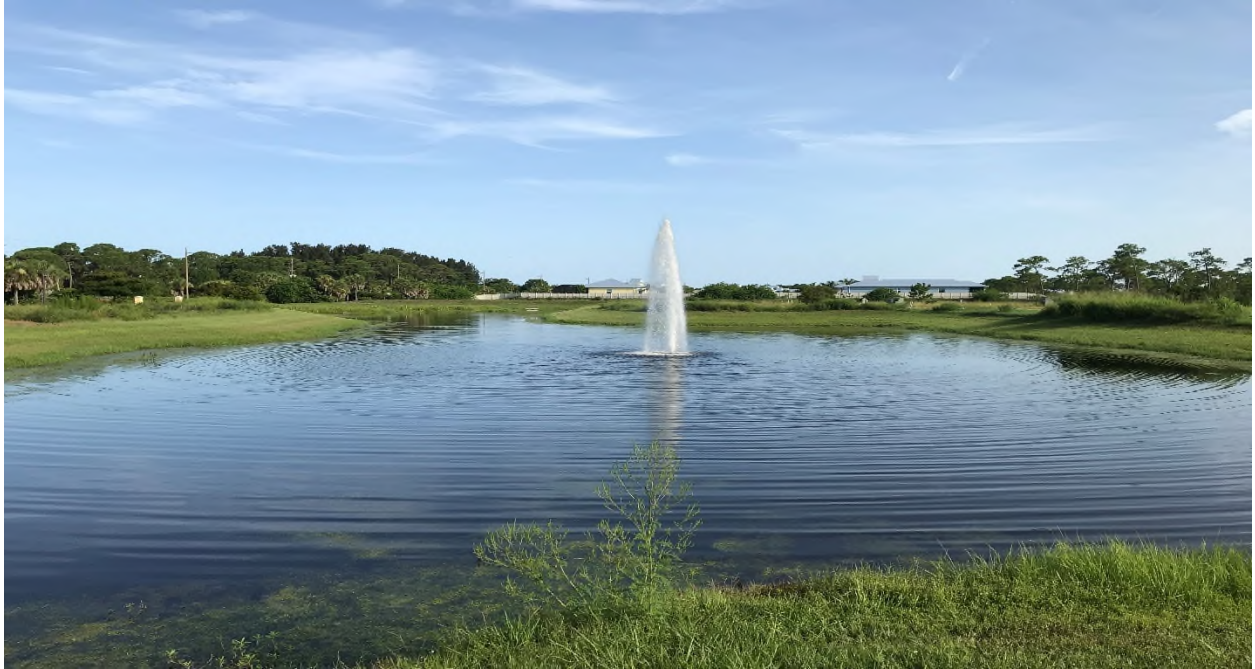
The two pond systems appear to be functioning as intended. The littoral shelf has aquatic plant growth, no significant erosion was observed, and the outlet structure appears to be in serviceable condition. The estimated useful life is 100 years. The estimated remaining life is 88 years and is also beyond the scope of this report.

The expected useful life for the two pond systems is 100 years.

Periodic inspections should occur annually and after significant storm events. Monitor sediment accumulation and remove when required under maintenance funds.

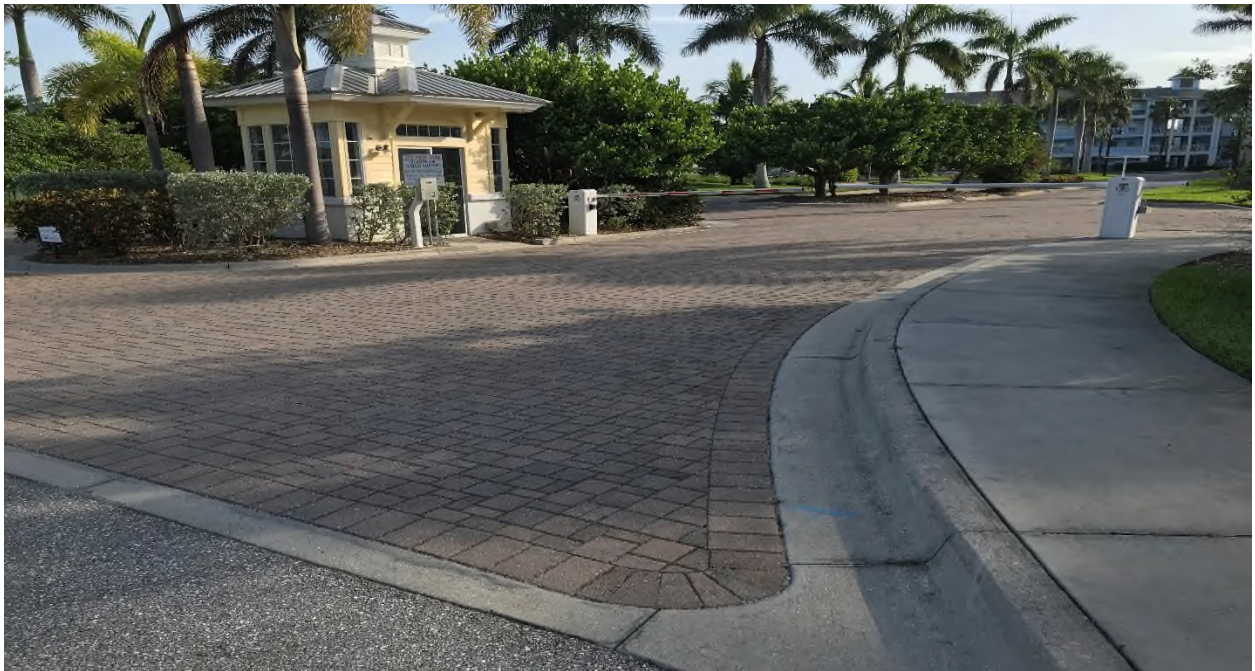
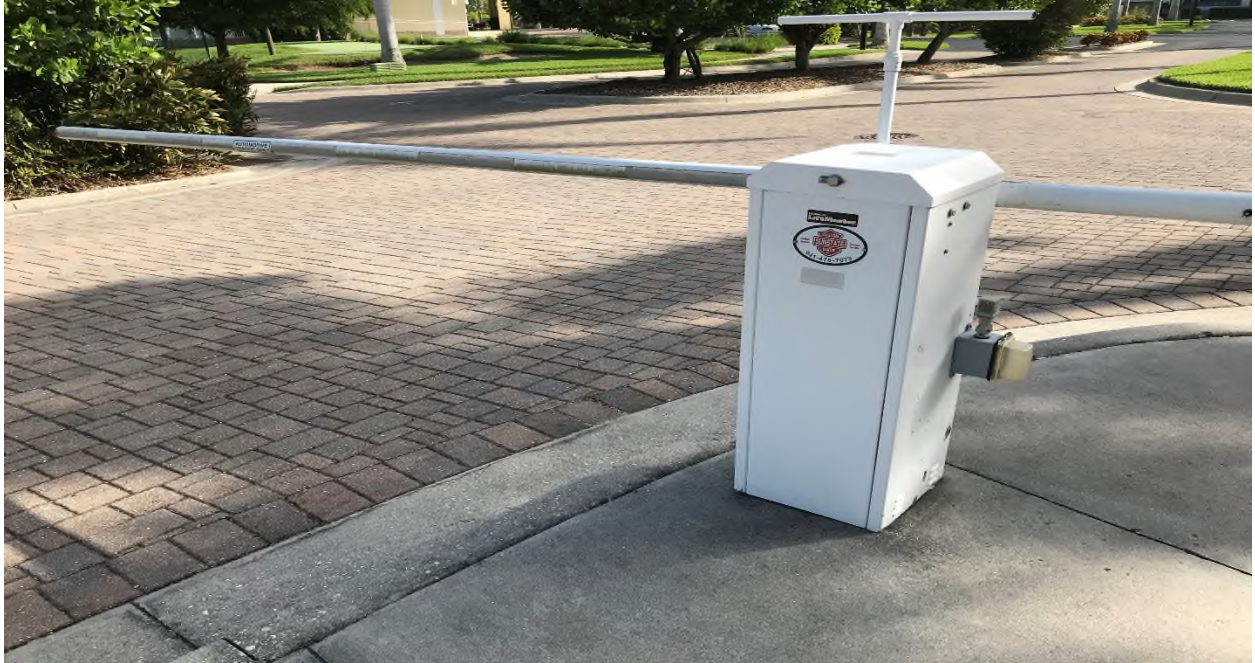
The front entry gate to Cape Haze Resort consists 5 total lift arm security gates. The all appear to be in good working condition. It is recommended that a servicing contract be in place to extend the equipment's useful life.

The expected useful life for the 5 lift arm security gates is 21 years assuming early 2019 replacement.

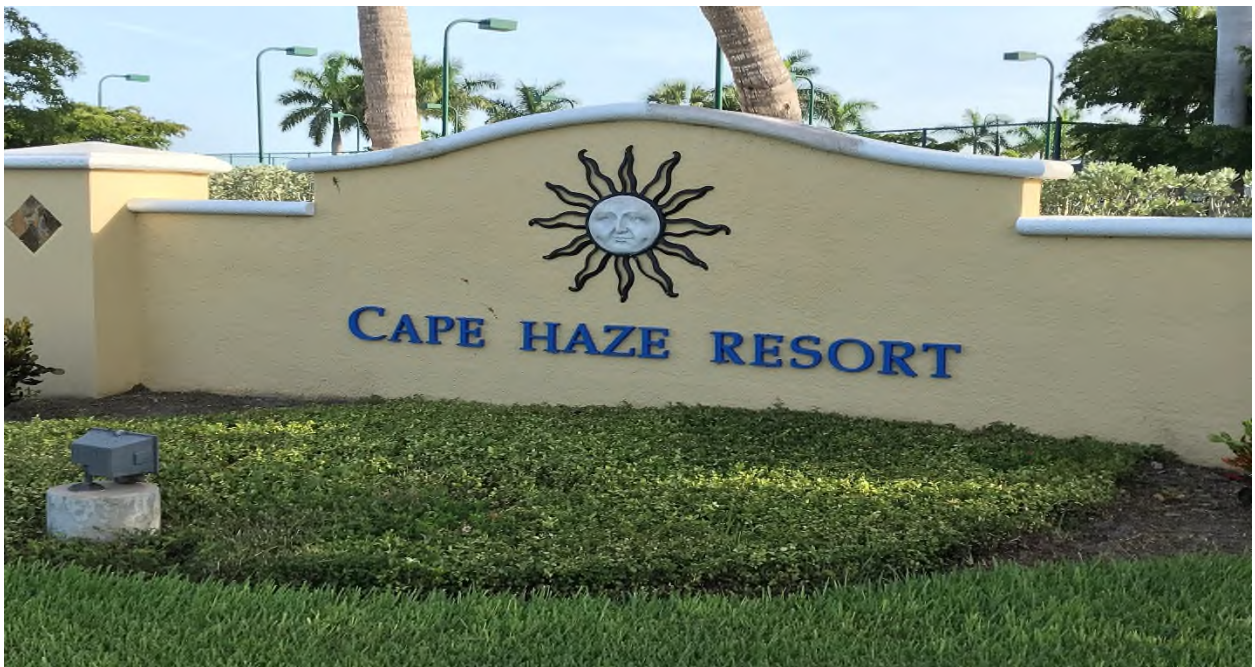
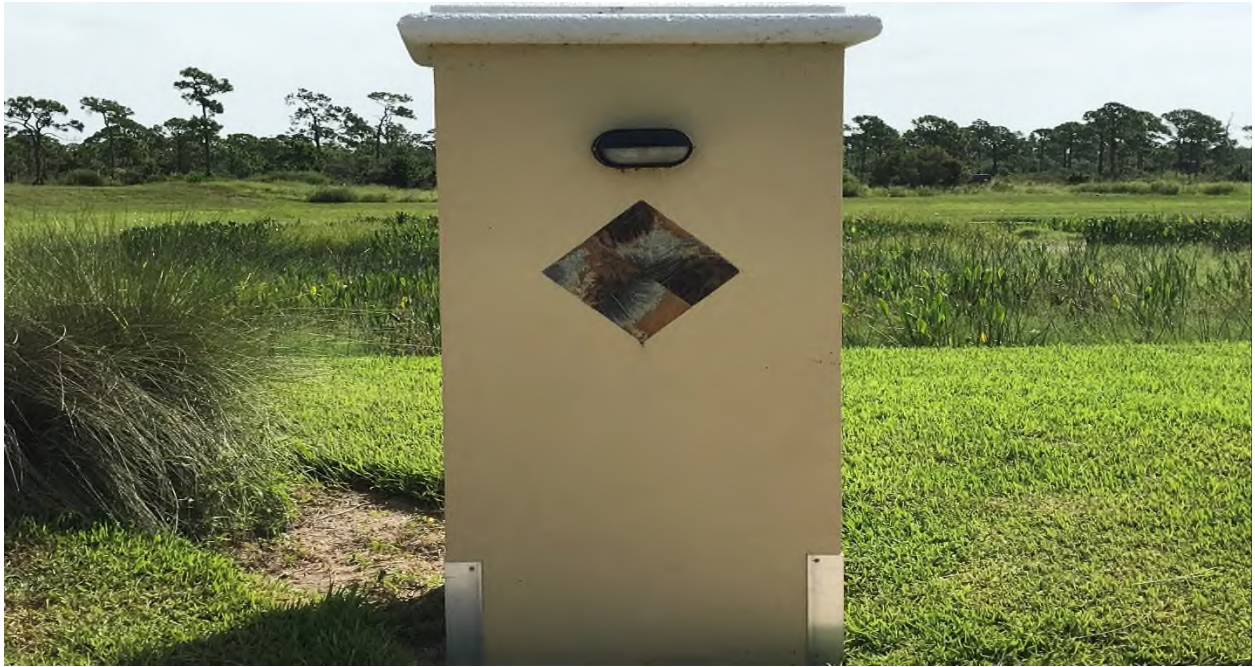
The Entry Sign and CMU Perimeter Columns are in excellent condition with no visual signs of wear. Entry signs and perimeter columns have an estimated useful life of 50 years.
