CAPITAL RESERVE STUDY

KEG File: 18RS-0562
June 27, 2018

*Cape Haze Resort Community
Association, Inc.
8401 Placida Road
Cape Haze, FL 33946*

Re: ***Cape Haze Resort Community Association, Inc.
KEG Project No. 18RS-0562
Professional Engineering Services – Capital Reserve Study***

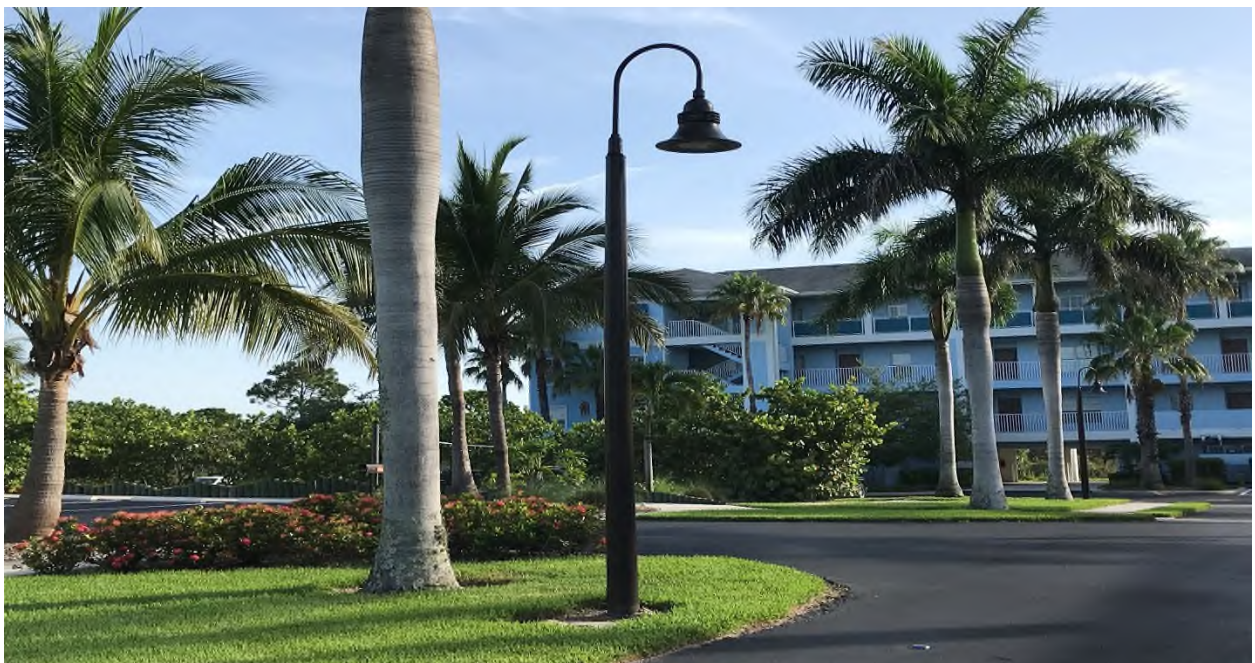
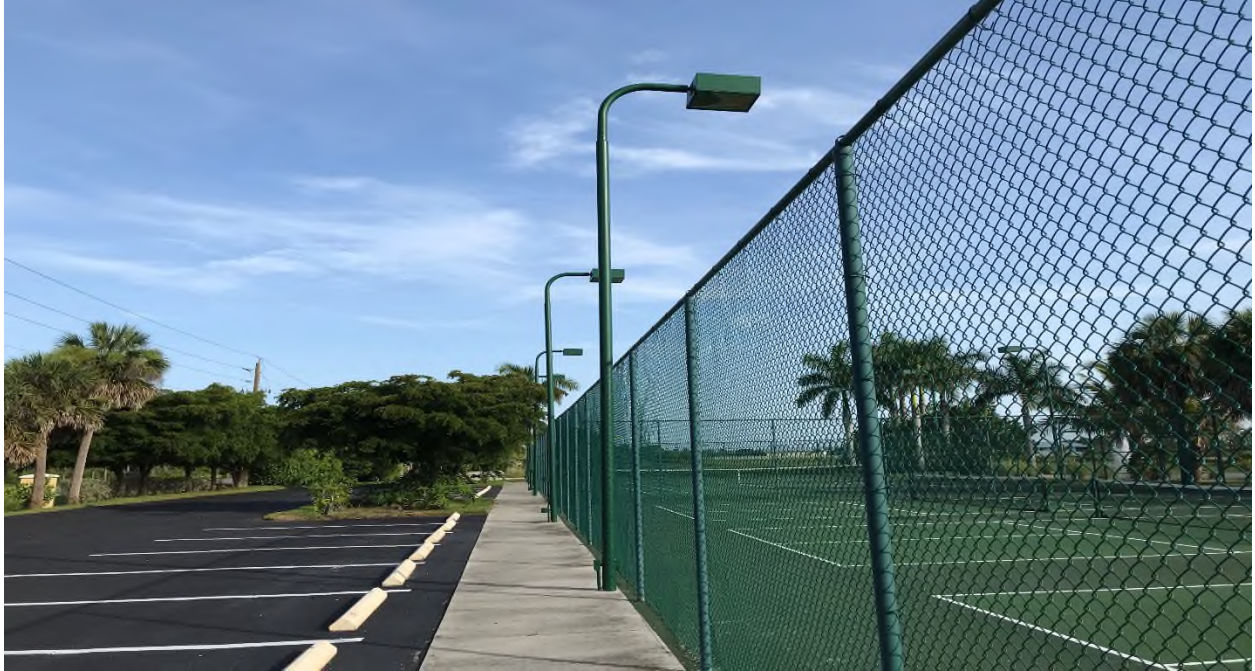
The expected useful life for the site lighting is 25 years.
The expected remaining useful life is 14 years.
The estimated replacement cost is \$43,400 in today's dollars.
