Quality Site Assessment

Property Name: Cape Haze Resort

Date: Tuesday, September 08, 2020

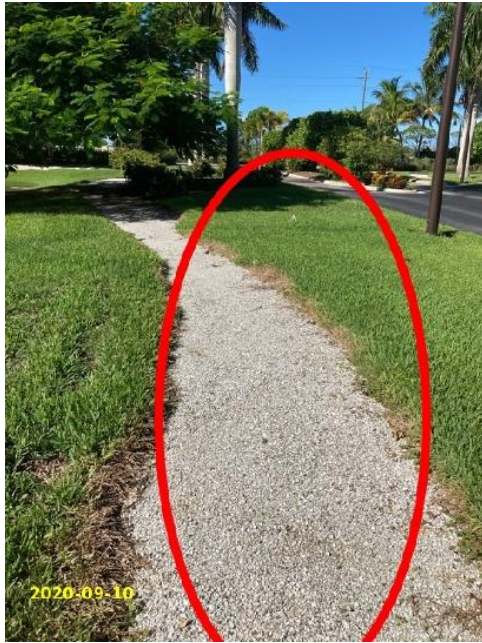
[1 / 12]

Shell path has been sprayed for weeds.

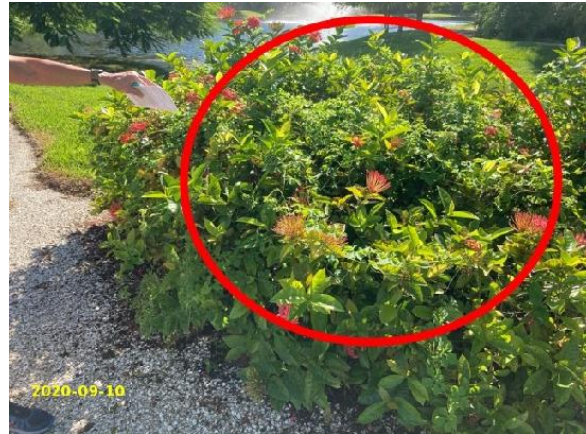
[2 / 12]

Vines are going and present in some of the older plantings around the community.

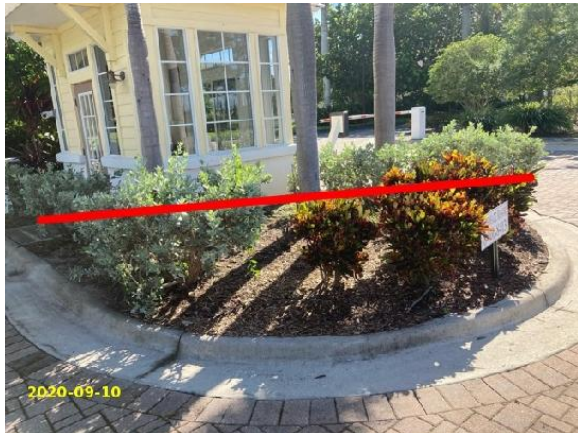
[3 / 12]

Pruning crews are present at the time walk through. Front entrance will be maintained lower to allow clear lines of sight.

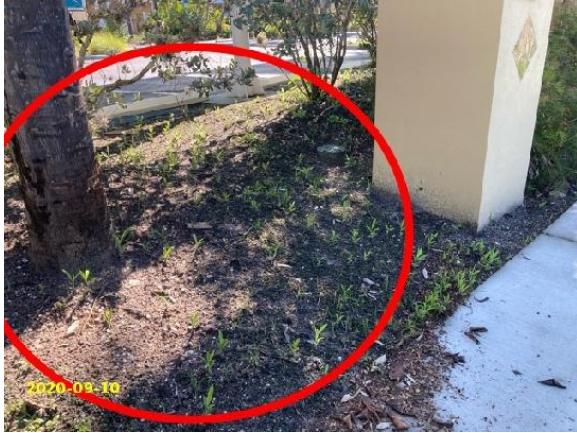
[5 / 12]

Beds weeds are currently present between monthly spraying rotations. Mulch will be scheduled and applied starting at the front of the property and working back at a maximum of 250 cubic yards.

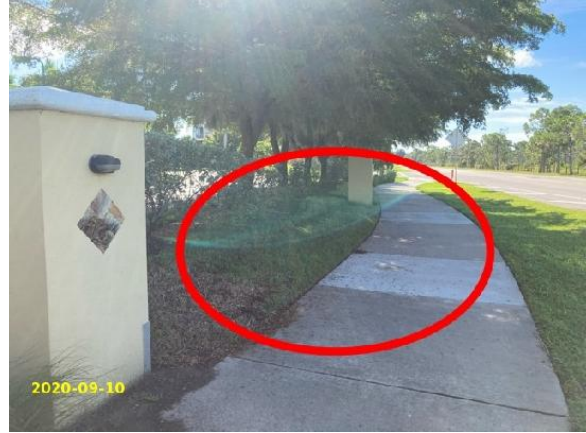
[6 / 12]

Turf is looking better following irrigation system inspection and repairs in this areas

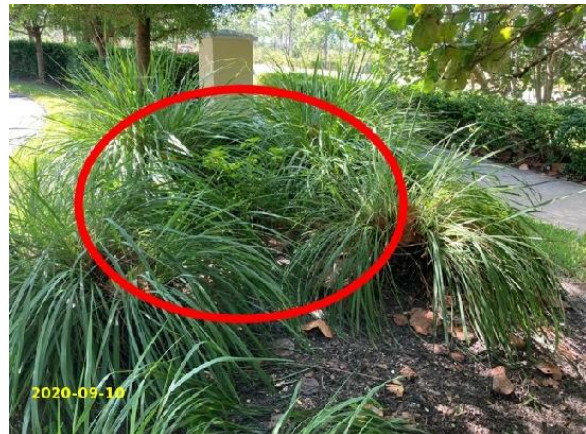
[8 / 12]

This area has been identified as Bentley's area by Kate. Trim crews are aware the area.

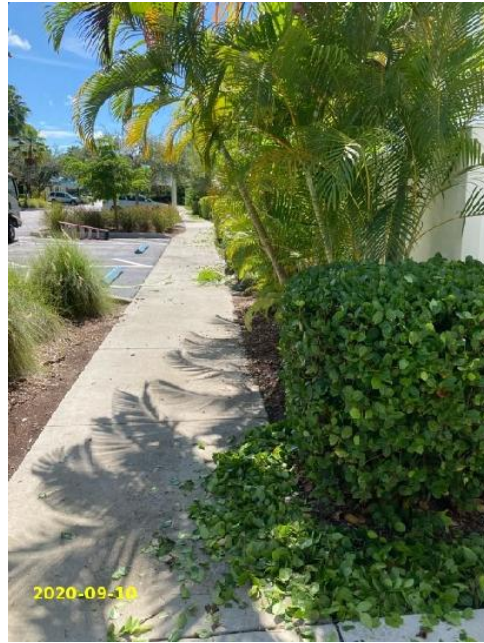
[10 / 12]

Prune crew in the community while walk through is taking place.

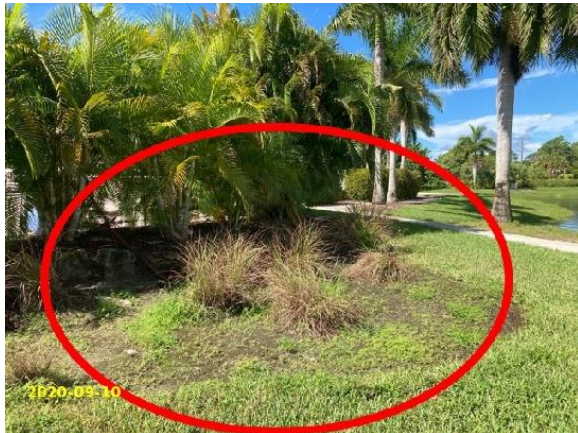
[11 / 12]

More bed areas that have essentially no mulch coverage. Will schedule installation

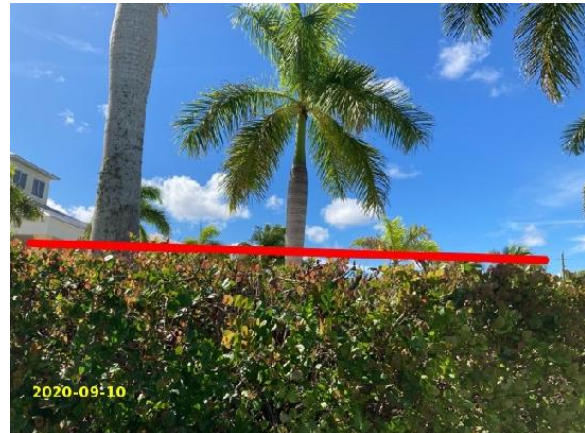
[12 / 12]

Coco plums have been trimmed around the pool area since the initial QSA preformed by Dan Brown

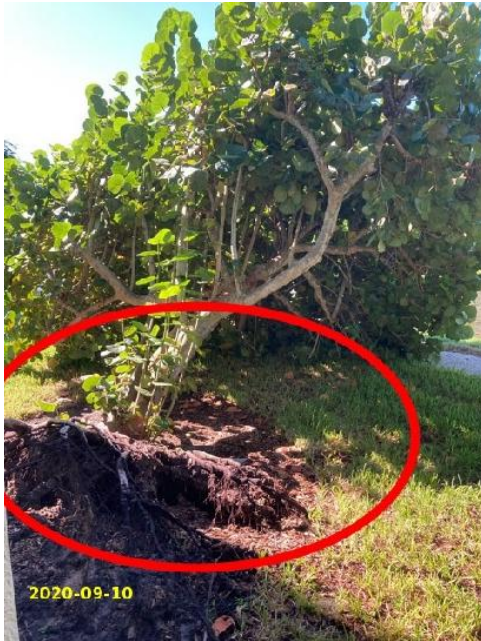
[1/6]

Sea grape tree has fallen onto shell path. Will submit a proposal for removal and clean up.

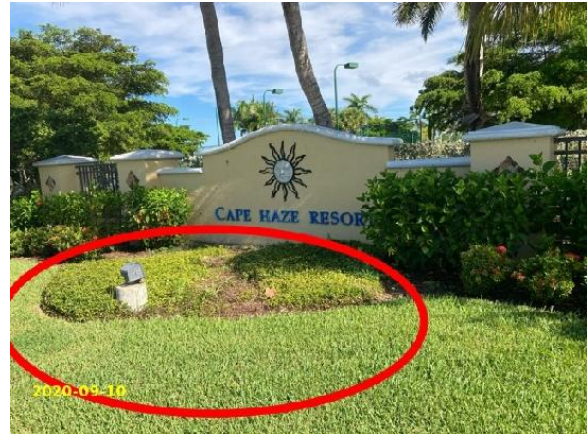
[2/6]

Area in front of the monuments is a concern for Kate. She has asked for some proposal ideas to add some low growth color in these areas.

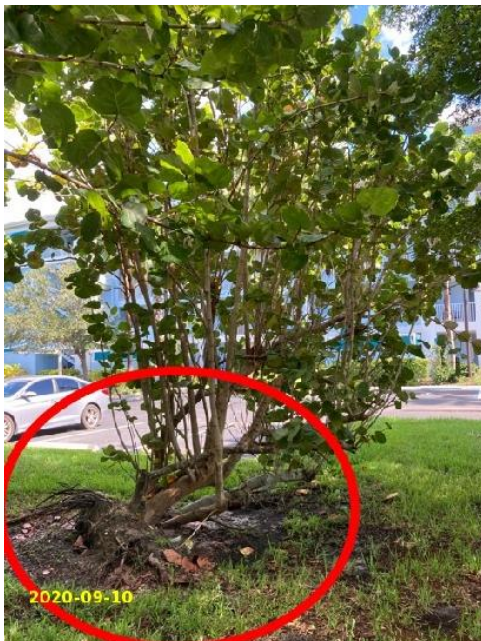
[3/6]

A second sea grape has uprooted toward the front of the property. Will submit proposal for removal and cleanup.

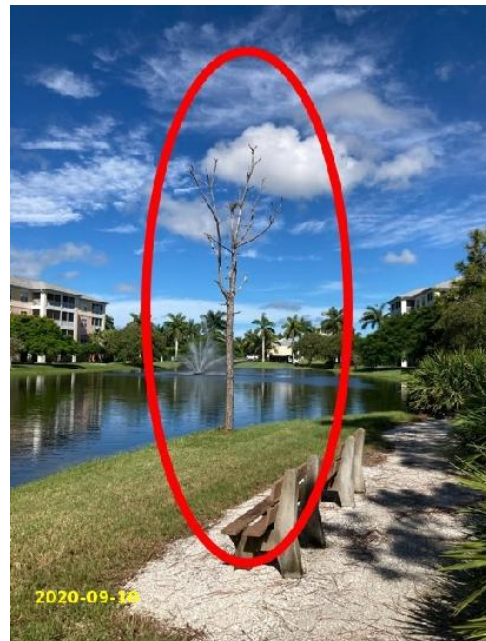
[4/6]

Noticed dead tree next to lake bank. Kate says she likes it there, but happy to submit a proposal for removal and clean up if you decided to remove it.

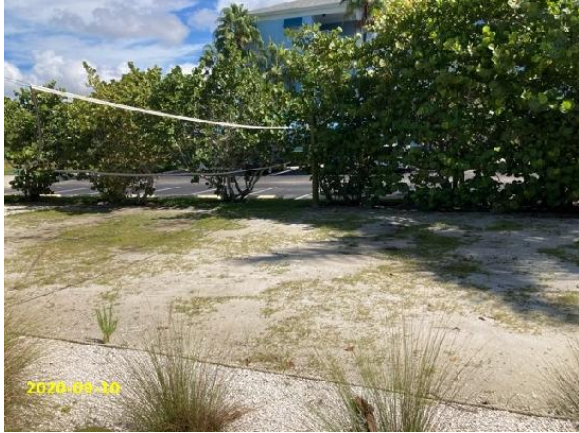
[5 / 6]

Volleyball area may become a corn hole area per conversation with Kate. Happy submit a proposal for clearing out the area and installing sod / irrigation.

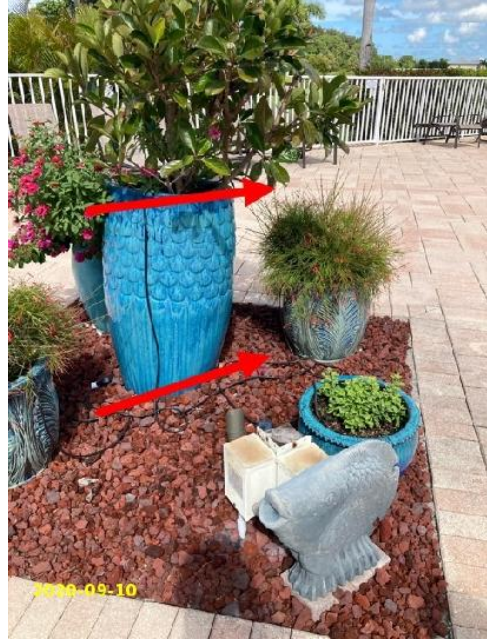
[6 / 6]

Kate noted this is leaning. I suggest put a paver as a base under it.
