API Home Inspection Report

1234 Inspection Street Wichita, Ks 67212

Prepared for: Sample

Prepared by: Amaris Property Inspections, LLC

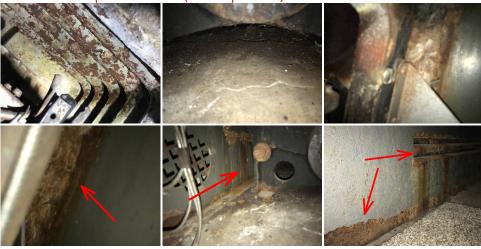
1. Heat Exchanger: Heavy rusting present, which could indicate a cracked heat exchanger. Recommend a qualified HVAC (boiler specialist) for further review and estimate of repair.

- 15. Utility room Heating System Heat Exchanger: Heavy rusting present, which could indicate a cracked heat exchanger. Recommend a qualified HVAC (boiler specialist) for further review and estimate of repair.
- 16. Utility room Heating System Cabinet: Rust noted at bottom. See heat exchanger
- 17. Utility room Heating System Other: Circulating pump noisy when operated. This pump should be silent. Recommend qualified HVAC (boiler specialist) for further evaluation and repair.
- 18. Utility room Heating System Back-flow preventer: No back-flow preventer present on water supply line. Recommend adding back-flow preventer to prevent cross contamination.
